FLOODS OF SEPTEMBER 16, 1975 IN THE TALLABOA VALLEY, PUERTO RICO

by
Karl G. Johnson
1981

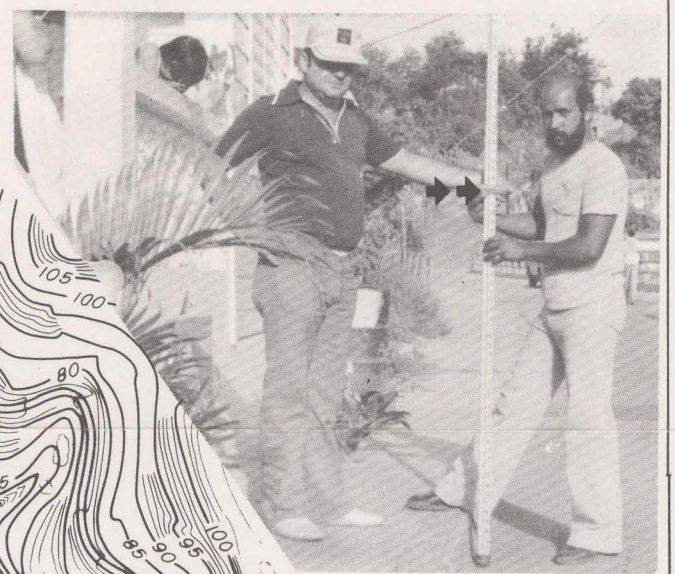
FIGURE 7.--Photograph D: Taken at same place as C. Elevation of water above ground was 1.3 meters (4.3 feet).
