EROSION AND SEDIMENTATION IN THE KENAI RIVER, ALASKA

U.S. GEOLOGICAL SURVEY OPEN-FILE REPORT 81-219

By Kevin M. Scott

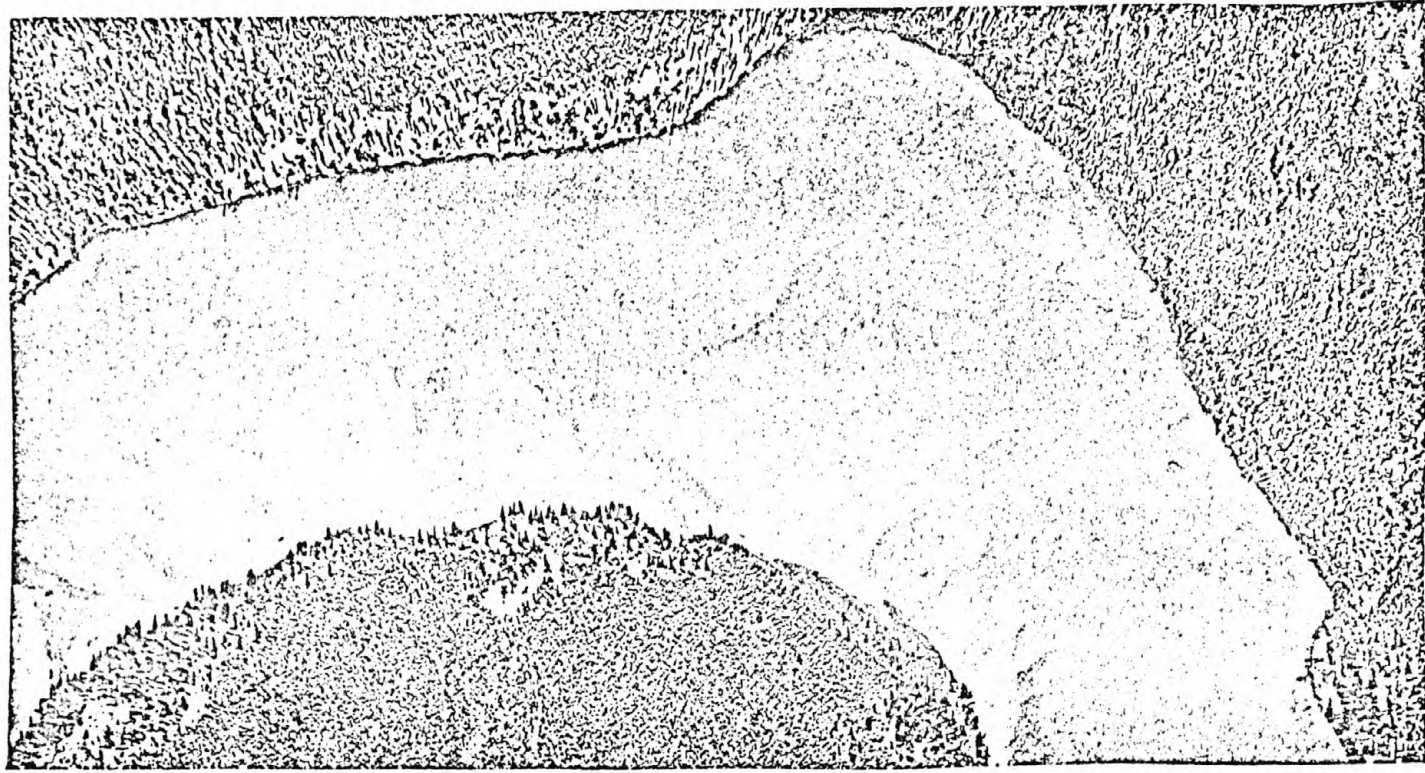
Fig 12

Figure 12. Aerial photograph of the Kenai River between approximate river miles 47.5 and 46.9. Crests of large crescentic gravel dunes appear just below the water surface as darker areas. Flow is from bottom of photograph toward the top. Scale of the photo is 1:4,800, or 1 in = 400 ft. Date: July 11, 1977.

The size of bed material in the active channel is shown in figure 11 as the median diameter (D_{50}). These data were obtained from large emersed bars by pebble-counting techniques that are statistically valid for coarse sediment (Wolman, 1954). Several estimates of the median grain size were made during a boat traverse of the river and these points are so designated. The estimates were made only for the submersed gravel dunes found in the reaches downstream from Skilak Lake (fig. 12)).

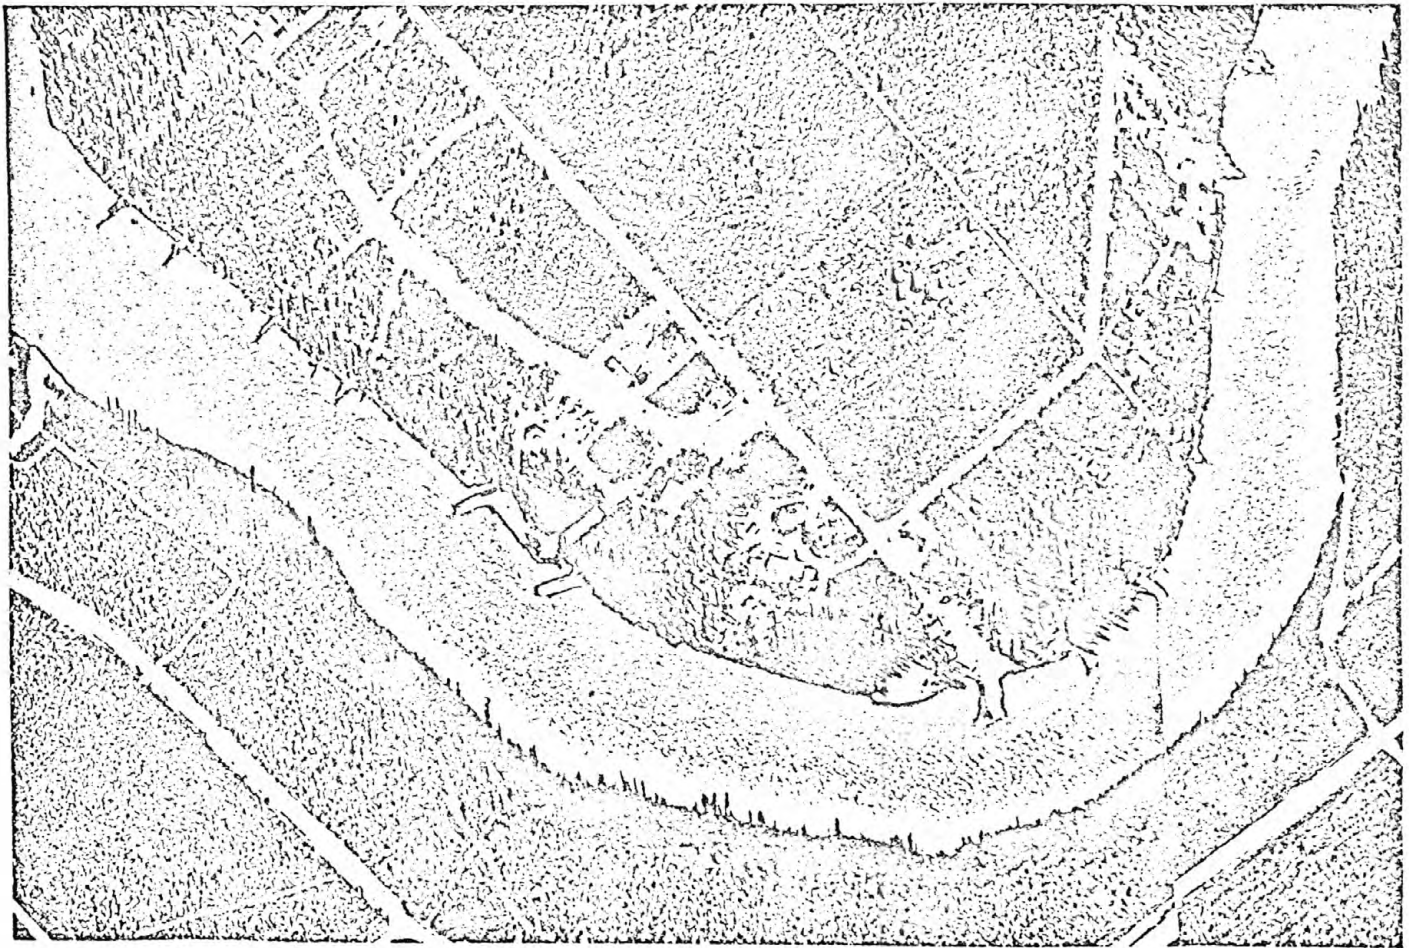
Fig. 18

Figure 18. Aerial photograph of Kenai River between approximate river miles 38.2 and 37.0. Flow is from right to left. Scale of the photo is 1:4800, or 1 in = 400 ft. Date: July 11, 1977.

The effect of boat wakes on the banks is sufficient to initiate and cause continued erosion of the high banks without other significant changes. Observations along the cut bank of meander 3-H (~~fig. 18~~) reveal that each wake runs up the loose gravel bank as much as 3 or 4 ft, eroding and entraining sediment, and creating a zone of visibly turbid water at the edge of the stream. The bank is progressively undercut and the slope profile is maintained by sediment from the upper sections of the bank. Where the bank is vegetated, or formed of cohesive sediment, the resistance to boat-wake erosion is greater.

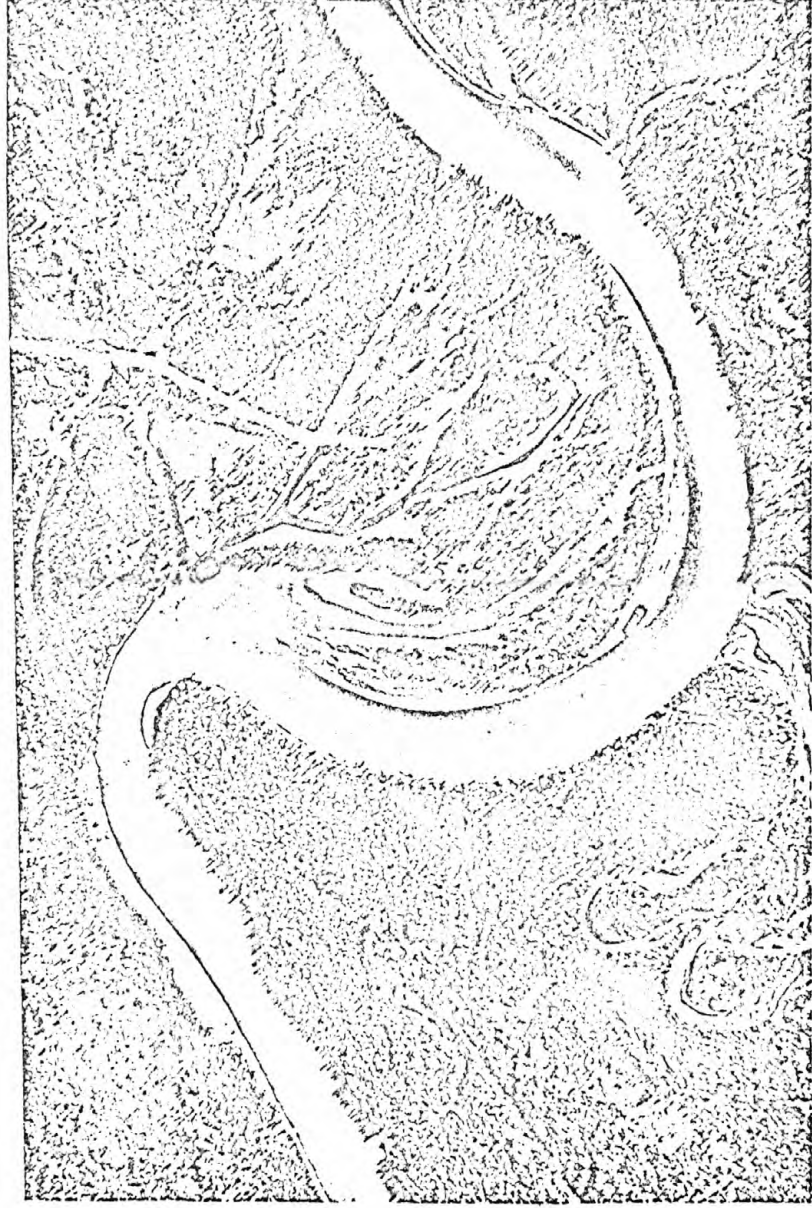
Fig. 19

Figure 19. Aerial photograph of Kenai River between approximate river miles 44.8 and 42.9. Interior of meander loop has been developed with canals. Note natural channels across neck of meander; one channel has been partially excavated to form a canal. The Killey River enters from bottom of photograph. Flow direction is from right to left. Scale of the photo is 1:12,000, or 1 in = 1000 ft. Date: September 24, 1972.
