LANDSLIDES AND RELATED FEATURES

OF THE MT. JEWETT, PA. QUADRANGLE

by
John S. Pomeroy
1981

U.S. Geological Survey
OPEN FILE MAP 81-238 (F-11)

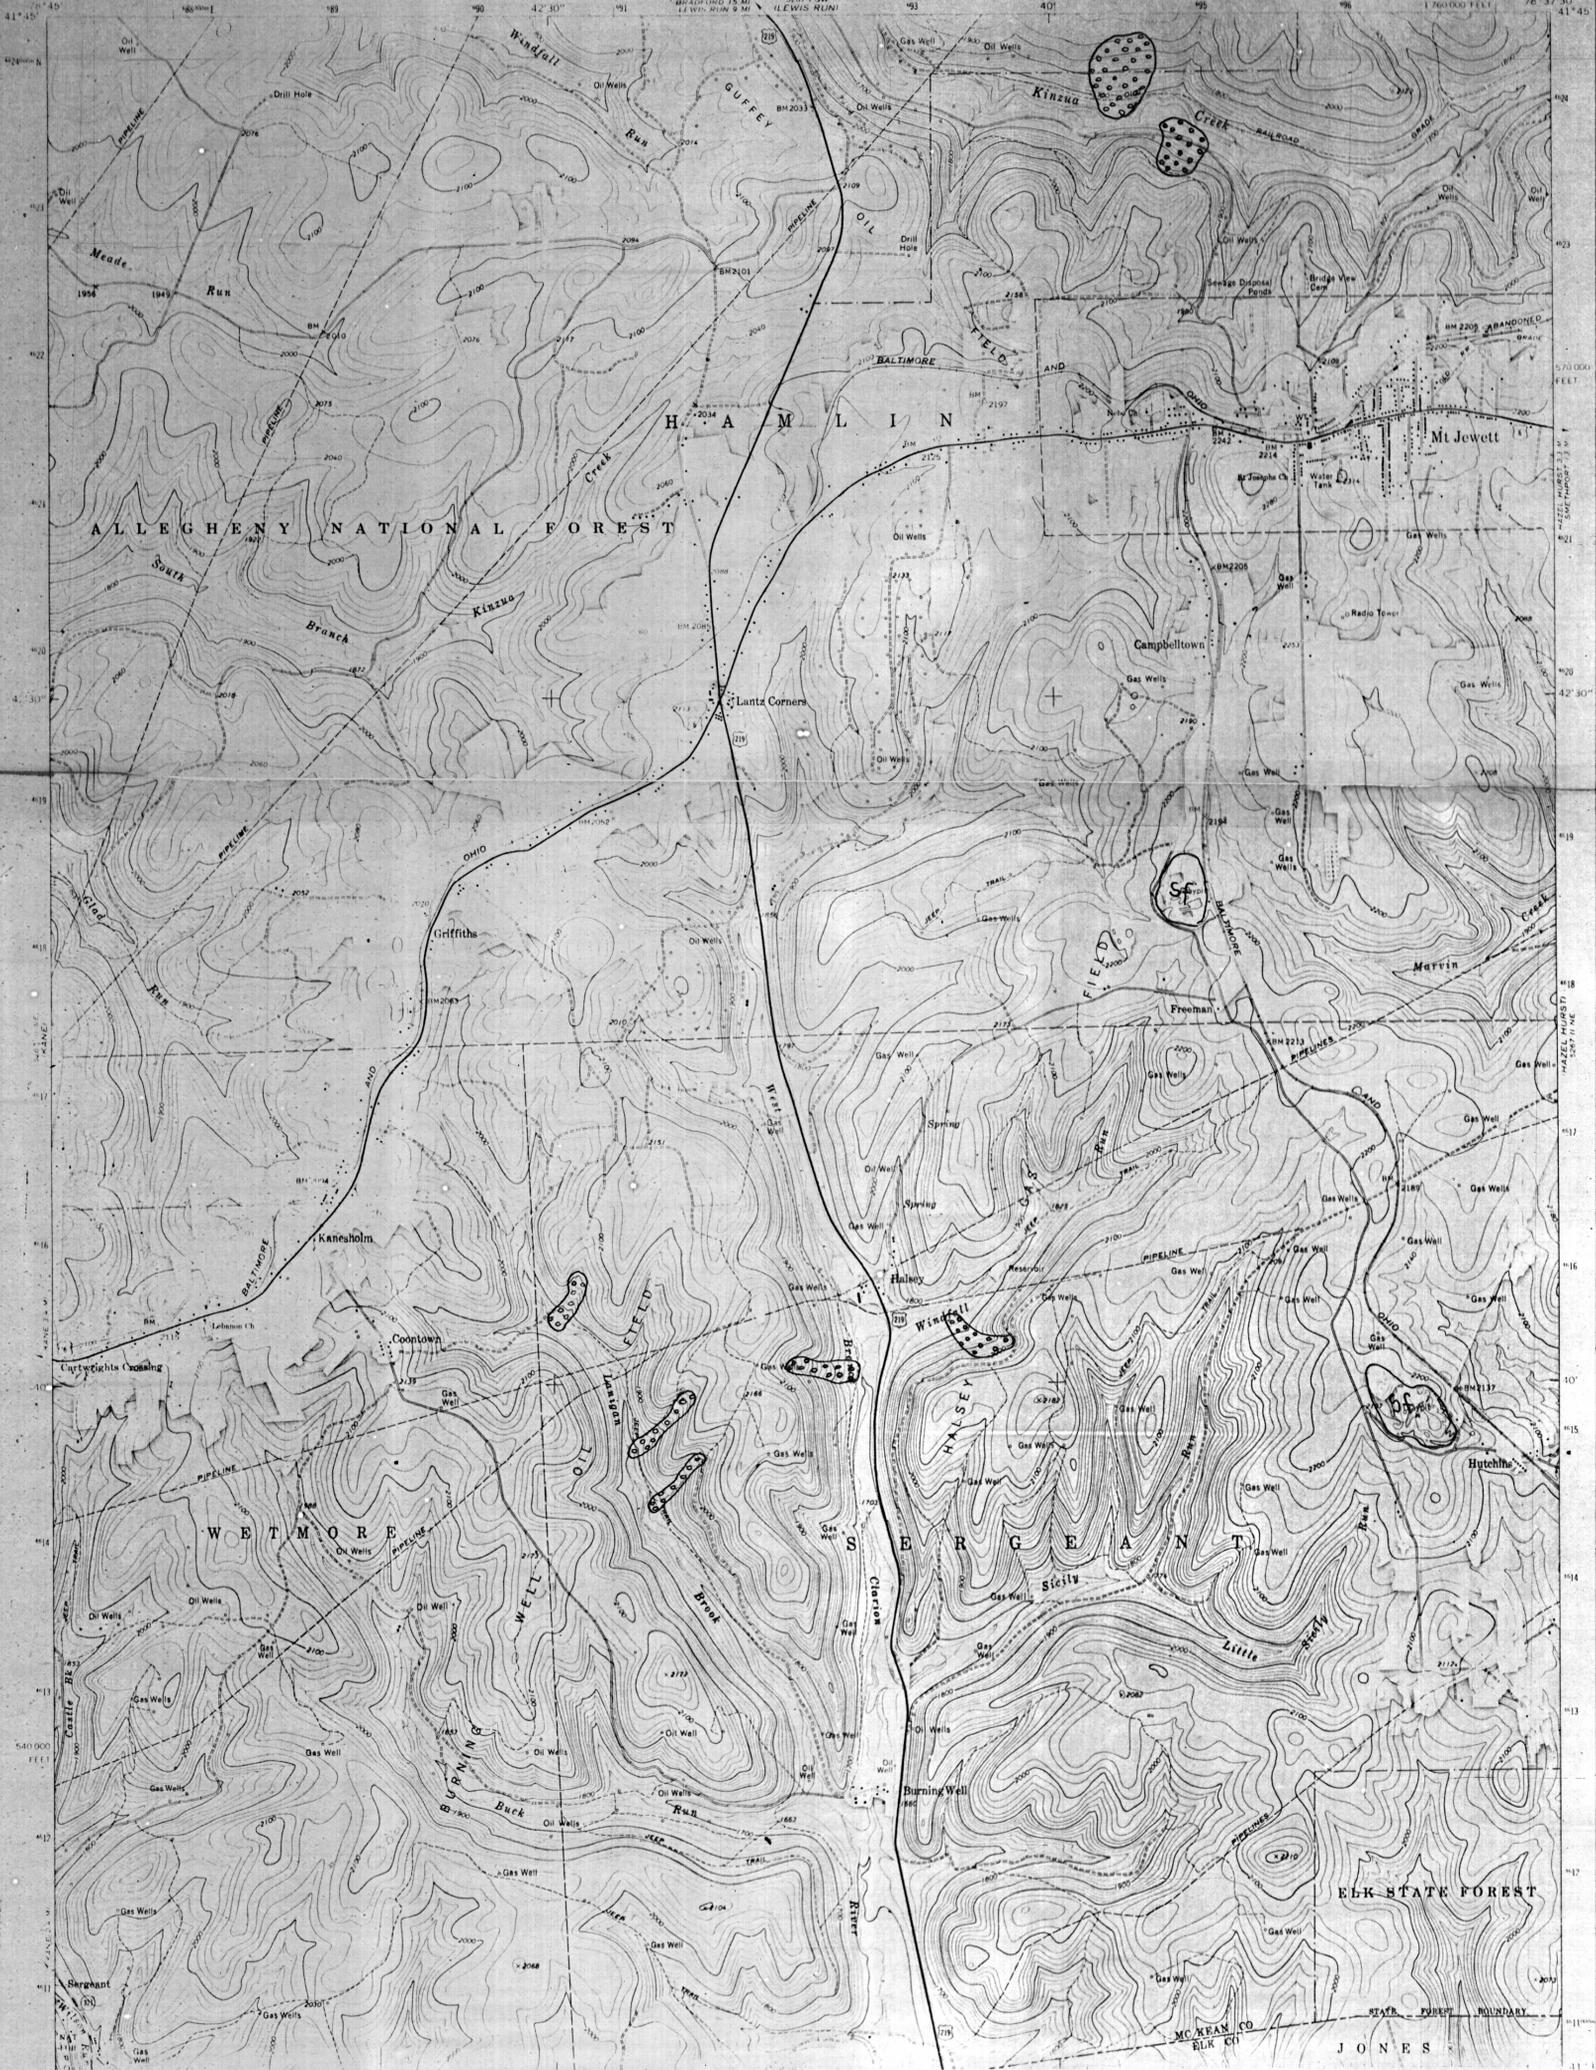
Landslides and related features interpreted from aerial photographs:
1:78,000 (black and white) 1977

Photointerpretation and field check 1978-1979
This map has not been edited or reviewed for conformity with Geological Survey standards and nomenclature.

- ACTIVE OR RECENTLY ACTIVE LANDSLIDE**
Complex landslide composed of earthflow, debris slide, earth and rock slump. Identified from historical records, and from scars, debris and other field evidence. Ground extremely unstable; sliding accelerated by excavation, loading and changes in drainage conditions. May include areas with several active slides too small to be shown separately. Questioned where doubtful. May be shown with symbol (a) where difficult to discern.

- OLD LANDSLIDE**
Area of extensive hummocky ground caused by earthflow and earth and rock slump. Lacks clear evidence of active sliding. Relatively stable in natural, undisturbed state, generally not affected by small structures properly sited in areas away from the edge of the toe; can be reactivated by extensive, rapid excavation, loading, and changes in ground water and surface water conditions. Area of old landslide probably includes recent ones not identified from field evidence or otherwise documented. Upslope boundary of landslide generally defined by modified scarp, but downslope (toe) may be gradational and not well defined. Questioned where doubtful.

- COLLUVIAL SLOPE**
Valley wall along major streams with slope as steep as 40° (85%); stony, clayey silt soil up to 50 ft. (15 m) thick; commonly buttressed by a terrace or bench at the toe of the slope; very susceptible to sliding by cutting of toe area, removal of terrace or bench, and overloading; slide commonly activated without apparent cause.

- AREAS SUSCEPTIBLE TO DEBRIS FLOWS AND DEBRIS AVALANCHES**
Primarily shallow, narrow ravines and chutes with accumulation of stony colluvium generally 10 ft. (3 m) or less in thickness; susceptible to rapid movement during intense rainfall. Most ravines and chutes designated show evidence of former debris flows and avalanches. Symbol (a) designates historical debris flow or debris avalanche.

- AREAS SUSCEPTIBLE TO ROCKFALL**
Steep, locally vertical, natural and man-made slopes and cliffs, 15 ft. (4.5 m) or more high; formed dominantly of sandstone, limestone, sandy shale, mudstone and claystone. Interbedded mudstone, claystone and shale weather rapidly leaving sandstone and limestone rock faces unsupported.

- SOIL AND ROCK SUSCEPTIBLE TO LANDSLIDING**
Soil and rock similar to that involved in landslides elsewhere in map area; primarily areas underlain by claystone, mudstone and shale associated with other rock types. Rock weathers rapidly on exposure forming clayey soil highly susceptible to sliding. Includes coves (U-shaped, shallow valleys) containing thick layers of clayey soil that are very susceptible to sliding where excavation breaks continuity of slope and where overloading by artificial fill.

AREAS LEAST PRONE TO LANDSLIDES
Map areas in which no patterns or symbols are shown; primarily valley floors, ridge tops and broad benches; modification by excavation and fill may lead to local landslides.
Includes slopes where landslides are sparse.
