FLOODFLOW CHARACTERISTICS OF THE SACRAMENTO RIVER IN THE VICINITY
OF GIANELLA BRIDGE, HAMILTON CITY, CALIFORNIA

U.S. GEOLOGICAL SURVEY

Open-File Report 81-328

Prepared in cooperation with the
CALIFORNIA DEPARTMENT OF TRANSPORTATION
DIVISION OF HIGHWAYS

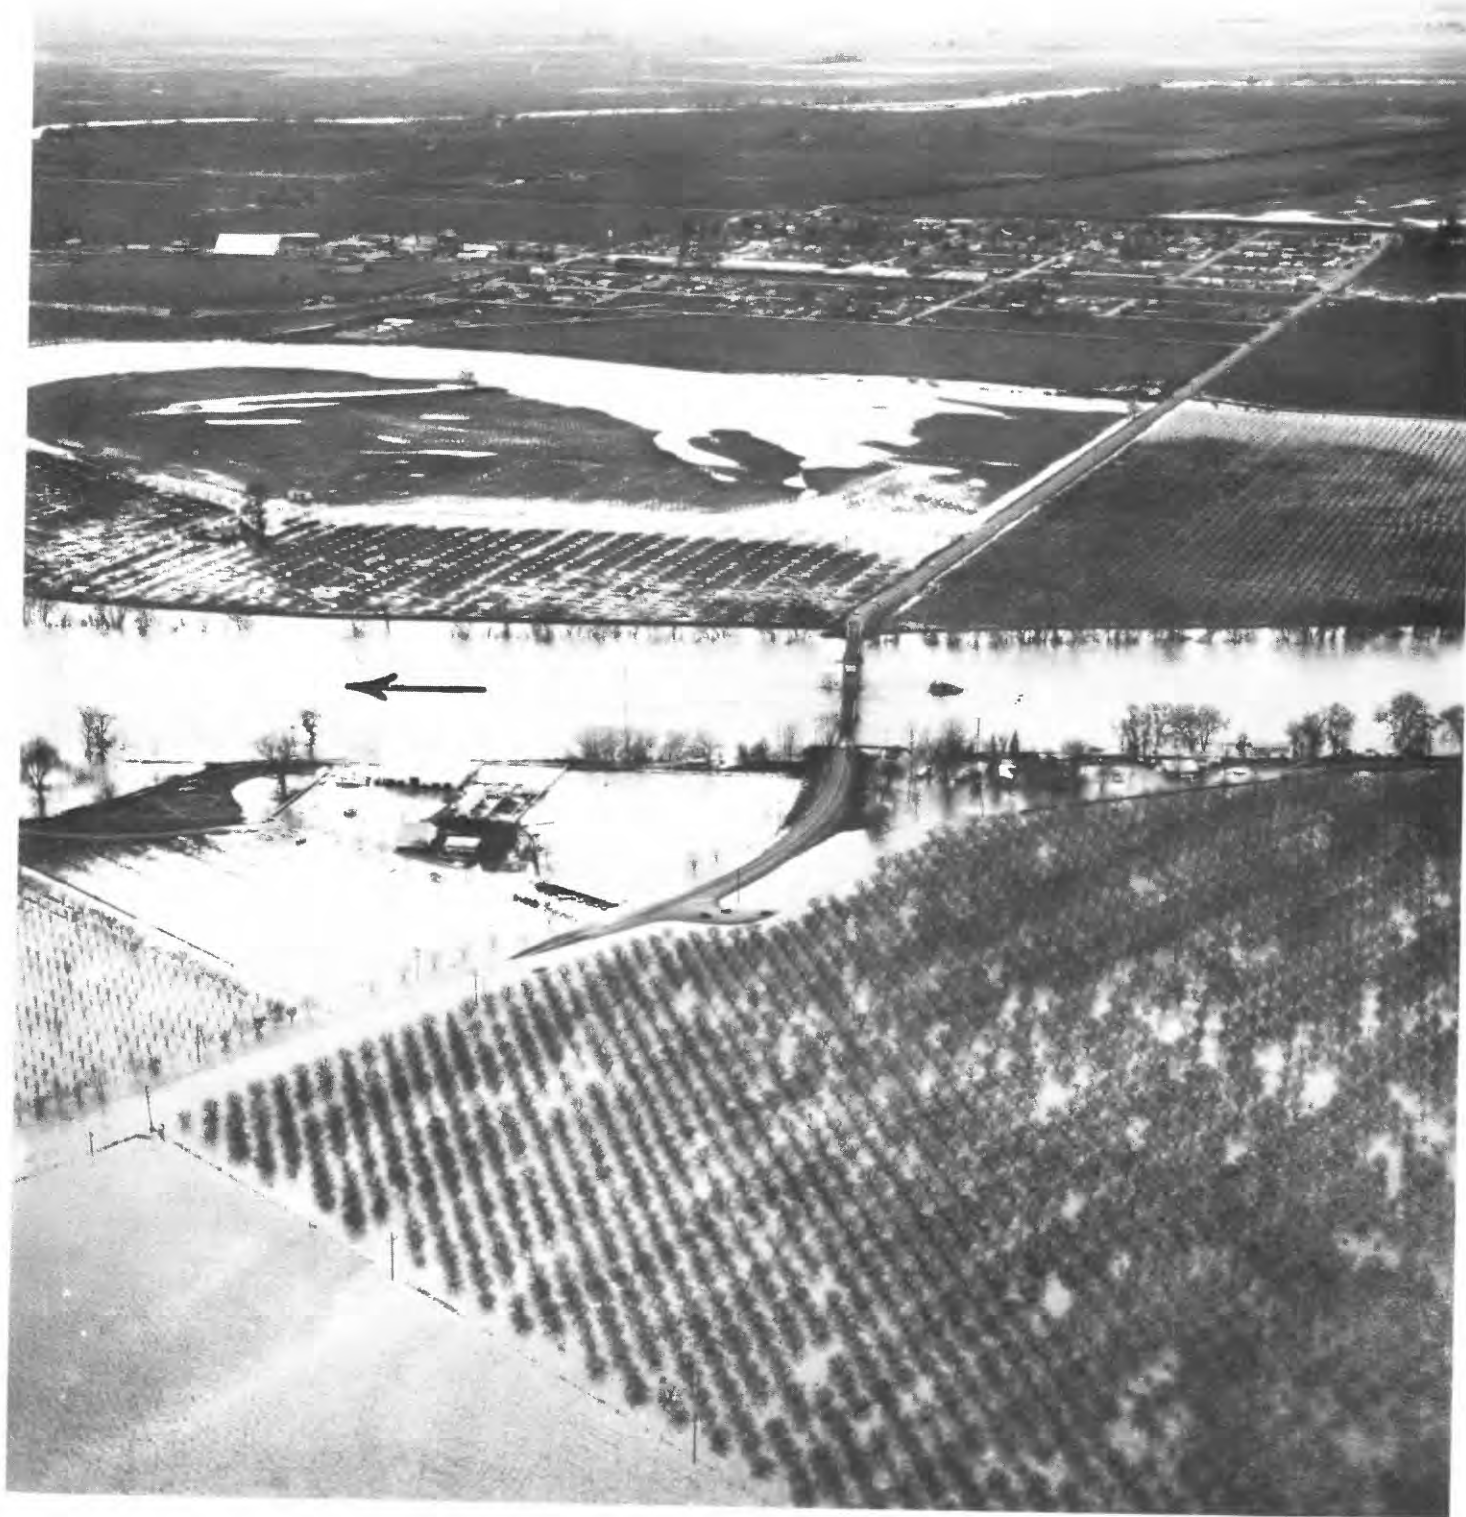
Flood of January 1970. Looking west over the Sacramento River and Gianella Bridge on State Highway 32. Hamilton City in background. (Photograph courtesy of CALTRANS.)

Highest velocities of flow are usually located near pier 2 in openings 2 or 3. The high velocities in this part of the channel are caused by the upstream channel alinement which directs flows toward the left bank (fig. 2), and by the concrete drift deflector located at cross section 5. The effect of the drift deflector on flow lines is illustrated by the lines of turbulence in the vicinity of the bridge shown on the frontispiece.

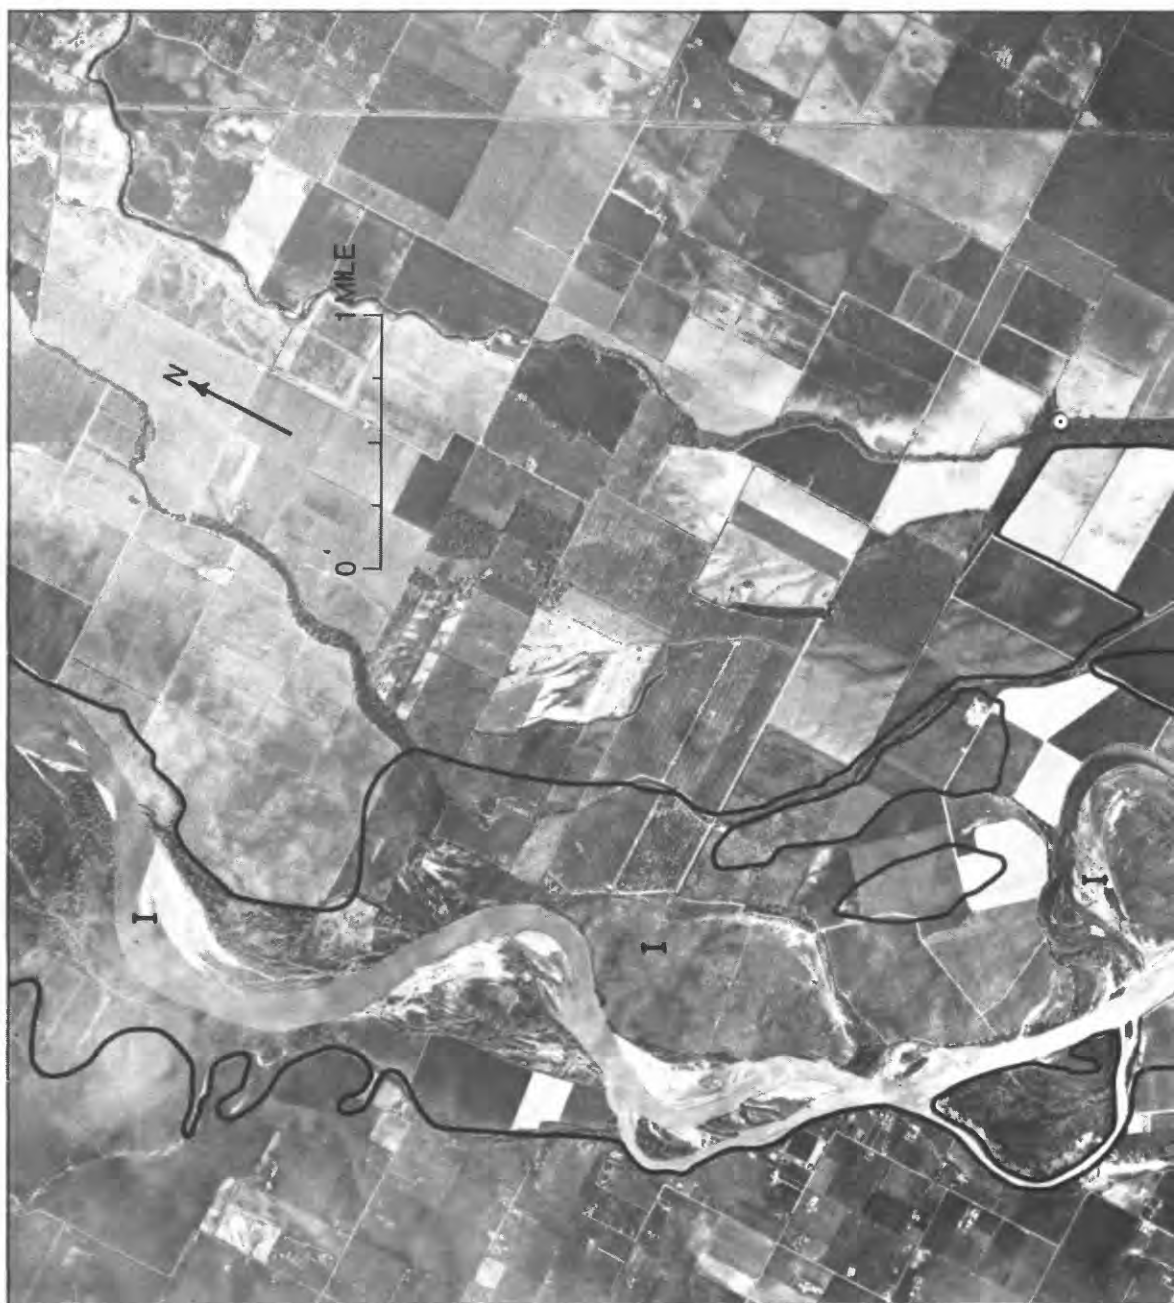
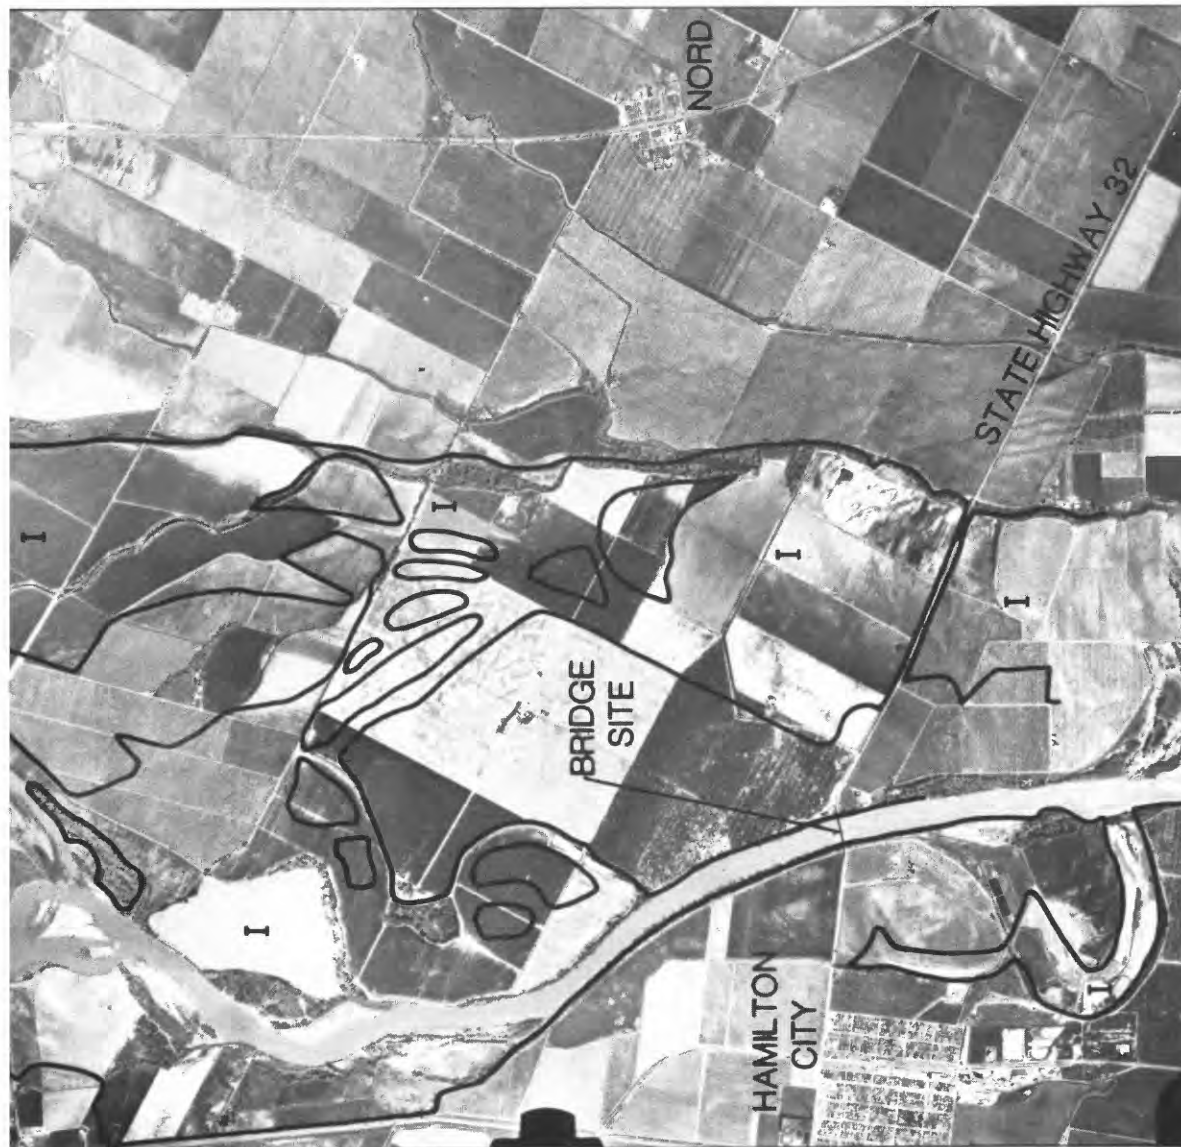
FIGURE 6.--Areas of inundation (I) during flood of April 2, 1974.
