FLOOD OF SEPTEMBER 16, 1975, IN THE YAUCO VALLEY, PUERTO RICO

By
Karl G. Johnson

DEPARTMENT OF THE INTERIOR
UNITED STATES GEOLOGICAL SURVEY

WATER RESOURCES INVESTIGATIONS
OPEN-FILE REPORT 81-331

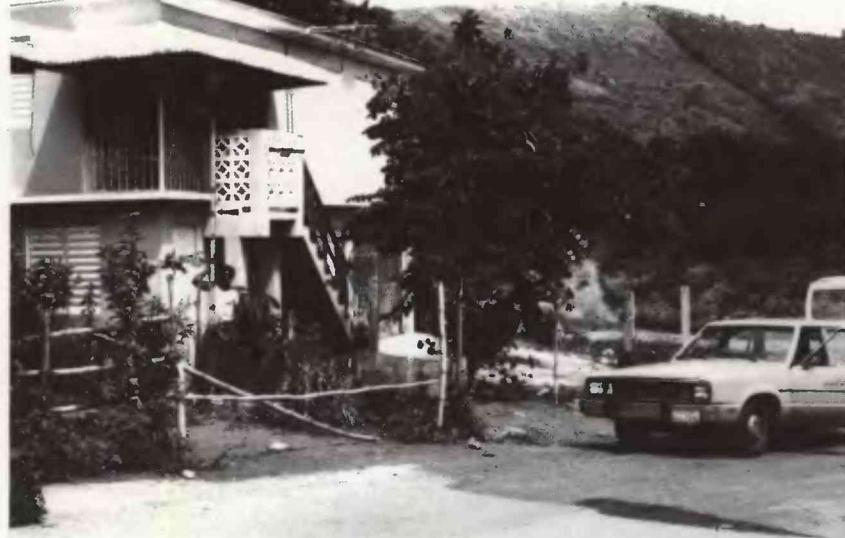
FIGURE 3. - Flood height (noted by arrow) at Tendam Street No. 1 (photograph A).

Photographs of selected sites in the Yauco area during the September 16, 1975 flood are shown in figures 3 to 17. The photograph locations are identified on the flood map by a circular symbol with an identifying letter and an arrow showing the direction in which the respective photograph was taken. A rod marked in feet and a black arrow is used to point out the depth of floodwaters on some photographs.

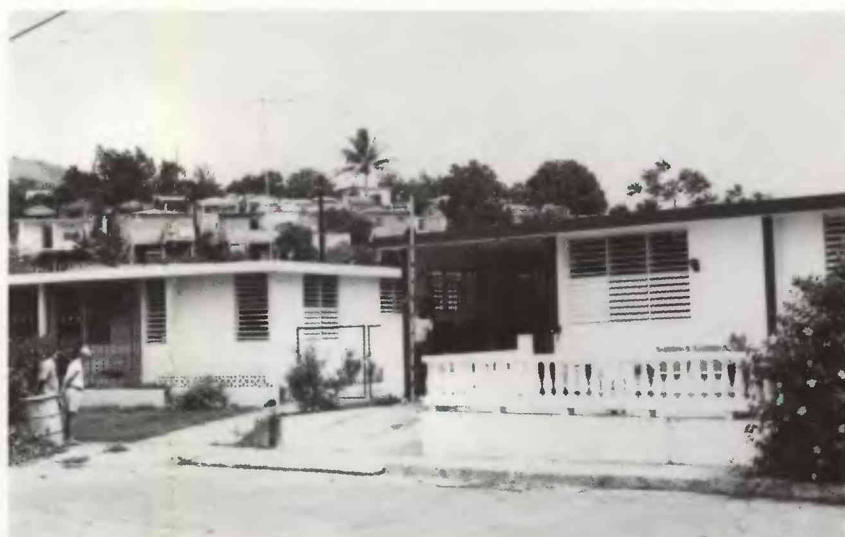
FIGURE 4. - Flood height (noted by arrow) at Lucchetti Urbanization Street 1, No. H-34 (photograph B).

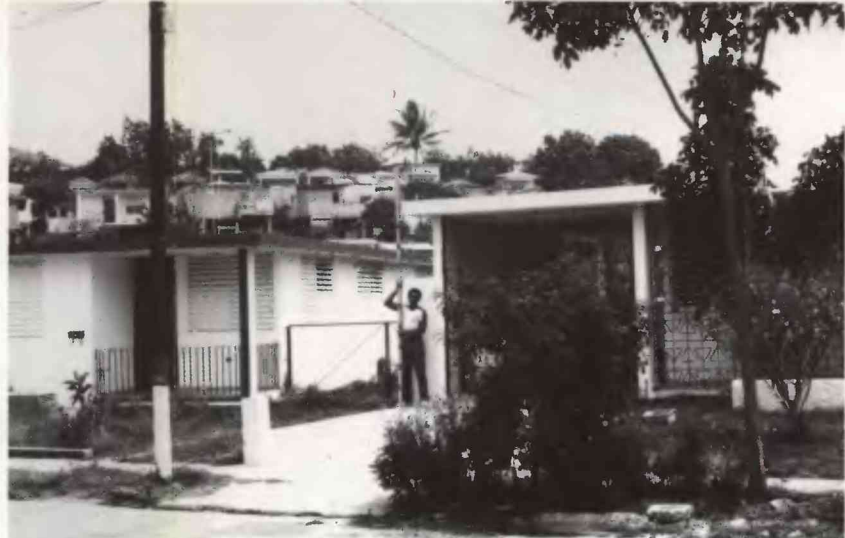
FIGURE 5. - Flood height (noted by arrow) at Lucchetti Urbanization Street 1, No. H-35 (photograph C).

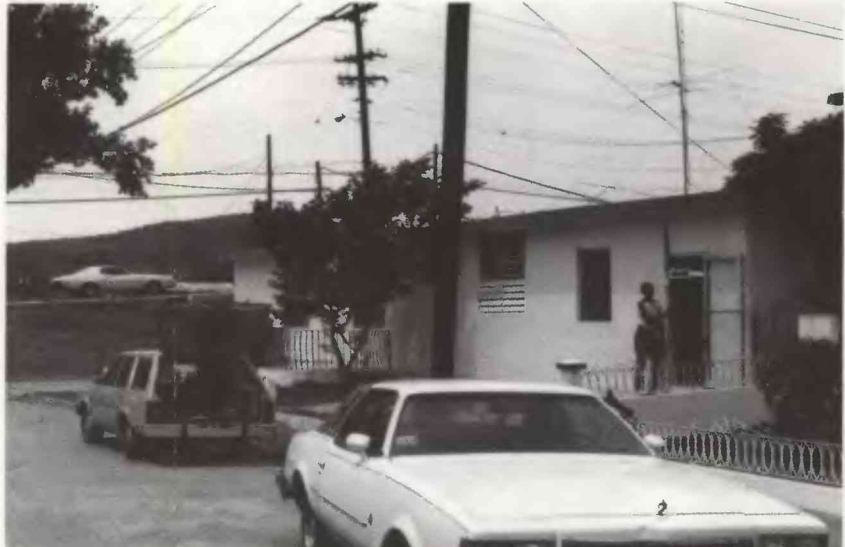
FIGURE 6. - Flood height (noted by arrow) at Lucchetti Urbanization Street 1, No. H-1 (photograph D).

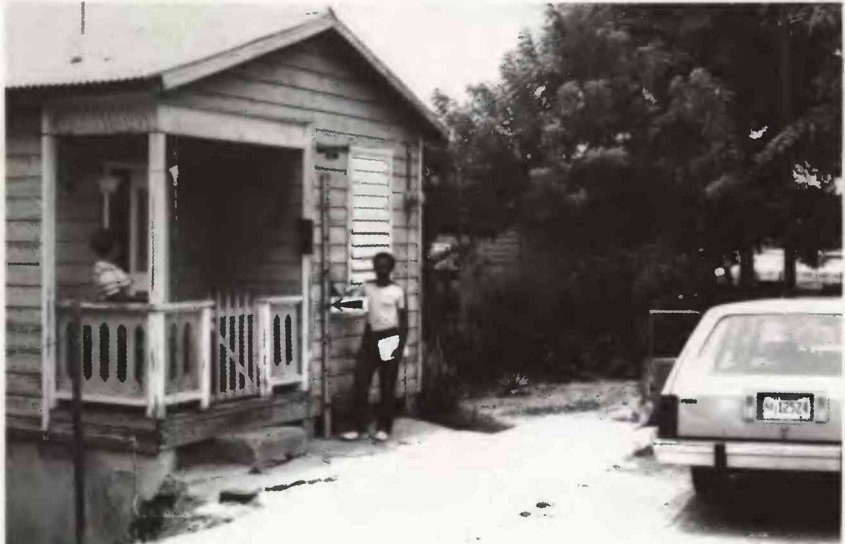
FIGURE 7. - Flood height (noted by arrow) at Calle Santo Domingo No. Sur 1 at Yauco (photograph E).

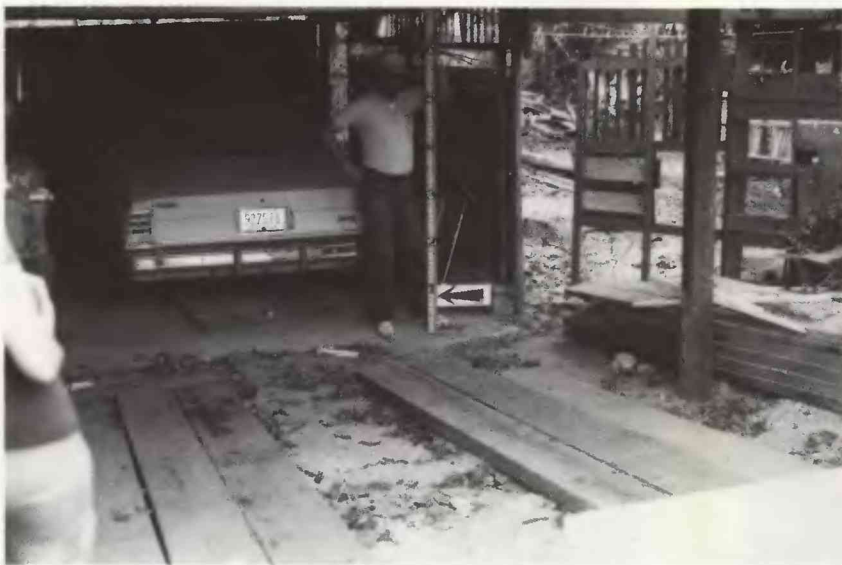
FIGURE 9. - Flood height (noted by arrow) inside of garage of house inside baseball park at Bo. Barinas (photograph G).

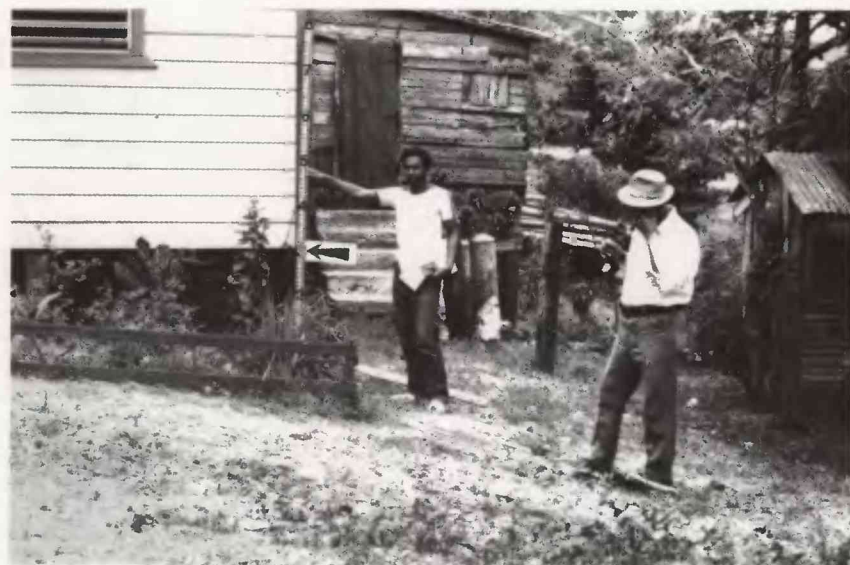
FIGURE 10. - Flood height (noted by arrow) on back of house of Sr. Biaz at Hacienda San Rafael, Bo. Lomas (photograph H).

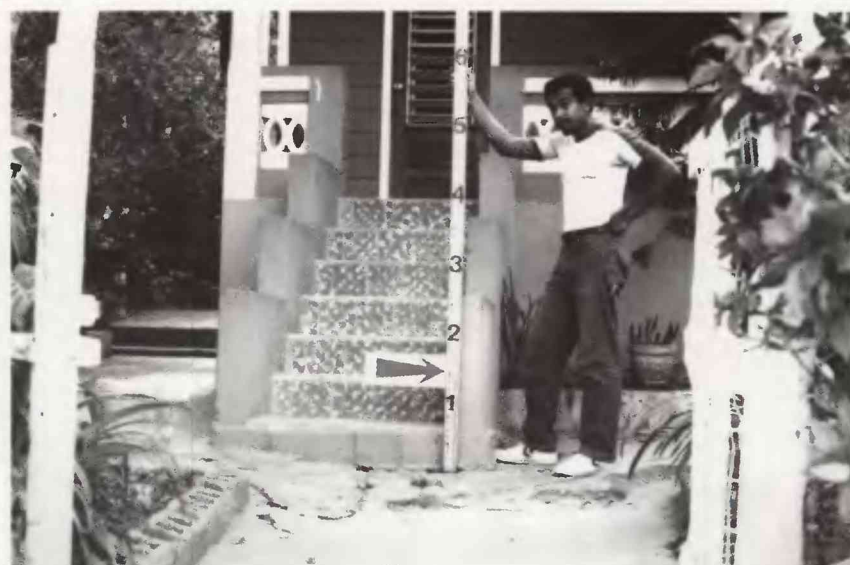
FIGURE 11. - Flood height (noted by arrow) in front of house of Sr. Cervasi at Highway 335, km. 8.3, Bo. Barinas (photograph I).

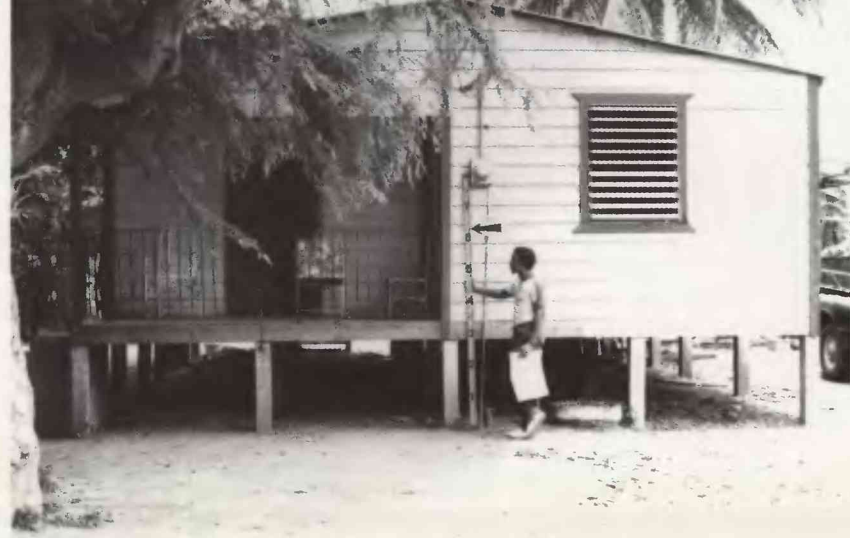
FIGURE 12. - Flood height (noted by arrow) on house near old Calles Barinas at Bo. Media Quijada (photograph J).

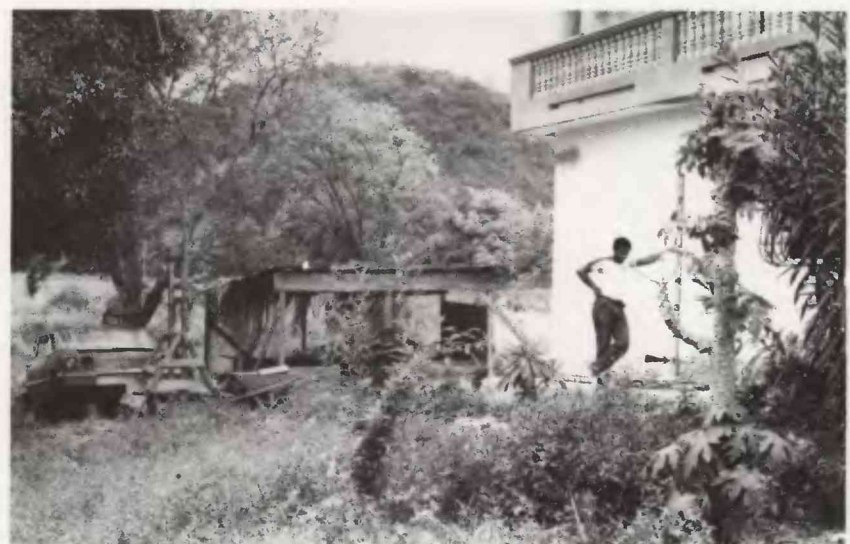
FIGURE 13. - Flood height (noted by arrow) on Calles Edmundo López, Bo. Media Quijada (photograph K).

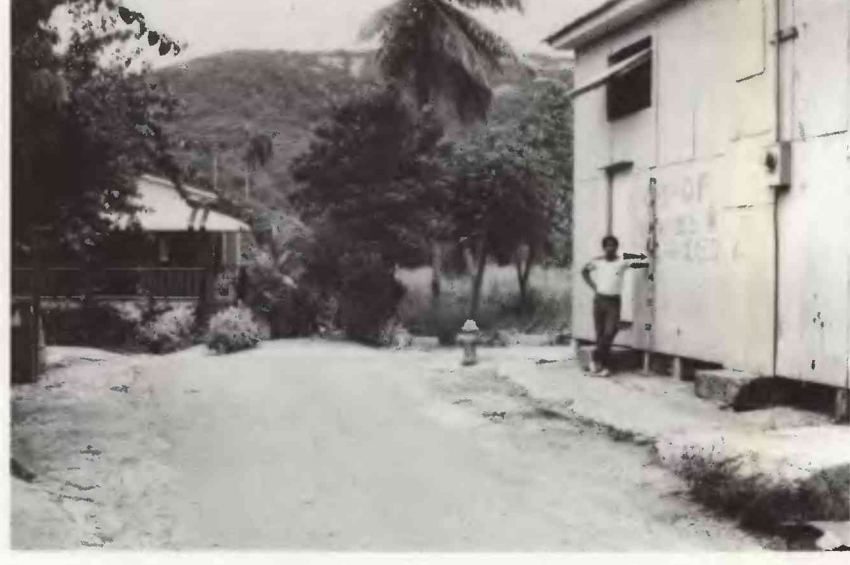
FIGURE 14. - Flood height (noted by arrow) at San Francisco Cooperative Superer, Bo. Media Quijada (photograph L).

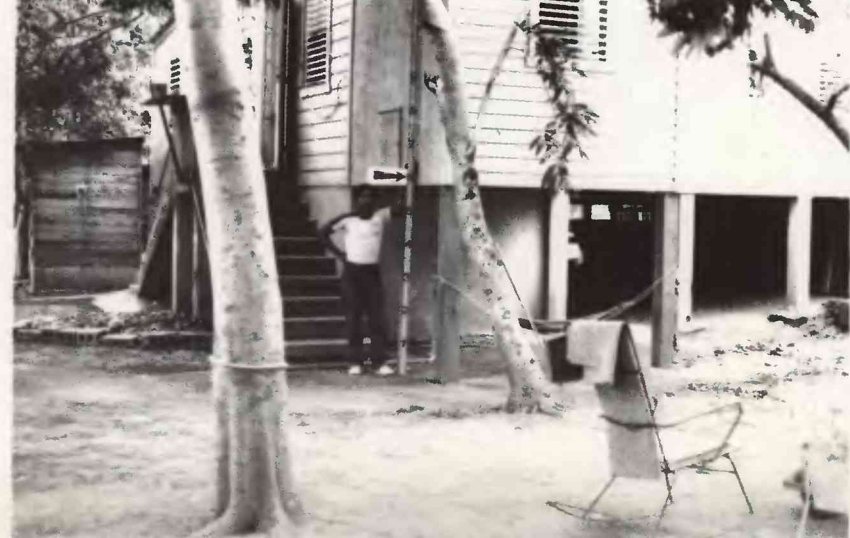
FIGURE 15. - Flood height (noted by arrow) at house of Sr. Soltero at Highway 335, km. 5.5, Bo. Indies (photograph M).

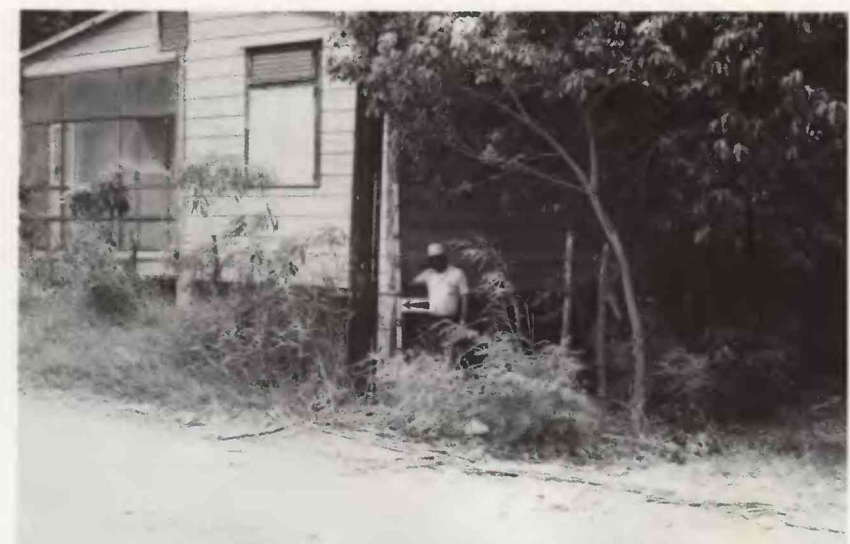
FIGURE 16. - Flood height (noted by arrow) on abandoned house at Central San Francisco (photograph N).

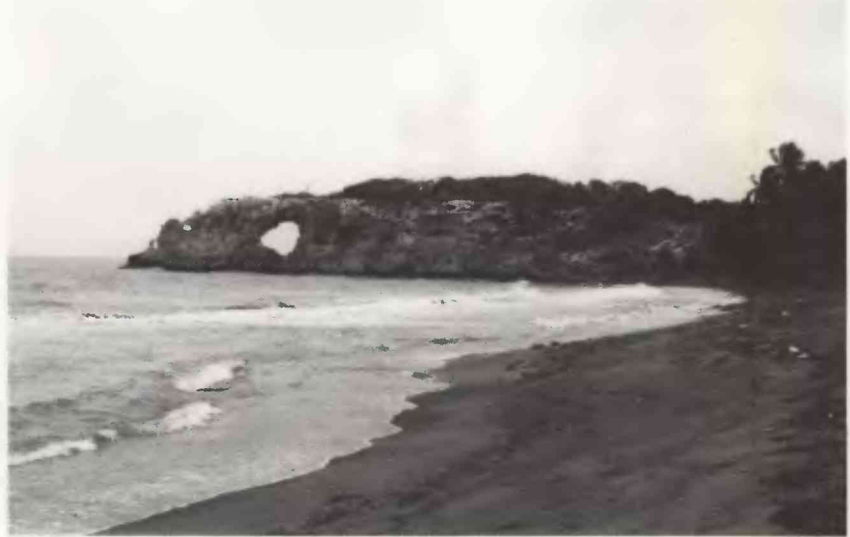
FIGURE 17. - Punta Ventana, water was flowing about 1 meter deep over beach section (photograph O).
