## FLOOD OF SEPTEMBER 16, 1975 AT UTUADO, PUERTO RICO

By  
Karl G. Johnson, Ferdinand Quiñones, and José Alicea-Ortiz

WATER RESOURCES INVESTIGATIONS OPEN-FILE REPORT 81-413

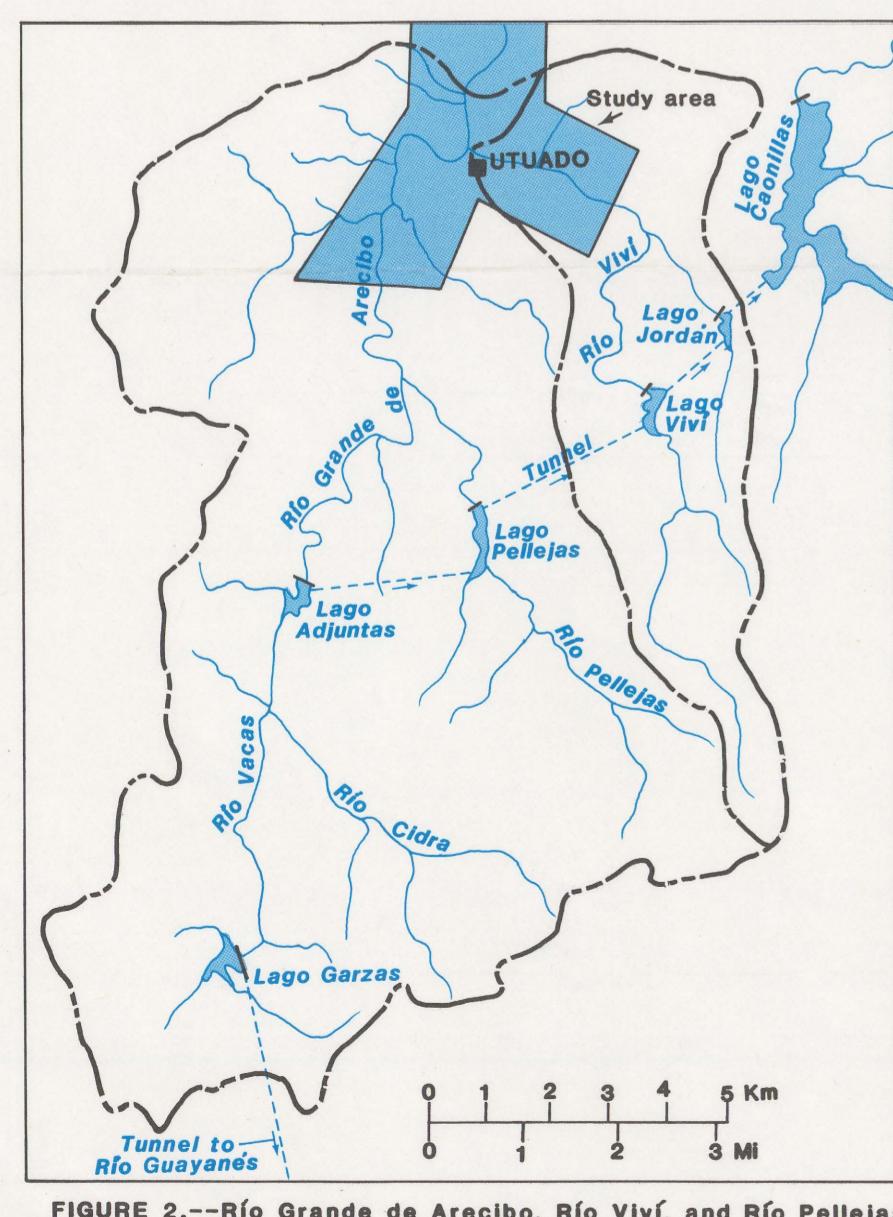
FIGURE 2.--Río Grande de Arecibo, Río Viví, and Río Pellejas drainage basins and study area.

The magnitude of floods in Utuado is not significantly affected by diversion tunnels interconnecting the reservoir system of Lagos Adjuntas, Pellejas, Viví, Jordan, and Caonillas with Lago Dos Bocas (fig. 2).

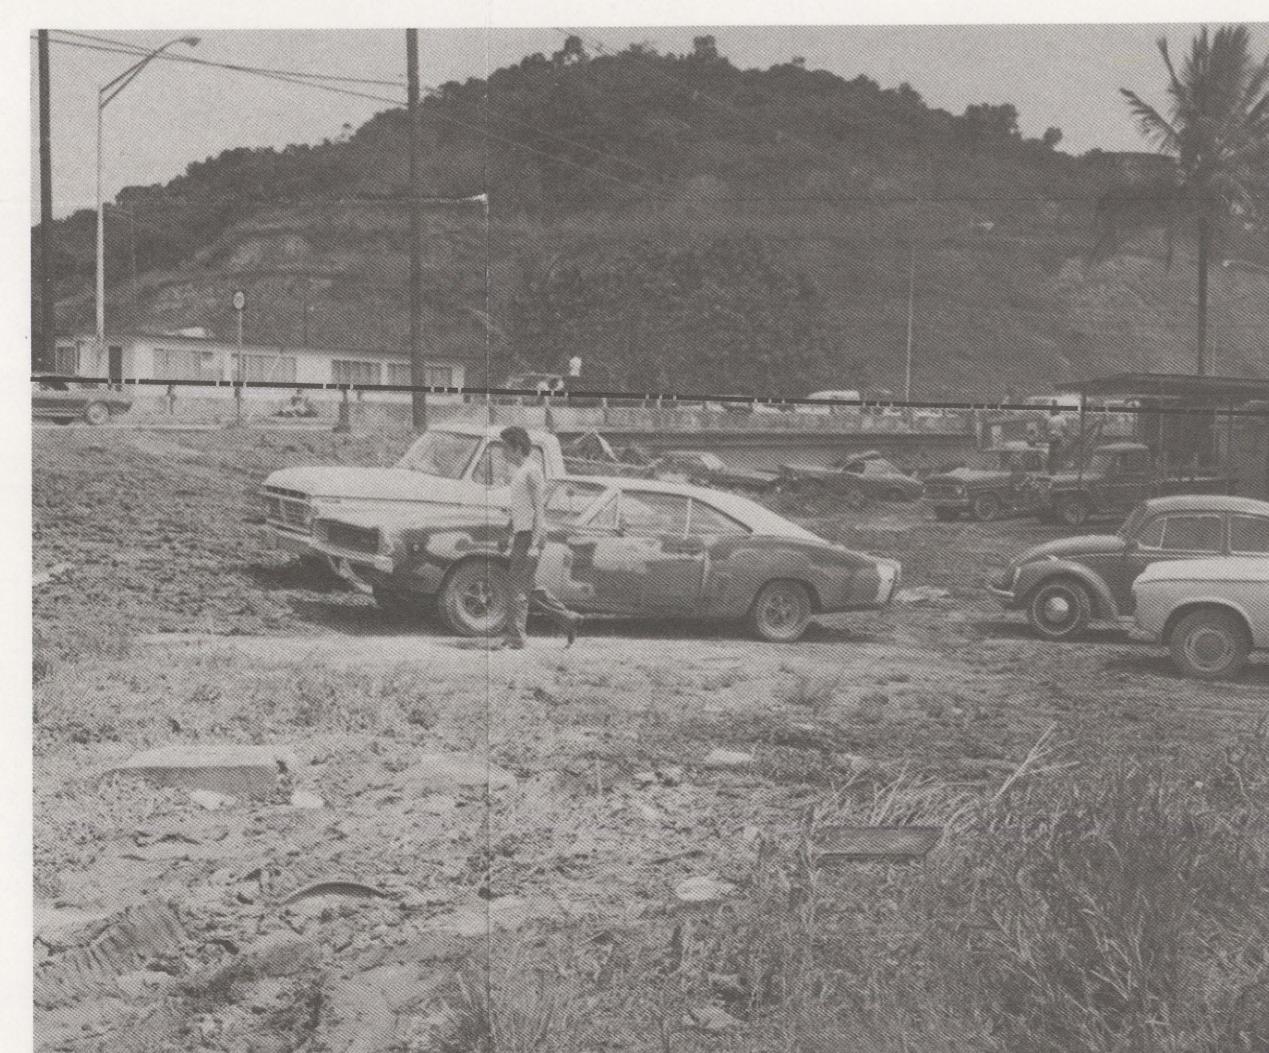
FIGURE 4.--Upstream side of Highway 111, facing bridge. Dashed line shows the approximate flood height reached, September 16, 1975 (Photograph A).

The most severe damage in the town of Utuado was caused by the Río Grande de Arecibo. The river backed up floodwaters for about 0.7 km into its main tributary, Río Viví, which flows through the town from east to west. The Río Viví peak flow was of lesser magnitude than the peak flow of Río Grande de Arecibo and consequently caused less damage. The photographs in figures 4 to 6 show the maximum height of the September 16, 1975, flood at selected sites in Utuado. Photographs are identified on the topographic map by a circular symbol with an identifying letter and an arrow showing the direction in which the photograph was taken.

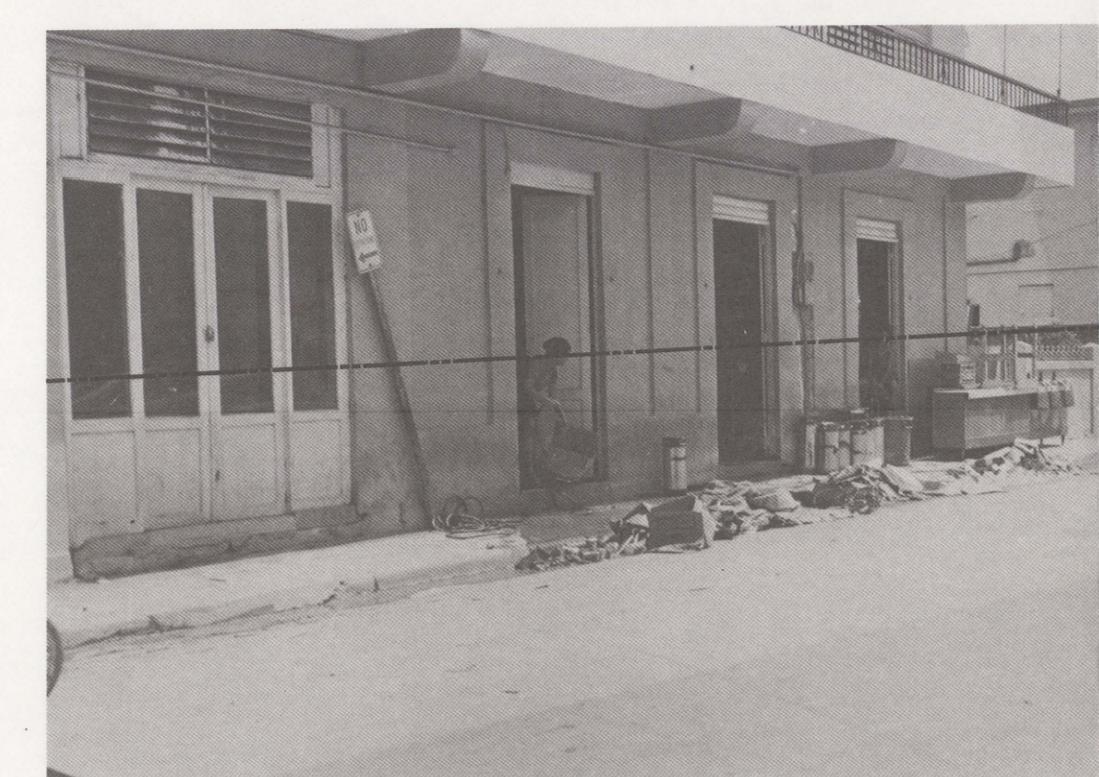
FIGURE 5.--Main street in Utuado looking northeast from the vicinity of Highway 10 bridge toward Highway 111. Dashed line shows approximate flood height reached, September 16, 1975 (Photograph B).

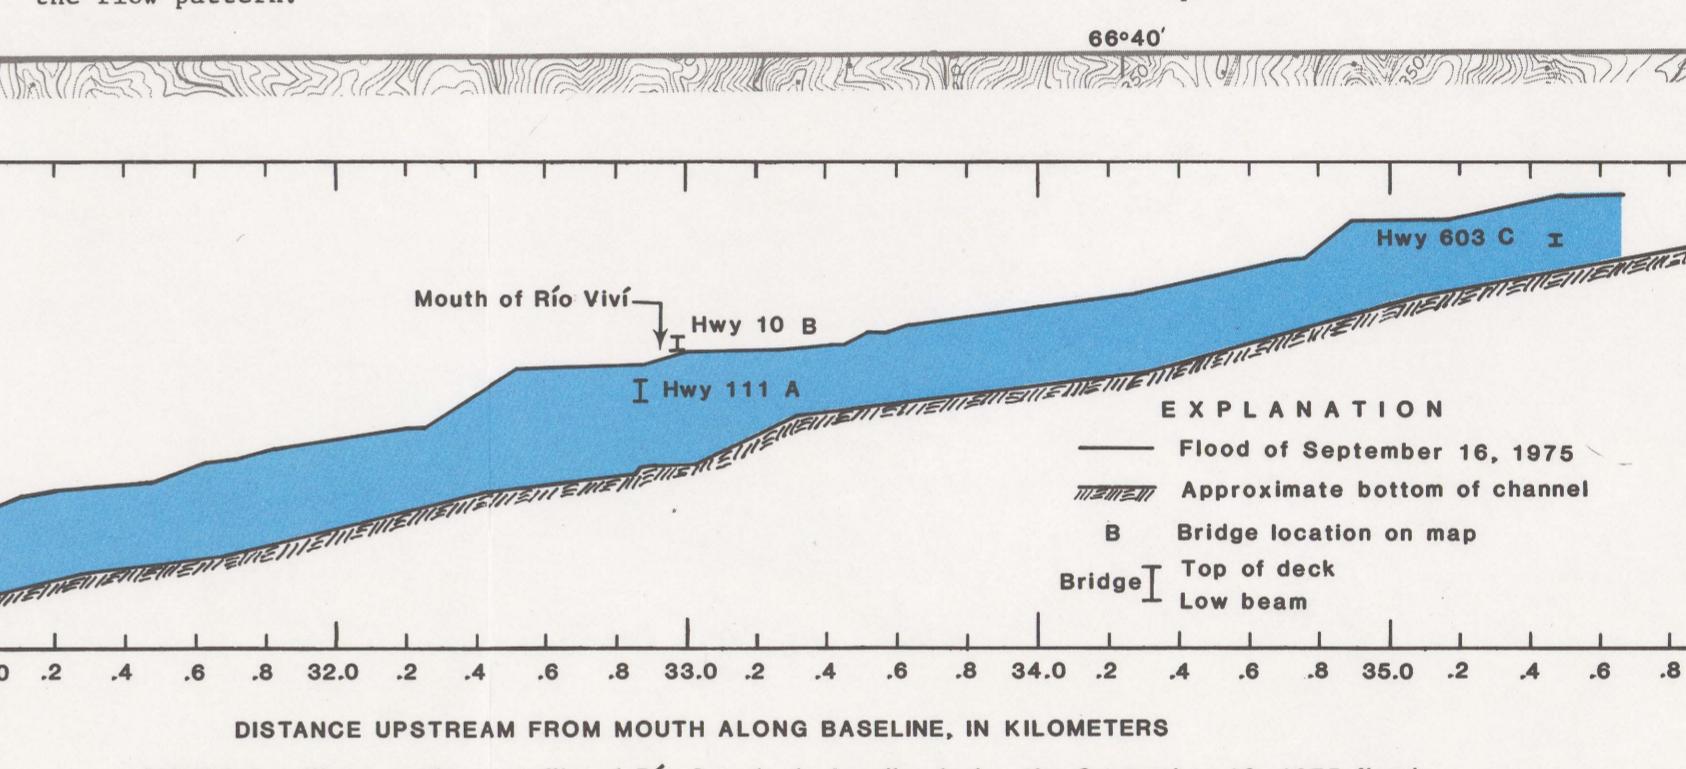
FIGURE 7.--Water surface profile of Río Grande de Arecibo during the September 16, 1975 flood.

The water-surface profiles for the September 16, 1975 floods of Río Grande de Arecibo and Río Viví, are shown in figures 7 and 8. Distances are referred to the arbitrary baseline shown on the flood map. The baseline, and therefore the profiles, are not confined to the configuration of the channel but follows a smoother path along the flood plain in the general direction of the flood flow. The water-surface profiles of Río Grande de Arecibo and Río Viví are based on flood marks, identified and surveyed by field crews of the U.S. Geological Survey after the flood. Interviews with residents in the study area aided the identification of high-water marks. There are six bridges in the study area, three over Río Grande de Arecibo and three over Río Viví (Table 1).

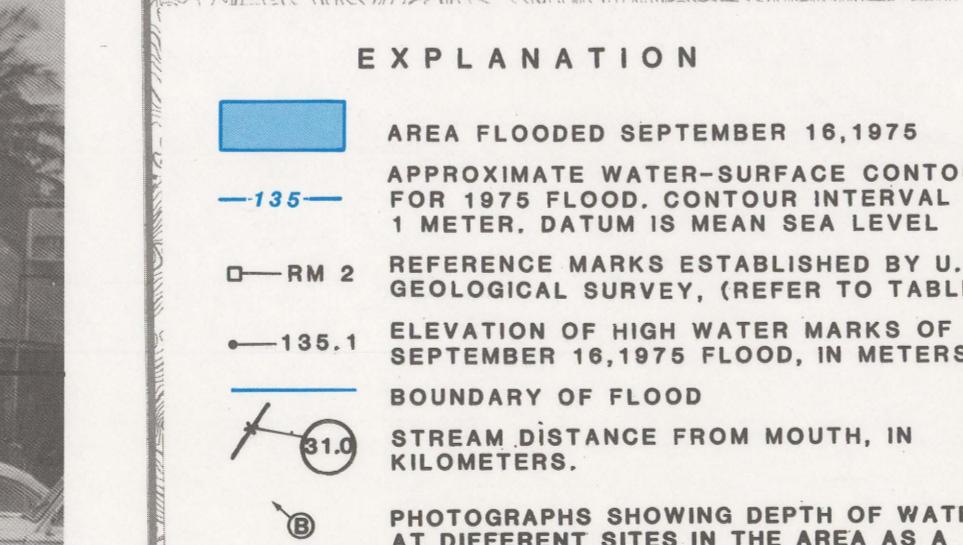
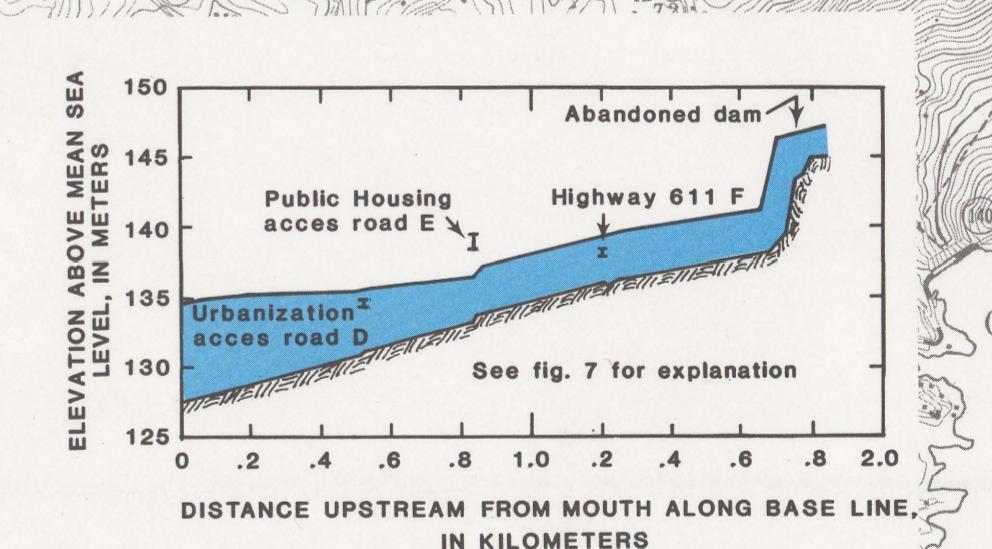
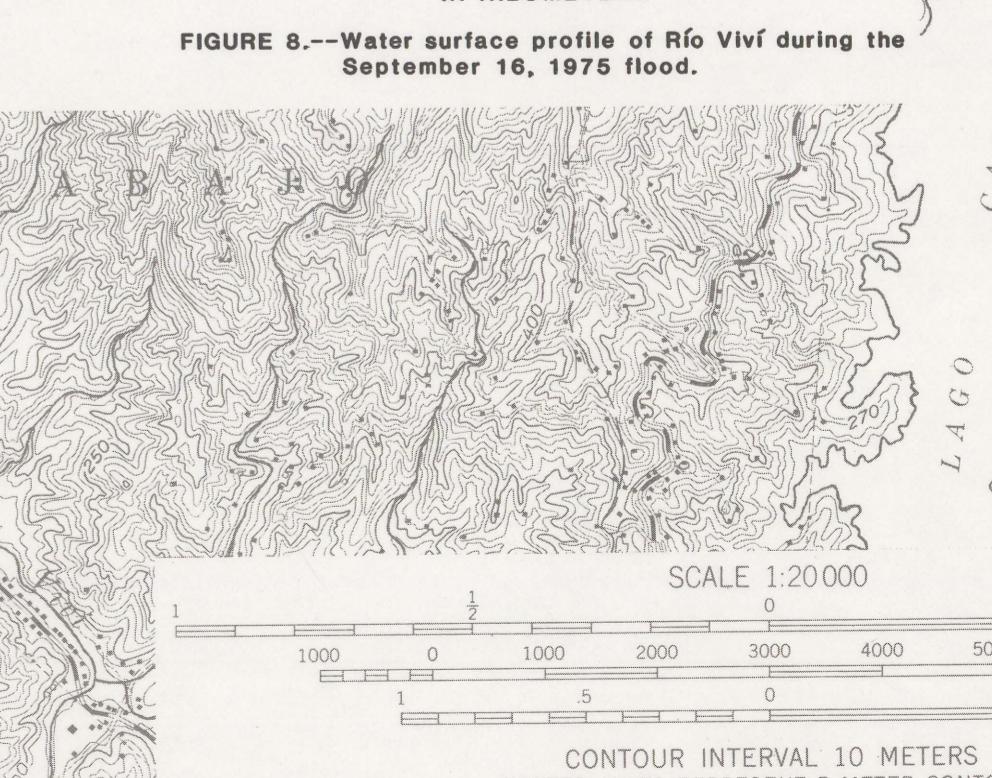
FIGURE 8.--Water surface profile of Río Viví during the September 16, 1975 flood.
