Project No. 14093B

Woodward-Clyde Consultants

MAP OF FAULT TRACES AND LINEAMENTS Little Cottonwood Canyon Site

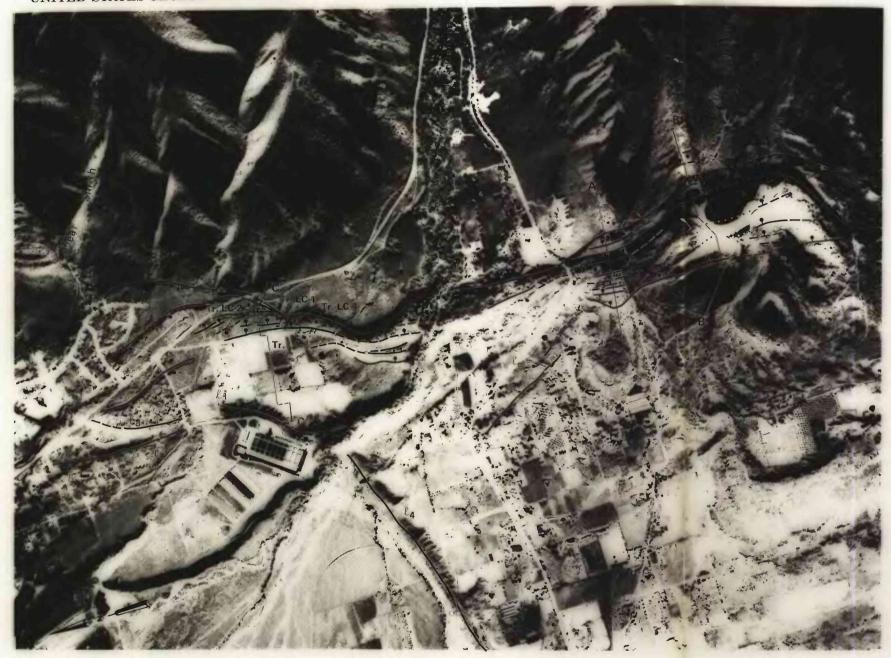
Figure 6

Fault; dashed where inferred; dotted where buried; ball and bar on downthrown side

Linear break in slope; dashed where less distinct; circle and bar on lower side

Tr. LC-1 Trench location

Topographic profile
