SUBSURFACE INVESTIGATION OF LIQUEFACTION,
IMPERIAL VALLEY EARTHQUAKE, CALIFORNIA,
OCTOBER 15, 1979

U.S. Geological Survey
Menlo Park, California
94025

Open-File Report 81-502

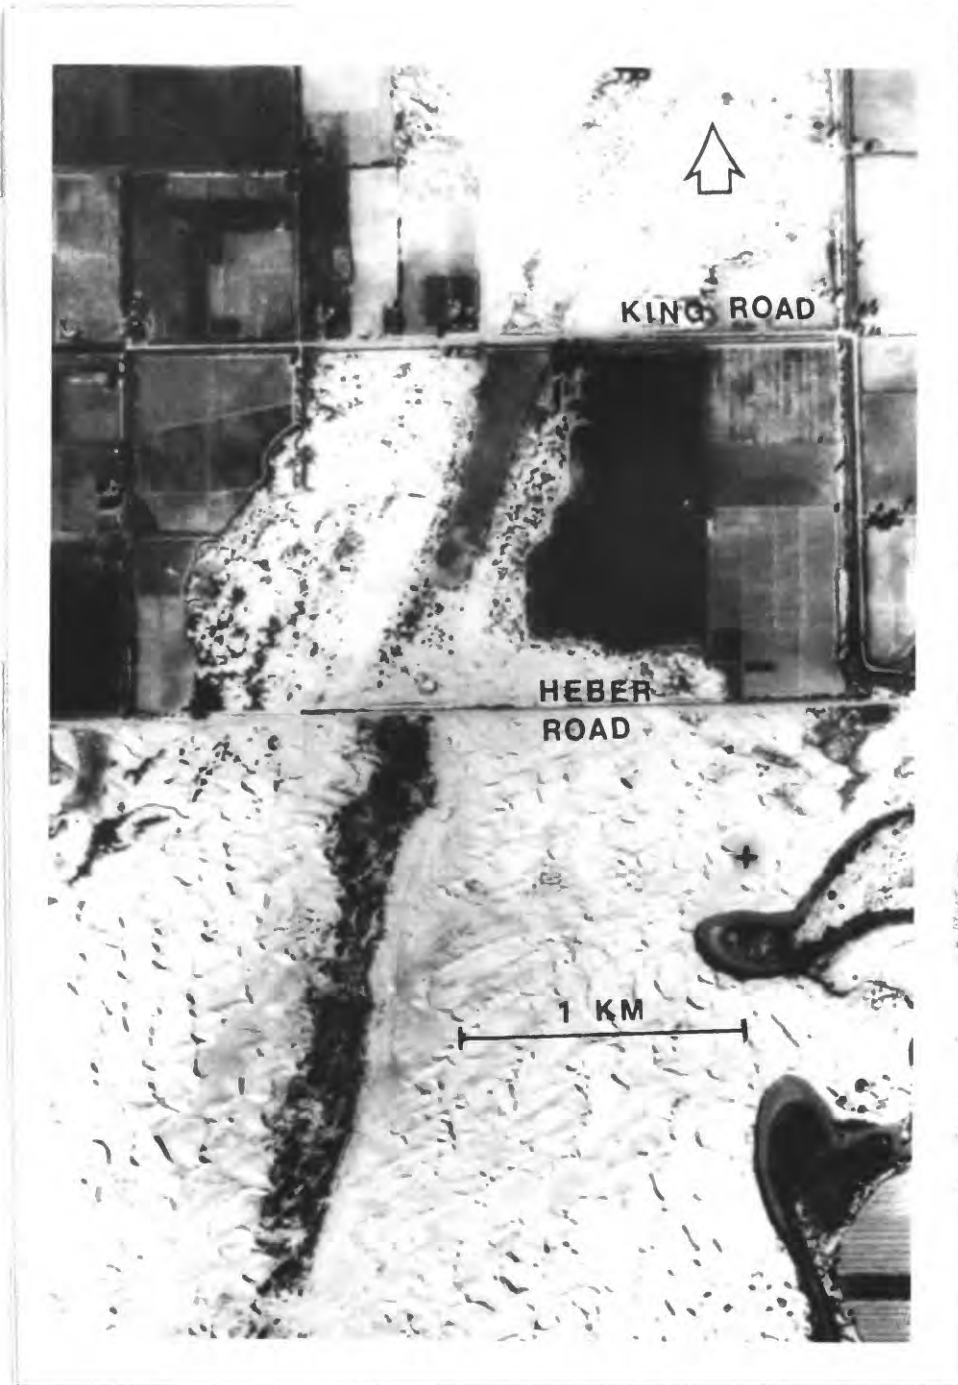
Figure 7. Aerial photograph from 1937 shows outline of relict channel (figure from Youd and Wiczorek, in press).

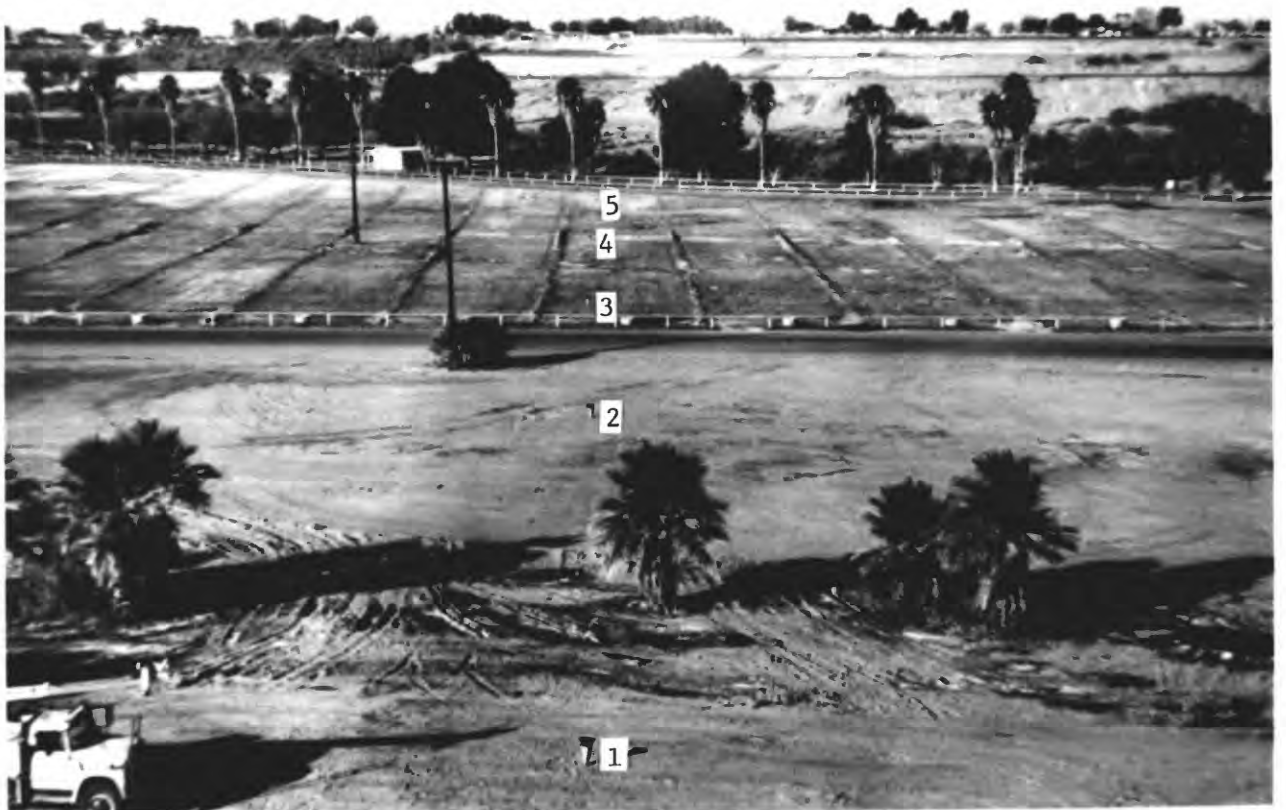
Figure 12. Numbers mark the location of holes on the flood plain at River Park (view looking west).

At River Park 5 CPT soundings were made across the flood plain at intervals of 60 m (figure 12). Six additional soundings at intervals of 10 m

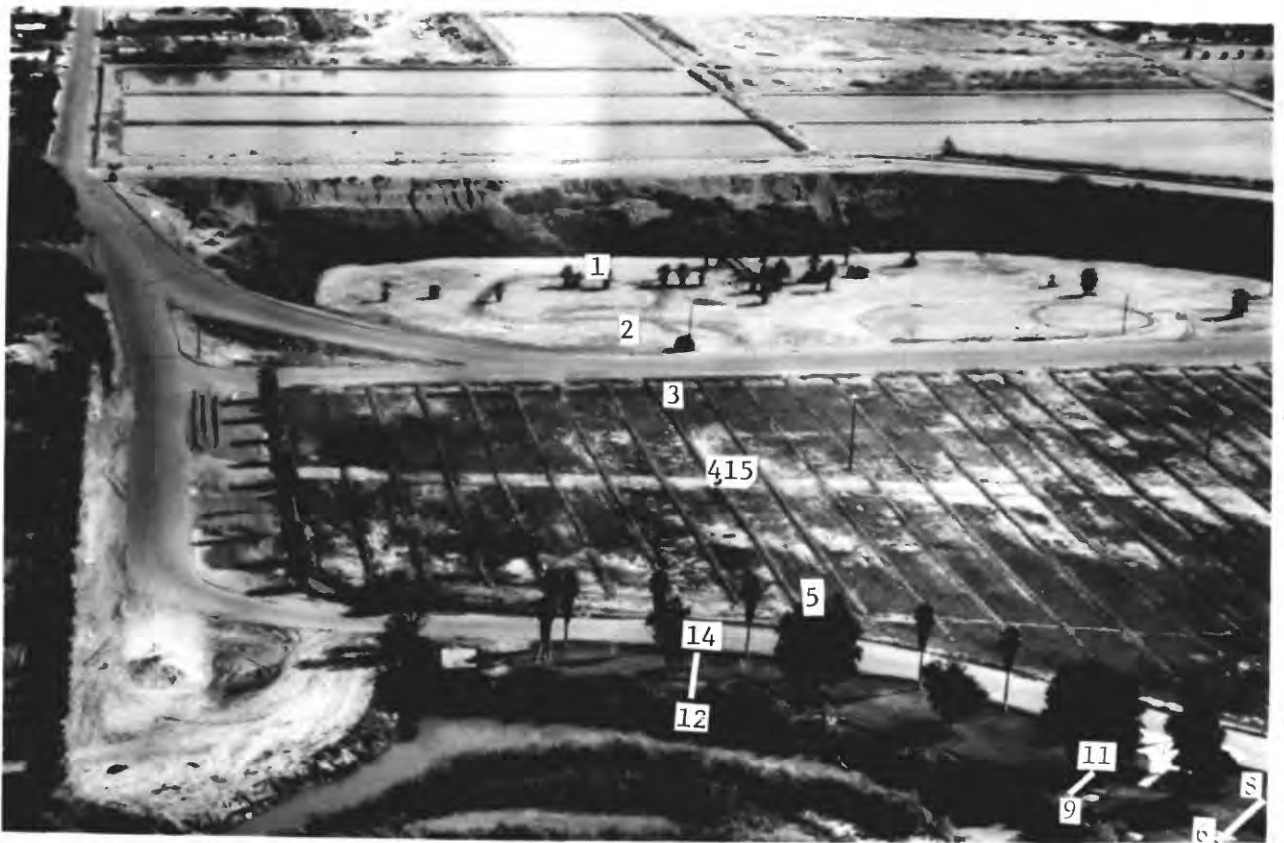
Figure 14. View of River Park looking east. Location of holes is marked by numbers. Profiles of holes 1-5 are shown in figure 20. Profiles of holes 6-14 are shown in figure 21.

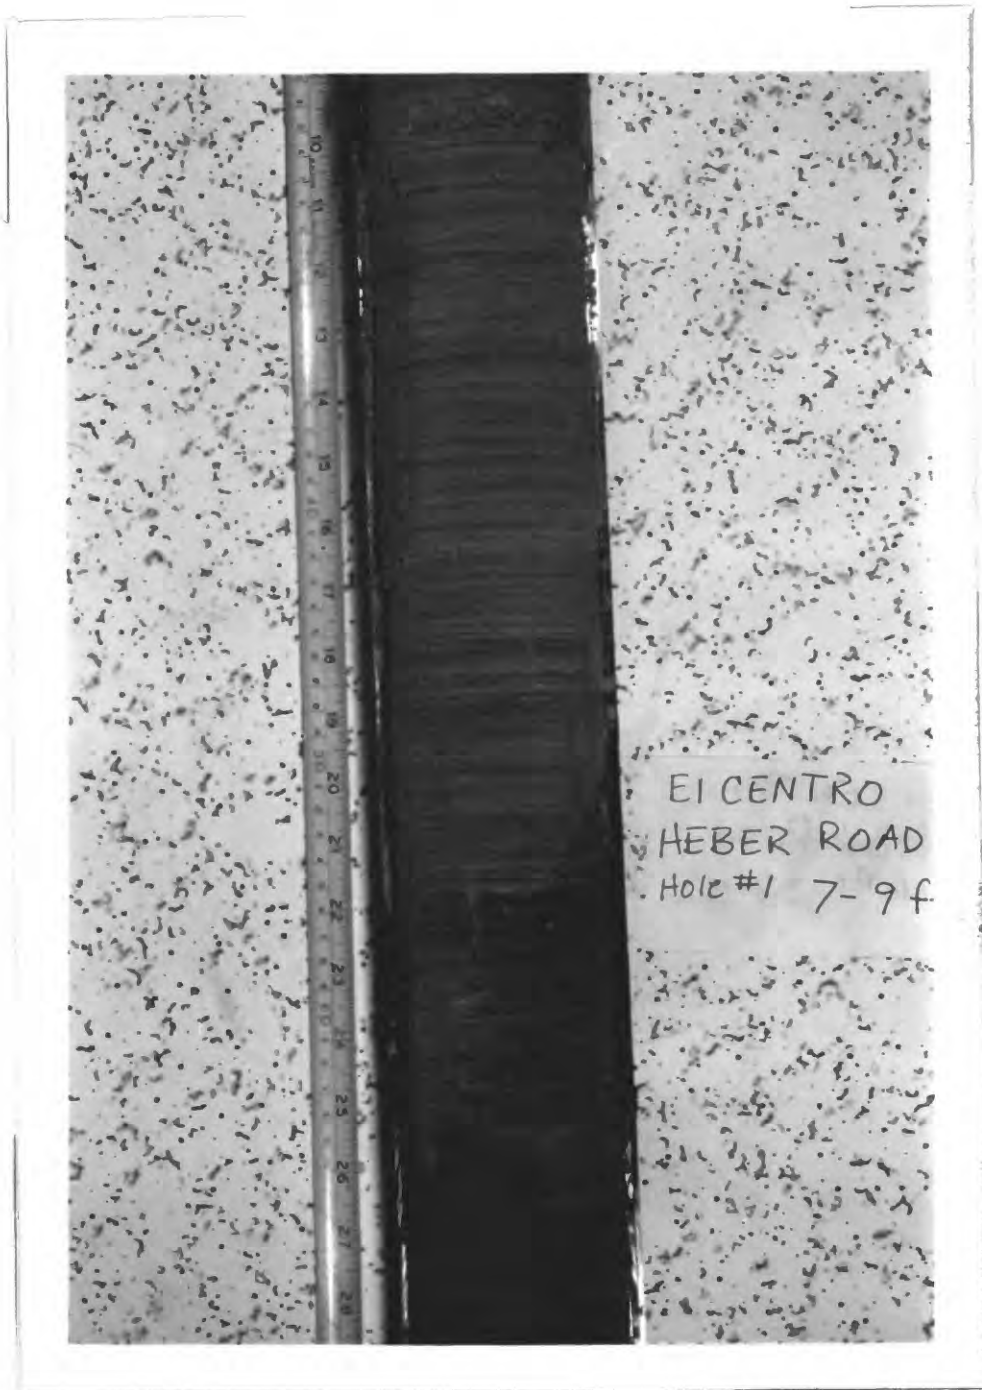
Figure 19. Tube sample, 2.1-2.7 m, hole 1. This sample contains 61 cm of undisturbed horizontal bedding from the point bar deposit.

13). The sediment in the unit is dark brown, dense to very dense, well sorted, very fine-grained sand. The unit shows a well defined upward decrease in grain size. The unit is wedge shaped, tapering from 5 m thick at hole 1 to less than 0.5 m thick in hole 4. The sand consists of about 95% rounded to subrounded quartz and feldspar grains. The other 5% of the sediment consists of heavy minerals, mica, and fragments of organic material. No gastropod shells or other shell fragments were present. A shelly tube sample from 1.1-1.7 m shows ripple bedding (figure 18). A Shelby tube sample from 2.1-2.7 m contains 0.6 m of horizontally laminated sand (figure 19).
