APPEARANCE AND WATER QUALITY OF TURBIDITY PLUMES

CREATED BY DREDGING IN TAMPA BAY, FLORIDA

WATER-RESOURCES INVESTIGATIONS

OPEN-FILE REPORT 81-541

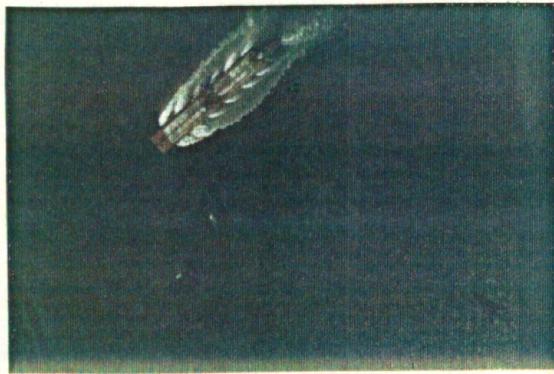
Site 1. Vertical view of background sample site 200 m southwest of dredge.

Turbidity (NTU)	Suspended solids (mg/L)	Transparency (cm)
Top	7	29	46
Middle	7	29	--
Bottom	9	32	--

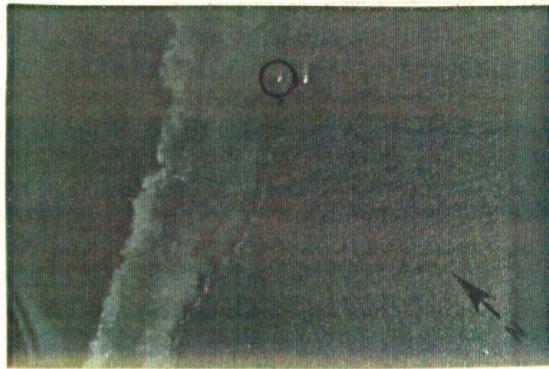
Site 4. Vertical view of sample site outside of plume, 1,300 m east of dredge.

Time: 1219 Depth: 9.1 m
Scale (approx.): 1:9,100

The dredge in operation and a background sampling site about 200 meters from the dredge are shown in photograph 1 (fig. 11). The sample site in photograph 4 (fig. 12), a few meters outside the edge of the visible plume, measured clearer water than at the background site. Sample sites at various locations within the plume are shown in photographs 2, 3, 5, 6, and 7 (figs. 11 and 12) over a time period of about 1 hour and 40 minutes during active dredge operation. Photograph 5 was taken as the dredge reversed direction and discharged additional turbid water onto its previously generated plume. Back-and-forth operation caused a plume of variable width, best seen in the mosaic, photograph 3.

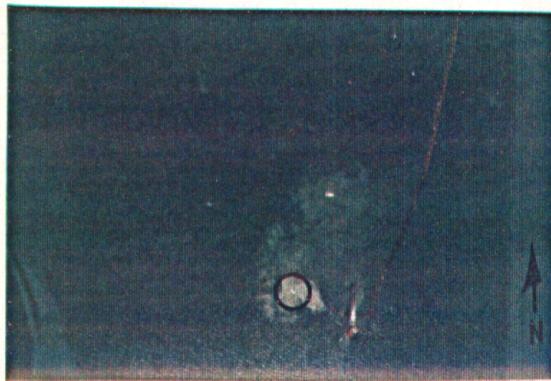
Site 9. Vertical view of open water disposal at slack tide.

Turbidity (NTU)	Suspended solids (mg/L)	Trans- parency (cm)
Top	25	60	15
Middle	70	234	--
Bottom	65	197	--

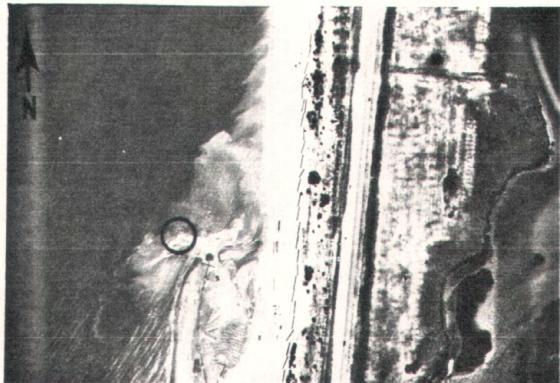
Site 12. Vertical view of beach nourishment on west shore of Mullet Key.

Time: 1200 Depth: 2.7 m
Scale (approx.): 1:9,100

On April 7, 1977, dredged material from the hopper dredge Ezra Sensibar was being pumped to a beach nourishment area on the western shore of Mullet Key (fig. 16). Material being discharged was primarily sand or larger material. Fifteen percent of the material was estimated to be silt and clay (table 6). A strong flood tide during data collection (fig. 17) caused a southward flow along the beach toward the entrance to Tampa Bay. Visible turbidity plumes were restricted to the vicinity of the discharge pipe and a narrow region along the beach. Turbidity levels ranging from 15 to 85 NTU were measured within 150 meters of the discharge pipe (photographs 12 and 13, fig. 18). Background data (fig. 18, no photograph) were collected at site 11.

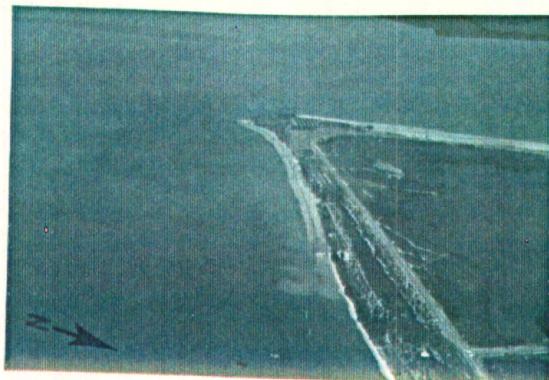
Site 15. Oblique view of beach nourishment on south shore of Mullet Key.

Time: 1210

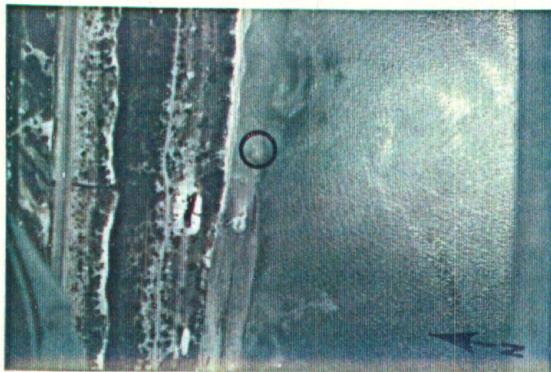
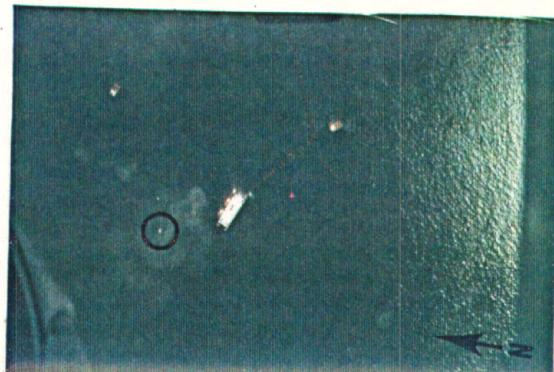
Site 16. Vertical view of beach nourishment on south shore of Mullet Key.

Time: 1140 Depth: 0.5 m
Scale (approx.): 1:9,100

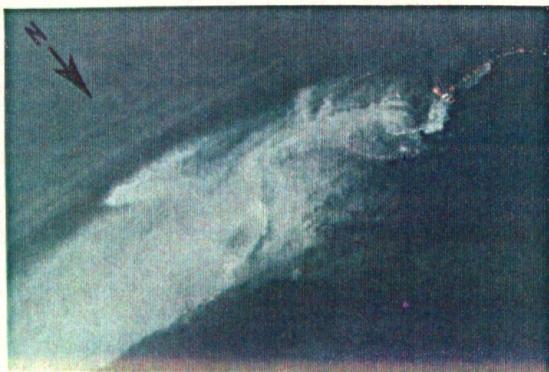
Turbidity (NTU)	Suspended solids (mg/L)	Trans- parency (cm)
Top	50	132	274
Middle	3	110	--
Bottom	9	122	--

Site 19. Oblique view of uncontained open water spoil disposal turbidity plume. Discharge outlet at top of picture is swinging from side to side causing the "S" patterns in the plume.

Secondary turbidity caused by erosion of previously deposited dredged material is visible in photographs 19, 20, and 21, particularly along the edges and openings in the primary S-shaped plume. Turbidity from eroding material is visually characterized by a linear series of dispersing puffs emanating from numerous points on the bottom. At a distance of about 500 meters from the discharge pipe, the primary and secondary plumes lose their identity and merge.

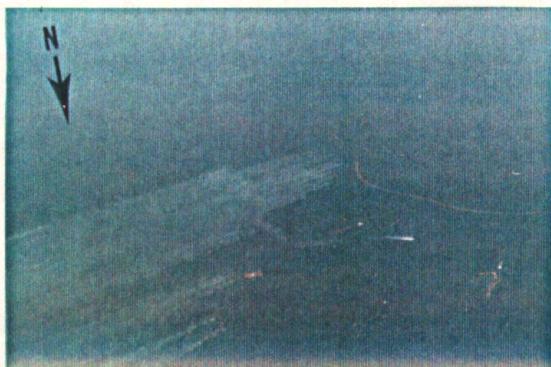
Turbidity (NTU)	Suspended solids (mg/L)	Trans- parency (cm)
Top	35	94	46
Middle	30	93	--
Bottom	35	105	--

Site 25. Oblique view of secondary erosional plume from previously deposited material in open-water disposal site. Dredge not operating.

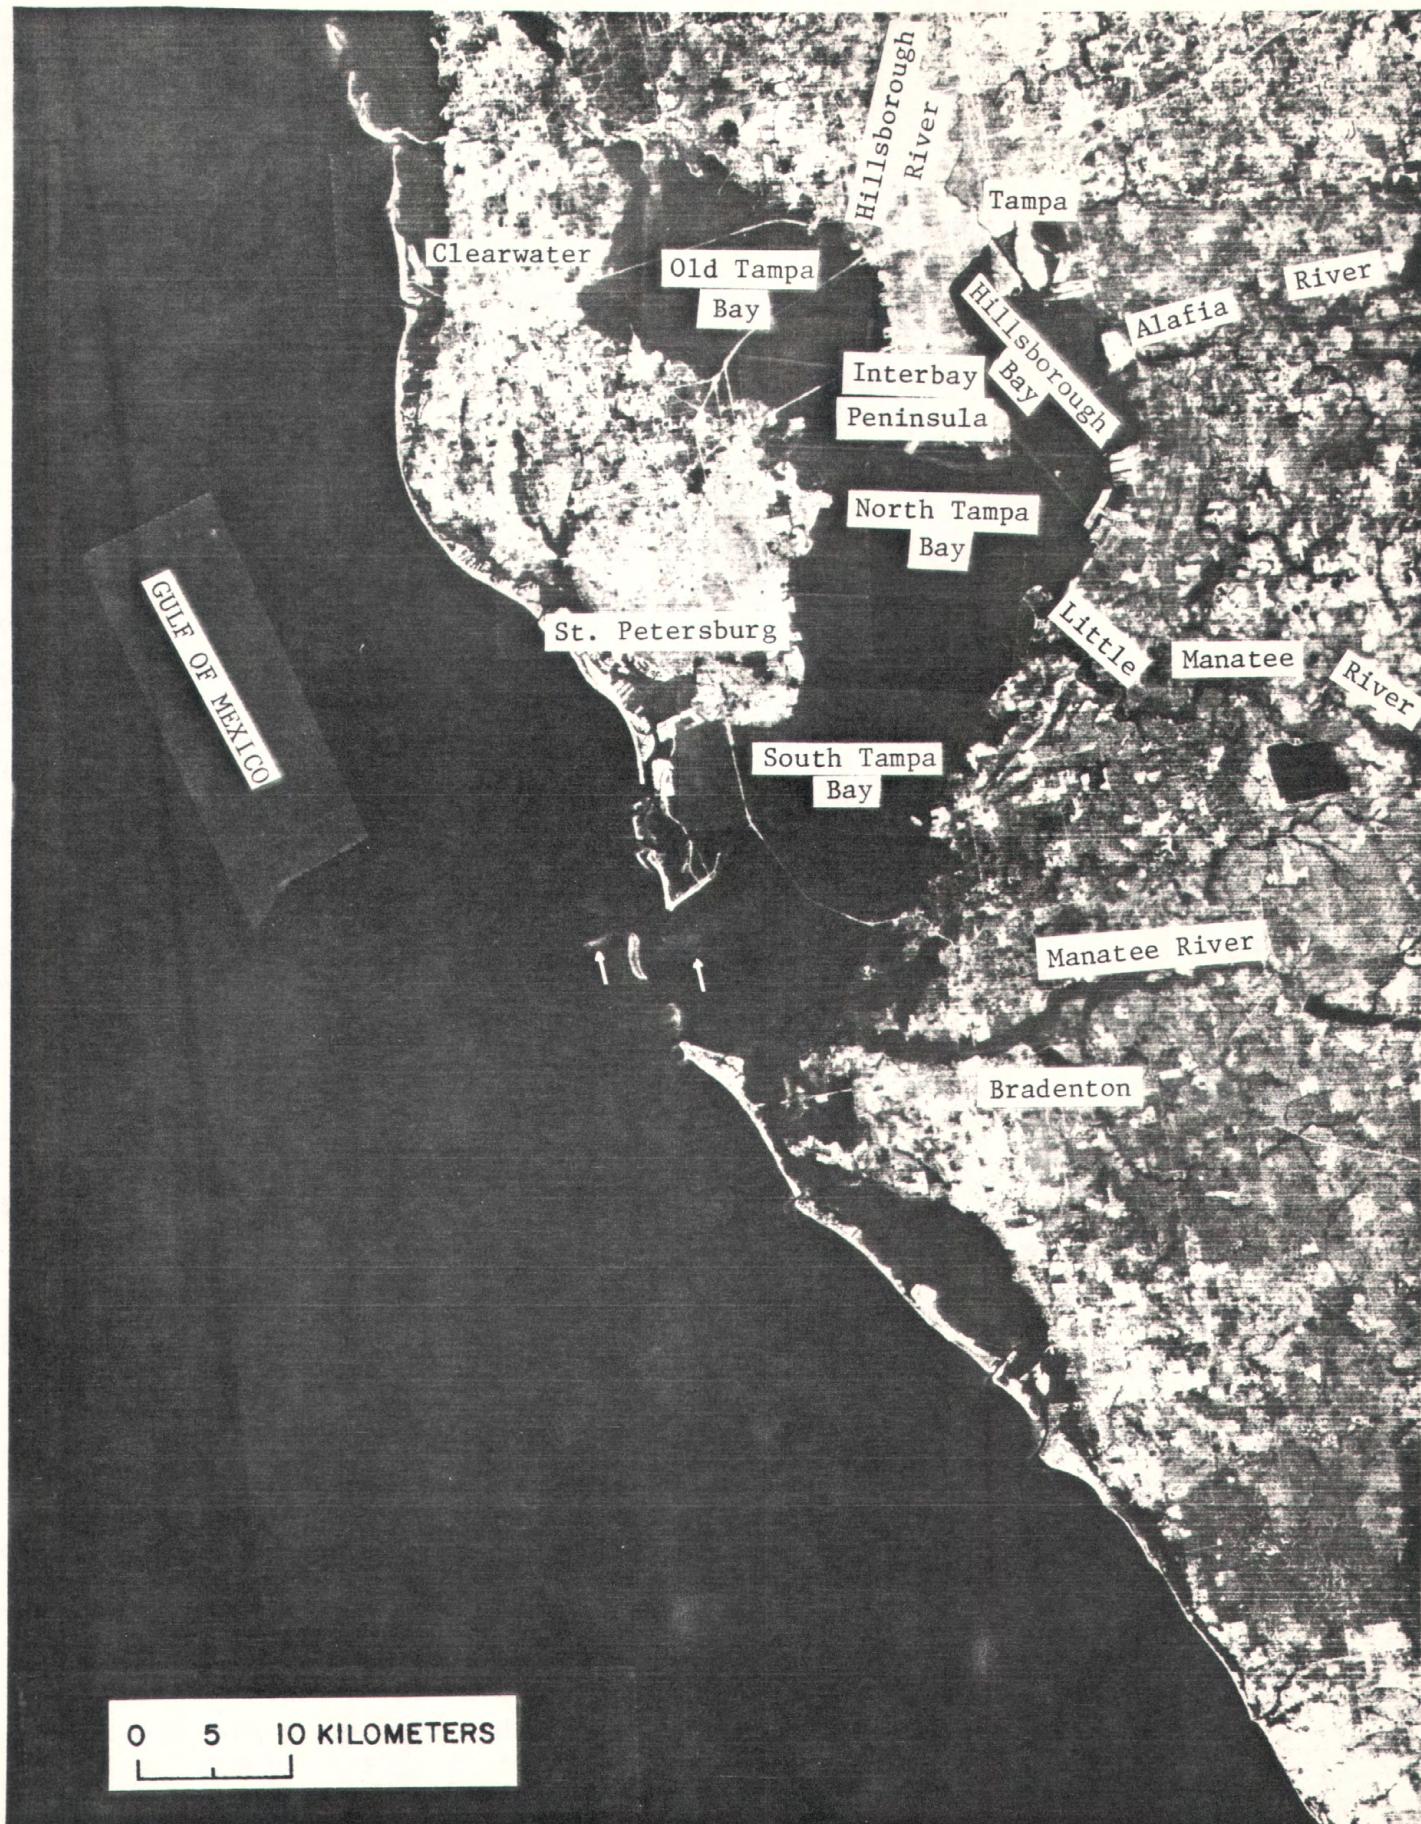
Figure 26.--Satellite image of west-central Florida showing both parts of a separated turbidity plume (arrows) at entrance to Tampa Bay.

A region of rapidly accelerating then decelerating flow near the mouth of Tampa Bay produced a two-part or separated plume. Flow acceleration contracted the width of the visible plume and subsequent flow deceleration caused plume expansion. The two wide parts of the plume appeared to be separated from each other because of the intervening narrow part.

The separated parts are indicated by arrows. Plume contraction and expansion is a surface expression of the rapidly accelerating and decelerating flow on either side of the relatively narrow, 800 meter, and locally deep, 20 to 30 meter, entrance channel to Tampa Bay between Egmont and Mullet Keys. In the region of highest velocities, at the northern tip of Egmont Key, the plume becomes narrow enough to lose its identity. One plume, therefore, appears as two distinct units, a separated plume.

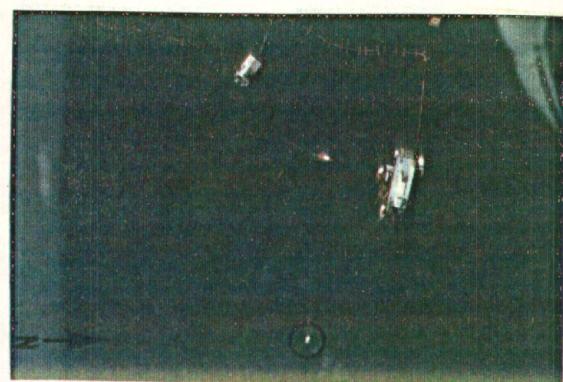
Site 32. Vertical view of cutterhead dredge Blackburn in operation. Sample site is about 110 m from dredge.

Time: 1200 Depth: 15.5 m
Scale (approx.): 1:6,100

Sampling locations successively closer to the pipeline discharge outlet, each having higher levels of turbidity and suspended solids, are shown in photographs 29, 30, and 31 (figs. 29 and 30). The intermittent nature of the primary plume is due to noncontinuous dredge operation or presence of hard limestone and difficult dredging conditions. Photograph 32 (fig. 30) shows a sample site in a small turbid patch apparently created by the dredge.

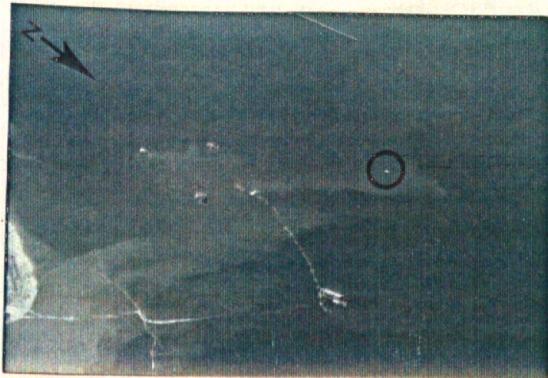
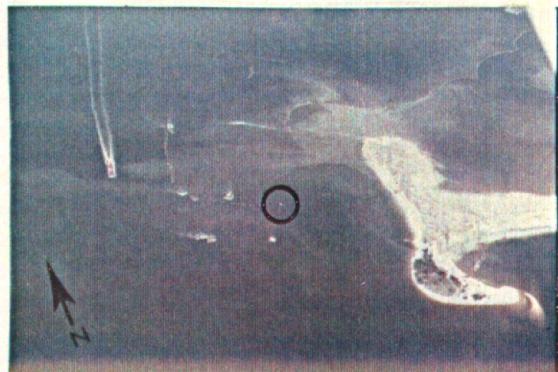
Site 34. Oblique view of sample site near edge of visible plume, 600 m from source.

Time: 1100 Depth: 4.9 m

A background sample (site 33, no photograph, fig. 33) was collected about 750 meters west of the discharge site. The relatively high bottom turbidity at the background site suggests a more widespread plume near the bay bottom than indicated by the visible plume near the water surface. Oblique photographs 34, 35, and 36 (fig. 33) show overviews of the area from three different vantage points (fig. 31). The visible turbidity plume extends to the west-southwest from the discharge site for about 2 kilometers. Sample sites shown in oblique photographs 34, 35, and 36 are within the plumes and outside the turbidity barrier. Vertical photographs 37, 38, 39, and 40 (fig. 34) show sample sites within the turbidity barrier or at points of incomplete barrier closure.

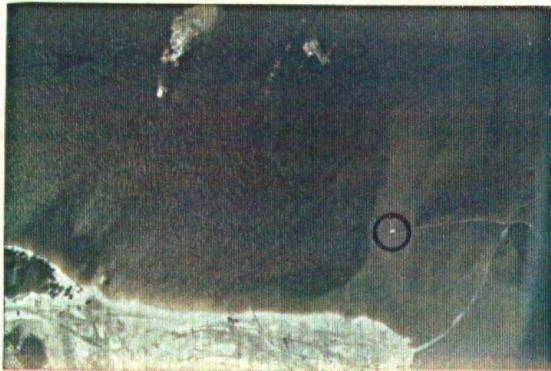
Site 37. Vertical view of sample site at opening between barrier and dike, 170 m from source.

Time: 1115 Depth: 2.1 m
Scale (approx.): 1:9,100

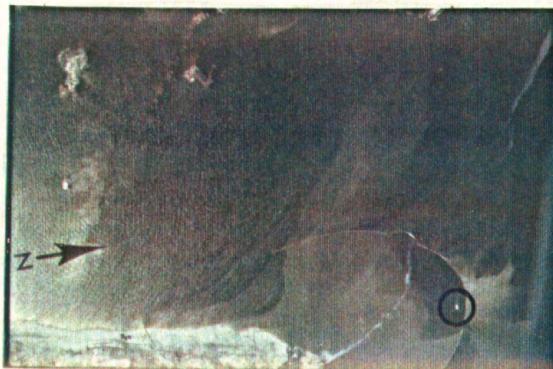
Site 39. Vertical view of sample site next to silt curtain, 270 m from source.

Time: 1130 Depth: 1.2 m
Scale (approx.): 1:9,100

Turbidity (NTU)	Suspended solids (mg/L)	Transparency (cm)
Top	30	81	30
Middle	35	92	--
Bottom	40	108	--

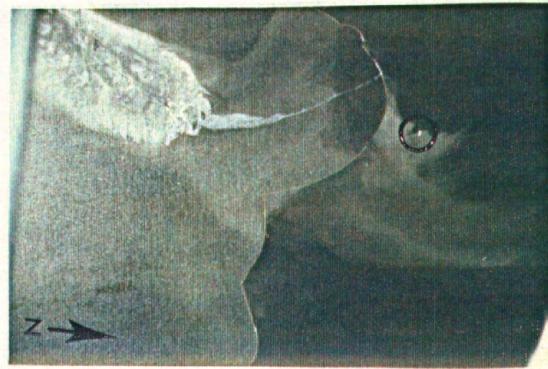
Site 40. Vertical view of sample site near gap, 320 m from source.

Time: 1135 Depth: 2.1 m
Scale (approx.): 1:9,100

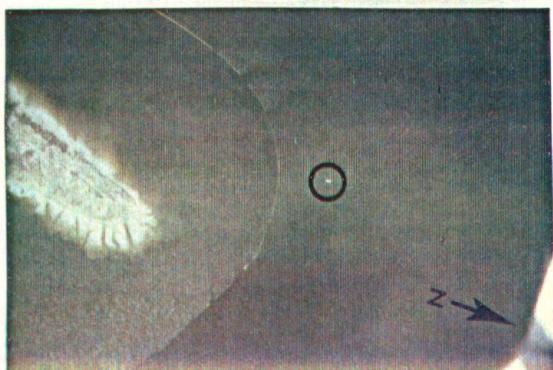
Site 43. Vertical view of sample site outside turbidity barrier.

Time: 1000 Depth: 3.0 m
Scale (approx.): 1:9,100

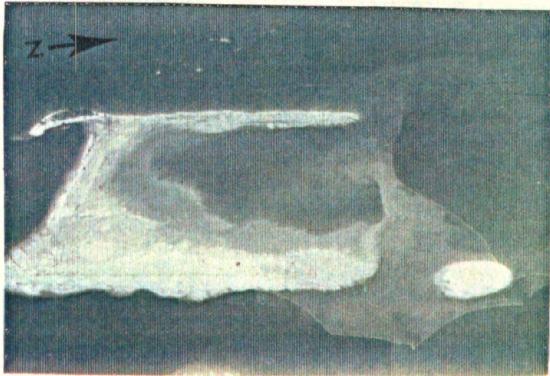
Site 42. Oblique view of partially completed diked impoundment with turbidity barrier in at dredge discharge on northern end of foreground dike.

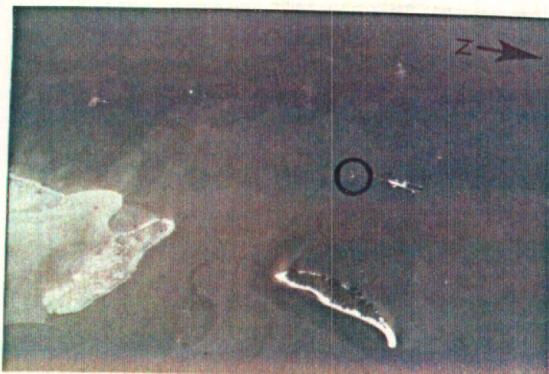
Site 52. Oblique view of sample site near Condor dredge.

Time: 0915 Depth: 13.7 m

A background sample, site 50 (fig. 41, no photograph), was collected northwest of the dredging area (fig. 39). A well-defined plume or turbid area was not visible near the dredge or disposal site outside the turbidity barrier (photograph 51, fig. 41). Two samples were taken near the dredge (photographs 52 and 53), and one was taken outside the barrier nearest the pipeline discharge site (photograph 54). High bottom turbidity in the construction area (sites 52, 53, and 54) indicated probable movement of fluid mud from the partly completed impoundment. Lower turbidity values at top and middle depths indicated rapid settling of fine material and effective operation of turbidity barriers. Photographs 55 and 56 (fig. 42) show an example of the generation of a secondary turbidity plume induced by turbulence from a pipe-towing vessel resuspending settled dredge material. Photograph 56 was taken 45 minutes after photograph 55 at the same shutter speed with a more open aperture. Some of the feathery texture visible in these two photographs may be bay-bottom features and edges of the secondary plume.

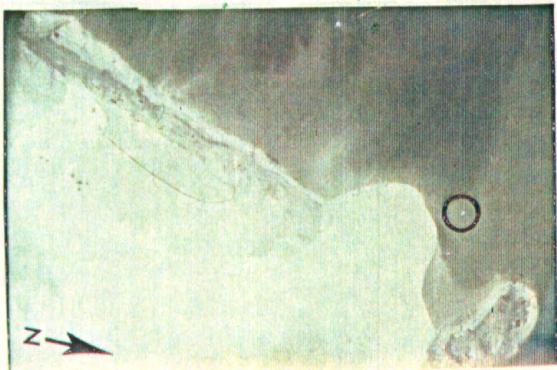
Site 54. Vertical view of sample site near turbidity barrier.

Time: 1000 Depth: 1.5 m
Scale (approx.): 1:9,100

Turbidity (NTU)	Suspended solids (mg/L)	Transpareny (cm)
Top	50	66	15
Middle	45	77	--
Bottom	2,000	5,430	--

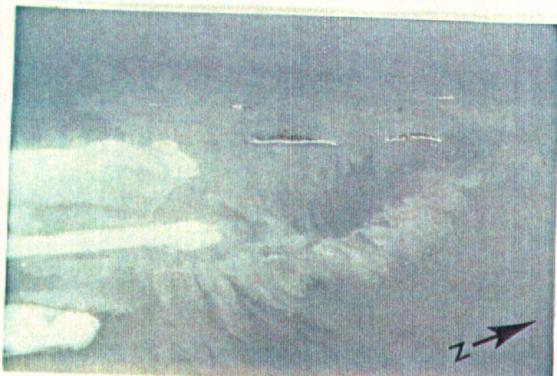
Site 56. Oblique view taken 45 minutes after photograph 55 showing dispersion of secondary plume. One stop greater exposure than photograph 55.

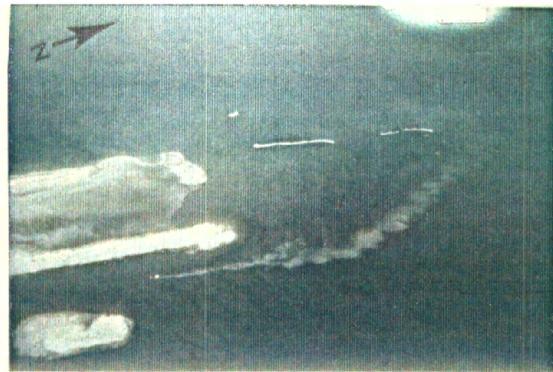
Site 55. Oblique view showing secondary turbidity plume in wake of vessel towing pipeline.

Time: 0920

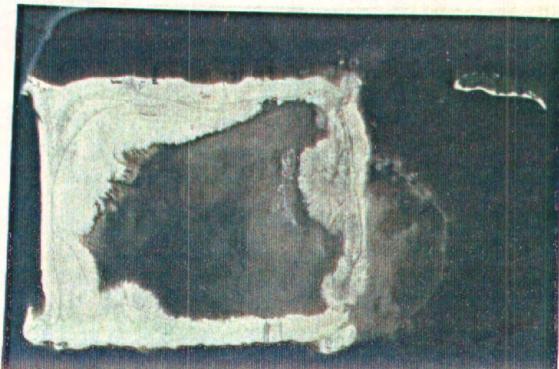
Site 58. Vertical view of completed impoundment taken on August 14, 1978, showing containment of fine material by turbidity barrier.
