**AERIAL PHOTOGRAPH SHOWING OUTLINES OF STUDY AREA AND SUBCATCHMENTS, LOCATION OF RAIN GAGE AND MONITORING SITE FOR VILLA ITALIA STORM DRAIN AT LAKEWOOD, COLORADO**

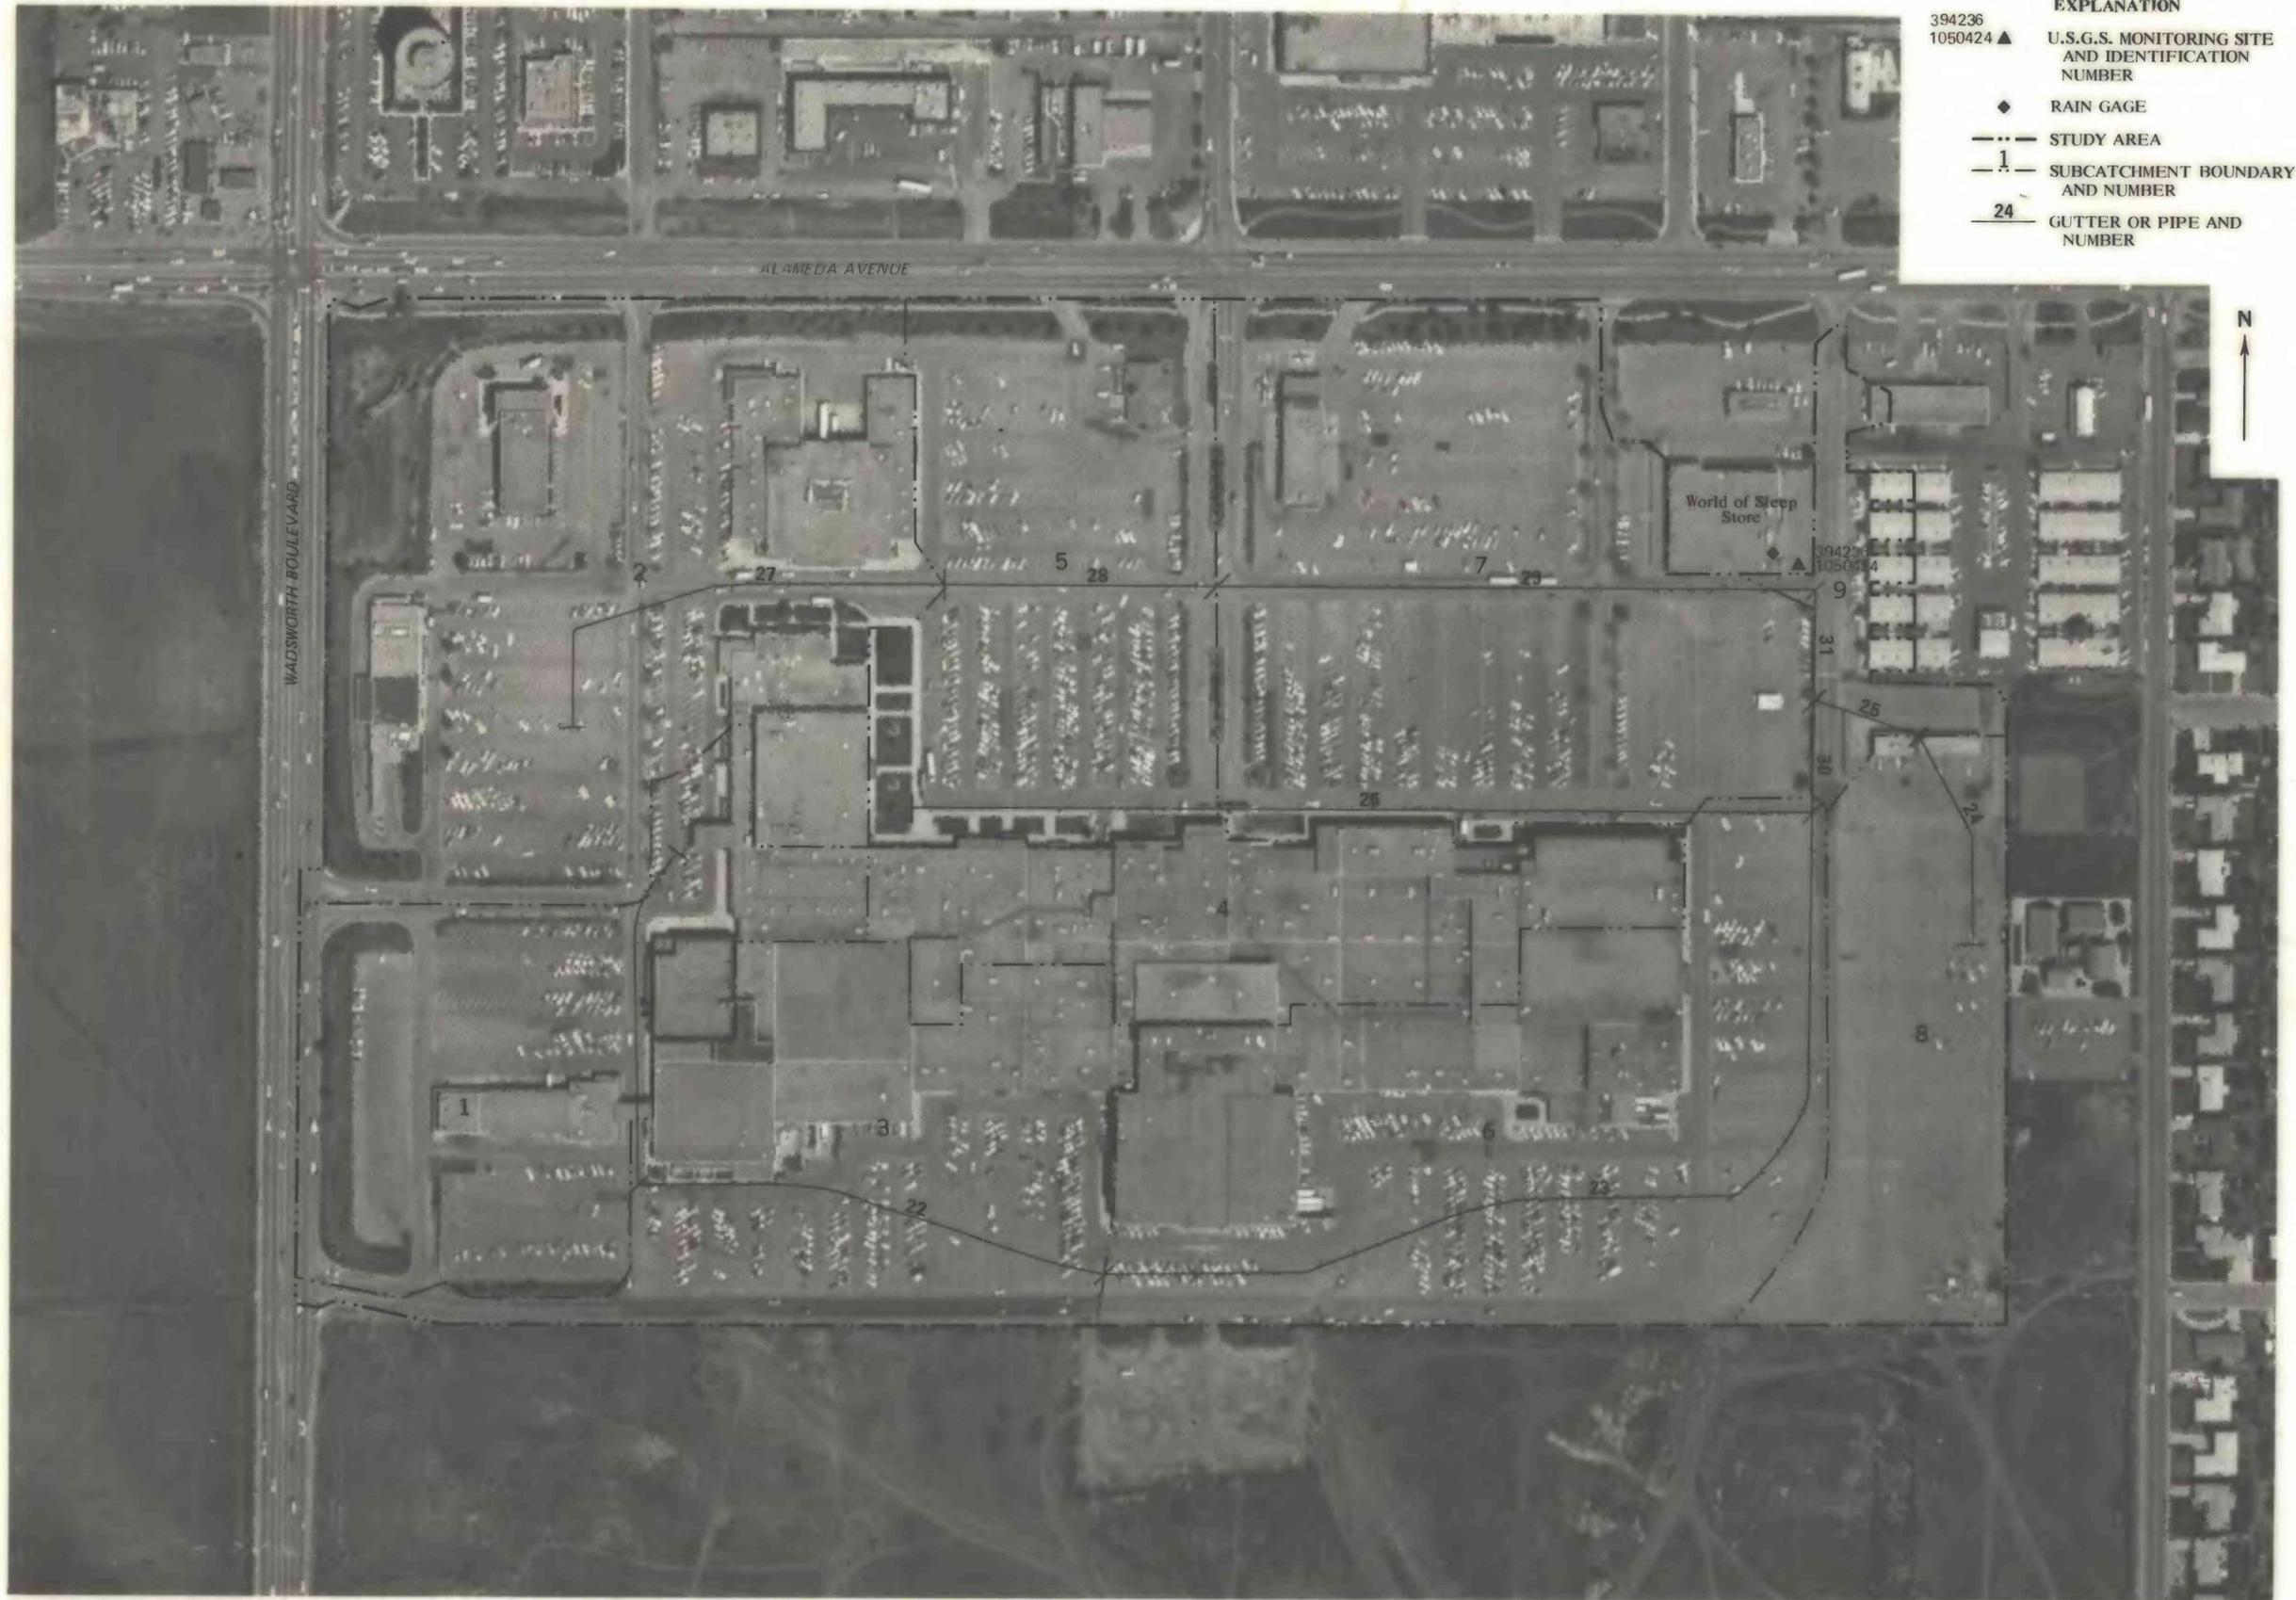
- EXPLANATION**
- 394236  
1050424 ▲ U.S.G.S. MONITORING SITE AND IDENTIFICATION NUMBER
  - ◆ RAIN GAGE
  - - - STUDY AREA
  - 1 - SUBCATCHMENT BOUNDARY AND NUMBER
  - 24 - GUTTER OR PIPE AND NUMBER
