LANDSLIDES AND RELATED FEATURES

OF THE BARNABUS, W. VA. QUADRANGLE

William F. Outerbridge 1982

OPEN FILE MAP 82-51 (F-16)

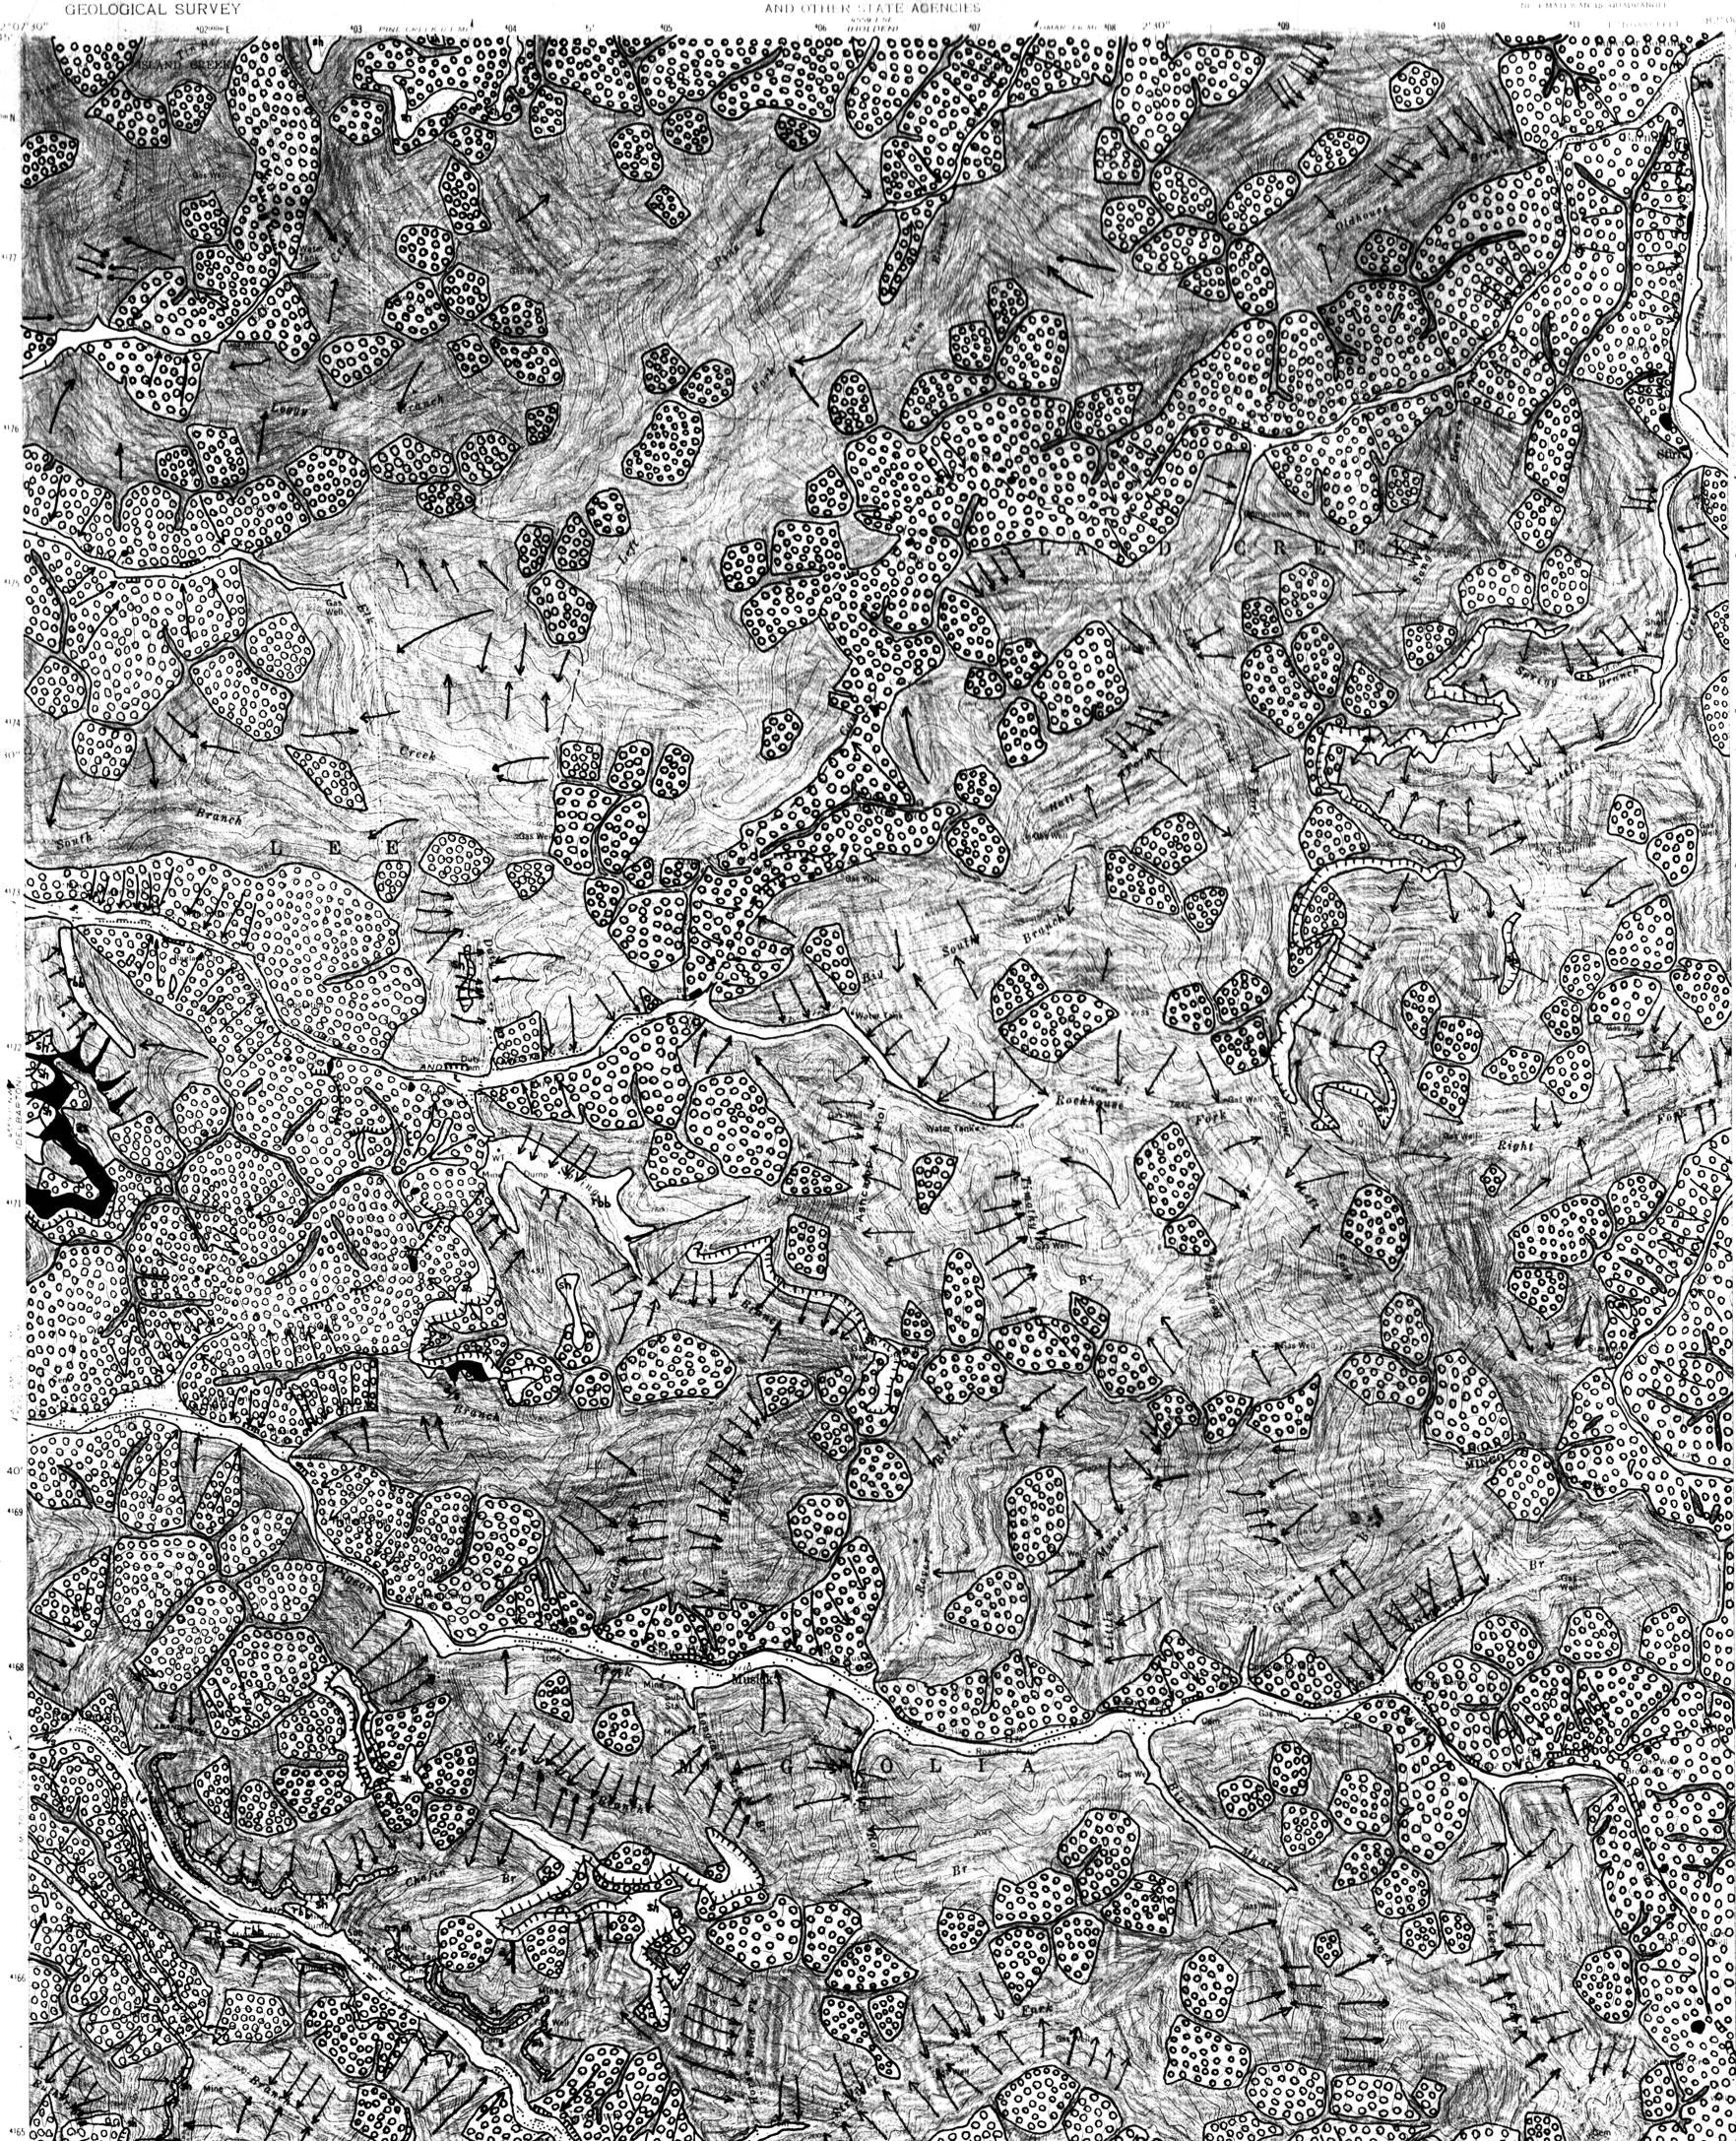
ACTIVE OR RECENTLY ACTIVE LANDSLIDE Complex landslide composed of earthflow, debris slide, earth and rock slump. Identified from historical records, and from scars, debris and other field evidence. Ground extremely unstable; sliding accelerated by excavation, loading and changes in drainage conditions. May include areas with several active slides too small to be shown separately. Questioned where doubtful.

Area of extensive hummocky ground caused by earthflow and earth and rock slump. Lacks clear evidence of active sliding. Relatively stable in natural, undisturbed state, generally not affected by small structures properly sited in areas away from the edge of the toe; can be reactivated by extensive, rapid excavation, loading, and changes in ground water and surface water conditions. Area of old landslide probably includes recent ones not identified from field evidence or otherwise documented. Upslope boundary of landslide generally defined by modified scarp, but downslope (toe) may be gradational and not well defined. Questioned where doubtful.

COLLUVIAL SLOPE Valley wall along major streams with slope as steep as 40° (85%); stony, clayey silt soil up to 50 ft. (15 m) thick; commonly buttressed by a terrace or bench at the toe of the slope; very susceptible to sliding by cutting of toe area, removal of terrace or bench, and overloading; slide commonly activated without apparent cause.

AREAS SUSCEPTIBLE TO DEBRIS FLOWS AND DEBRIS AVALANCHES Primarily shallow, narrow ravines and chutes with accumulation of stony colluvium generally 10 ft. (3 m) or less in thickness; susceptible to rapid movement during intense rainfall. Most ravines and chutes designated show evidence of former debris flows and avalanches. Symbol & designates historical debris flow or debris avalanche.

AREAS SUSCEPTIBLE TO ROCKFALL Steep, locally vertical, natural and man-made slopes and cliffs, 15 ft. (4.5 m) or more high; formed dominantly of sandstone, limestone, sandy shale, mudstone and claystone. Interbedded mudstone, claystone and shale weather rapidly leaving sandstone and limestone rock faces unsupported.

SOIL AND ROCK SUSCEPTIBLE TO LANDSLIDING Soil and rock similar to that involved in landslides elsewhere in map area; primarily areas underlain by claystone, mudstone and shale associated with other rock types. Rock weathers rapidly on exposure forming clayey soil highly susceptible to sliding. Includes coves (U-shaped, shallow valleys) containing thick layers of clayey soil that are very susceptible to sliding where excavation breaks continuity of slope and where overloaded by artificial fill.

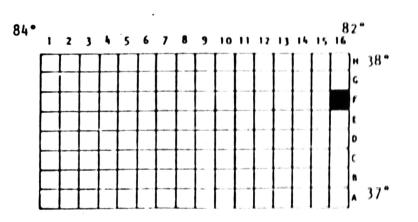
earth flow in coal refuse JENKINS 1°x2° SHEET

The first four digits of the open file number designate the specific 1:250,000 scale map sheet of which this quadrangle is a part. The last two digits designate the position of the quadrangle in a subdivision of the 1:250,000 scale map based on rows and tiers shown in the diagram to the right. The location of this quadrangle is shown by the black square.
