SLADE, KY.  
SW 1/4 PRELIMINARY TO QUADRANGLE  
N 3745 W 8337.5 7.5  
1966

## LANDSLIDES AND RELATED FEATURES

OF THE SLADE, KY. QUADRANGLE  
by  
William F. Outerbridge  
1982  
U.S. Geological Survey  
OPEN FILE MAP 82-51 (G-3)

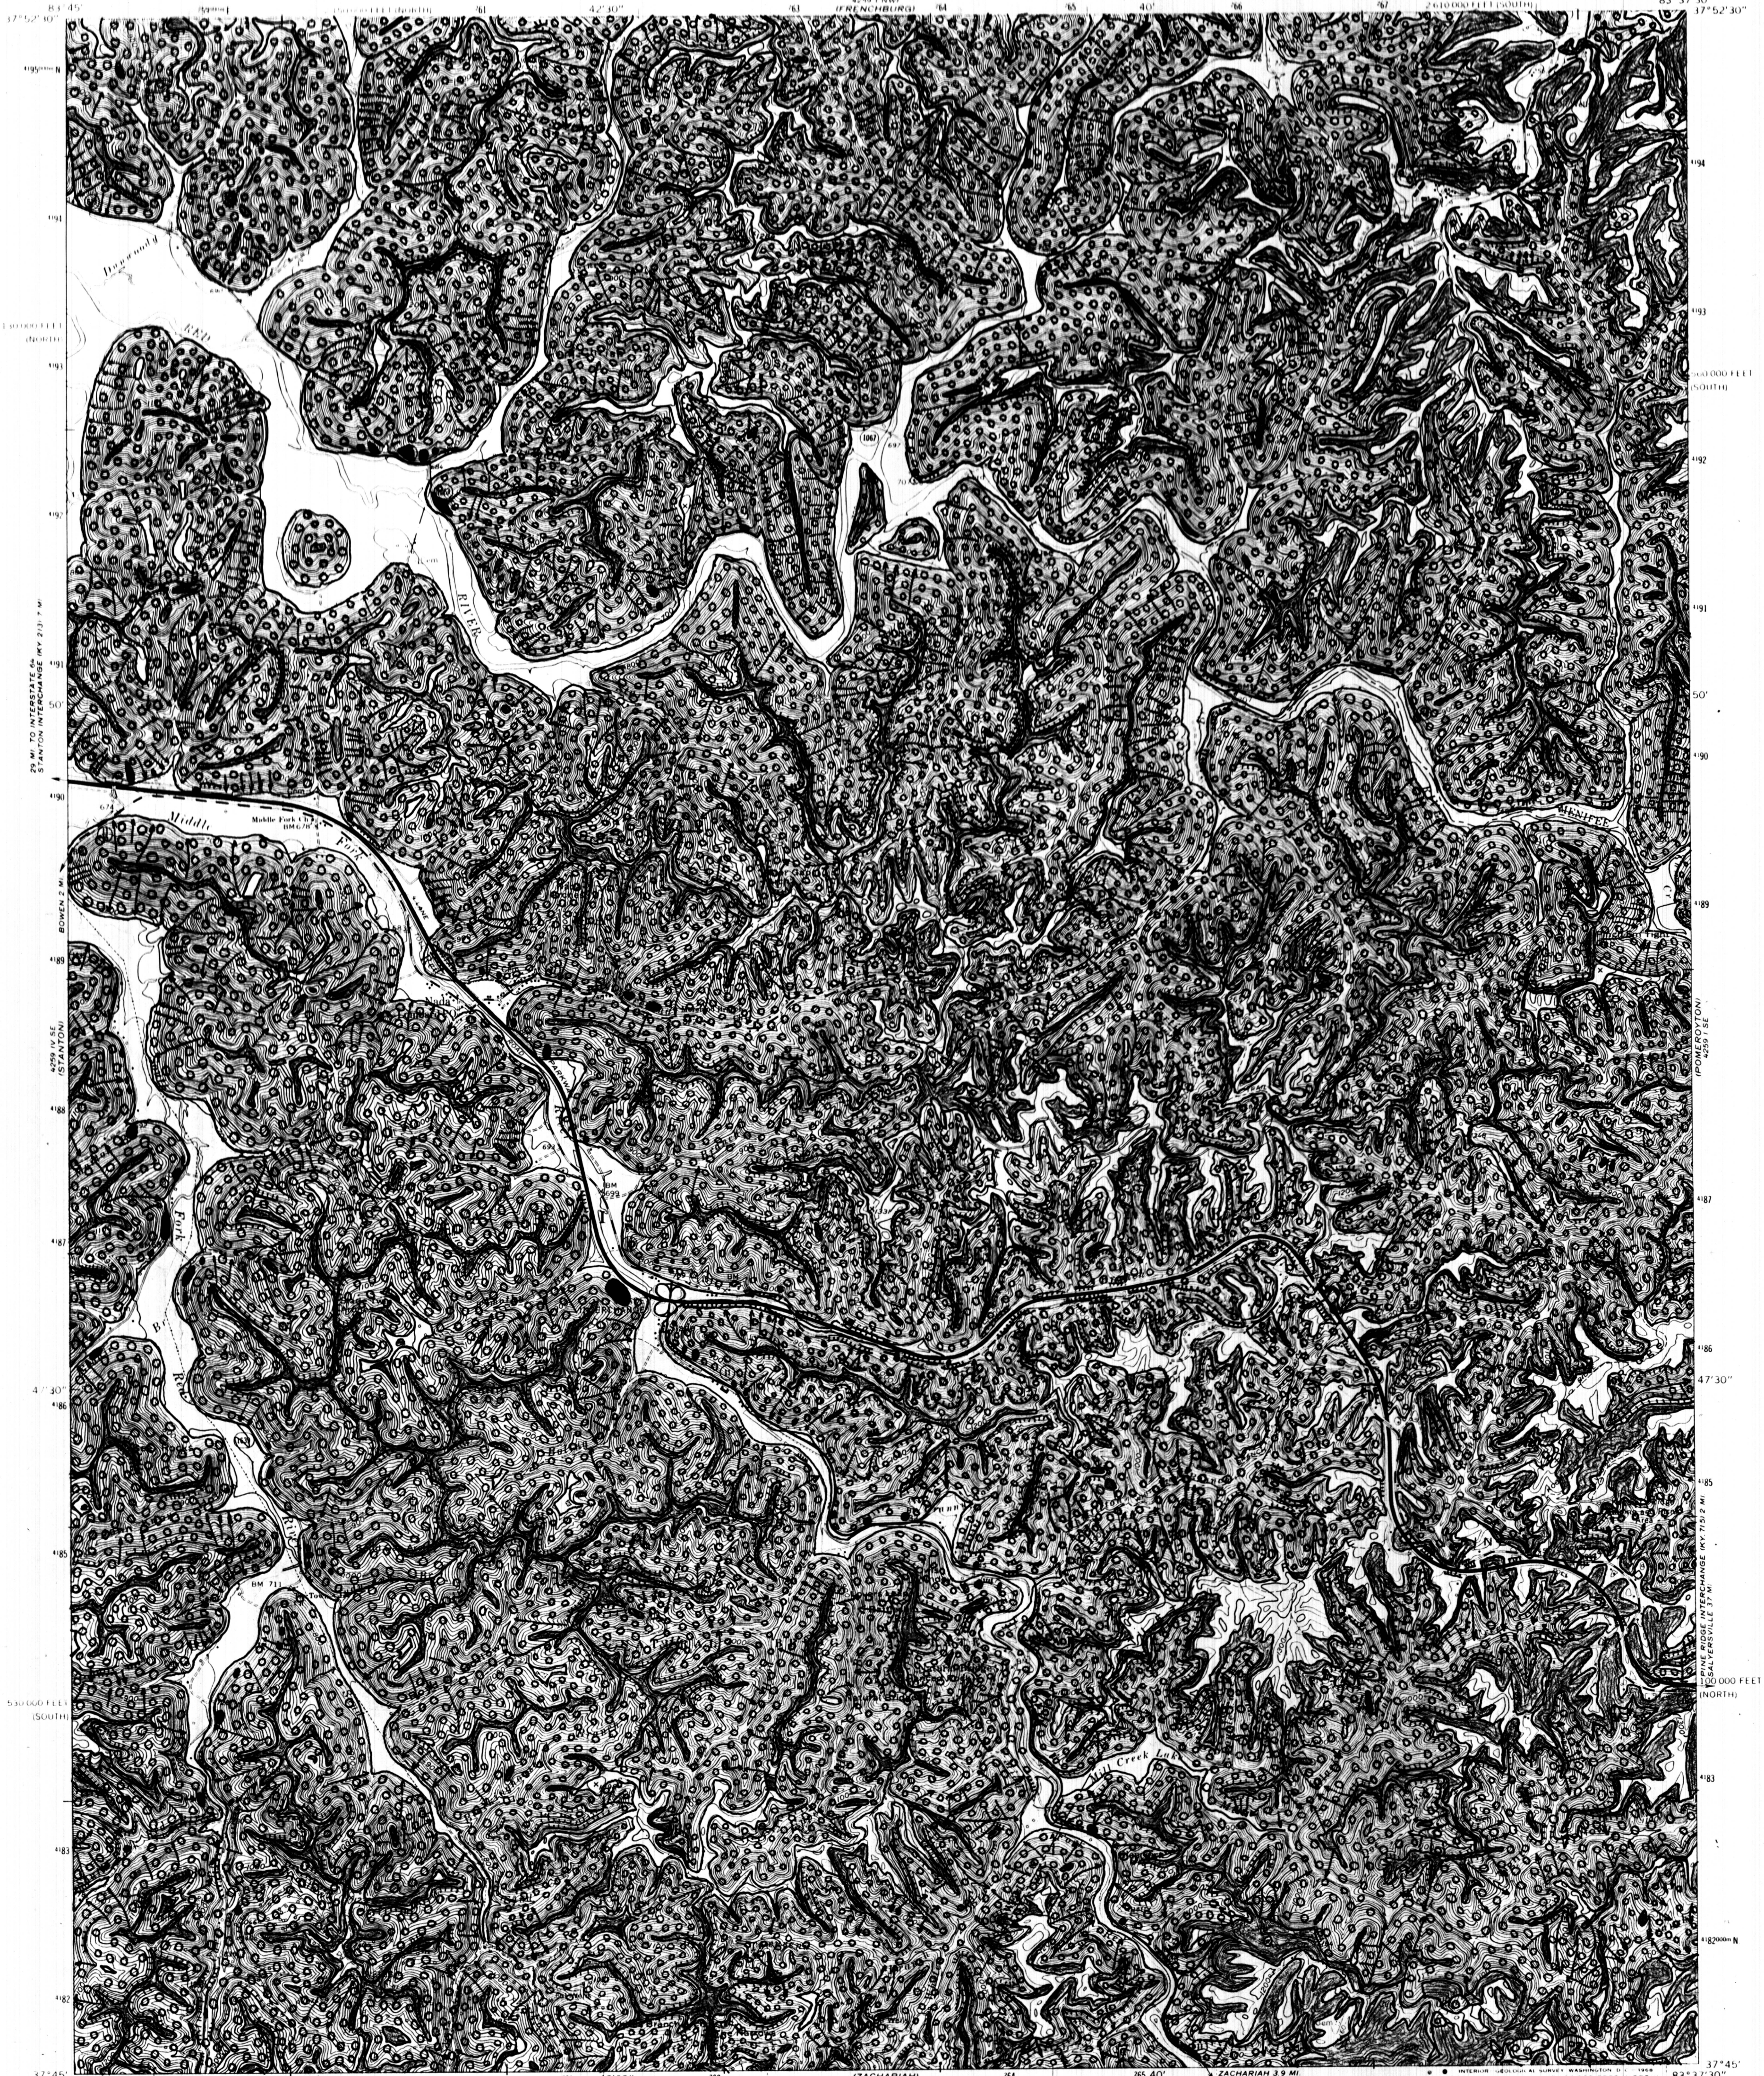
Landslides and related features interpreted  
from aerial photographs:  
1:60,000 (black and white) 1959  
1:80,000 (black and white) 1977

Photointerpretation and field check 1978,9  
This report is preliminary and has not  
been reviewed for conformity with U. S.  
Geological Survey editorial standards.

- ACTIVE OR RECENTLY ACTIVE LANDSLIDE**  
Complex landslide composed of earthflow, debris  
slide, earth and rock slump. Identified from  
historical records, and from scars, debris and  
other field evidence. Ground extremely unstable;  
sliding accelerated by excavation, loading and  
changes in drainage conditions. May include  
areas with several active slides too small to  
be shown separately. Questioned where doubtful.

- OLD LANDSLIDE**  
Area of extensive hummocky ground caused by  
earthflow and earth and rock slump. Lacks  
clear evidence of active sliding. Relatively  
stable in natural, undisturbed state,  
generally not affected by small structures properly  
sited in areas away from the edge of the toe;  
can be reactivated by extensive, rapid exca-  
vation, loading, and changes in ground water and  
surface water conditions. Area of old landslide  
probably includes recent ones not identified  
from field evidence or otherwise documented.  
Upslope boundary of landslide generally defined  
by modified scarp, but downslope (toe) may be  
gradational and not well defined. Questioned  
where doubtful.

- COMBINATION LANDSLIDE**  
Area of recent and old slides in which  
individual slides are not identified.
- COLLUVIAL SLOPE**  
Valley wall along major streams with slope as  
steep as 40° (85%); stony, clayey silt soil up  
to 50 ft. (15 m) thick; commonly buttressed by  
a terrace or bench at the toe of the slope; very  
susceptible to sliding by cutting of toe area,  
removal of terrace or bench, and overloading;  
slide commonly activated without apparent cause.

- COLLUVIAL SLOPES WITH LANDSLIDES**  
Landslides too small or obscure to map  
individually.
- AREAS SUSCEPTIBLE TO DEBRIS FLOWS AND DEBRIS  
AVALANCHES**  
Primarily shallow, narrow ravines and chutes with  
accumulation of stony colluvium generally 10 ft.  
(3 m) or less in thickness; susceptible to rapid  
movement during intense rainfall. Most ravines  
and chutes designated show evidence of former  
debris flows and avalanches. Symbol & design-  
ates historical debris flow or debris avalanche.

- AREAS SUSCEPTIBLE TO ROCKFALL**  
Steep, locally vertical, natural and man-made  
slopes and cliffs, 15 ft. (4.5 m) or more high;  
formed dominantly of sandstone, limestone, sandy  
shale, mudstone and claystone. Interbedded mud-  
stone, claystone and shale weather rapidly leaving  
sandstone and limestone rock faces unsupported.

- SOIL AND ROCK SUSCEPTIBLE TO LANDSLIDING**  
Soil and rock similar to that involved in land-  
slides elsewhere in map area; primarily areas  
underlain by claystone, mudstone and shale  
associated with other rock types. Rock weathers  
rapidly on exposure forming clayey soil highly  
susceptible to sliding. Includes coves (U-shaped,  
shallow valleys) containing thick layers of clayey  
soil that are very susceptible to sliding where  
excavation breaks continuity of slope and where  
overloaded by artificial fill.

- AREAS LEAST PRONE TO LANDSLIDES**  
Map areas in which no patterns or symbols are shown;  
primarily valley floors, ridge tops and broad  
benches; modification by excavation and fill may  
lead to local landslides.

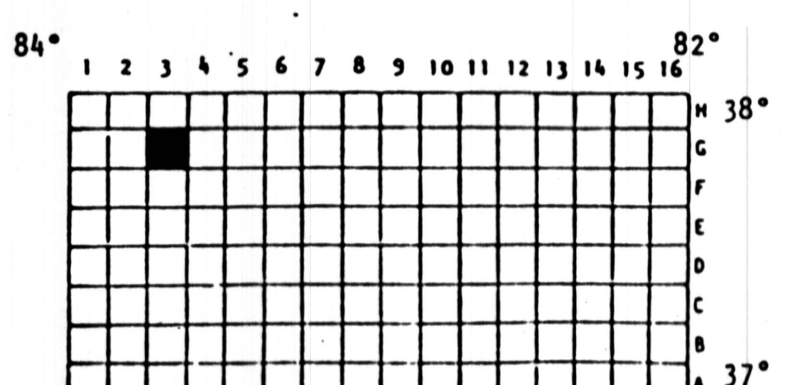
The first four digits of the open file number designate the  
specific 1:250,000 scale map sheet of which this quadrangle  
is a part. The last two digits designate the position of the  
quadrangle in a subdivision of the 1:250,000 scale map based  
on rows and tiers shown in the diagram to the right. The  
location of this quadrangle is shown by the black square.
