INTRODUCTION

HYDROGEOLOGY FOR LAND-USE PLANNING: THE POTTER CREEK AREA, ANCHORAGE, ALASKA

By Richard P. Emanuel and Derrill J. Cowing
1982

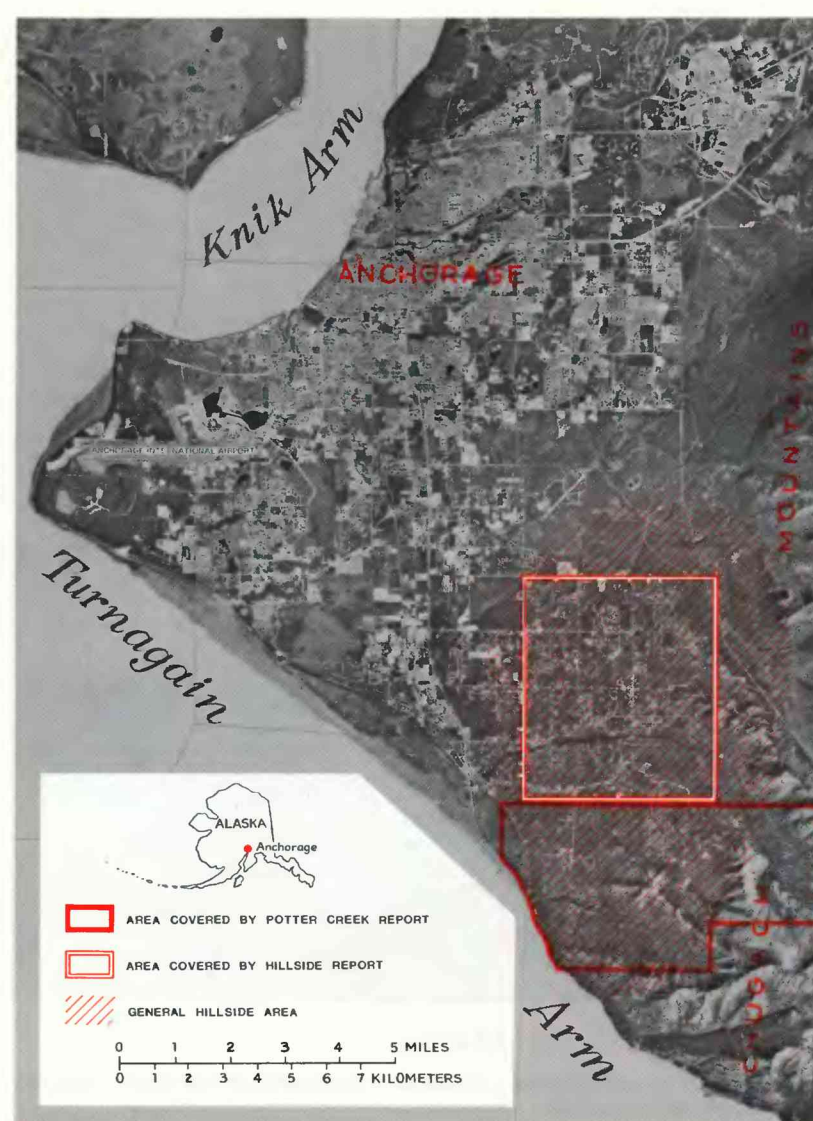
Figure 1. -- Location of Potter Creek study area. Also shown are the study area of the "Hillside report", (Dearborn and Barnwell, 1975) and the general Hillside area which encompasses both study areas.

Many new homes are being built in the southeast quadrant of the Anchorage bowl, an area locally known as the Hillside and which includes the Potter Creek area (fig. 1). By mid-1980, about 220 homes had been built in the study area (Bruce Silva, Municipality of Anchorage, written commun., June 1980).

A map showing wetlands and areas of shallow ground water in the Potter Creek area is presented on sheet 3 of this report (fig. 1). Further discussion of the limitations on development created by drainage problems and the occurrence of shallow ground water is presented with figure 11.

Figure 5 shows monthly precipitation for 3 years of record (1977-79) at two National Weather Service stations in Anchorage: the Little Rabbit Creek station on Nickleken Drive (fig. 2), and the Anchorage International Airport station (fig. 1), about 11 mi northwest of Nickleken Drive. Data for the Little Rabbit Creek station are from unpublished National Weather Service records (Gerald Nibler, National Weather Service, written commun., May 1980). For the 4 months when Little Rabbit Creek station data were not available, estimates were made based on National Weather Service data from a nearby station at Glen Alps (fig. 3). Precipitation in the Anchorage area is derived primarily from warm, moist air from the Gulf of Alaska. As the air rises to pass over the mountains, it cools, inducing precipitation. There is thus a general increase in precipitation toward and into the Chugach Mountains, reflecting a general increase with altitude.

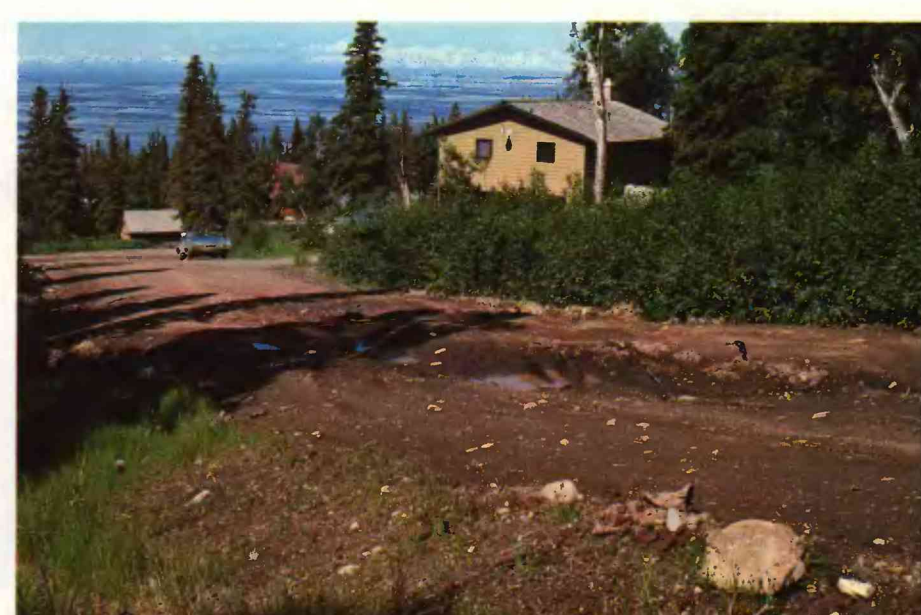
Figure 3a. -- Road damaged by seepage of shallow groundwater (172nd Avenue near Goldenview Drive, June 1979).

Except for the Old and New Seward Highways, all roads in the Potter Creek area are unpaved. In winter, ice builds up where ground water seeps onto road surfaces. In spring, runoff from melting snow and ice causes locally uneven, muddy surfaces where drainage is poor, or it may erode the roadway or, in more extreme cases, cause washouts. In places, roads are not passable for periods of time each spring. Some sites where drainage, icing, and erosion have damaged road surfaces or created other problems are shown in figures 3a-d. In addition to the inconvenience and hazards created by these road conditions, erosion of road surfaces and embankments adds to the suspended-sediment loads of nearby streams, which affects water quality. Although road washouts and winter icings are highly visible and sometimes spectacular, they are not the only problems that can arise in poorly drained soils. Ground-water seepage and frost heave can cause structural damage to houses as well as roads. In addition, shallow ground water can prevent proper functioning of septic systems. Special attention to potential drainage problems during design and construction of roads and houses can reduce or eliminate these problems.

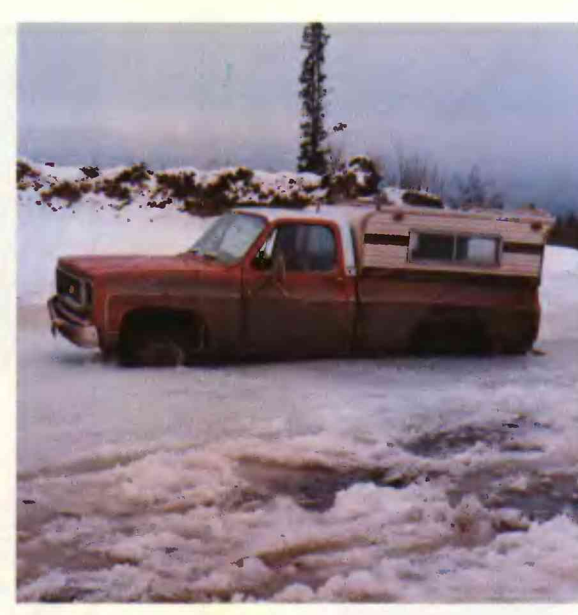
Figure 3b. -- Hazardous road conditions created by malfunctioning road drainage systems and freezing of subsequent ground-water seepage (Goldenview Drive, December 1980).

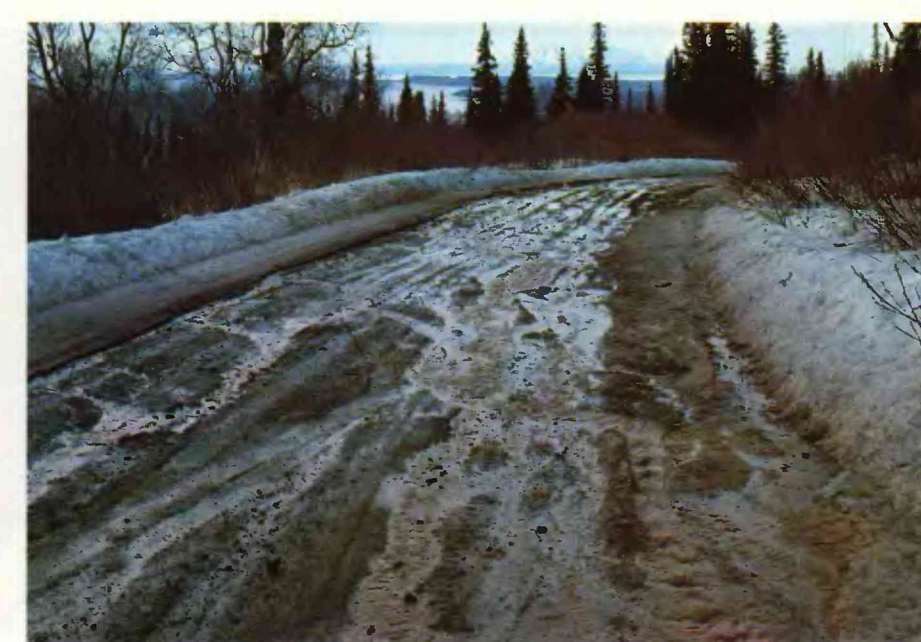
Figure 3c. -- Erosion of road by melt water during the spring (Spain Drive near Potter Creek, April 1980).

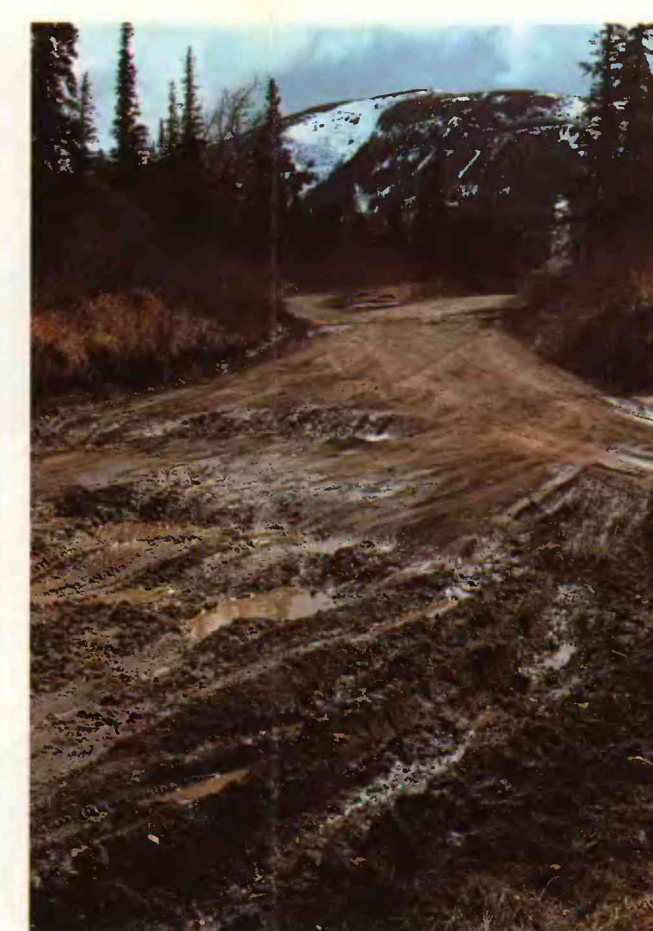
Figure 3d. -- Road damaged by poor drainage and high water table during the spring (Carl Street near upper Little Rabbit Creek, May 1980).

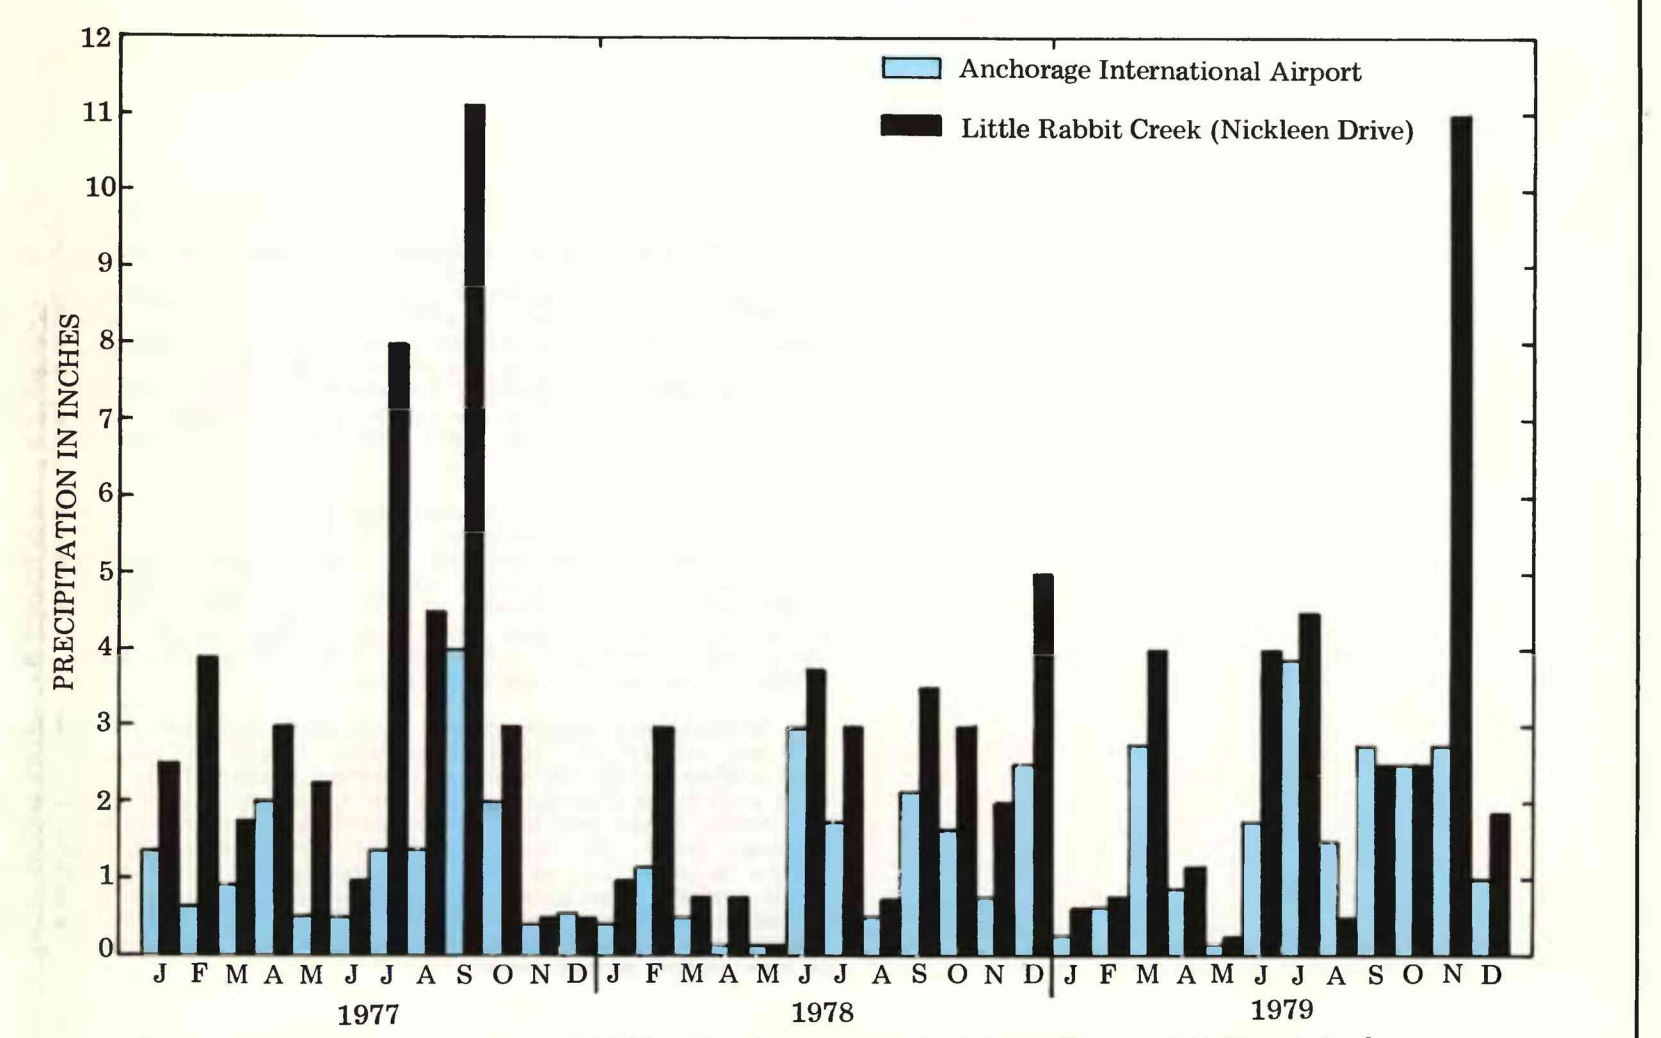
Figure 5. -- Monthly precipitation, 1977-79. Blue bars represent total monthly precipitation at Anchorage International Airport; black bars represent monthly precipitation at Little Rabbit Creek station on Nickleken Drive (fig. 2).
