FLOODING IN NORTHWESTERN HILLSBOROUGH AND  
SOUTHERN PASCO COUNTIES, FLORIDA, IN 1979

By  
W.R. Murphy, Jr., R.P. Evans, and J.K. Whalen  
1983

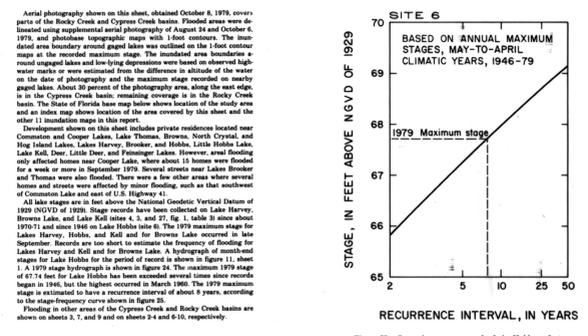
Figure 25.—Stage-frequency curve for Lake Hobbs at Lutz.

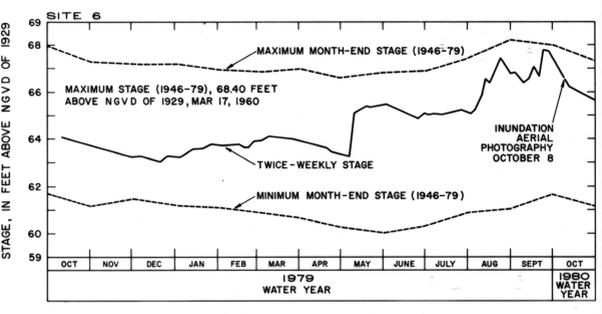
Figure 24.—Stage hydrographs for Lake Hobbs at Lutz.

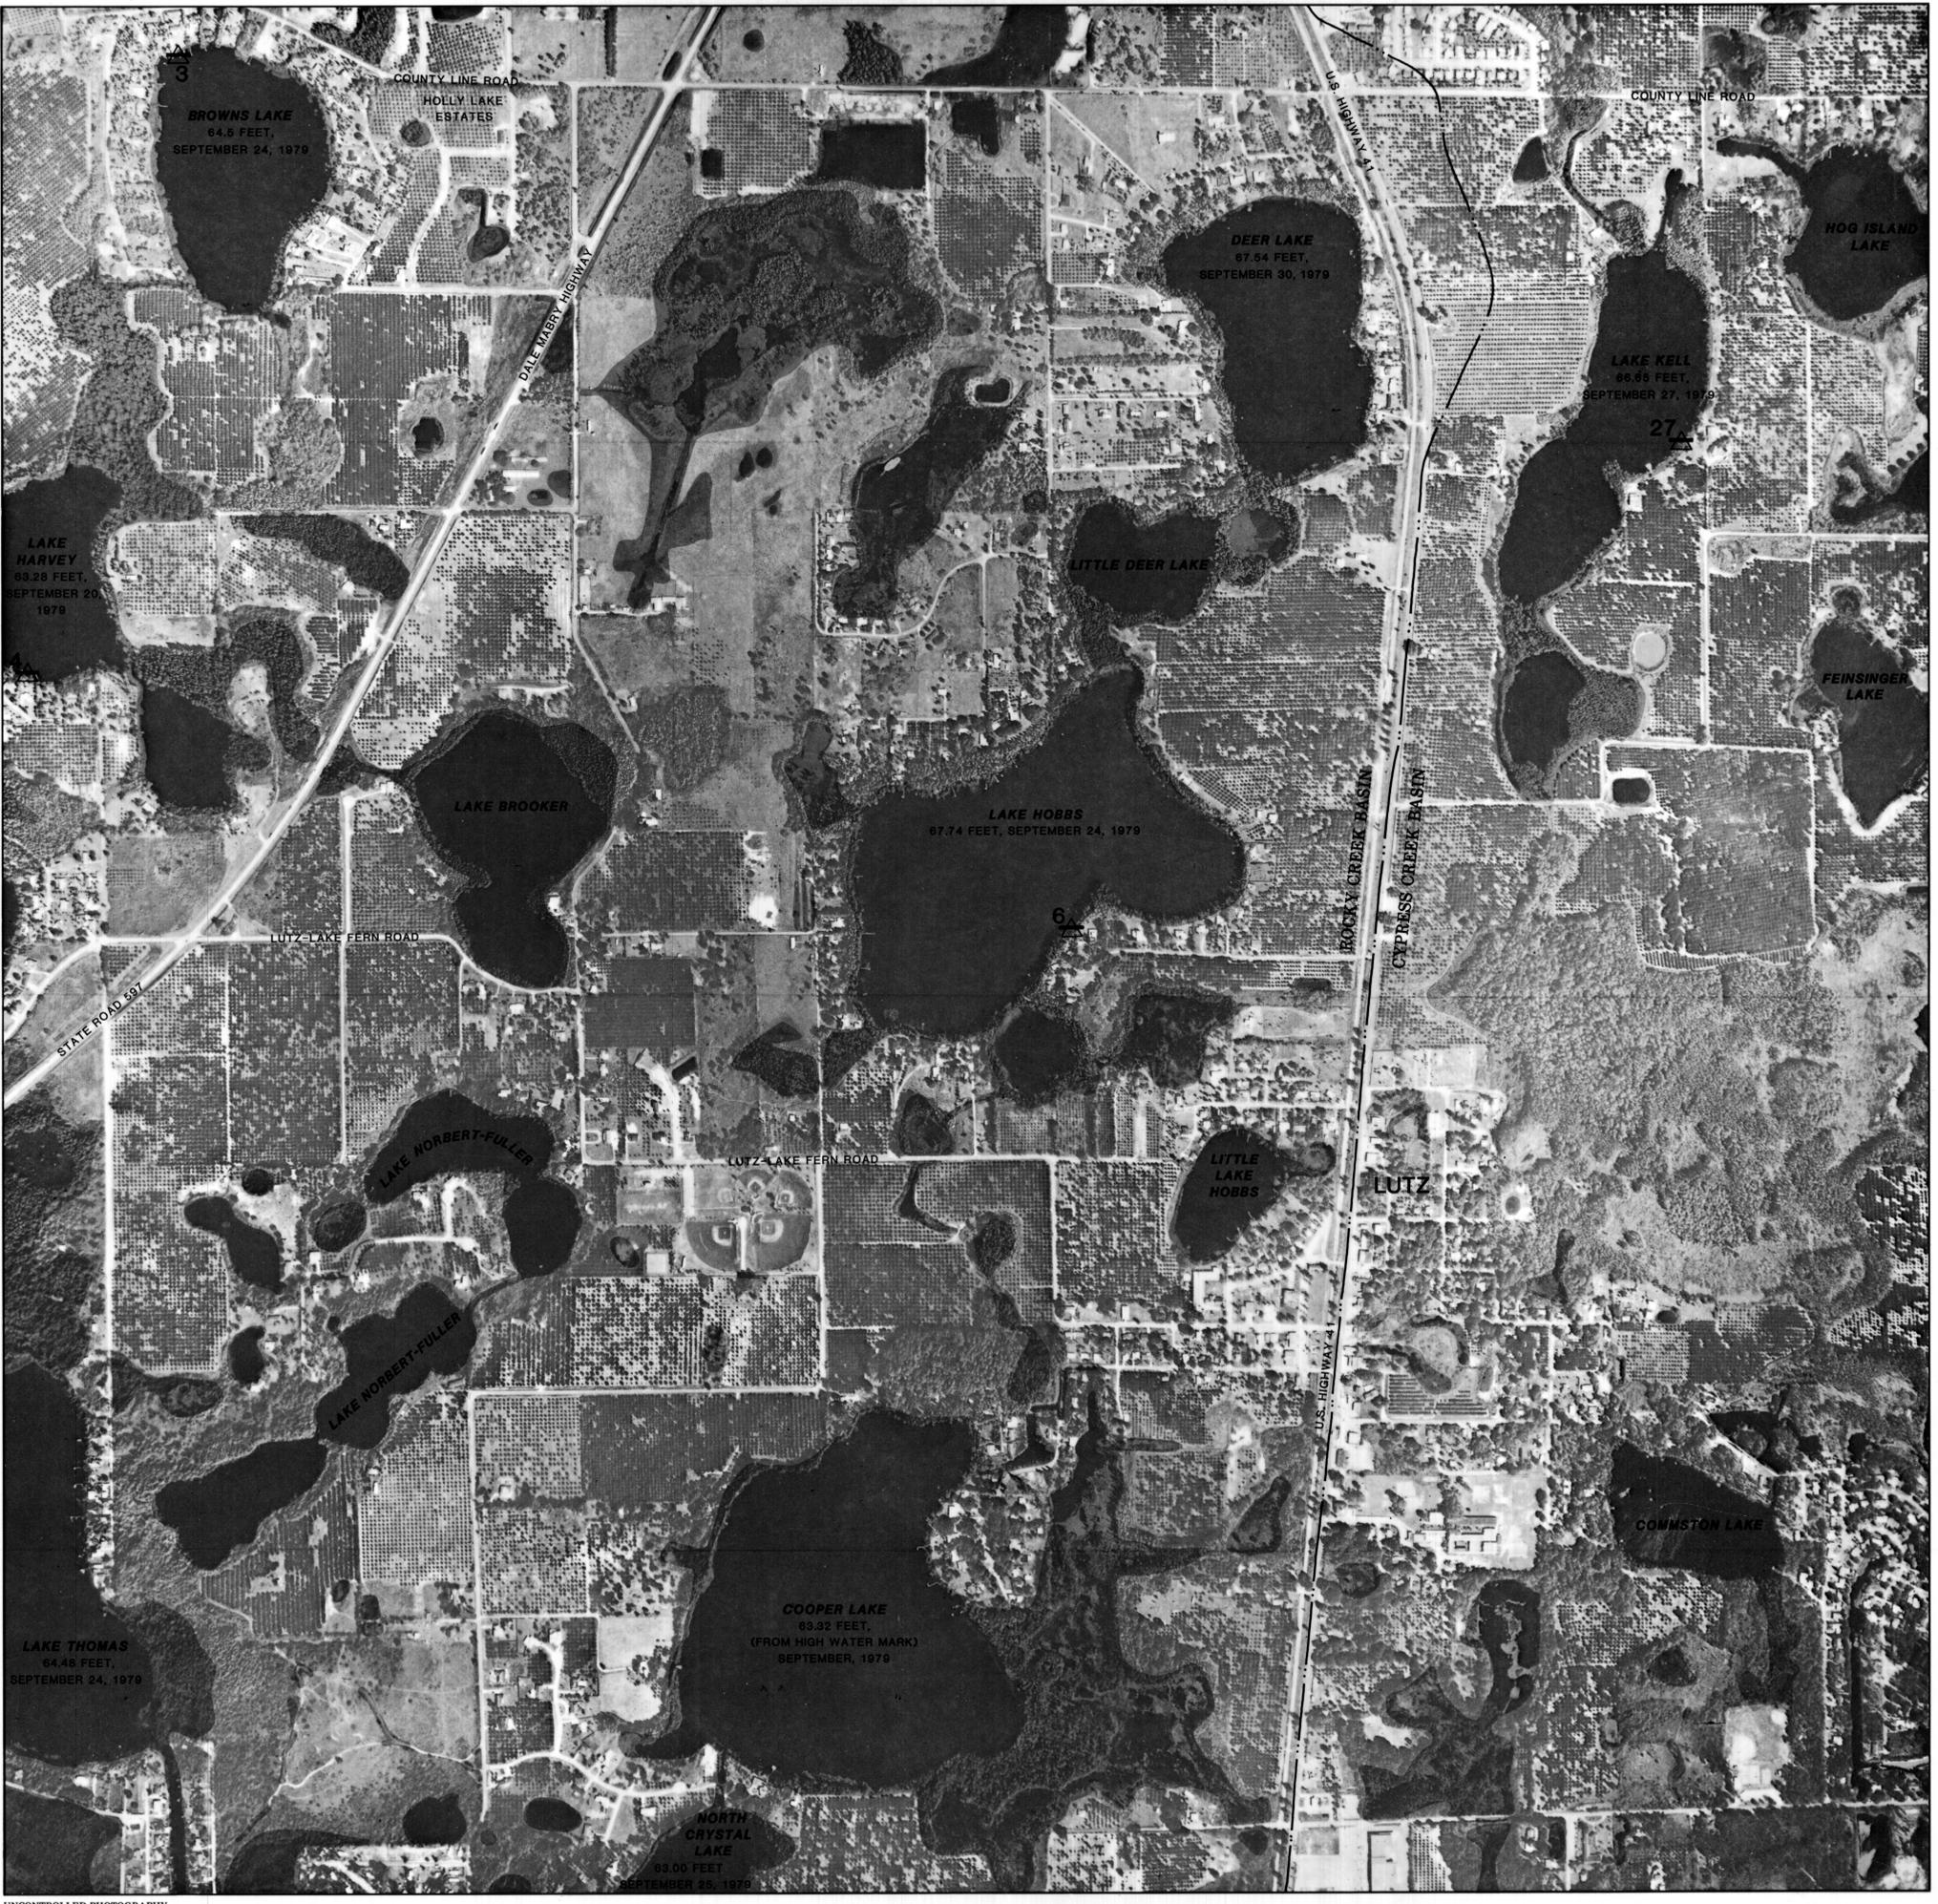
FLOOD DELINEATION BY  
SOUTHWEST FLORIDA WATER MANAGEMENT DISTRICT  
USING PHOTOGRAMMETRIC METHODS

AERIAL PHOTOGRAPHY BY  
KUCERA AND ASSOCIATES, INC.  
(SHEETS 2-11, OCTOBER 8, 1979)  
AND  
ABRAM AERIAL SURVEY  
(SHEETS 12, 13, OCTOBER 5, 1979)

UNCONTROLLED PHOTOGRAPHY
