ABSTRACT
Heavy rainfall in the late spring and summer of 1979 caused severe flooding in northwestern Hillsborough County, including north Tampa. Rainfall amounts of 10 to 15 inches were measured at many rain-gaging stations on May 7-9, cumulative rainfall for August and September averaged 30 to 35 inches. The May 7-9 maximum rainfall for some stations had a recurrence interval of about 100 years, and the August and September rainfall total had a recurrence interval of about 20 years. Maximum stages of flooding of streams and lakes in the study area for the May 7-9 event ranged from less than 4 to 20 feet. Flooding of 10 to 20 years and lakes during August to October had recurrence intervals ranging from about 1 to 30 years.

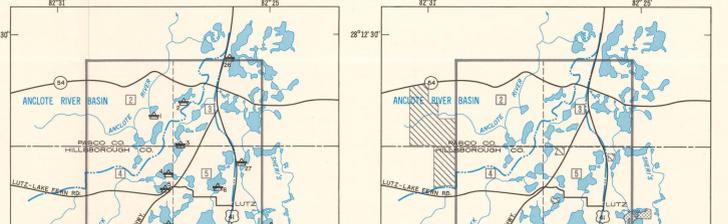
Figure 1.—Location of the study area, surface drainage systems, lake-stage and stream-gaging stations, and boundaries of flood maps sheets 218 through 231.

INTRODUCTION
Hillsborough County in west-central Florida (fig. 1) is one of the fastest growing population centers in the country. Although spreading into northern and northeastern parts of the county at approximately the same rate, the area has been rapidly becoming residential developments and shopping centers. The area is flat and has numerous lakes, canals, and drainage structures. The area has several streams (fig. 1), but most drainages by interconnected lakes, swamps, and wetlands. The high ground between the western and eastern portions of the county is a narrow strip of land.

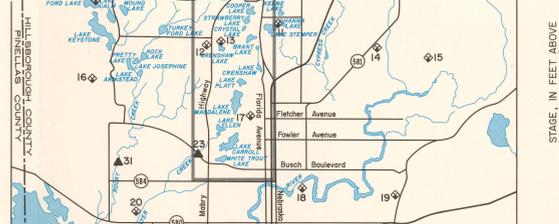
Figure 13.—Stage hydrographs for various lakes in the study area.

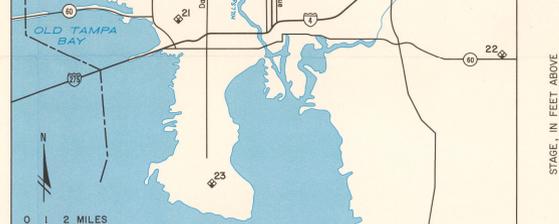
Figure 14.—Stage hydrographs for various lakes in the study area.

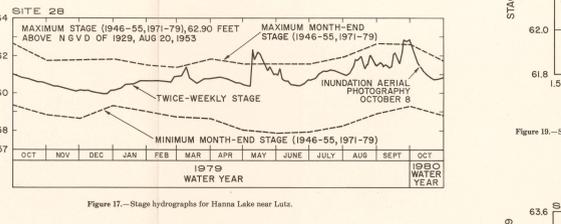
Figure 22.—Stage hydrographs for various lakes in the study area.

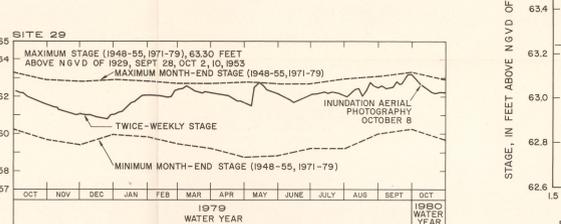
Figure 23.—Stage hydrographs for various lakes in the study area.
