PHYSICAL, HYDROLOGICAL, AND BIOLOGICAL CHARACTERISTICS OF THE LOXAHATCHEE RIVER ESTUARY, FLORIDA

By
Benjamin F. McPherson, Maryann Sabanskas, and William A. Long

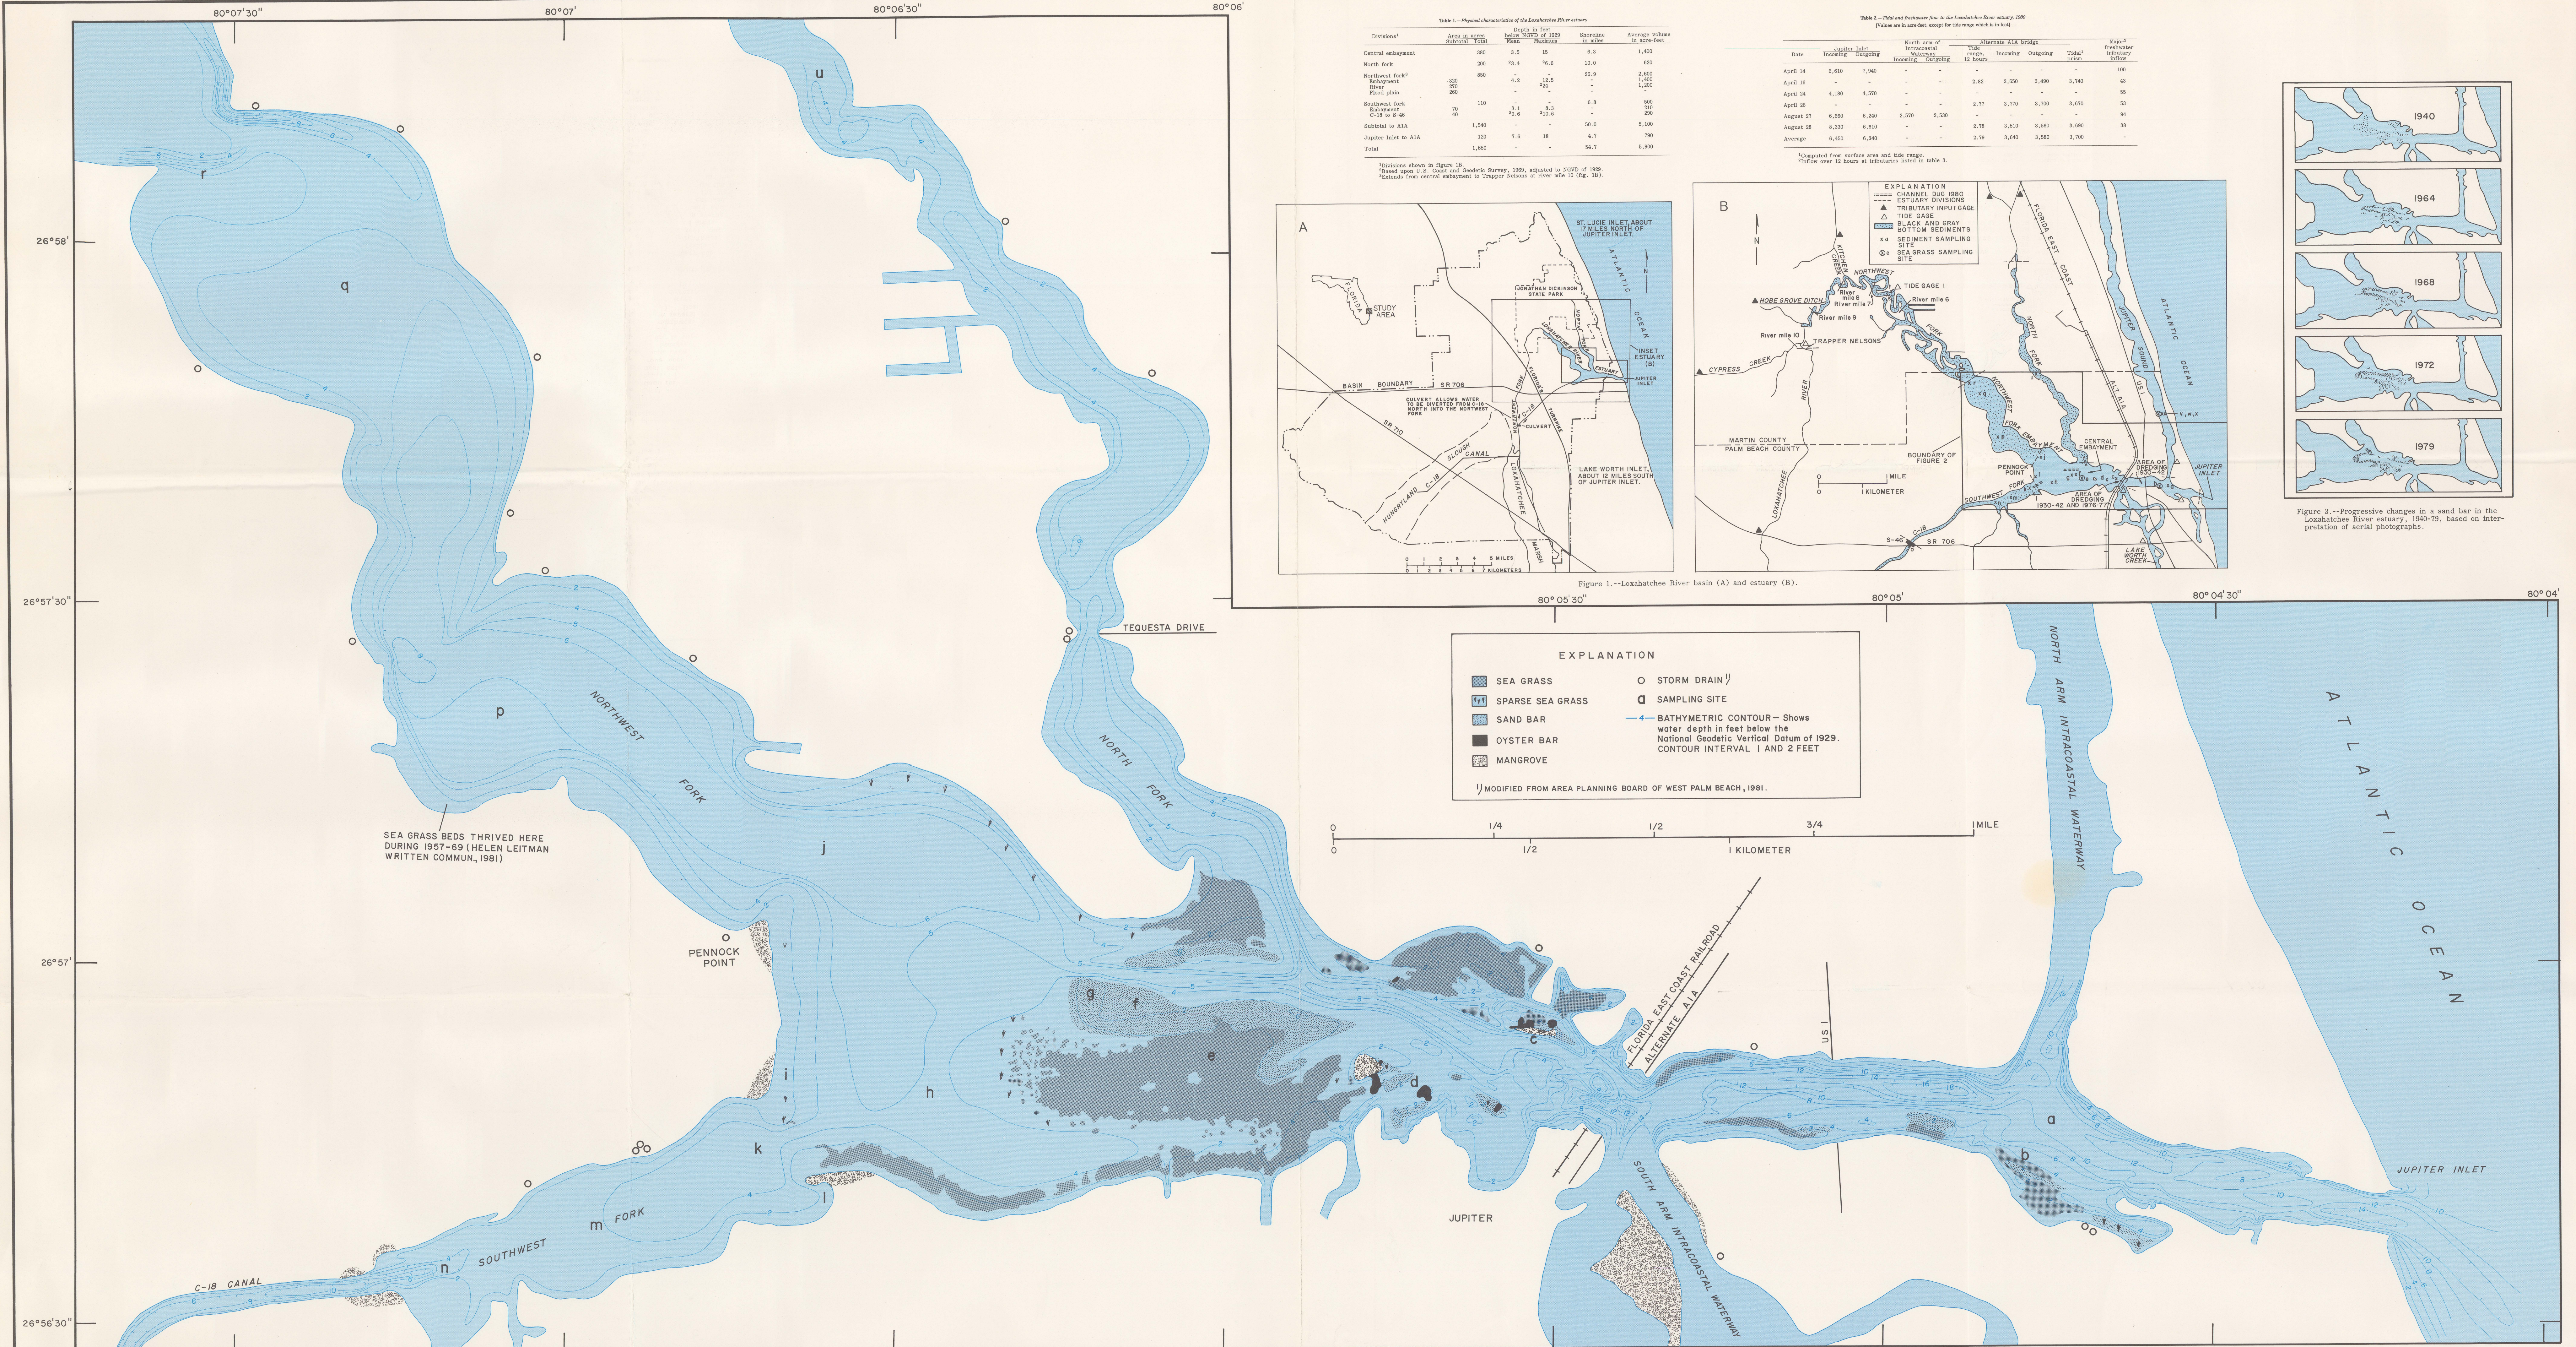
Figure 2.—Bathymetric and benthic features in the Loxahatchee River estuary, 1980-81.
