NEVELSVILLE, KY.  
S84 BURNSIDE 15' QUADRANGLE  
N 36°45' - W 84°15' 7.5  
1964

Landslides and related features interpreted  
from aerial photographs:  
1:80,000 (Black and White) 1975  
Photointerpretation and field check 1979-1980  
This report is preliminary and has not  
been reviewed for conformity with U.S.  
Geological Survey editorial standards.

**LANDSLIDES AND RELATED FEATURES**  
OF THE NEVELSVILLE, KY. QUADRANGLE  
by  
Alfred R. Taylor and Roger E. Thomas  
1982  
U.S. Geological Survey  
OPEN FILE MAP 82-653 (G-12)

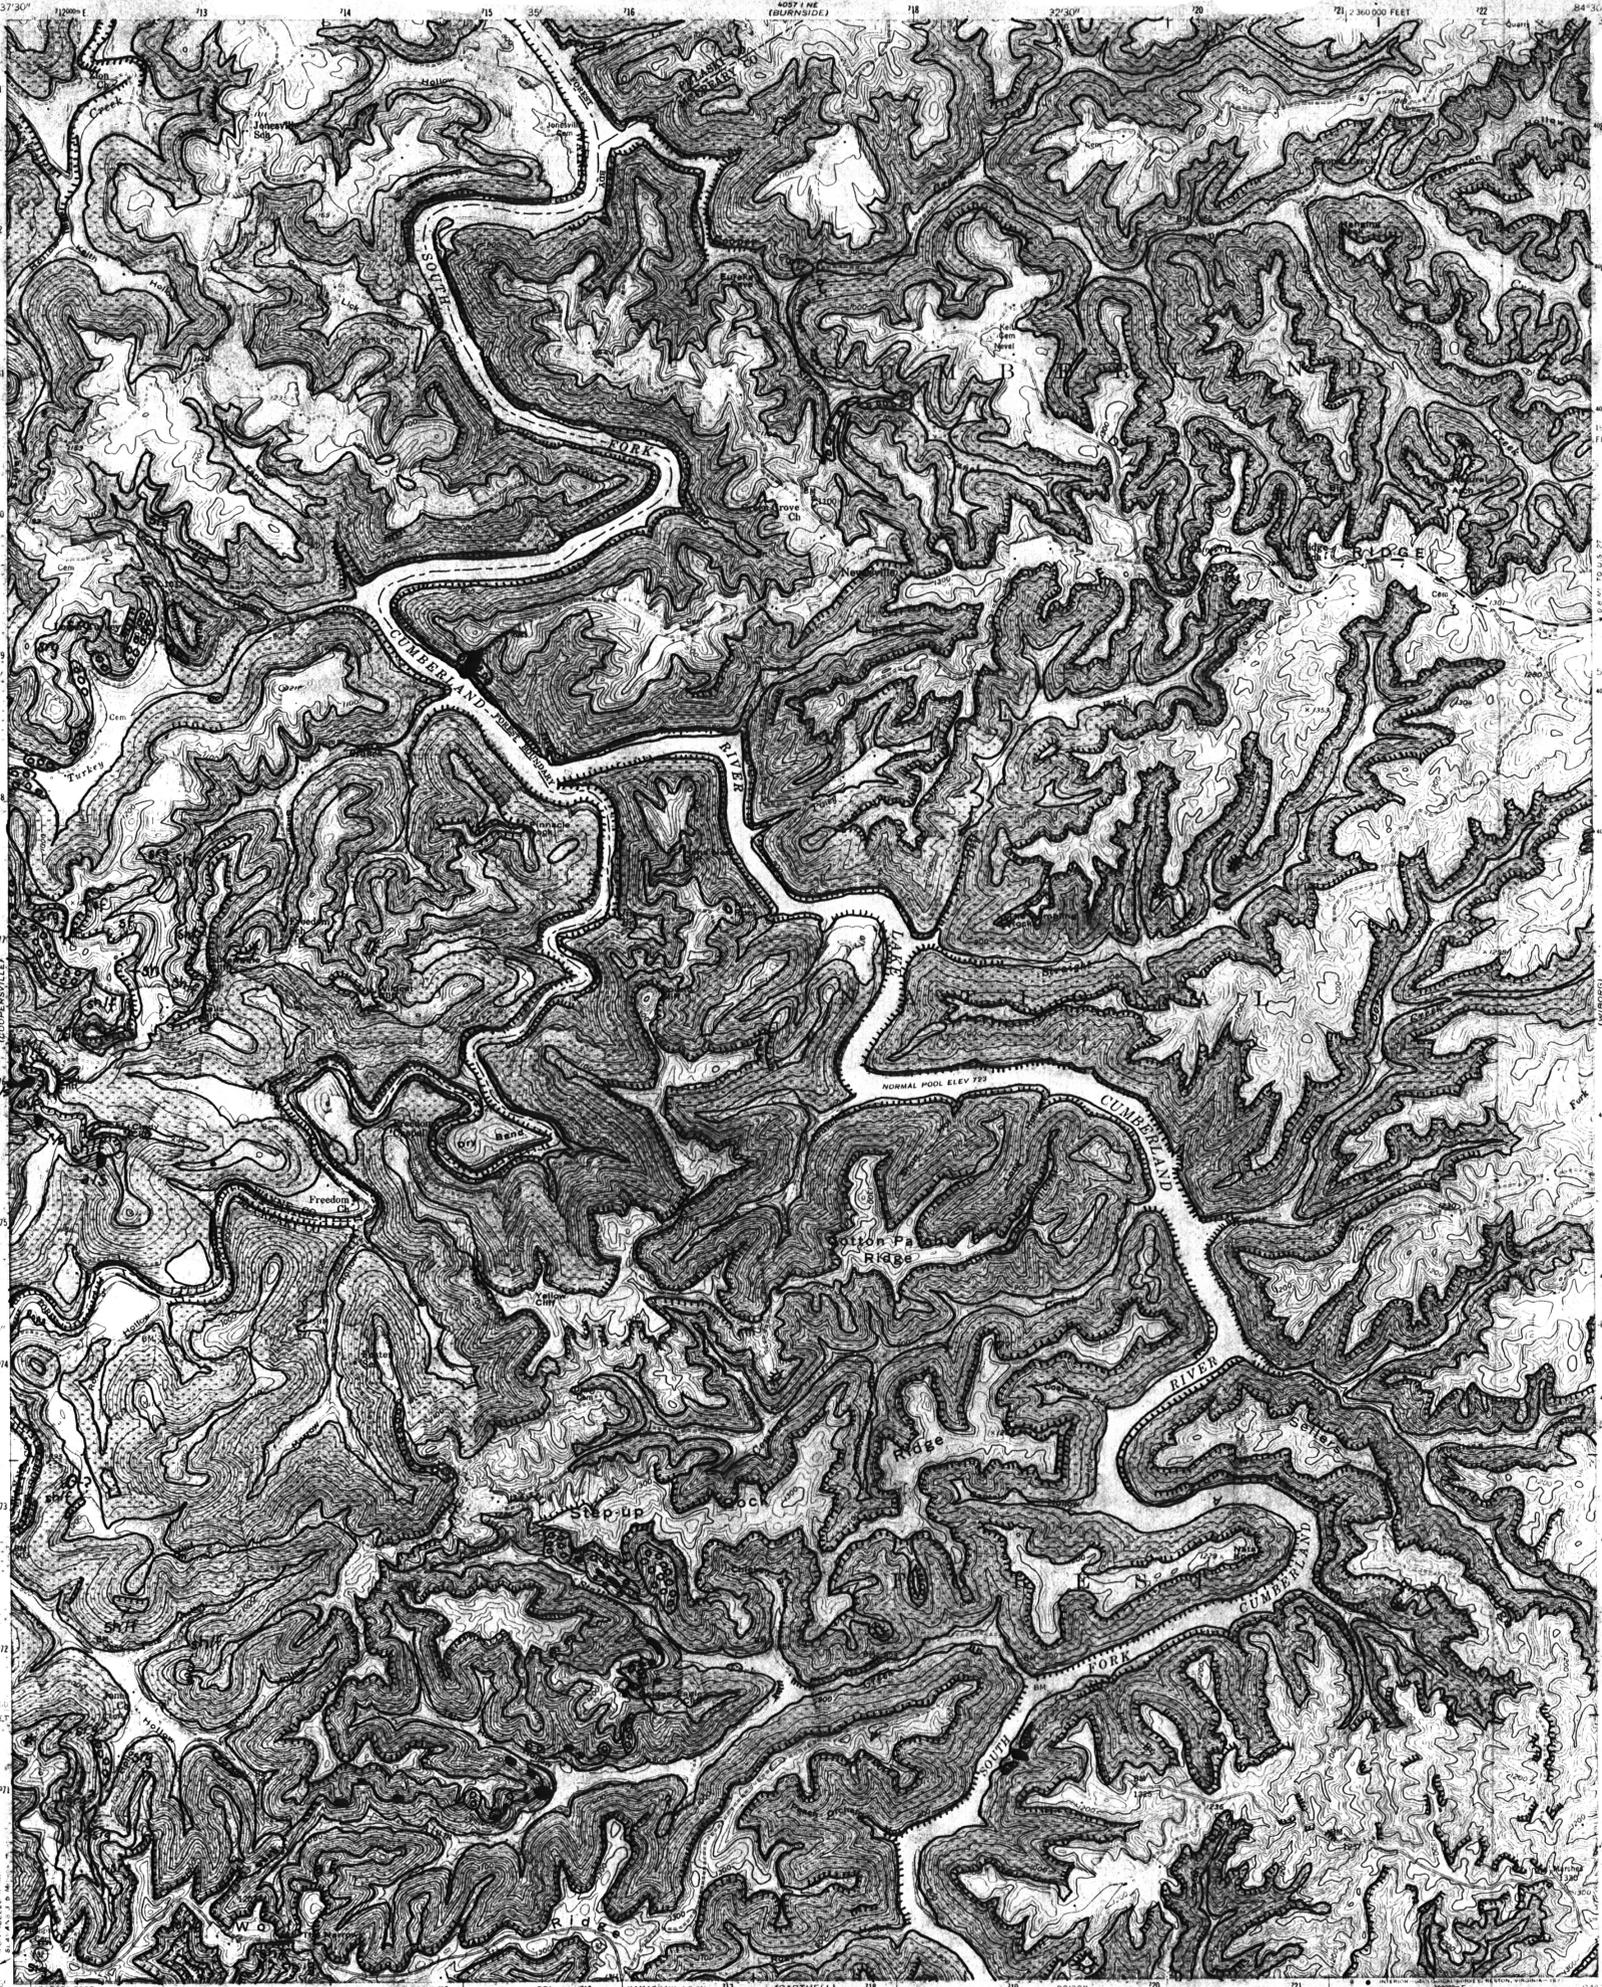
**NOTE**  
Information shown is intended as a  
general guide to ground conditions as of  
the date of field check. Additional  
landslides and rockfalls should be anticipated  
in all map units. The map unit depicts  
the dominant condition in the area delineated,  
and variations in slope stability may occur  
at any point in the unit. This map is suit-  
able for general planning purposes and as a  
supplement to more detailed studies for site  
selection. The map cannot be used as a sub-  
stitute for detailed geologic and engineering  
investigations to establish design and  
construction criteria of specific sites.  
Some symbols may not appear on this map  
because the description is applicable to a  
series of maps.

- ACTIVE OR RECENTLY ACTIVE LANDSLIDE**  
Complex landslide composed of earthflow, debris  
slide, earth and rock slump. Identified from  
historical records, and from scars, debris and  
other field evidence. Ground extremely unstable;  
sliding accelerated by excavation, loading and  
changes in drainage conditions. May include  
areas with several active slides too small to  
be shown separately. Questioned where doubtful.

- OLD LANDSLIDE**  
Area of extensive hummocky ground caused by  
earthflow and earth and rock slump. Lacks  
clear evidence of active sliding. Relatively  
stable in natural, undisturbed state,  
generally not affected by small structures properly  
sited in areas away from the edge of the toe;  
can be reactivated by extensive, rapid exca-  
vation, loading, and changes in ground water and  
surface water conditions. Area of old landslide  
probably includes recent ones not identified  
from field evidence or otherwise documented.  
Upslope boundary of landslide generally defined  
by modified scarp, but downslope (toe) may be  
gradational and not well defined. Questioned  
where doubtful.

- COMBINATION LANDSLIDE**  
Area of recent and old slides in which  
individual slides are not identified.
- COLLUVIAL SLOPE**  
Valley wall along major streams with slope as  
steep as 40° (85%); stony, clayey silt soil up  
to 50 ft. (15 m) thick; commonly buttressed by  
a terrace or bench at the toe of the slope; very  
susceptible to sliding by cutting of toe area,  
removal of terrace or bench, and overloading;  
slide commonly activated without apparent cause.

- COLLUVIAL SLOPES WITH LANDSLIDES**  
Landslides too small or obscure to map  
individually.
- AREAS SUSCEPTIBLE TO DEBRIS FLOWS AND DEBRIS  
AVALANCHES**  
Primarily shallow, narrow ravines and chutes with  
accumulation of stony colluvium generally 10 ft.  
(3 m) or less in thickness; susceptible to rapid  
movement during intense rainfall. Most ravines  
and chutes designated show evidence of former  
debris flows and avalanches.

- AREAS SUSCEPTIBLE TO ROCKFALL**  
Steep, locally vertical, natural and man-made  
slopes and cliffs, 15 ft. (4.5 m) or more high;  
formed dominantly of sandstone, limestone, sandy  
shale, mudstone and claystone. Interbedded mud-  
stone, claystone and shale weather rapidly leaving  
sandstone and limestone rock faces unsupported.

- SOIL AND ROCK SUSCEPTIBLE TO LANDSLIDING**  
Soil and rock similar to that involved in land-  
slides elsewhere in map area; primarily areas  
underlain by claystone, mudstone and shale  
associated with other rock types. Rock weathers  
rapidly on exposure forming clayey soil highly  
susceptible to sliding. Includes coves (U-shaped,  
shallow valleys) containing thick layers of clayey  
soil that are very susceptible to sliding where  
excavation breaks continuity of slope and where  
overloaded by artificial fill.

- AREAS LEAST PRONE TO LANDSLIDES**  
Map areas in which no patterns or symbols are shown;  
primarily valley floors, ridge tops and broad  
benches; modification by excavation and fill may  
lead to local landslides.

- MAN-MADE FEATURES**  
Strip mines (combination of letter symbols  
indicates complex formed of more than one  
type of strip mine)
- sh bench with high wall
  - sf furrowed with high wall
  - sd multiple furrows and multiple benches
  - ss hilltop removed
  - srq reclaimed by grading
  - sru reclaimed by secondary use
  - sh/r regraded in part, high wall  
remains
- Coal refuse banks  
r identified on aerial photographs;  
not classified in field check
- rb not burnt nor on fire
  - rbb burnt
- Quarries  
q quarry site
- Gravel pits  
g site of gravel pit
- Slides in man-made features  
af earth flow in fill  
a/s earth flow in strip castings  
a/r earth flow in coal refuse
