UNITED STATES
DEPARTMENT OF THE INTERIOR
GEOLOGICAL SURVEY
Water Resources Division

HYDROLOGIC INVESTIGATIONS AT
WYTHEVILLE NATIONAL FISH HATCHERY NO. 2
MAX MEADOWS, VA., 1976 to 1979

OPEN-FILE REPORT 82-686

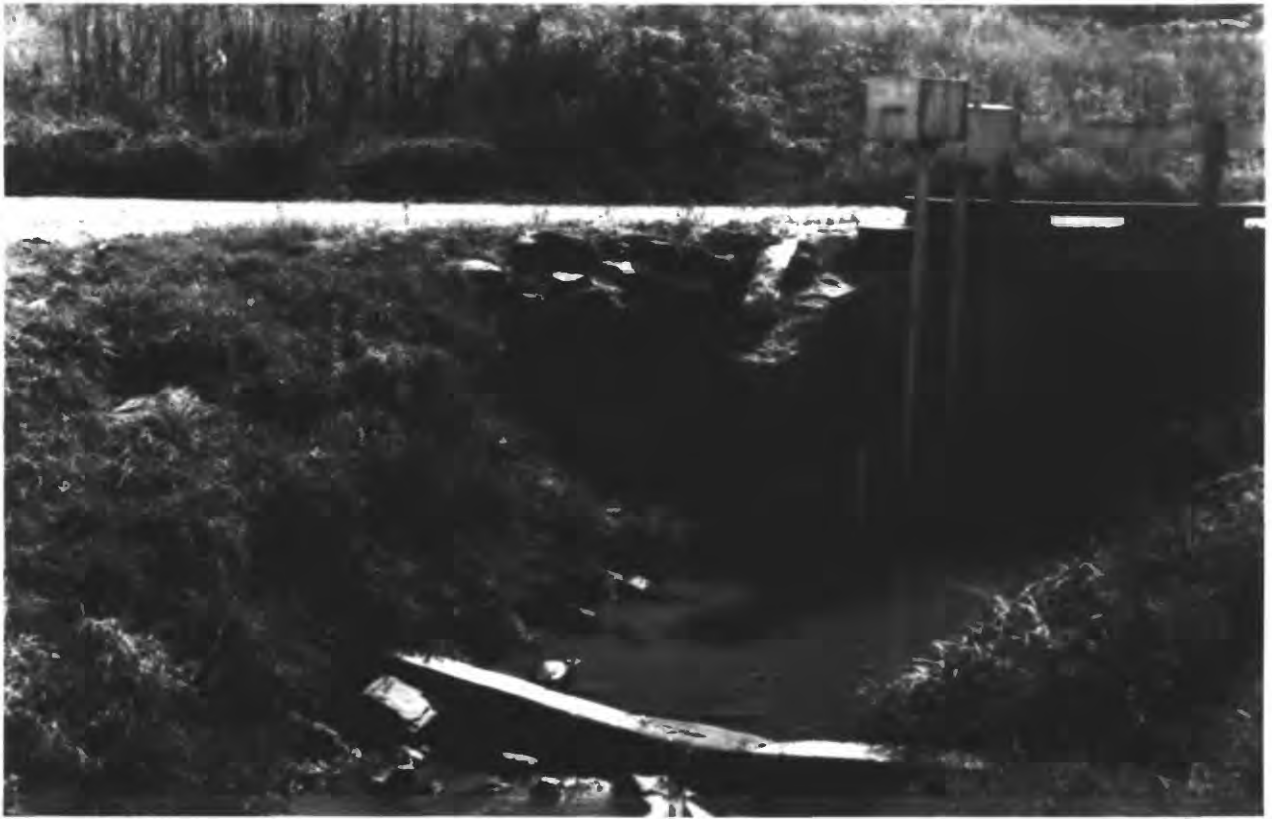
Figure 3. -- Photograph of the Glade Creek monitoring site facing upstream.

In May 1976, two recorders were installed on Glade Creek near the entrance to the hatchery (fig. 3) to collect rainfall and streamflow data. The streamflow recorder gaged a drainage area of 7.15 square miles, most of which lies upstream from Interstate 77.

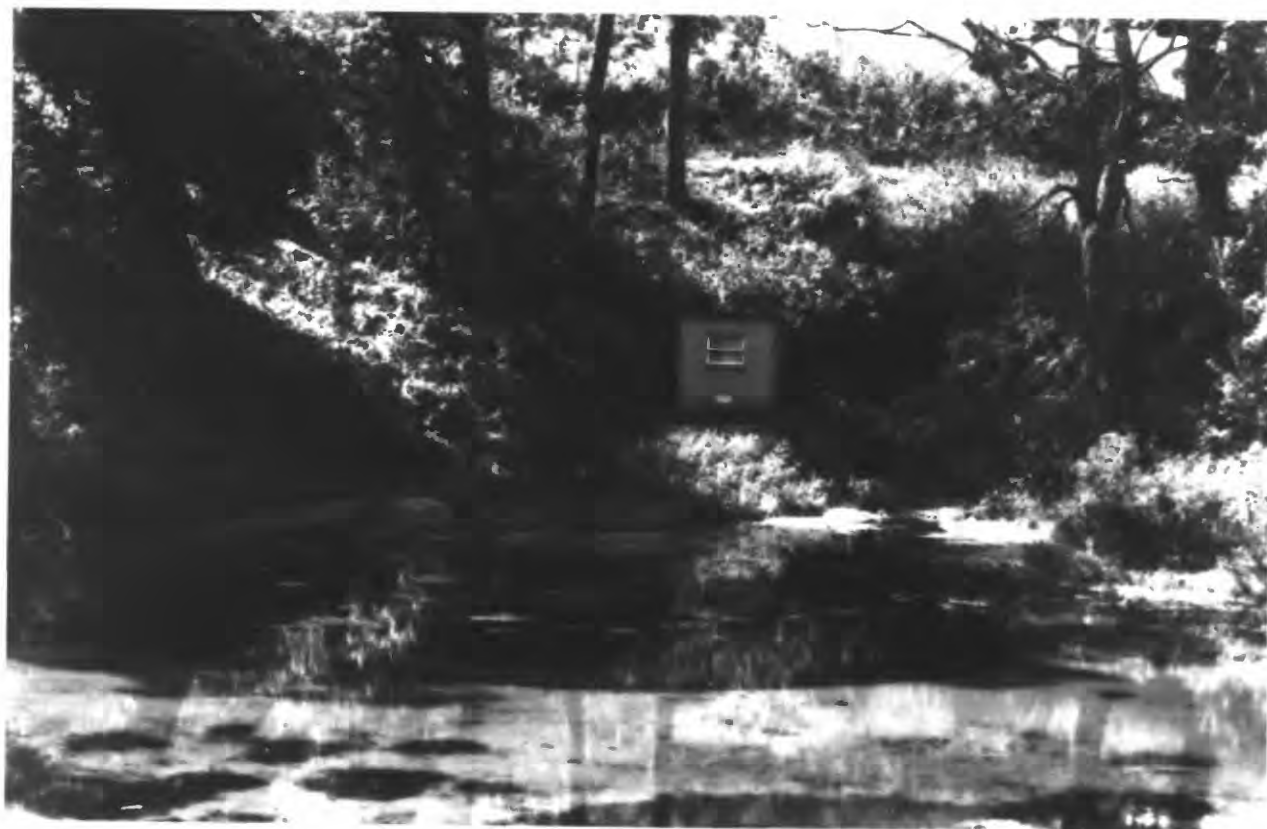
Figure 4. -- Photograph of Boiling Spring facing upstream.

Boiling Spring (fig. 2) flows from an opening in limestone and silty limestone. The water originally "boiled" from a small outlet, hence the name. The spring has been enclosed by a concrete box and a building that

houses two pumps (fig. 4). One pump is operated continuously to pump water to the hatchery raceways. The second pump is reserved for emergency use. A recorder installed in the pump house obtained data to determine the overflow of the spring (water that is not pumped to the hatchery). A record was kept of the water pumped to the hatchery so that the total flow of the spring could be calculated. Turbidity and water-level recorders identical to those at West Spring were operated at Boiling Spring.
