LYNCHBURG EAST, TENN.
(FORMERLY COLUMBIAN SPRINGS)
N3515-8615/7.5
1978

LANDSLIDES AND RELATED FEATURES

OF THE LYNCHBURG EAST, TENN. QUADRANGLE

U.S. Geological Survey
Open-File Map 82-750 (C-14)

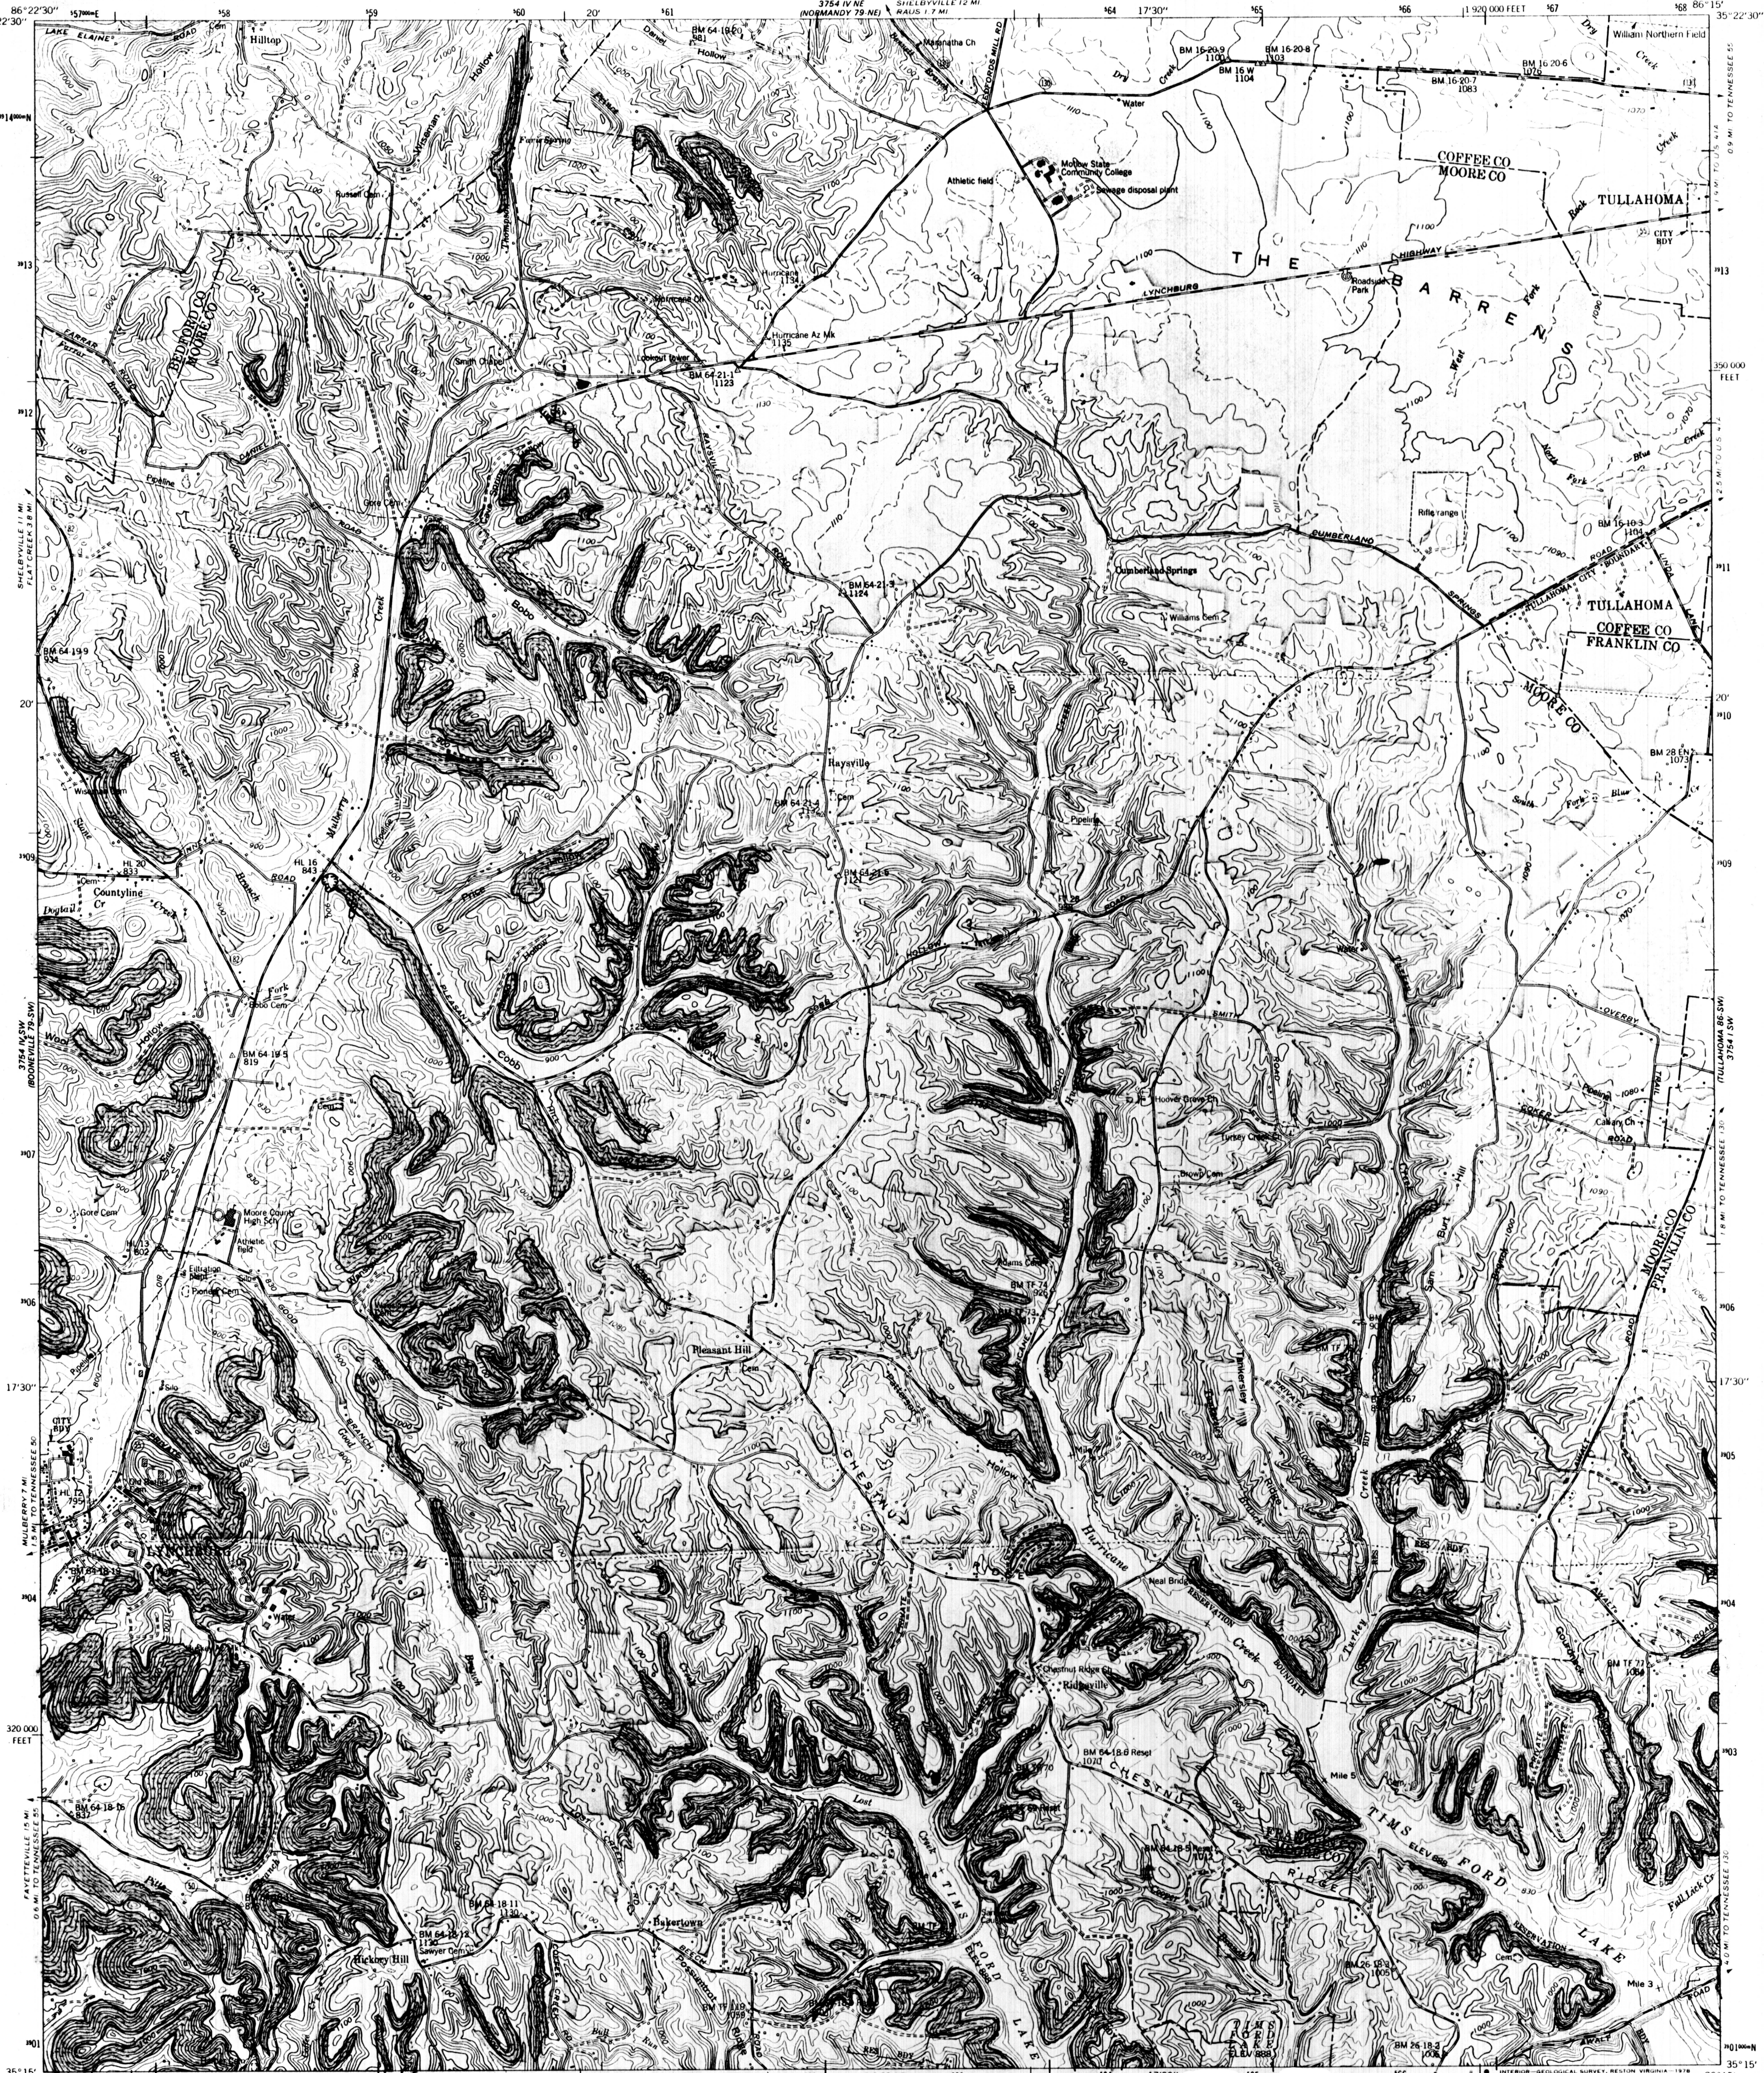
ACTIVE OR RECENTLY ACTIVE LANDSLIDE
Complex landslide composed of earthflow, debris
slide, earth and rock slump. Identified from
historical records, and from scars, debris and
other field evidence. Ground extremely unstable;
sliding accelerated by excavation, loading and
changes in drainage conditions. May include
areas with several active slides too small to
be shown separately. Questioned where doubtful.

OLD LANDSLIDE
Area of extensive hummocky ground caused by
earthflow and earth and rock slump. Lacks
clear evidence of active sliding. Relatively
stable in natural, undisturbed state,
generally not affected by small structures properly
sited in areas away from the edge of the toe;
can be reactivated by extensive, rapid exca-
vation, loading, and changes in ground water and
surface water conditions. Area of old landslide
probably includes recent ones not identified
from field evidence or otherwise documented.
Upslope boundary of landslide generally defined
by modified scarp, but downslope (toe) may be
gradational and not well defined. Questioned
where doubtful.

COMBINATION LANDSLIDE
Area of recent and old slides in which
individual slides are not identified.

COLLUVIAL SLOPE
Valley wall along major streams with slope as
steep as 40° (85%); stony, clayey silt soil up
to 50 ft. (15 m) thick; commonly buttressed by
a terrace or bench at the toe of the slope; very
susceptible to sliding by cutting of toe area,
removal of terrace or bench, and overloading;
slide commonly activated without apparent cause.

COLLUVIAL SLOPES WITH LANDSLIDES
Landslides too small or obscure to map
individually.

**AREAS SUSCEPTIBLE TO DEBRIS FLOWS AND DEBRIS
AVAILANCES**
Primarily shallow, narrow ravines and chutes with
accumulation of stony colluvium generally 10 ft.
(3 m) or less in thickness; susceptible to rapid
movement during intense rainfall. Most ravines
and chutes designated show evidence of former
debris flows and avalanches.

AREAS SUSCEPTIBLE TO ROCKFALL
Steep, locally vertical, natural and man-made
slopes and cliffs, 15 ft. (4.5 m) or more high;
formed dominantly of sandstone, limestone, sandy
shale, mudstone and claystone. Interbedded mud-
stone, claystone and shale weather rapidly leaving
sandstone and limestone rock faces unsupported.

SOIL AND ROCK SUSCEPTIBLE TO LANDSLIDING
Soil and rock similar to that involved in land-
slides elsewhere in map area; primarily areas
underlain by claystone, mudstone and shale
associated with other rock types. Rock weathers
rapidly on exposure forming clayey soil highly
susceptible to sliding. Includes coves (U-shaped,
shallow valleys) containing thick layers of clayey
soil that are very susceptible to sliding where
excavation breaks continuity of slope and where
overloaded by artificial fill.

AREAS LEAST PRONE TO LANDSLIDES
Map areas in which no patterns or symbols are shown;
primarily valley floors, ridge tops and broad
benches; modification by excavation and fill may
lead to local landslides.
