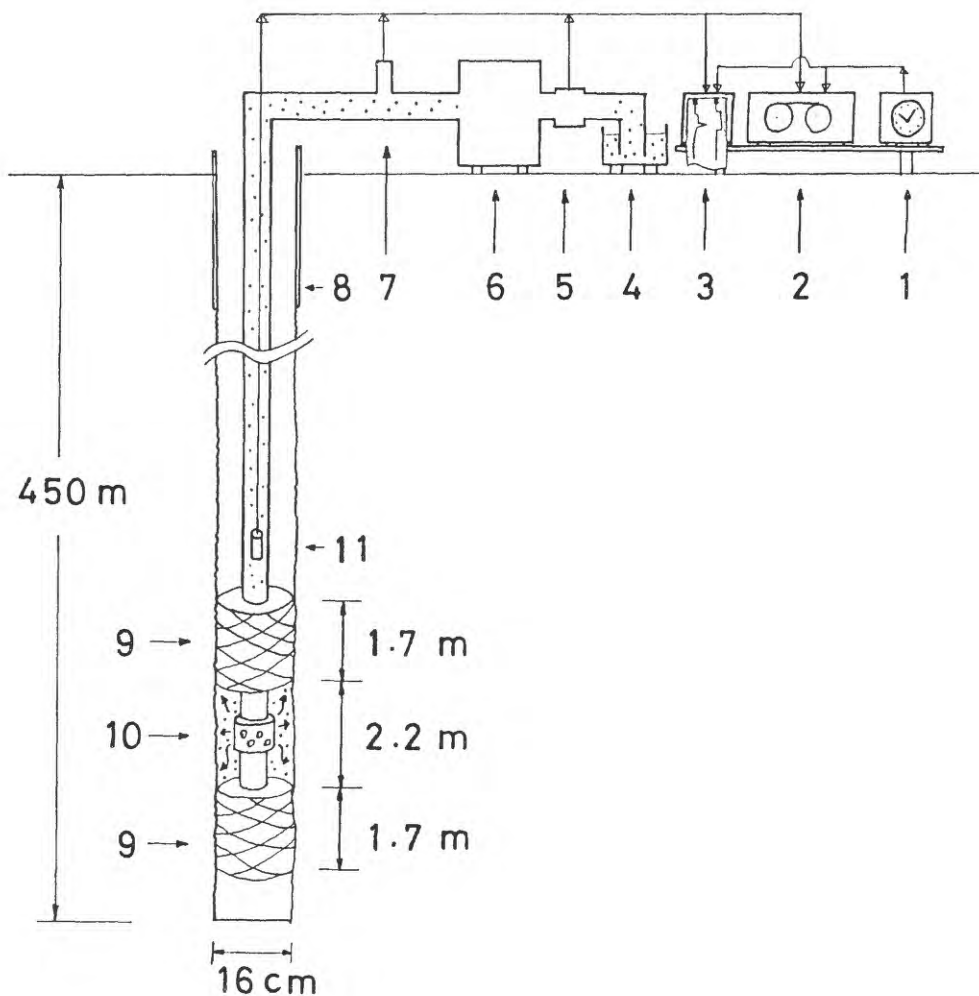
Fig. 3 Equipment for hydraulic fracturing. 1: Clock, 2: Magnetic tape recorder, 3: Multipen chart recorder, 4: Water tank, 5: Flow rate meter, 6: Water pump, 7: Pressure transducer, 8: Casing pipe (16 cm, 50 m), 9: Inflatable packers, 10: Fluid outlet, and 11: Downhole Pressure transducer with a hydrophone.

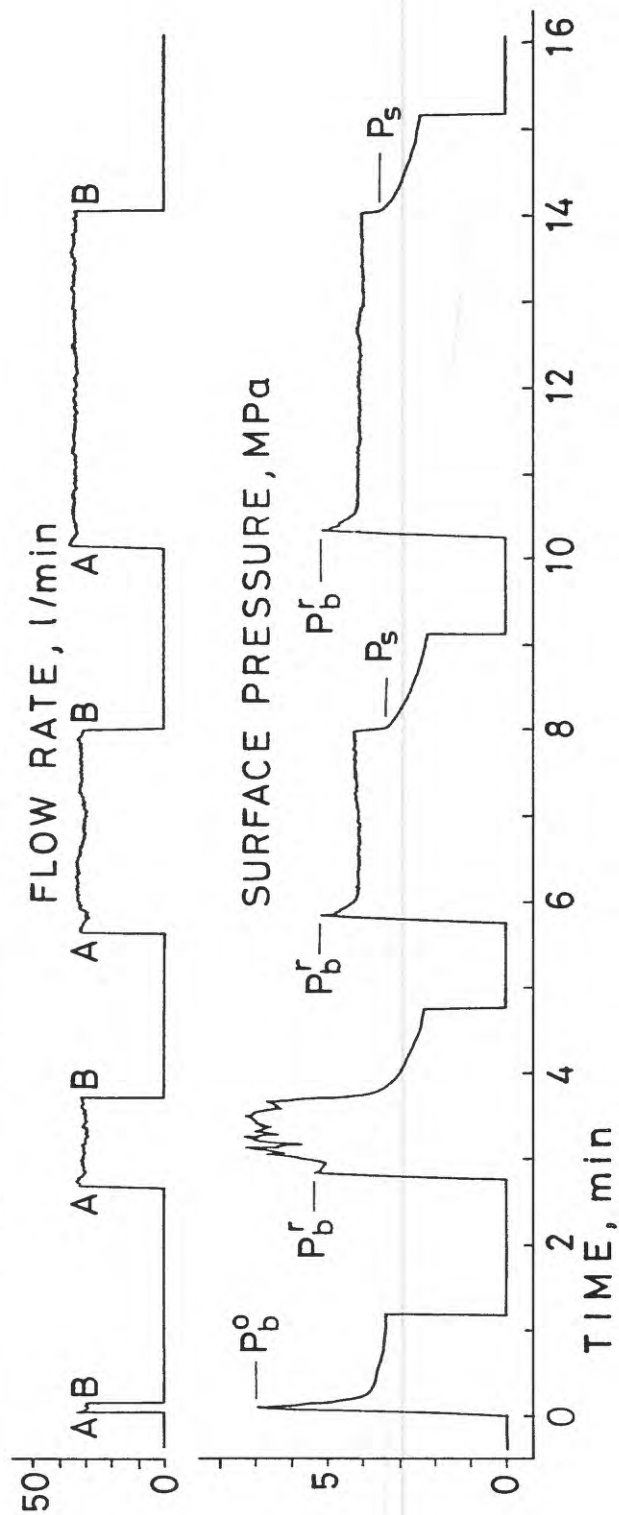
NAKAMINATO 248m (NA-248)

Fig. 4 Typical records of water pressure and flow rate vs. time plot (at 248 m in the Nakaminato well). Pumping was maintained in each injection cycle between points A and B. P_b^O : Breakdown pressure, P_b^r : Reopening pressure, and P_s : Instantaneous shut in pressure.

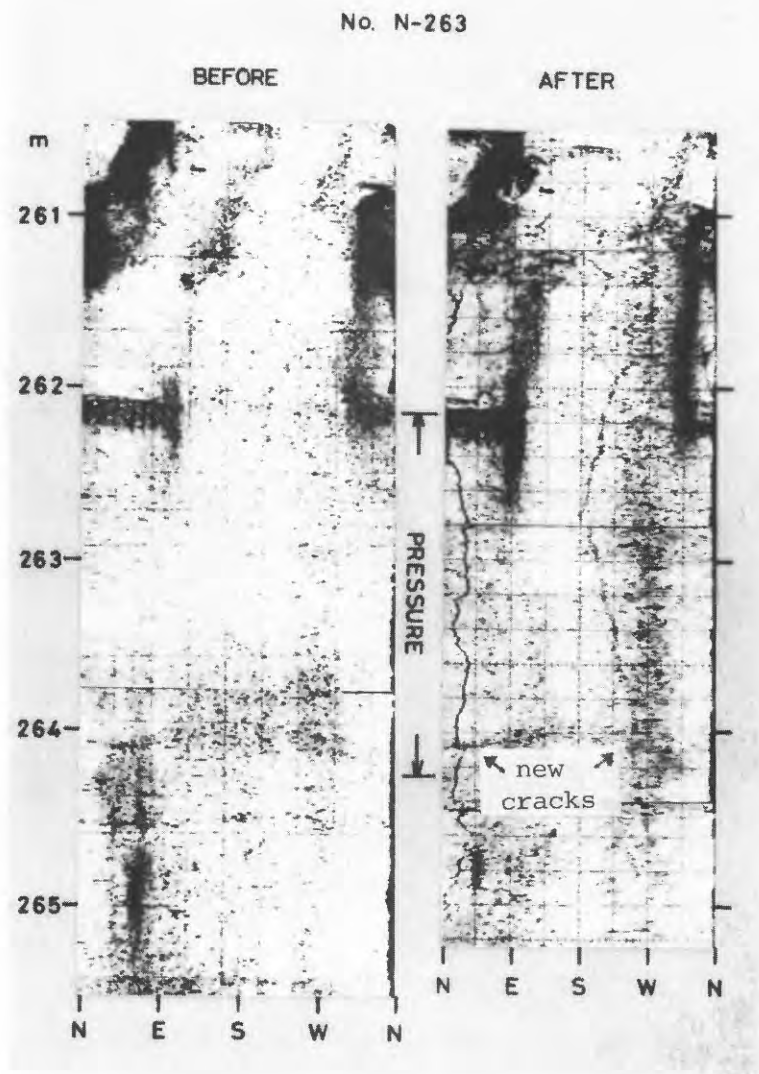
Fig. 5 Comparison of ultrasonic borehole televiewer log taken before hydraulic fracturing (left-hand picture) with that taken after hydraulic fracturing (right-hand), which shows new vertical cracks created by hydraulic fracturing. Nishiizu, 263 m depth.

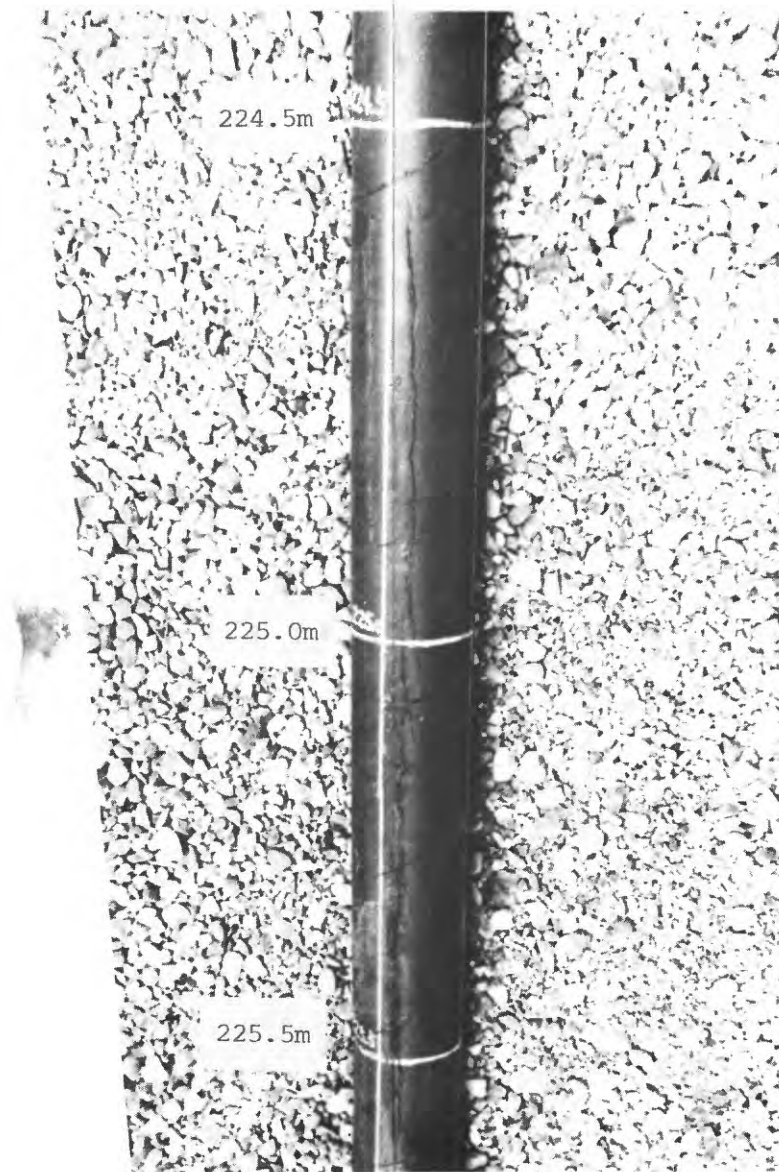
Fig. 6 Newly created cracks printed on the impression packer for the 225 m deep experiment at the Okabe site.

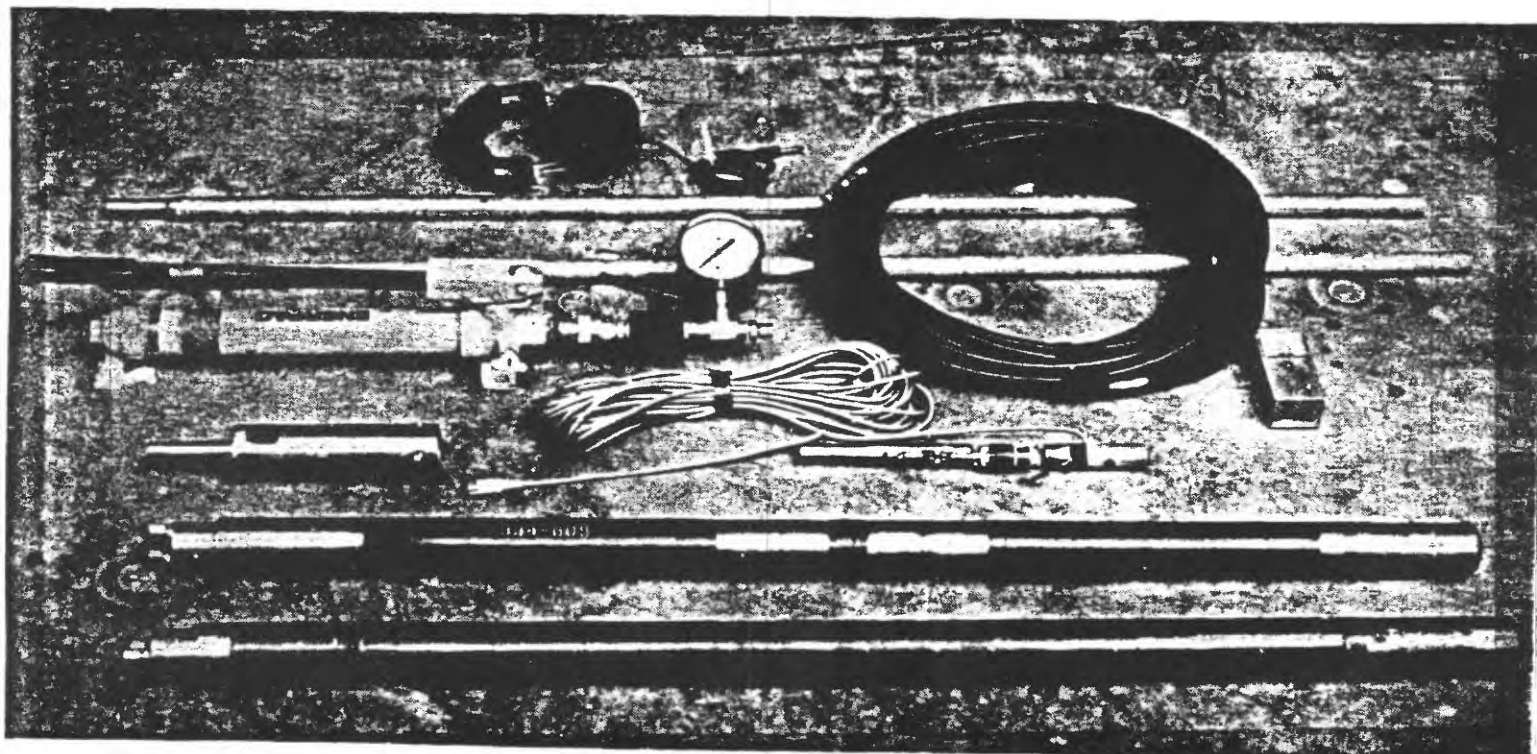
Figure 1. Equipment for underground testing, from top: Installation rods, hand pump, hoses, fracturing tool and impression packer. The sonic detector was used in early applications to help in detection of crack initiation, but was not found necessary.

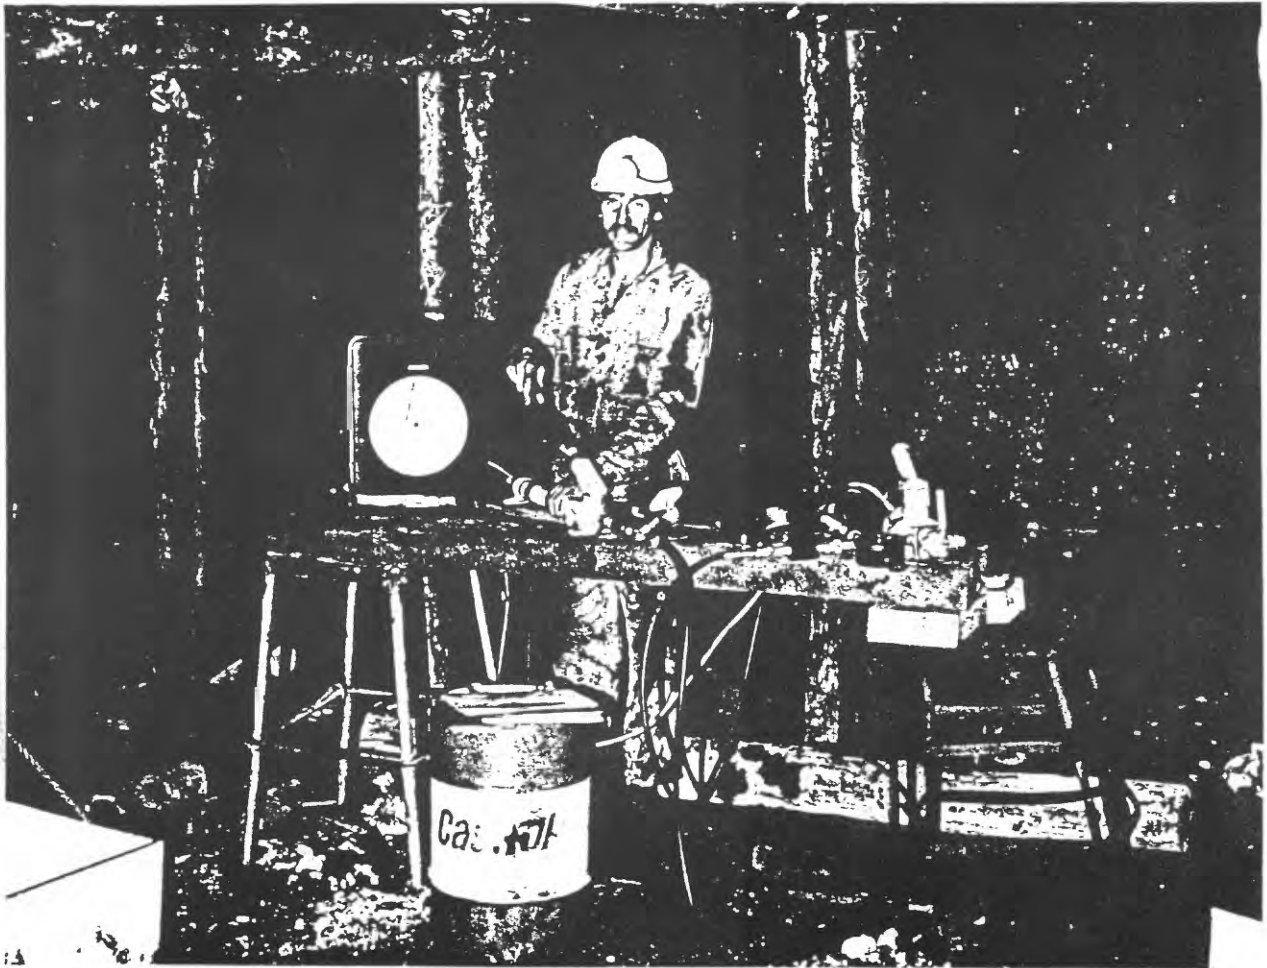
Figure 2. Typical experimental arrangement for underground tests, showing pumps and clockwork pressure recorder.

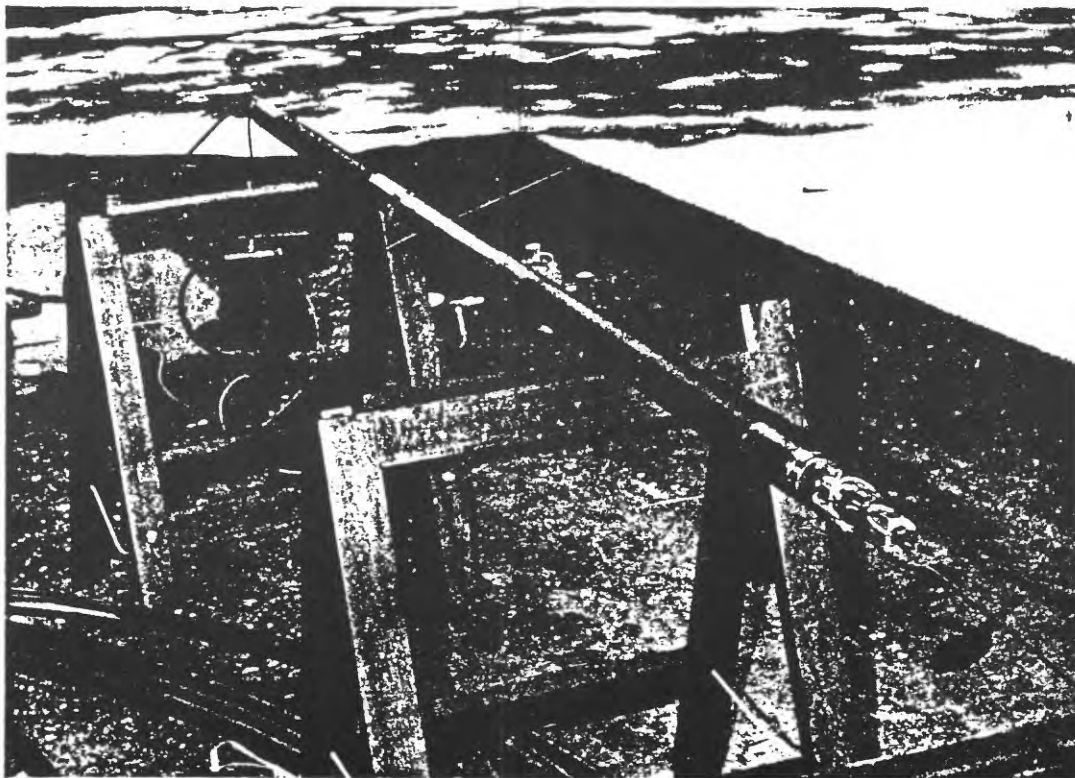
Figure 3. Fracturing tool for surface use, showing hydraulic hose and instrument cable.

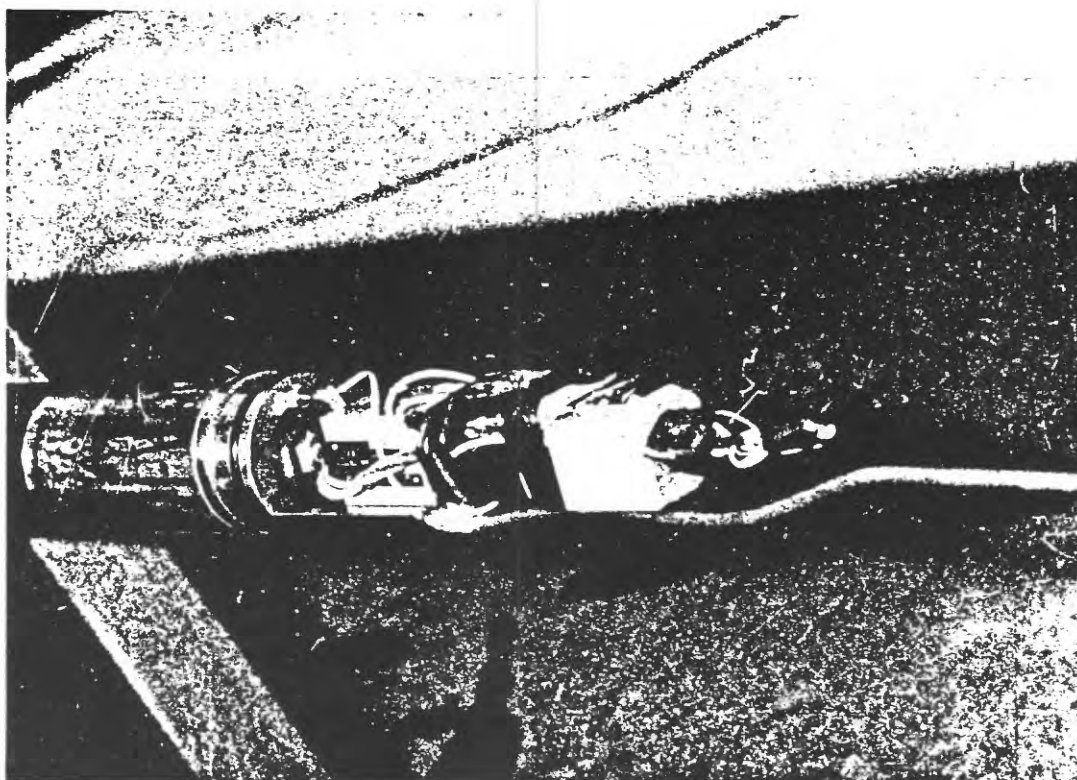
Figure 4. Detail of down-hole pressure transducers and solenoid valve for surface fracture tool.

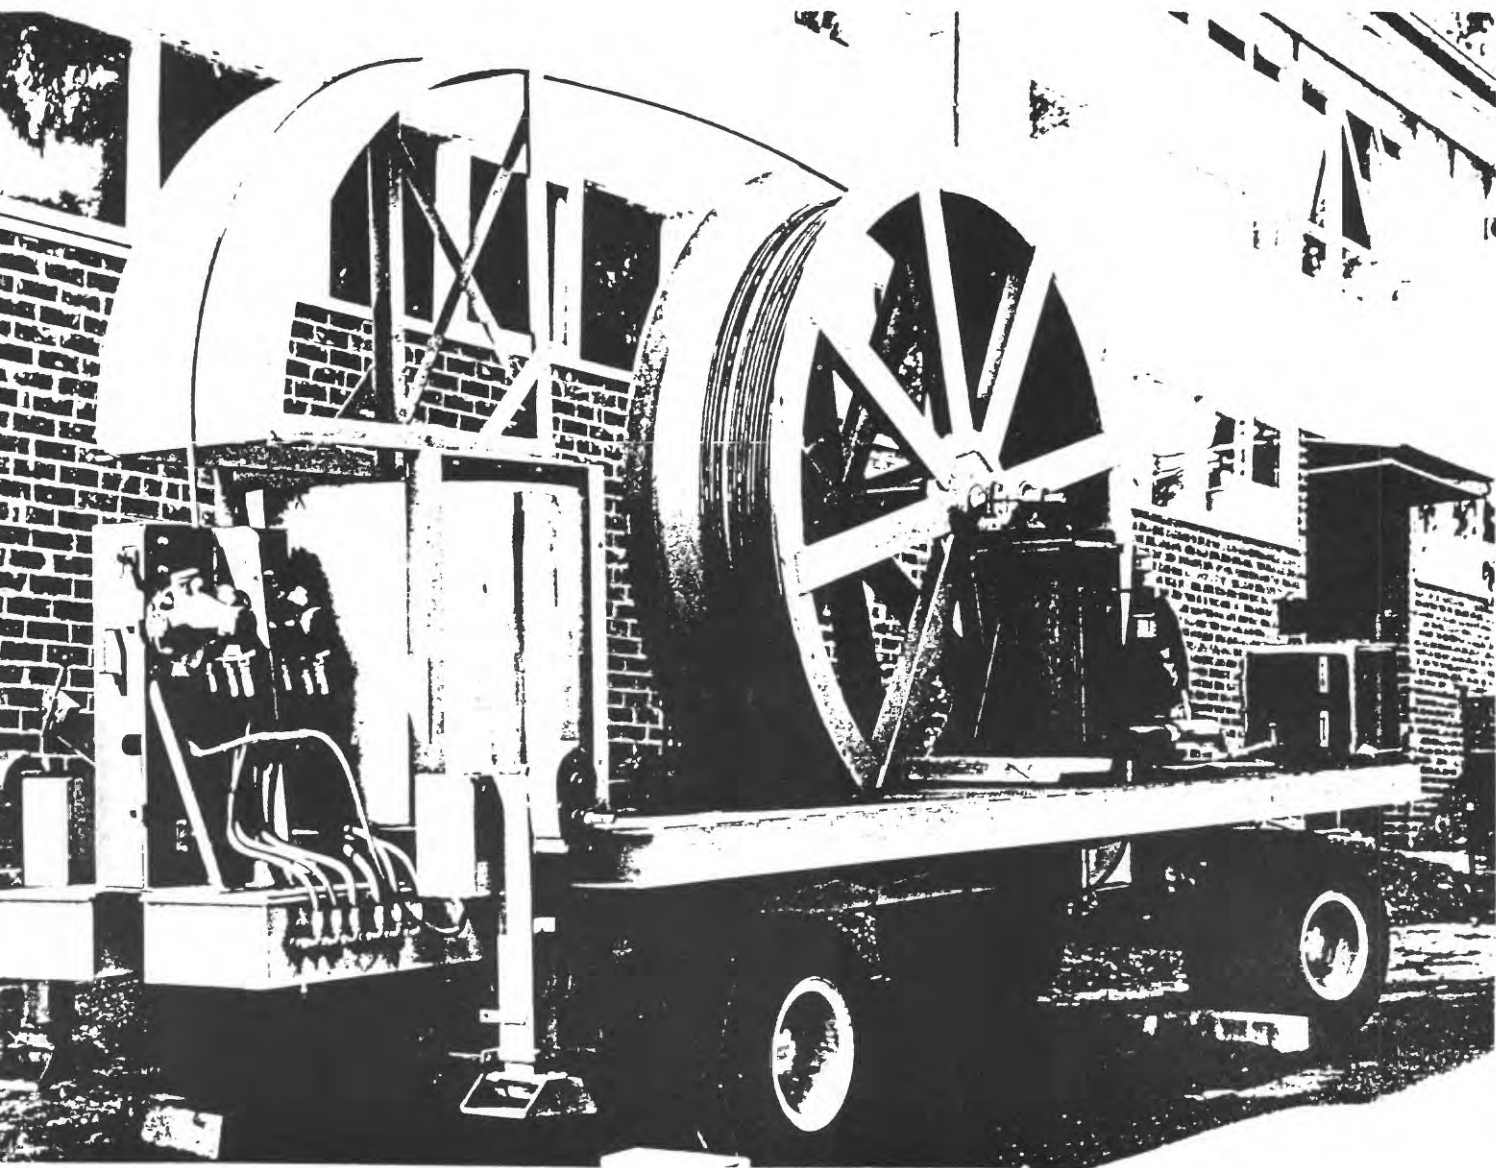
Figure 5. General arrangement of "Endless Tubing Unit"

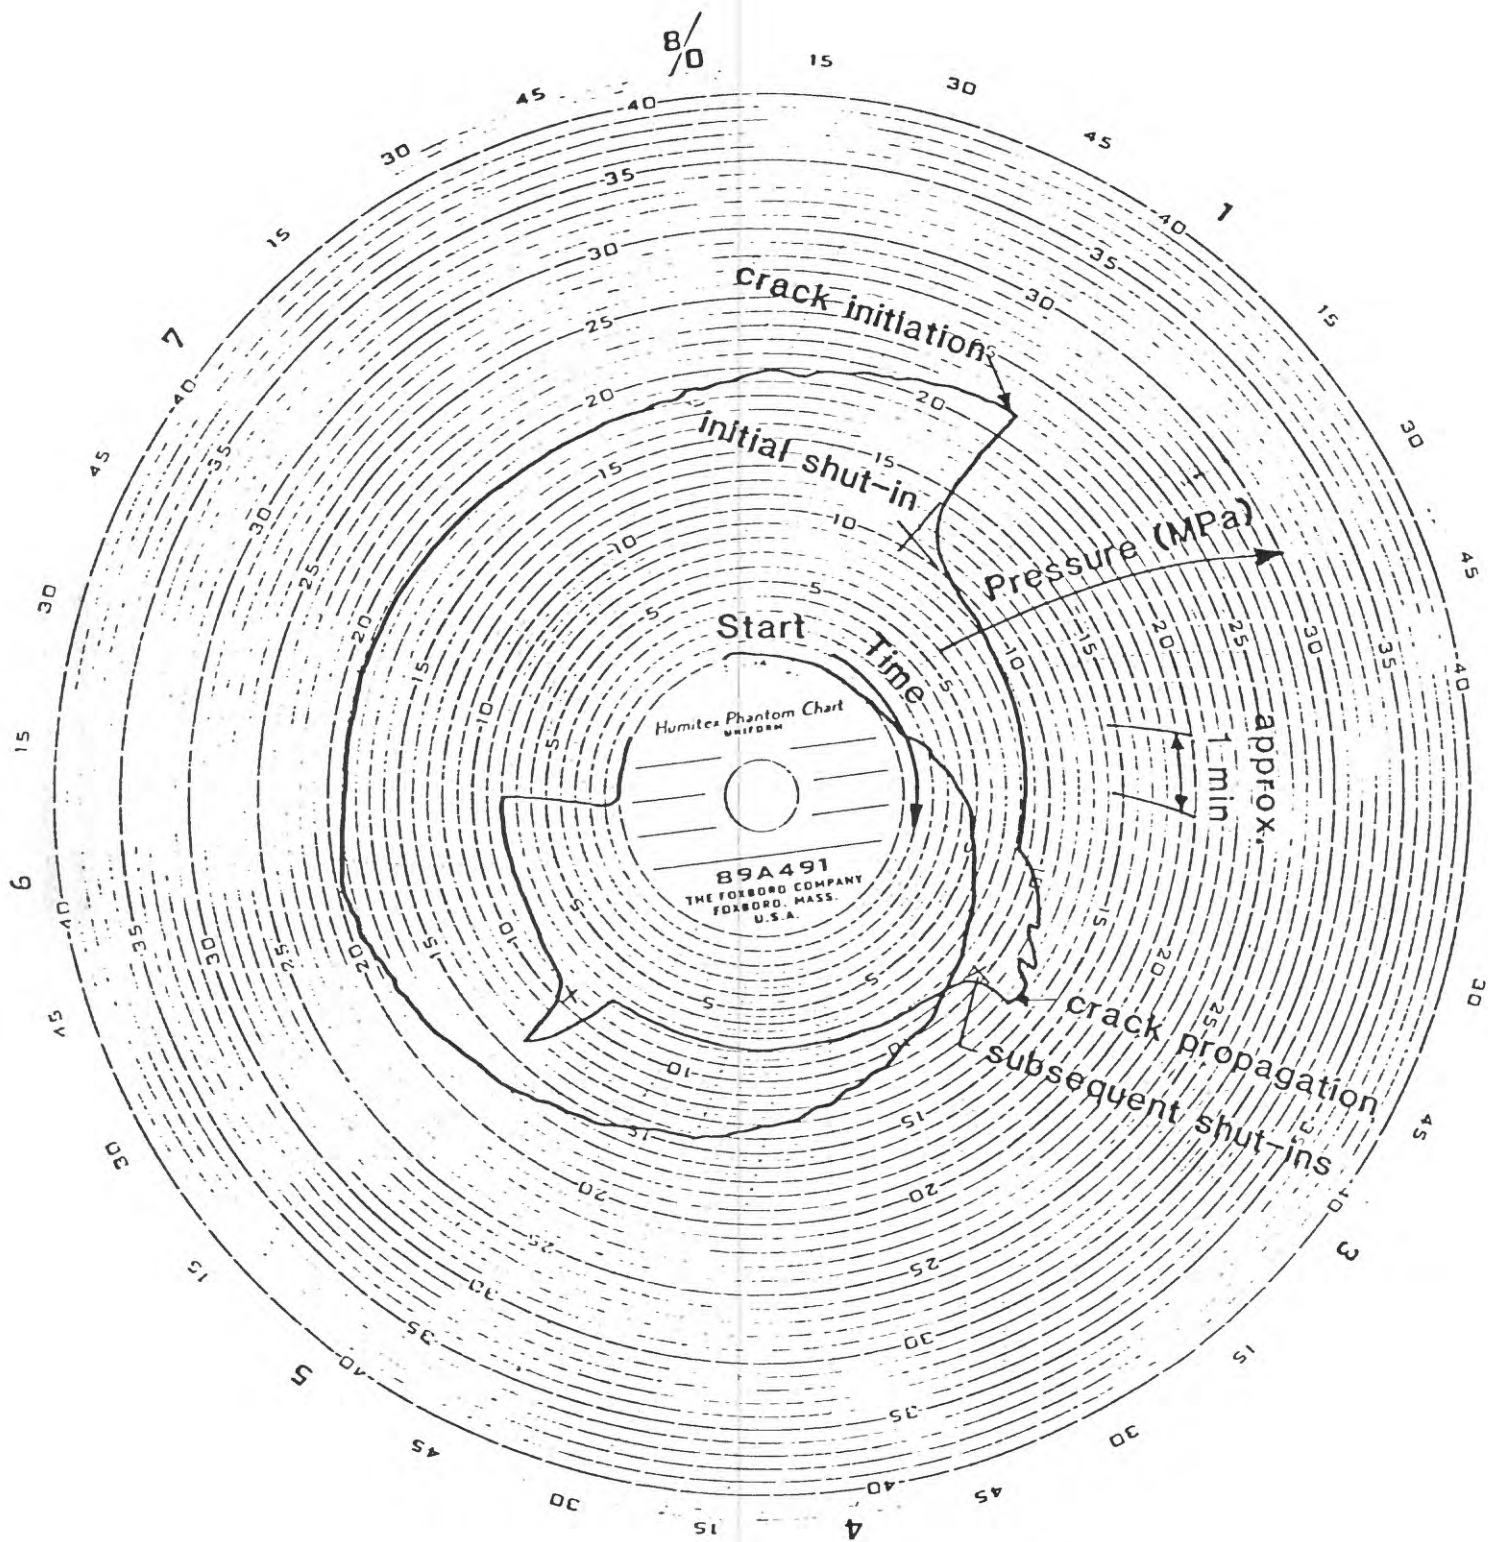
Fig. 7.- Typical pressure record obtained during testing at Tahhmoor Colliery, N.S.W.

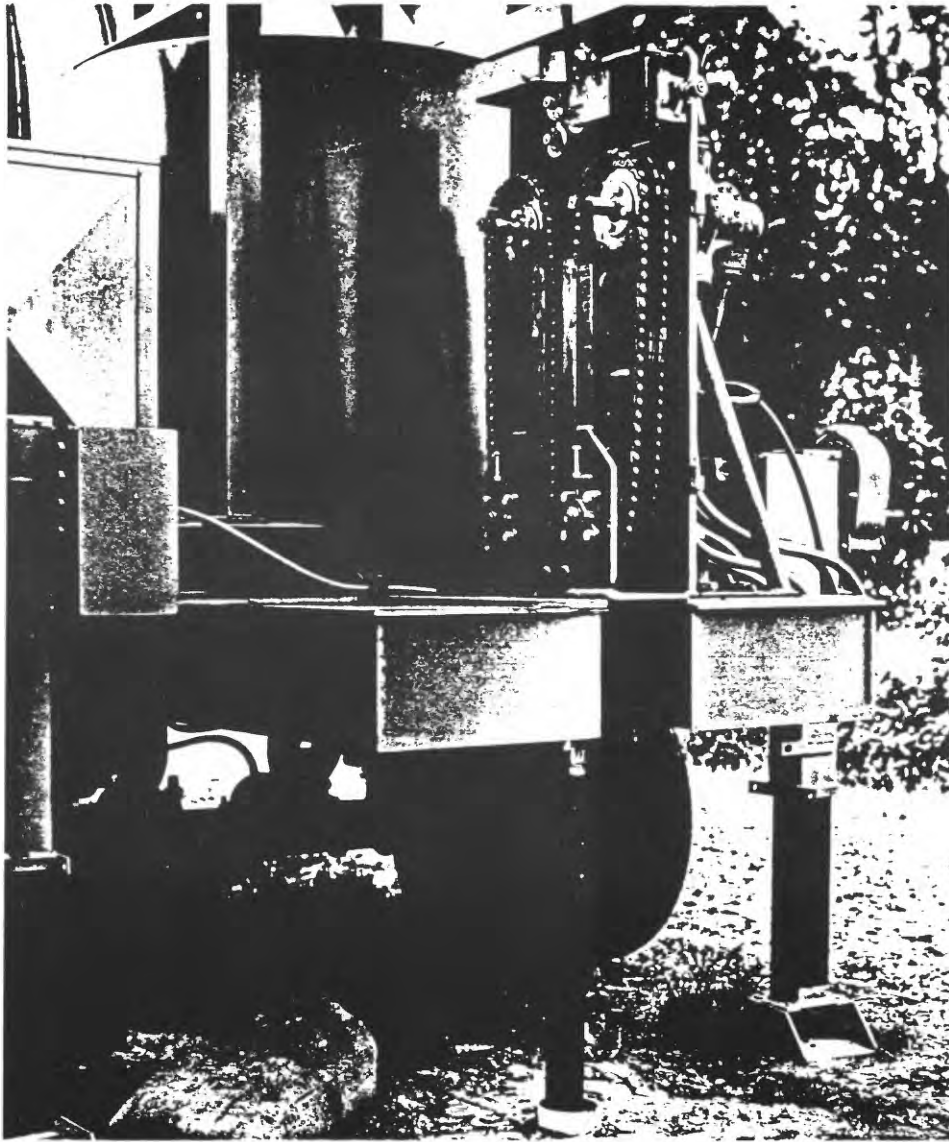
Figure 6. Detail of injector head on "Endless Tubing Unit".

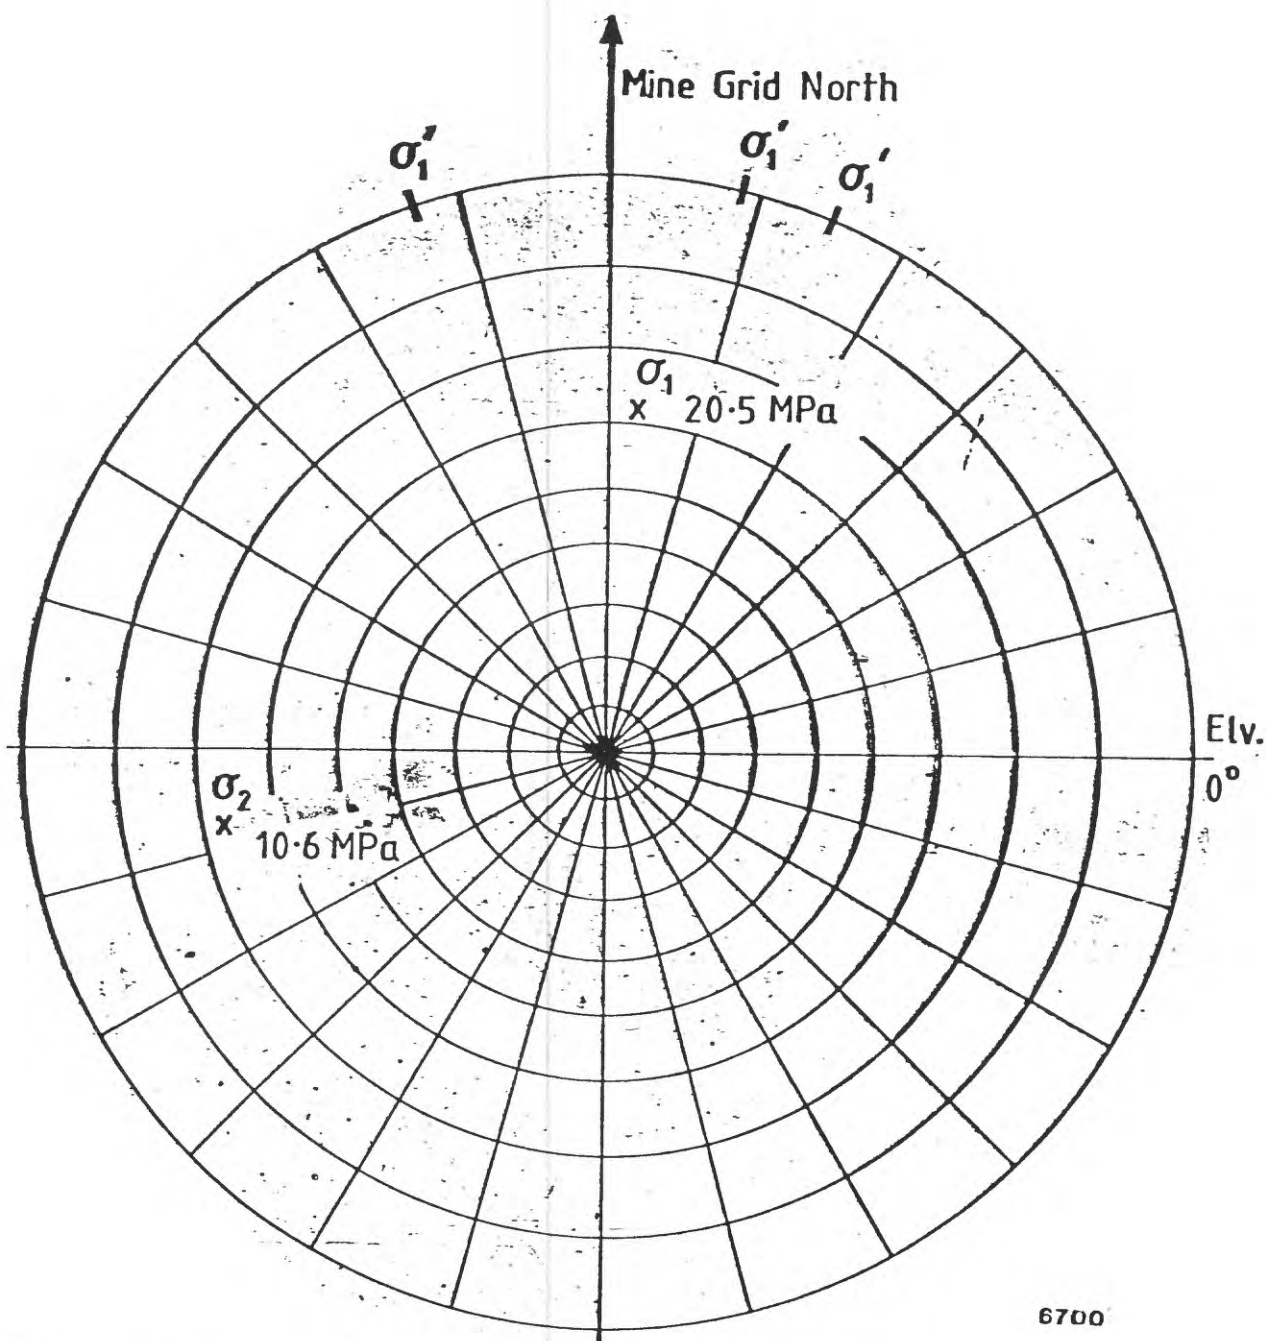
Fig. 8.- Summary of orientation information obtained during testing at Tahhmoor Colliery:

- σ_1' is major secondary principal stress component in horizontal plane indicated by fracturing (orientation assumed to correspond to crack orientation)
- σ_1 , σ_2 are near horizontal principal stress components determined by overcoring.
