# LANDSLIDES AND RELATED FEATURES

OF THE MARLINTON, W.VA. QUADRANGLE

by  
GREGORY C. OHLMACHER  
U.S. Geological Survey  
OPEN FILE MAP 83-80 (B-16)

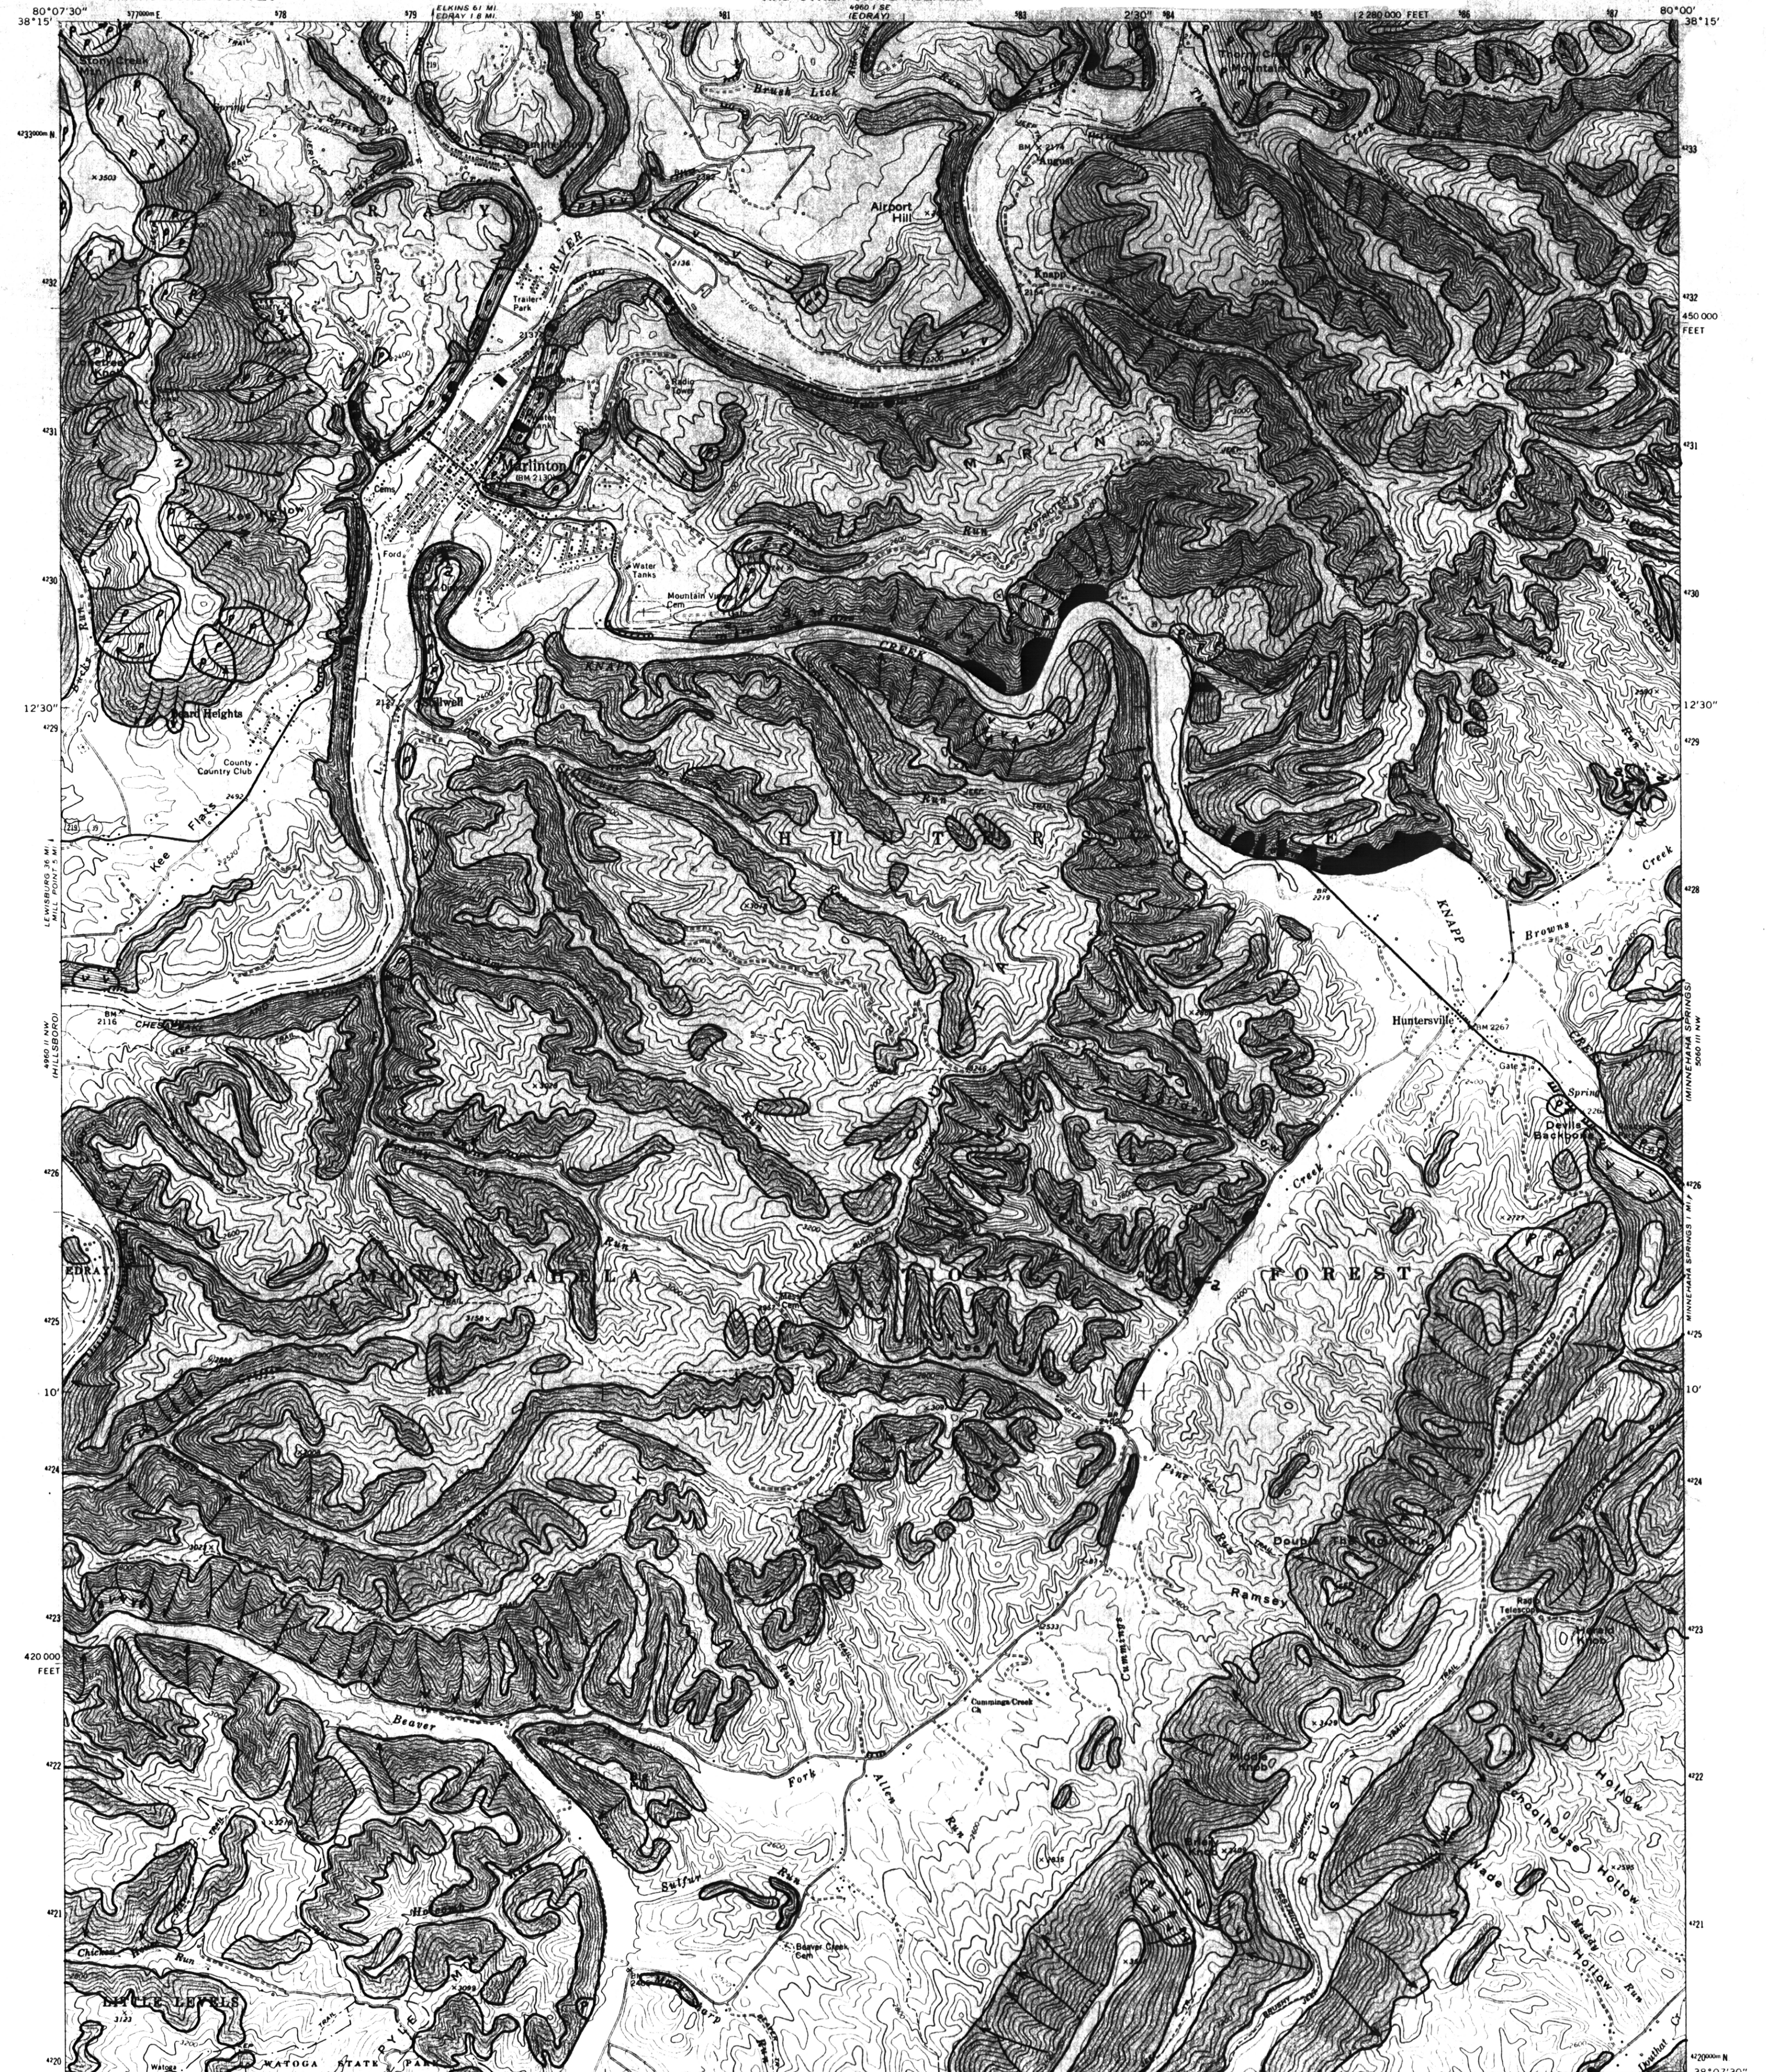
Landslides and related features interpreted  
from aerial photographs:  
1:60,000 SCALE BLACK AND WHITE 1960  
1:125,000 SCALE COLOR INFRARED 1973  
Photointerpretation and field check 1980.  
This map has not been edited or reviewed  
for conformity with Geological Survey  
standards and nomenclature.

ACTIVE OR RECENTLY ACTIVE LANDSLIDE  
Complex landslide composed of earthflow, debris  
slide, earth and rock slump. Identified from  
historical records, and from scars, debris and  
other field evidence. Ground extremely unstable,  
sliding accelerated by excavation, loading and  
changes in drainage conditions. May include  
areas with several active slides too small to  
be shown separately.  
OLD LANDSLIDE  
Area of extensive hummocky ground caused by  
earthflow and earth and rock slump. Lacks  
clear evidence of active sliding. Relatively  
stable in natural, undisturbed state,  
generally not affected by small structures properly  
sited in areas away from the edge of the toe,  
can be reactivated by extensive, rapid exca-  
vation, loading, and changes in ground water and  
surface water conditions. Area of old landslide  
probably includes recent ones not identified  
from field evidence or otherwise documented.

Upslope boundary of landslide generally defined  
by modified scarp, but downslope (toe) may be  
gradational and not well defined.  
COLLUVIAL SLOPE  
Valley wall along major streams with slope as  
steep as 40° (85%), stony, clayey silt soil up  
to 50 ft. (15 m) thick, commonly buttressed by  
a terrace or bench at the toe of the slope, very  
susceptible to sliding by cutting of toe area,  
removal of terrace or bench, and overloading,  
slide commonly activated without apparent cause.

AREAS SUSCEPTIBLE TO DEBRIS FLOWS AND DEBRIS  
AVALANCHES  
Primarily shallow, narrow ravines and chutes with  
accumulation of stony colluvium generally 10 ft.  
(3 m) or less in thickness, susceptible to rapid  
movement during intense rainfall. Most ravines  
and chutes designated show evidence of former  
debris flows and avalanches. Symbol-a-dusig-  
nates historical debris flow or debris avalanche.  
AREAS SUSCEPTIBLE TO ROCKFALL  
Steep, locally vertical, natural and man-made  
slopes and cliffs, 15 ft. (4.5 m) or more high,  
formed dominantly of sandstone, limestone, sandy  
shale, mudstone and claystone. Interbedded mud-  
stone, claystone and shale weather rapidly leaving  
sandstone and limestone rock faces unsupported.  
SOIL AND ROCK SUSCEPTIBLE TO LANDSLIDING  
Soil and rock similar to that involved in land-  
slides elsewhere in map area; primarily areas  
underlain by claystone, mudstone and shale

associated with other rock types. Rock weathers  
rapidly on exposure forming clayey soil highly  
susceptible to sliding. Includes coves (U-shaped,  
shallow valleys) containing thick layers of clayey  
soil that are very susceptible to sliding where  
excavation breaks continuity of slope and where  
overloaded by artificial fill.  
AREAS LEAST PRONE TO LANDSLIDES  
Map areas in which no patterns or symbols are shown;  
primarily valley floors, ridge tops and broad  
benches; modification by excavation and fill may  
lead to local landslides.
