SPENCER, W. VA.
QUADRANGLE LOCATION
N3845—W8115/7.5

LANDSLIDES AND RELATED FEATURES OF THE SPENCER, W.VA. QUADRANGLE

by
GREGORY C. OHLMACHER
U.S. Geological Survey
OPEN FILE MAP 83-80 (G-6)

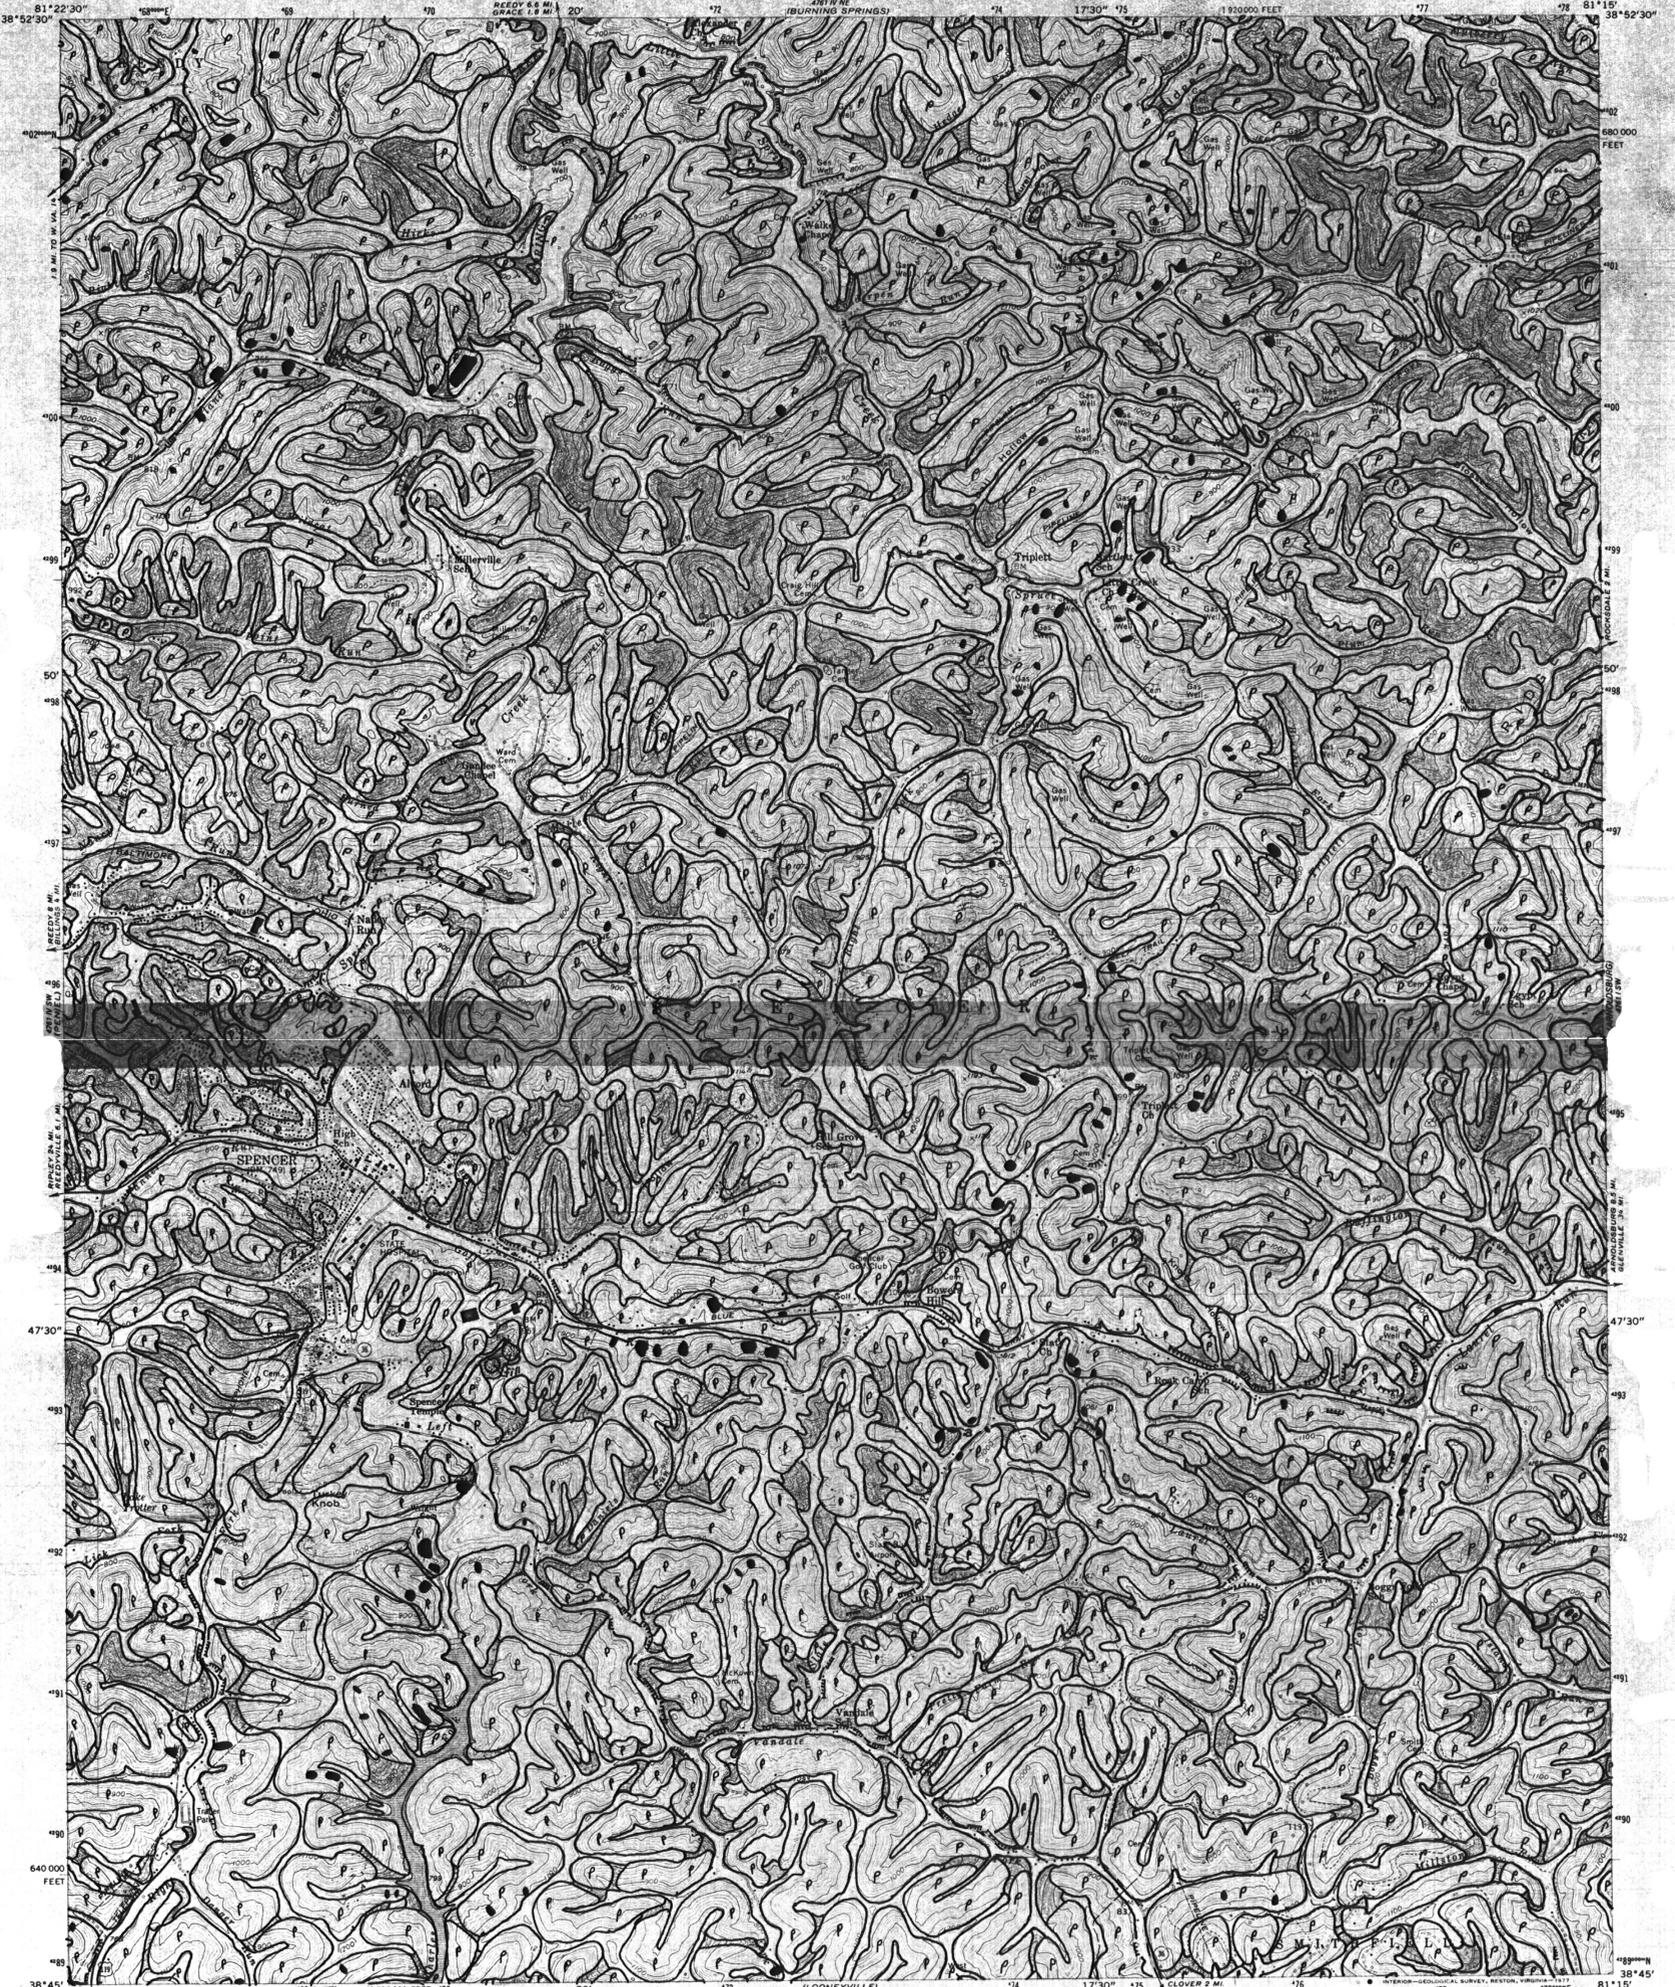
- ACTIVE OR RECENTLY ACTIVE LANDSLIDE**
Complex landslide composed of earthflow, debris
slide, earth and rock slump. Identified from
historical records, and from scars, debris and
other field evidence. Ground extremely unstable;
sliding accelerated by excavation, loading and
changes in drainage conditions. May include
areas with several active slides too small to
be shown separately.

- OLD LANDSLIDE**
Area of extensive hummocky ground caused by
earthflow and earth and rock slump. Lacks
clear evidence of active sliding. Relatively
stable in natural, undisturbed state,
generally not affected by small structures properly
sited in areas away from the edge of the toe,
can be reactivated by extensive, rapid exca-
vation, loading, and changes in ground water and
surface water conditions. Area of old landslide
probably includes recent ones not identified
from field evidence or otherwise documented.
Upslope boundary of landslide generally defined
by modified scarp, but downslope (toe) may be
gradational and not well defined.

- COLLUVIAL SLOPE**
Valley wall along major streams with slope as
steep as 40° (85%), stony, clayey silt soil up
to 50 ft. (15 m) thick; commonly buttressed by
a terrace or bench at the toe of the slope; very
susceptible to sliding by cutting of toe area,
removal of terrace or bench, and overloading;
slide commonly activated without apparent cause.

- AREAS SUSCEPTIBLE TO DEBRIS FLOWS AND DEBRIS
AVALANCHES**
Primarily shallow, narrow ravines and chutes with
accumulation of stony colluvium generally 10 ft.
(3 m) or less in thickness; susceptible to rapid
movement during intense rainfall. Most ravines
and chutes designated show evidence of former
debris flows and avalanches. Symbol designa-
tes historical debris flow or debris avalanche.

- AREAS SUSCEPTIBLE TO ROCKFALL**
Steep, locally vertical, natural and man-made
slopes and cliffs, 15 ft. (4.5 m) or more high,
formed dominantly of sandstone, limestone, sandy
shale, mudstone and claystone. Interbedded mud-
stone, claystone and shale weather rapidly leaving
sandstone and limestone rock faces unsupported.

- SOIL AND ROCK SUSCEPTIBLE TO LANDSLIDING**
Soil and rock similar to that involved in land-
slides elsewhere in map area; primarily areas
underlain by claystone, mudstone and shale
associated with other rock types. Rock weathers
rapidly on exposure forming clayey soil highly
susceptible to sliding. Includes coves (U-shaped,
shallow valleys) containing thick layers of clayey
soil that are very susceptible to sliding where
excavation breaks continuity of slope and where
overloaded by artificial fill.

- AREAS LEAST PRONE TO LANDSLIDES**
Map areas in which no patterns or symbols are shown;
primarily valley floors, ridge tops and broad
benches; modification by excavation and fill may
lead to local landslides.

- MAN-MADE FEATURES**
Strip mines (combination of letter symbols
indicates complex formed or more than one
type of strip mine)
- sh bench with high wall
 - sf furrowed with high wall
 - sd multiple furrows and multiple benches
 - ss hilltop removed
 - sry reclaimed by grading
 - sru reclaimed by secondary use
 - shr regraded in part, high wall
remains
 - Coal refuse banks
r identified on aerial photographs;
not classified in field check
 - rb not burnt nor on fire
 - rbb burnt
 - rbd burning
 - rbs sludge
 - Quarries
q quarry site
 - Gravel pits
g site of gravel pit
 - Slides in man-made features
 - af earth flow in fill
 - as earth flow in strip castings
 - ar earth flow in coal refuse
