LIVERPOOL, W. VA.
NE 4 REPLY 13' QUADRANGLE
N3852.5—W8130/7.5

LANDSLIDES AND RELATED FEATURES OF THE LIVERPOOL, W. VA. QUADRANGLE

by
GREGORY C. OHLMACHER
U.S. Geological Survey
OPEN FILE MAP 83-80 (H-4)

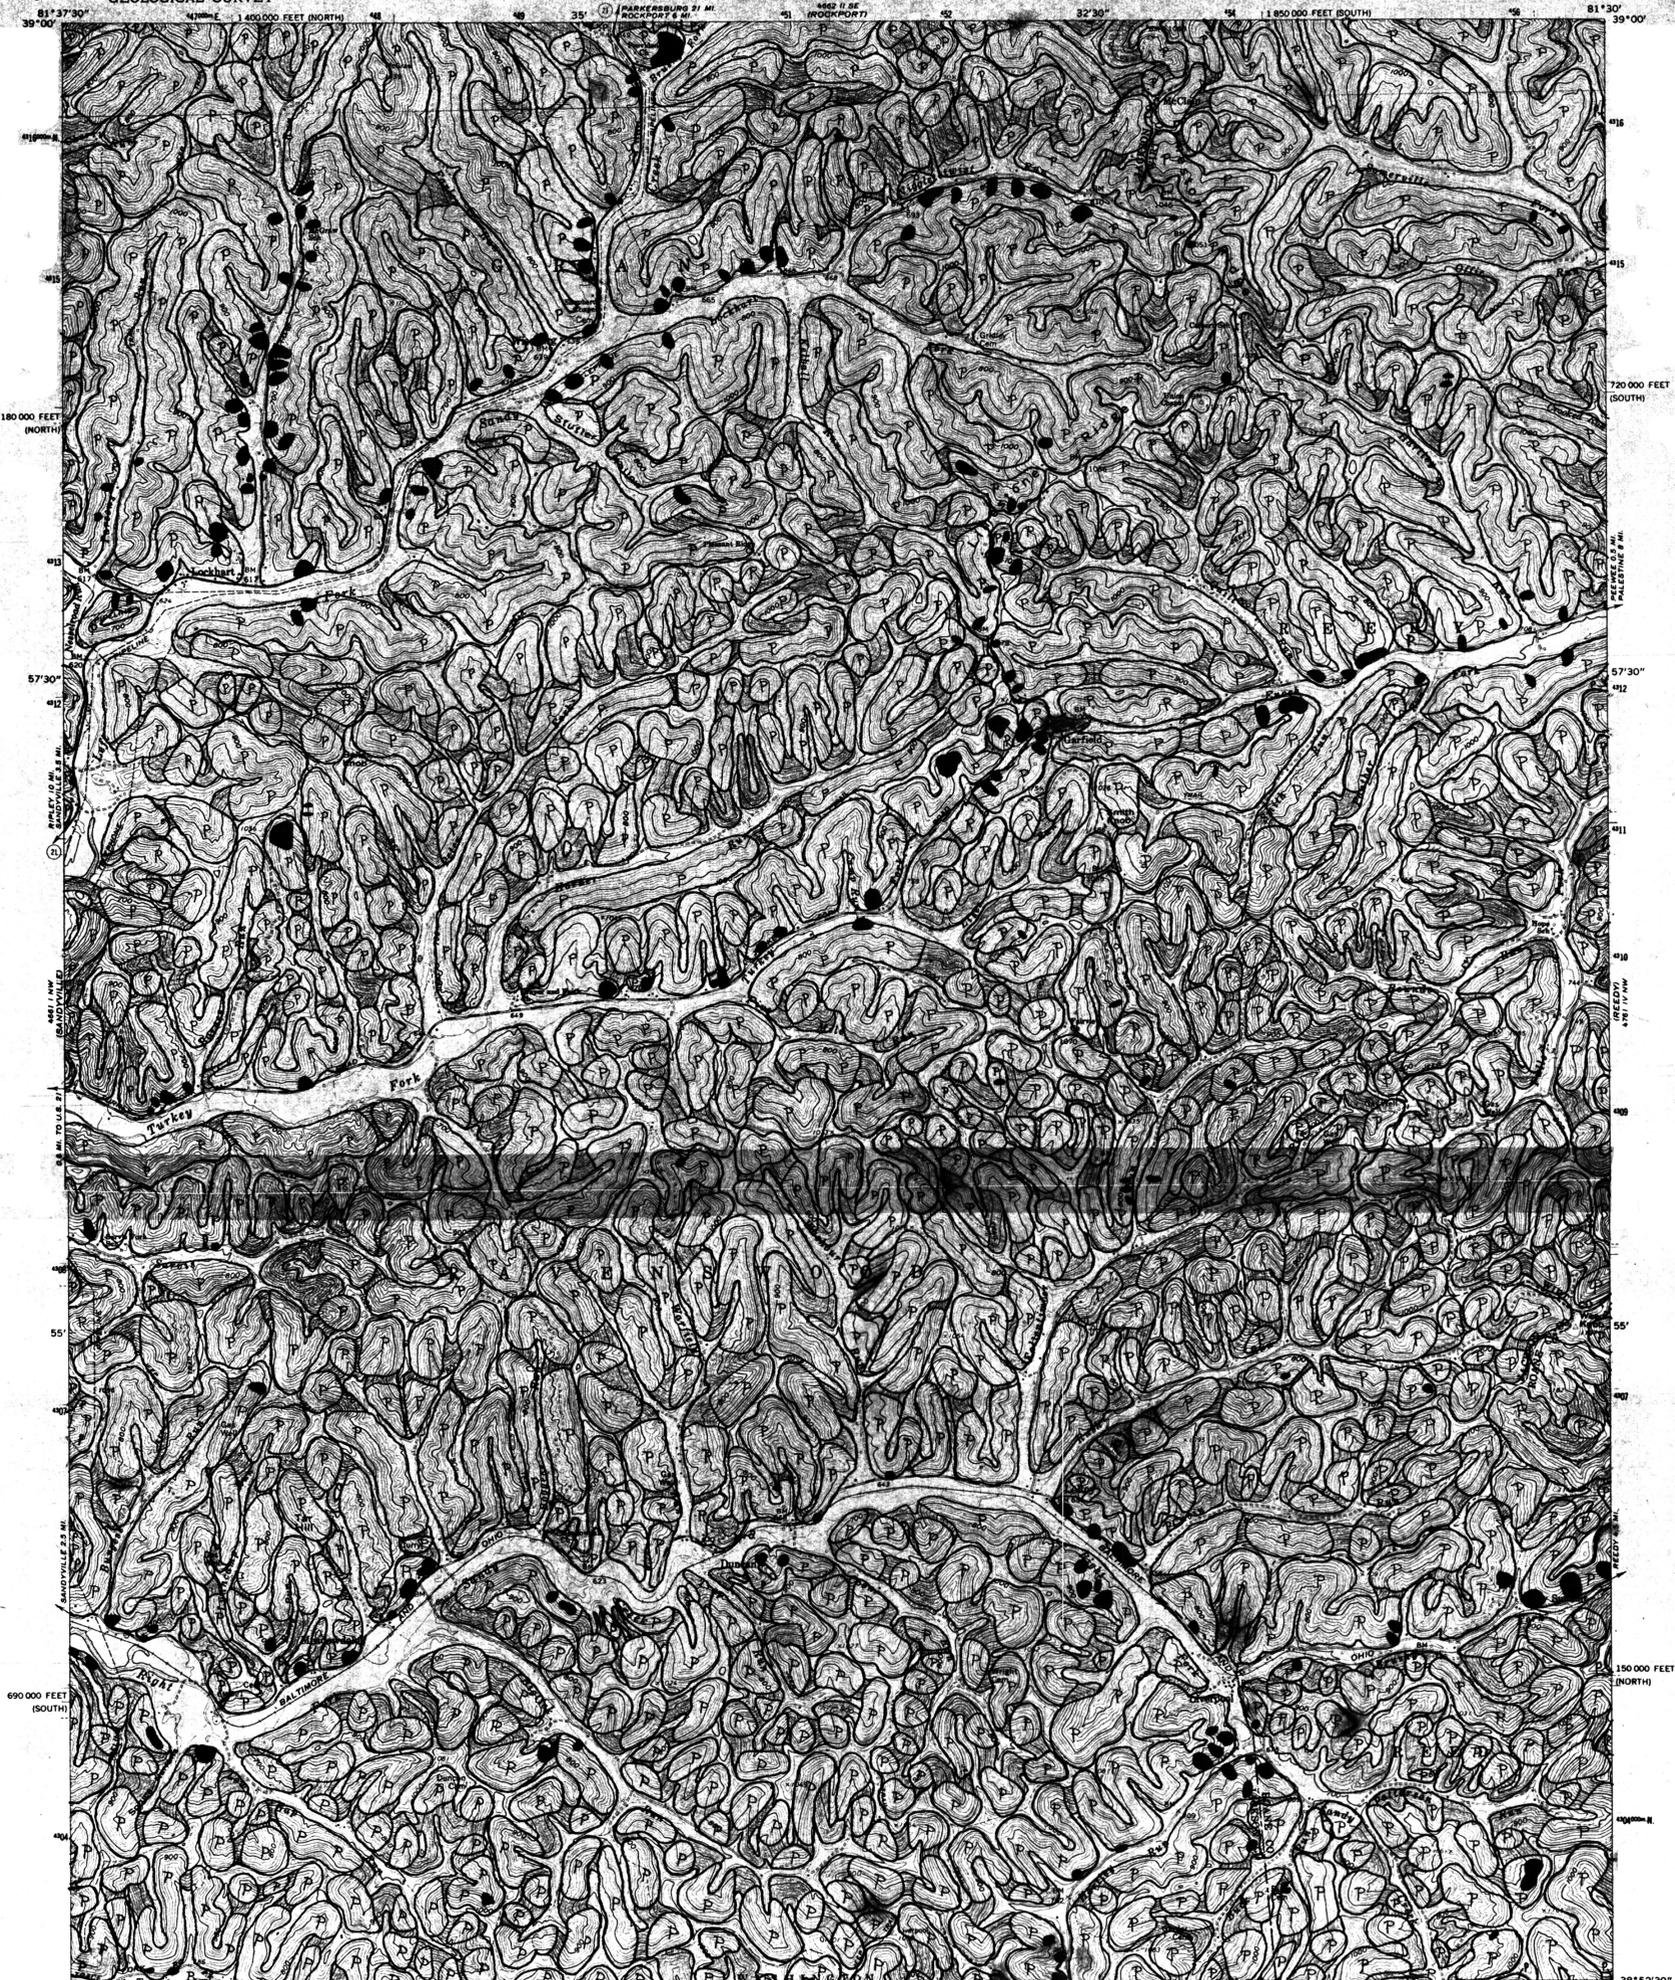
Landslides and related features interpreted from aerial photographs:
1:60,000 SCALE BLACK AND WHITE 1960
1:125,000 SCALE COLOR INFRARED 1973
1:80,000 SCALE BLACK AND WHITE 1975

- ACTIVE OR RECENTLY ACTIVE LANDSLIDE**
Complex landslide composed of earthflow, debris slide, earth and rock slump. Identified from historical records, and from scars, debris and other field evidence. Ground extremely unstable; sliding accelerated by excavation, loading and changes in drainage conditions. May include areas with several active slides too small to be shown separately.

- OLD LANDSLIDE**
Area of extensive hummocky ground caused by earthflow and earth and rock slump. Lacks clear evidence of active sliding. Relatively stable in natural, undisturbed state, generally not affected by small structures properly sited in areas away from the edge of the toe, can be reactivated by extensive, rapid excavation, loading, and changes in ground water and surface water conditions. Area of old landslide probably includes recent ones not identified from field evidence or otherwise documented. Upslope boundary of landslide generally defined by modified scarp, but downslope (toe) may be gradational and not well defined.

- COLLUVIAL SLOPE**
Valley wall along major streams with slope as steep as 40° (85%), stony, clayey silt soil up to 50 ft. (15 m) thick, commonly buttressed by a terrace or bench at the toe of the slope; very susceptible to sliding by cutting of toe area, removal of terrace or bench, and overloading, slide commonly activated without apparent cause.

- AREAS SUSCEPTIBLE TO DEBRIS FLOWS AND DEBRIS AVALANCHES**
Primarily shallow, narrow ravines and chutes with accumulation of stony colluvium generally 10 ft. (3 m) or less in thickness, susceptible to rapid movement during intense rainfall. Most ravines and chutes designated show evidence of former debris flows and avalanches. Symbol 'A' designates historical debris flow or debris avalanche.

- AREAS SUSCEPTIBLE TO ROCKFALL**
Steep, locally vertical, natural and man-made slopes and cliffs, 15 ft. (4.5 m) or more high, formed dominantly of sandstone, limestone, sandy shale, mudstone and claystone. Interbedded mudstone, claystone and shale weather rapidly leaving sandstone and limestone rock faces unsupported.

- SOIL AND ROCK SUSCEPTIBLE TO LANDSLIDING**
Soil and rock similar to that involved in landslides elsewhere in map area, primarily areas underlain by claystone, mudstone and shale associated with other rock types. Rock weathers rapidly on exposure forming clayey soil highly susceptible to sliding. Includes coves (U-shaped, shallow valleys) containing thick layers of clayey soil that are very susceptible to sliding where excavation breaks continuity of slope and where overloaded by artificial fill.

- AREAS LEAST PRONE TO LANDSLIDES**
Map areas in which no patterns or symbols are shown; primarily valley floors, ridge tops and broad benches; modification by excavation and fill may lead to local landslides.

- MAN-MADE FEATURES**
Strip mines (combination of letter symbols indicates complex formed or more than one type of strip mine)
- sh bench with high wall
 - sf furrowed with high wall
 - sd multiple furrows and multiple benches
 - ss hilltop removed
 - sry reclaimed by grading
 - sru reclaimed by secondary use
 - shr regraded in part, high wall remains
- Coal refuse banks
Identified on aerial photographs; not classified in field check
- rb not burnt nor on fire
 - rbb burnt
 - rbd burning
 - rbs sludge
- Quarries
q quarry site
- Gravel pits
g site of gravel pit
- Slides in man-made features
- af earth flow in fill
 - as earth flow in strip castings
 - ar earth flow in coal refuse
