Potential for debris flow and debris flood along the  
Wasatch Front between Salt Lake City and Willard, Utah,  
and measures for their mitigation

Gerald F. Wieczorek, Stephen Ellen, Elliott W. Lips, and Susan H. Cannon  
U.S. Geological Survey  
Menlo Park, California

Open-File Report 83-635  
1983

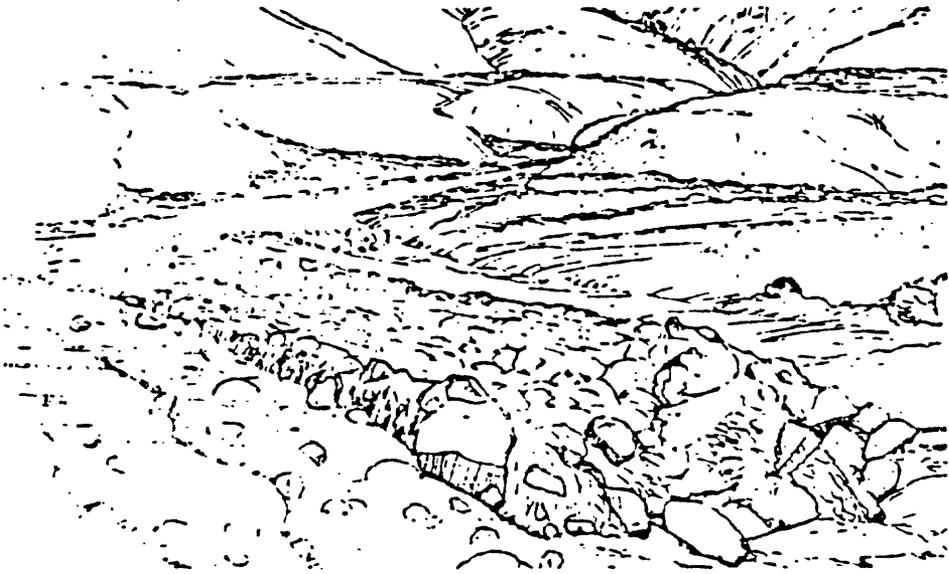
Figure 2. Sketch of debris flow (from Croft, 1967).

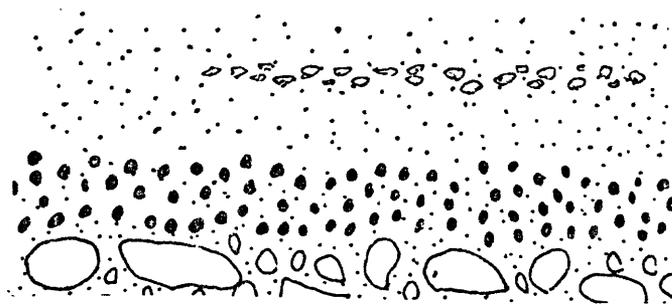
Figure 3. Comparison of deposits left by (A) debris flood and (B) debris flow.
