Liquefaction During the 1981 and Previous Earthquakes  
Near Westmorland, California

T. L. Youd  
G. F. Wieczorek

Open-File Report 84-680

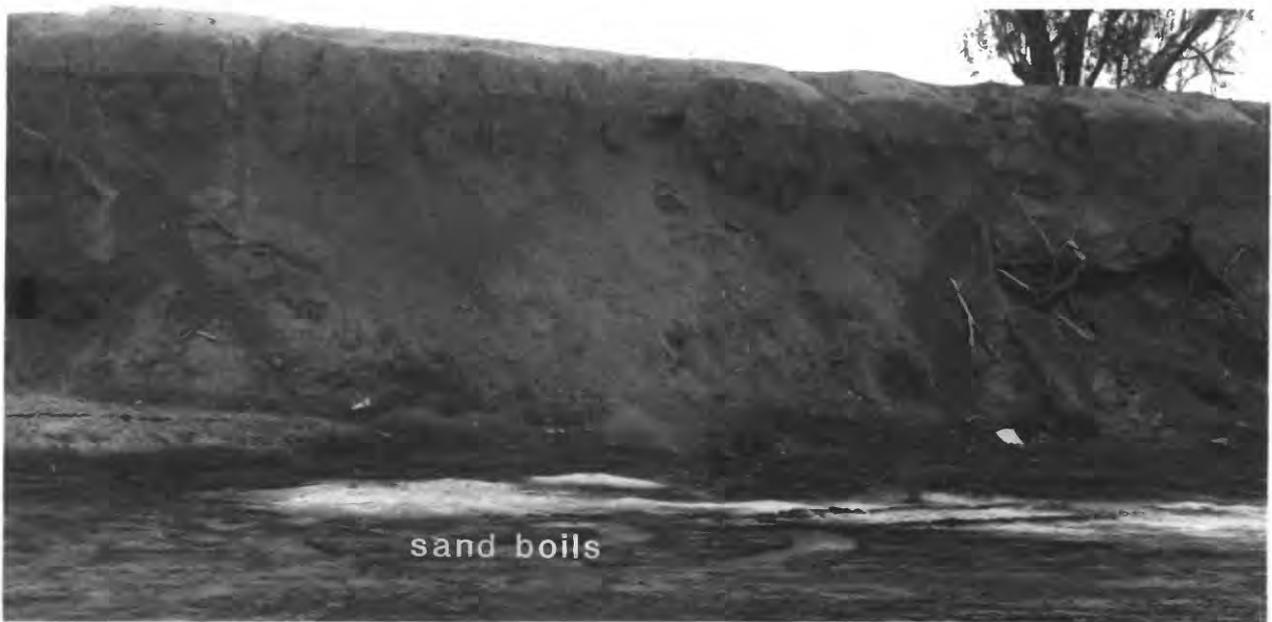
**B**

Figure 2. (A) Sand boils (white patches on photo) generated by 1979 Imperial Valley earthquake which (B) slightly reactivated and spotted the ground surface with water during the 1981 earthquake (site 1). Pencil is 13.7 cm long.

Site 1. During the 1979 earthquake, several sand boils expelled considerable volumes of water and sand and created a small pond in the New River flood plain about 100 m east of the KROP radio tower. Small fissures developed around that pond, and larger fissures developed at the margin of the river flood plain and locally in the adjacent bluffs (Heaton, and others, 1983, p. 1163; Youd and Wieczorek, 1982, p. 233). That site is 14.2 km southeast of the 1981 epicenter and 12.0 from the estimated source zone. During the 1981 event, small amounts of water and sediment spurted from several 1979-event sand boils, spotting the tops of the old sand-boil deposits with new sediment (figure 2). The slight rejuvenation of these sand boils indicates that shaking intensities were near the threshold for generating liquefaction in the underlying sediment during the 1981 event. Apparently

this sediment had been left in a very susceptible condition by the previous occurrence of liquefaction. Because of the shorter distance from the source, peak ground acceleration at this site was probably slightly greater than the 0.18 g recorded at the Brawley instrument station (at Brawley Airport), which is 2.7 km southeast of the radio tower site (Maley and Ethridge, 1981 p. 13).

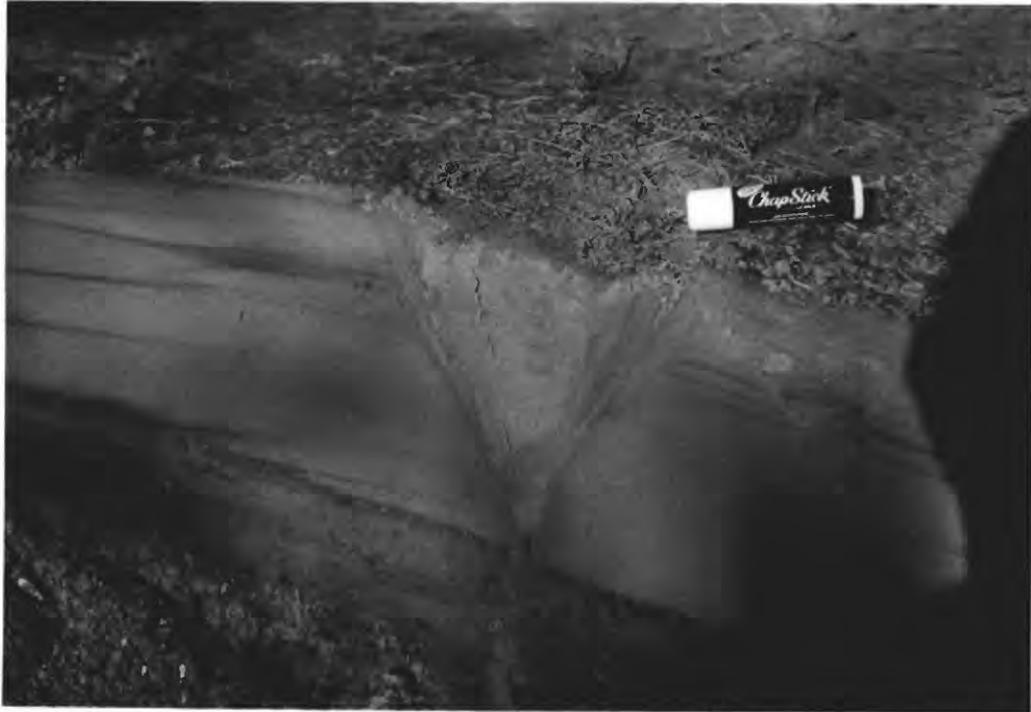
Figure 3. Vertical section through sand boil in Imperial Wildlife Managemnt Area showing horizontal layers of sand boil deposit and funnel-shaped spout through which sediment was ejected. (Photograph by M. J. Bennett).

Site 4. Numerous sand boils, fissures, and slumped banks occurred along both sides of a 3-km-long stretch of the Alamo River within the Imperial Wildlife Management Area. Sand boils and fissures extended as far as 100 m from the river but were more concentrated nearer the channel. At several places, segments of bank as wide as 5 m collapsed into the river. Figure 3 shows a vertical cross section exposed by a shallow trench we excavated through one of the sand boil deposits.

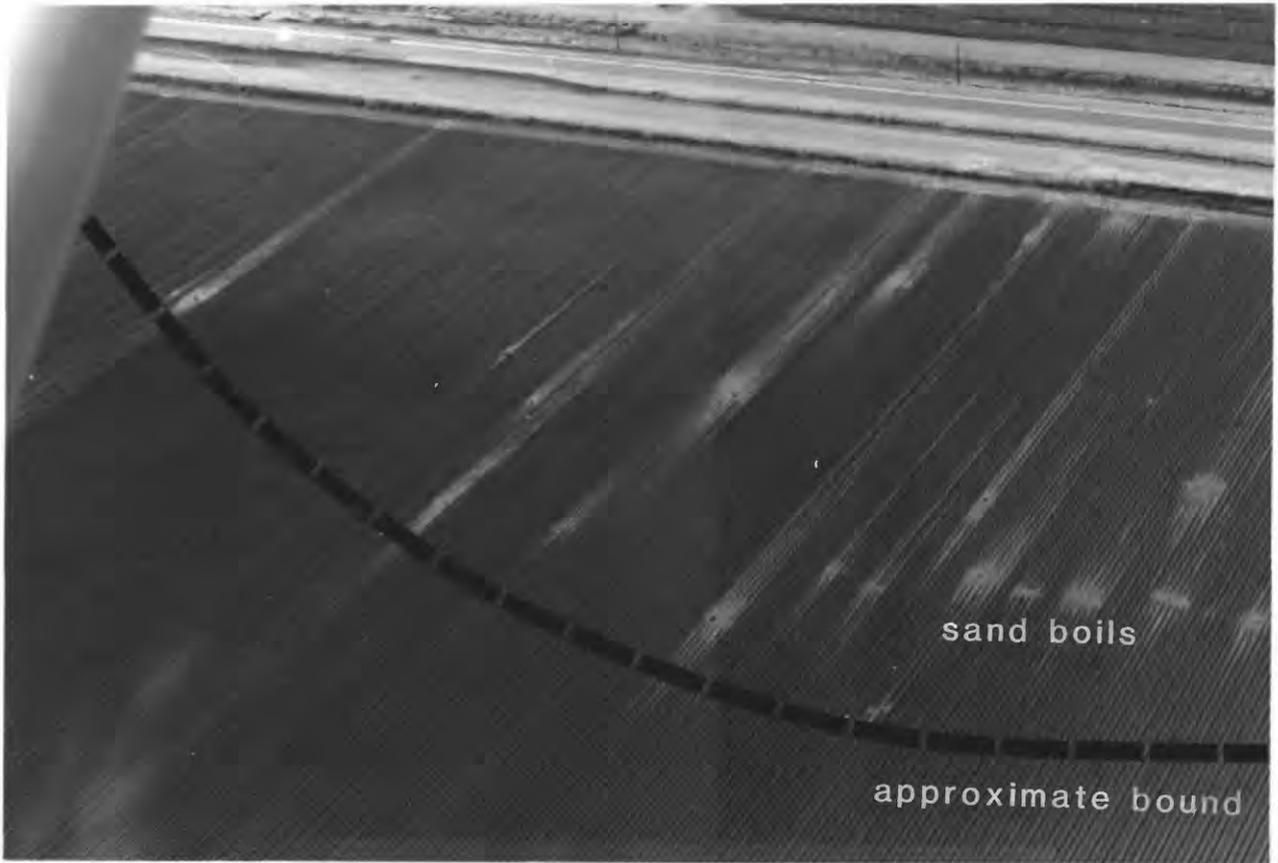
Figure 7. South-southeast view showing sand boils, some of which discharged large quantities of water, and location of breach in Vail Canal (Site 6). The dashed line indicates approximate bound of zone within which sand boils erupted.

Site 6. About 4.6 km southwest of Calipatria, more than 50 sand boils erupted in a field and on Vail Road which bounds the south edge of the field (figure 7). The sand boils were among the largest generated by the earthquake. In some instances, water from sand boils flooded several furrows for more than 100 m, a feat requiring several cubic meters of water. In one place (figure 8), the gush of water from the ground eroded and left open a 20-cm diameter tube, an action requiring many liters per second of flow. Although the amounts of flow were great, the amount of sediment carried to the surface was not particularly large, indicating high water to sediment ratios.

The sand boils and canal break lie within a zone bounded on the north by the curved line on figure 7. The curved shape of the line suggests that a former stream channel lies below the ground surface and that liquefaction of sediment deposited by that stream produced the sand boils. Further evidence of past fluvial activity at this site is a terrace with a curved scarp at the north end of the field (not visible in photo), which is an erosional feature produced during incision of the New River.

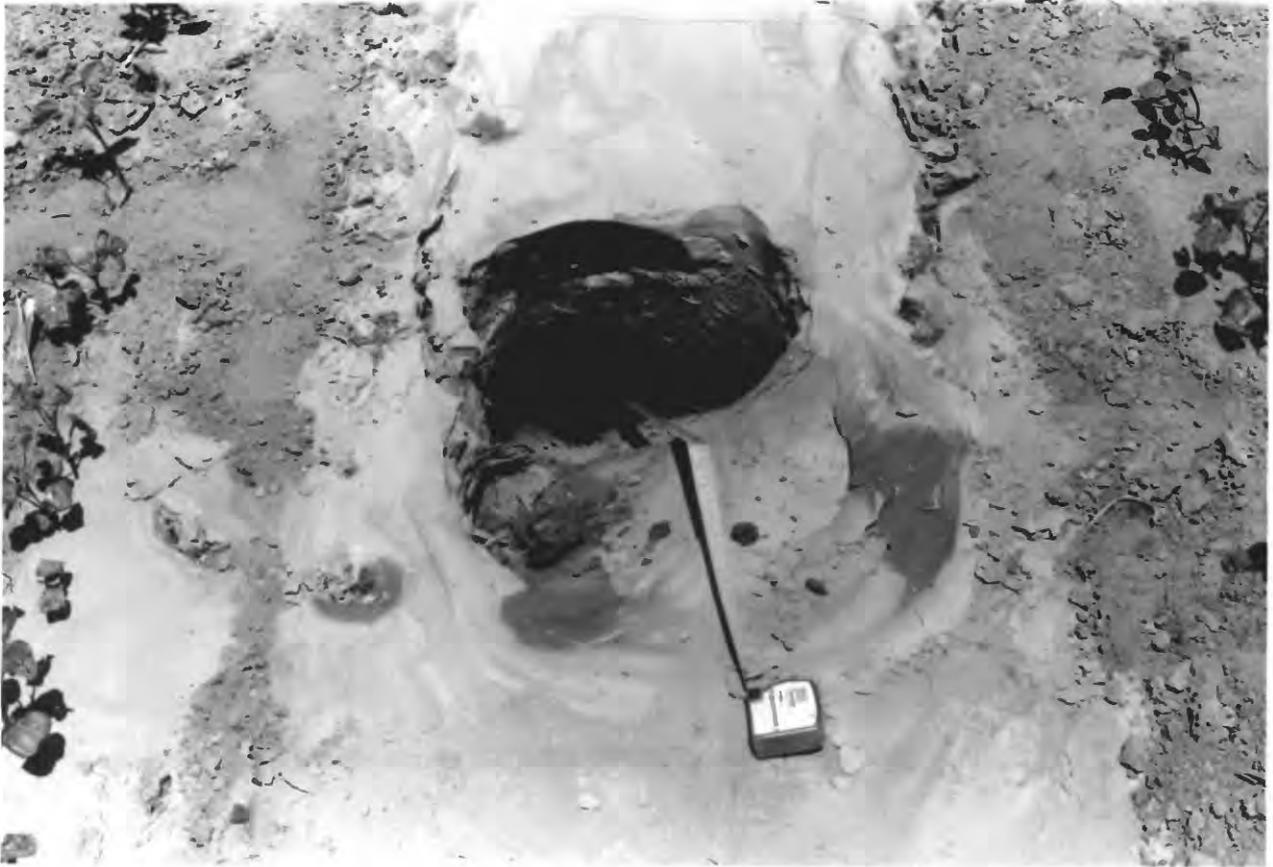
Figure 8. Sand boil near Vail Canal (Site 6) that discharged a gusher of water and eroded a 20-cm diameter tube. The small amount of deposited sediment here indicates that the water-to-sediment ratio for this sand boil was very high.

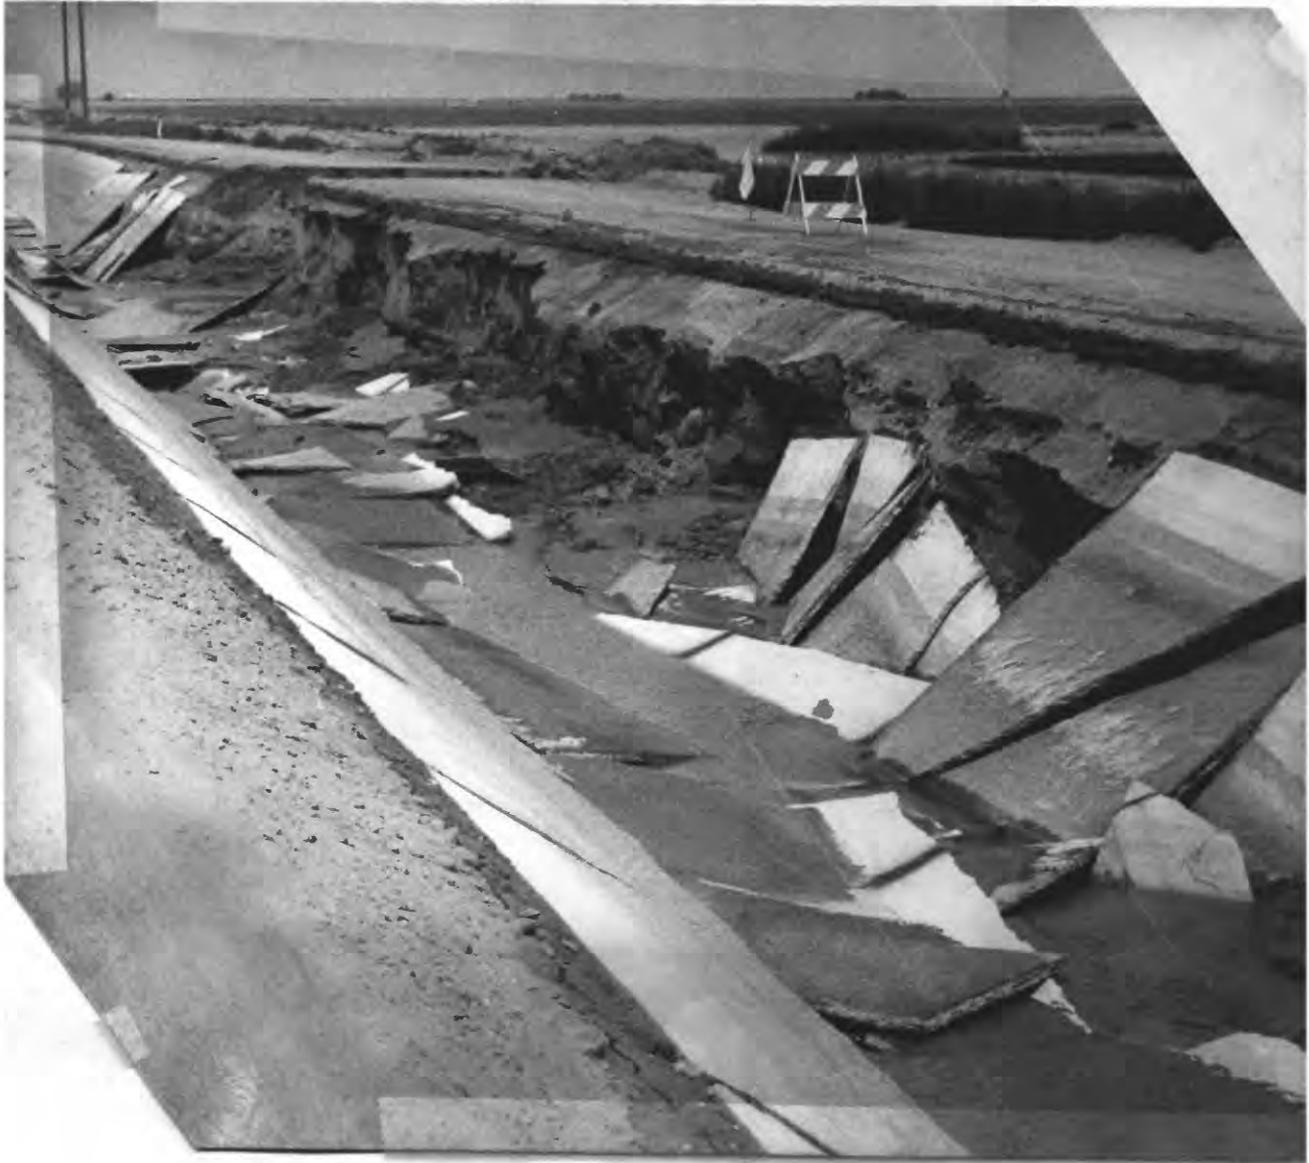
Figure 9. Photograph taken shortly after the 1981 earthquake showing washout in Vail Canal at Site 6. (Photograph courtesy of Imperial Valley Press).

The Vail Canal, which is parallel to Vail Road and is a major water-supply artery for the region, ruptured and washed out near several sand boils at the eastern margin of the sand boil zone (figure 9). The breach diverted the full flow of the concrete-lined canal southward through the embankment and into a drainage ditch parallel to the canal. The washout of the embankment and its rapid repair (within hours of the earthquake) obliterated any evidence of ground failure. A probable cause of failure, however, is vertical or horizontal ground displacement of less than a few tenths of a meter, caused by liquefaction and consequential settlement, slumping, or lateral shifting of the ground. Such displacement could fracture the concrete lining and allow

water to penetrate, rapidly flow through the lining, and wash the embankment into the nearby drain.

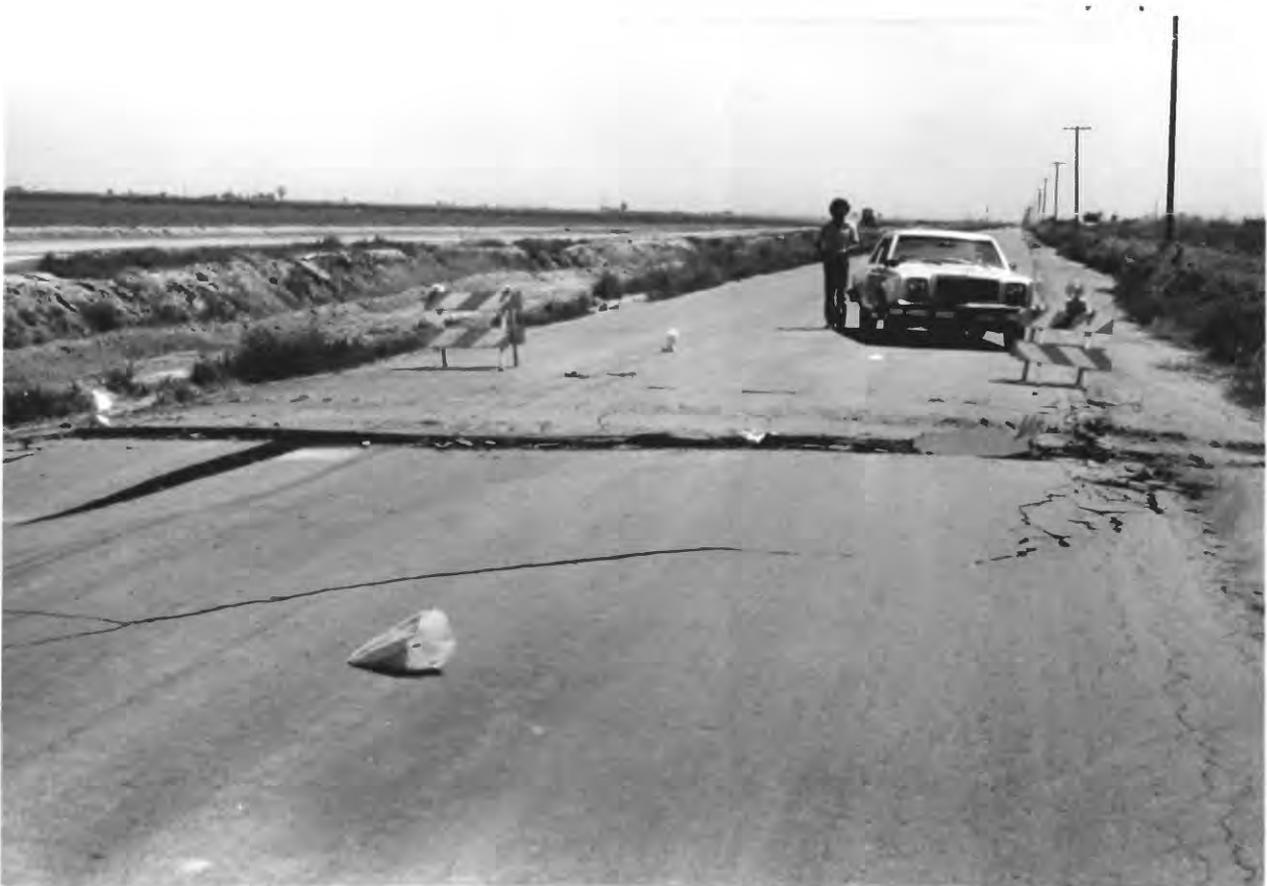
Figure 10. View of Lack Road showing fissures that disrupted pavement (Site 15). The disturbance was caused by lateral spreading toward drainage canal at left edge of photo.

Site 15. About 2.7 km northwest of Westmorland, lateral spreading disrupted the pavement on Lack Road about 100 m south of Bannister Road (figure 10). The spreading resulted in a few tenths of a meter of displacement of the road toward a 5-m-deep drainage ditch. Several arcuate fissures cut across the the bank of the drainage ditch and into the east side of the paved road; the largest of these fissures left an open crack 22 cm wide in the asphalt pavement. A few of the arcuate fissures crossed the road and died out in a wide shiulder to the west. A single linear fissure that extended across the pavement in a south-southwest direction marked the southern margin of the failure zone. The pavement was down 5 cm on the north and slightly buckled across this fissure (figure 10). We observed no other secondary effects, such as sand boils, at this site.

The spreading most likely was caused by soil weakening due to liquefaction. An estimate of ground motions at this site is provided by the strong-motion record made at Westmorland 2.8 km to the southeast; that record has a peak horizontal acceleration of 0.49 g (Maley and Ethridge, 1981). These accelerations are strong enough to produce liquefaction in most moderately susceptible sediments, but they probably were not strong enough nor of sufficient duration to produce the displacements observed here without soil weakening (R.C. Wilson, oral commun., 1981).

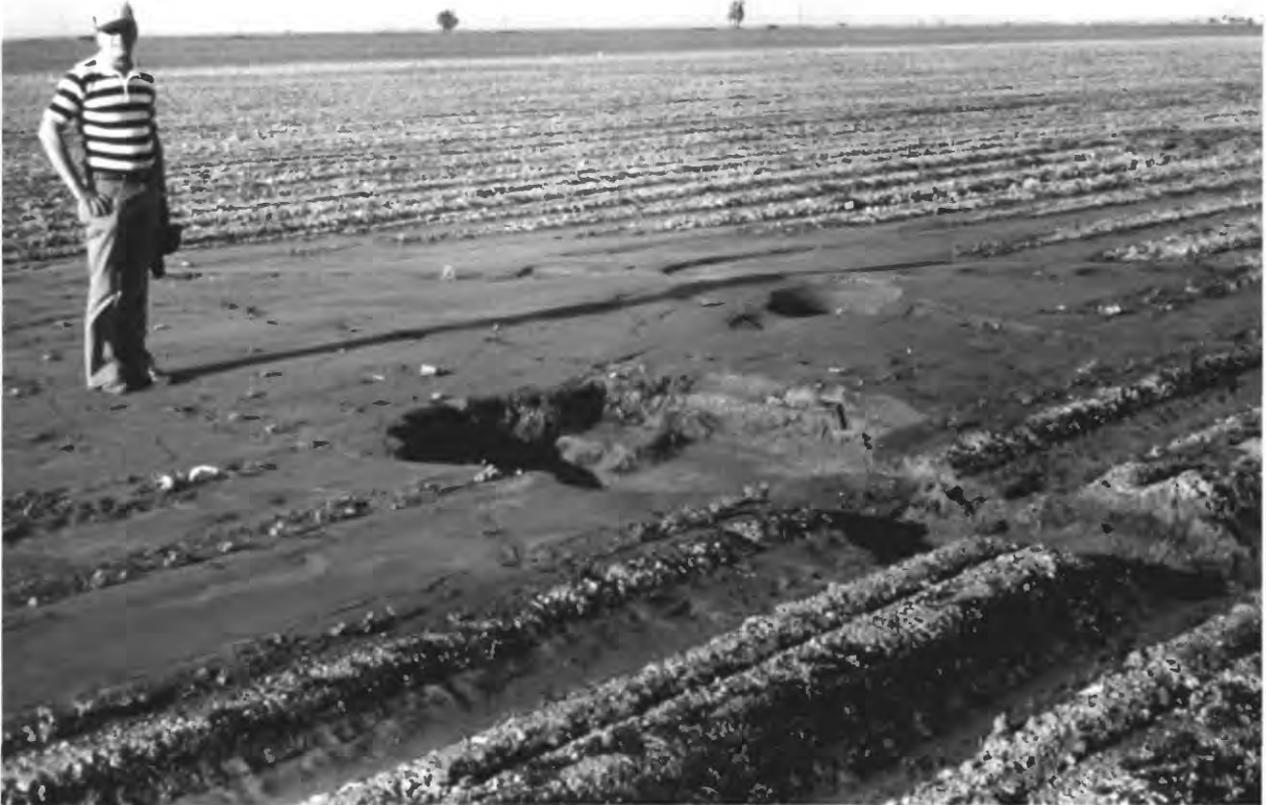
FIGURE 11. View of a 10- to 15-m diameter sand boil deposit about 100 m east of Kornbloom Road (Site 15); this is one of the largest sand boils that erupted during the 1981 event. (Photograph by John Sarmiento.)

erupted along short ground fissures, whereas others erupted at random in the field. Sand boil deposits were as much as 15 m in diameter (figure 11). These deposits, being composed of silt and fine sand, are unusually fine-grained. Figure 12 gives grain-size distribution curves for samples from two of the finer of these deposits.

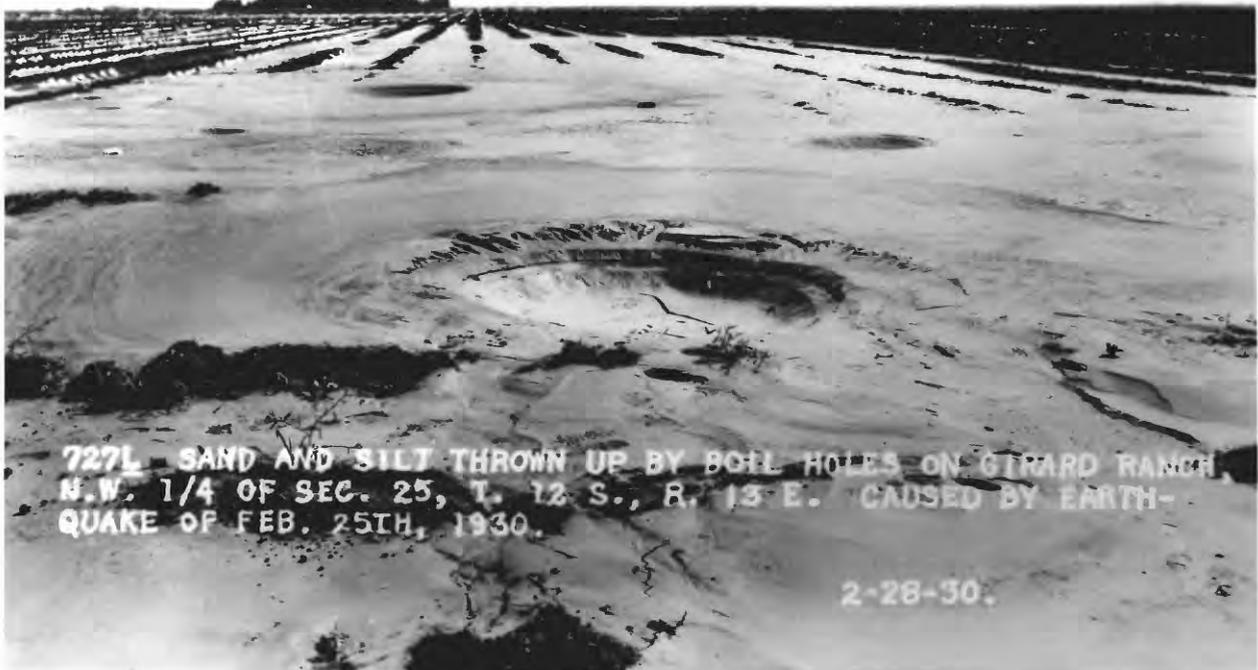
Figure 14. Sand boils that erupted during earthquake of February 25, 1930, near Site 8. Other than near the far west end, where some 1-m diameter sand boils erupted, crop cover prevented reconnaissance of this field in 1981. (Photograph from files of Imperial Valley Irrigation District.)

1930 earthquakes. On February 25, 1930, an earthquake centered north of Westmorland produced Rossi-Forel Intensity of VIII over a small area (Neumann and Bodle, 1932). A similarly intense but less widely felt aftershock struck the same area on March 1. The February 25 event generated several large sand boils in the open field shown in figure 14. This same field contains Site 16 where smaller sand boils erupted in 1981. At that time, nearly mature wheat obscured the field and could have hidden many sand boils from our view, but probably none as large as those which erupted in 1930. No other information is given on occurrences or distribution of sand boils or other secondary ground effects of the 1930 event.
