UNITED STATES DEPARTMENT OF THE INTERIOR
GEOLOGICAL SURVEY

Landslides and debris flows
east of Mount Pleasant, Utah, 1983 and 1984

Open-File Report 85-382

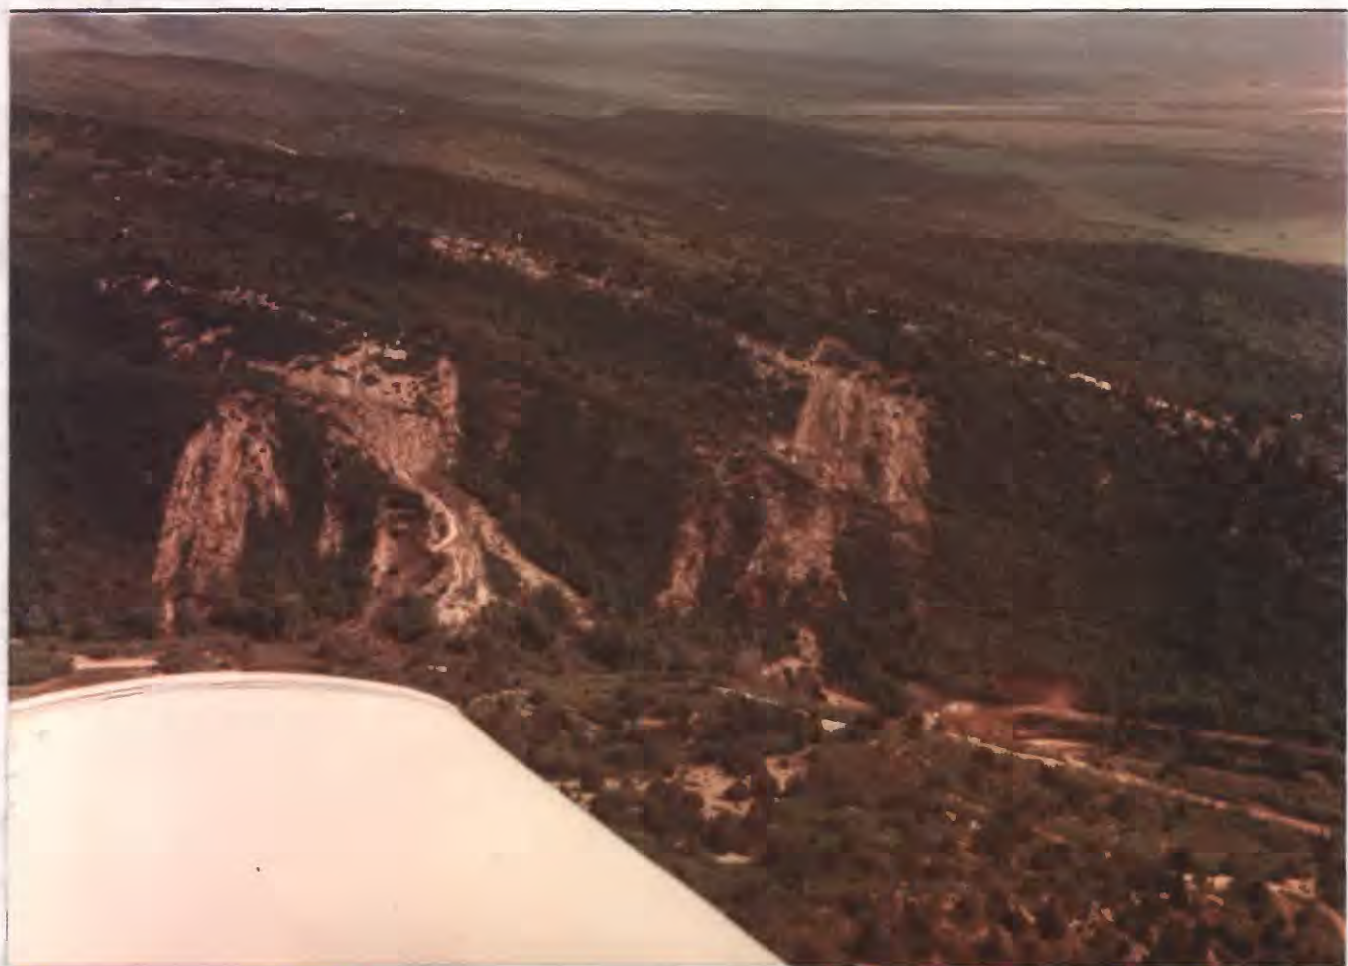
Figure 2. Birch Creek.

Oblique aerial photograph showing the north-facing slope in lower reaches of Birch Creek. The beds of the Wasatch Monocline are seen dipping westward toward Sanpete Valley, which appears at upper right. The large landslide in the center is believed to have a slip surface within bedrock, and is therefore identified as a block slide. The movement of the block slide has generated some debris slides, left center and right center, and also a debris flow, far left. Small stream-bank debris slides can be seen at foot of slope in right and left center.

Most landslides in this inventory occurred within the soil mantle overlying weathered bedrock. The landslide deposits therefore consist of a mixture of soil, water, and organic debris (where hillsides are vegetated). The proportions of these constituents were not evaluated, and there was no systematic sampling of the deposits to determine grain-size distribution. For these reasons the materials, which are largely granular soils are simply referred to as debris, and the landslides are classified solely on the basis of type of movement. The processes include slides, both translational and rotational, and flows (Varnes, 1978). Most of the debris flows developed from debris slides, and where this complex process occurred the feature is mapped as a debris flow. Landslides were mapped as debris slumps only if rotation was distinct; where rotation was questionable they were mapped as translational slides. Block slides were mapped only where the slip surface appeared to be within bedrock and the material moved for the most part as a single unit (fig. 2).

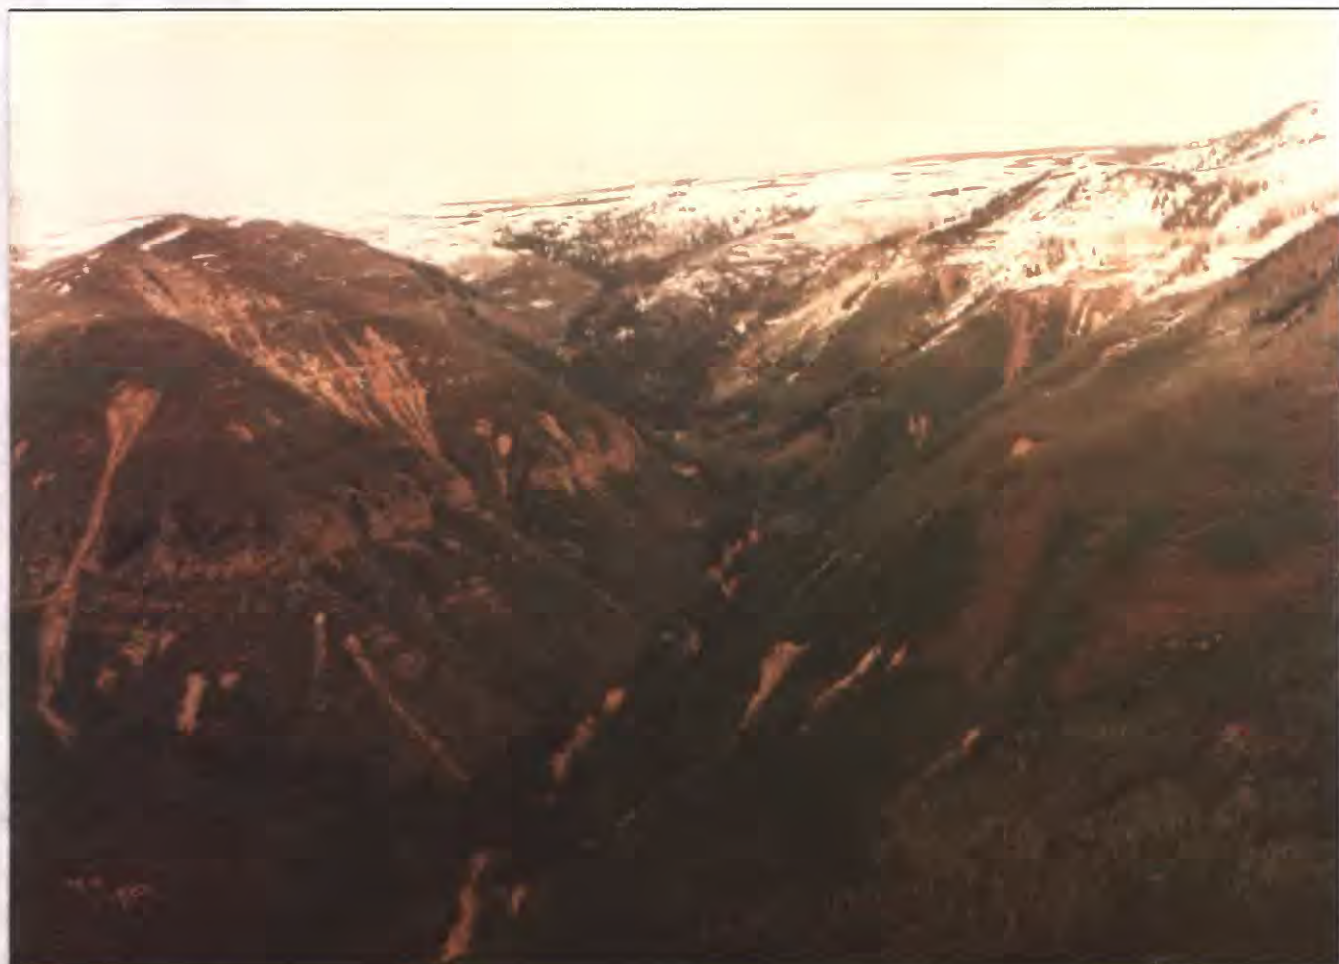
Figure 3. South Fork of Birch Creek

Oblique aerial view showing drainage basin of the South Fork of Birch Creek. Scars on the hillsides are debris slides that have mobilized into debris flows. Some flows traveled short distances down hillsides, whereas other flows reached the channel bottom. In the lower reach of the channel, fresh sediment is accumulating from recent debris flows. Most debris slides occurred in either topographic planar parts of hillsides or in gentle swales. The debris flows farthest up the canyon, on the right, occurred near the snow line, demonstrating the rapid response of soils to influx of melt water.

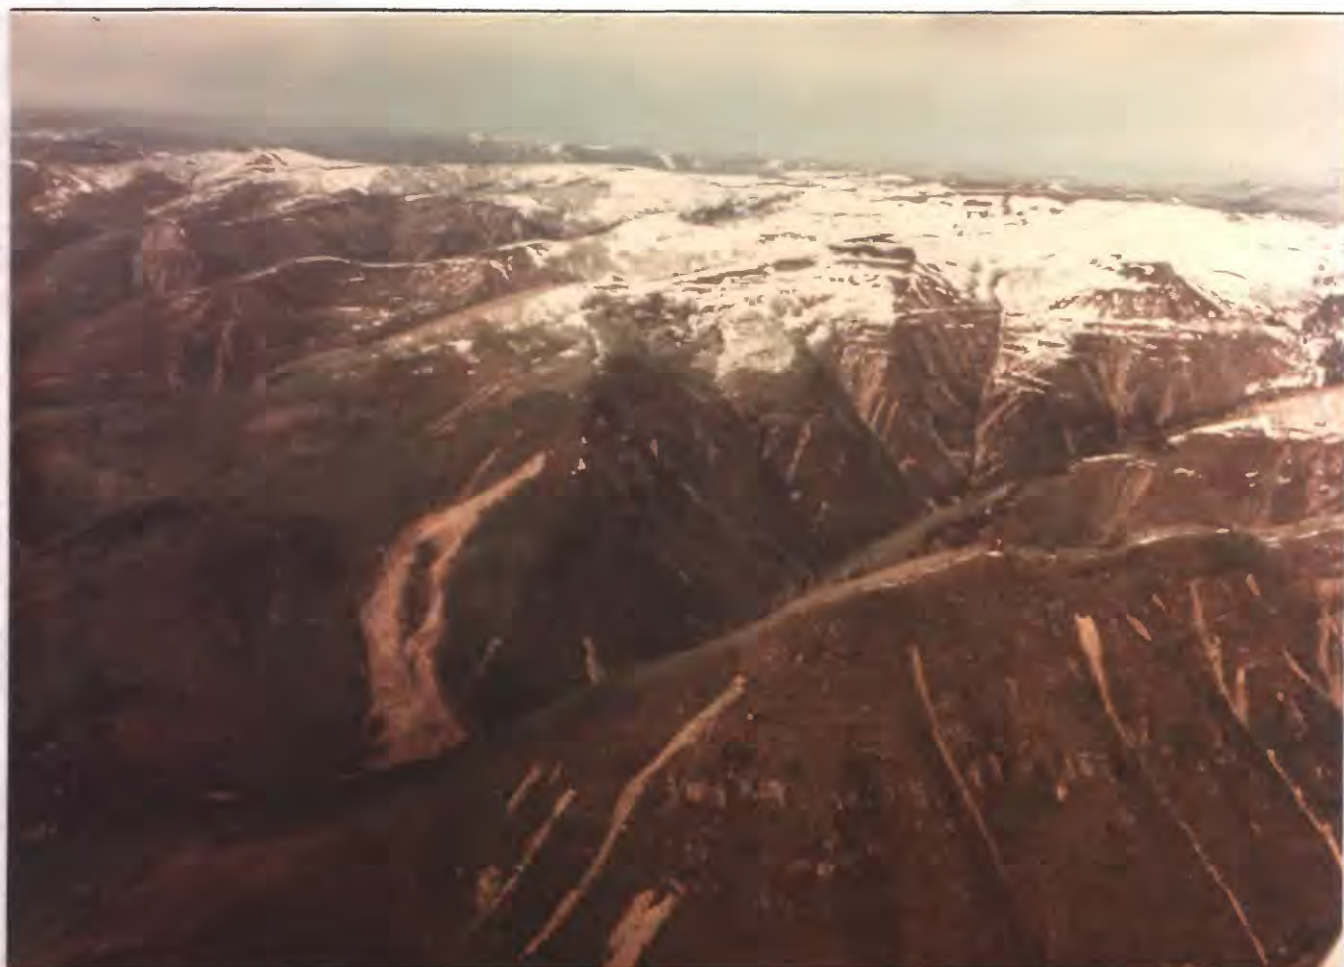
Figure 4. South Fork of North Creek and North Fork of Pleasant Creek

Oblique aerial photograph looking northeast over the Wasatch Plateau. South Fork of North Creek is shown in the center and North Fork of Pleasant Creek in the lower right. The debris flows in the North Fork of Pleasant Creek occurred in gentle swales and first order drainages near the ridge crest. The large debris flow at left center, which occurred in 1983, traveled 2.9 miles (4.6 km). Debris flows in upper reaches of South Fork of North Creek occurred as the snow line receded up the hill. The debris flows at lower elevations in the basin occurred earlier in the spring as the snow line receded.

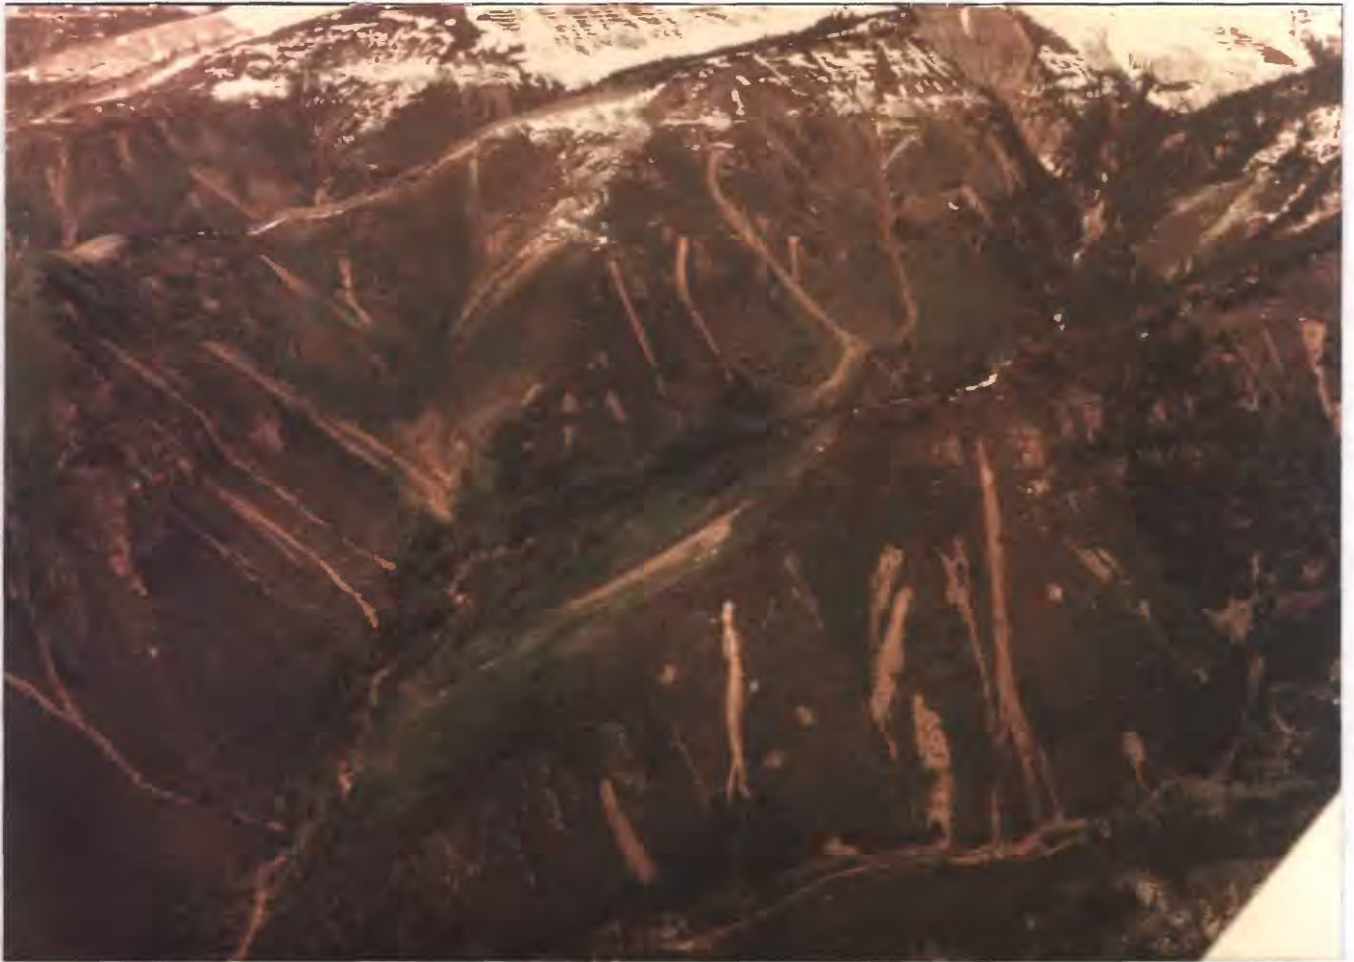
Figure 5. Blue Slide Fork of Pleasant Creek and Straight Fork of Pleasant Creek

Oblique aerial view showing the drainages of Blue Slide Fork of Pleasant Creek (center) and Straight Fork of Pleasant Creek (lower right). Some debris flows and debris slides in Straight Fork of Pleasant Creek have deposited material in the channel bottom and this material has the potential to mobilize into debris flows in the future. A similar situation in Blue Slide Fork of Pleasant Creek resulted in the large debris flow on July 24, 1984.

In addition to the debris flows that resulted from debris slides one large debris flow resulted on July 24, 1984, from mobilization of channel material during an intense thunderstorm

(Blue Slide Fork, Pleasant Creek). The source material for this debris flow was the loose, unconsolidated deposit of a debris flow that had occurred earlier in the spring. In evaluating the potential for events similar to this, two factors must be considered: a sudden increase in discharge in a stream, and accumulations of material available for mobilization. With regard to suddenly increasing discharge, one possibility is an intense local summer thunderstorm, similar to that of July 24, 1984. Such thunderstorms are not rare during the summer months in this area. Another manner in which discharge might suddenly increase is if a landslide were to temporarily dam the stream, creating an accumulation of water, which can surge down the channel when the dam is breached. Because both thunderstorm and landslide dams are difficult to predict the potential for debris flows of this type is best evaluated by considering the amount of unconsolidated material in the channel bottom. Such material commonly results from landslide activity, especially stream-bank slumps and slides in channels recently scoured by debris-flow activity. One drainage which has a large amount of loose material in the channel bottom, and hence a high potential for a debris flow of this type, is the PC Fork of North Fork of Birch Creek. Other drainages can be evaluated similarly.
