DEPARTMENT OF THE INTERIOR

GEOLOGICAL SURVEY

Descriptions of Backhoe Trenches Dug on New River Terraces
between Radford and Pearisburg, Virginia, June 1981

Open-File Report 85-474

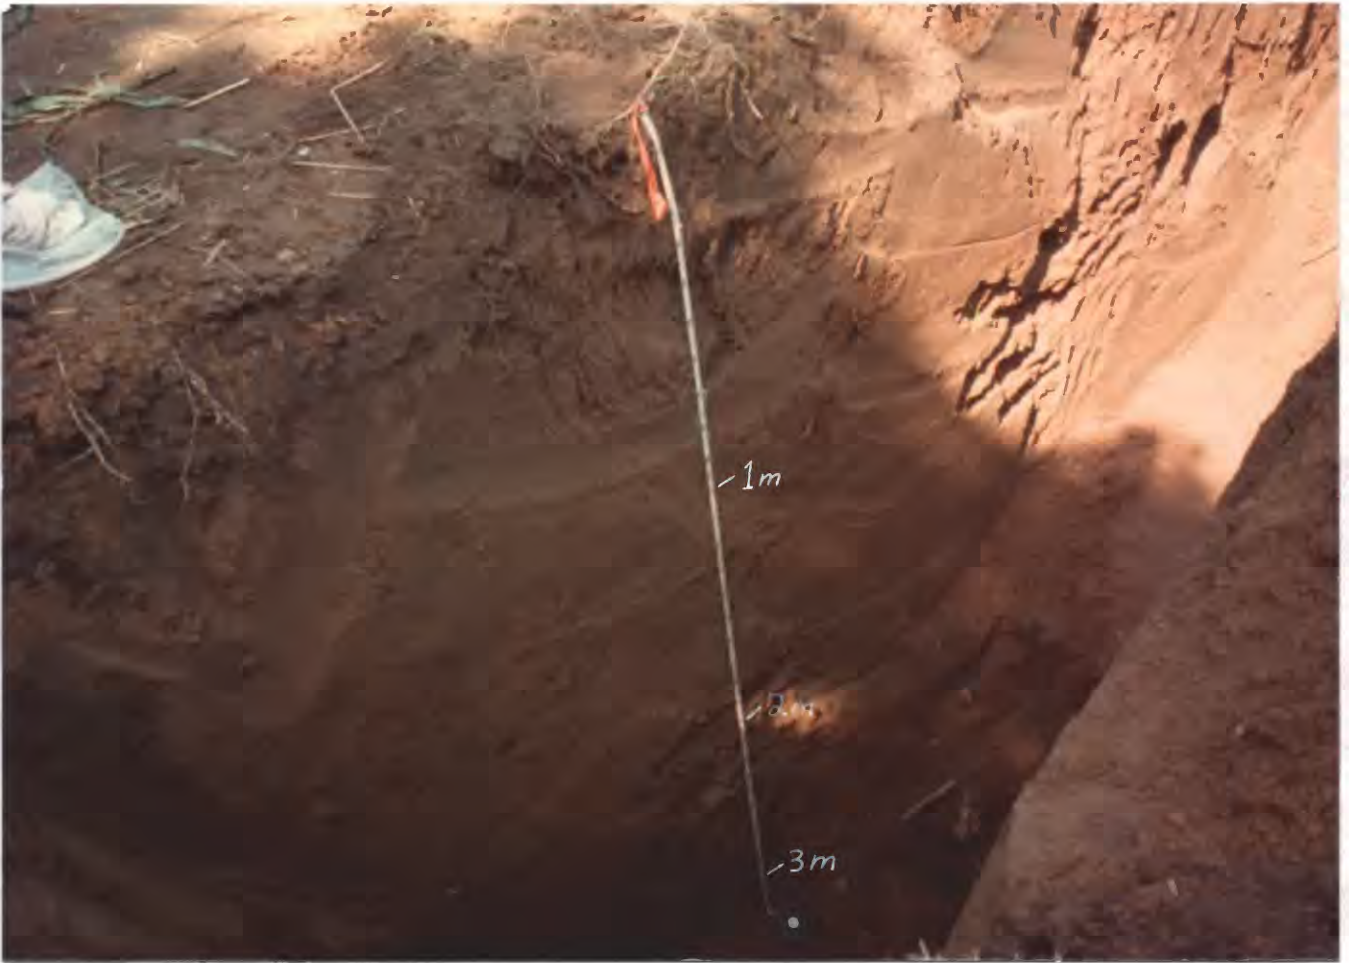
Figure 2. Trench 1, Profile 1.

<u>Depth</u>	<u>Description</u>
0-18 cm	Sandy loam (64 % sand, 26 % silt, 10 % clay), 10 YR 4/3, faint root casts, rare pebbles, cobbles.
18-50 cm	Sandy loam (52 % sand, 33 % silt, 15 % clay), 8.75 YR 4/4, rare pebbles, cobbles.
50-110 cm	Loam (50 % sand, 32 % silt, 18 % clay), 8.75 YR 4/4, clear wavy boundary.
110-120 cm	Loamy sand, 7.5 YR 4/4.
120-210 cm	Loamy sand (76 % sand, 20 % silt, 4 % clay), 10 YR 4/4, with irregular layers and lenses of redder (7.5 YR 4/4) sandy loam (65 % sand, 21 % silt, 14 % clay).
210-330 cm	Loam (49 % sand, 33 % silt, 18 % clay), 10 YR 4/3. Massive.

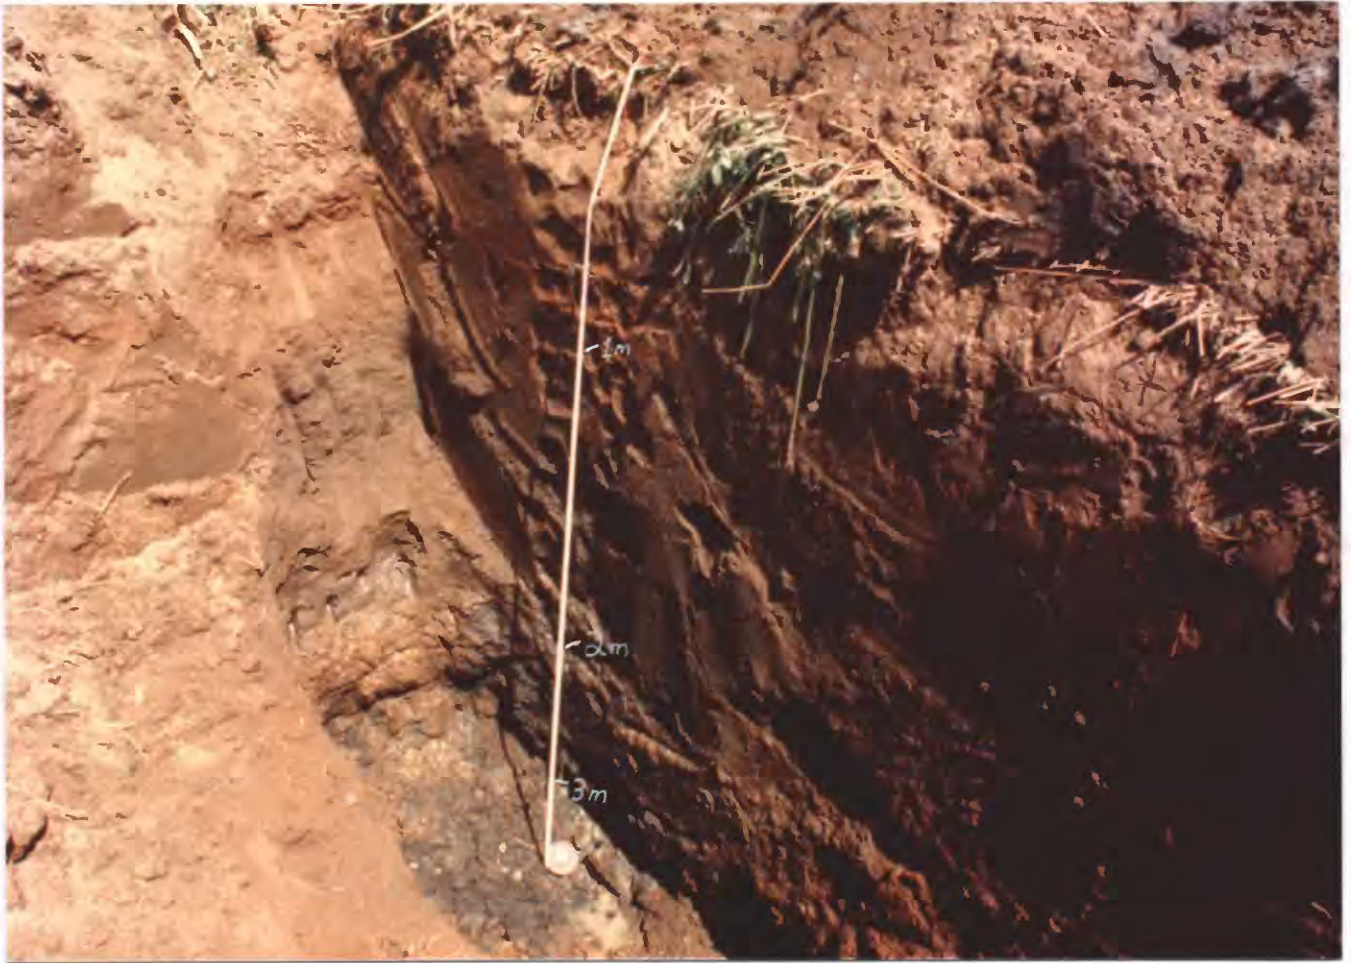
Figure 3. Trench 1, Profile 2.

<u>Depth</u>	<u>Description</u>
0-30 cm	Sandy loam, 10 YR 3/3
30-70 cm	Loamy sand, 8.75 YR 3/4.
70-95 cm	Clay loam, 7.5 YR 4/4.
95-135 cm	Sandy loam, 10 YR 4/3.
135-155 cm	Loamy sand, 10 YR 4/2.
155-220 cm	Loamy sand, mottling (10 YR 4/1, 5 YR 3/4).
220-300 cm	Loamy sand, gleyed, 10 YR 3/1. Logs for radiocarbon dating collected at 270 cm and 300 cm (Fig. 4). Clear, wavy boundary.
300-340 cm	Sandy gravel, gleyed, 10 YR 5/1.

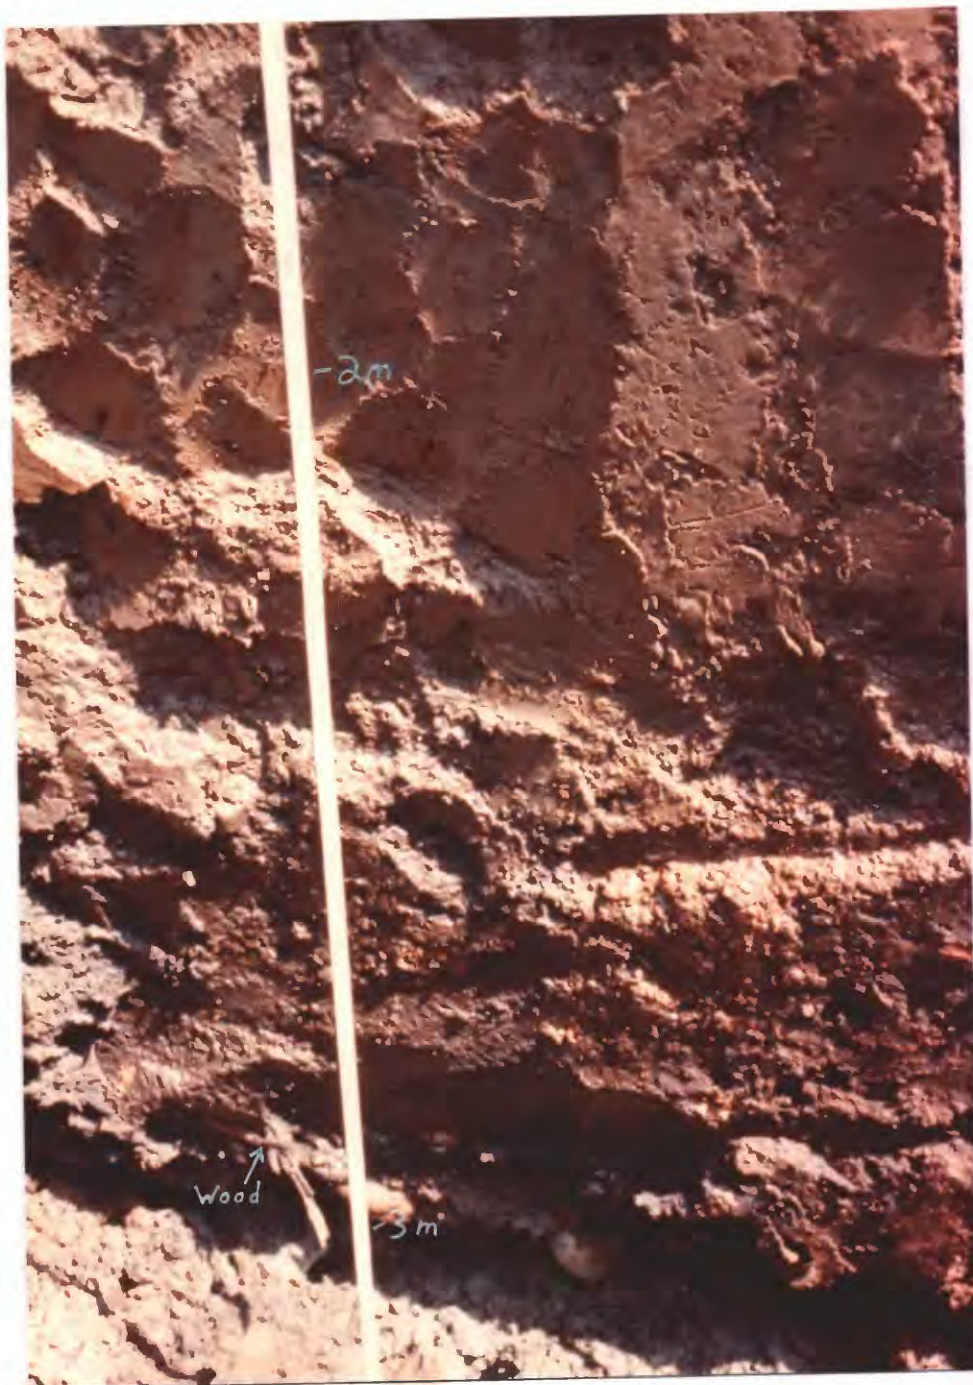
Figure 4. Trench 1, Profile 2. Close-up of gleyed sand unit containing log. Upper limit of gleying corresponds with water table.

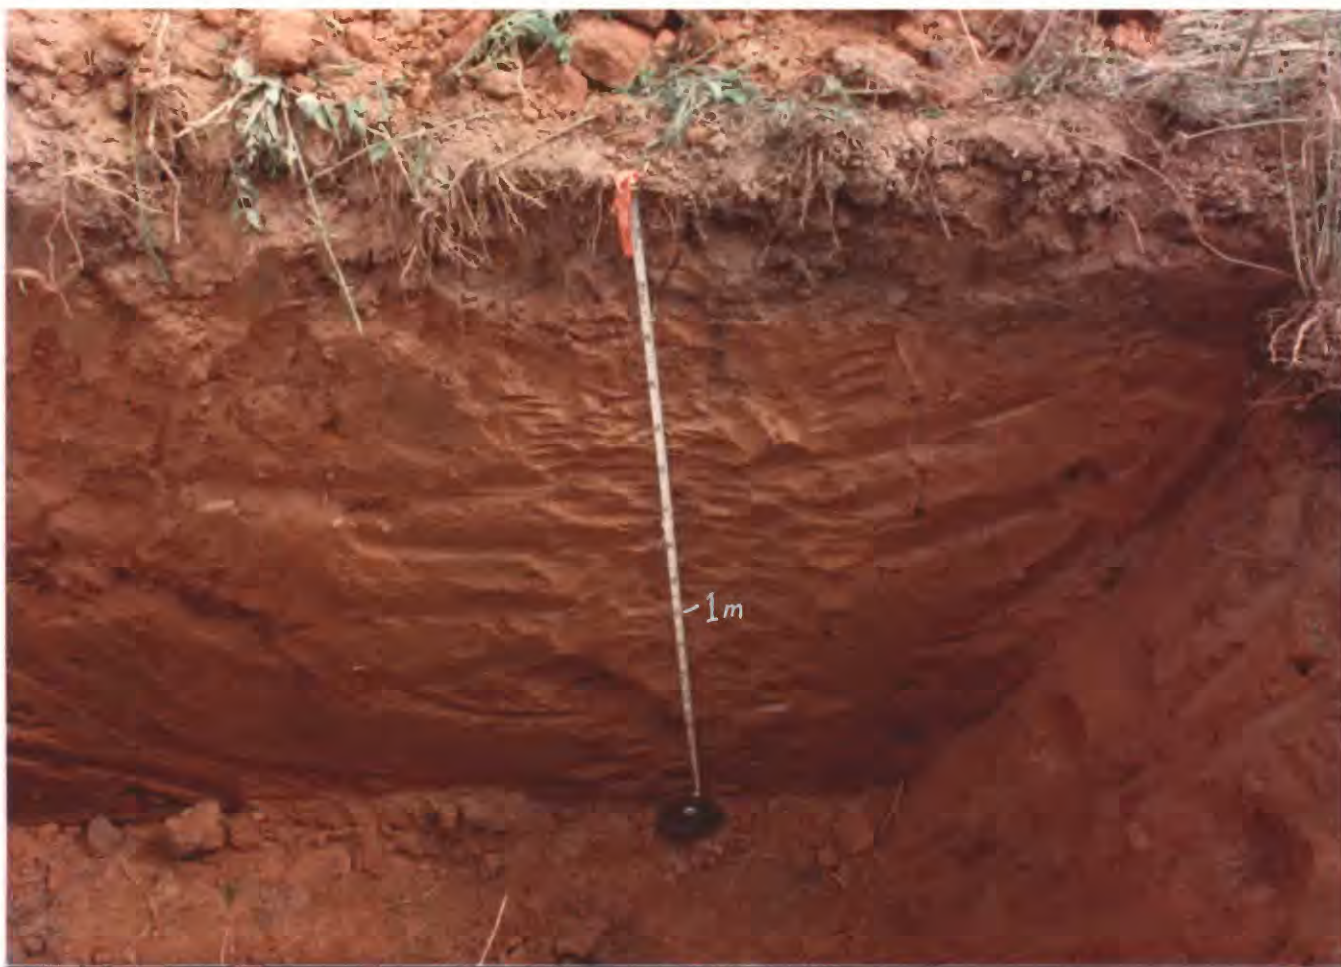
Figure 6. Trench 3, Profile 1.

<u>Depth</u>	<u>Description</u>
0-25 cm	A1 horizon. Clay loam (33 % sand, 35 % silt, 32 % clay), 10 YR 4/3. Rare pebbles and cobbles.
25-30 cm	Clay (31 % sand, 28 % silt, 41 % clay), 7.5 YR 4/4. Clay films on peds. Rare pebbles and cobbles.
30-50 cm	Clay loam (36 % sand, 24 % silt, 40 % clay), 7.5 YR 5/6. Iron-manganese-oxide staining (Fig. 7). Rare pebbles and cobbles.
50-170 cm	Sandy clay loam (48 % sand, 26 % silt, 26 % clay), 7.5 YR 5/6. Iron-manganese-oxide staining. Rare cobbles and pebbles.

Comments Iron-manganese-oxide films on peds and clasts, especially in upper 1 m. Crystalline clasts, including schist, still hard, although feldspars appeared more chalky than on clasts in Trench 2. Quartzite clasts unweathered, but some sandstone clasts could be broken by hand.

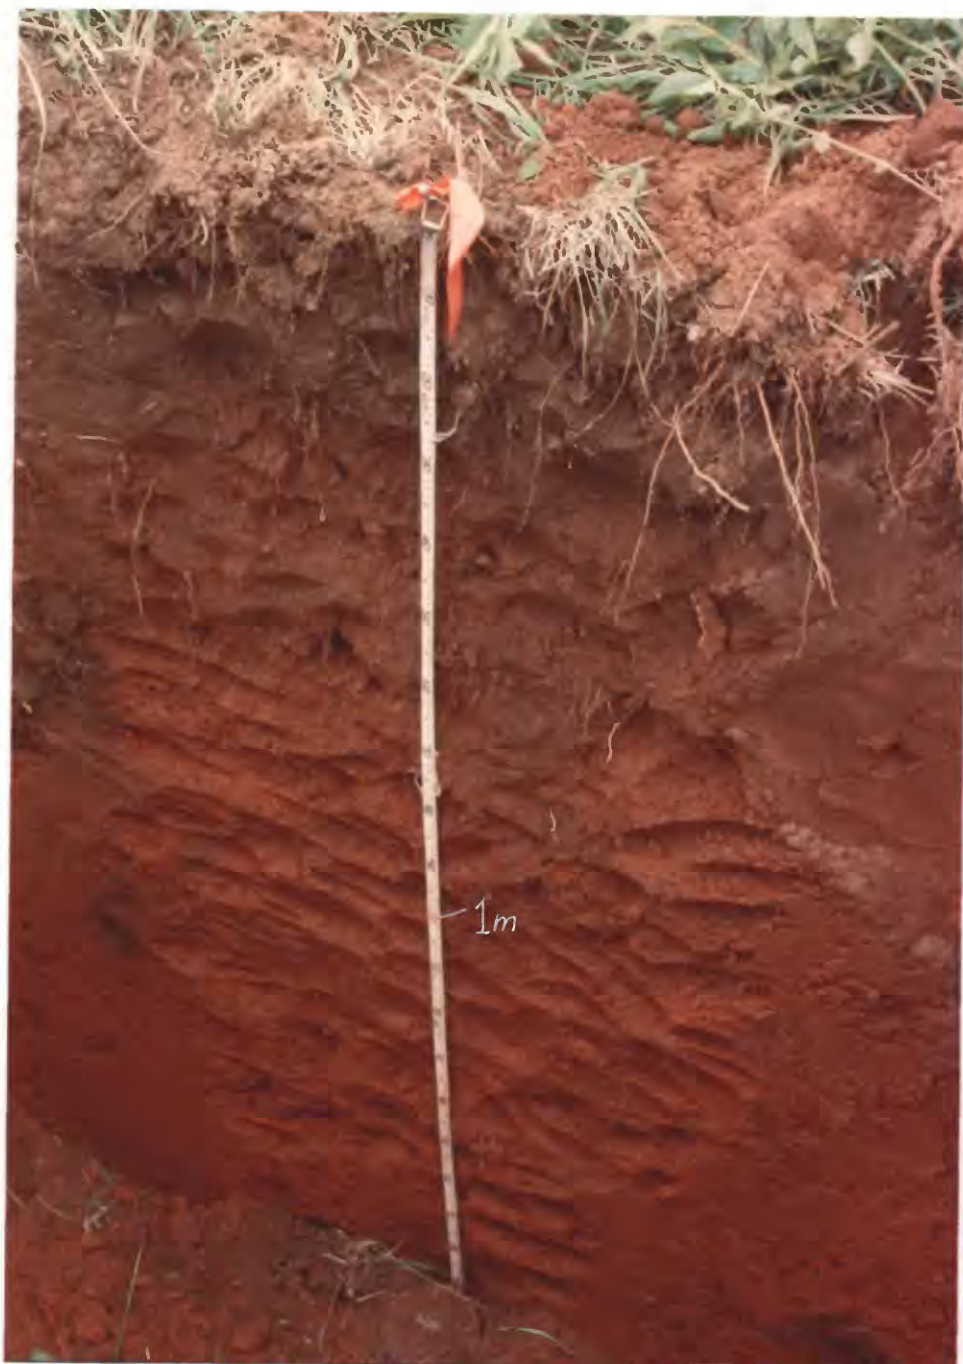
Figure 8. Trench 4, Profile 1.

<u>Depth</u>	<u>Description</u>
0-25 cm	Loam (41 % sand, 35 % silt, 24 % clay), 10 YR 3/3.
25-50 cm	Loam (42 % sand, 32 % silt, 26 % clay), 6.25 YR 4/6.
50-70 cm	Clay loam (37 % sand, 31 % silt, 32 % clay), 3.75 YR 4/8.
70-230 cm	Clay (27 % sand, 24 % silt, 49 % clay), 2.5 YR 4/8.

Comments Much less iron-manganese-oxide staining than in trench 3. Some sandstone clasts totally decomposed. Small purplish igneous rocks (porphyritic rhyolite ?) could be broken apart by hand, whereas larger ones were decomposed on the outside, but still hard within. Metamorphic clasts and one granitic clast still hard. Most observed clasts occurred below 300 cm. Mica also appeared to be more plentiful at lower levels.

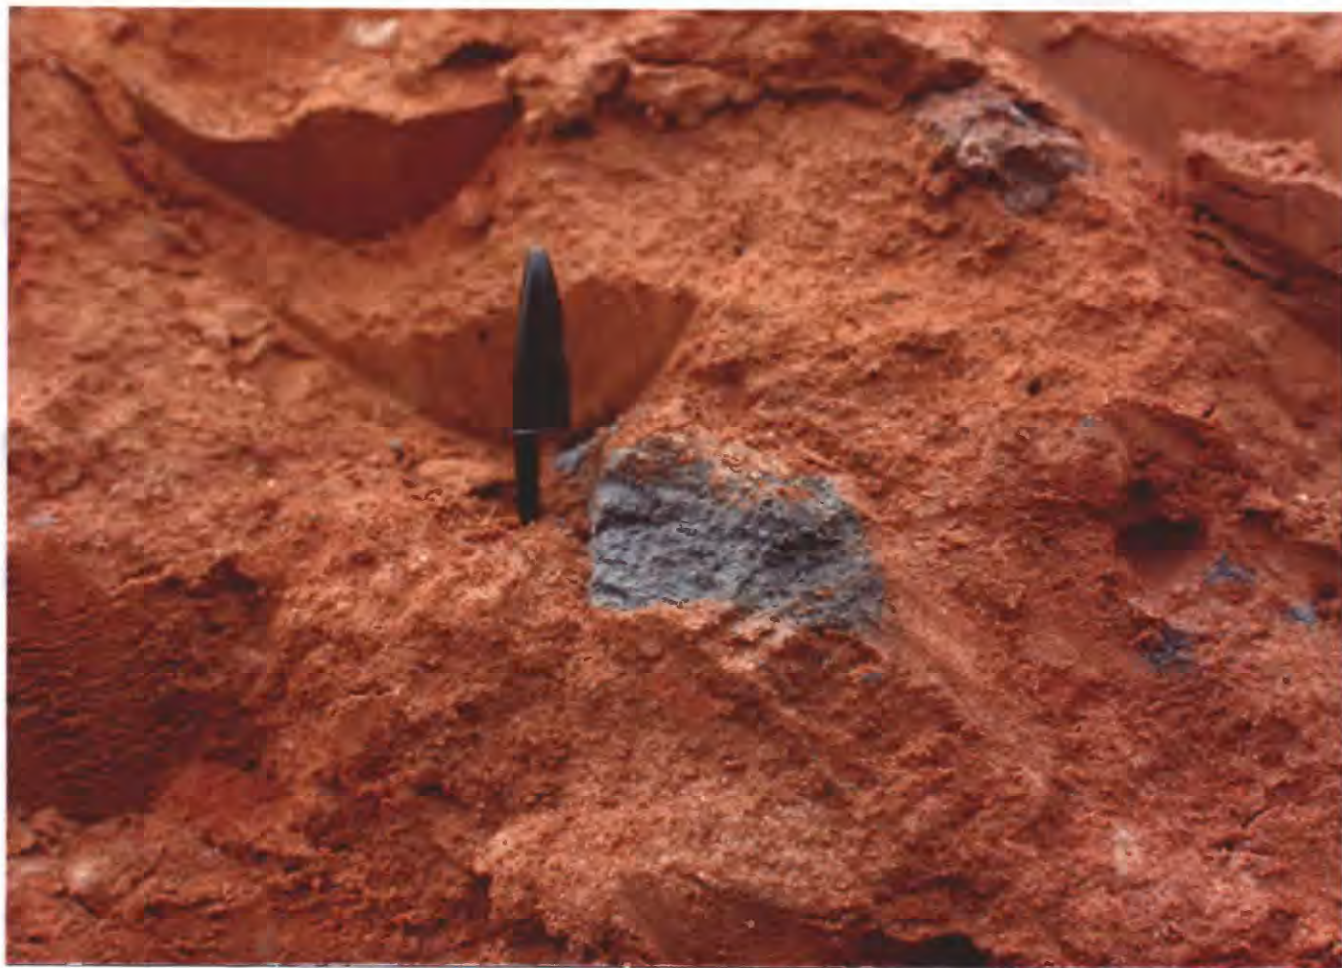
Figure 10. Trench 5, Profile 1. Close-up showing decomposed igneous clast.

Comments This trench showed the most intricate layering, and the greatest variety of texture and color, of any dug. Igneous clasts observed were completely decomposed (Fig. 10).

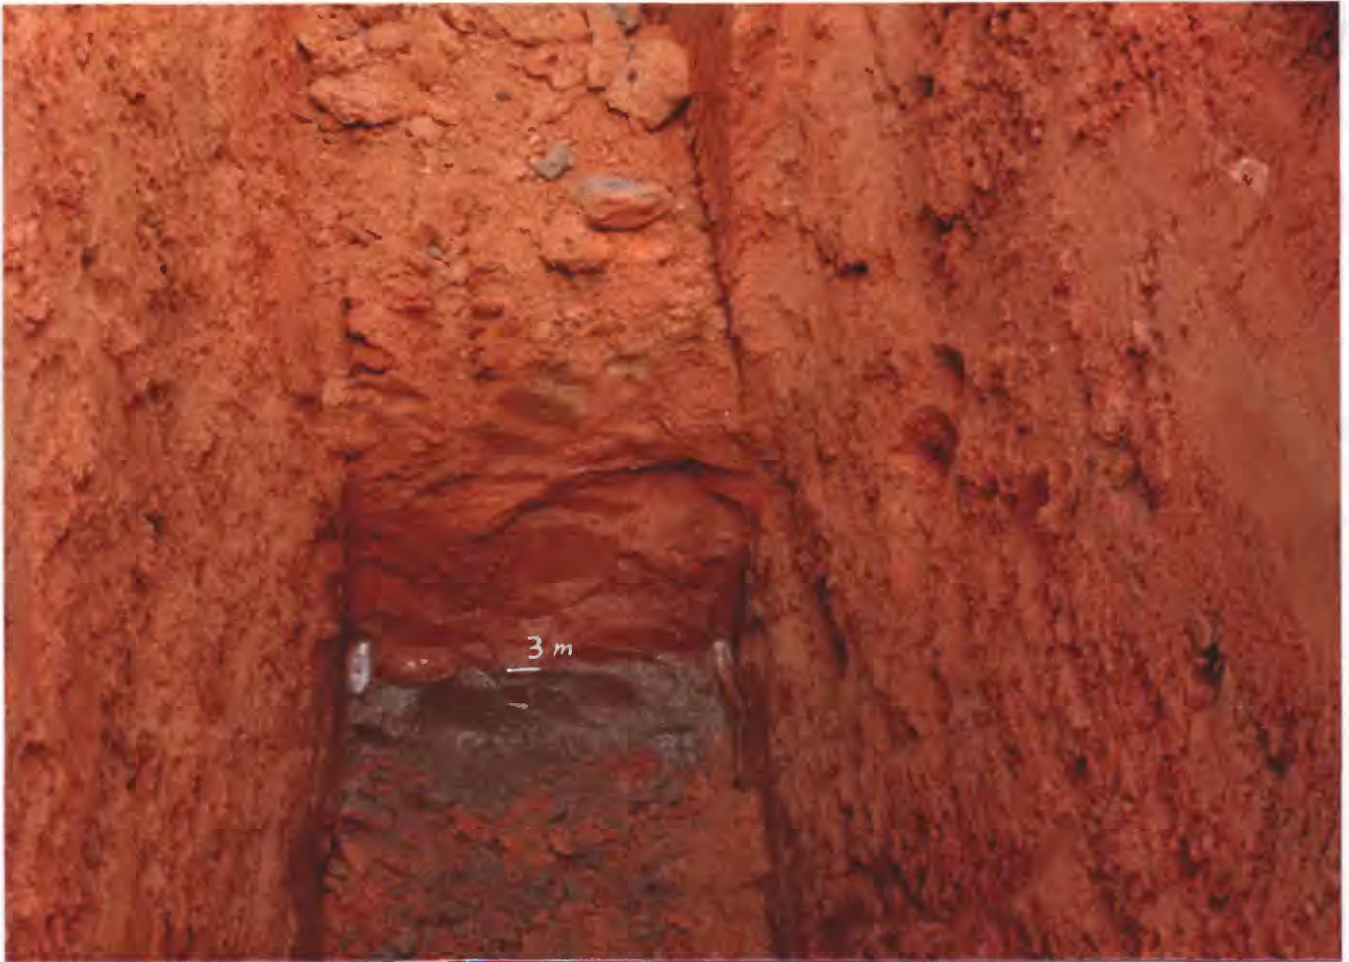
<u>Depth</u>	<u>Description</u>
260-300 cm	Sandy clay, 2.5 YR 4/6. Some cobbles. Boundary abrupt, smooth.
300-320+ cm	Sandy clay loam, 10 YR 5/2. Grey unit (Fig. 11).

Figure 11. Trench 5, Profile 2, showing abrupt contact between red sandy clay unit at 260-300 cm and grey sandy loam unit at 300-320+ cm.

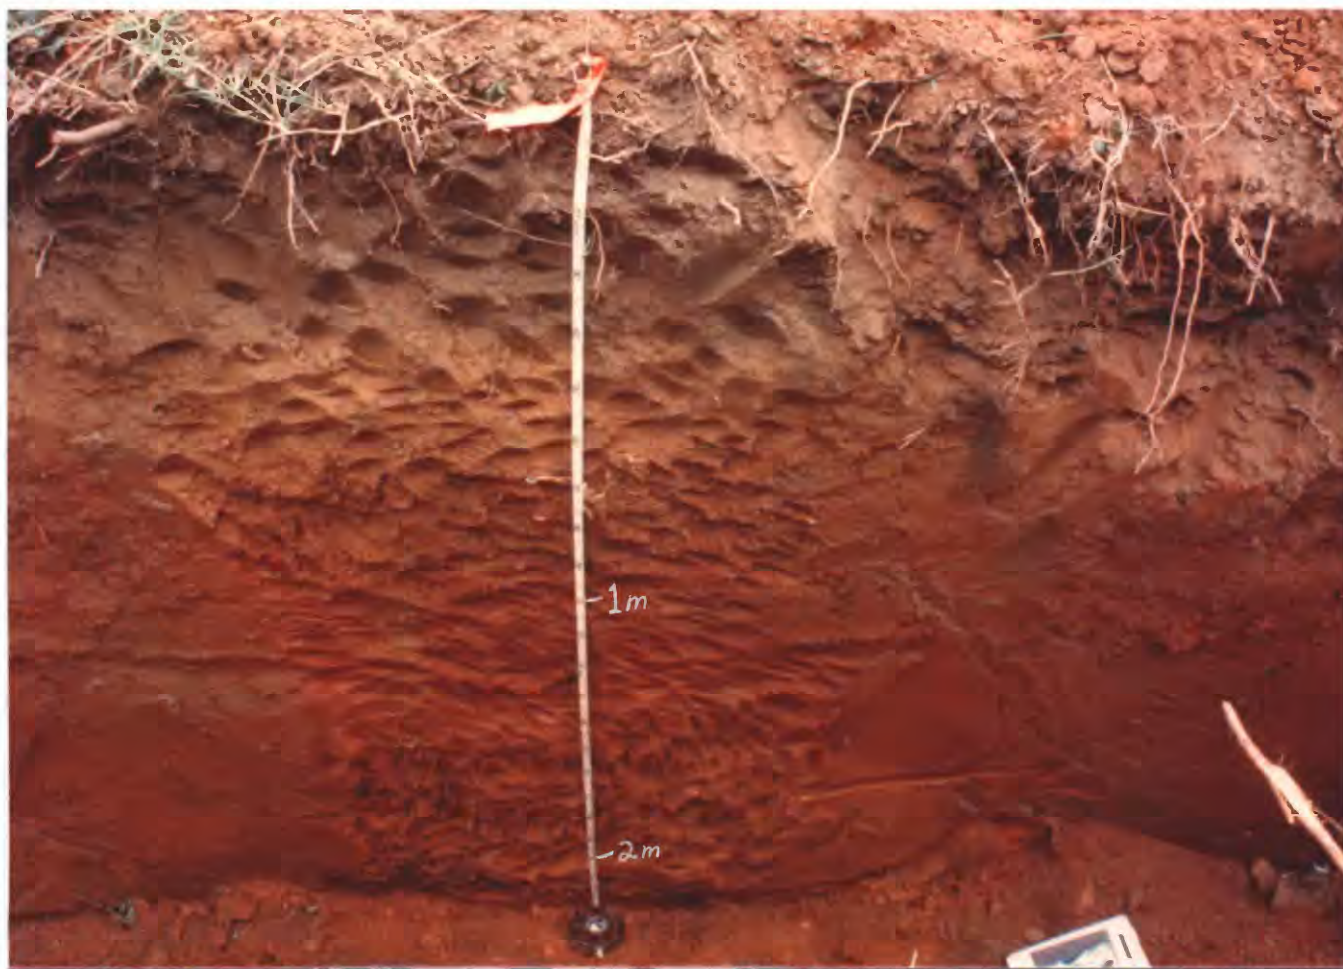
Figure 12. Trench 6, Profile 1.

<u>Depth</u>	<u>Description</u>
0-40 cm	Plow layer. Sandy loam, 10 YR 4/3. Inclusions of red soil.
40-65 cm	Clay loam (44 % sand, 30 % silt, 26 % clay), 7.5 YR 5/6.
65-85 cm	Clay (30 % sand, 21 % silt, 49 % clay), 5 YR 5/8. Faint mottling. Thick clay skins on peds.
85-210 cm	Clay (34 % sand, 16 % silt, 50 % clay), 2.5 YR 4/7. Yellow mottles (10 YR 5/6). Thick clay skins on peds.
210-222 cm	Hard iron-manganese-oxide-rich layer (Fig. 13).
222-230+ cm	Sandy clay loam. Red and yellow mottling.

Comments Little mica compared to previous trenches.

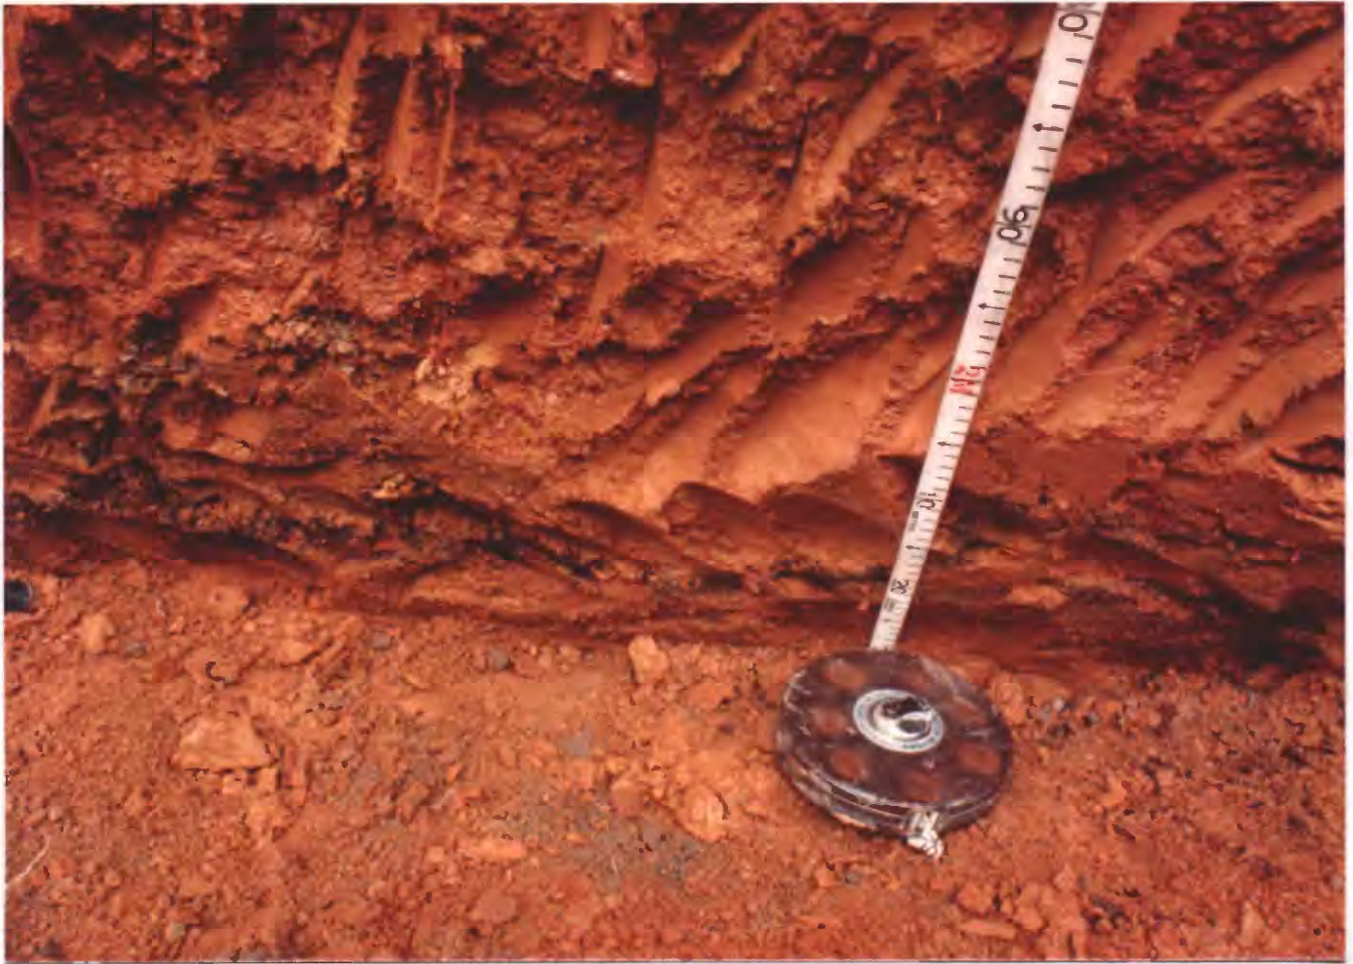
Figure 13. Trench 6, Profile 1, showing iron-manganese-oxide layer at 220 cm.

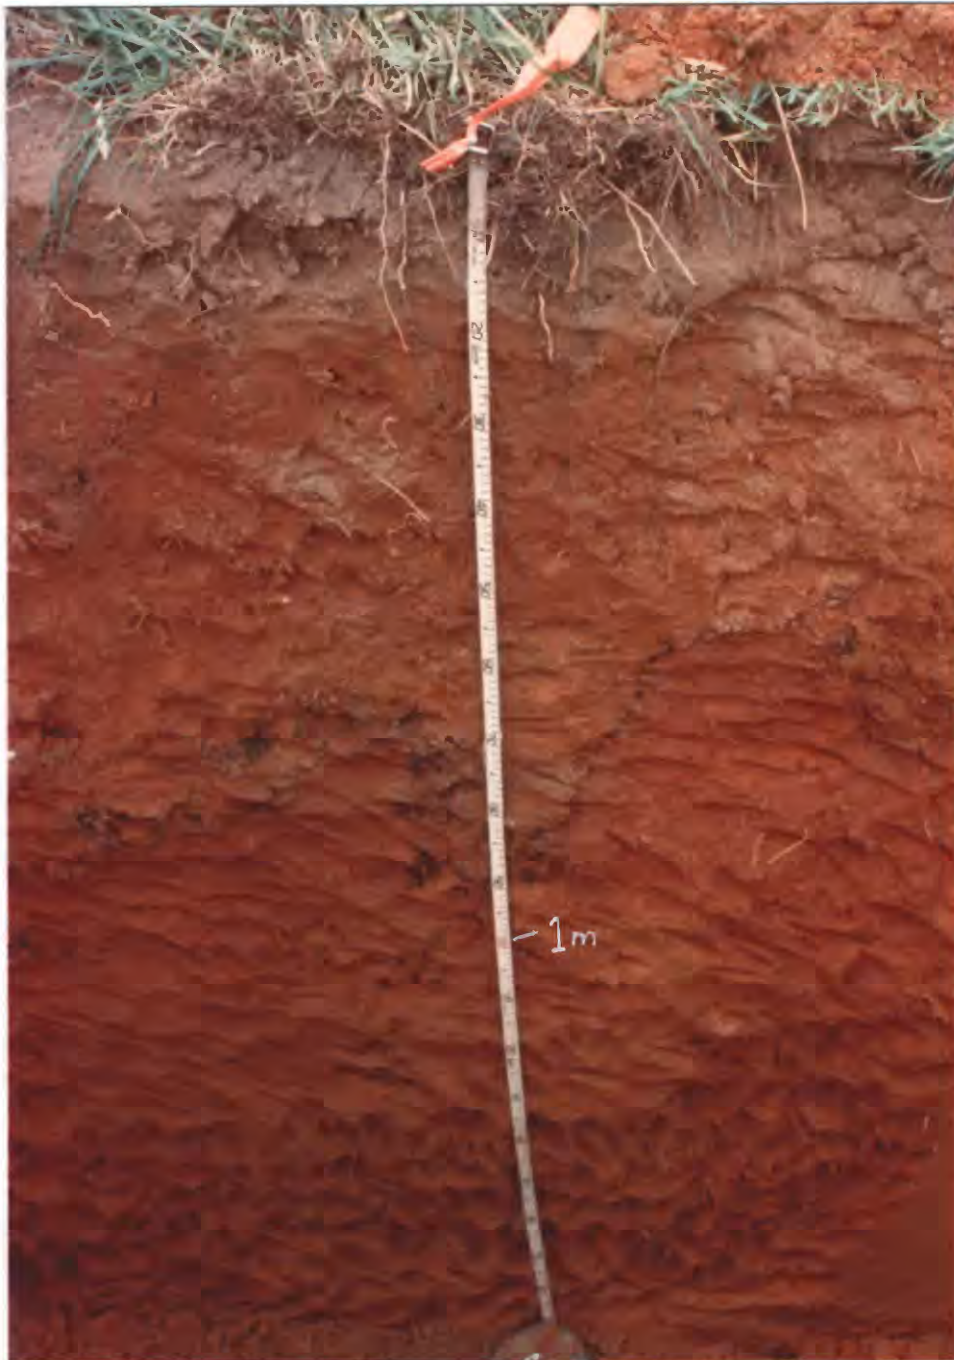
Figure 14. Trench 7, Profile 1.

<u>Depth</u>	<u>Description</u>
0-18 cm	A1 horizon. Sandy loam (61 % sand, 21 % silt, 18 % clay), 10 YR 4/3.
18-84 cm	Clay (31 % sand, 26 % silt, 43 % clay), 6.25 YR 5/8. Some yellow mottling, root casts. Some quartz pebbles and cobbles. Boundary abrupt, irregular, and marked by iron-manganese-oxide layer.
84-90 cm	Iron-manganese-oxide layer, varies laterally from 1 to 6 cm thick. Contains iron-manganese-oxide nodules. Boundary abrupt, irregular. (Fig. 15).

90-200 cm Clay (42 % sand, 10 % silt, 48 % clay). Color varies laterally from 3.75 YR 4/8 to 10 R 4/8, with latter material having a slightly finer texture. Streaks and nodules of iron-manganese oxide. Sandstone and igneous clasts are completely weathered through. Some quartz cobbles and pebbles.

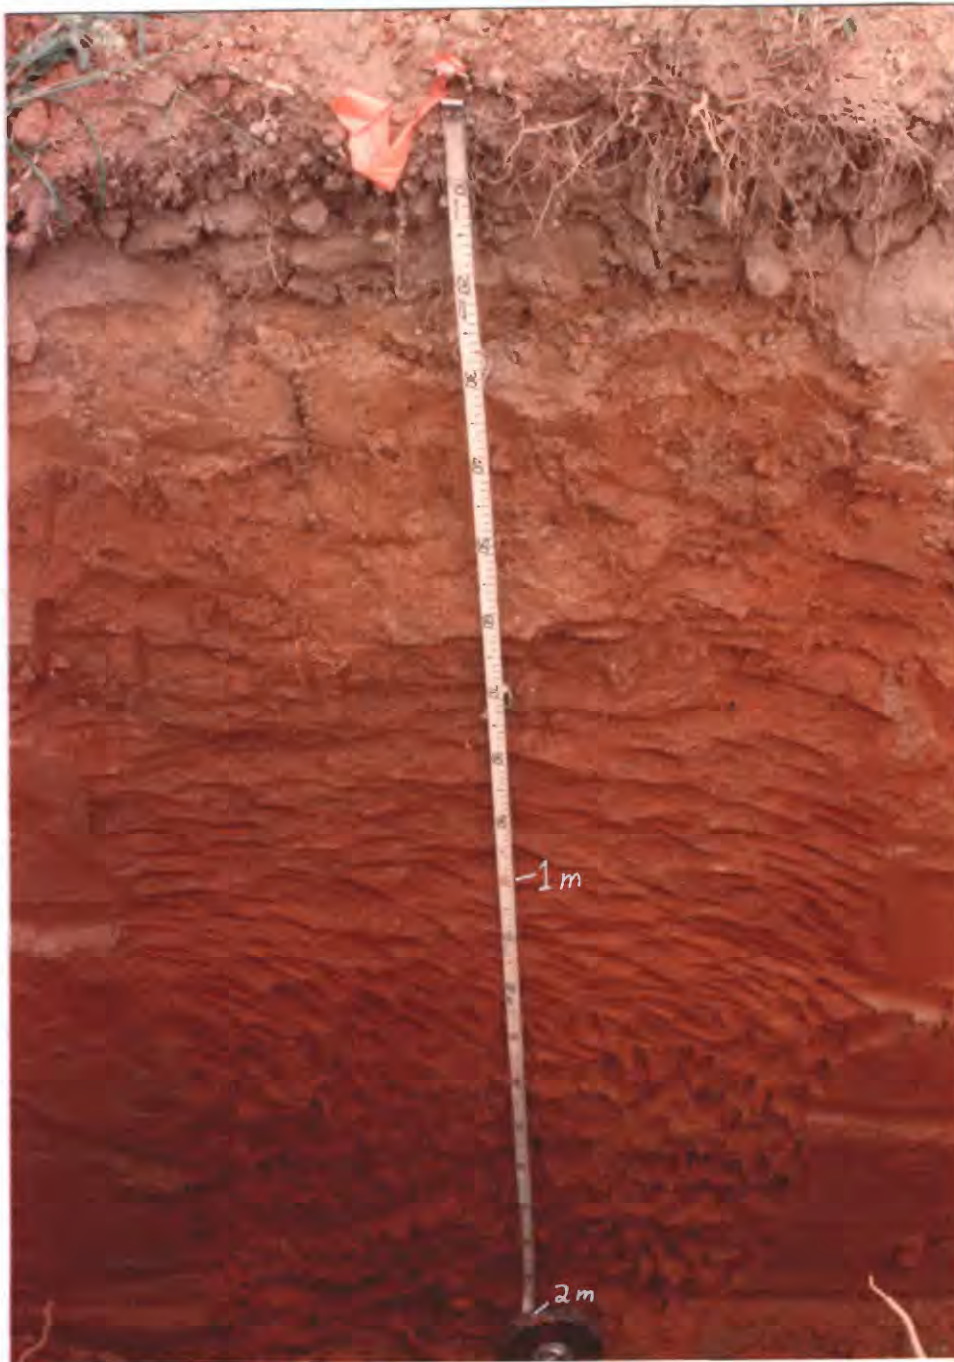
Figure 17. Trench 8, Profile 1.

<u>Depth</u>	<u>Description</u>
0-25 cm	Loam (48 % sand, 34 % silt, 18 % clay), 10 YR 4/3.
25-40 cm	Loam (41 % sand, 33 % silt, 26 % clay), 7.5 YR 5/6.
40-58 cm	Clay (26 % sand, 27 % silt, 47 % clay), 5 YR 5/6.
58-104 cm	Clay loam (23 % sand, 40 % silt, 37 % clay), red (2.5 YR 4/8) with yellow (10 YR 5/6) mottles.
104-138 cm	Clay loam (26 % sand, 38 % silt, 36 % clay), red (2.5 YR 4/6) with rare yellow mottles.
138-210 cm	Clay (32 % sand, 24 % silt, 44 % clay), red (2.5 YR 4/8) with yellow (10YR 6/8) mottles.

Comment Mica at this location confined chiefly to lower two units above.

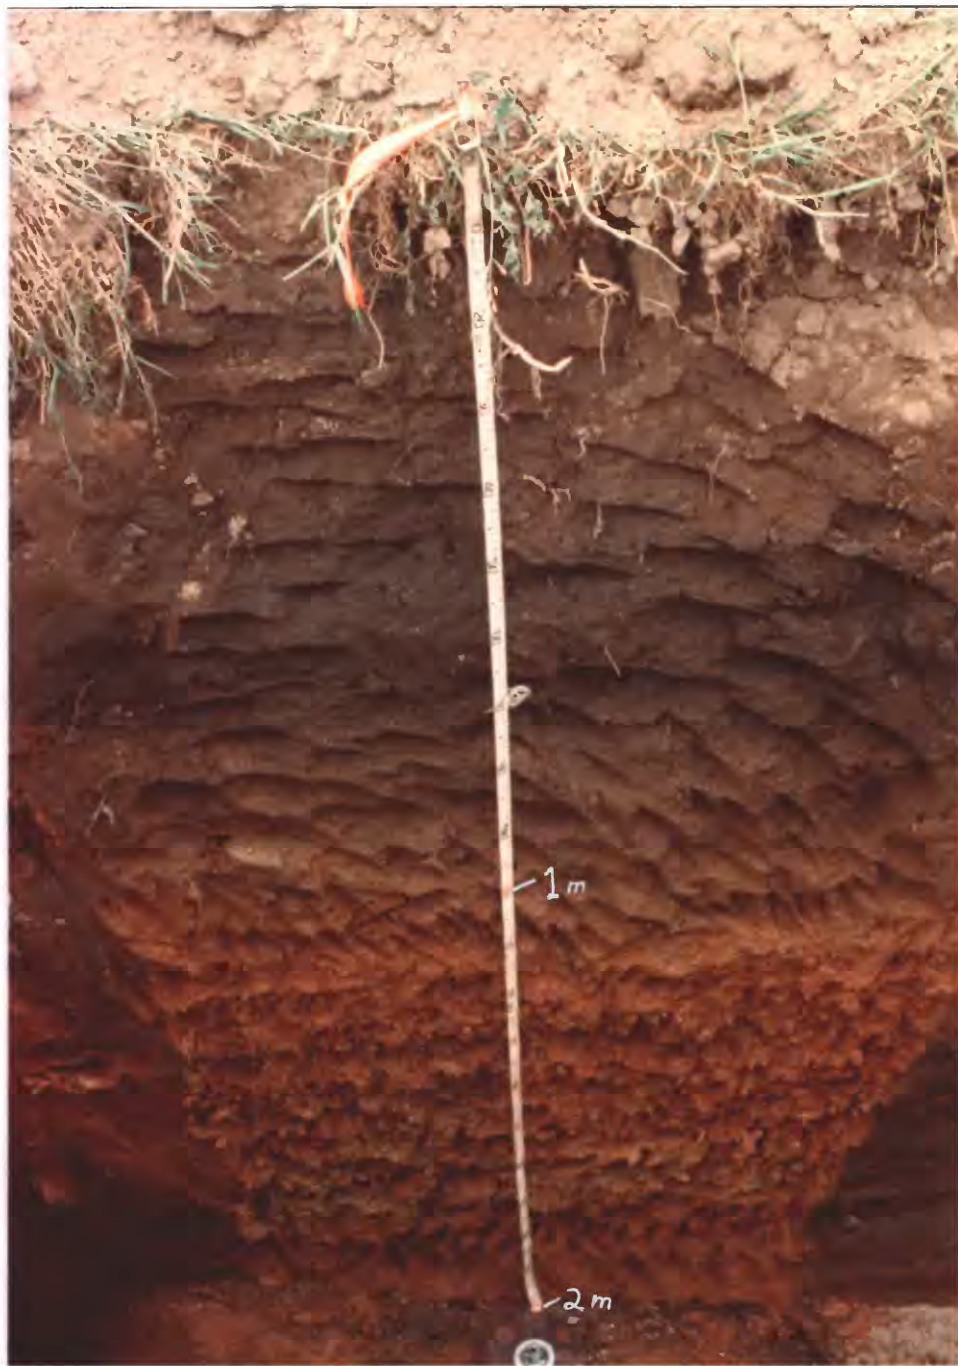
Figure 18. Trench 9, Profile 1.

<u>Depth</u>	<u>Description</u>
0-75 cm	Organic-rich sandy clay loam (52 % sand, 20 % silt, 28 % clay), 10 YR 3/2.
75-105 cm	Transitional layer. Sandy clay.
105-163 cm	Clay (23 % sand, 36 % silt, 41 % clay), red (5 YR 5/6) and yellow (10 YR 6/4) mottling.
163-166 cm	Iron-manganese-oxide stained sandy unit, micaceous. Variegated colors.
166-175 cm	Clay (18 % sand, 38 % silt, 44 % clay), yellow (10 YR 6/4) with red mottling.
175-177 cm	Iron-manganese-oxide stained sandy unit.
177-250 cm	Sandy clay loam (66 % sand, 10 % silt, 24 % clay), 6.25 YR 5/6.
250-300+ cm	Loamy sand, 6.25 YR 5/6.

Comment Immediately to north is gravel lens with rounded pebbles and cobbles.

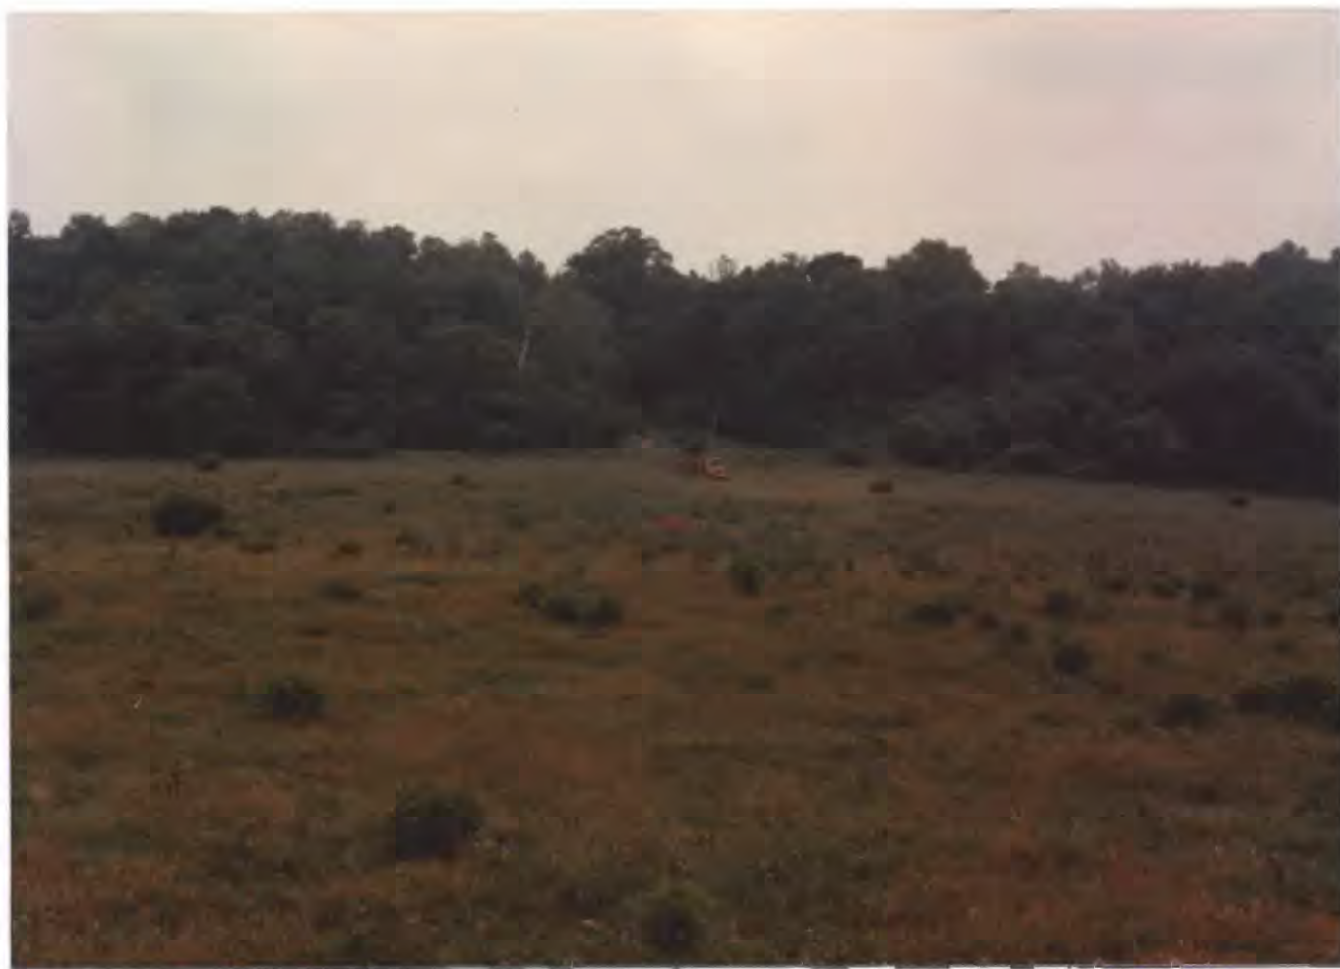
Trench 10 North end of trench about 340 m south of river at 37° 09' 15" N, 80° 32' 10" W, about 10.5 m above river level. Orientation of trench 360°, in line with trench 9. Length about 15 m. Located within about 30 m of head of alluvial fan (Fig. 20), oriented down slope of fan. Slope angle about 5°.

Figure 20. View of Trench 10, located on alluvial fan descending from upland onto terrace, from vicinity of Trench 9. Slope angle near head of fan about 5° .

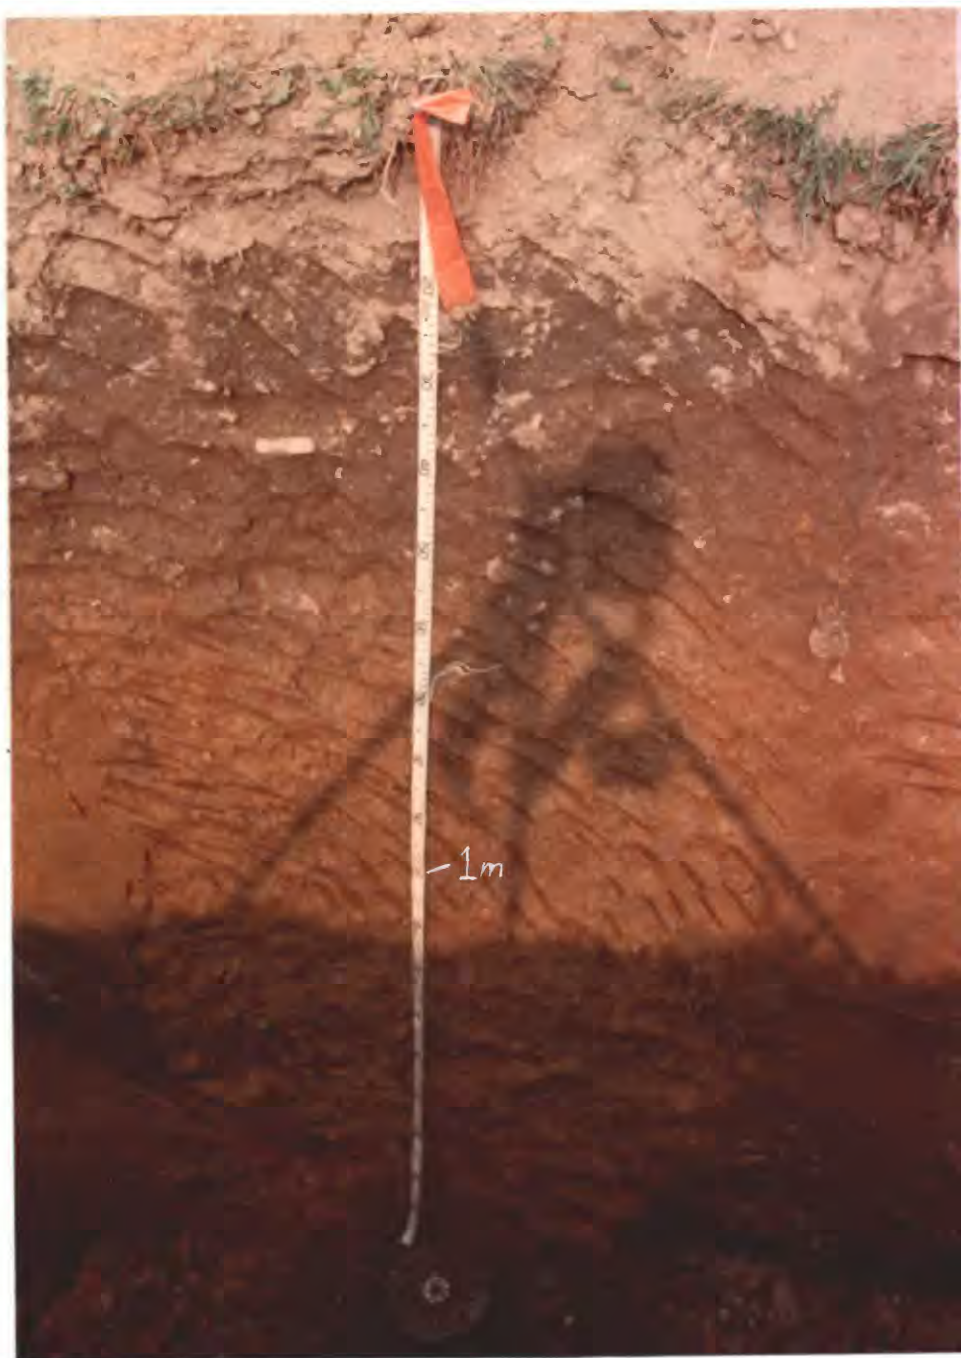
Figure 21. Trench 10, Profile 1 (upper part).

<u>Depth</u>	<u>Description</u>
0-50 cm	Sandy clay loam (51 % sand, 27 % silt, 22 % clay), 10 YR 4/2. Many pebbles and granules, some angular (angularity suggests fan deposits).
50-60 cm	Sandy clay loam (45 % sand, 25 % silt, 30 % clay), 10 YR 4/2.
60-135 cm	Clay (33 % sand, 17 % silt, 50 % clay), 7.5 YR 5/6. Faint mottling.
135-158 cm	Clay loam (42 % sand, 20 % silt, 38 % clay), 10 YR 5/6 with mottling.
158-200 cm	Clay loam (44 % sand, 17 % silt, 39 % clay), variegated mottled layer, with red (3.75 YR 4/8) the dominant color. Clear, smooth boundary.
200-350 cm	Sandy gravel (matrix is sandy loam - 80 % sand, 7 % silt, 13 % clay) with pebbles and cobbles. 5 YR 5/6. Contains angular clasts.
350+ cm	Sand layer below gravel.

Comments The above profile is seen throughout the trench. That is, the upper layers contain much clay and relatively few clasts, but about 200 cm down is found a reddish gravel-rich layer containing some angular clasts. The contact at 200 cm slopes in a direction parallel to that of the fan slope.

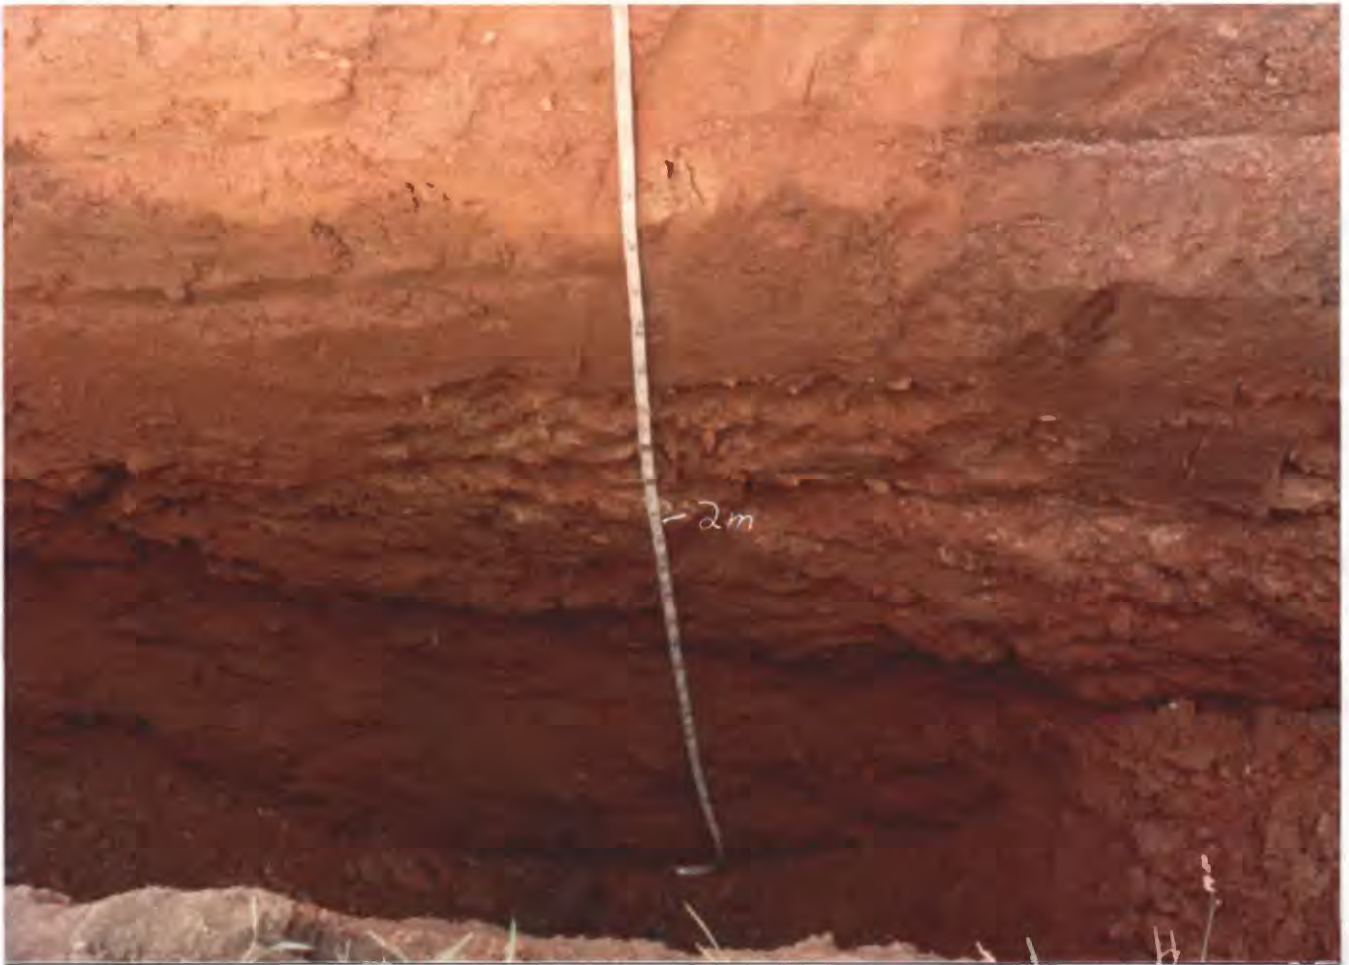
Figure 22. Trench 10, Profile 2 (lower part). Note contact between clay loam unit above and gravel unit below at about 200 cm. (Tape in photo does not correspond to position of tape used for profile measurements).
