DEPARTMENT OF THE INTERIOR

GEOLOGICAL SURVEY

Descriptions of Backhoe Trenches Dug on New River Terraces
between Radford and Pearisburg, Virginia, June 1981

Open-File Report 85-474

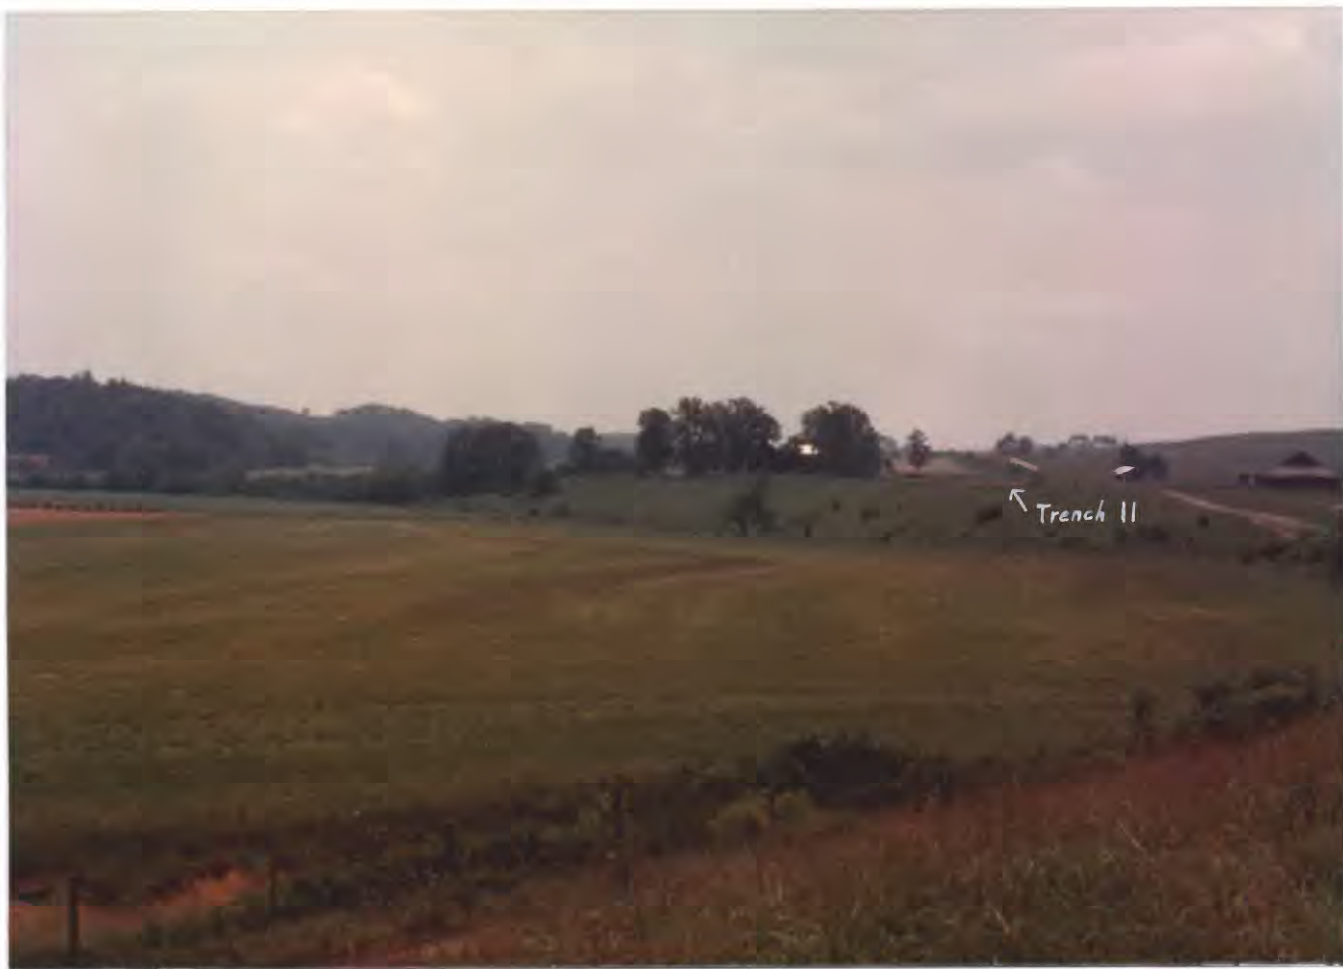
Comments This is an excellent example of a strath terrace, as despite the prominent form of the terrace (Fig. 23), the alluvial mantle is less than 2 m thick. The top of the gravel layer increases in depth to the northwest. Of interest is the fact that relatively fresh gravel overlies weathered bedrock. Whether this occurs because the porous alluvium weathers more slowly than the shale bedrock, or because the New River flowed over weathered bedrock at the time it cut this strath, is unknown, although the former explanation seems more probable.

Figure 23. View looking southwest of part of Matthews farm. Prominent terrace at right is location of Trench 11; broad terrace in foreground is location of Trench 14. New River is off picture to left.

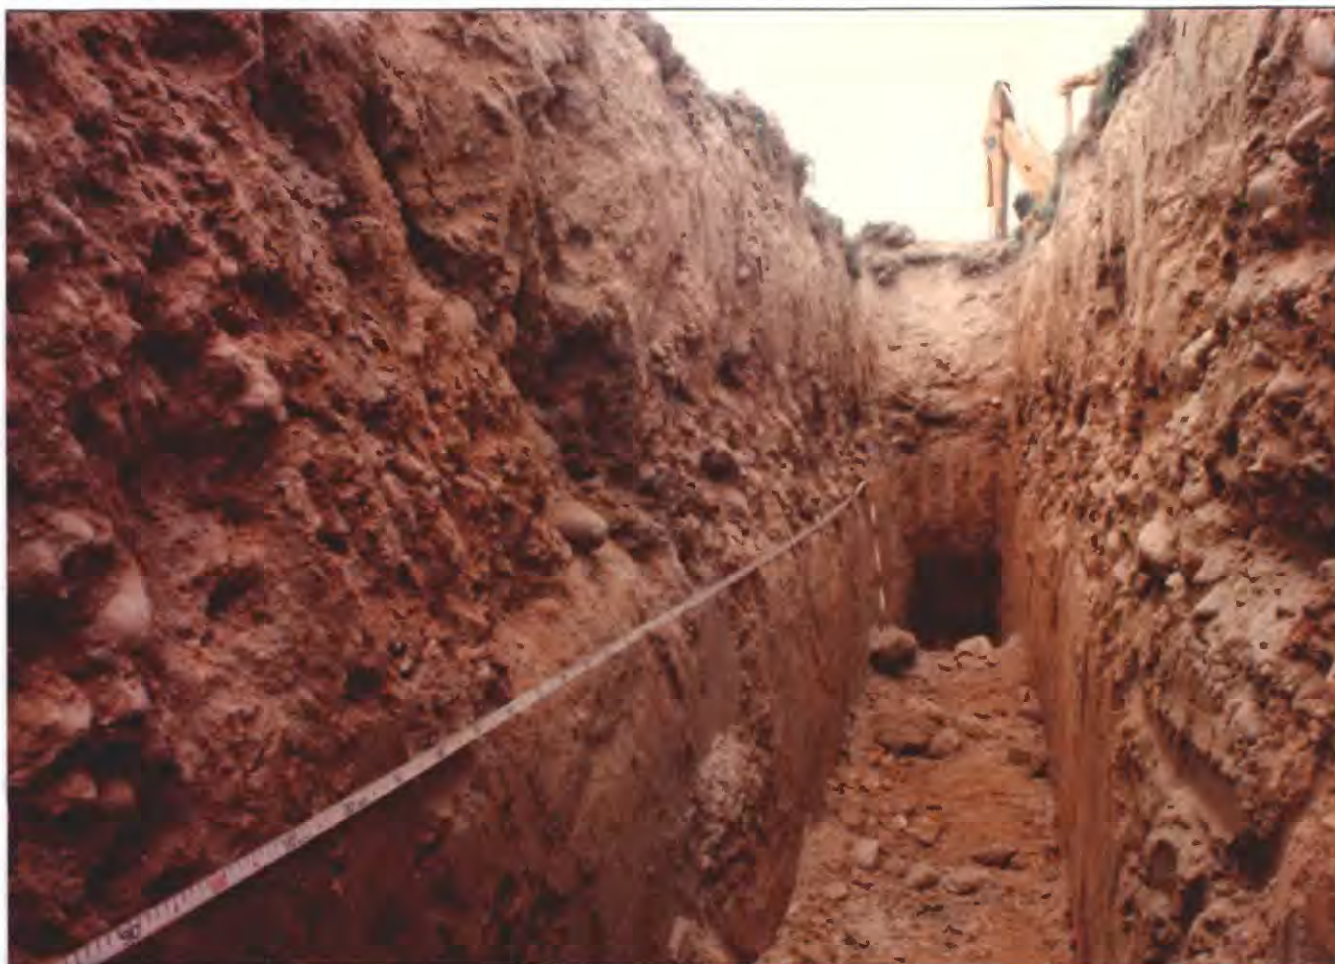
<u>Depth</u>	<u>Description</u>
0-20 cm	Loam (44 % sand, 43 % silt, 13 % clay), 10 YR 3/3. Numerous cobbles and pebbles.
20-58 cm	Loam (36 % sand, 41 % silt, 23 % clay), 10 YR 6/4. Numerous cobbles and pebbles.
58-140 cm	Gravel with clasts ranging in size from granules to small boulders. Some sandstone clasts weathered, but most clasts relatively unweathered. Matrix is clay loam (34 % sand, 26 % silt, 40 % clay), with variegated colors (7.5 YR 5/6, 7.5 YR 5/8, 10 YR 5/3). Abrupt, smooth boundary. Contact with underlying shale dips to northwest at about 2°. A long-axis fabric was measured on clasts in this layer, and showed a weak, though significant, preferred orientation oblique to the modern river trend.
140-350+ cm	Weathered shale, variegated colors (10 YR 5/8, 2.5 YR 4/8, 7.5 YR 5/8). Strike and dip of shale beds, 110°, 14° S.

Figure 24. Trench 11. Tape is just below contact of gravel unit with underlying weathered shale.

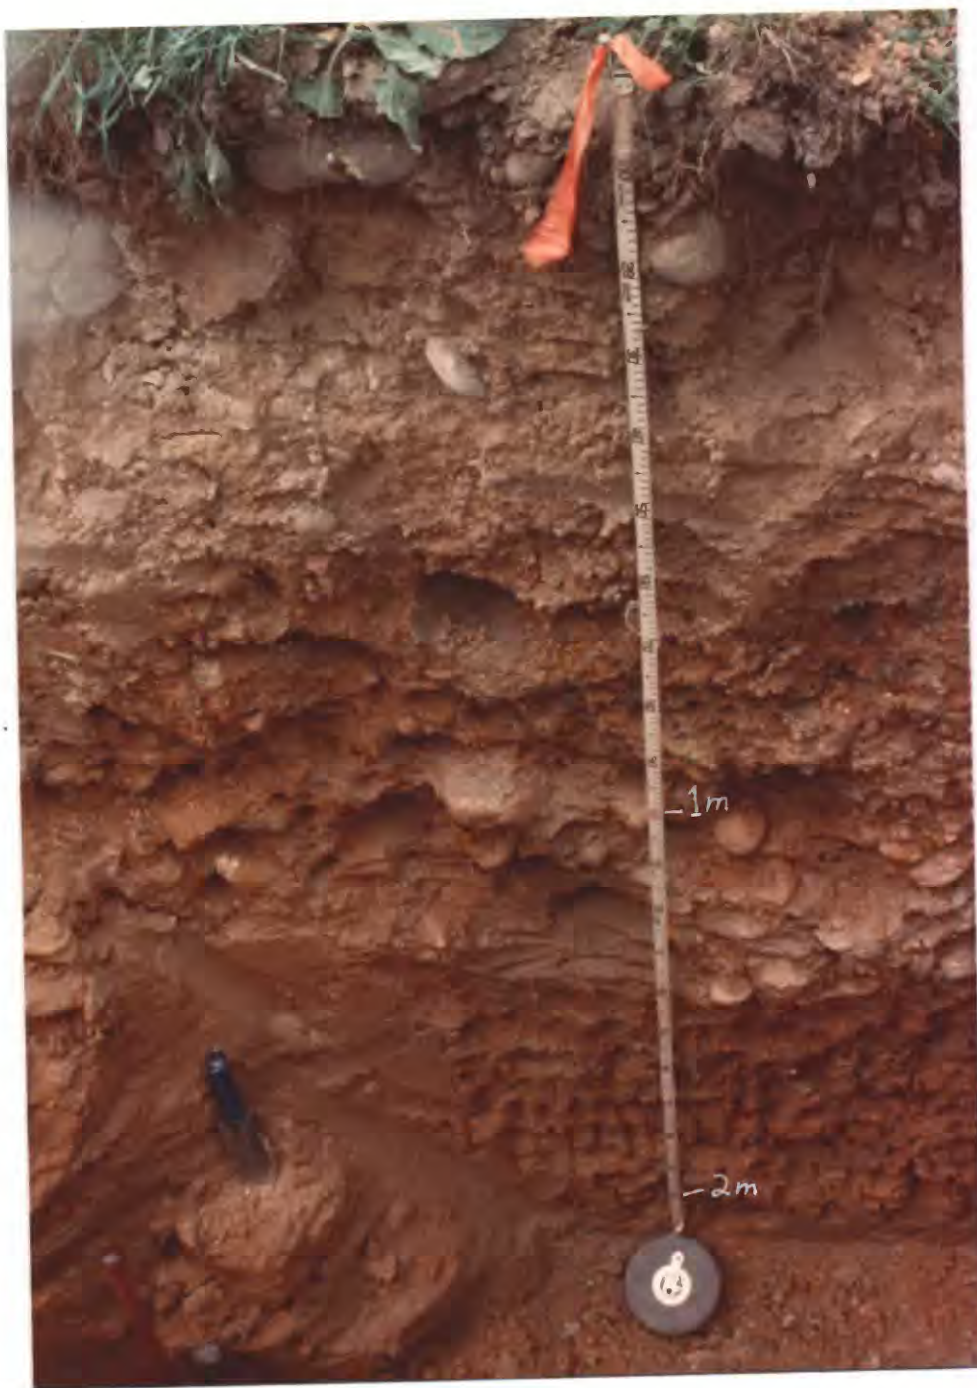
Figure 25. Trench 11, near Profile 1. Contact of gravel unit with underlying weathered shale is at about 140 cm.

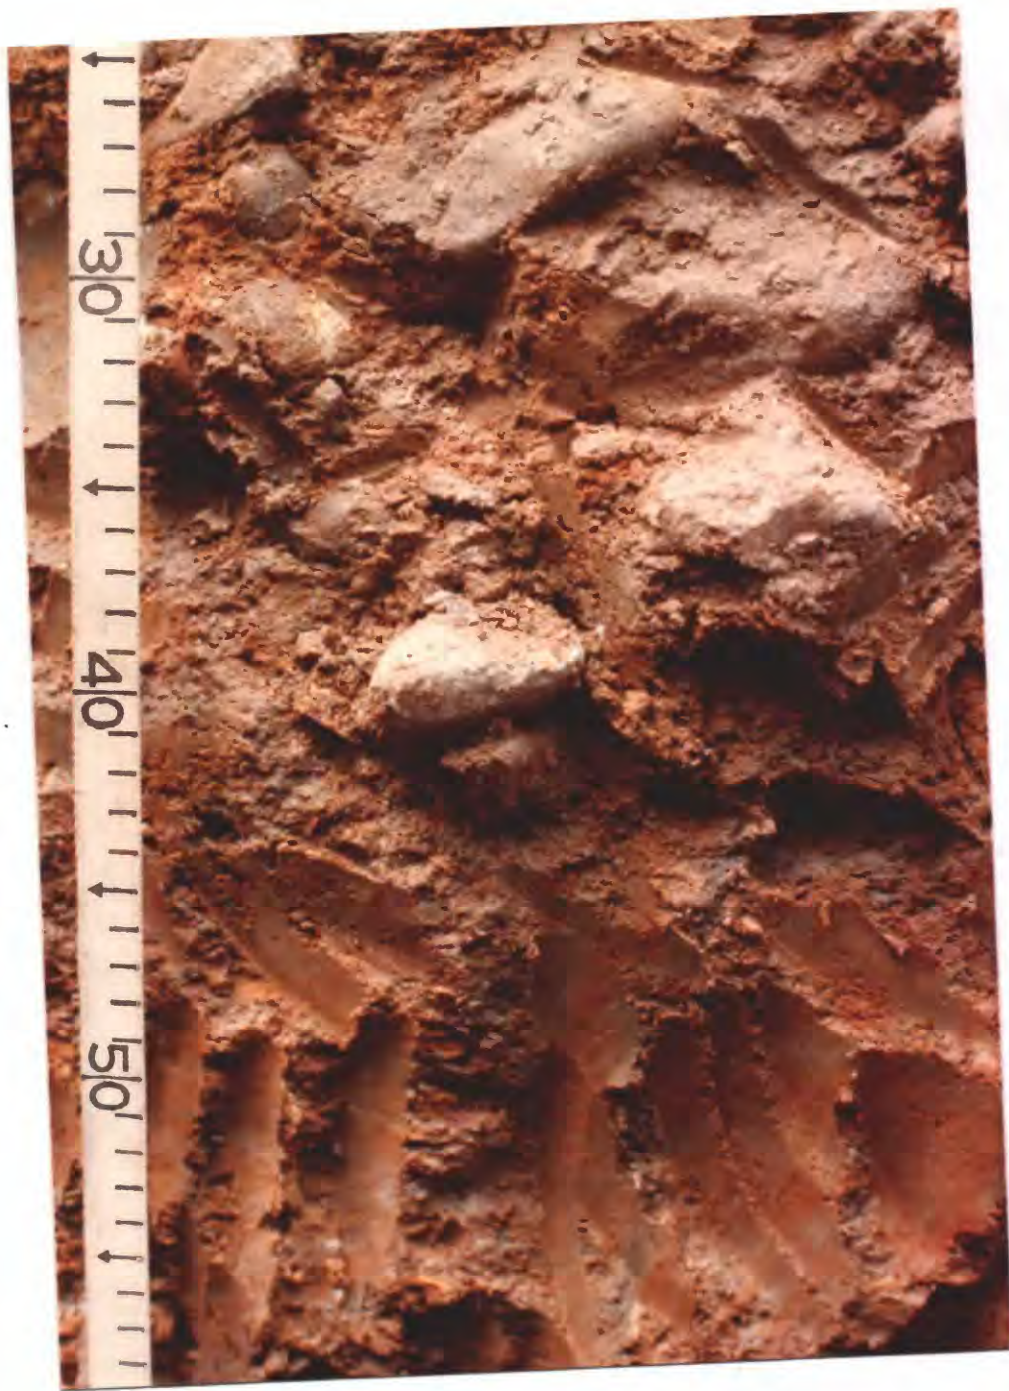
Figure 26. Trench 11, near Profile 1. Close-up of contact of gravel unit with underlying weathered shale.

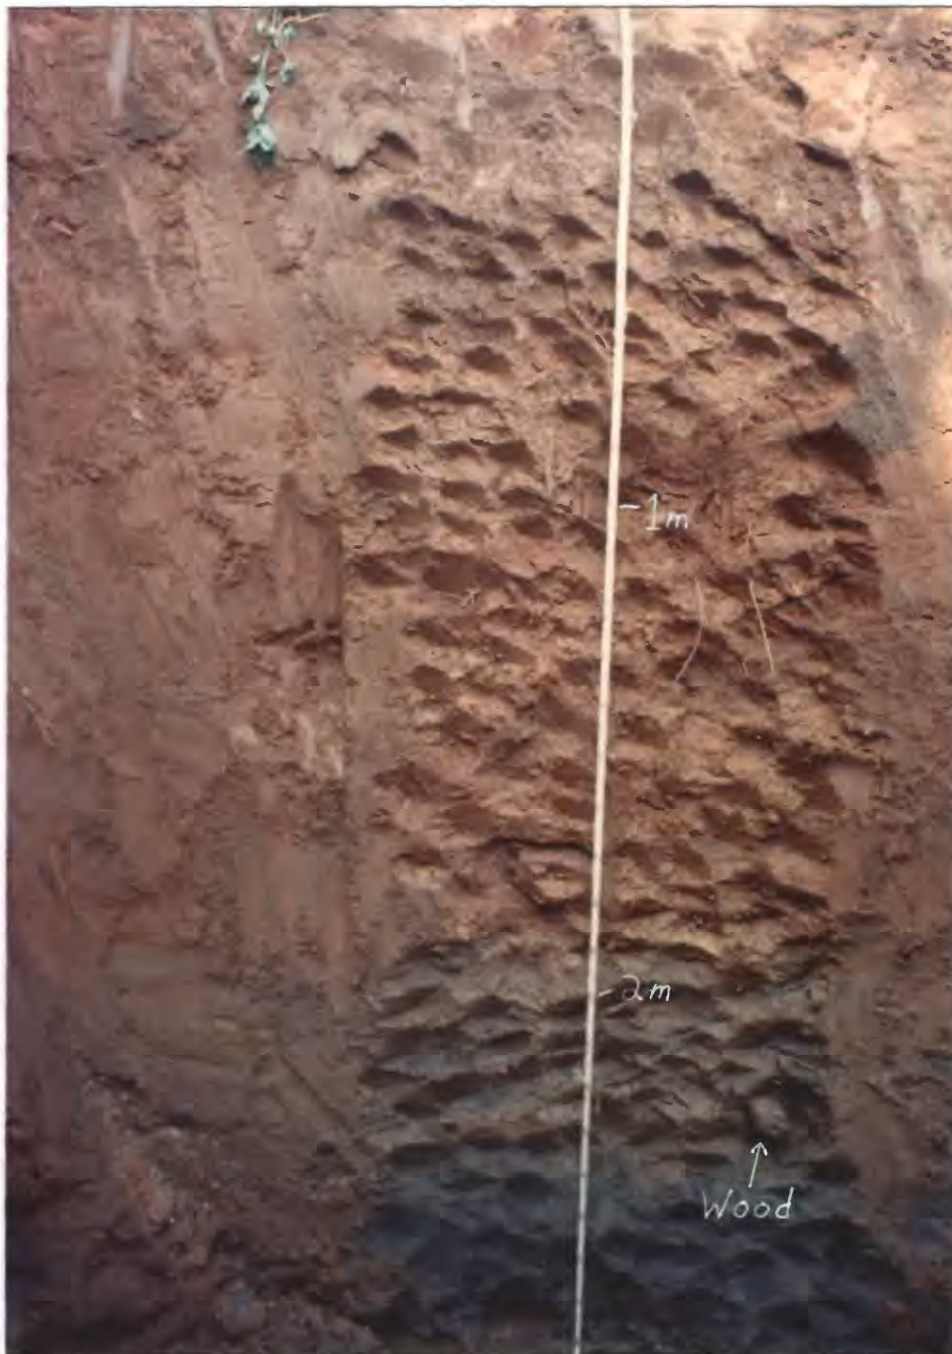
<u>Depth</u>	<u>Description</u>
0-60 cm	Silty clay loam (44 % sand, 43 % silt, 13 % clay), 10 YR 4/3.
60-70 cm	Silty clay loam, 10 YR 3/4.

Figure 28. Trench 12, Profile 1. Note gleyed zone and log near base of profile.

70-95 cm	Silty clay loam. Colors mottled (7.5 YR 4/6, 10 YR 4/4).
95-180 cm	Clay loam (30 % sand, 38 % silt, 32 % clay), 7.5 YR 4/4.
180-183 cm	Loamy sand, 7.5 YR 3/2.
183-200 cm	Silty clay, 7.5 YR 4/4.
200-245 cm	Alternating layers and lenses of silty and sandy sediments (finer layer is clay loam: 23 % sand, 43 % silt, 34 % clay). Variegated colors (2.5 Y 4/2, 10 YR 3/3, 10 YR 3/3, 8.75 YR 4/4. Log for radiocarbon dating obtained at 235 cm (Fig. 28).
245-283 cm	Sandy loam (71 % sand, 21 % silt, 8 % clay), 10 YR 4/1 (gleyed).
283-295 cm	Pebble-size gravel with loamy sand matrix. 10 YR 4/1 (gleyed).
295+ cm	Unweathered siltstone bedrock.

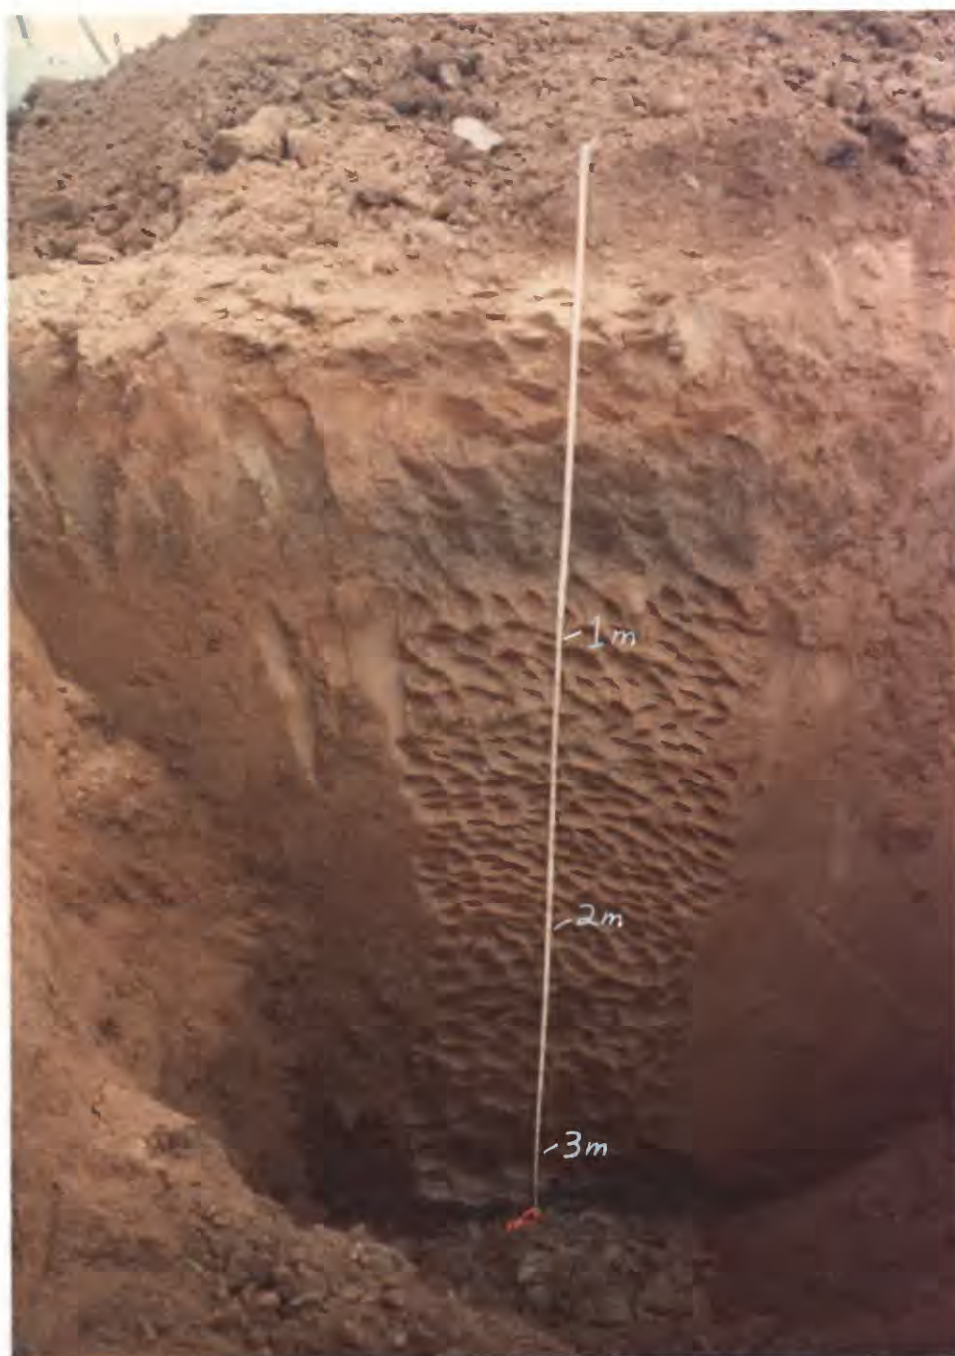
<u>Depth</u>	<u>Description</u>
0-30 cm	Silt loam, 7.5 YR 4/4
30-42 cm	Loam (33 % sand, 44 % silt, 23 % clay), 7.5 YR 3/4.
42-60 cm	Sandy loam, 10 YR 3/2.

Figure 30. Trench 13, Profile 1. Note gleyed zone near base from which log was taken.

60-85 cm	Loam (20 % sand, 51 % silt, 29 % clay), 10 YR 3/2.
85-310 cm	Silty clay loam (sample at 190 cm - 13 % sand, 50 % silt, 37 % clay) to clay loam (sample at 220 cm - 25 % sand, 44 % silt, 31 % clay), 10 YR 4/3.
310-330 cm	Silty clay loam, 10 YR 5/3.
330-390 cm	Sandy loam (75 % sand, 17 % silt, 8 % clay), 10 YR 3/1 (gleyed). Logs for radiocarbon dating obtained from about 370 cm.
390+ cm	Unweathered siltstone bedrock.

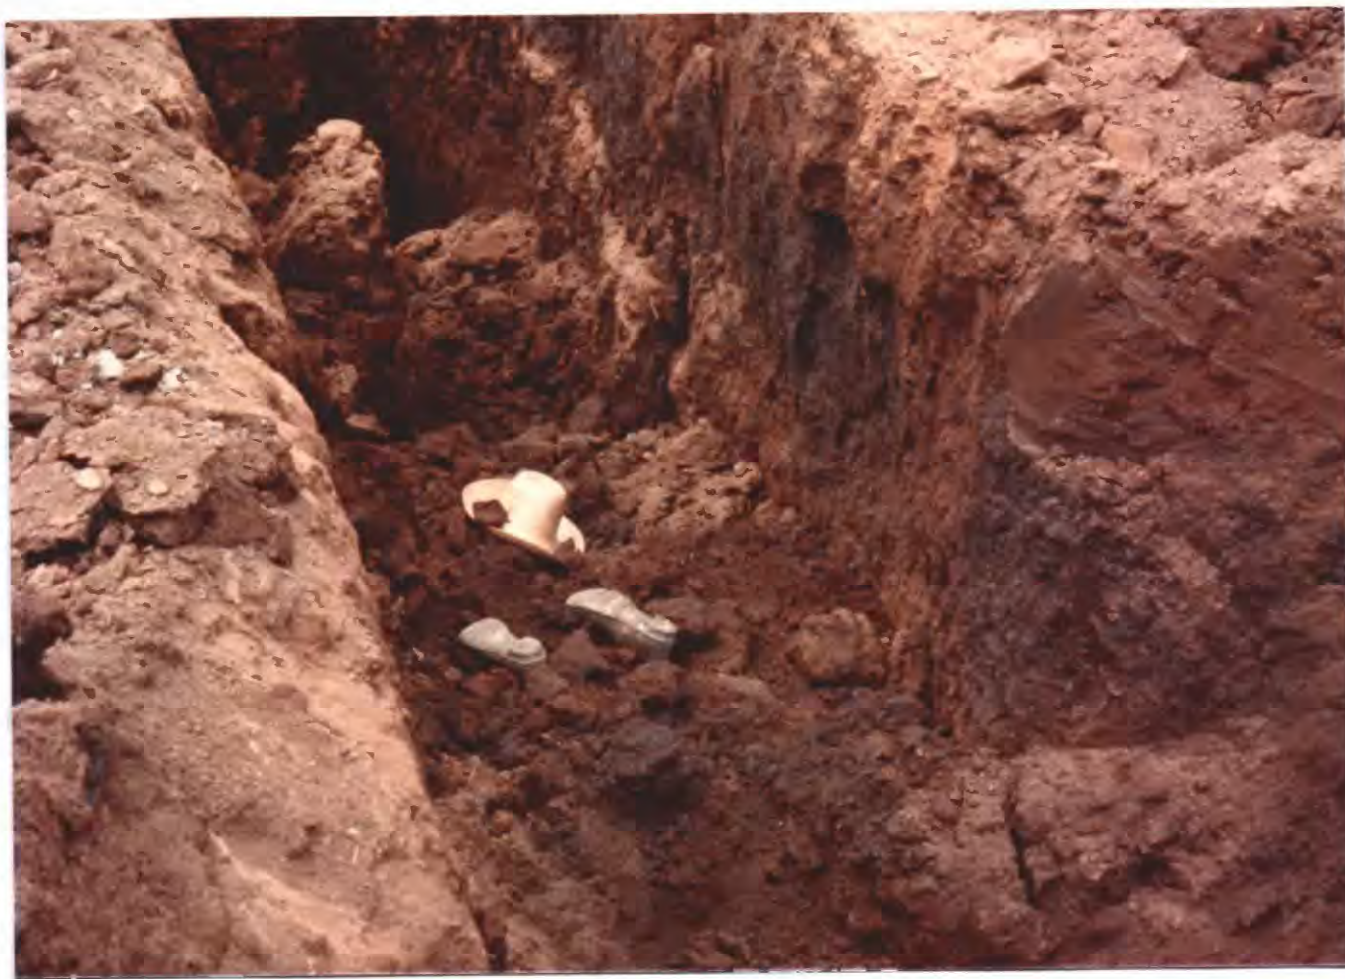
Figure 31. Trench 13, after collapse.

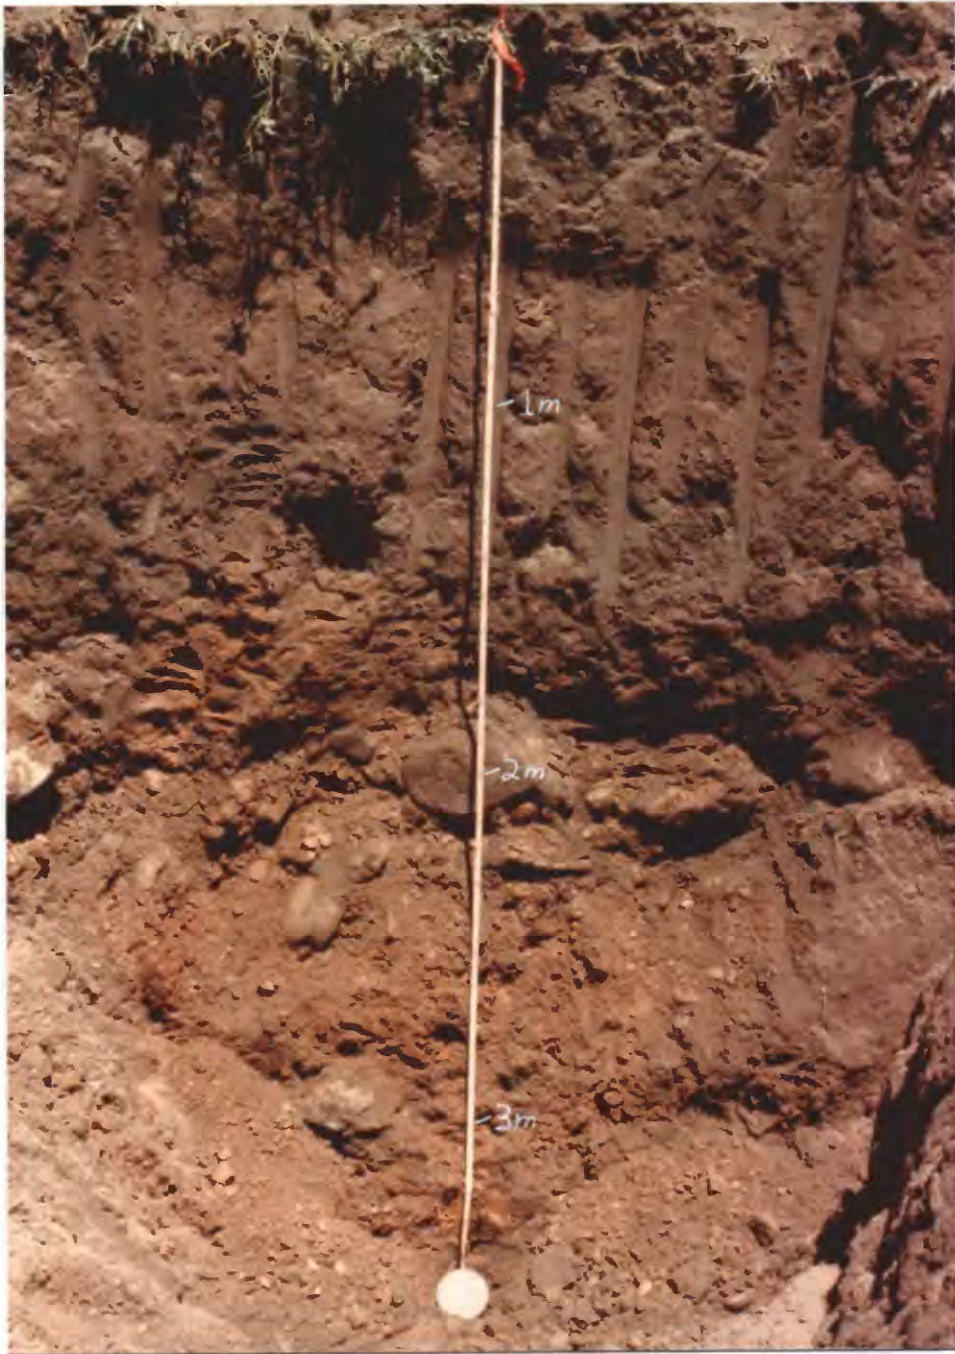
Figure 34. Trench 16, Profile 1.

<u>Depth</u>	<u>Description</u>
0-40 cm	Sandy loam, 10 YR 4/2.
40-110 cm	Sandy loam (58 % sand, 27 % silt, 15 % clay), 10 YR 3/3.
110-155 cm	Sandy clay loam (49 % sand, 27 % silt, 24 % clay), 10 YR 4/3.
155-175 cm	Sandy clay loam (52 % sand, 25 % silt, 23 % clay), 10 YR 4/4. Few clasts in this and higher units.
175-315 cm	Boulder-gravel unit, with boulders as large as 600 mm by 500 mm by 300 mm. Matrix of sandy loam (68 % sand, 13 % silt, 19 % clay), matrix color 8.75 YR 4/6. Figure 35 shows contact between this unit and overlying sandy units.
315-350 cm	Loam (28 % sand, 47 % silt, 25 % clay) with gravel, 2.5 Y 7/6.
350+ cm	Sandstone bedrock.

Comments Boundaries all gradual and wavy. Two test pits were dug on the same terrace as Trench 16. The first was located 55 m ESE from Trench 16, and hit boulder gravel at 280 cm. The second was located about 320 m downstream from Trench 16, about 100 m from river. Boulder gravel was encountered at 150 cm, and bedrock at 190 cm.

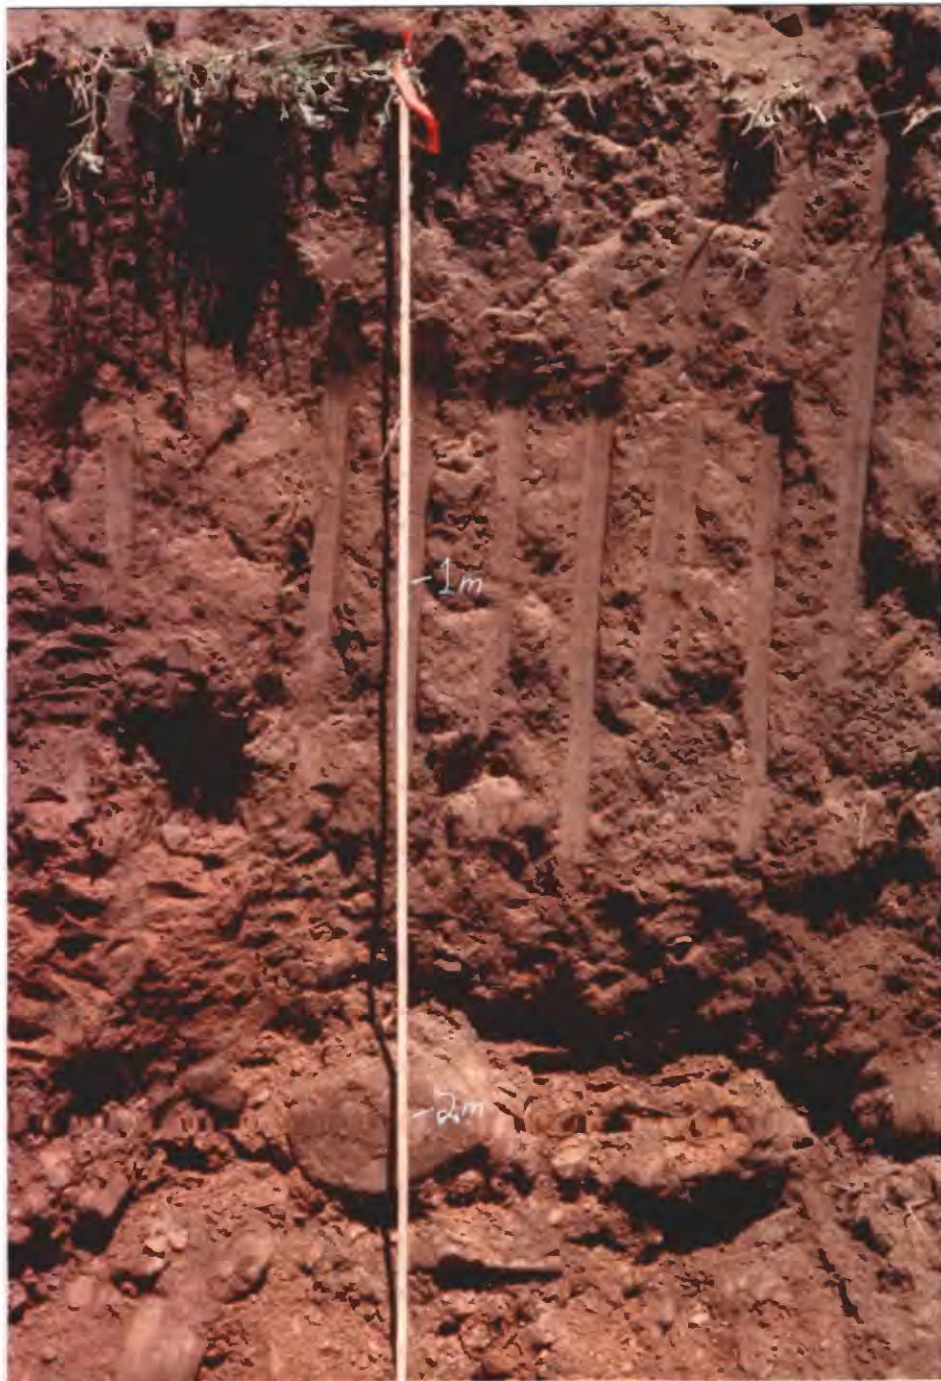
Figure 35. Trench 16, Profile 1. Close-up showing contact of sandy unit with underlying boulder-gravel unit at about 175 cm.

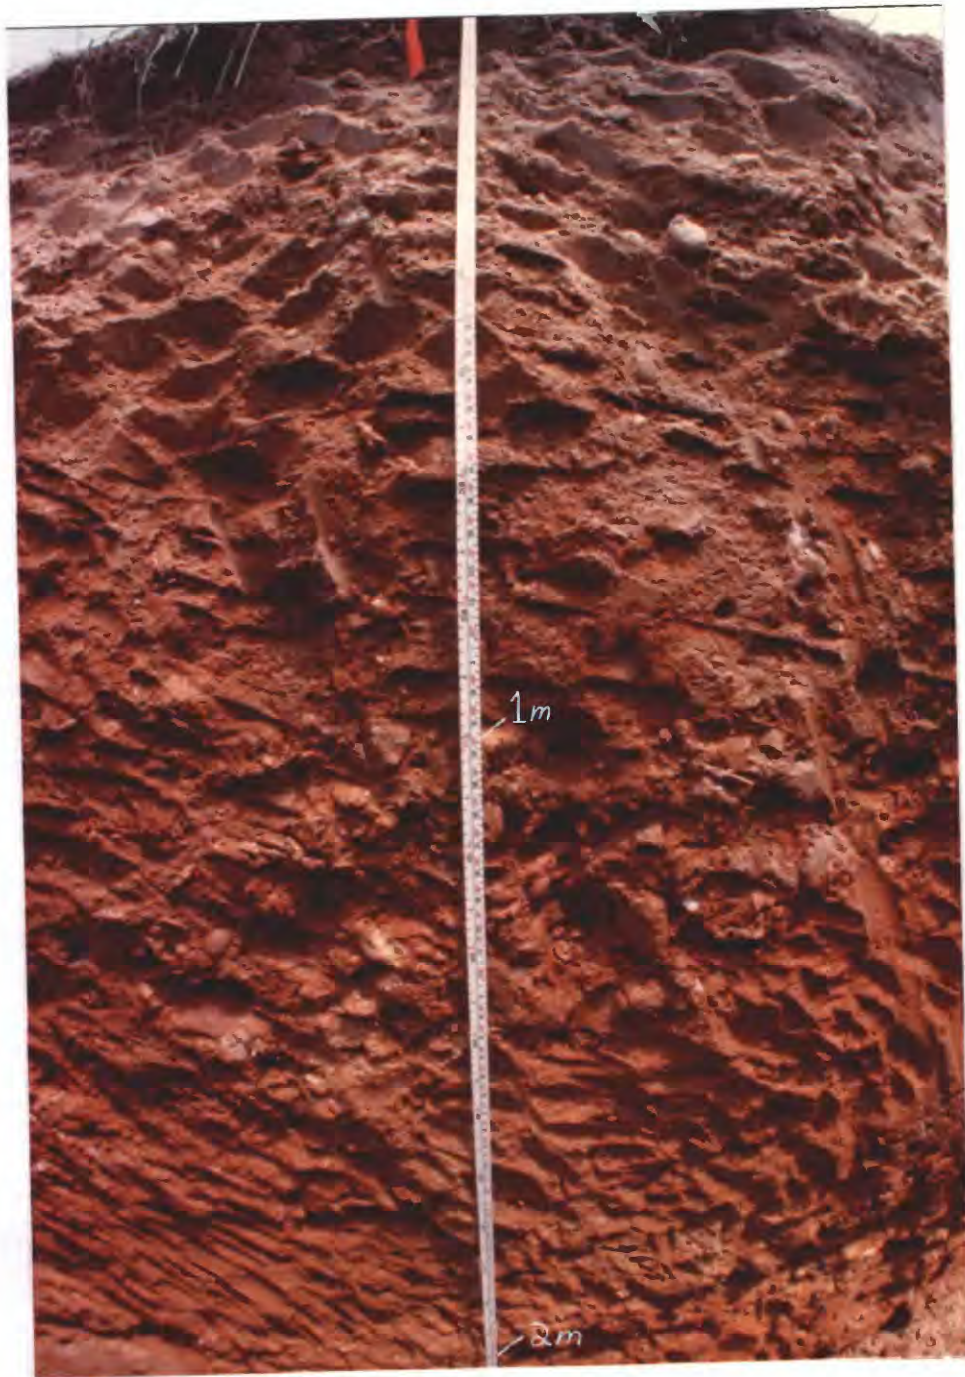
Figure 36. Trench 17, Profile 1.

175-178 cm	Sandy loam, 7.5 YR 5/8. Boundary abrupt, irregular.
178-190 cm	Loamy sand, 7.5 YR 6/8. Boundary abrupt, wavy, dips 20° to NW.
190-220 cm	Gravel unit, mainly pebbles and small cobbles. Sandstone and crystalline clasts generally decomposed. Sandy loam matrix, 8.75 YR 6/8. Iron-manganese-oxide stains and layers. Boundary abrupt, wavy, dips steeply to NW. Unit continues about 3 m NW, 5 m SE. Relatively little mica compared to lower terraces.
220-250+ cm	Sandy loam, 7.5 YR 7/8.

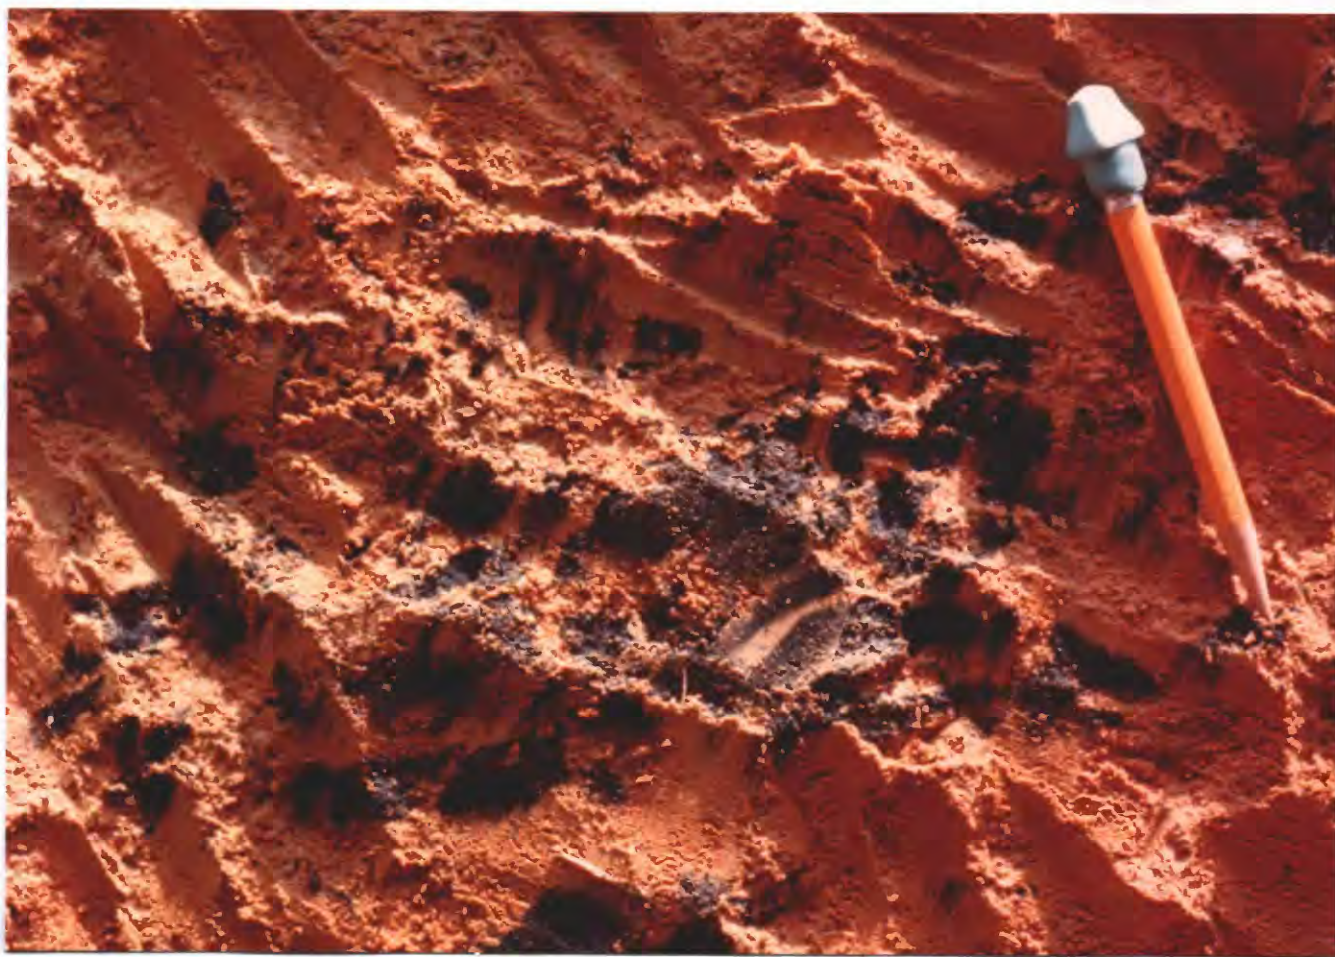
Figure 37. Trench 17, near Profile 1. Close-up of iron-manganese-oxide staining.

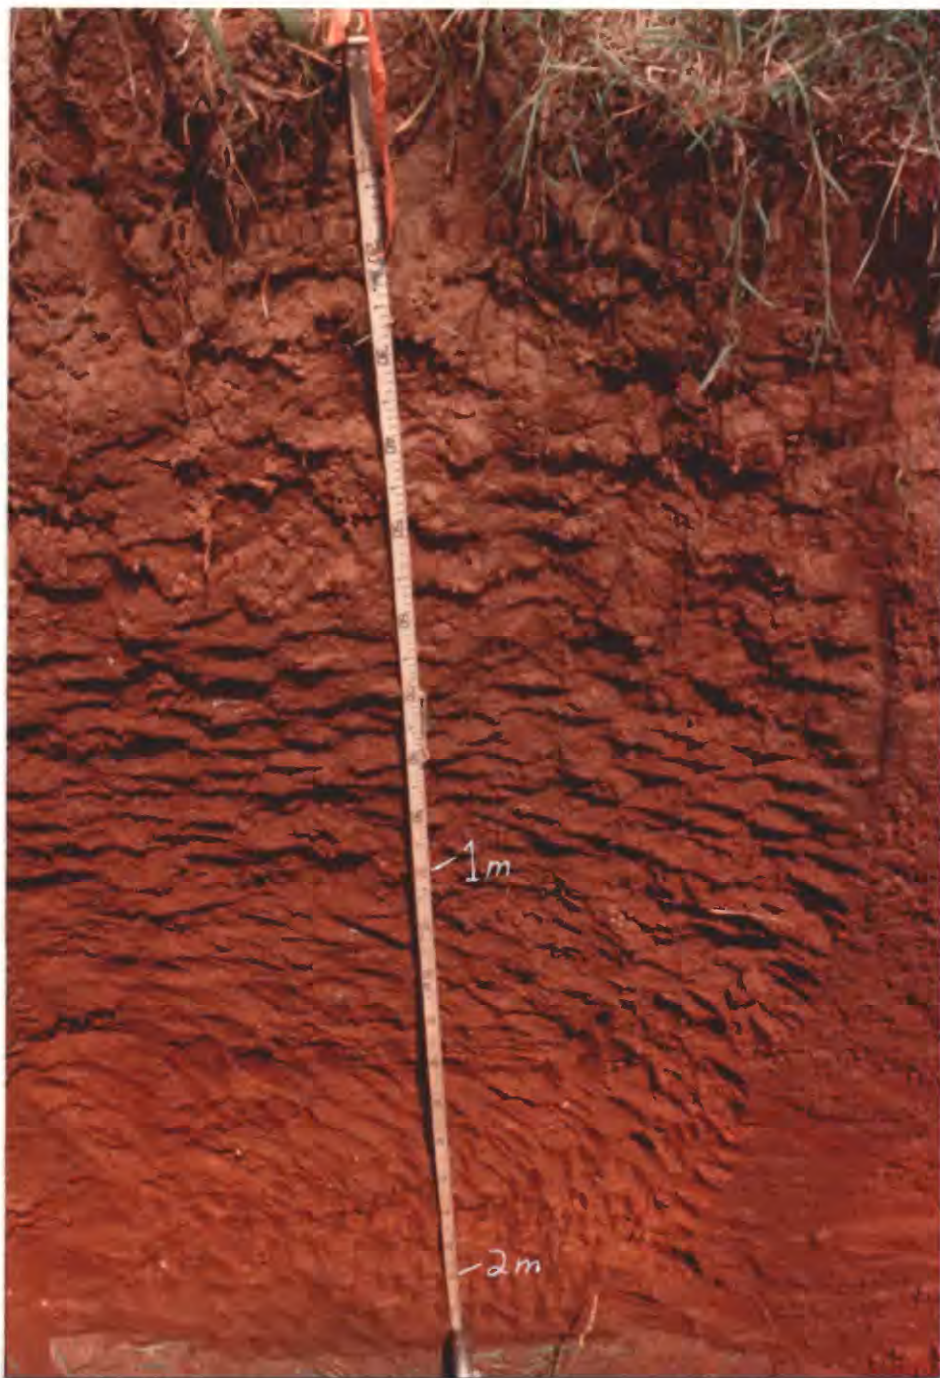
Figure 39. Trench 17, Profile 2.

<u>Depth</u>	<u>Description</u>
0-15 cm	Sandy loam, 10 YR 3/3.

15-40 cm	Sandy clay loam with some cobbles, pebbles. 10 YR 5/4.
40-65 cm	Gravel layer, pebbles and cobbles. Sandy clay loam matrix, 10 YR 6/6.
65-110 cm	Sandy clay loam, mottled color (10 YR 5/8, 5 YR 5/8). Rare pebbles, small cobbles. Boundary abrupt, wavy, dips 18° to NW.
110-142 cm	Gravel layer with sandy clay matrix, matrix color 5 YR 5/8. Corresponds to lower gravel unit, profile 1. Boundary abrupt, wavy, dips to NW, then becomes horizontal.
142-165 cm	Loamy sand, 7.5 YR 6/8. Rare pebbles. Boundary abrupt, wavy.
165-185 cm	Gravel layer with sandy clay loam matrix, matrix color 6.25 YR 5/8. Boundary abrupt, wavy, dips NW.
185-230+ cm	Sandy loam, 7.5 YR 5/8. Rare clasts. Abundant iron-manganese oxide.

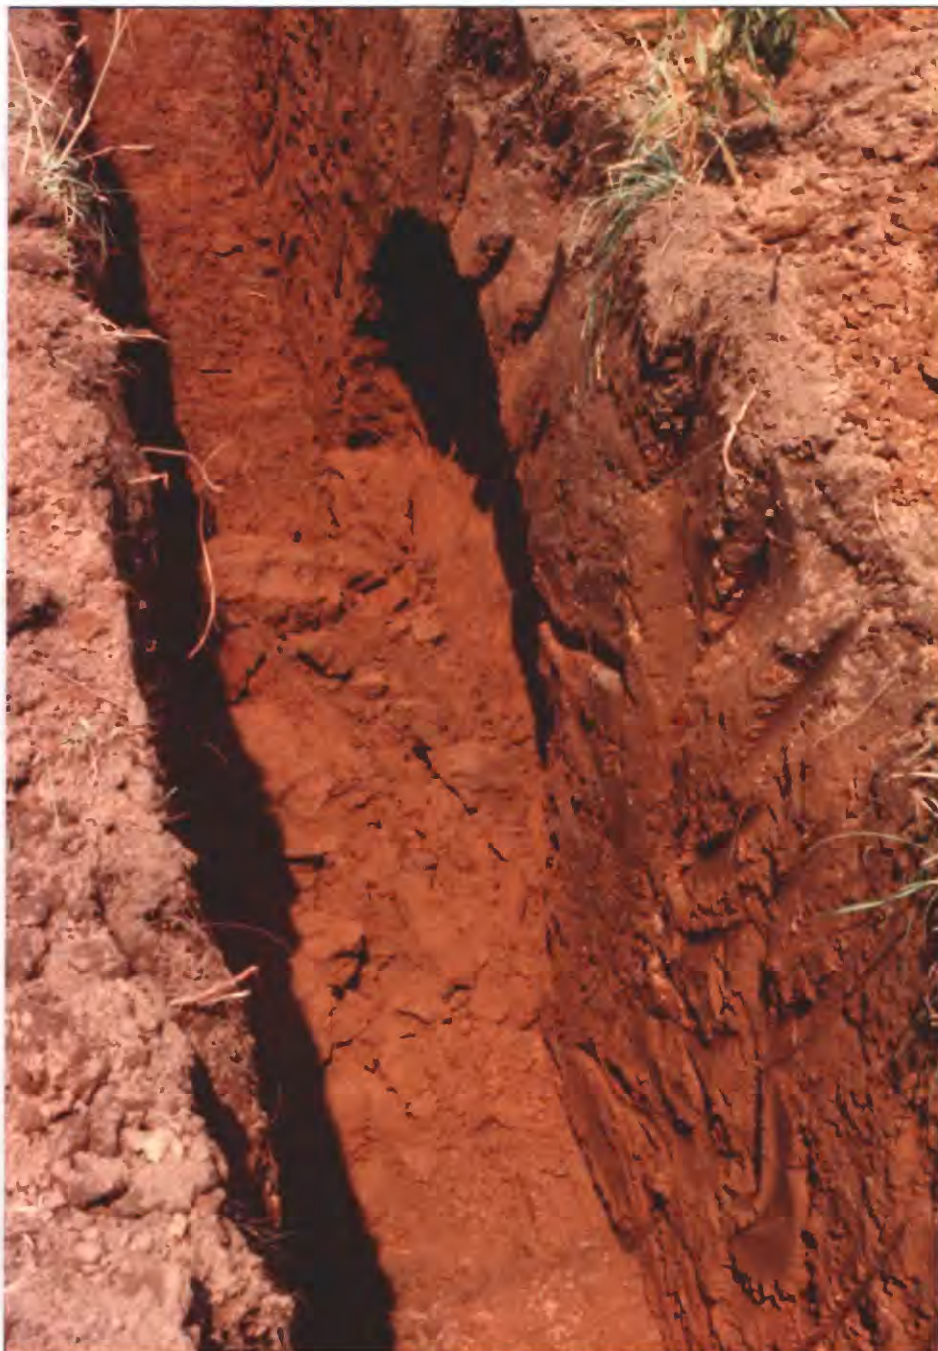
Figure 41. Trench 19, showing arch-shaped slump in trench wall.

The profiles observed at both Trench 19 and 20 probably were the most monotonous seen during the trenching project. There was virtually no bedding, with little variation in texture or color. Almost no clasts were observed. One unique feature of these trenches was the arch-shaped slumps that occurred (Fig. 41). In other trenches, slumping occurred only where the trench floor was below the water table, or where non-cohesive gravel layers collapsed. As the particle-size distributions in profiles revealed by Trenches 19 and 20 were not unusual, perhaps the deposits here have other unusual physical properties that make them prone to slumping. As this location is near the center of the Giles County seismogenic zone (Fig. 1), perhaps these properties are ones induced by shaking. A future research project might consist of comparing geotechnical properties of New River flood-plain and low-terrace sediments in the center of the seismogenic zone with those distant from the zone.
