UNITED STATES
DEPARTMENT OF THE INTERIOR
GEOLOGICAL SURVEY

THE STORAGE AND RELEASE OF WATER FROM A LARGE GLACIER-DAMMED LAKE:
RUSSELL LAKE NEAR YAKUTAT, ALASKA, 1986

Open-File Report 86-545

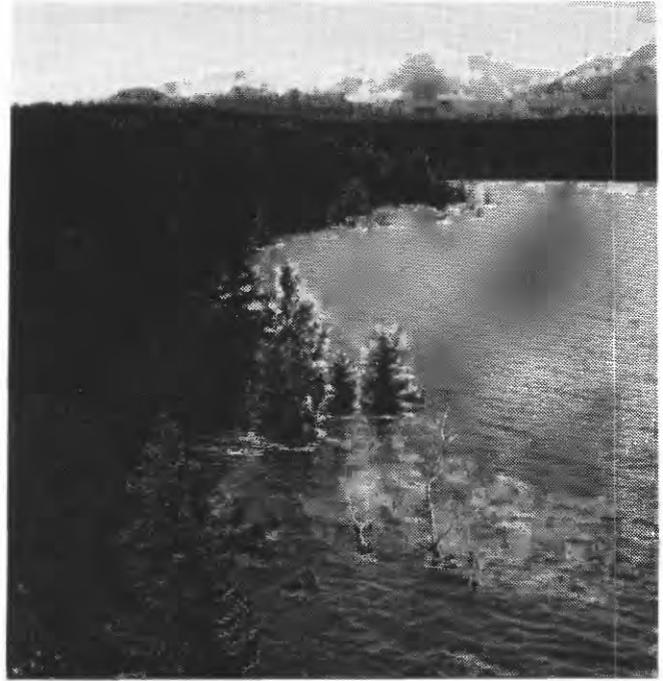
Figure 4. -- "Drowned" trees near southern end of Russell Lake.

During the period May 29 to October 7, 1986, the water level in Russell Lake rose to an elevation of 83 ft above sea level, inundating alluvial fans, outwash plains in front of several tributary glaciers, and in places the densely forested fringes of Russell Fiord (fig. 4). The lake level rose at an average rate of 0.6 ft/d, with a maximum rise of 1 ft/d (fig. 5 and table 1). The volume of water in Russell Lake at its maximum stage, excluding the water of the "original" Russell Fiord, was calculated to have been 187 billion ft³ (or 4.3 million acre/ft), so that the
