# HYDROLOGIC HAZARDS ALONG SQUAW CREEK FROM A HYPOTHETICAL FAILURE OF THE GLACIAL MORaine IMPOUNDING CARVER LAKE NEAR SISTERS, OREGON

U.S. GEOLOGICAL SURVEY

Open-File Report 87-41

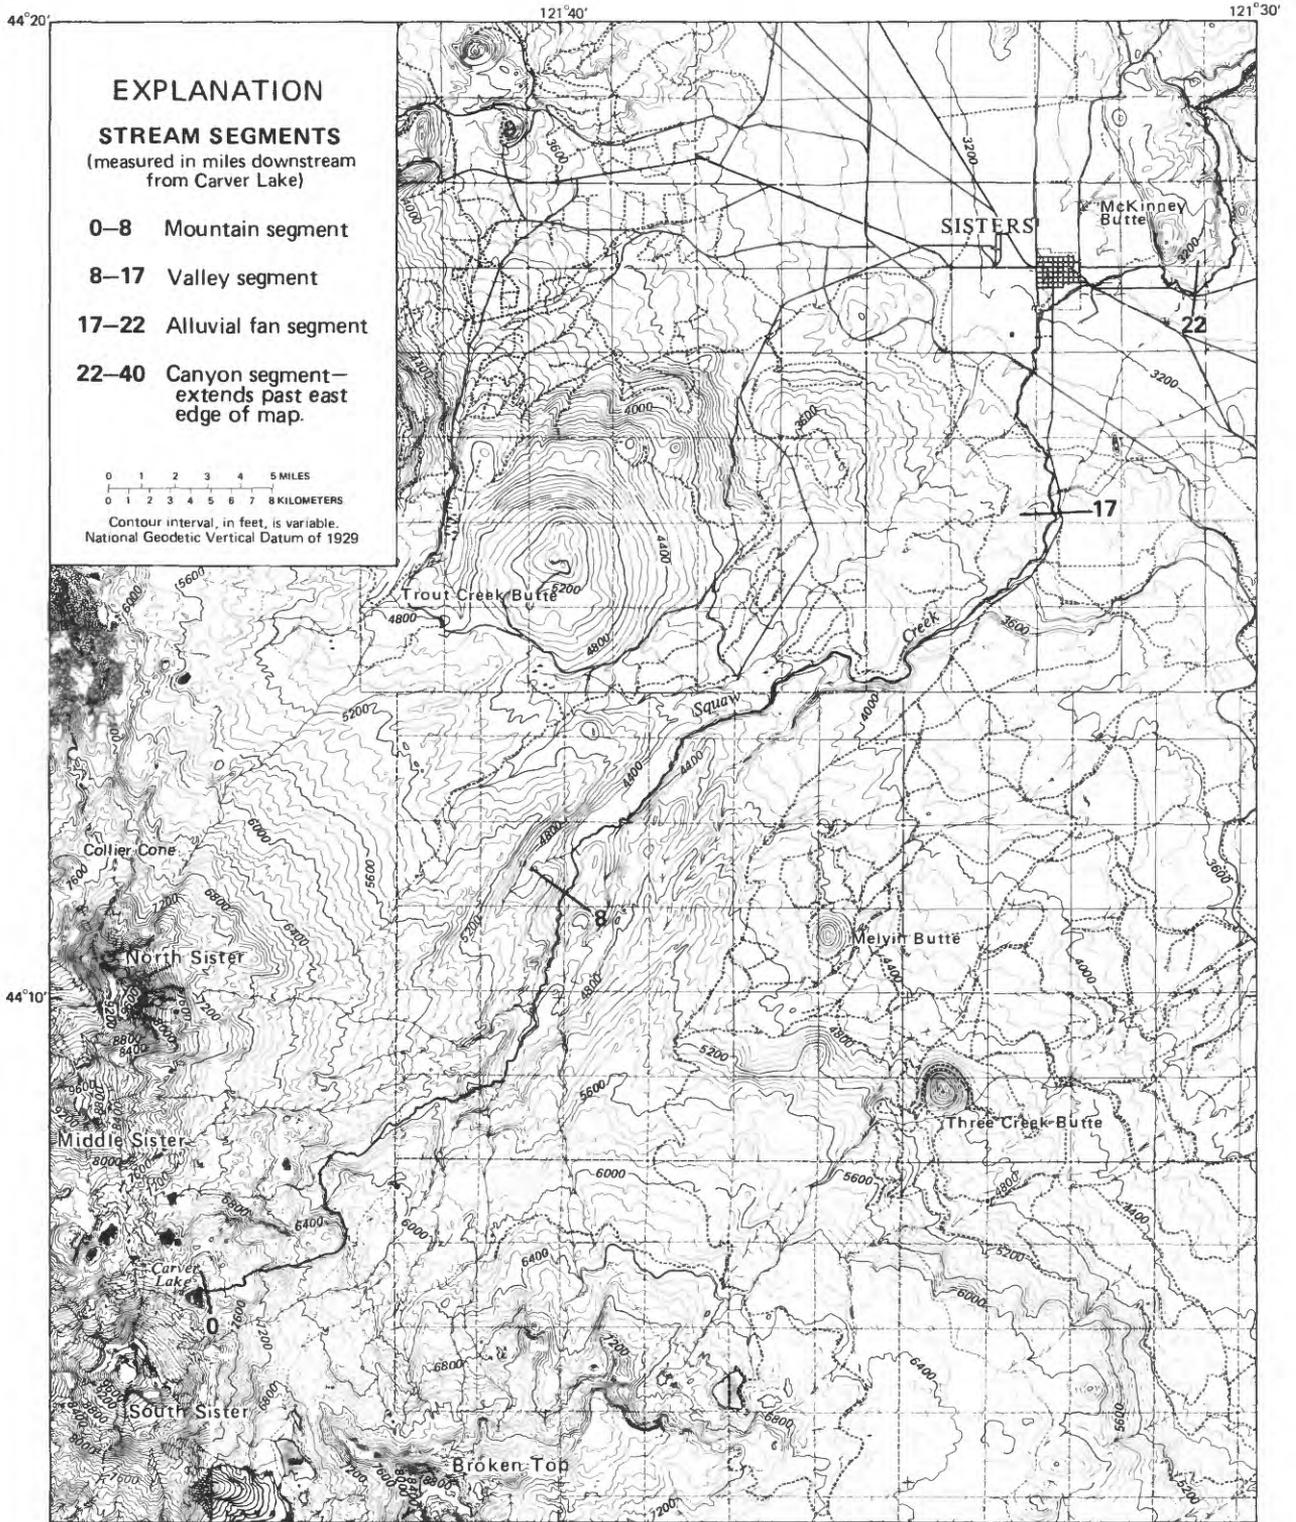
Figure 2. — Topographic map of study area showing Squaw Creek divided into segments dependent on slope and geometry.

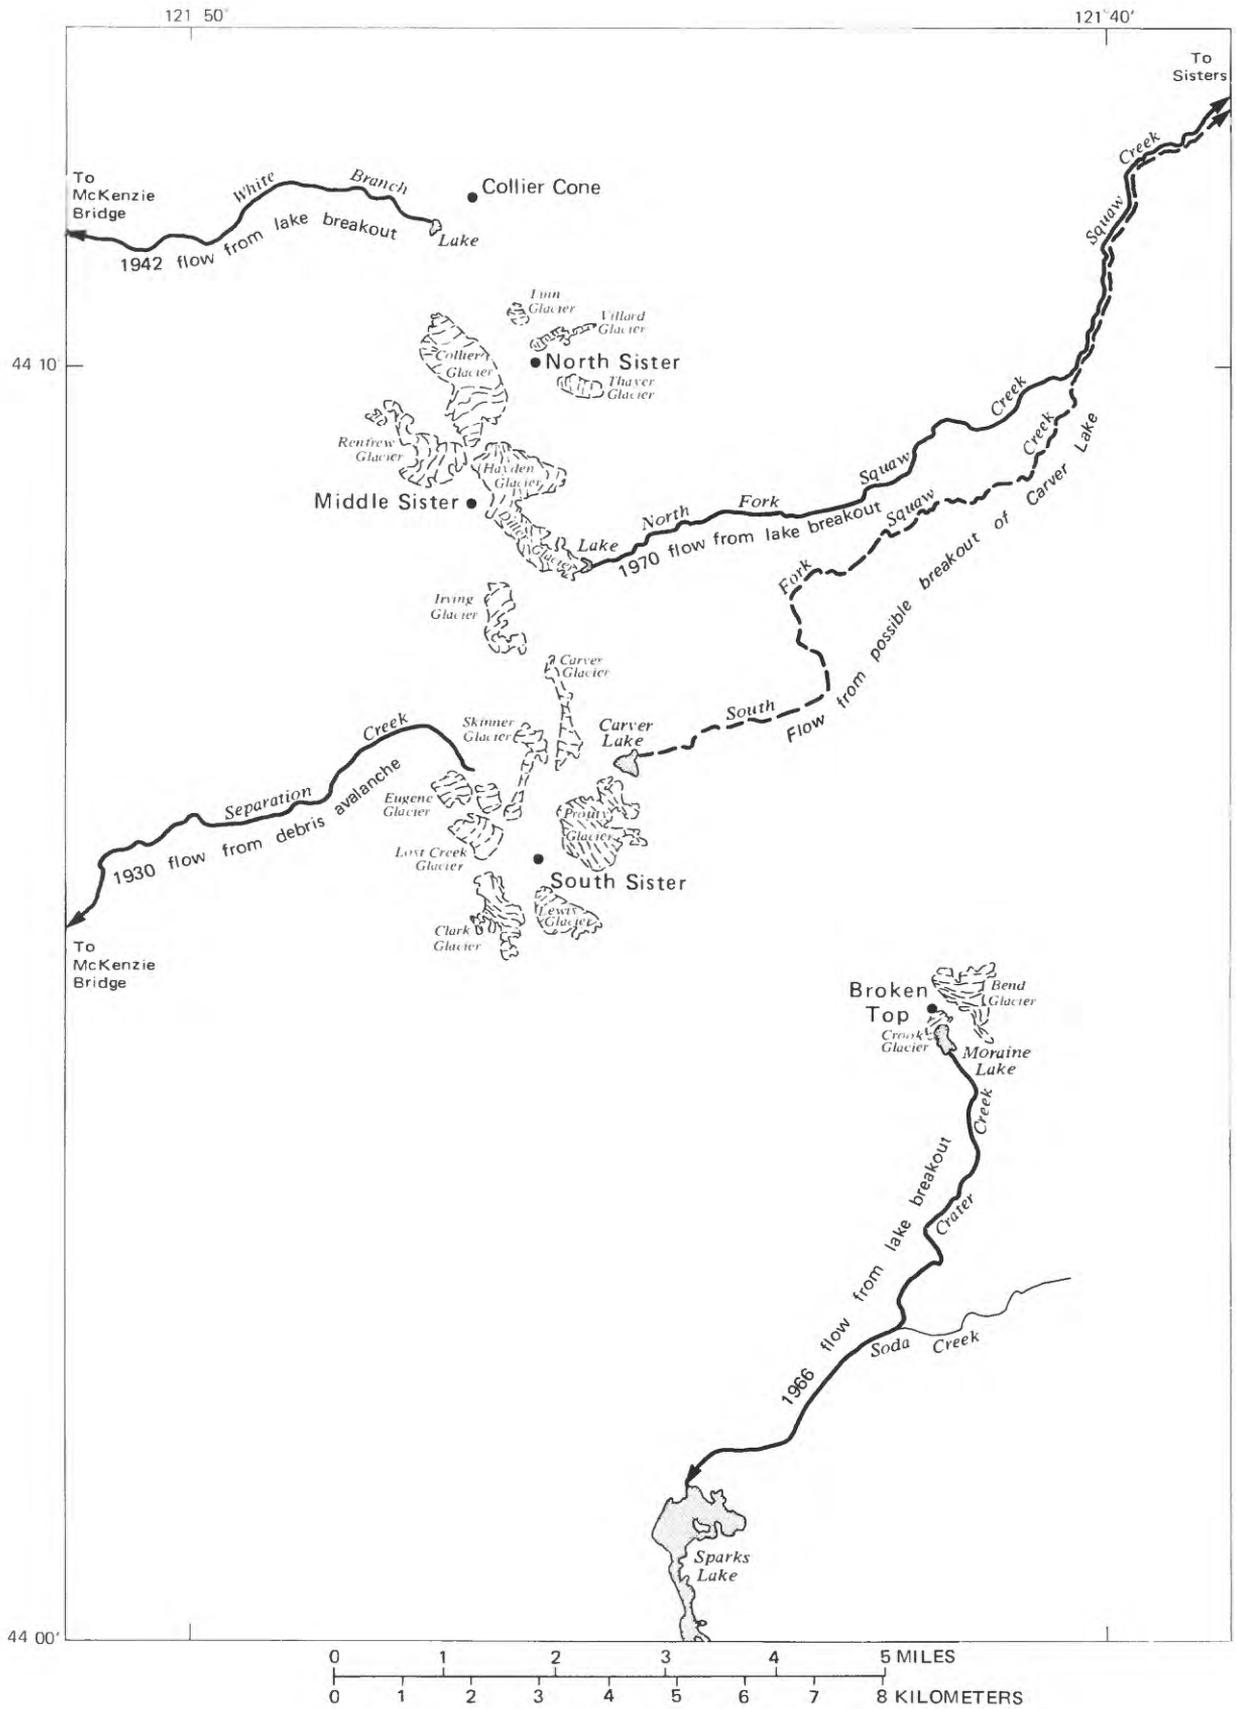
Figure 3. – Generalized flow paths of recent floods of glacial origin.

- (3) Avalanches of rock and ice that could cause the lake to overtop the moraine are highly probable. In August of 1930, a large avalanche occurred on the west side of South Sister (fig. 3). Large volumes of potentially unstable rock rise with vertical slopes above the headwaters of the lake. The steeply sloping and heavily crevassed Prouty Glacier also is located almost immediately above the lake.

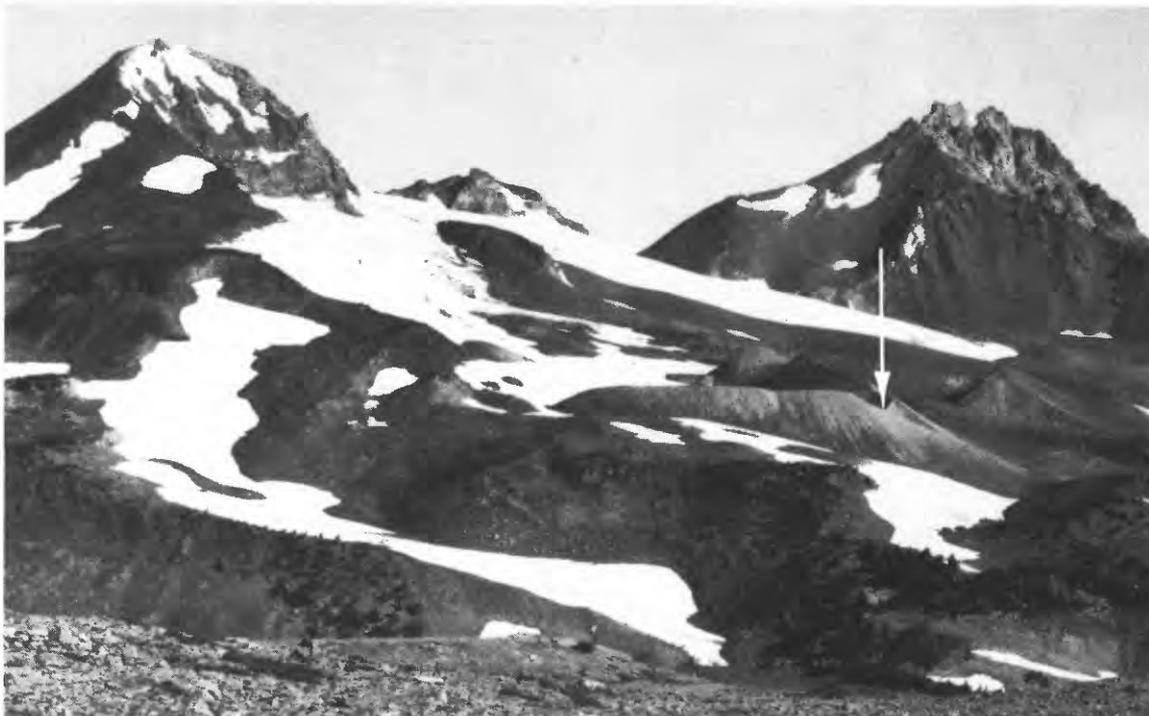
Figure 4. – Moraine breach in the North Fork Squaw Creek drainage that occurred September 7, 1970 (see arrow). Diller Glacier on Middle Sister is in the background. The lake level dropped 84 feet, completely emptying the lake. This photo shows how moraines are deposited in front of glaciers, August 1986.

Part of the recent field work in the area documented a flow originating from a moraine-lake breakout that occurred on September 7, 1970 in the upper North Fork Squaw Creek drainage (fig. 4). A volume of approximately 200 acre-ft of water was released from this moraine lake, which drained entirely. This flow reached a magnitude in excess of 10,000 ft<sup>3</sup>/s several times during descent from the 7,500-foot elevation. The peak attenuated to 8,000 ft<sup>3</sup>/s as it exited from steeply sloping canyons at about elevation 4,400 feet, 7 miles from the source. As the peak flow passed the Geological Survey gage (14075000) approximately 15 miles downstream from the source, it had been drastically reduced to 1,200 ft<sup>3</sup>/s (2.5 feet of stage increase at the gage). (For comparison purposes, the highest peak of record since 1909 at the Geological Survey gage was 2,000 ft<sup>3</sup>/s, which occurred on December 25, 1980.) At Sisters the peak flow had attenuated even more drastically and passed through as a small muddy-water surge of about 1 foot in height.

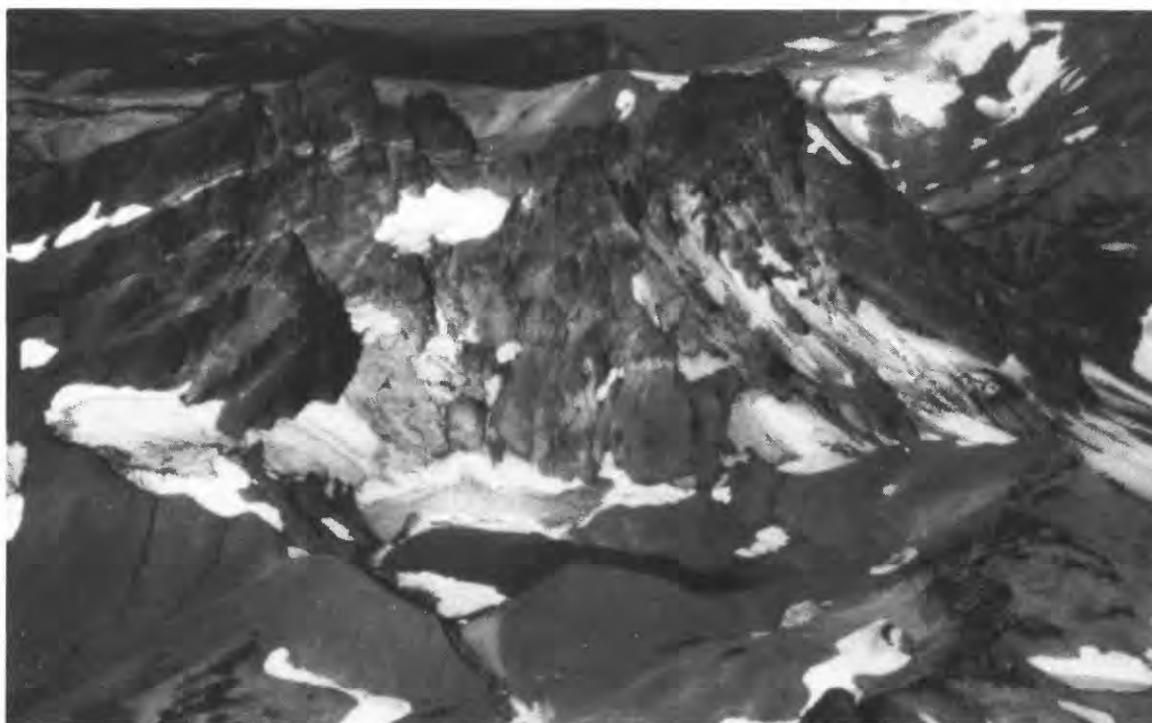
Figure 5. – Moraine lake with Broken Top in the background. The moraine breach occurred on October 7, 1966, causing a flood in the Soda Creek drainage. (Photo courtesy of U.S. Forest Service, 9/3/86)

Another well documented moraine-lake breakout in the area occurred in the Soda Creek drainage (Nolf, 1966). About 150 acre-ft of water was released, only partially draining Moraine Lake on Broken Top Mountain at elevation 8,000 feet (fig. 5). This moraine-dam failure created a maximum flood peak of about 7,000 ft<sup>3</sup>/s at higher elevations and a flood peak of about 2,000 ft<sup>3</sup>/s as it inundated the Sparks Lake area, 6 miles downstream. Moraine Lake could breach again in the near future, causing a flood event of similar magnitude. About another 150 acre-ft of water remain in this lake.

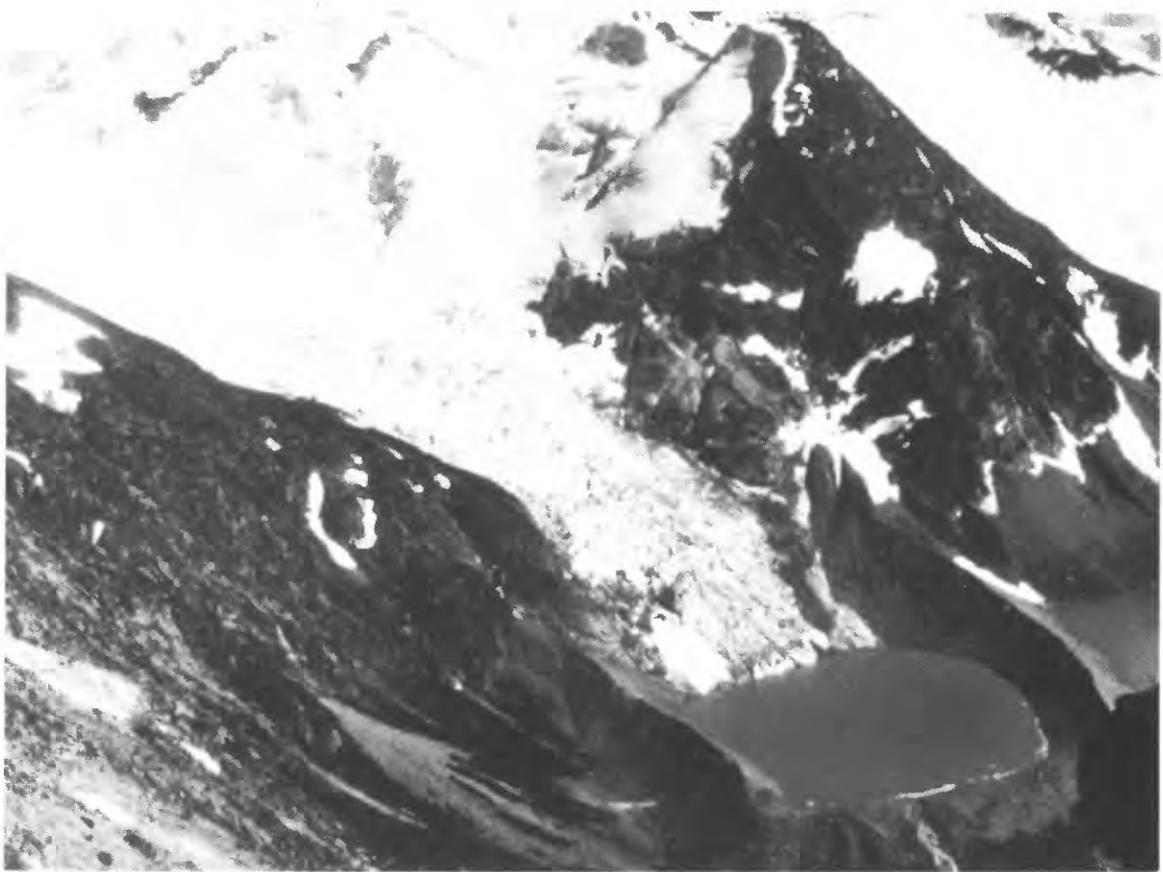
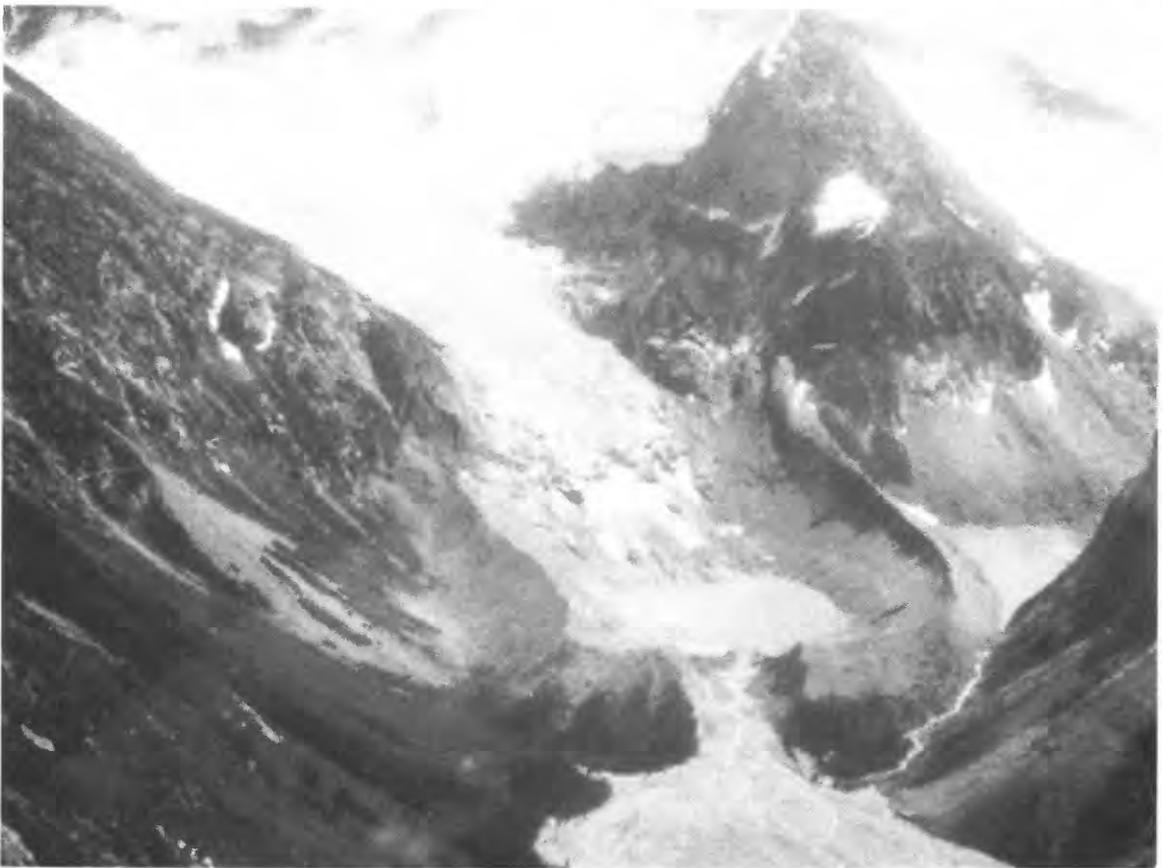
Figure 6. – Before and after views of Nostetuko Lake, British Columbia, Canada. The moraine breached in 1983. (Photos courtesy of J.M. Ryder and Michael Church)

The most comprehensive description of the failure of a morainal dam known to us, as reported by Blown and Church (1985), is the failure of the morainal dam of Nostetuko Lake, British Columbia, Canada (fig. 6). On July 19, 1983, Nostetuko Lake, dammed by the neoglacial moraine of Cumberland Glacier in the Coast Mountains of British Columbia, partly drained and sent a large flood of water and debris down the Nostetuko River. The lake was lowered by 126 feet as 5,200 acre-ft of water was released. The breach of the moraine dam was initiated when glacial ice collapsed into the lake, forming a single large wave that translated across the lake to the outlet channel across the top of the moraine. The wave augmented flow in the outlet channel, initiating erosion that permitted increased flow from the lake as it began to drain.

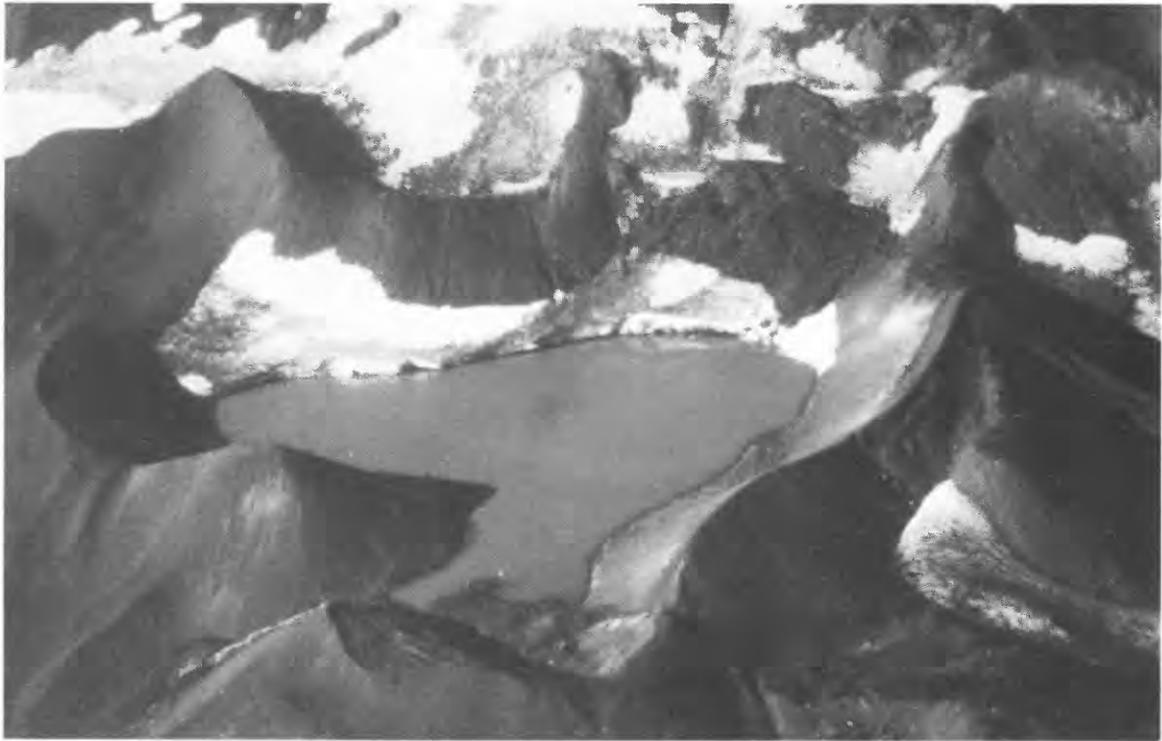
Figure 7. – View of Carver Lake from the northeast showing encircling moraines September 3, 1986.  
(Photo courtesy U.S. Forest Service)

The moraine that contains Carver Lake is a push type terminal moraine of neoglacial origin. The texture of the moraine material is a silty, sandy, bouldery till with very little clay (less than 5 percent). Morainal material completely encircles the lake (fig. 7; see also cover and frontispiece). A terminal moraine curves gently around the downstream side of the lake. Another terminal moraine abuts the upstream end of the lake, and lateral moraines form the remaining sides.

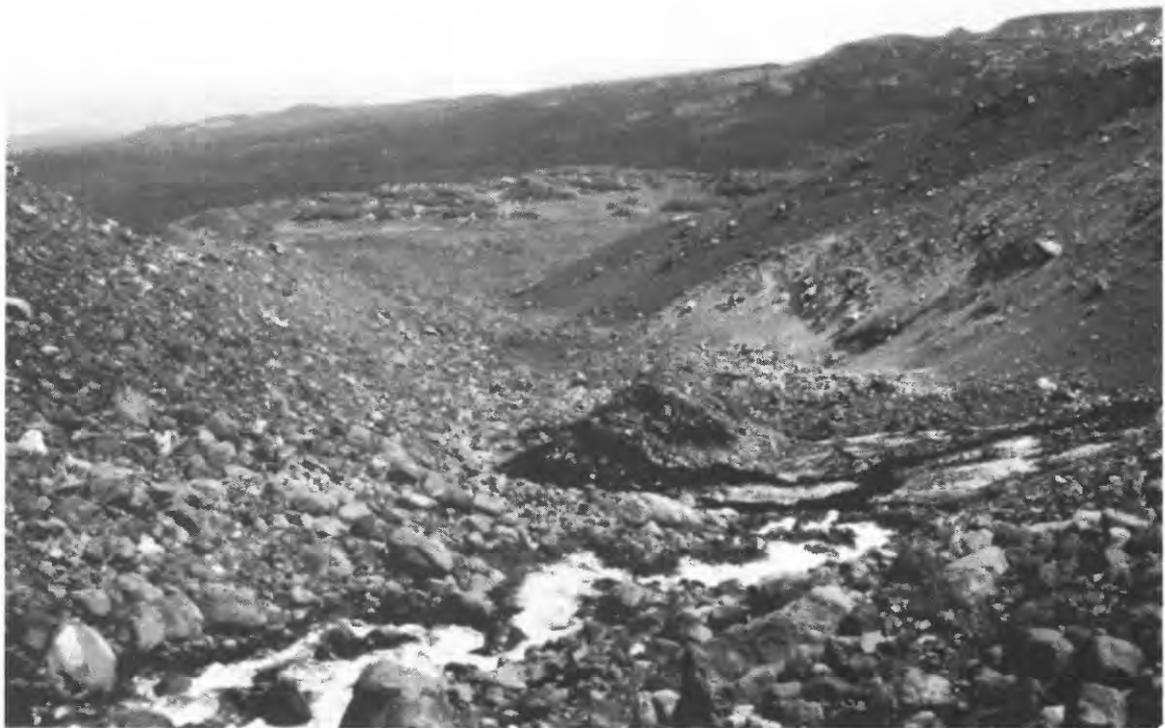
Figure 8. – Boulder plain downstream of Carver Lake with outlet channel and moraine in the foreground, August 31, 1986.  
(Photo courtesy U.S. Forest Service)

The downstream terminal moraine shows the remains of a previous breach. A bouldery field that was laid downstream as a result of this breach is shown in figure 8. The stream that now runs in the bottom of the breach travels level for about 200 feet and then plummets down the steep face of the moraine, incising a channel (figs. 7 and 9). Because the moraine is 200 feet wide at the present lake level, smaller avalanches probably would not trigger downcutting of the moraine. However, the downcutting of the small stream on the face of the moraine continues to gradually reduce moraine stability. Also, the stability of the moraine probably is dependent on the proximity to the surface of a frozen ice or ground-water core. Techniques for identifying ice interfaces in moraines involving geophysical investigations have been developed by Haeberli (1986), but were not used in this study. The use of ground penetrating radar also may help to identify any ice interface.

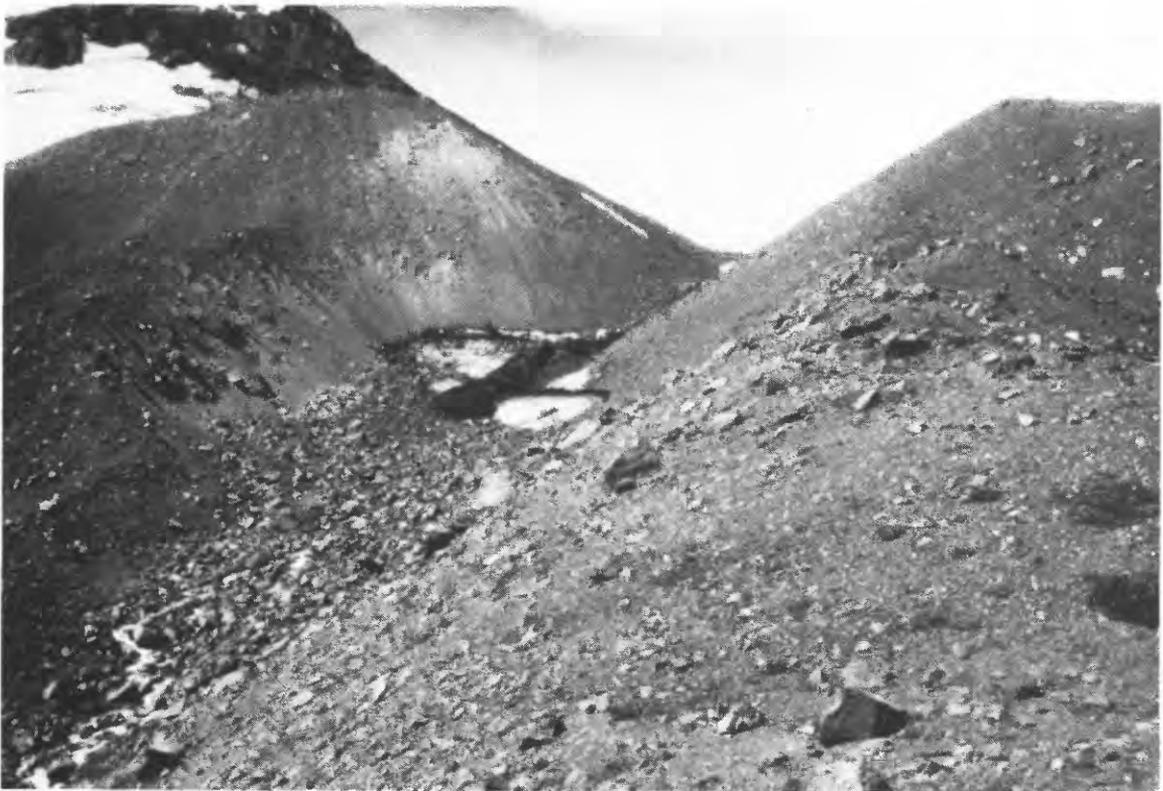
Figure 9. – Carver Lake outlet channel flowing down steep face of moraine. August 31, 1986.  
(Photo courtesy U.S. Forest Service)

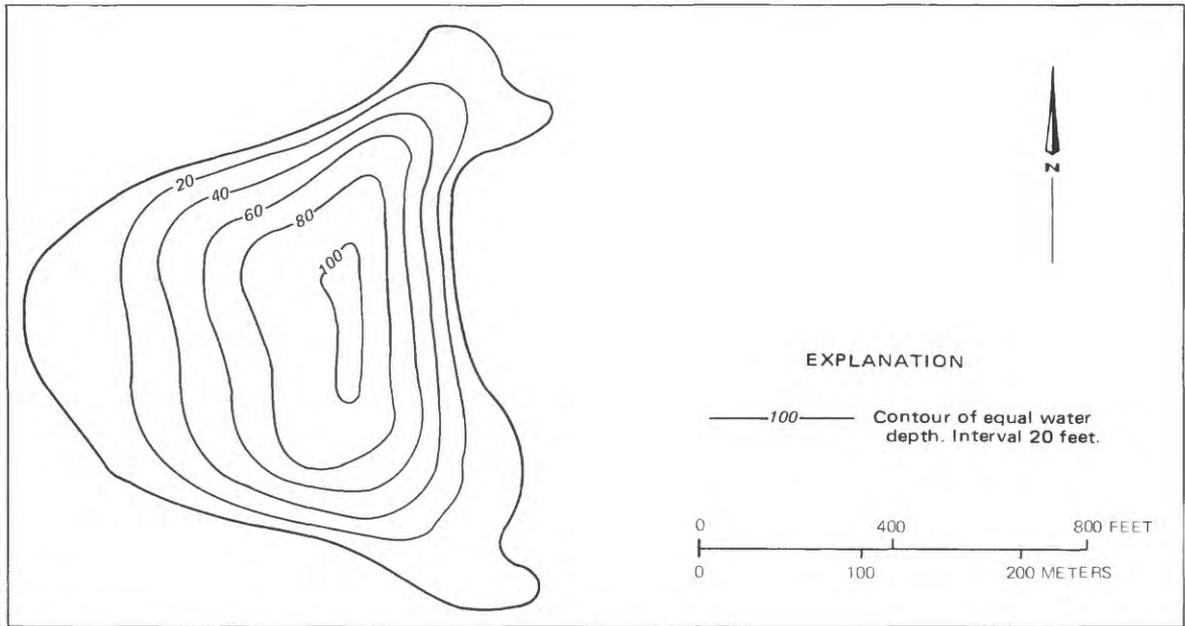
Figure 10. – Bathymetric map of Carver Lake, August 12, 1986.

A survey of Carver Lake showed the maximum depth to be 101 feet. A bathymetric map made from this survey is shown in figure 10. The lake has a surface area of 15.4 acres and a volume of 740 acre-ft. The crew making the survey, while on the lake, experienced the thrill of riding a 6-inch wave created from snow calving from the adjacent field (fig. 11). This minor surge probably created an instantaneous peak of about 10  $\text{ft}^3/\text{s}$  at the outlet. Assuming that a large section of rock or ice were to "splash" into the lake and create a 10-foot wave, the instantaneous peak would then be about 4,000  $\text{ft}^3/\text{s}$ --a discharge sufficiently large to begin erosion of the channel and breach the moraine.

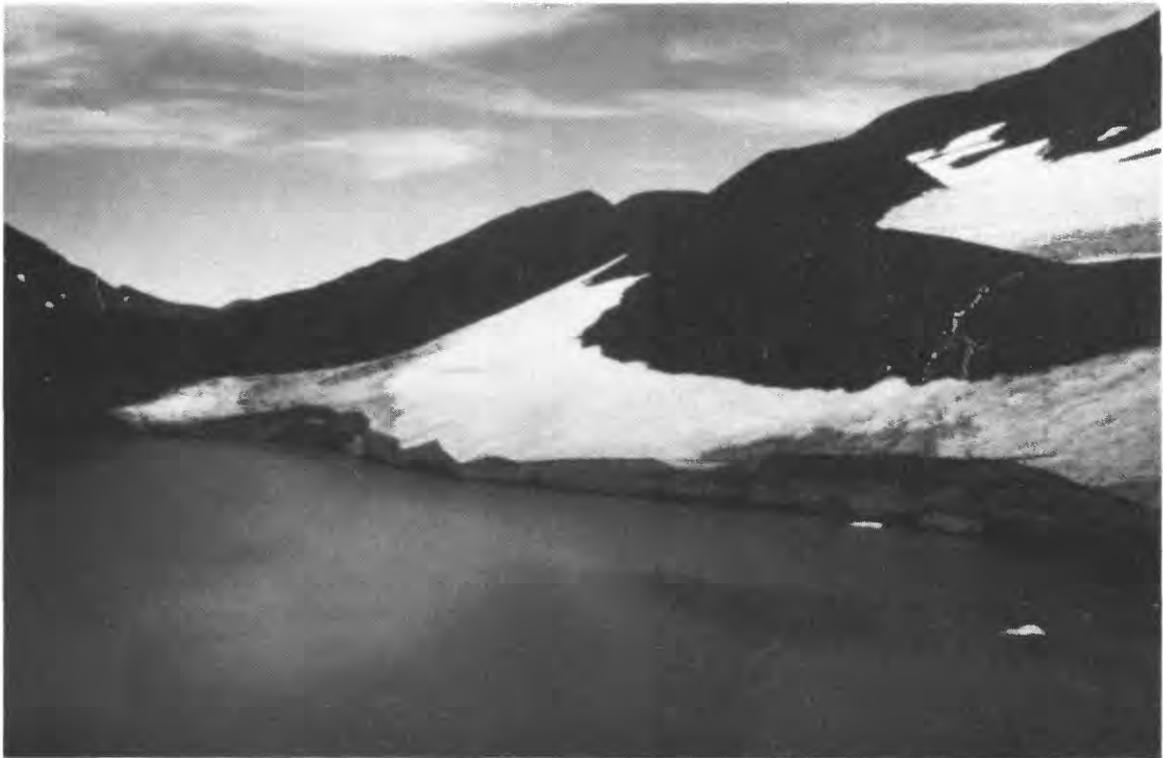
Figure 11. – Snowfield on southwest shore of Carver Lake. Note icefall at lower right of photo, August 31, 1986.  
(Photo courtesy U.S. Forest Service)

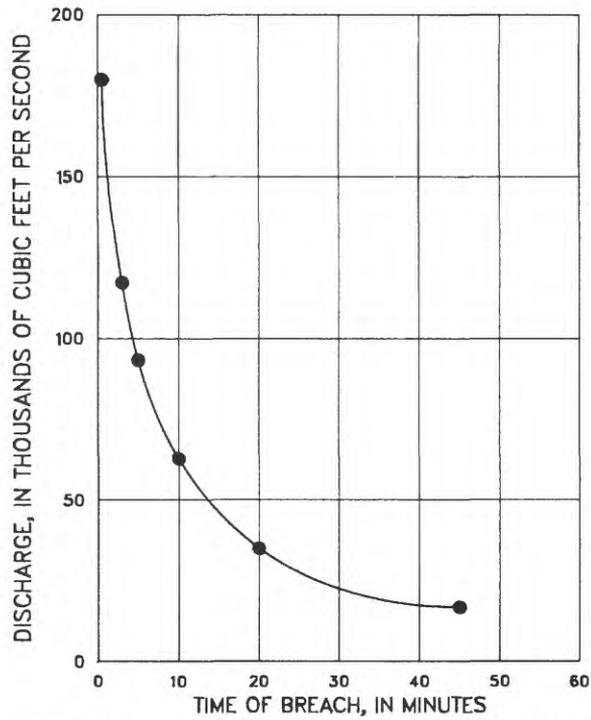
Figure 12. – Peak discharges from hypothetical breach for various times to maximum breach (for a breach geometry with 1:1 side slopes and 10 foot bottom width).

The National Weather Service model DAMBRK by Fread (1980) was used to simulate a number of breach scenarios to identify the sensitivity of the authors' assumptions. For all scenarios, a breach side slope of 1:1 with a bottom width of 10 feet was assumed. How the outflow peak discharge varied with time of breach development over the maximum depth of breach (assumed to be 80 feet) is shown in figure 12. Figure 13 shows how different breach depths affected the peak discharge for a 3-minute time-to-maximum breach. Breach volumes were included with the volume of the lake for simulation purposes. The maximum breach volume totaled less than 10 percent of the total volume.

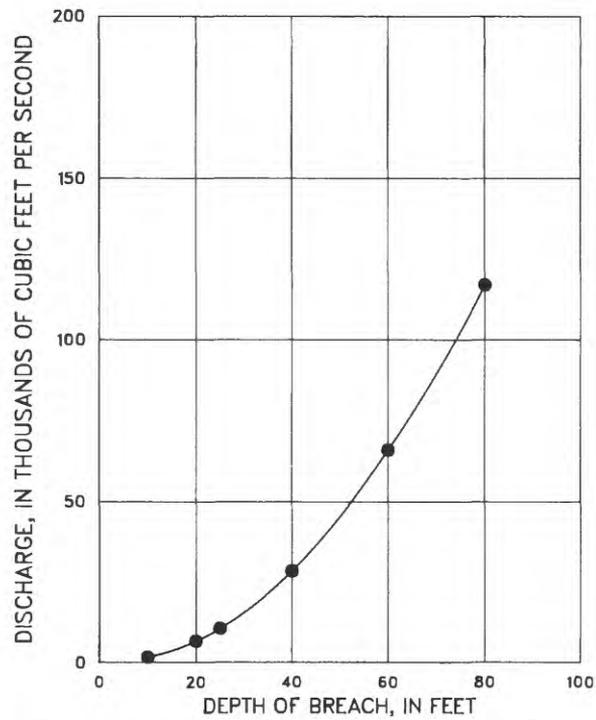
Figure 13. – Peak discharges from hypothetical breach for various depths in a maximum breach time of three minutes (for a geometry breach with 1:1 side slopes and 10 foot bottom width).

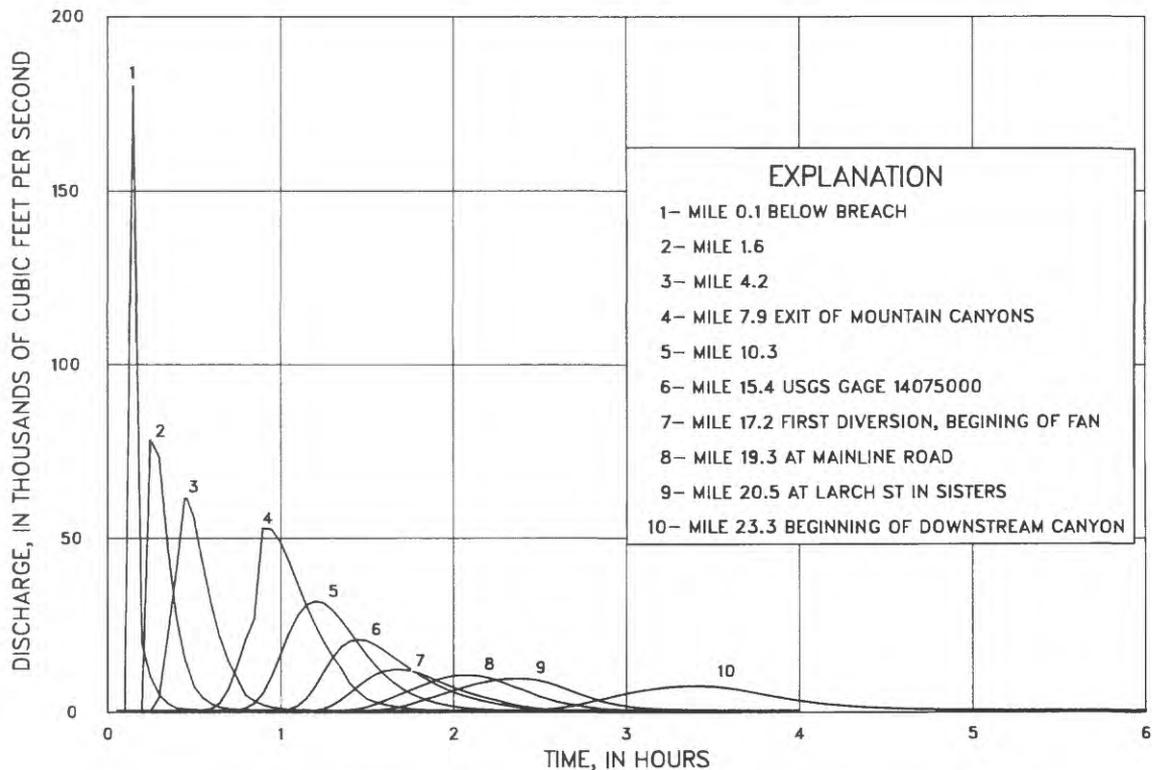
Figure 14. – Hypothetical discharge hydrographs at selected cross sections on Squaw Creek showing progression of flood downstream.

For the most extreme scenario, a peak discharge of 180,000 ft<sup>3</sup>/s, with a volume of 810 acre-ft, is used as the starting hydrograph. The model was stopped and additional volumes added to simulate bulking at river miles 0.5, 1.6, 4.2, and 7.9, on the rising limb and on one-third of the receding limb of the hydrograph. The total lake volume of 740 acre-ft was doubled by mile 8. By the end of this segment, the peak had increased in volume but had attenuated to 53,000 ft<sup>3</sup>/s (fig. 14). The peak had taken 0.9 hours to reach this location. For the next extreme scenario, a peak discharge of 120,000 ft<sup>3</sup>/s, with a volume of 810 acre-ft, was used as the starting hydrograph. Similar bulking techniques were applied, and the resulting peak downstream attenuated to 43,000 ft<sup>3</sup>/s, arriving in 1.0 hours. For the least extreme scenario, a peak discharge of 11,000 ft<sup>3</sup>/s, with a volume of 750 acre-ft, was used to define a downstream hydrograph with a peak of 25,000 ft<sup>3</sup>/s in 1.3 hours. (If these assumptions are reasonable, bulking actually increased the least extreme scenario peak to a discharge larger than the starting peak discharge.)

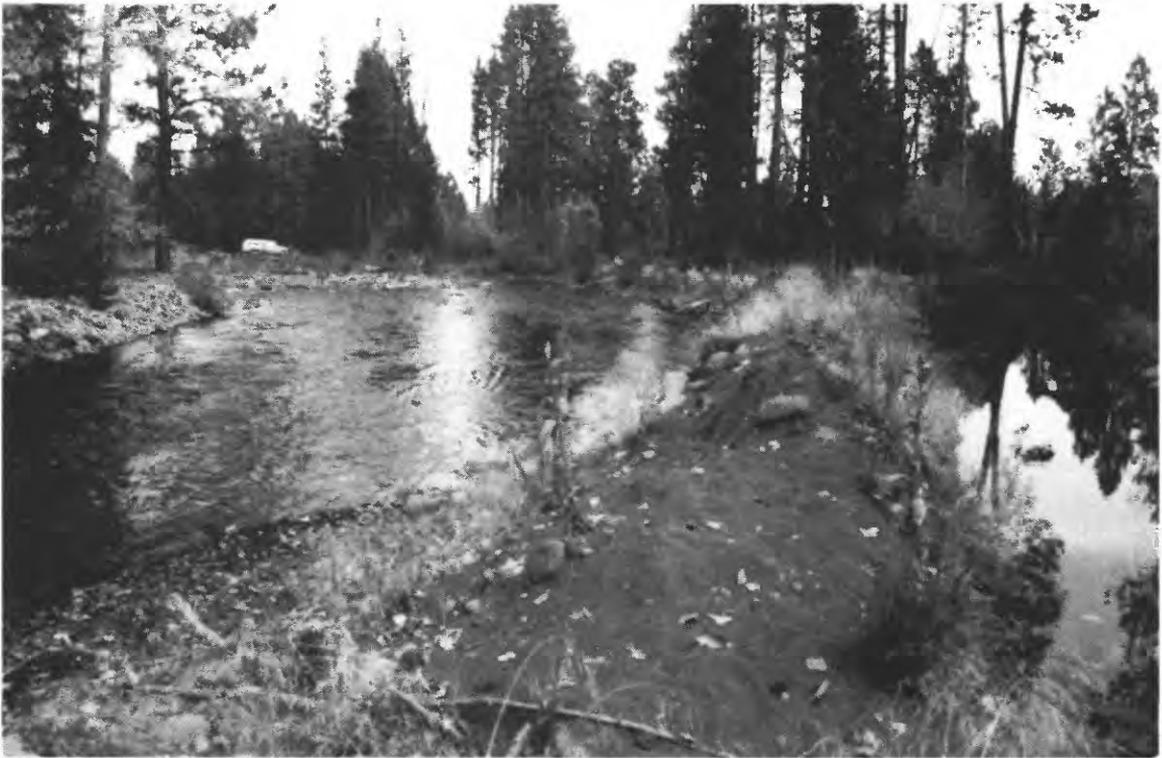
Figure 15. – Squaw Creek channel at 17.2 miles downstream of Carver Lake. A large magnitude flood could easily flow straight ahead through the ponderosa pines (just right of vehicle) in an old abandoned stream channel. October 1986.

At mile 17.2, an old diversion set in the channel diverts flow down an abandoned stream channel (fig. 15). At this location, flow in Squaw Creek follows a tight curve to the left; considerable flow could conceivably be diverted down the abandoned channel. For modeling purposes, a maximum estimate is assumed for each route: a maximum of 75 percent of the flow is assumed as a worse case, to follow the Squaw Creek channel and a maximum of 50 percent (assumed worse case) to be diverted towards the abandoned channel. It was also assumed that the flows would never coalesce. At mile 17.9 along the abandoned channel, the flow again has alternatives: across Squaw Creek Ditch or down the Ditch. Because the Ditch follows a side slope, the left bank over the levee is downhill. Therefore, the flow in the ditch was limited to full capacity (approximately 1,000 ft<sup>3</sup>/s) and the remainder of the flow was allowed to follow the approximate path of the abandoned channel. Because the abandoned channel has a small capacity, flows would diffuse and coalesce on the debris fan and would attenuate rapidly.

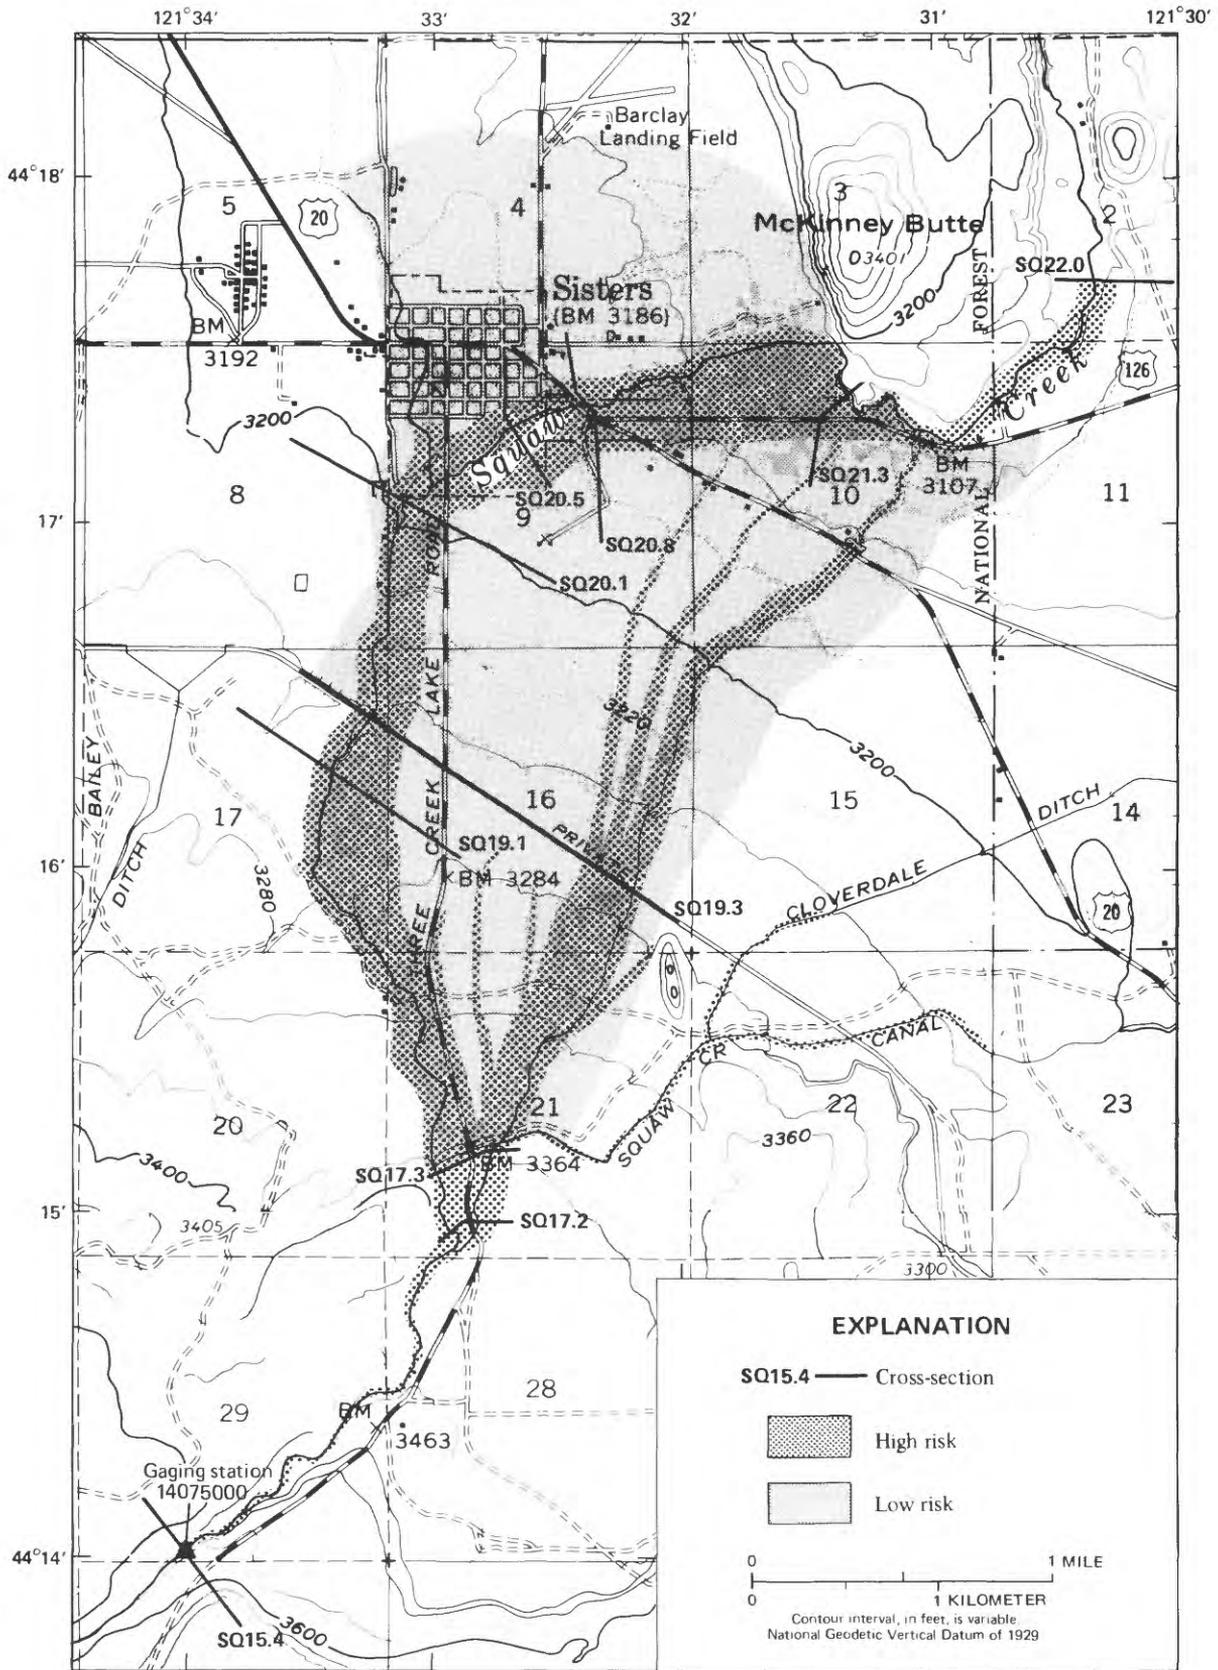
Figure 16. – Inundated area near Sisters from hypothetical breakout (most extreme scenario) showing high and low risk areas.

If no damming occurs along the main stem, inundation along Squaw Creek in the alluvial fan area would be somewhat (but not appreciably) greater than the 500-year frequency meteorological flood predicted by the COE (1978). Damming at any of the ditch diversion structures (fig. 17), road crossings, or sharp stream bends could cause local flooding beyond what is shown in figure 16 as most probable flooding. As the hypothetical extreme peak flow reaches Sisters, velocities would still be high (maximum 14 ft/s) and would be more than enough to create new channels beyond the most probable flow route. This is especially likely at mile 20.2, where a small distributary diverts water along Ash Street in Sisters. Figures 18 and 19 are photographs from a COE 1978 report. The probable flood elevations from the most extreme moraine-dam failures scenario are shown in comparison to probable 100- and 500-year- frequency events.

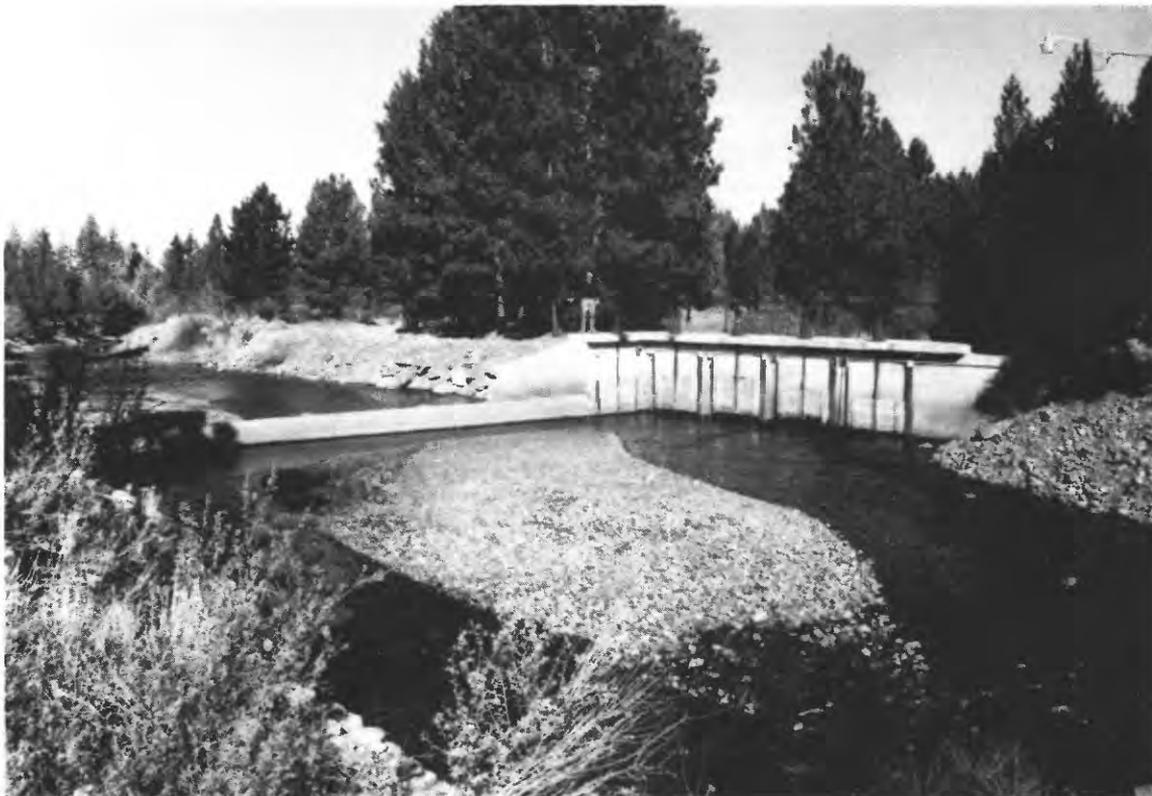
Figure 17. - Squaw Creek at Squaw Creek ditch diversion. A possible place for damming because of constriction. Note the flat topography beyond the channel incision, October 1986.

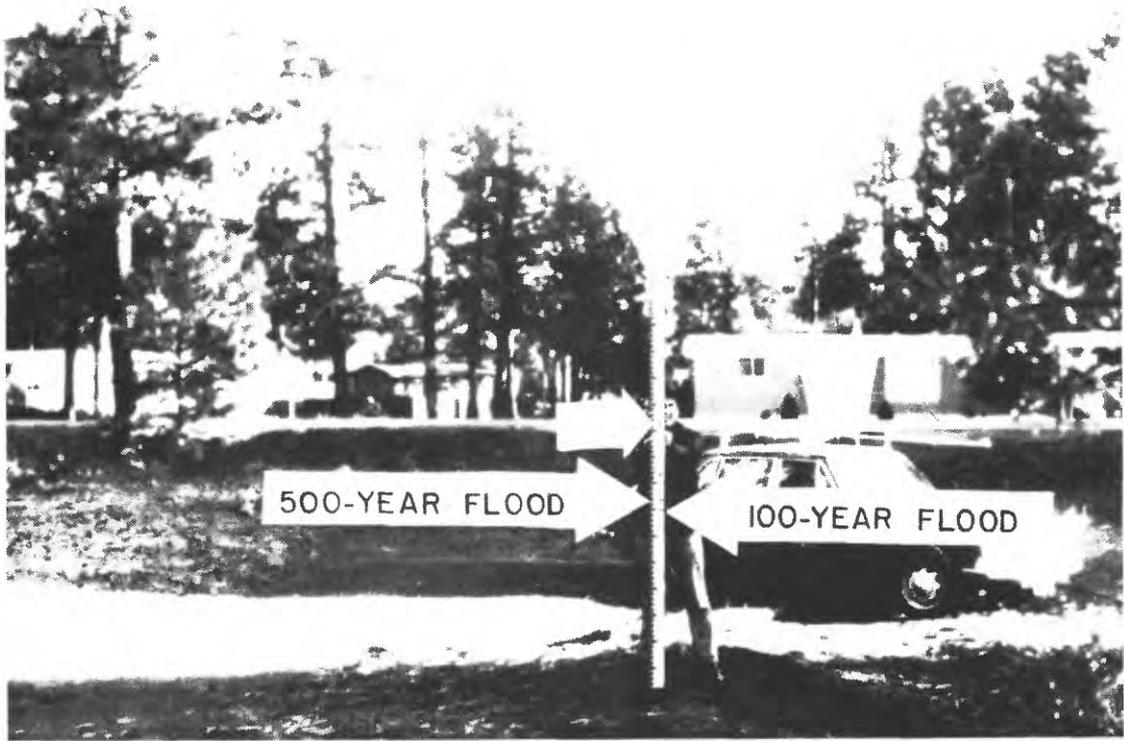
Figure 18. – Potential flood elevations in Sisters near Elm Street (Three Creek Lake Road) bridge. Small arrow shows estimated elevation of most extreme flood caused by Carver Lake breakout. The 100- and 500-year flood elevations are from U.S. Army Corps of Engineers (1978).

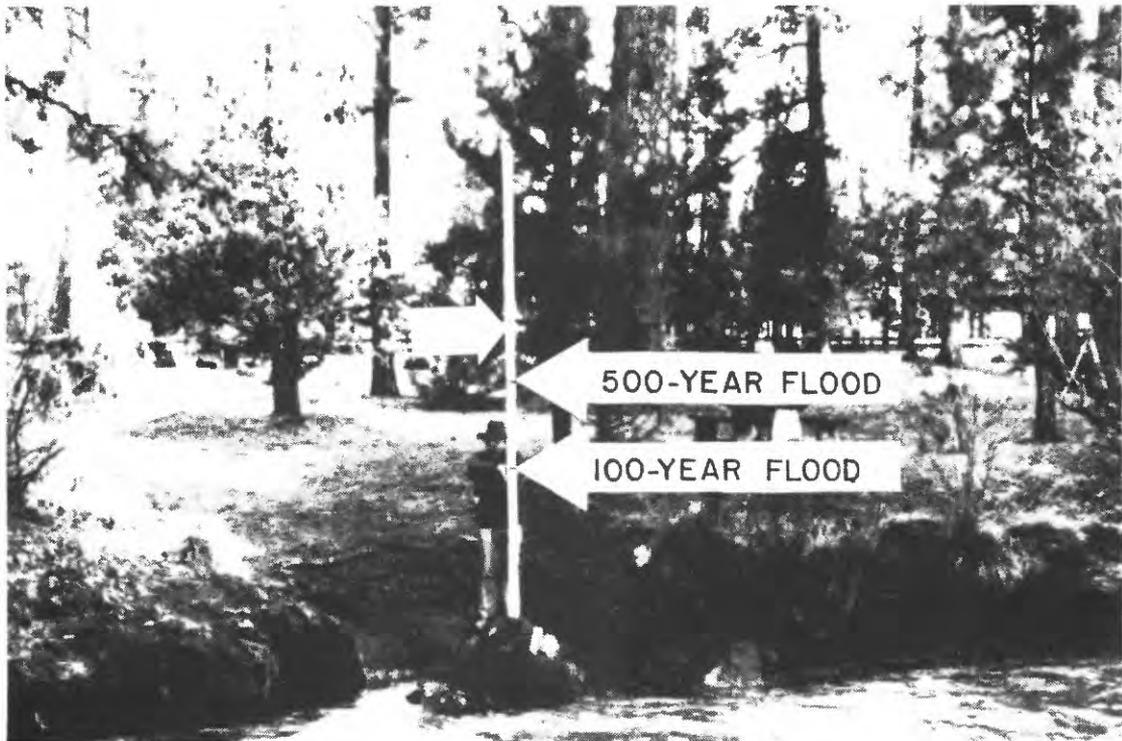
Figure 19. – Potential flood elevation in Sisters City Park. Small arrow shows estimated elevation of most extreme flood caused by Carver Lake breakout. The 100- and 500-year flood elevations are from the U.S. Army Corps of Engineers (1978).
