# HYDROLOGIC HAZARDS ALONG SQUAW CREEK FROM A HYPOTHETICAL FAILURE OF THE GLACIAL MORaine IMPOUNDING CARVER LAKE NEAR SISTERS, OREGON

U.S. GEOLOGICAL SURVEY

Open-File Report 87-41

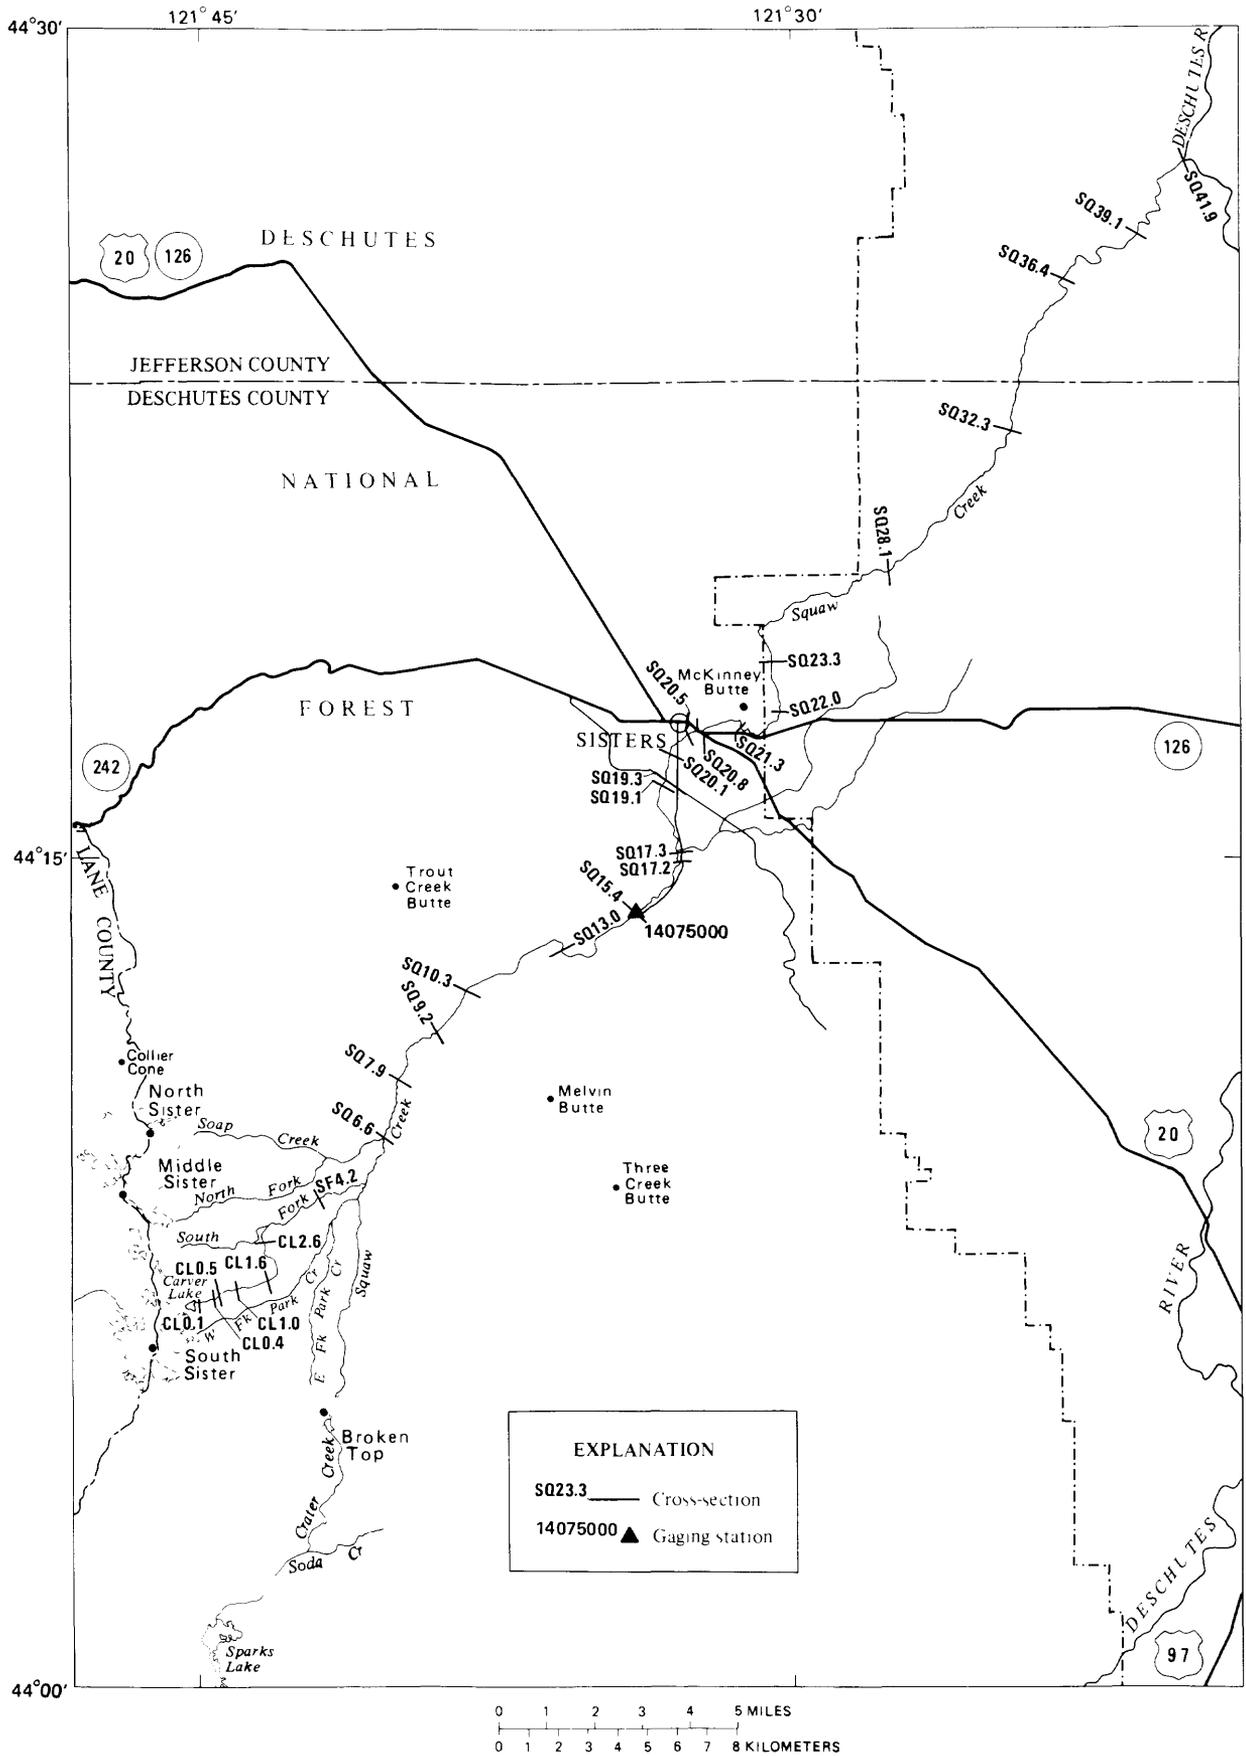
Locations of cross-sections downstream of Carver Lake.
