U.S. GEOLOGICAL SURVEY

An Atlas of Facies Microfabrics of the Bootlegger Cove Formation
Using the Scanning Electron Microscope

Revised 10 November 1986

Open-File Report 87-60

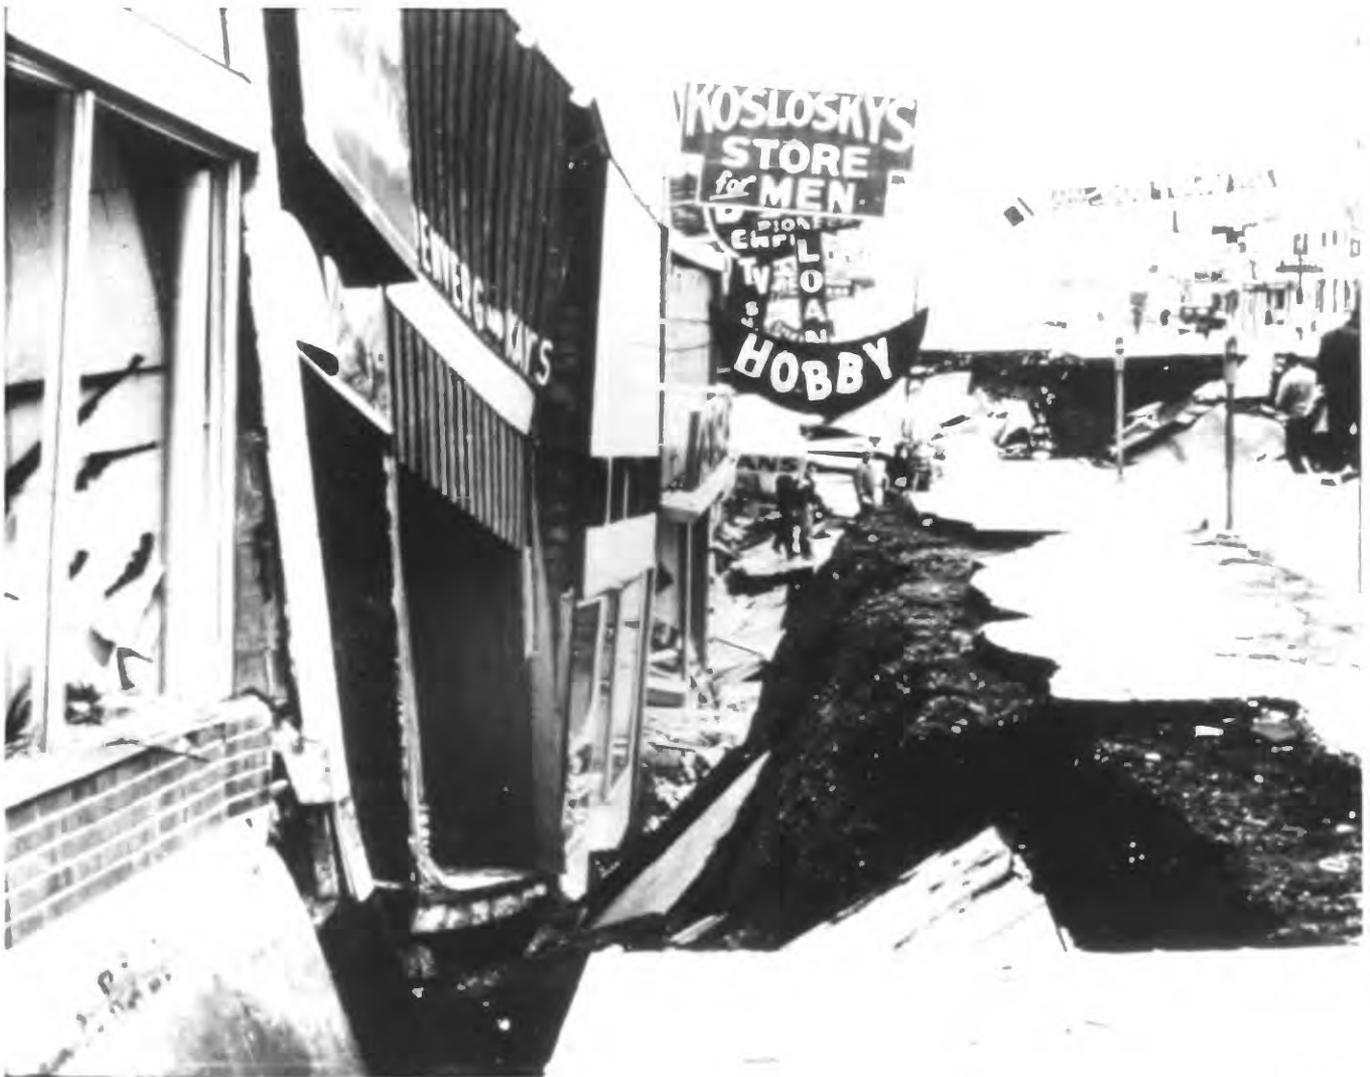
Figure 1. Fourth Avenue landslide scarp immediately after March 27, 1964 Earthquake. View looking east toward intersection at 4th Avenue and "A" Street. Note approximately 3 m of vertical displacement. Sample locality for specimens used in this report approximately four blocks from this picture. (Photograph from NOAA-EDIS Files)

Among the numerous phenomena initiated by the 1964 Prince William Sound Earthquake, the several catastrophic landslides in the Anchorage area (fig. 1) are among the most commonly cited. In the 20 years subsequent to that earthquake, these landslides still prevail as a major concern to geologists, engineers, and the general public. Serious ramifications result if similar slides are to occur in the future in a city which is now far more urbanized than in 1964.

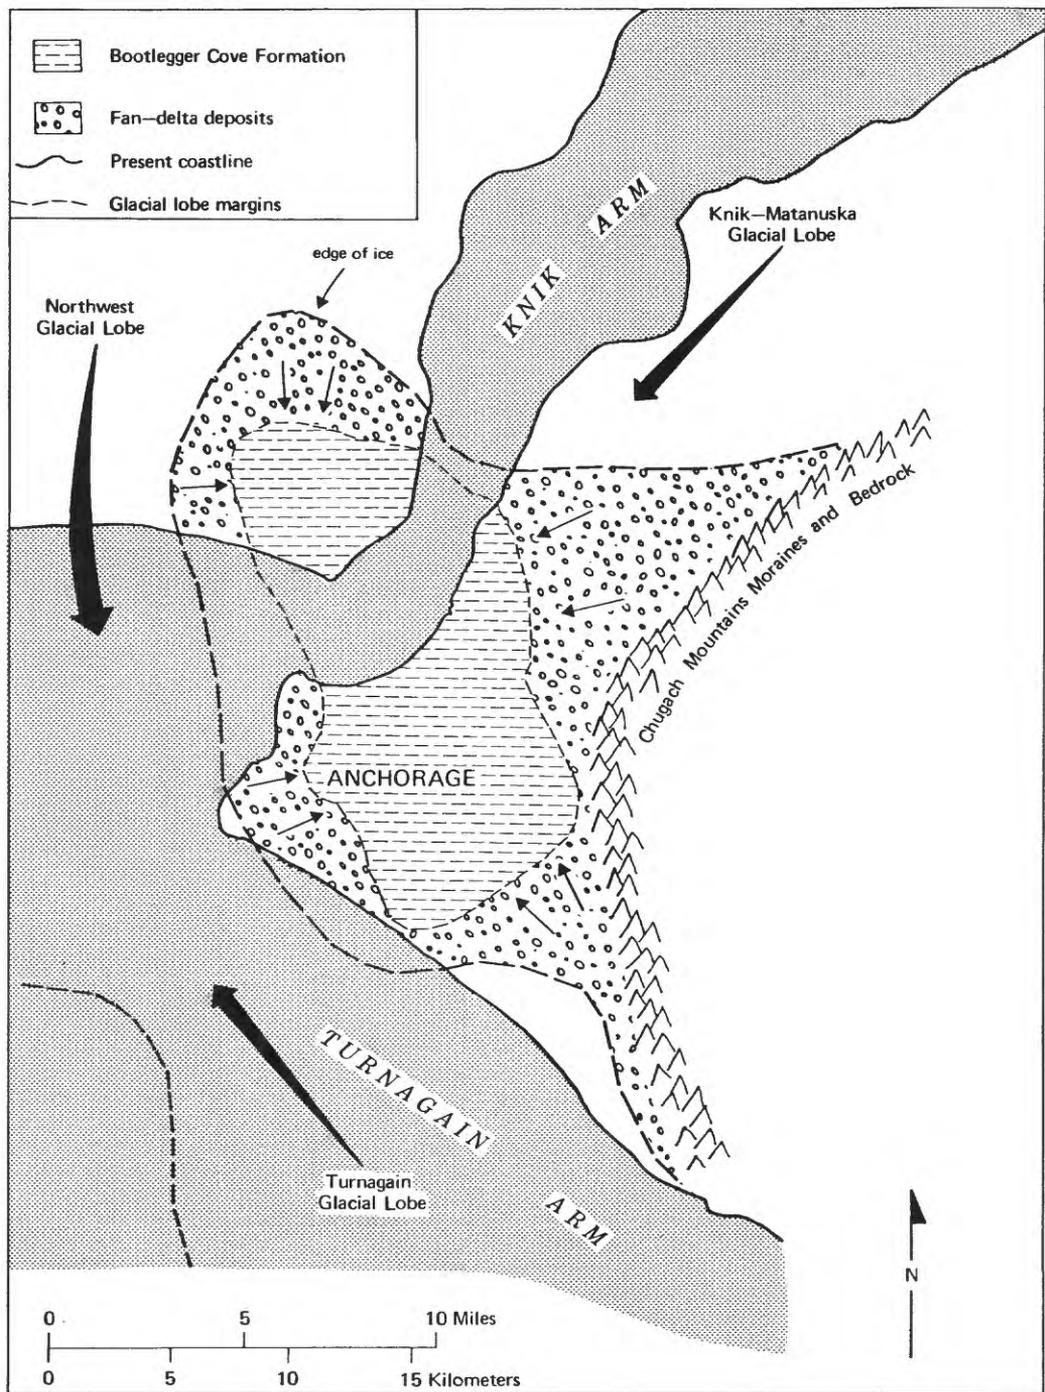
Figure 2. Idealized map showing the relationship of major glacial ice-lobes that surrounded the Bootlegger Cove Formation depositional basin at about 14,000 years ago. Bold arrows show the general direction of ice flow; light arrows indicate the depositional trends of sediment derived from these lobes into the basin. The fan delta deposits graded laterally into the finer deposits in the center of the basin.

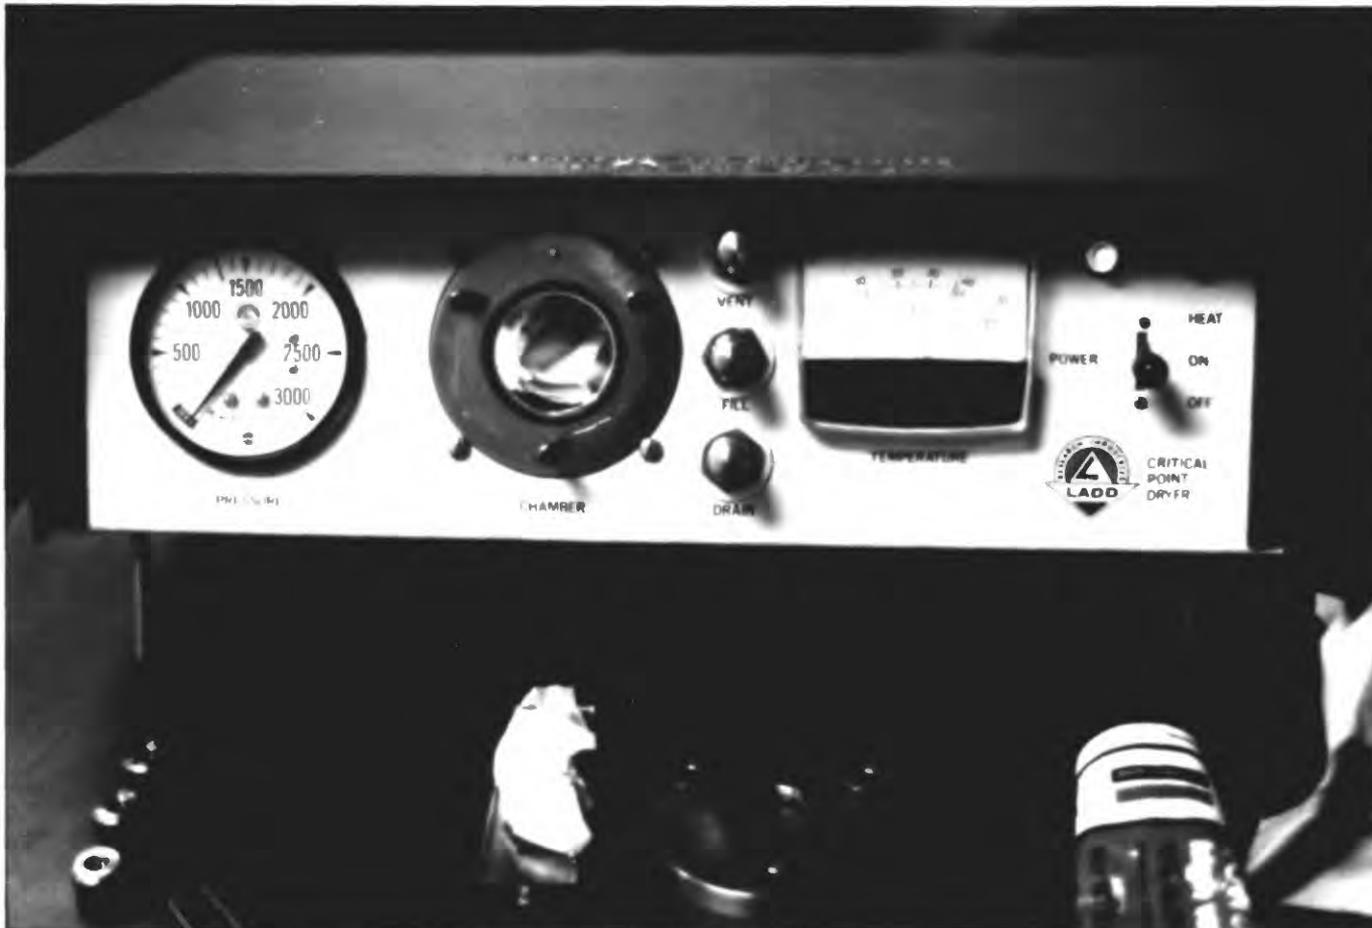
Figure 3. Ladd Critical Point Dryer, a pressure-temperature bomb used for Freon 13 phase conversion. Note sample in chamber prior to sealing with faceplate in foreground.

The final fluid exchange from Freon TF to Freon 13 (monochlorotrifluoromethane) was accomplished in the Ladd Critical Point drying apparatus (fig. 3). This is a pressure-temperature bomb into which the Freon TF-saturated samples were introduced and sealed. The drying chamber was flooded with Freon 13 and the samples allowed to soak for 15 minutes. The chamber was drained and then refilled with Freon 13. With the transitional fluid replacement completed, temperature and pressure were elevated to and above the critical point for Freon 13. The system was held at 40°C for approximately 15 minutes, then a drain was partially opened to allow Freon 13 gas to be slowly tapped off. While maintaining the elevated temperature, all of the gas was thus evacuated from the chamber and totally dried samples resulted.

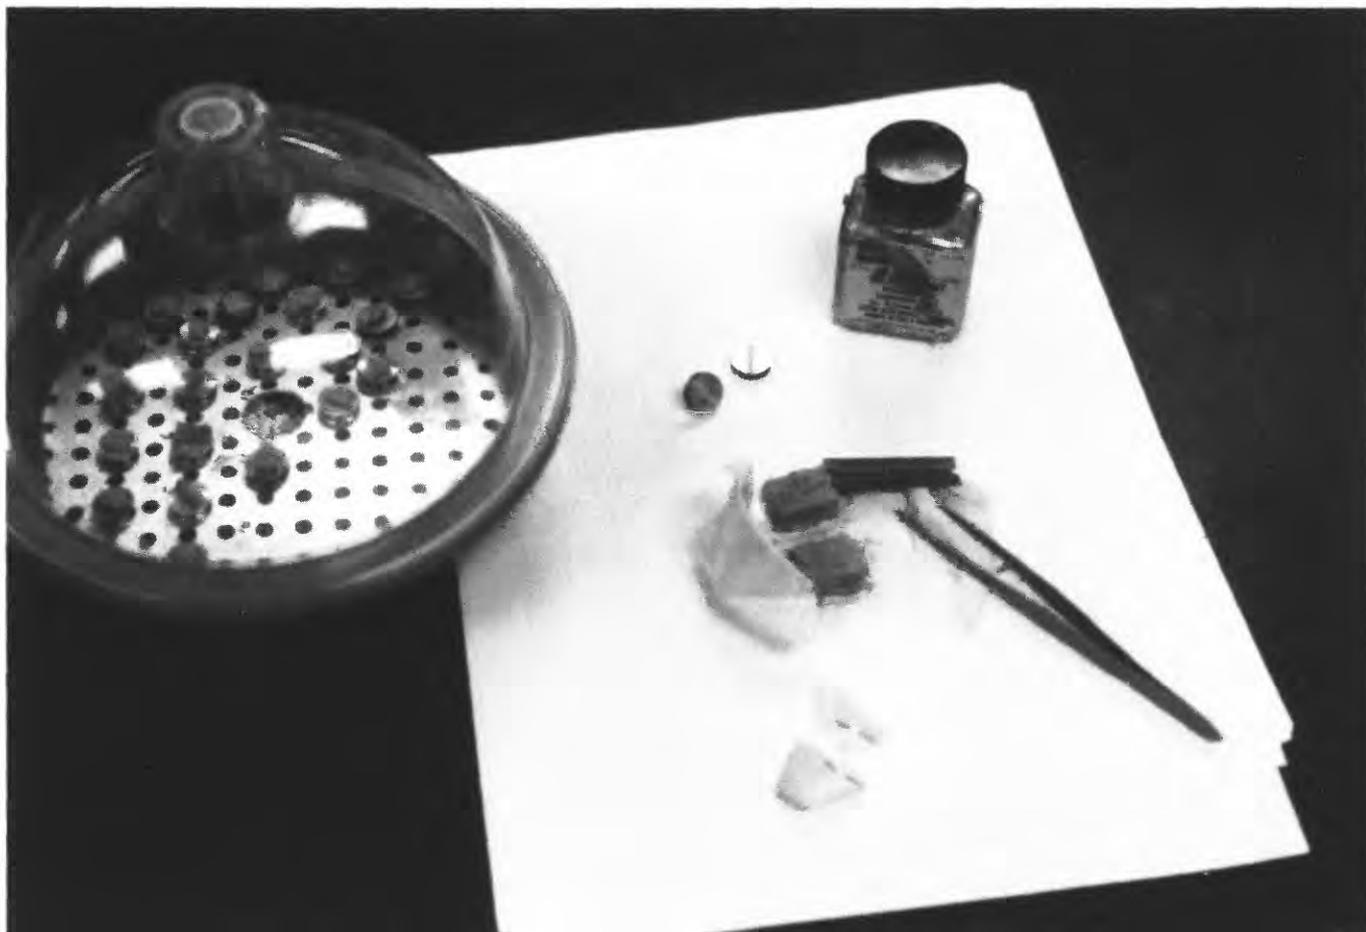
Figure 4. Preparation of sample for SEM after critical point drying. Split sample (center) will be trimmed and mounted on an alloy stub (top center) using silver paint. Prepared stubs are stored in desiccator until being plated with gold and palladium.

Using a razor blade, the dried samples were fractured along selected planes and then mounted on standard SEM stubs using silver paint as an

adhesive (fig. 4). Each sample was electrostatically cleaned to remove loose debris using the technique of Hulbert and Bennett (1975). The samples were then coated with gold-palladium in a Technics Hummer vacuum sputter coater for 5 minutes to provide a conductive surface for the SEM. A total of 73 stubs were thus produced from the two field localities.

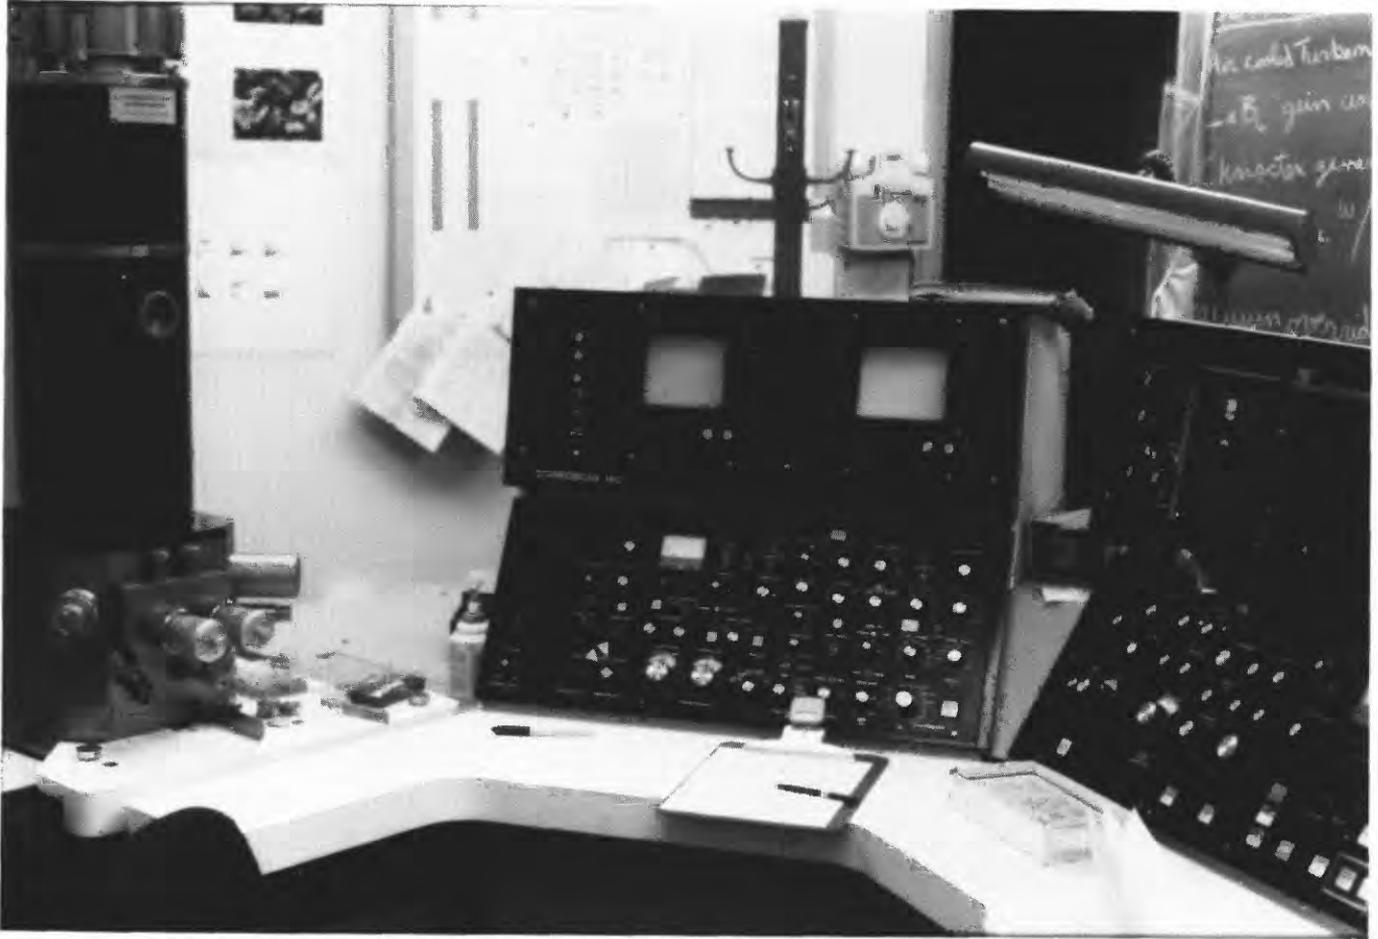
Figure 5. Cambridge Stereoscan 180 Scanning Electron Microscope, U.S. Geological Survey, Menlo Park, California.

The Cambridge Stereoscan 180 scanning electron microscope at the Office of the Chief Geologist, USGS, Menlo Park, California, was used for all examinations and photography (fig. 5). The system is interfaced with the energy dispersive X-ray analyzer (Edax 707B) which allows spot-checking of mineral grain composition within the plane of view (fig. 6).

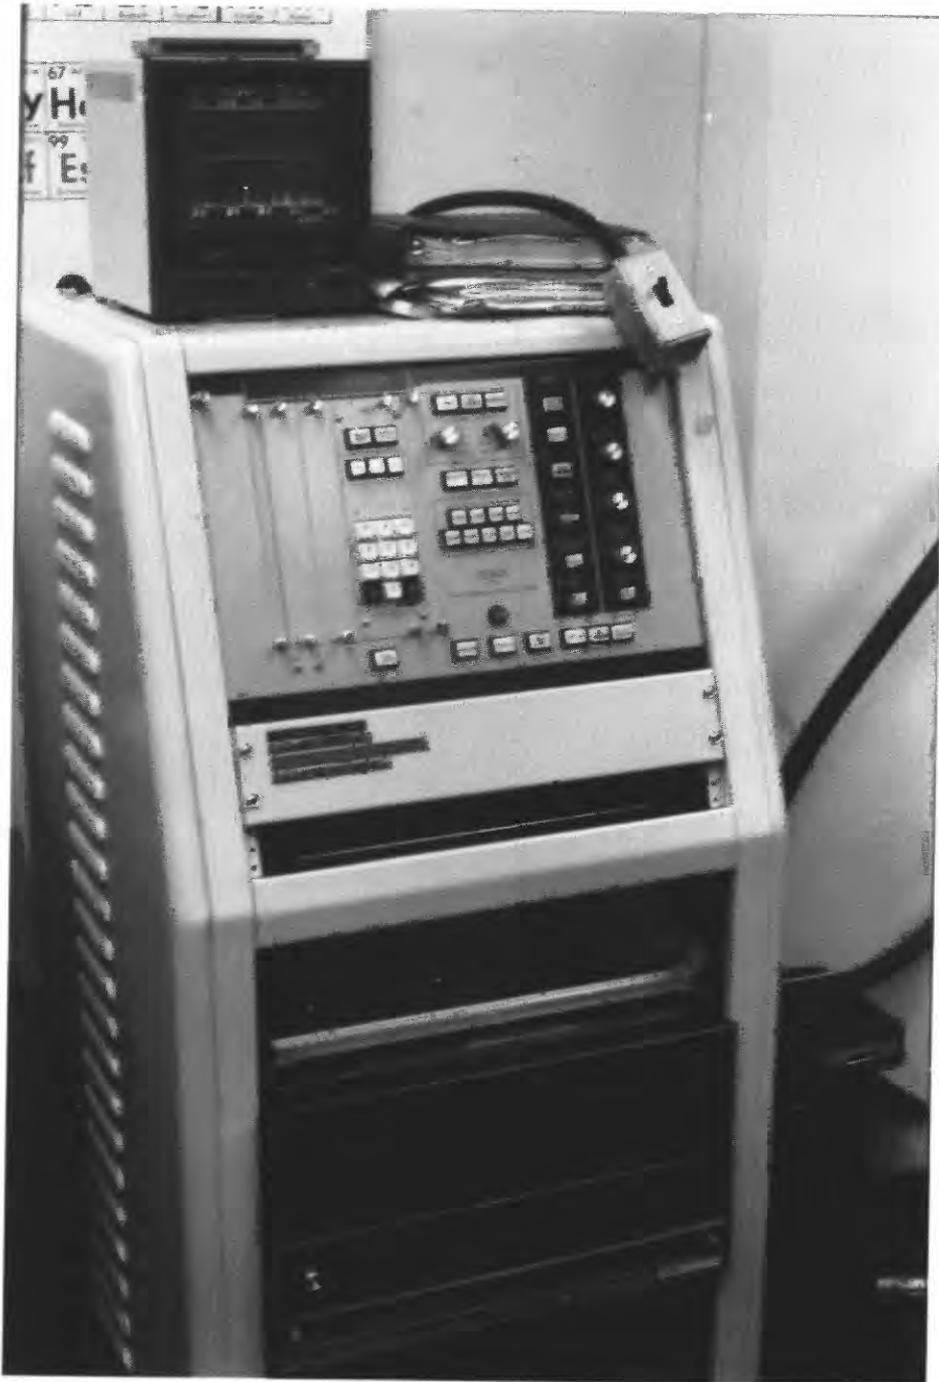
Figure 6. EDAX 707B energy dispersive X-ray analyzer used in routine composition analyses of mineral grains viewed by the linked SEM system.

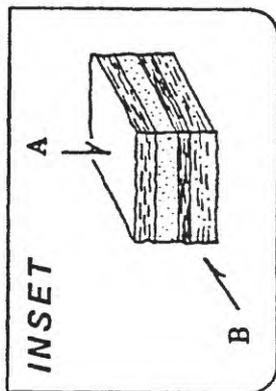
Figure 7. Orientation view; mag. = 3200X. Silt grain (s), clay grain (c), silt-clay assemblage (a), inter-assemblage void (rv), intra-assemblage void (av). Note clay grains clinging to the silt grains. Inset shows view orientation terminology used in the following figures. Direction "A" is a view normal to bedding planes; direction "B" is a view parallel to bedding planes.

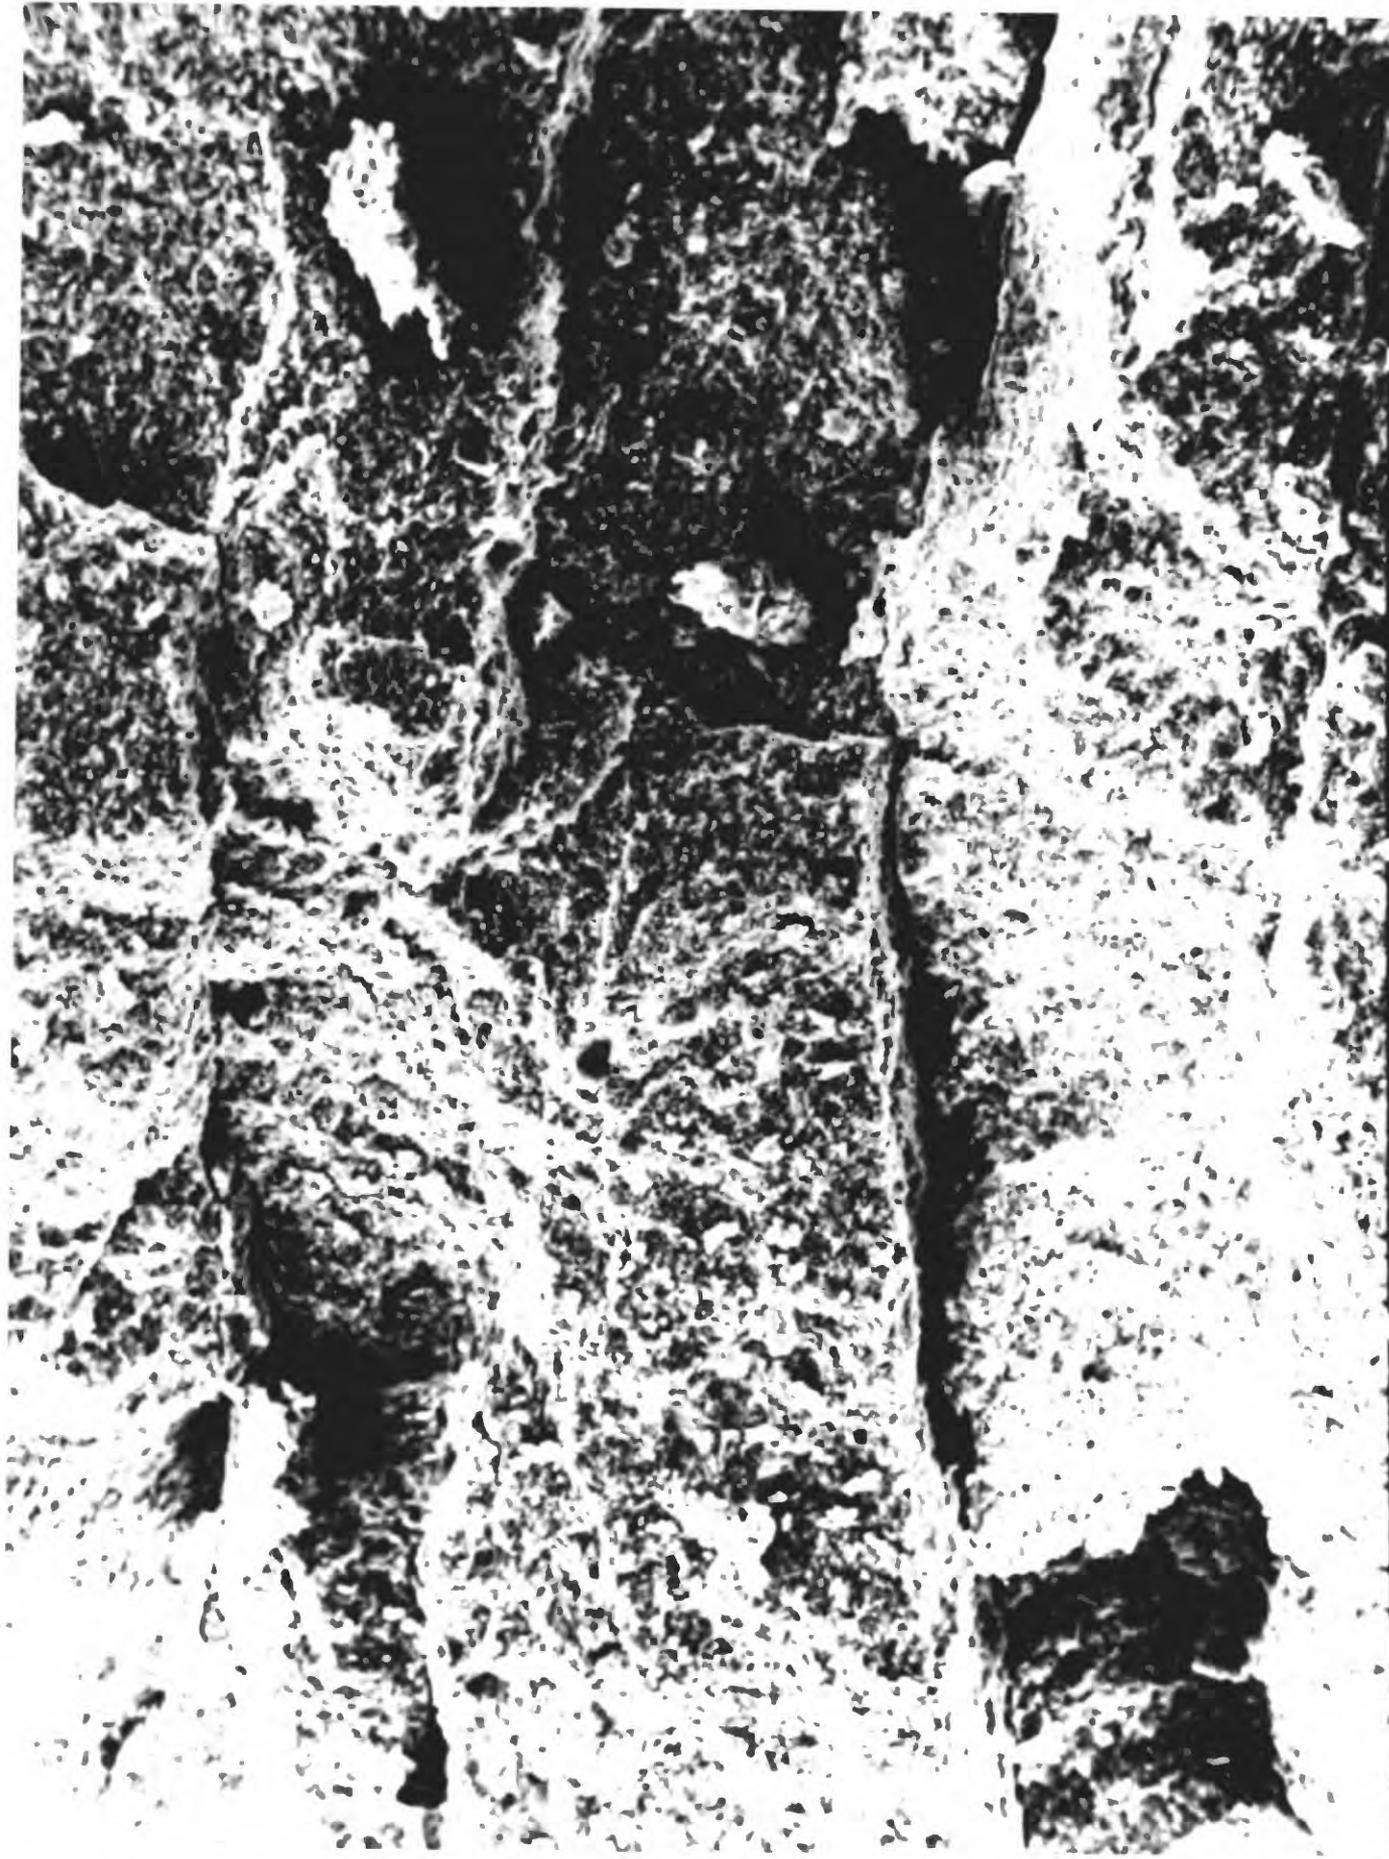
Figure 9. Facies F.IV, parallel to bedding planes, mag. = 36X. Low magnification view of low sensitivity sample shown at high magnification in figure 42. Compare to high sensitivity sample having thinner laminae but otherwise similar appearance (fig.8).

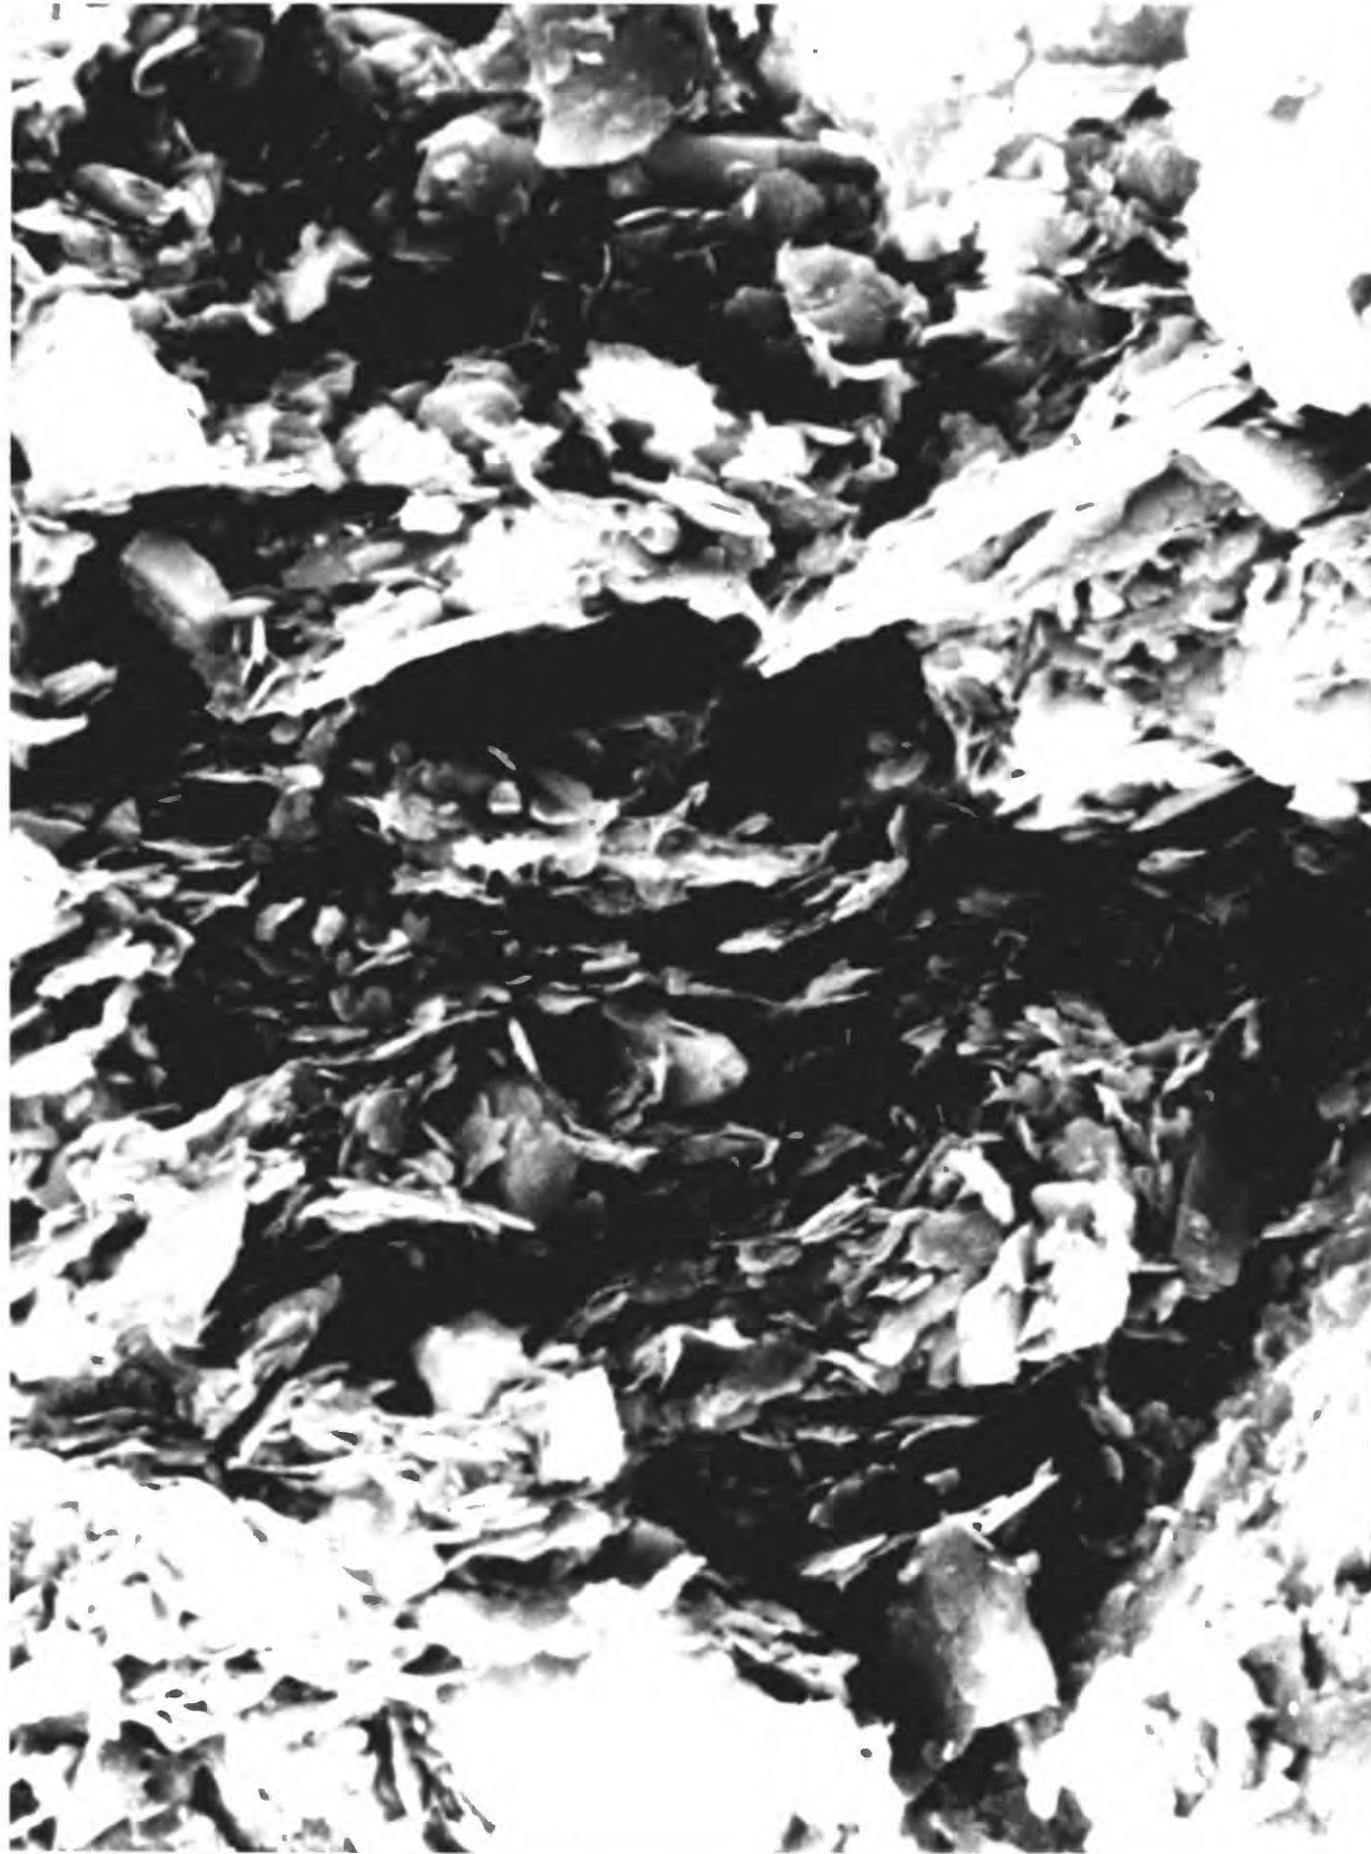
Figure 11. Facies I, normal to bedding plane, mag. = 9900X. Essentially all clay-size particles, most lying in plane of bedding. Compare to figure 20. Note limited assemblage development due to uniformity of particle sizes and parallel orientation of grains.

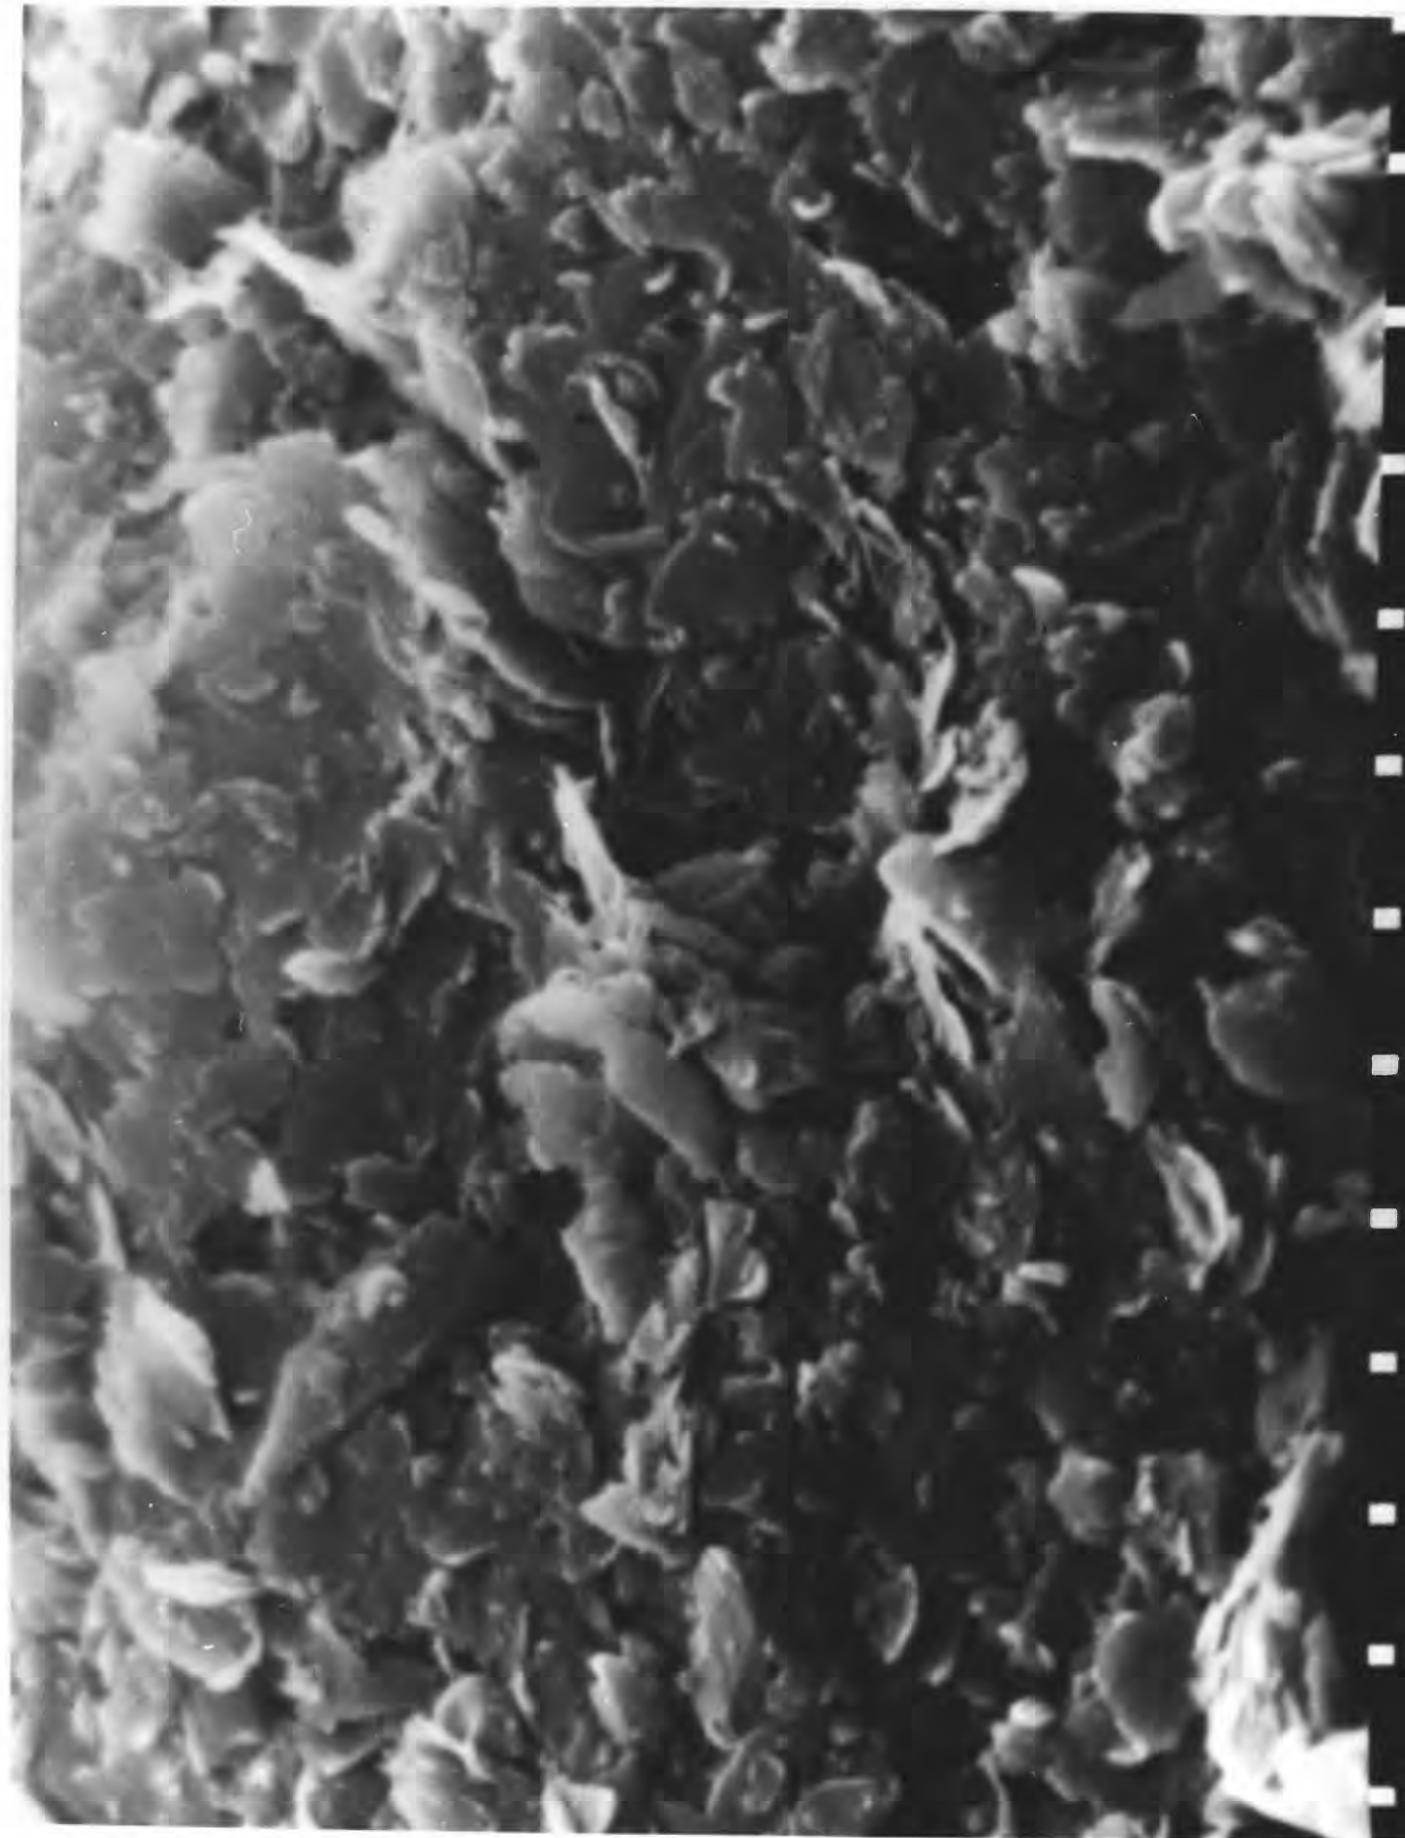
Figure 12. Facies F.II, parallel to bedding planes, mag. = 3300X. Bedding strikes top to bottom. Clay platelets in turbostratic arrangement having more intra-assemblage porosity around silt grains. Contrast with figure 10. This sample generally yielded low sensitivity.

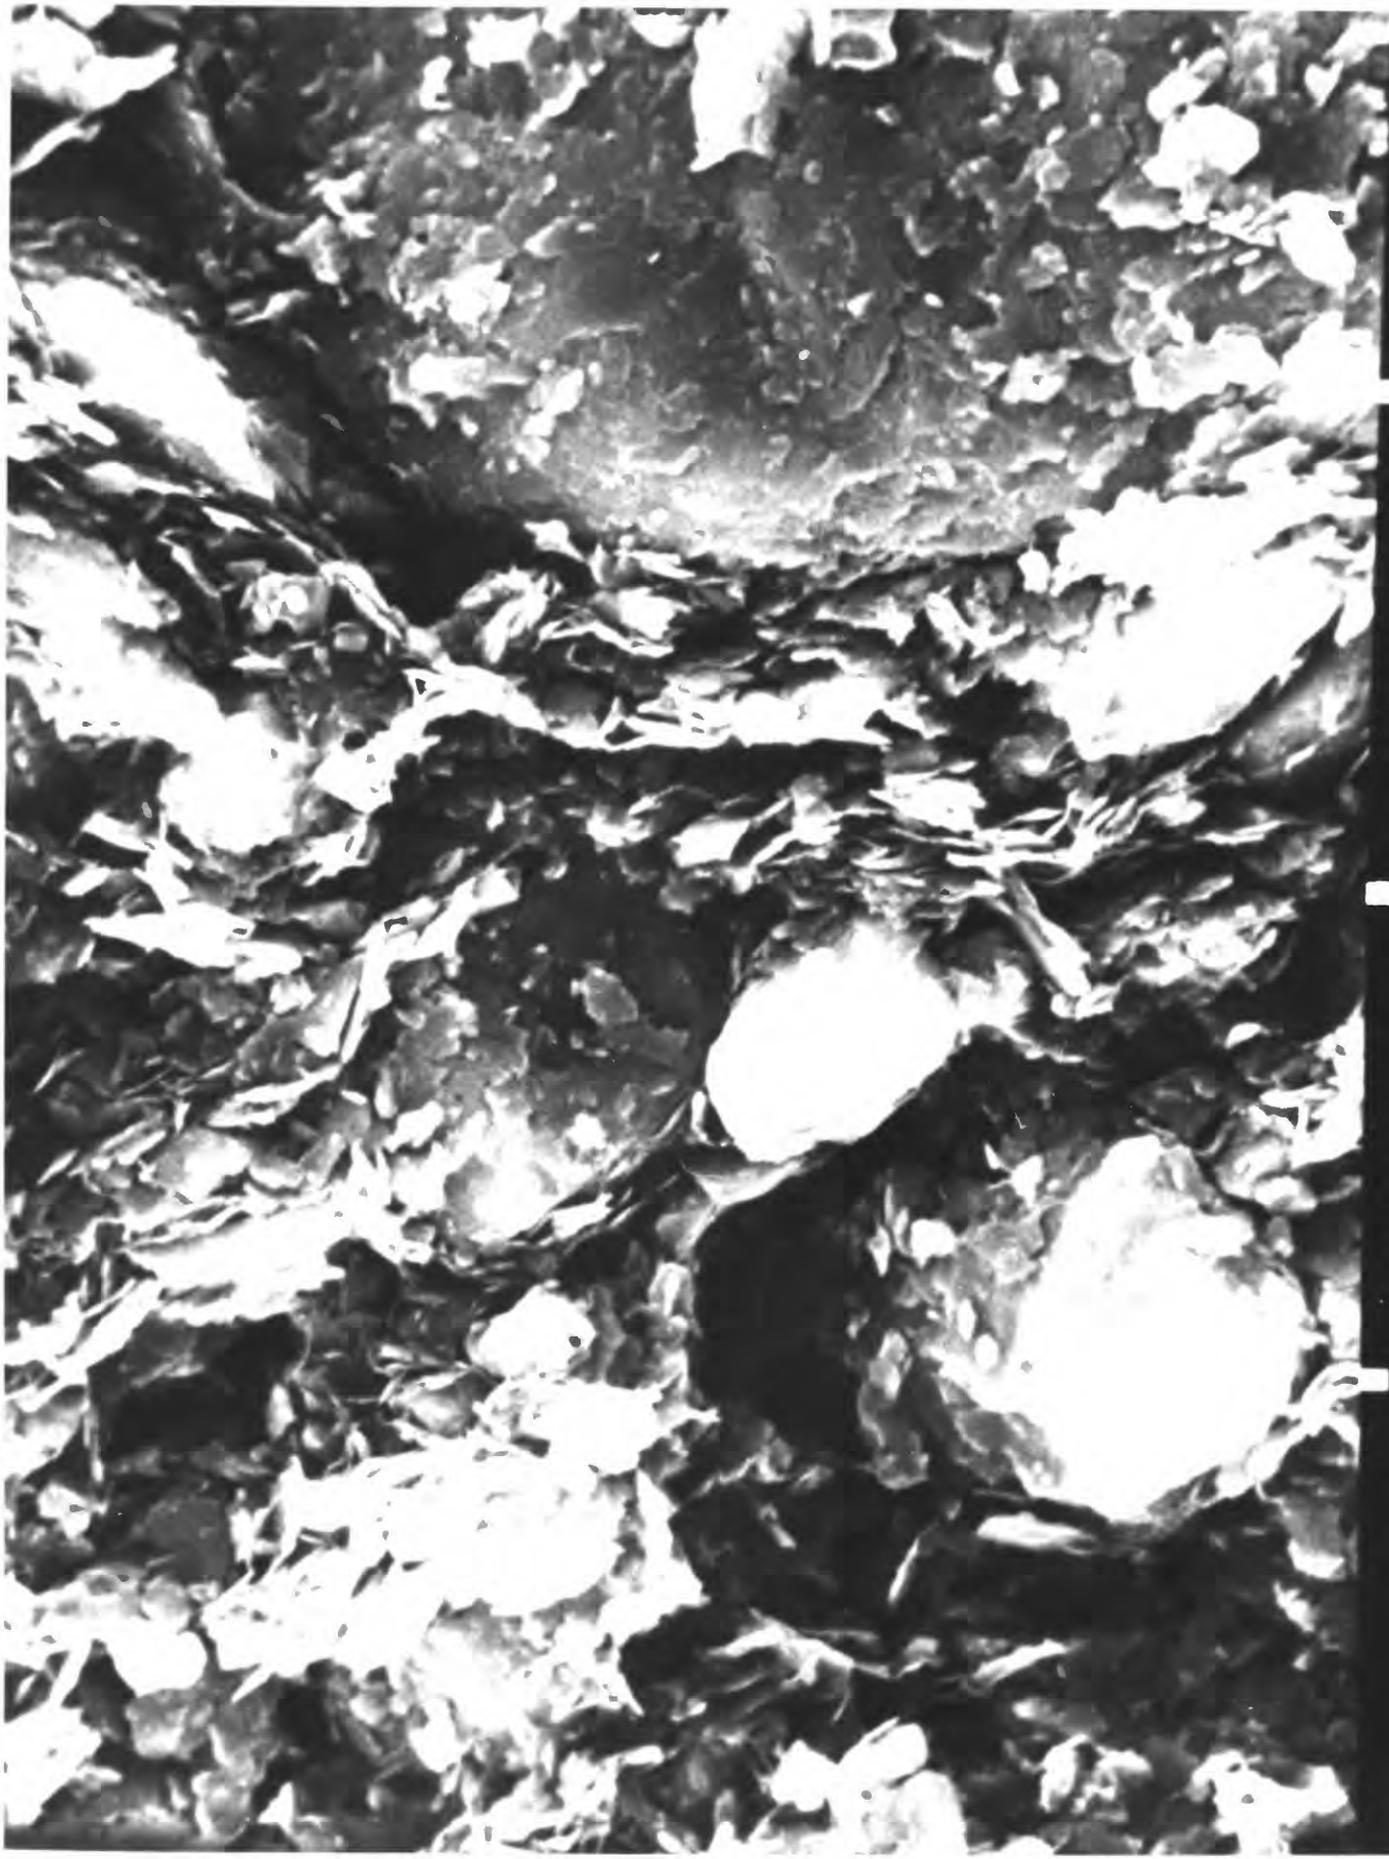
Figure 13. Facies F.II, parallel to bedding planes, mag. = 1010X. Bedding from upper left to lower right. Fully dispersed clay layers (df) interbedded with angular silt grains. Inter-assemblage voids (rv) predominate. Compare to partially flocculated fabric of figure 12.

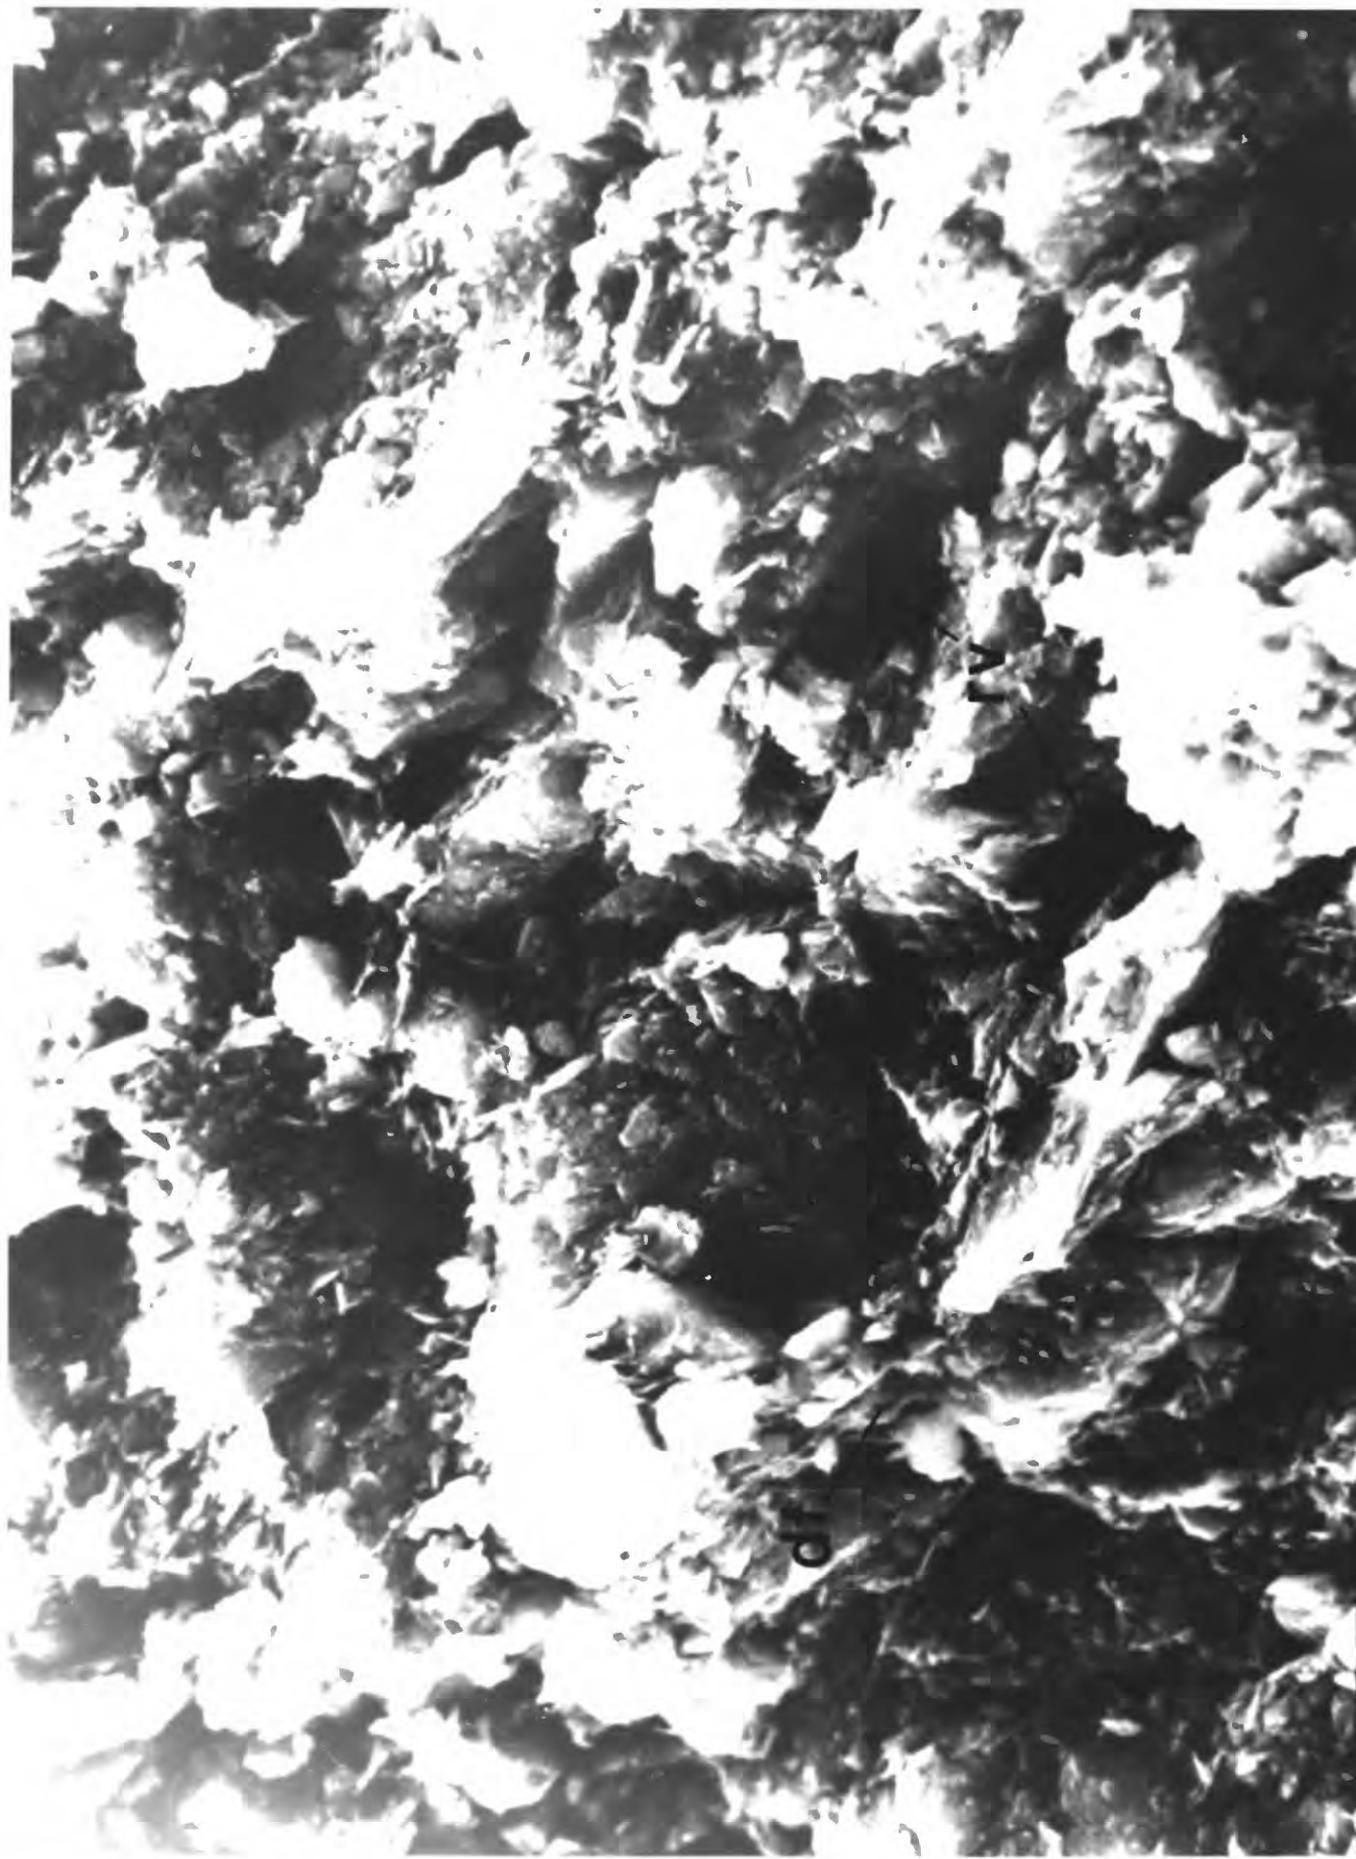
Figure 14. Facies F.II, normal to bedding planes, mag. = 5700X. Both silt (s) and clay (c) oriented in bedding plane. Inter-assemblage voids (rv) small and indistinct.
