U.S. GEOLOGICAL SURVEY

An Atlas of Facies Microfabrics of the Bootlegger Cove Formation
Using the Scanning Electron Microscope

Revised 10 November 1986

Open-File Report 87-60

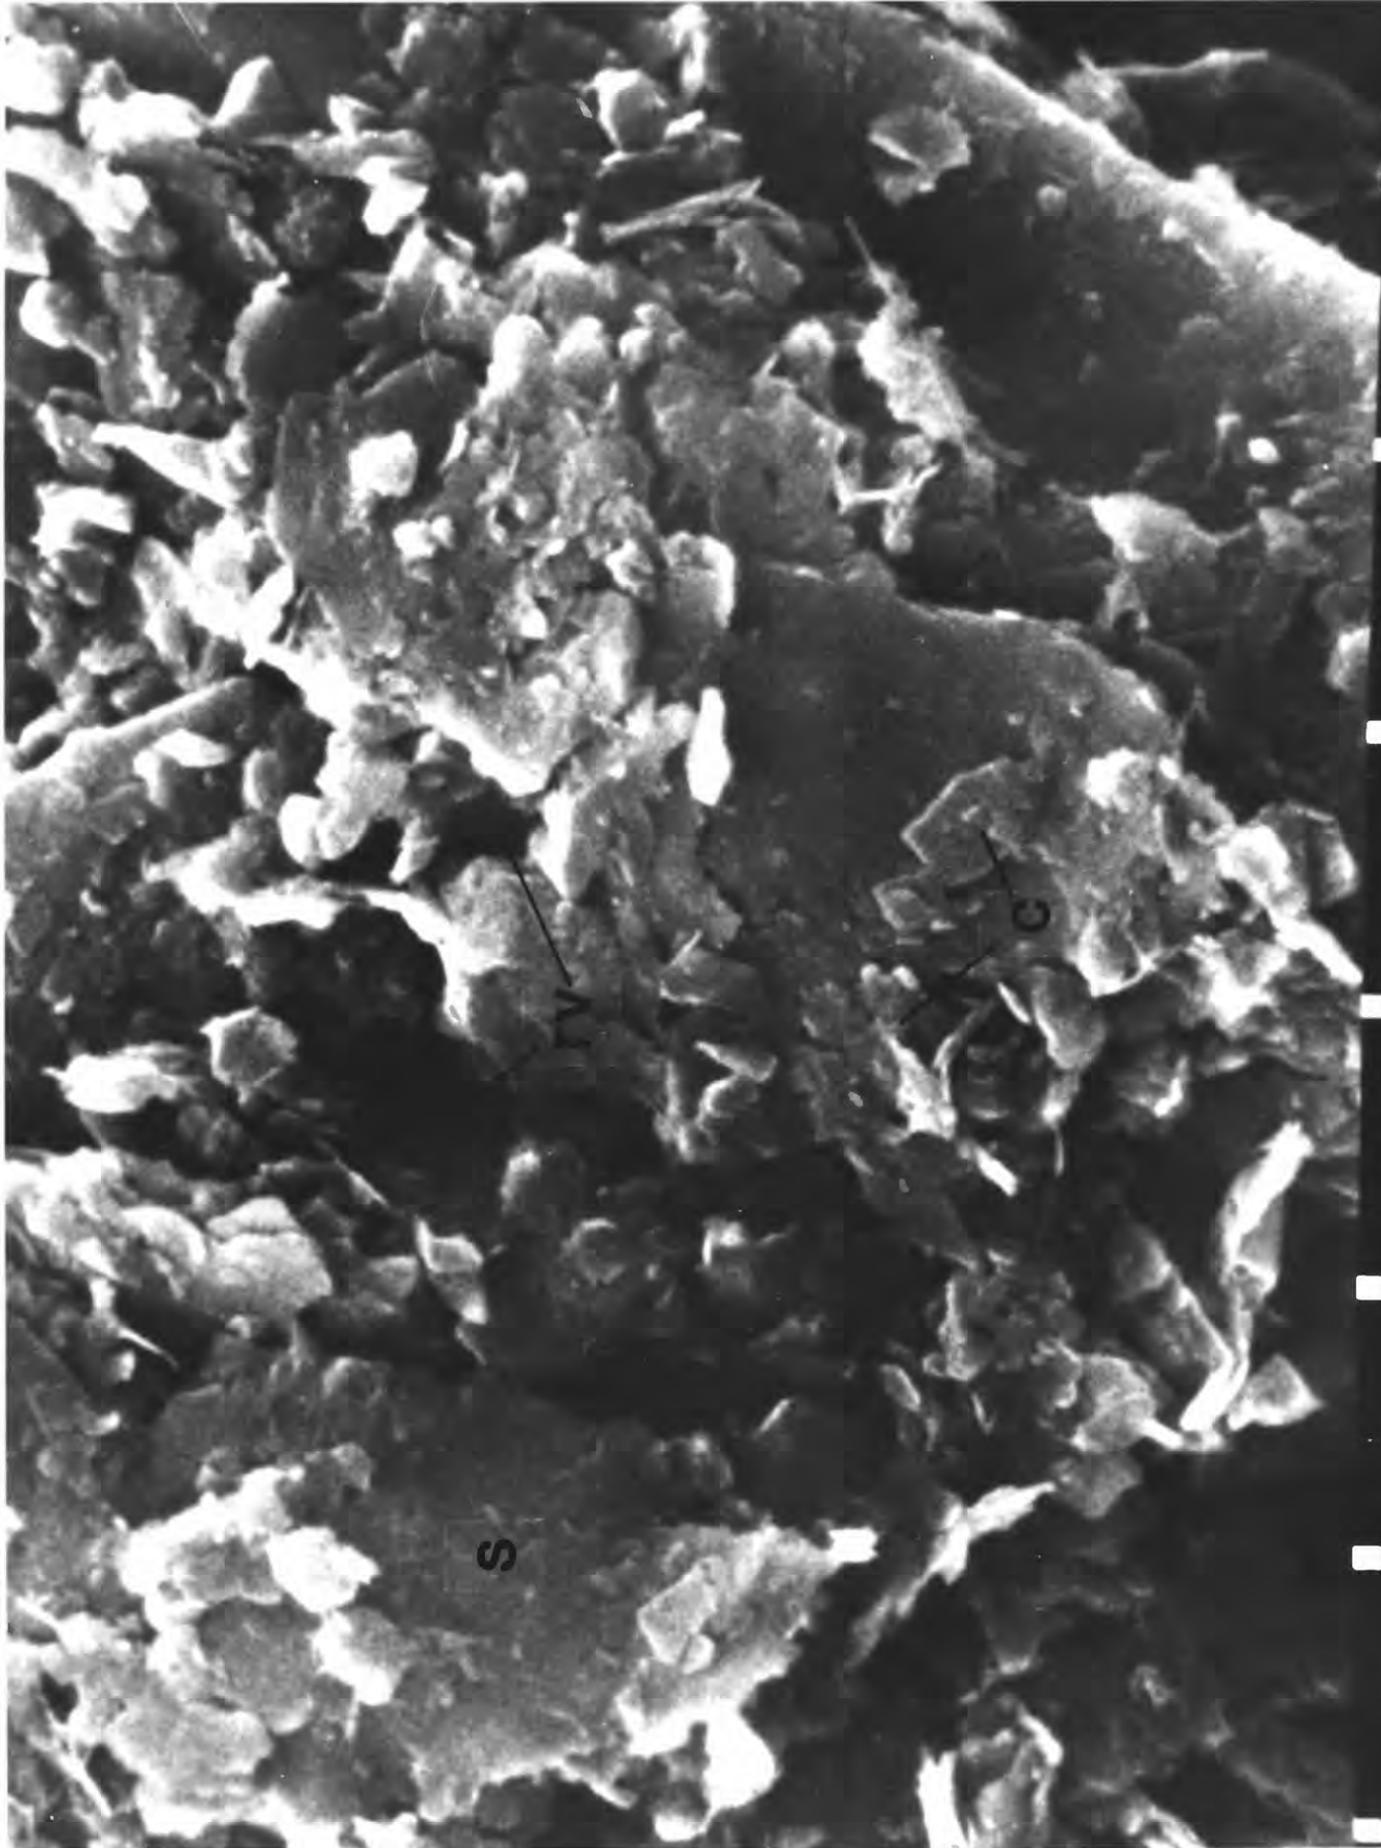
Figure 15. Facies F.II, parallel to bedding planes, mag. = 3190X. Bedding from top to bottom, clay turbostratic groups (ts) with random scattered silt grains.

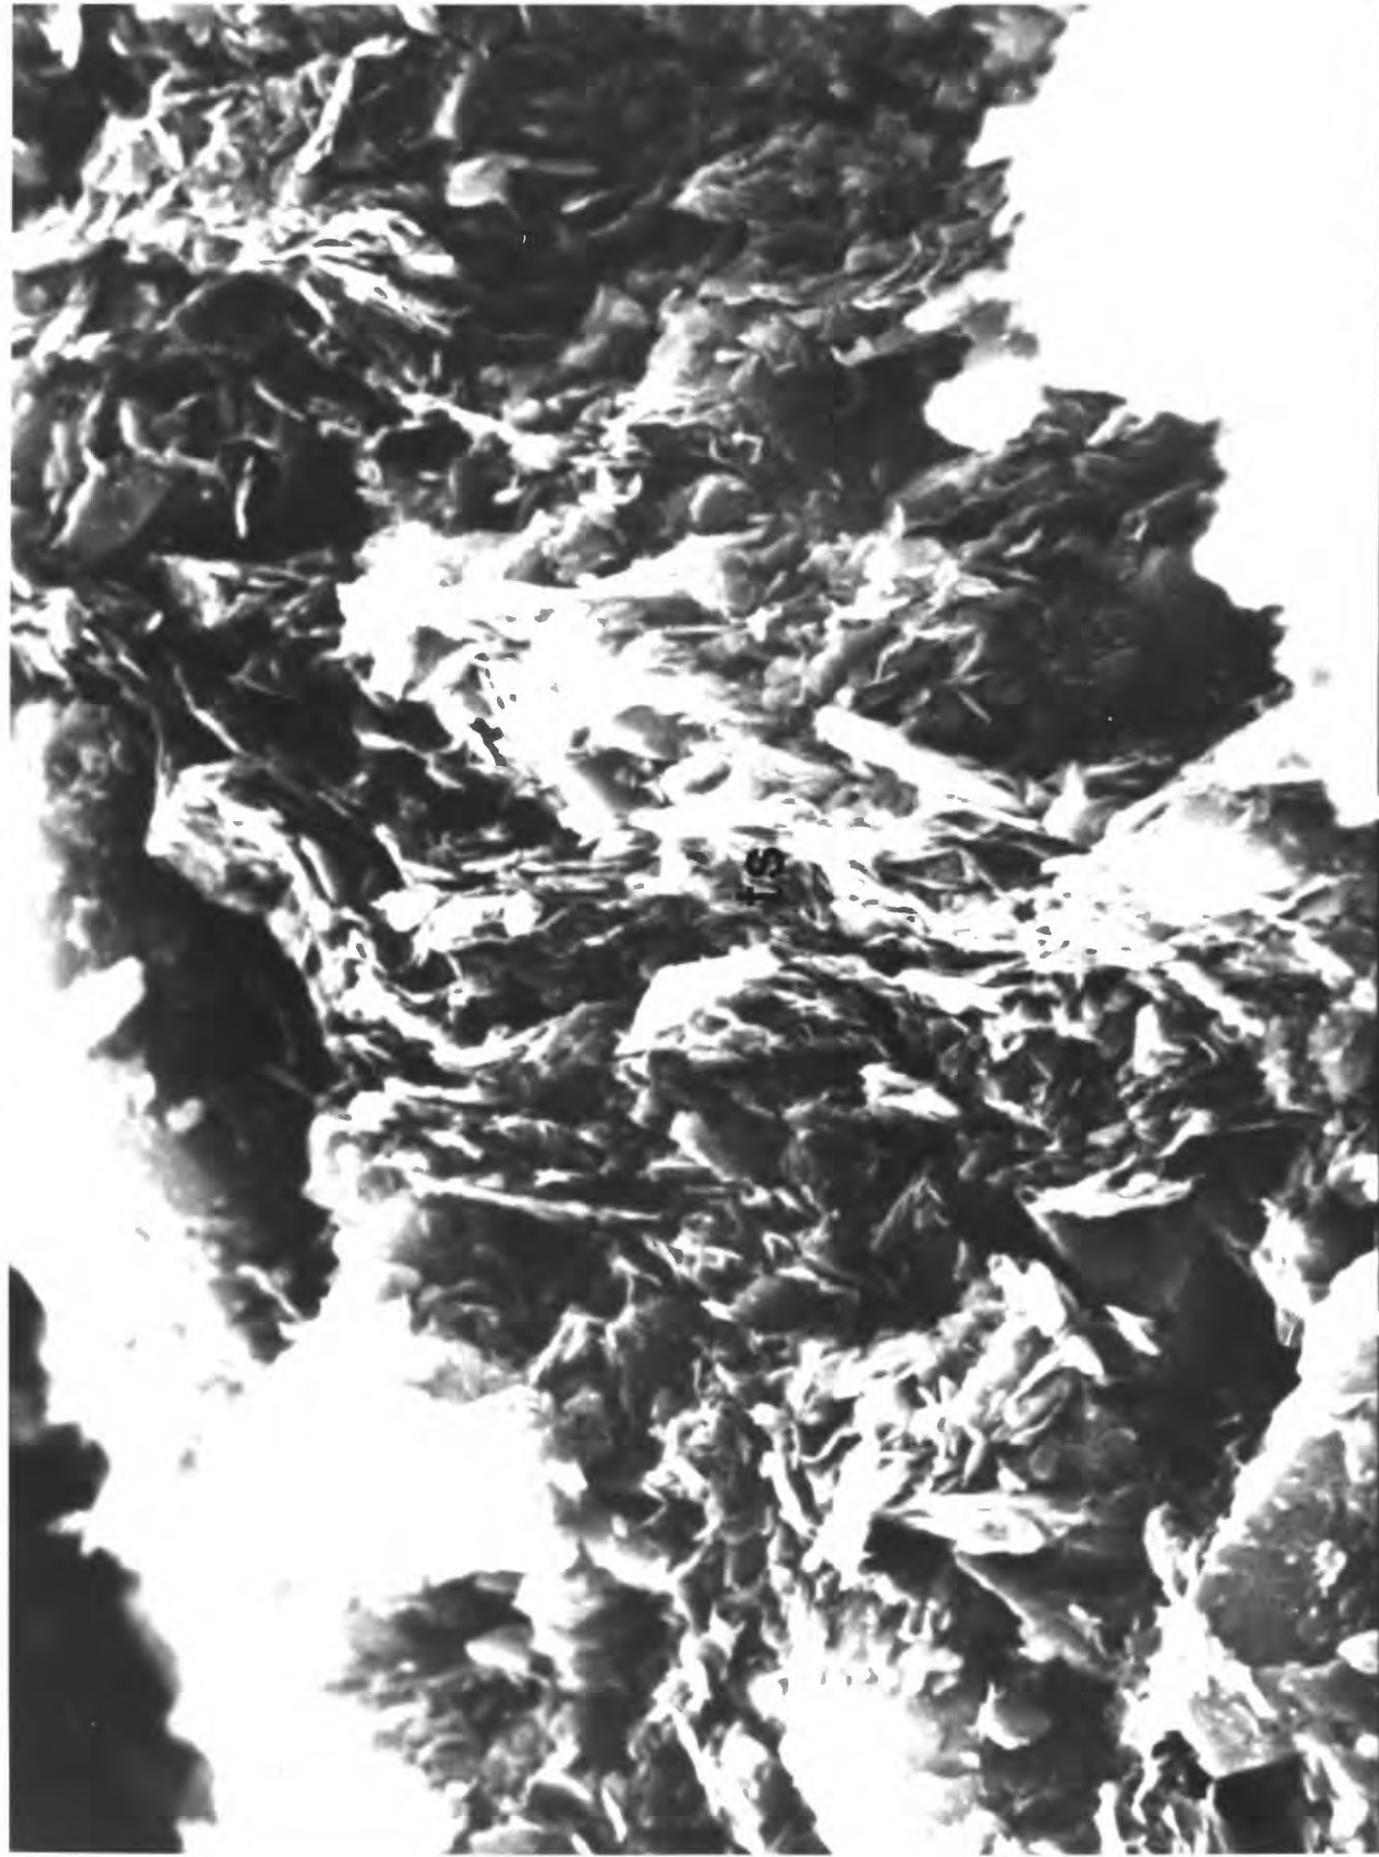
Figure 16. Facies F.II, normal to bedding, mag. = 10,000X. Detail along collapsed zone (cz) which has curvature suggesting shear strain may have occurred.

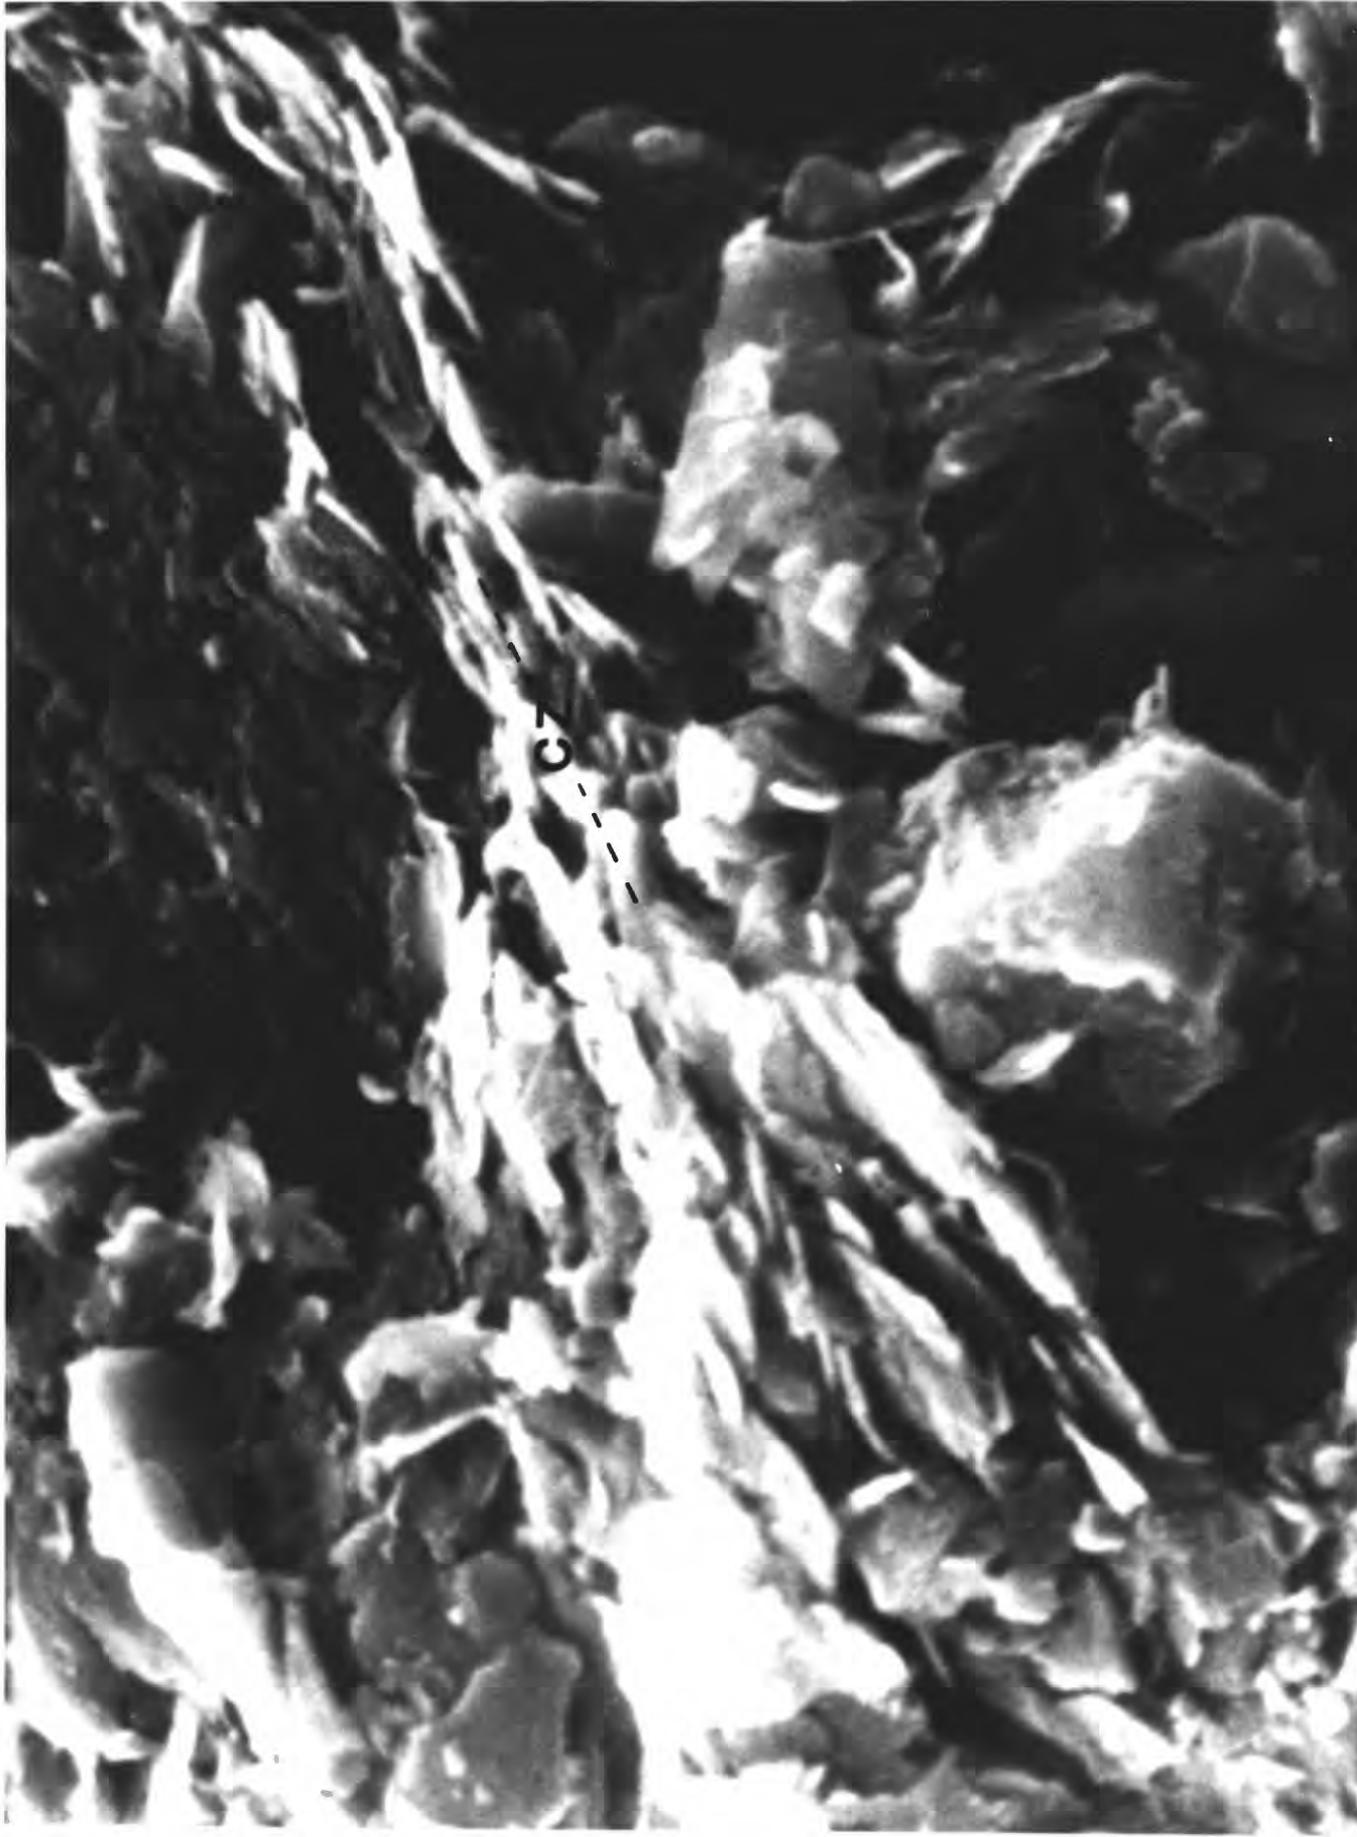
Figure 17. Facies F.II, parallel to bedding planes, mag. = 3700X. Approximately equal amounts of silt and clay, in laminae from left to right. Note distended elliptical voids in clay zones parallel to bedding.

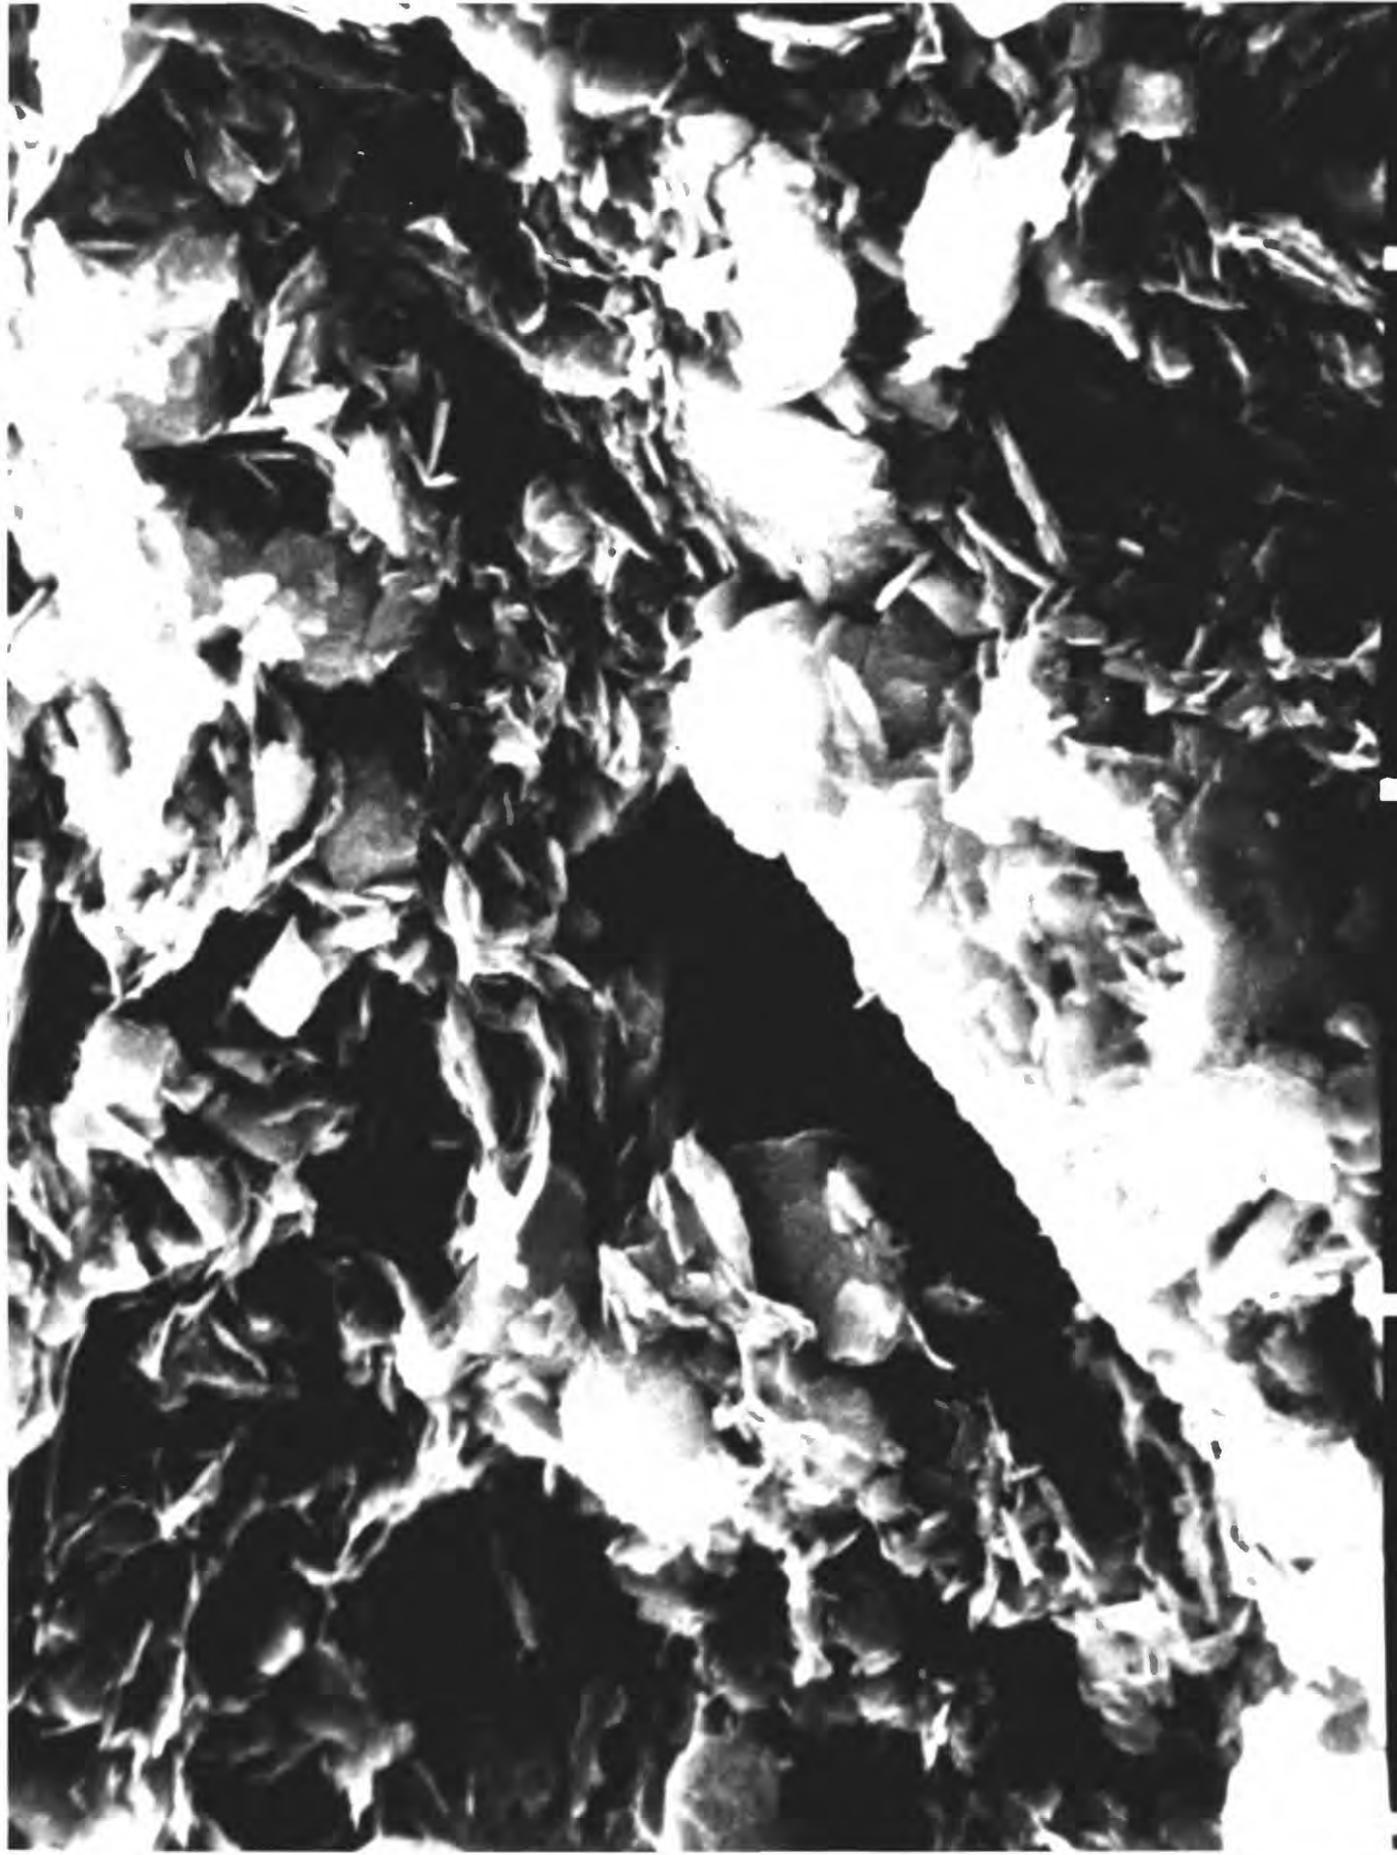
Figure 18. Facies F.II, normal to bedding, mag. = 2050X. This sample was medium sensitive although within F.II. Here flocculated fabric (of) is present but of restricted extent compared to figures 24 and 25. Colloidal floccules (cf) are also small and uncommon.

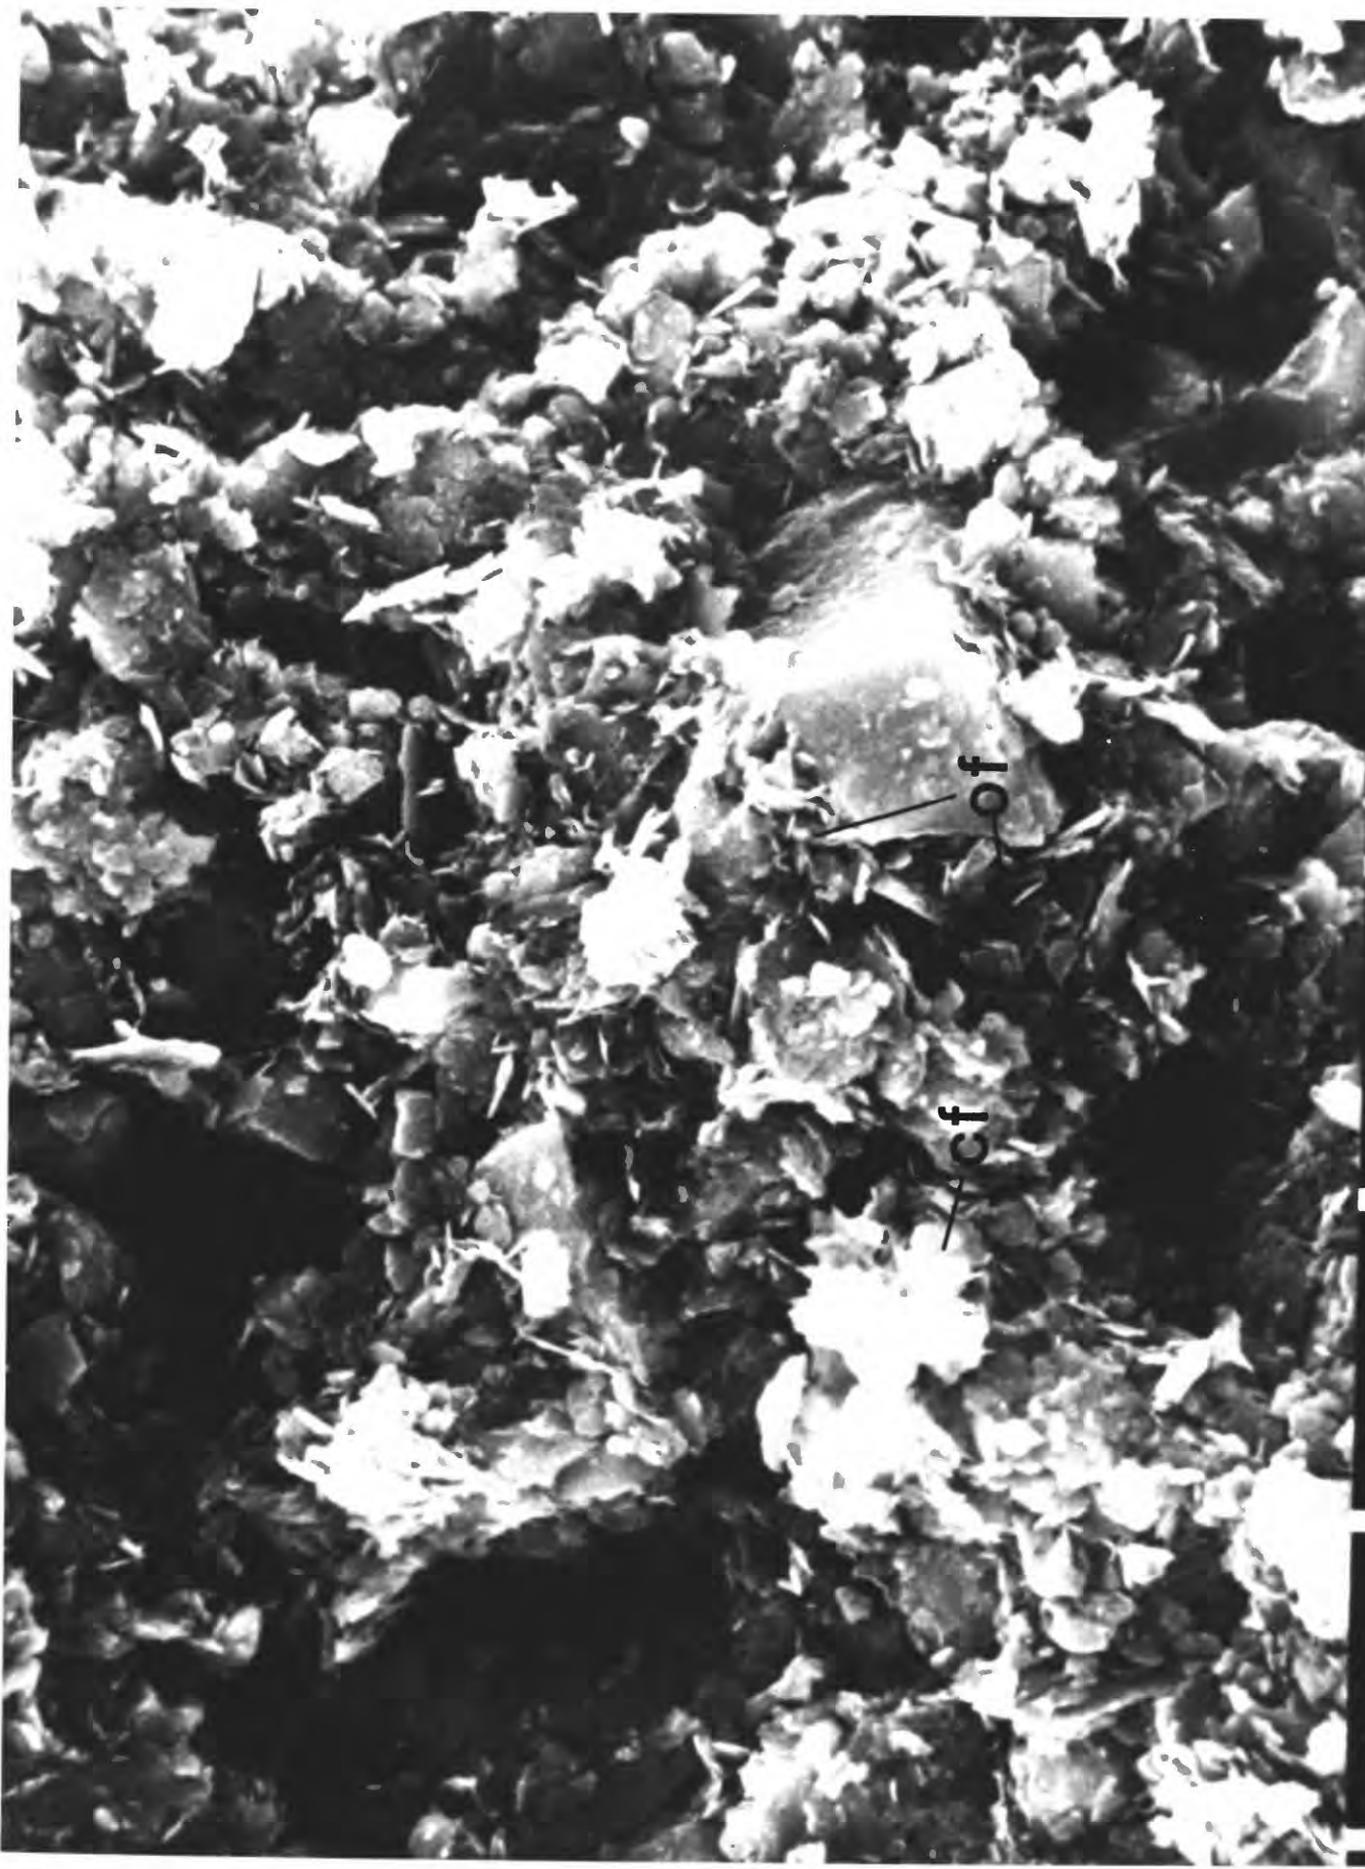
Figure 19. Facies F.II, normal to bedding, mag. = 4200X. Fracture zone lower left to upper right. Silt common with clay as silt connectors. Silt grain weathering, presumably in situ (sw).

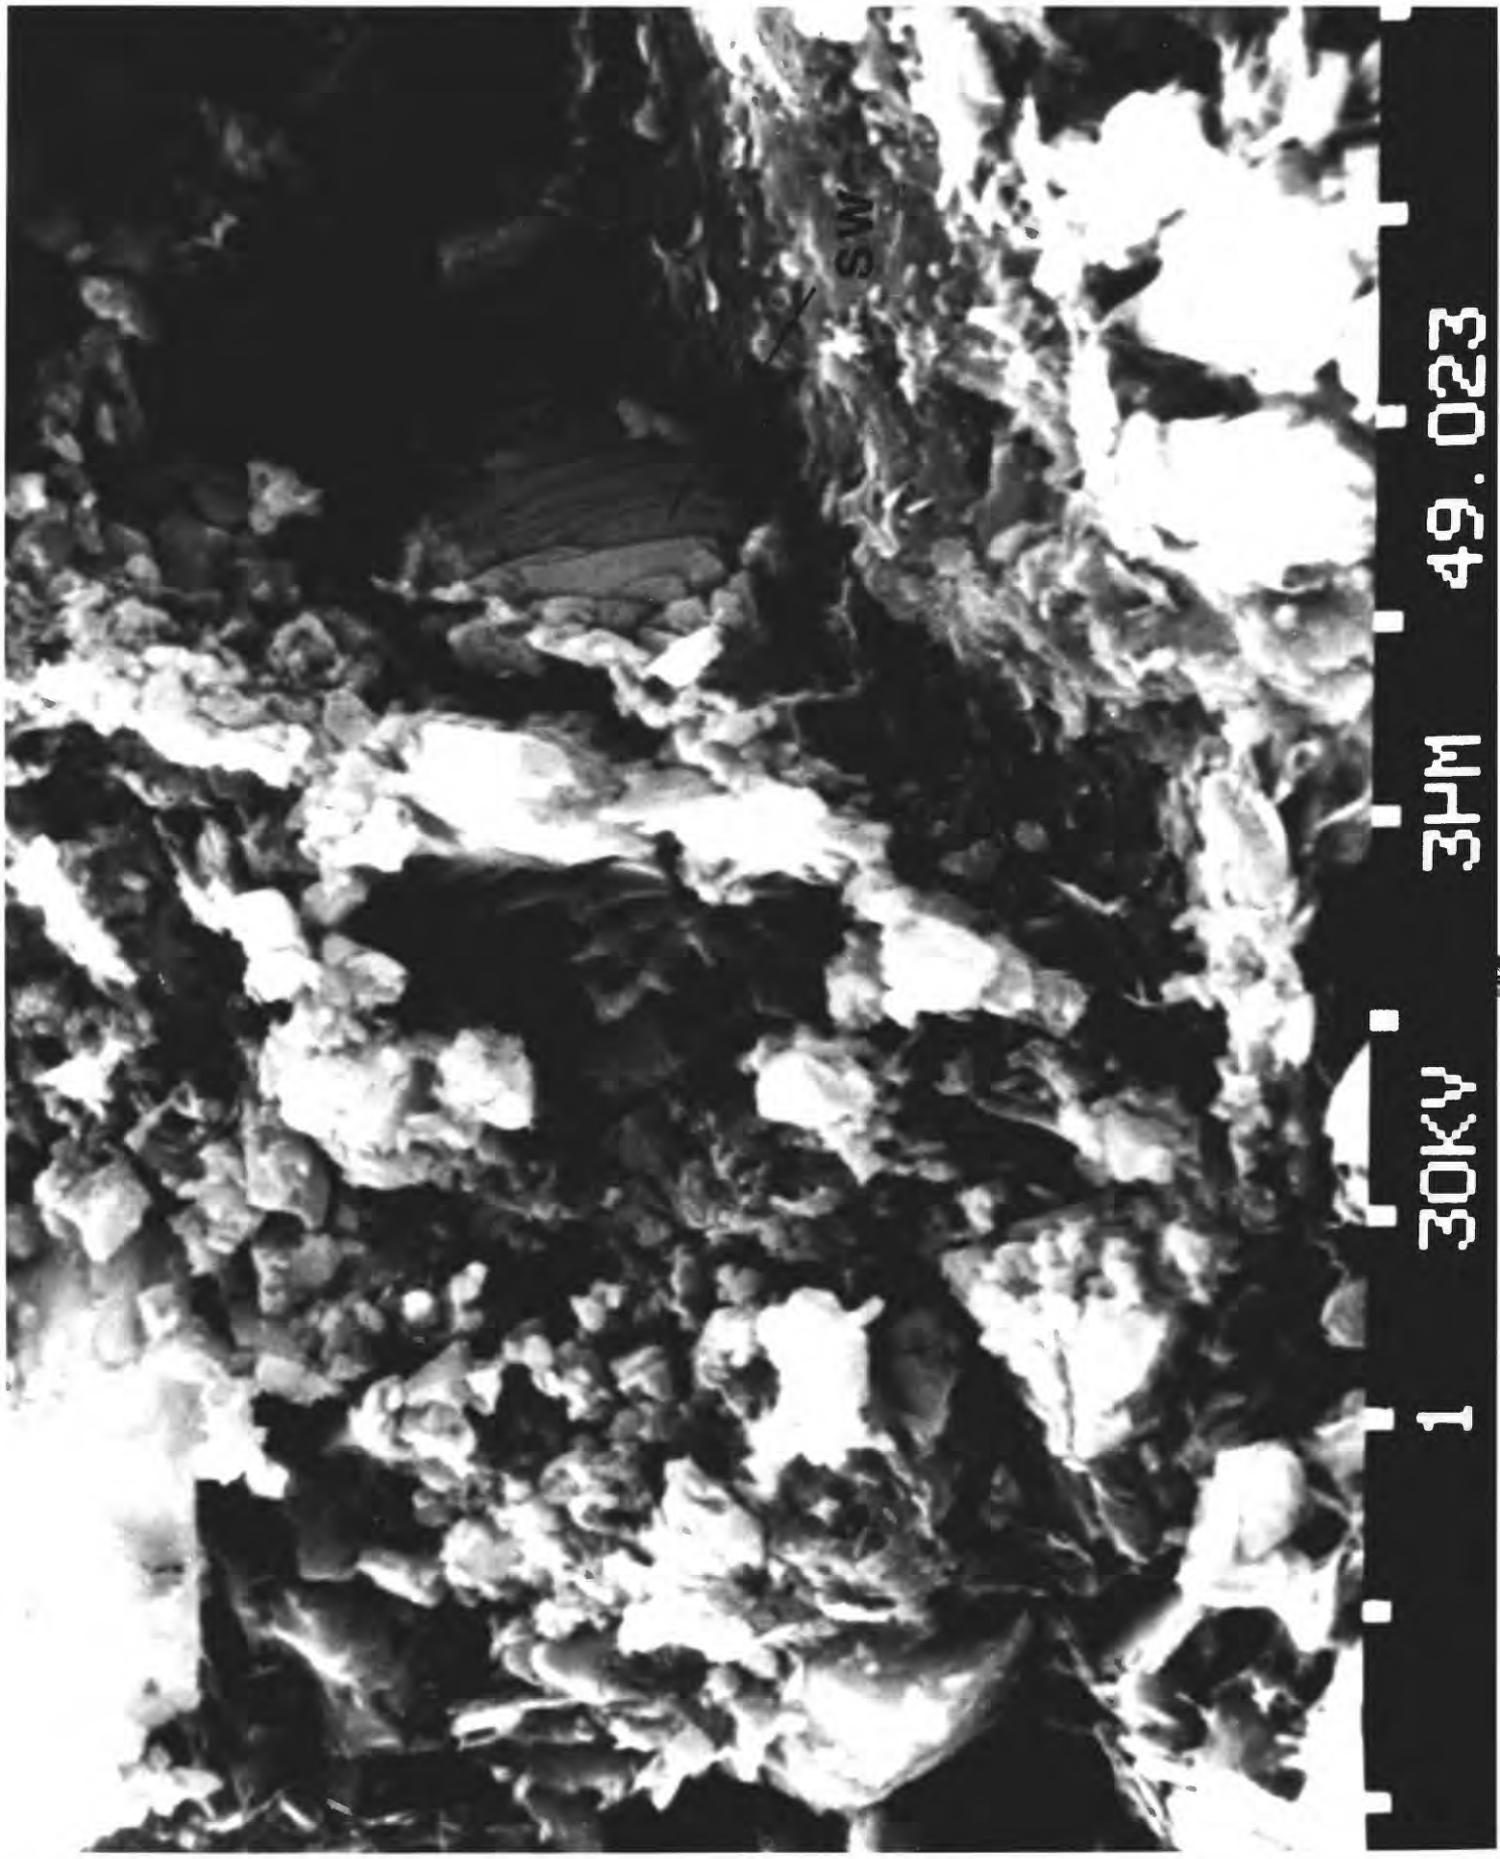
Figure 20. Facies F.III, normal to bedding planes, mag. = 4100X. Major axes of most of clay and silt grains in plane of image. See figures 21 and 22.

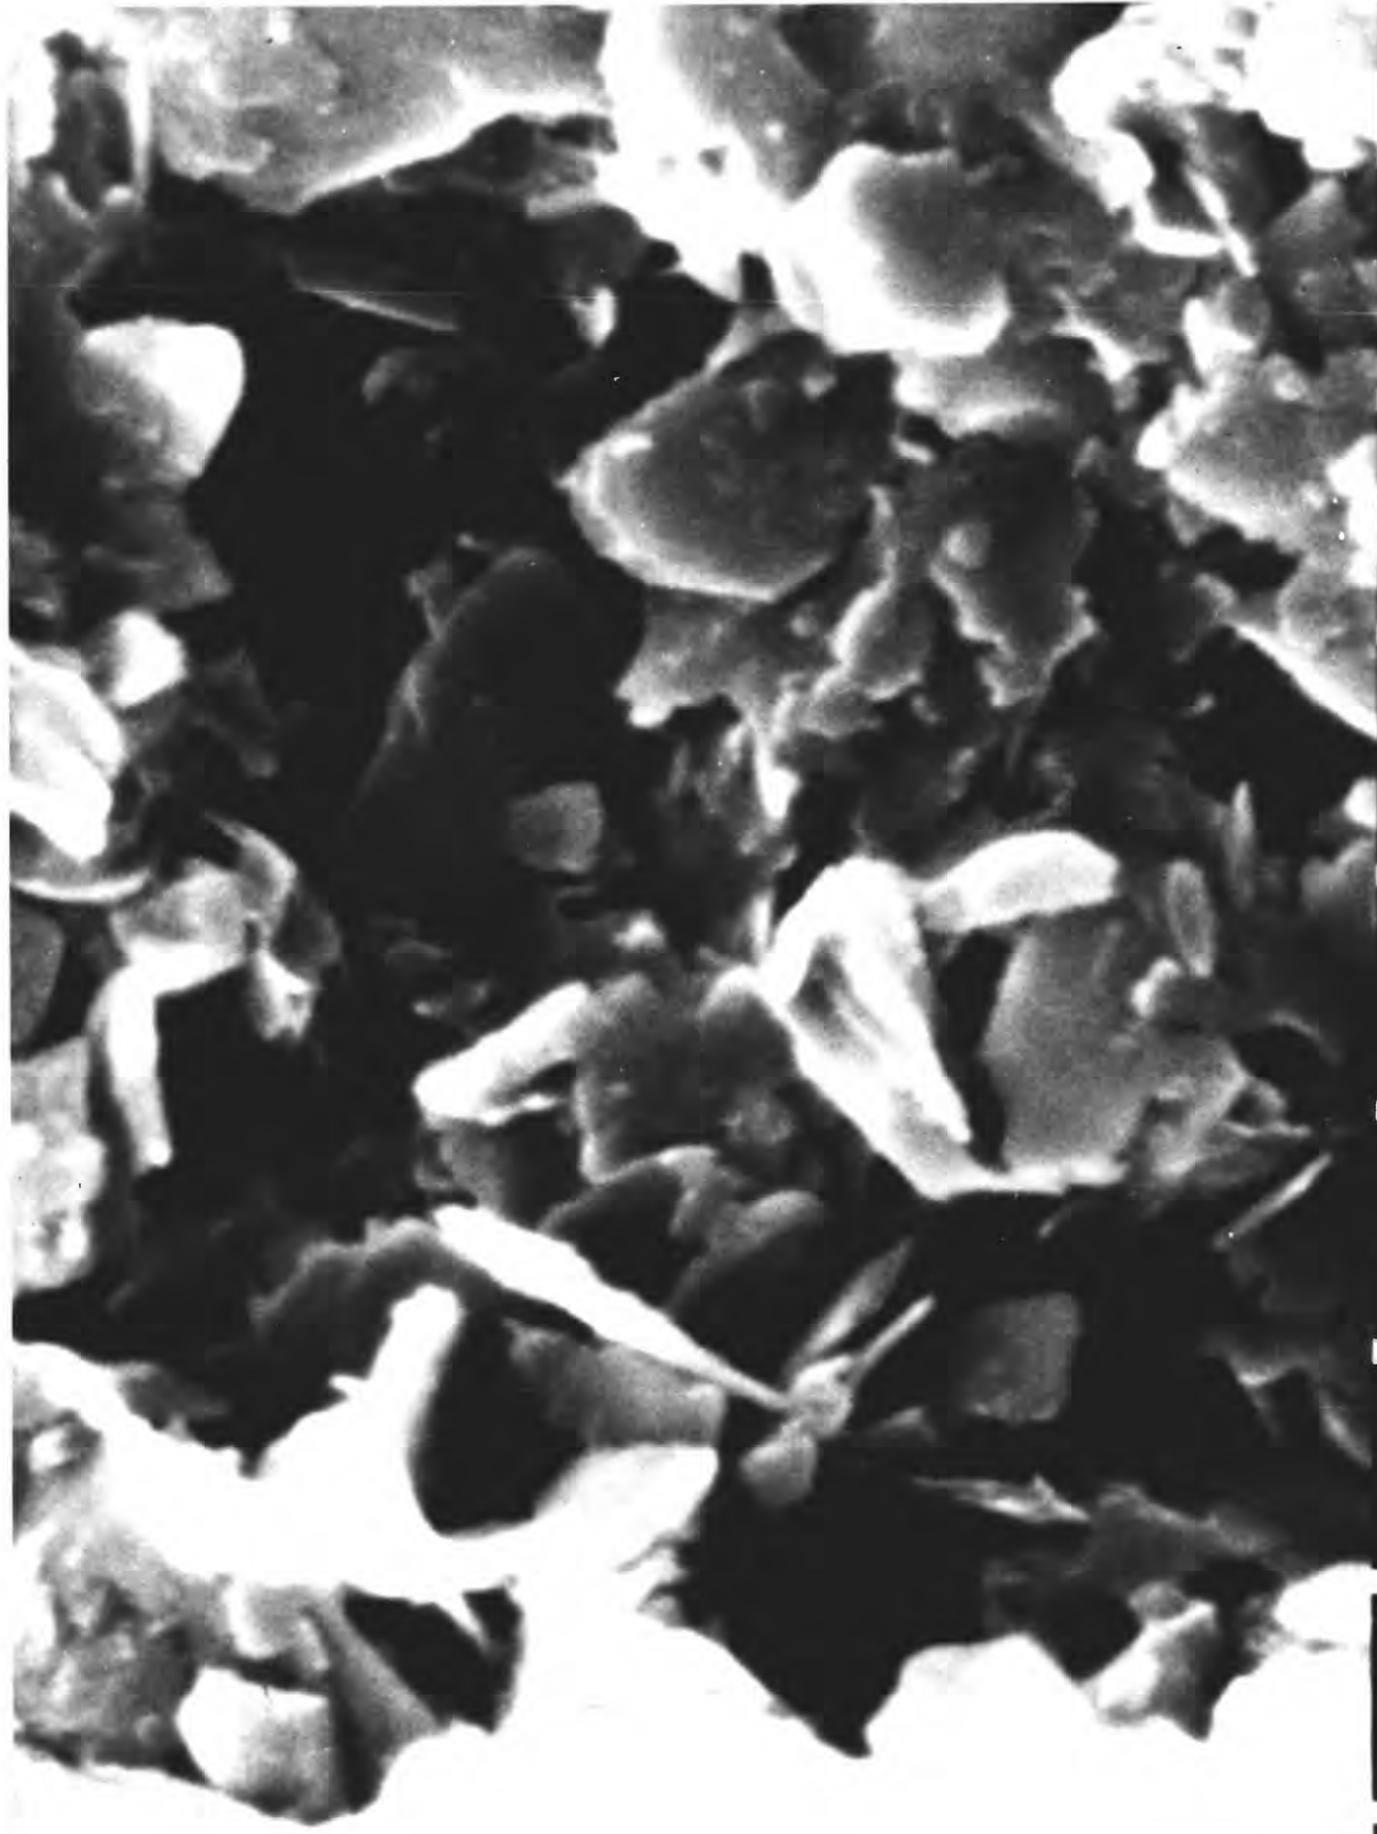
Figure 23. Facies F.III, parallel to bedding planes, mag. 2590X. General view showing silt grains (s) surrounded by open flocculated clay assemblages (of).

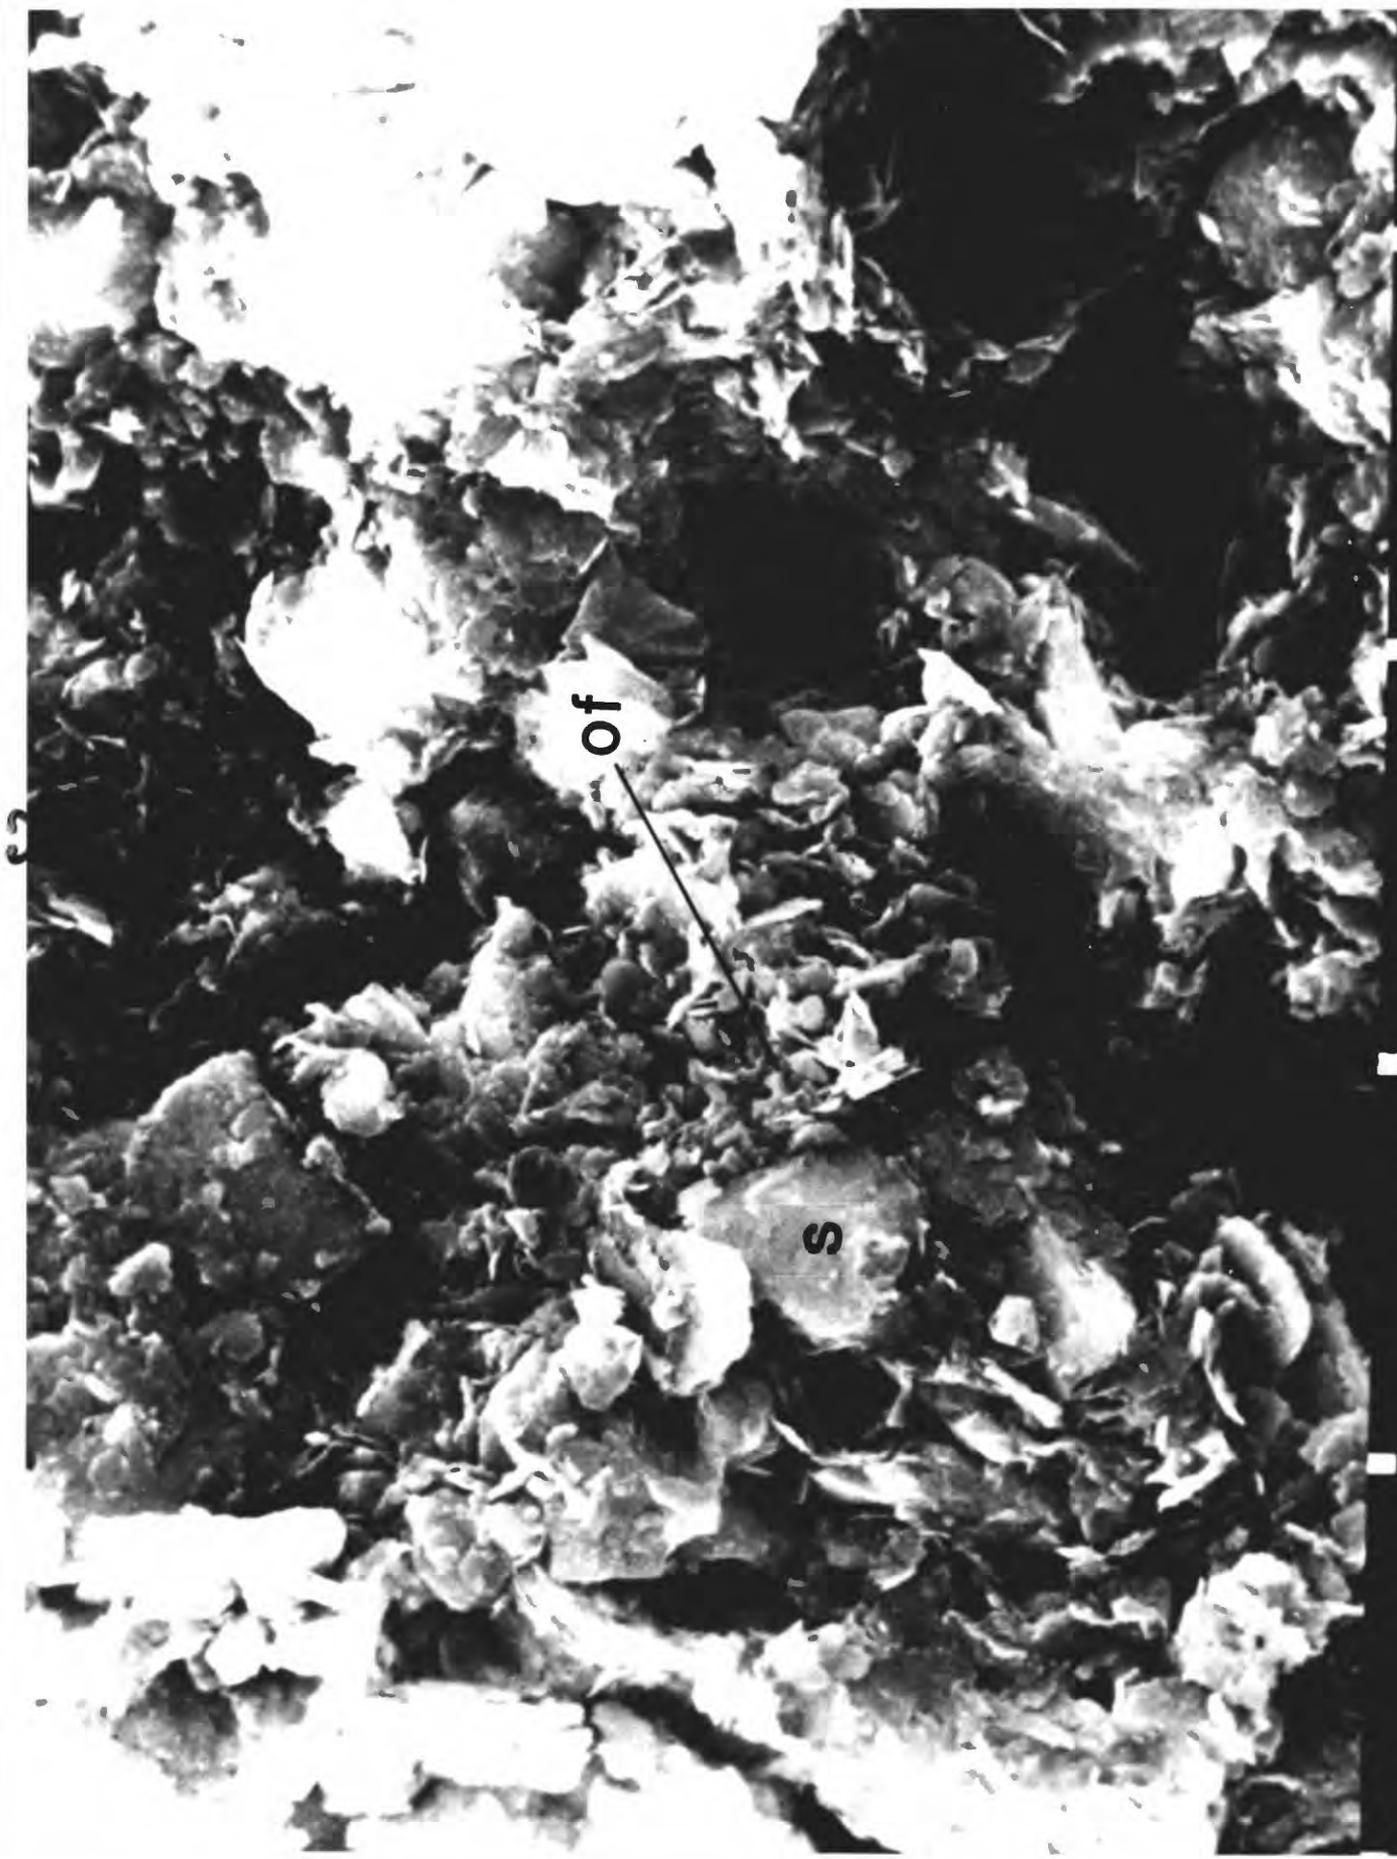
Figure 24. Facies F.III, parallel to bedding planes, mag. = 3200X. Honey-comb fabric (hc) well-developed with intervening areas comprised of flocculated aggregates (of) and random, rare silt grains (s).
