U.S. GEOLOGICAL SURVEY

An Atlas of Facies Microfabrics of the Bootlegger Cove Formation
Using the Scanning Electron Microscope

Revised 10 November 1986

Open-File Report 87-60

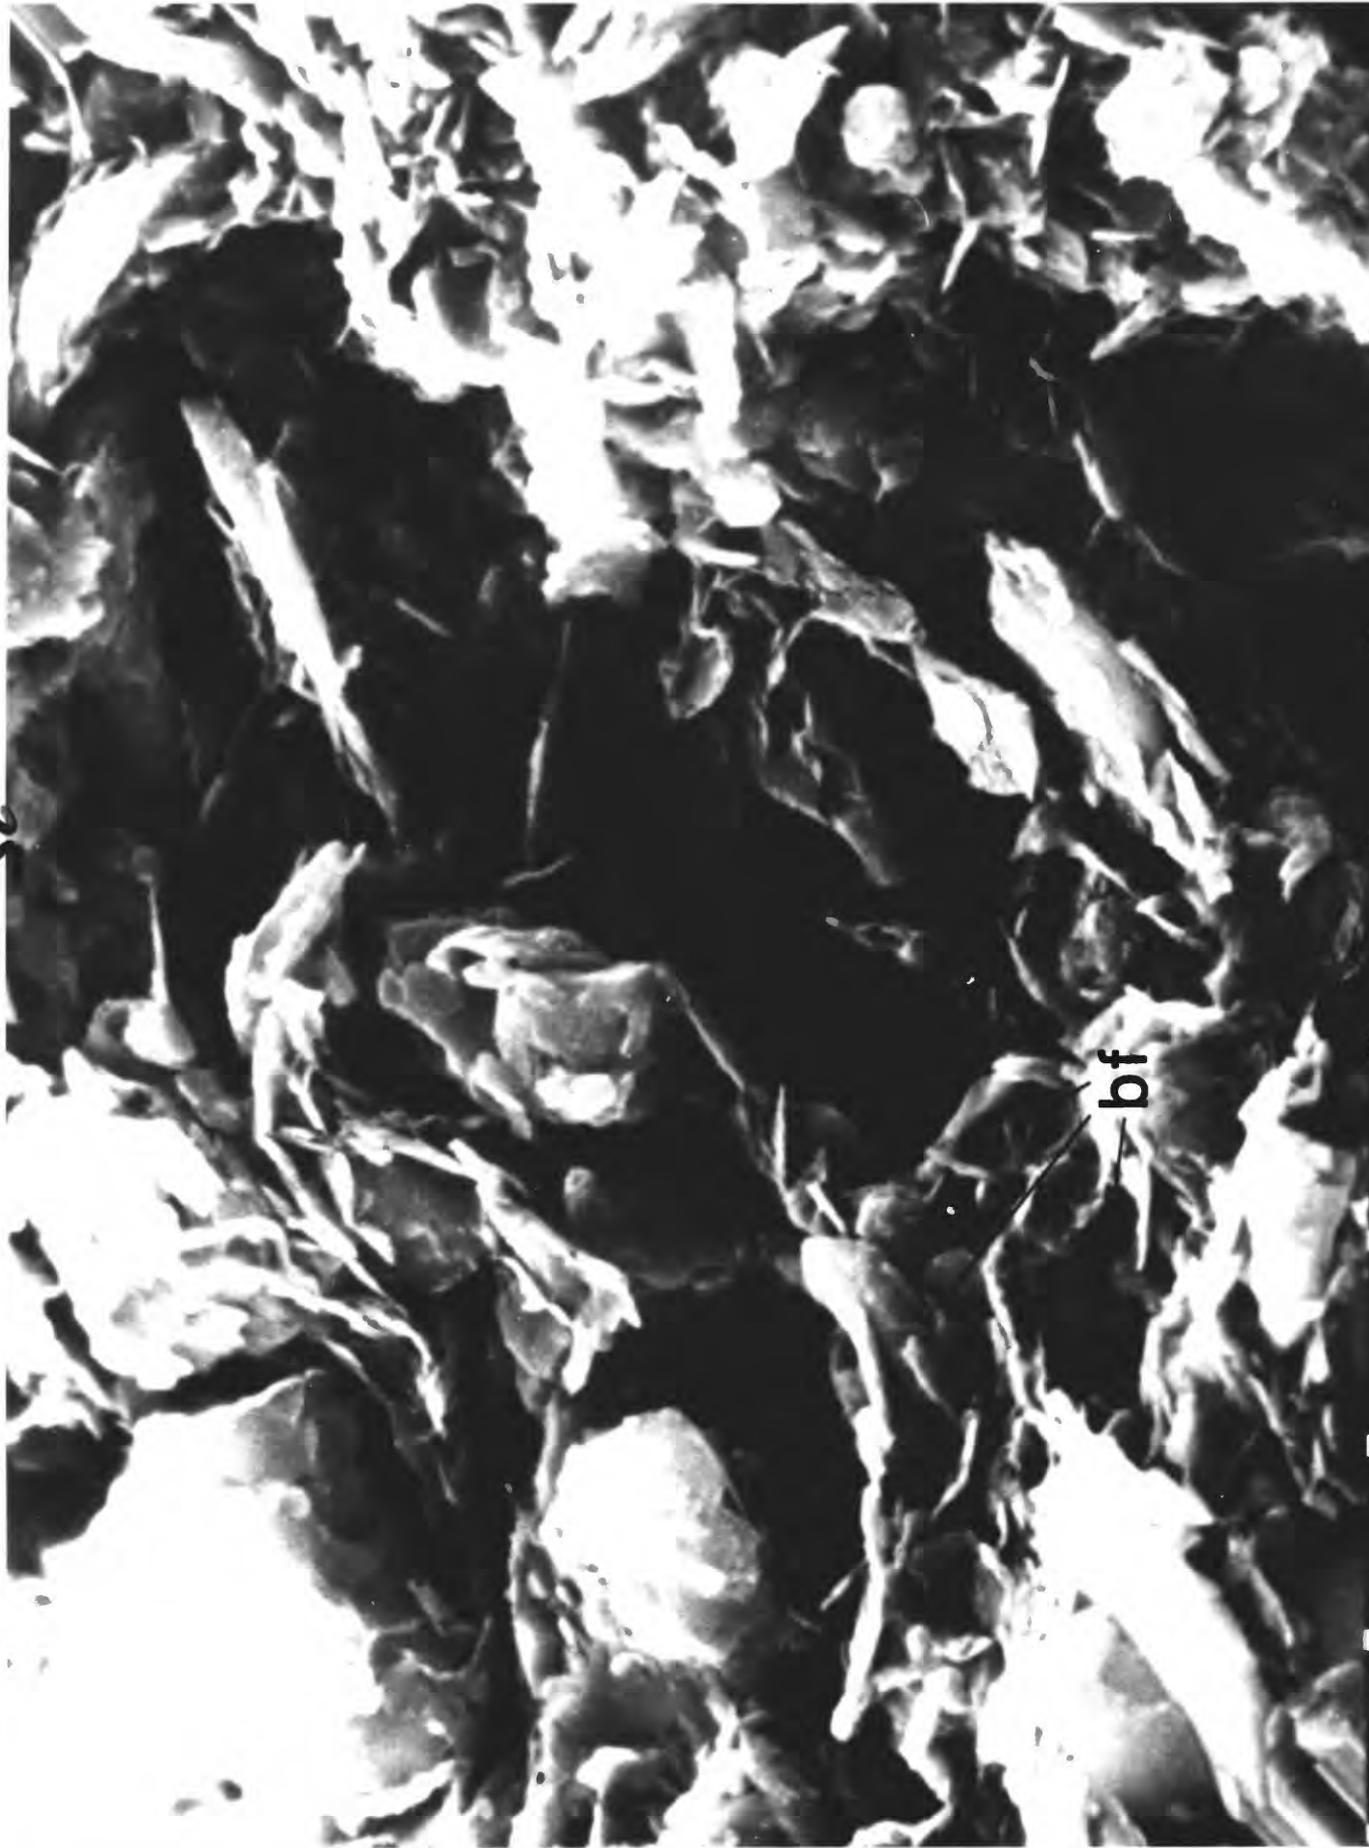
Figure 26. Facies F.III, parallel to bedding planes, mag. = 4300X. Typical view of sensitive metastable fabric. Note dominance of clay. Bedding left to right, enhanced by collapsed zones (cz).

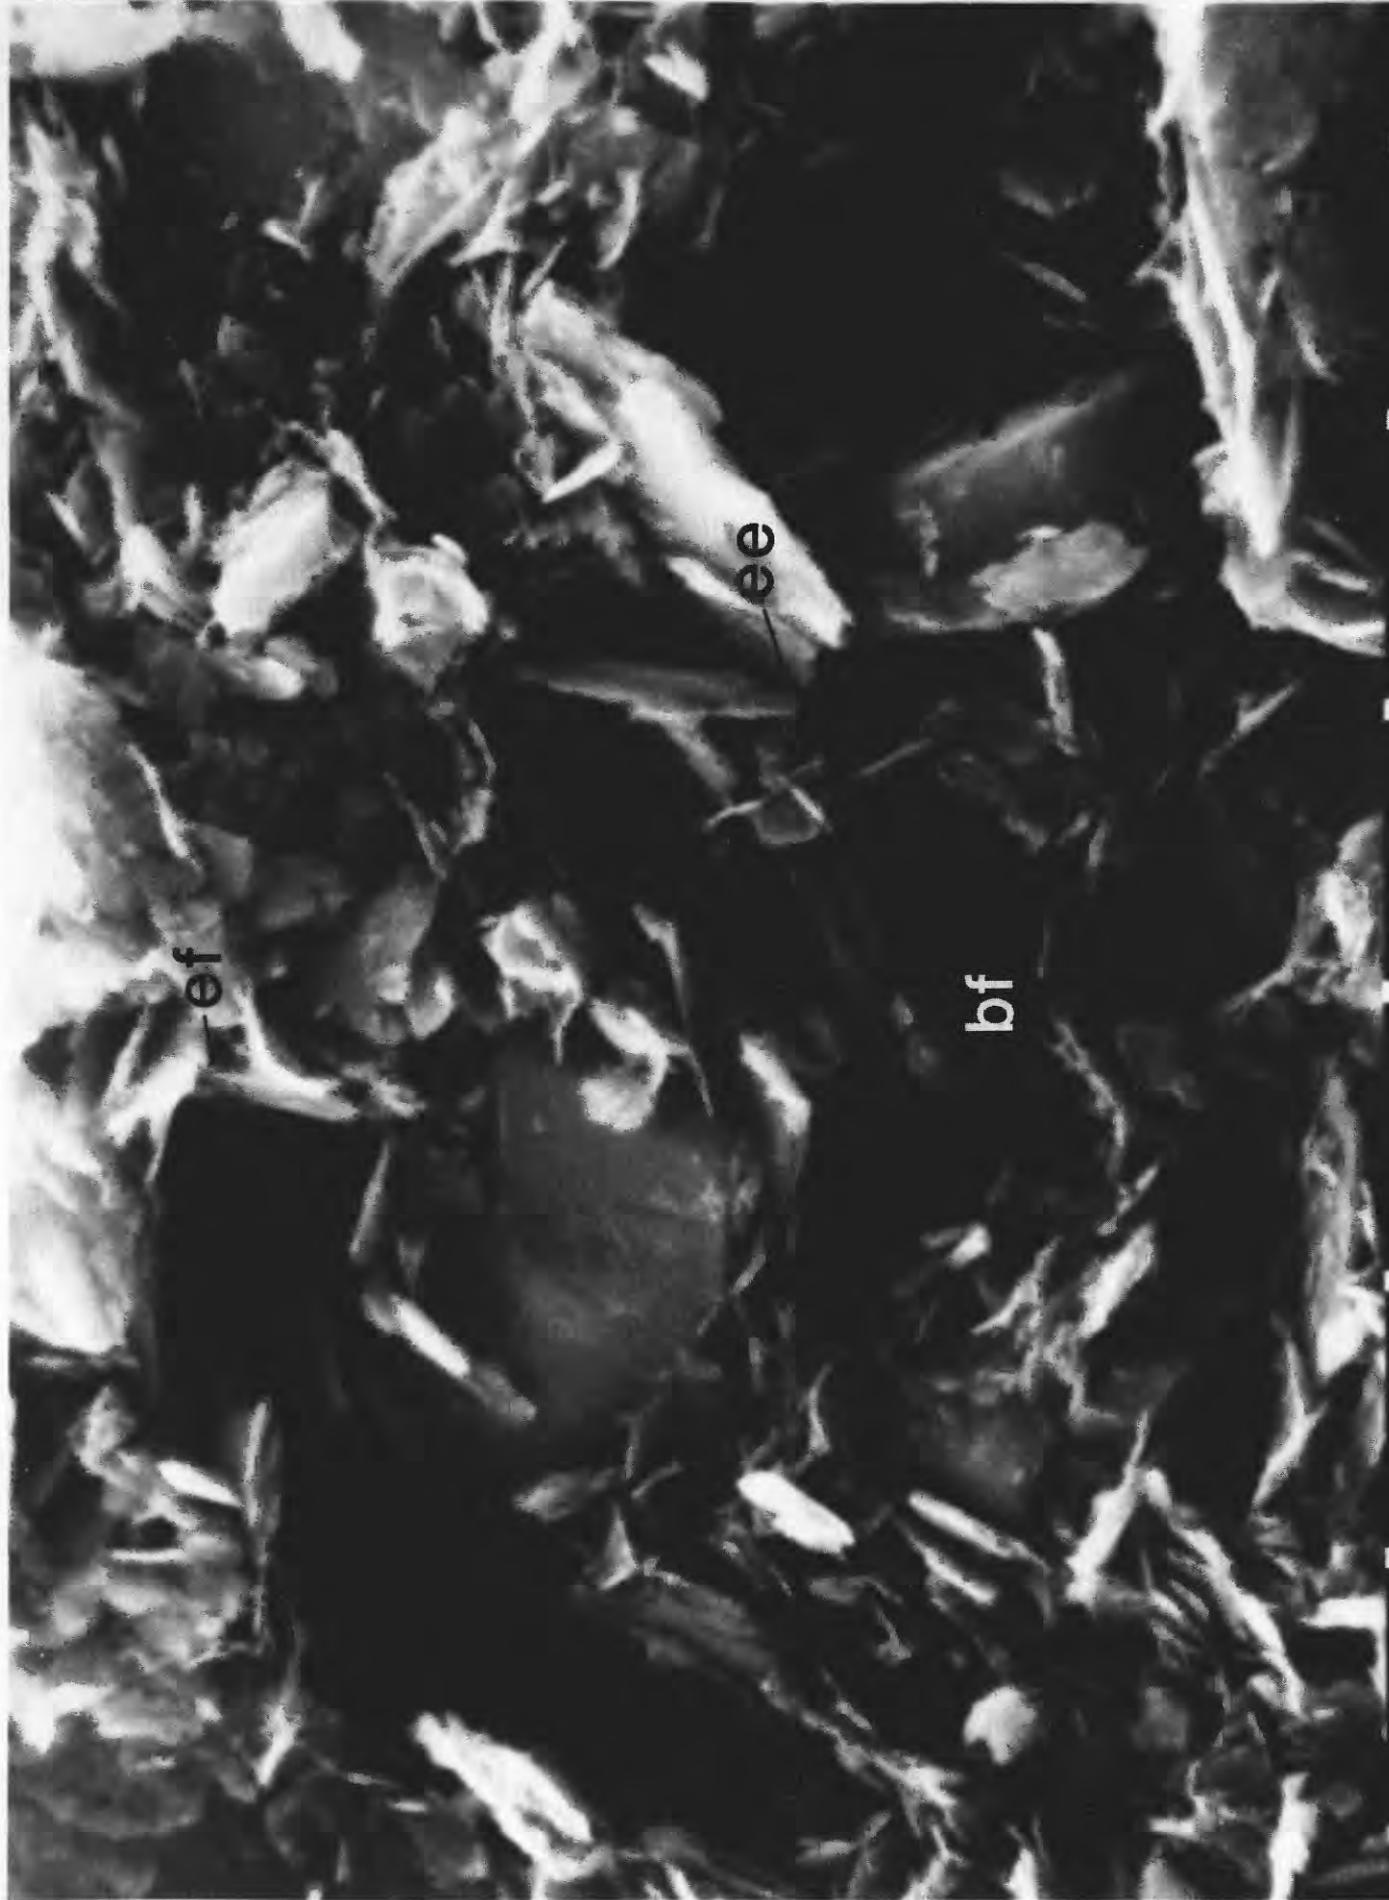
Figure 29. Facies F.III, parallel to bedding planes, mag. = 10,000X. High sensitivity sample consisting of clay-coated silt grains (s) surrounded by flocculated clay fabric with edge-to-face (ef) and edge-to-edge (ee) contacts forming boxwork structure (bf).

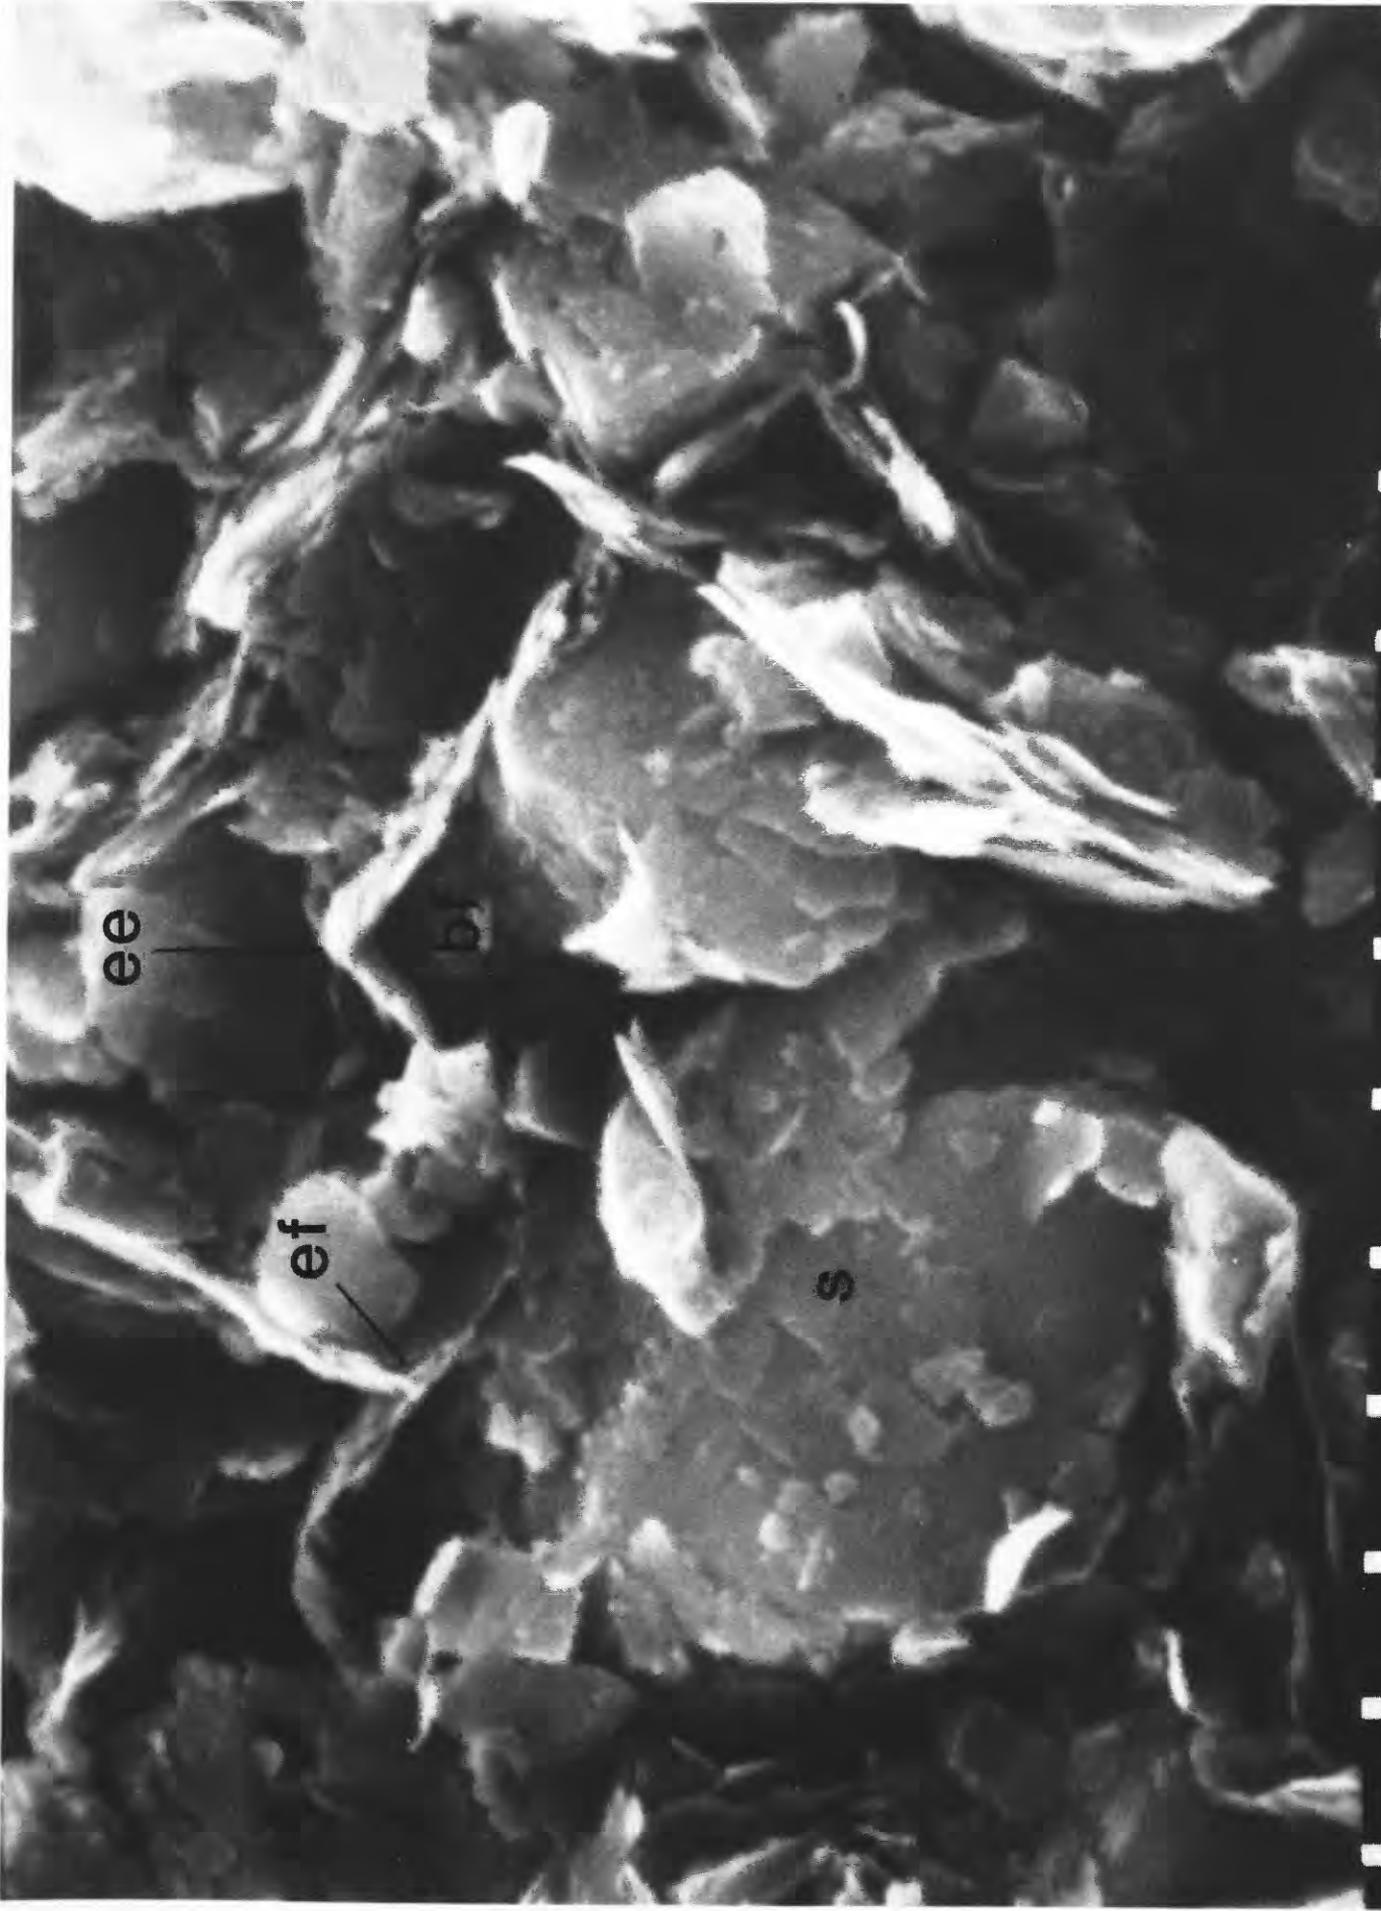
Figure 30. Facies F.III, parallel to bedding planes, mag. 11,000X. Boxwork fabric (bf) consisting of edge-to-edge (ee) and edge-to-face (ef) contacts. Collapsed zone (cz) may represent shear plane.

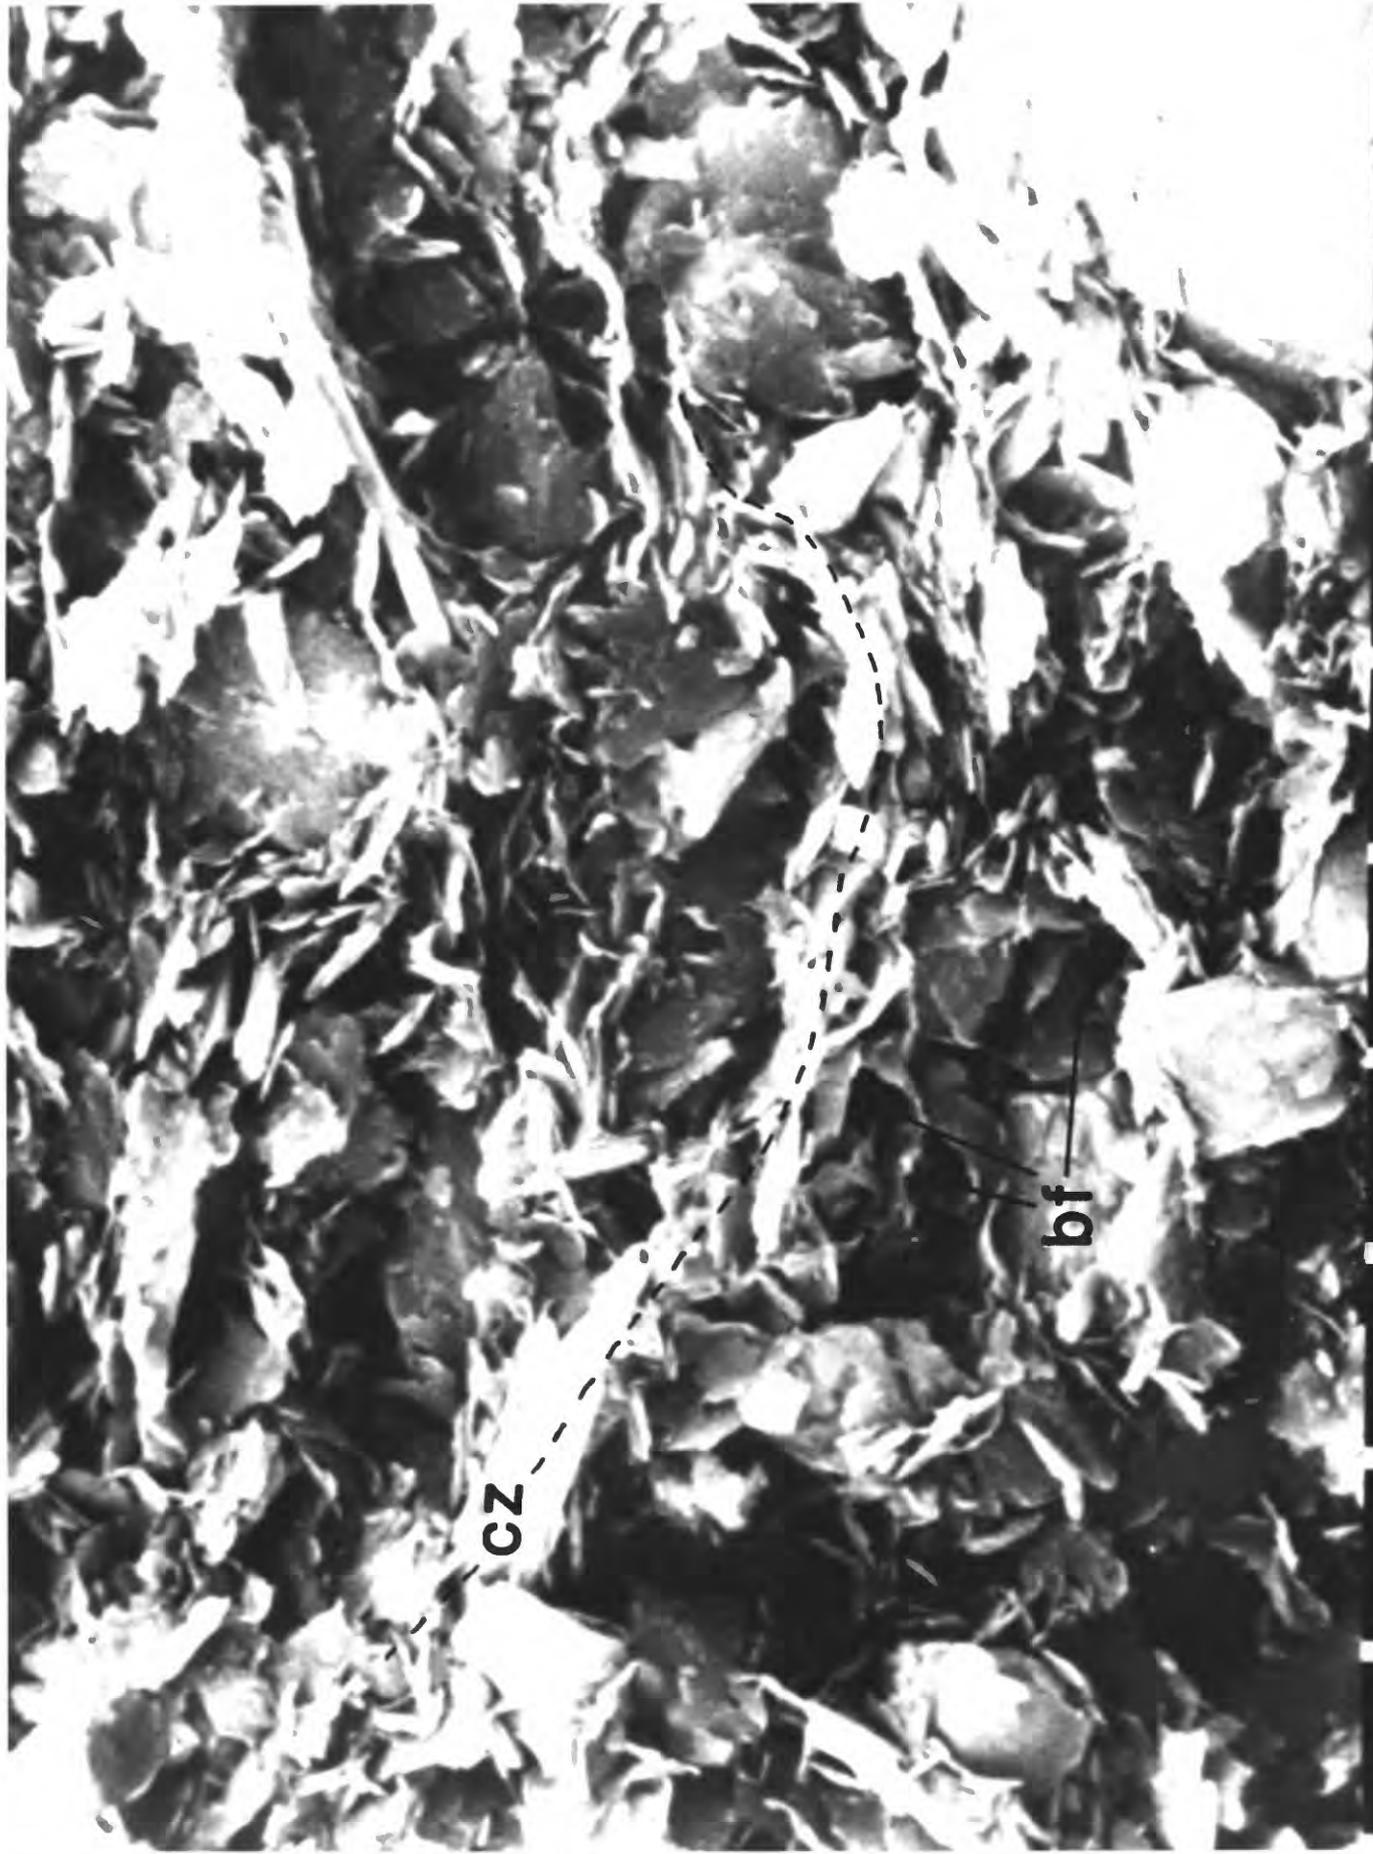
Figure 34. Facies F.III, detail of figure 33, mag. = 15000X. Collapsed zones (cz) surround small flocculated assemblage (of). Several examples of edge-to-face (ef) contacts.

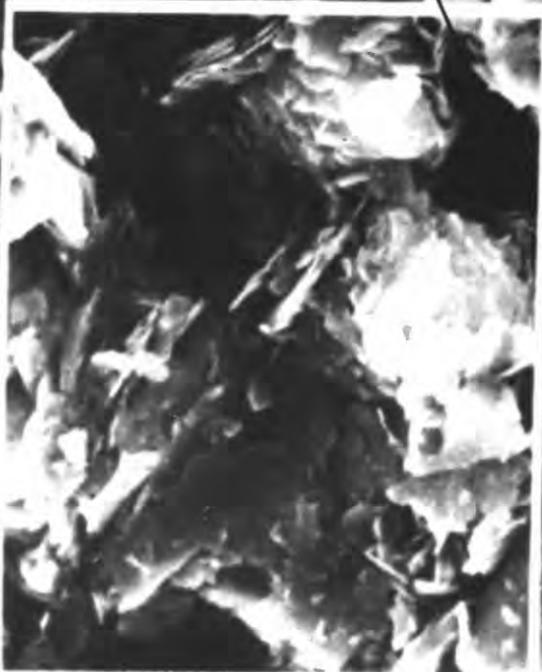
Figure 36. Facies F.III, detail from figure 35, mag. = 7800X. Collapsed and oriented clay grains indicate bedding attitude. Box-work fabric (bf) surrounds honey-comb void (hc).

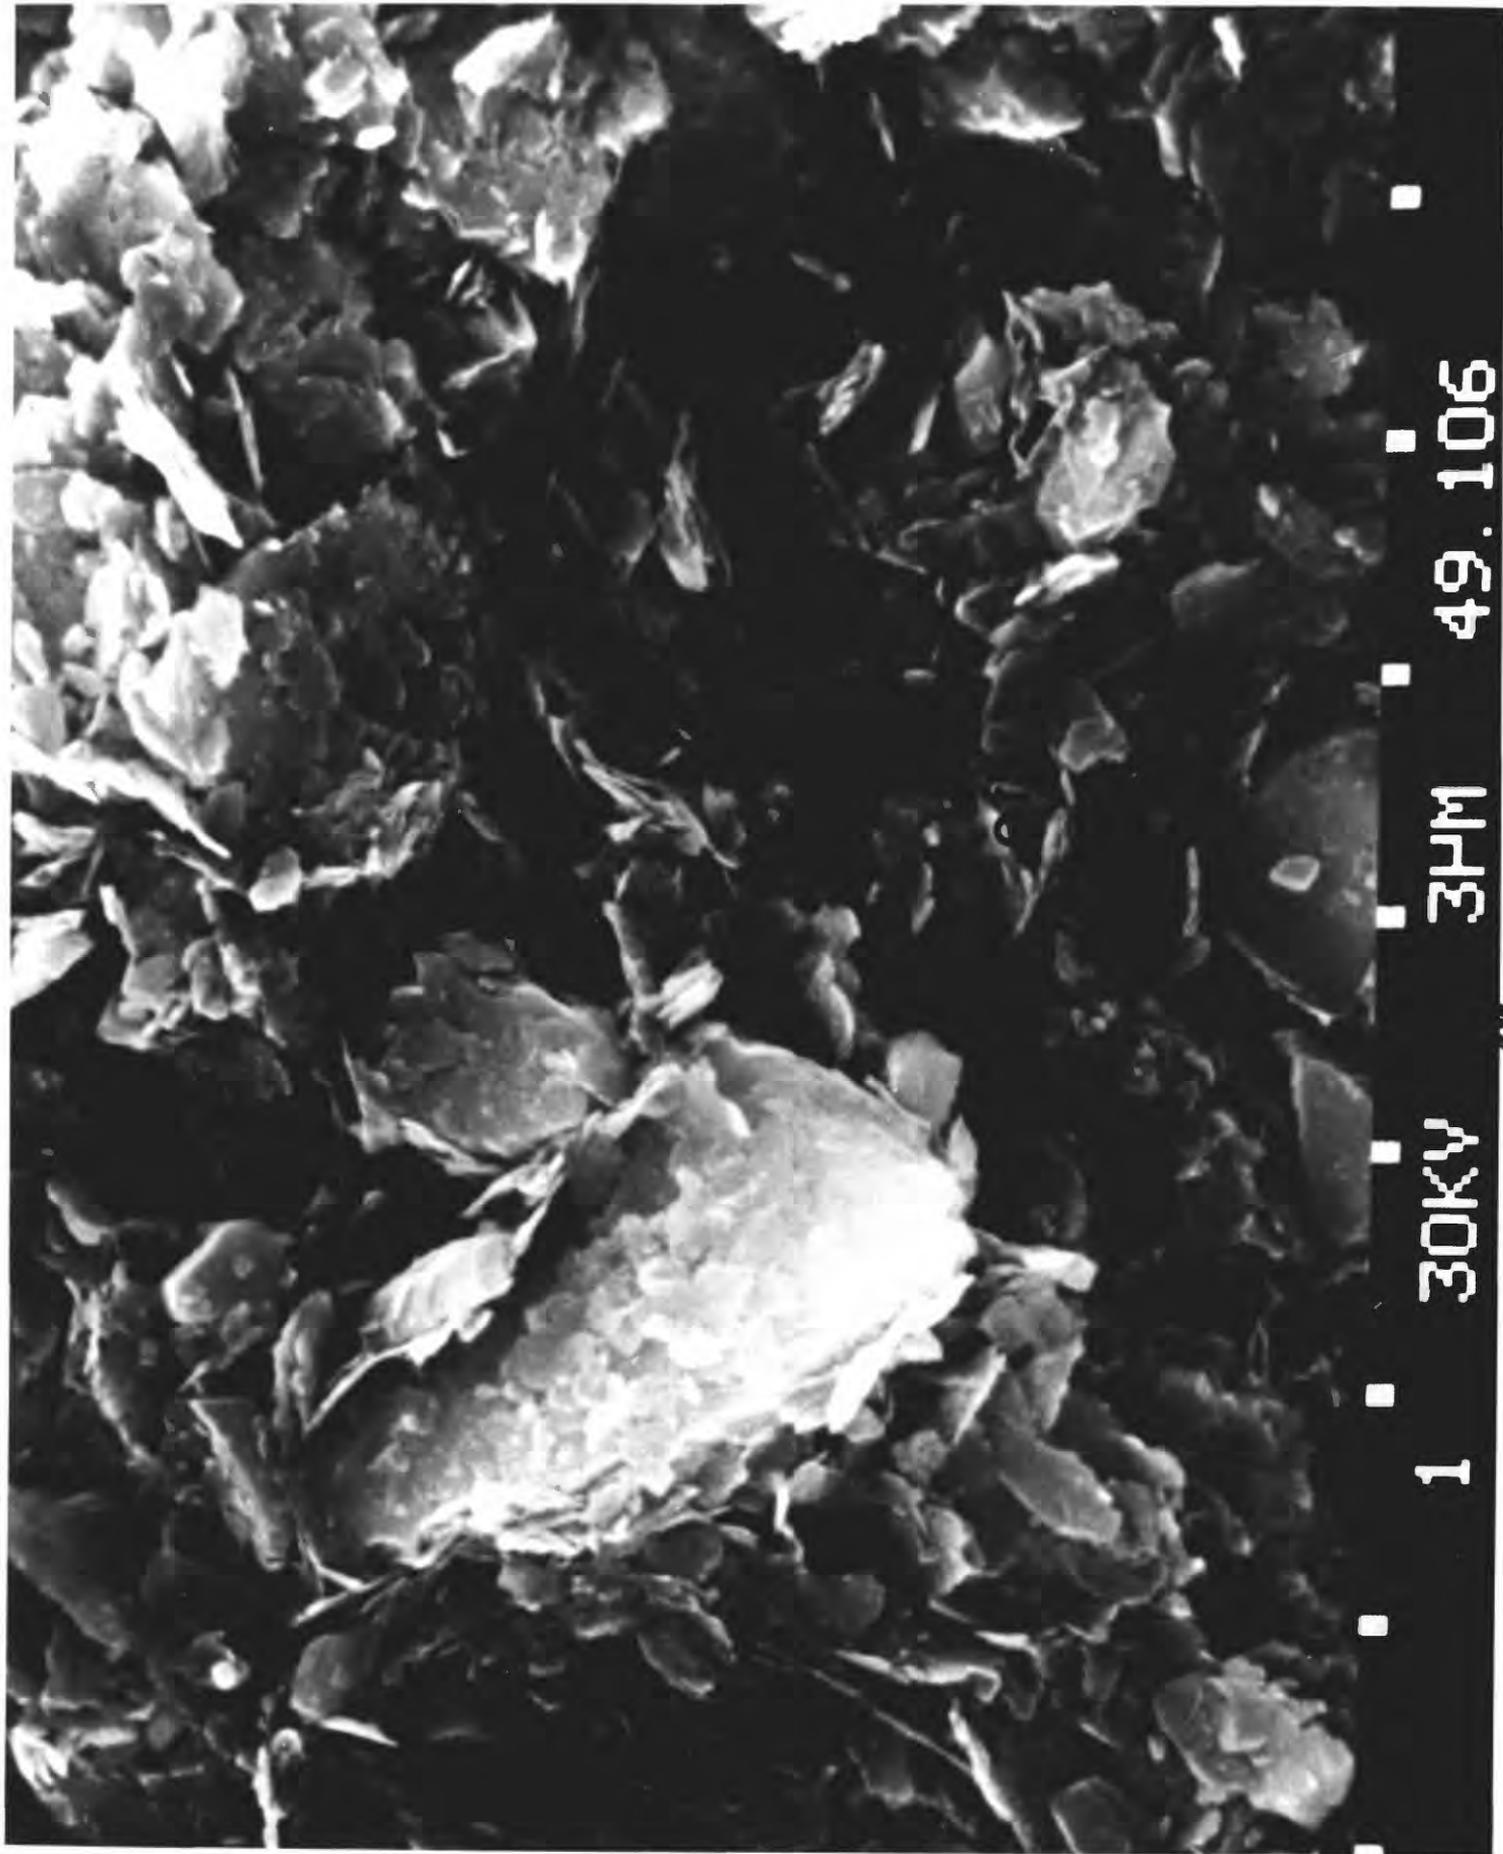
Figure 38. Facies F. IV, parallel to bedding planes, mag. = 3190X. Sample from a core which varied from low to moderate sensitivity. Bedding from upper left to lower right, with alternating silt and clay layers. Clay platelets vary from dispersed (df) to open flocculated (of) fabric in thin layers.

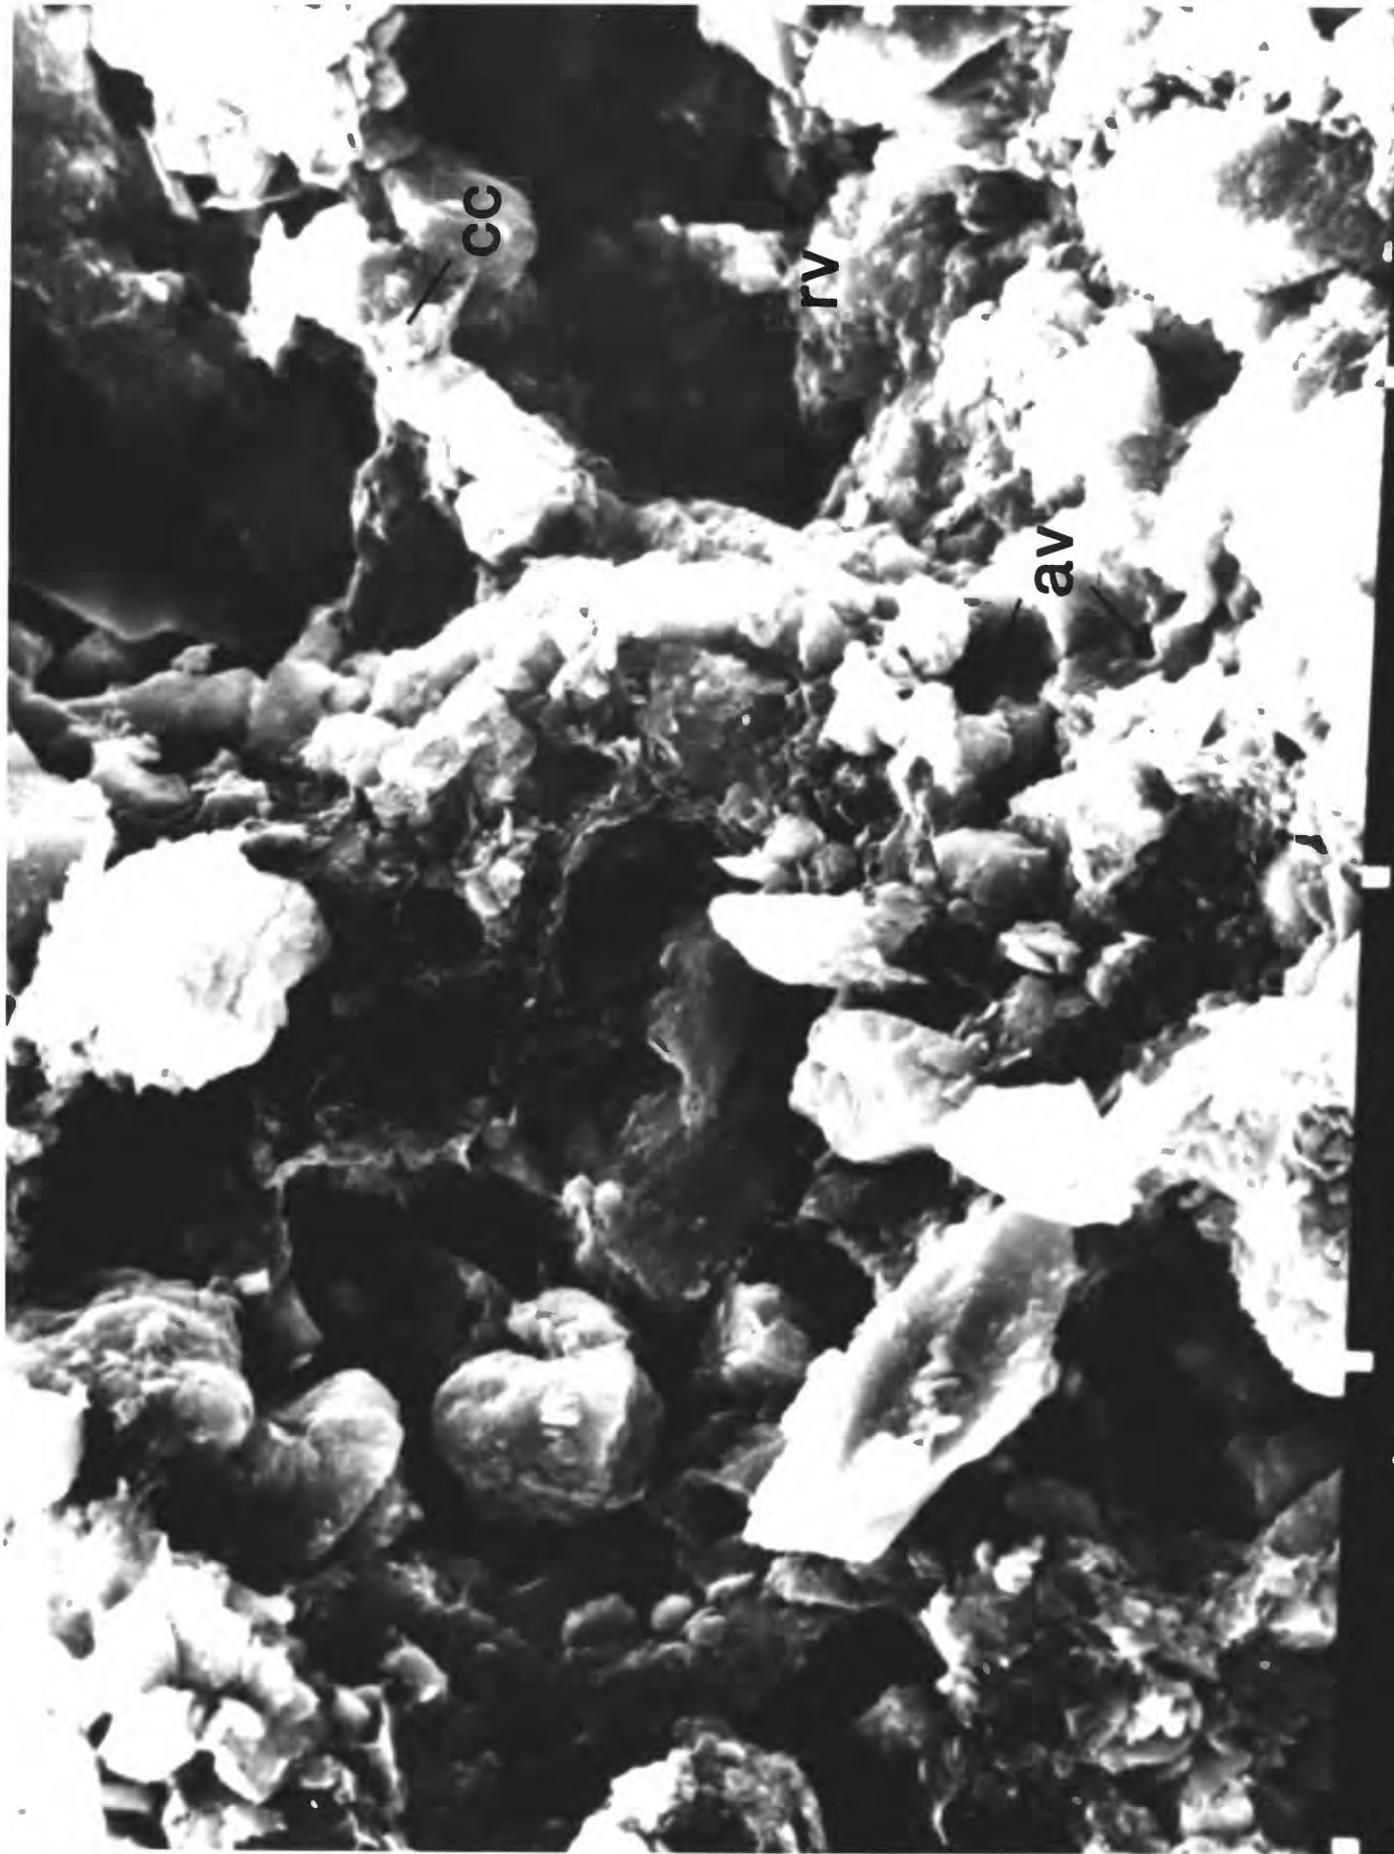
Figure 41. Facies F.IV, parallel to bedding plane, mag. = 5200X. Detail of sinuous clay connector assemblage between silt grains (s). Note intra-assemblage voids (av) and inter-assemblage voids (rv).

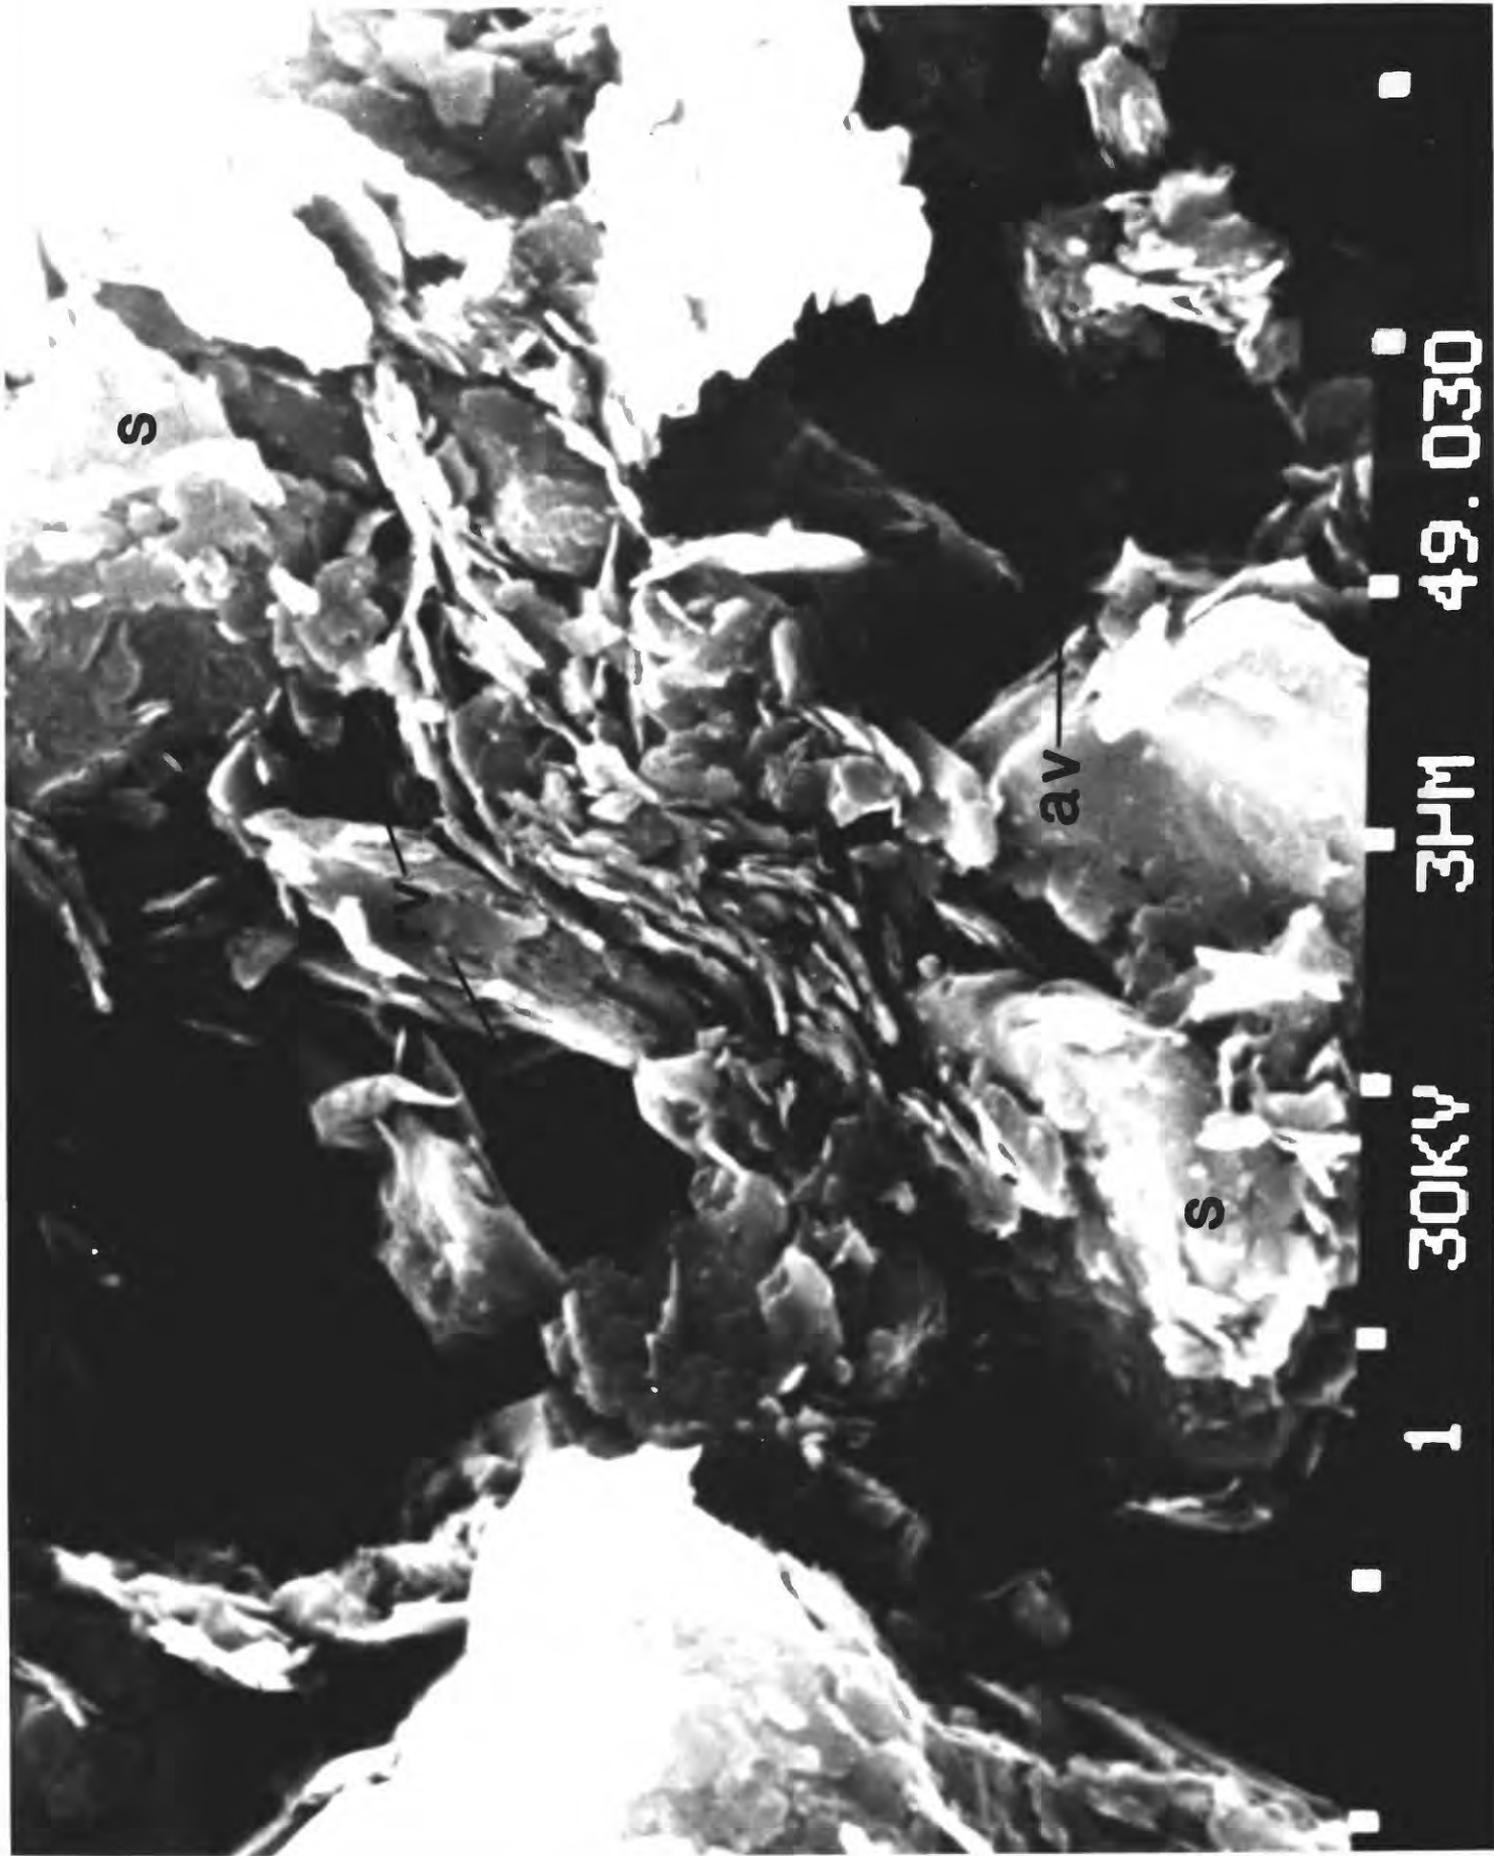
Figure 42. Facies F.IV, parallel to bedding planes, mag. = 5900X. Open-flocculated fabric in high sensitivity zone of a low sensitivity core (see fig. 38). Bedding from upper left to lower right. Note resultant high void ratio that results from boxwork fabric.

the silt grains (figs. 42 and 43). This could be caused by excessive prehistoric loading (for example, by ice) or by shrinkage due to desiccation.

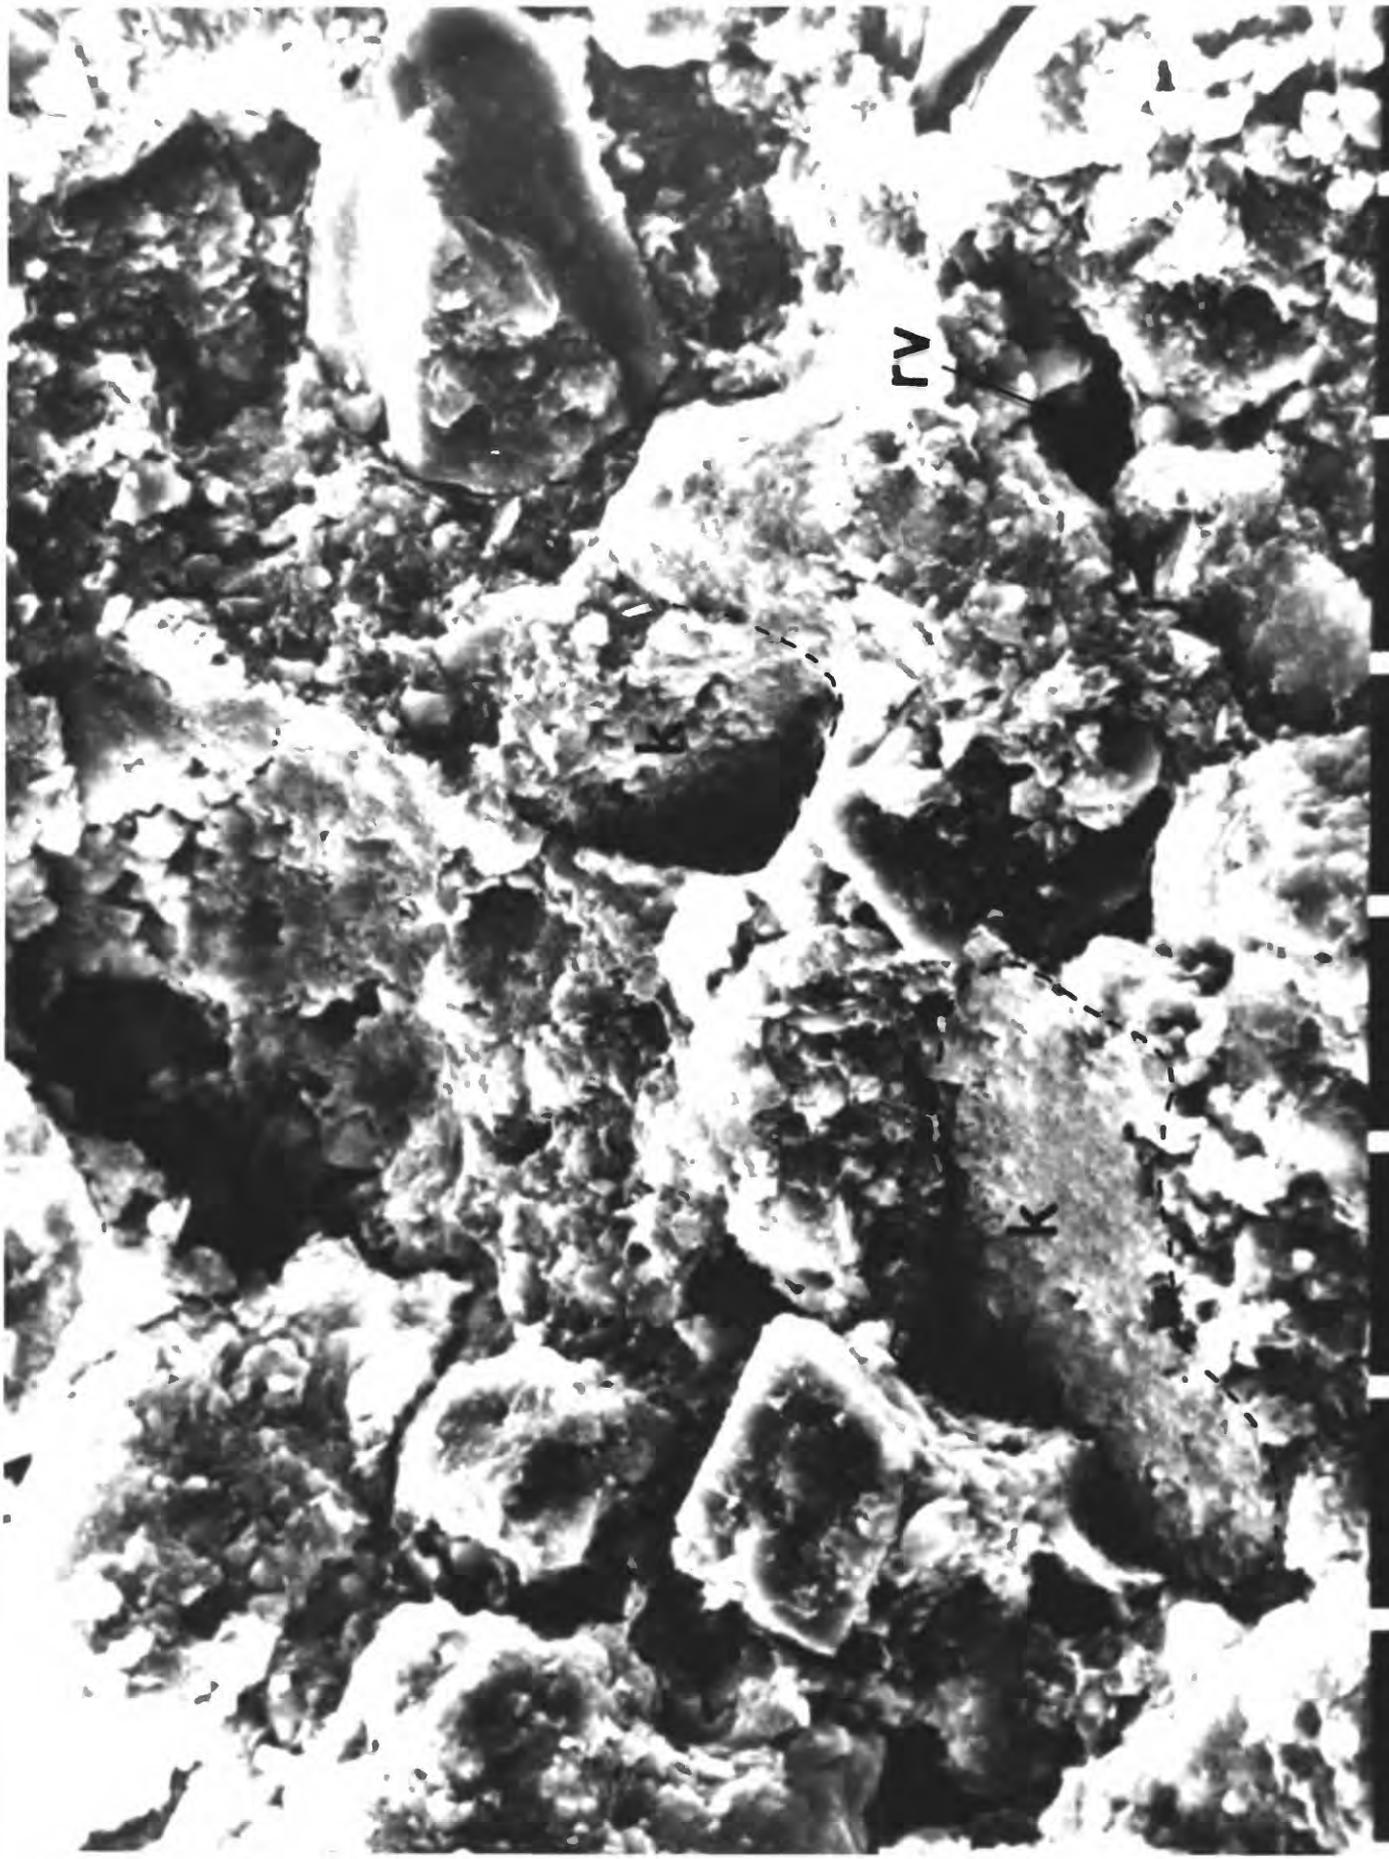
Figure 44. Facies F.V, normal to bedding plane, mag. = 1360X. Higher magnification of compressed fine silt and clay fabric showing detail of casts from plucked coarser clasts (k).

9. The coarse, non-cohesive character of facies F.VII causes it to be outside the capabilities of this study. A few samples of F.VI were successfully prepared and examined (figs. 44 through 47). Where clays were present they served as connectors between the silt and fine sand grains. Some iron oxide precipitates were noted between and coating the grains, but both clay connectors and precipitates were often nearly absent. Moderate to dense packing apparently accounts for the observed high penetration resistance (e.g., see Updike, 1984).
