U.S. GEOLOGICAL SURVEY

An Atlas of Facies Microfabrics of the Bootlegger Cove Formation
Using the Scanning Electron Microscope

Revised 10 November 1986

Open-File Report 87-60

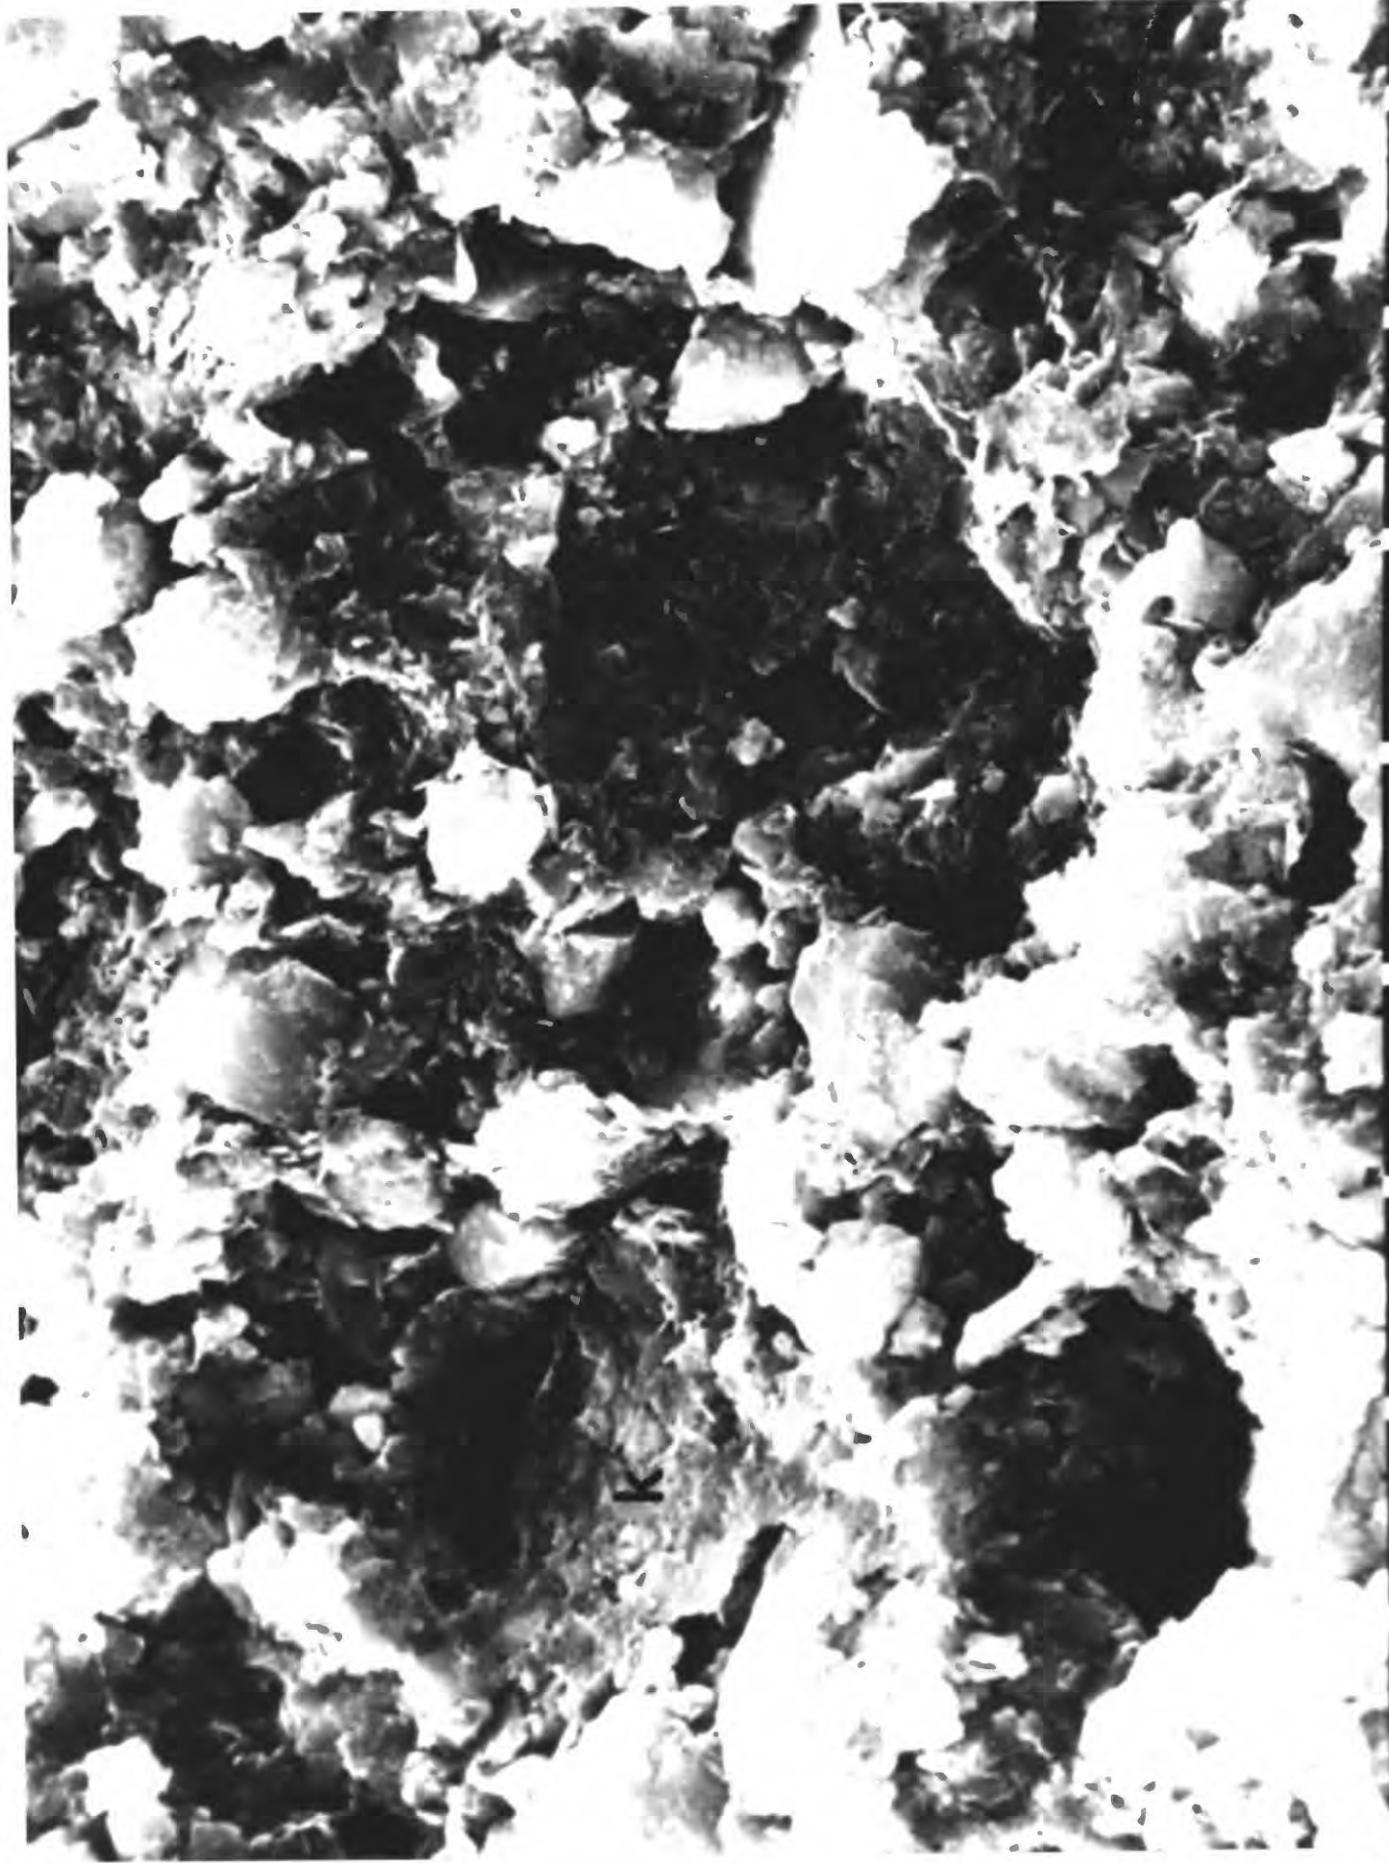
Figure 45. Facies F.VI within F.IV, normal to bedding plane, mag. = 320X. Medium to coarse silt, with fine sand. Note minor role of clay connector assemblages (cc), general angularity of grains, lack of cementation, and clean interparticle voids. Compare to figures 46, 47, and 48, at similar magnifications, which show clay connectors.

9. The coarse, non-cohesive character of facies F.VII causes it to be outside the capabilities of this study. A few samples of F.VI were successfully prepared and examined (figs. 44 through 47). Where clays were present they served as connectors between the silt and fine sand grains. Some iron oxide precipitates were noted between and coating the grains, but both clay connectors and precipitates were often nearly absent. Moderate to dense packing apparently accounts for the observed high penetration resistance (e.g., see Updike, 1984).

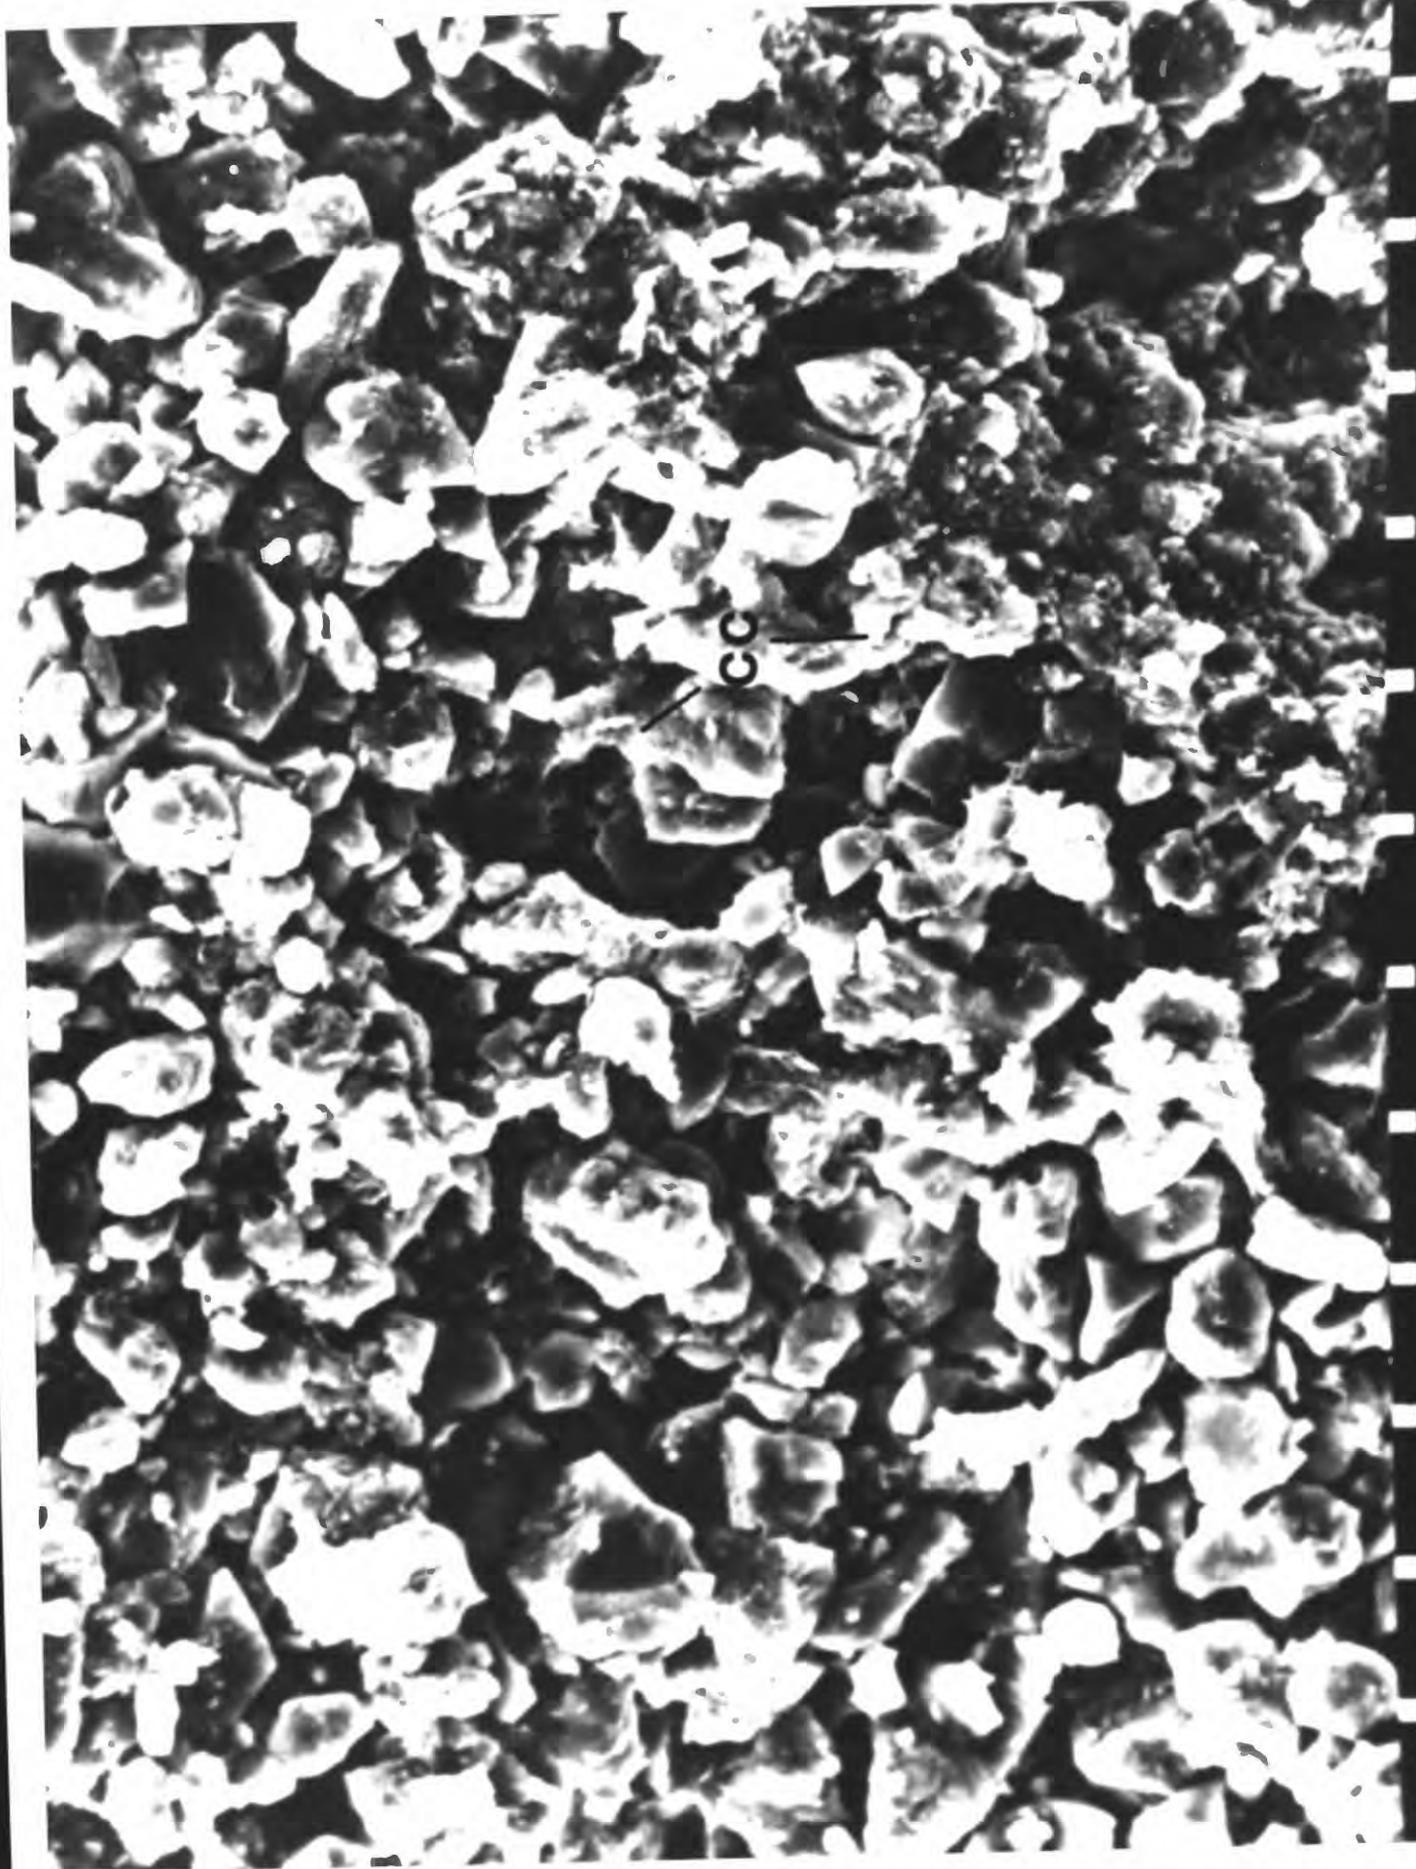
Figure 46. Facies F.VI within F.IV, normal to bedding planes, mag. = 320X. Angular coarse silt to very fine sand in a compact fabric with grain-to-grain contacts and minor development of connectors (cc). Some chemical precipitates (cp) on grain surfaces. Compare to figures 45 and 47 at similar magnification.

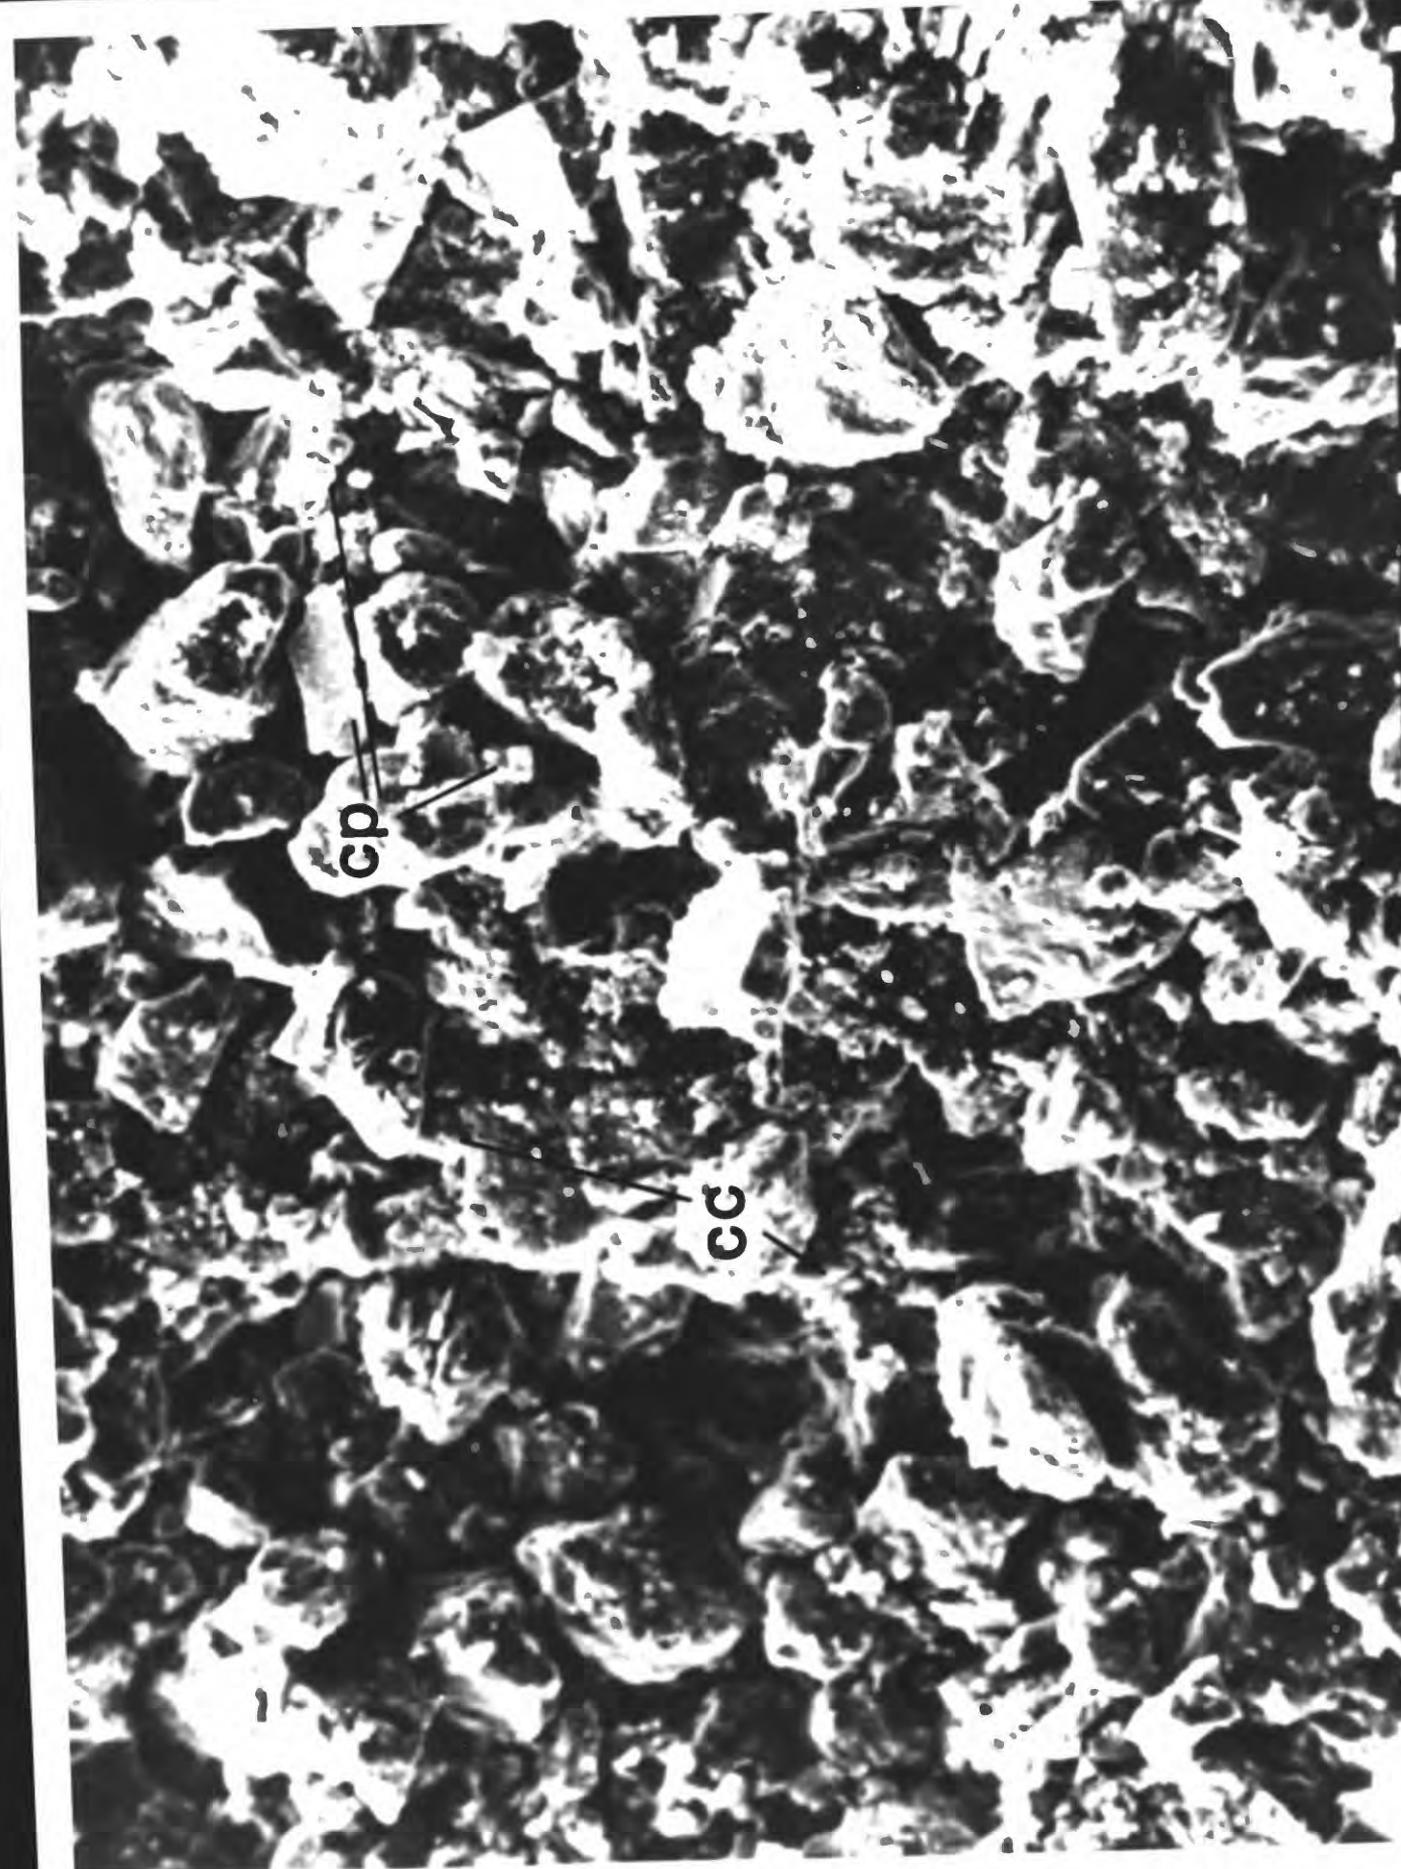
Figure 47. Facies F.VI within F.IV, parallel to bedding plane, mag. = 900X. Silt-dominant zone with chemical precipitate connectors. Bedding approximately left to right. See detail of boxed area in figure 48.
