**THE FLOODS OF MAY 17-18, 1985
AND
OCTOBER 6-7, 1985 IN PUERTO RICO**

**U.S. GEOLOGICAL SURVEY
OPEN-FILE REPORT 87-123**

**Prepared in cooperation with the
PUERTO RICO DEPARTMENT OF NATURAL RESOURCES,
PUERTO RICO ENVIRONMENTAL QUALITY BOARD,
AND PUERTO RICO HIGHWAY AUTHORITY**

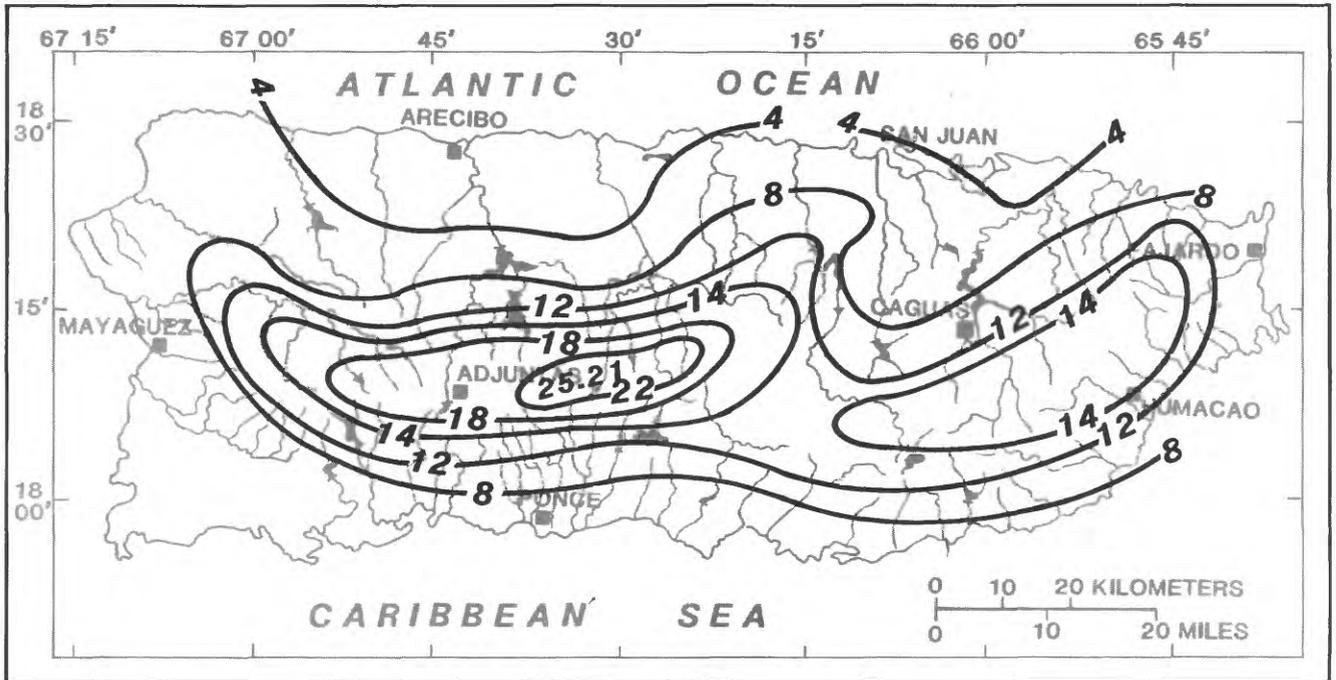
Figure 2.--Cumulative precipitation (isohyets in inches) over Puerto Rico during May 15-19, 1985.

Precipitation totals for the 5 days of the storm ranged from 8 to 25 inches (fig. 2). The most intense rainfall occurred over an area extending west of a north-south line at the town of Orocovis toward Mayaguez. A second cell of less intense rainfall affected the Río Grande de Loíza basin, in the eastern part of the island. The recorded precipitation total for the 5-day period May 15-19 was 25.21 inches at Jayuya. Precipitation totals for the 5-day period at individual stations operated by the NWS-NOAA are summarized in table 1.

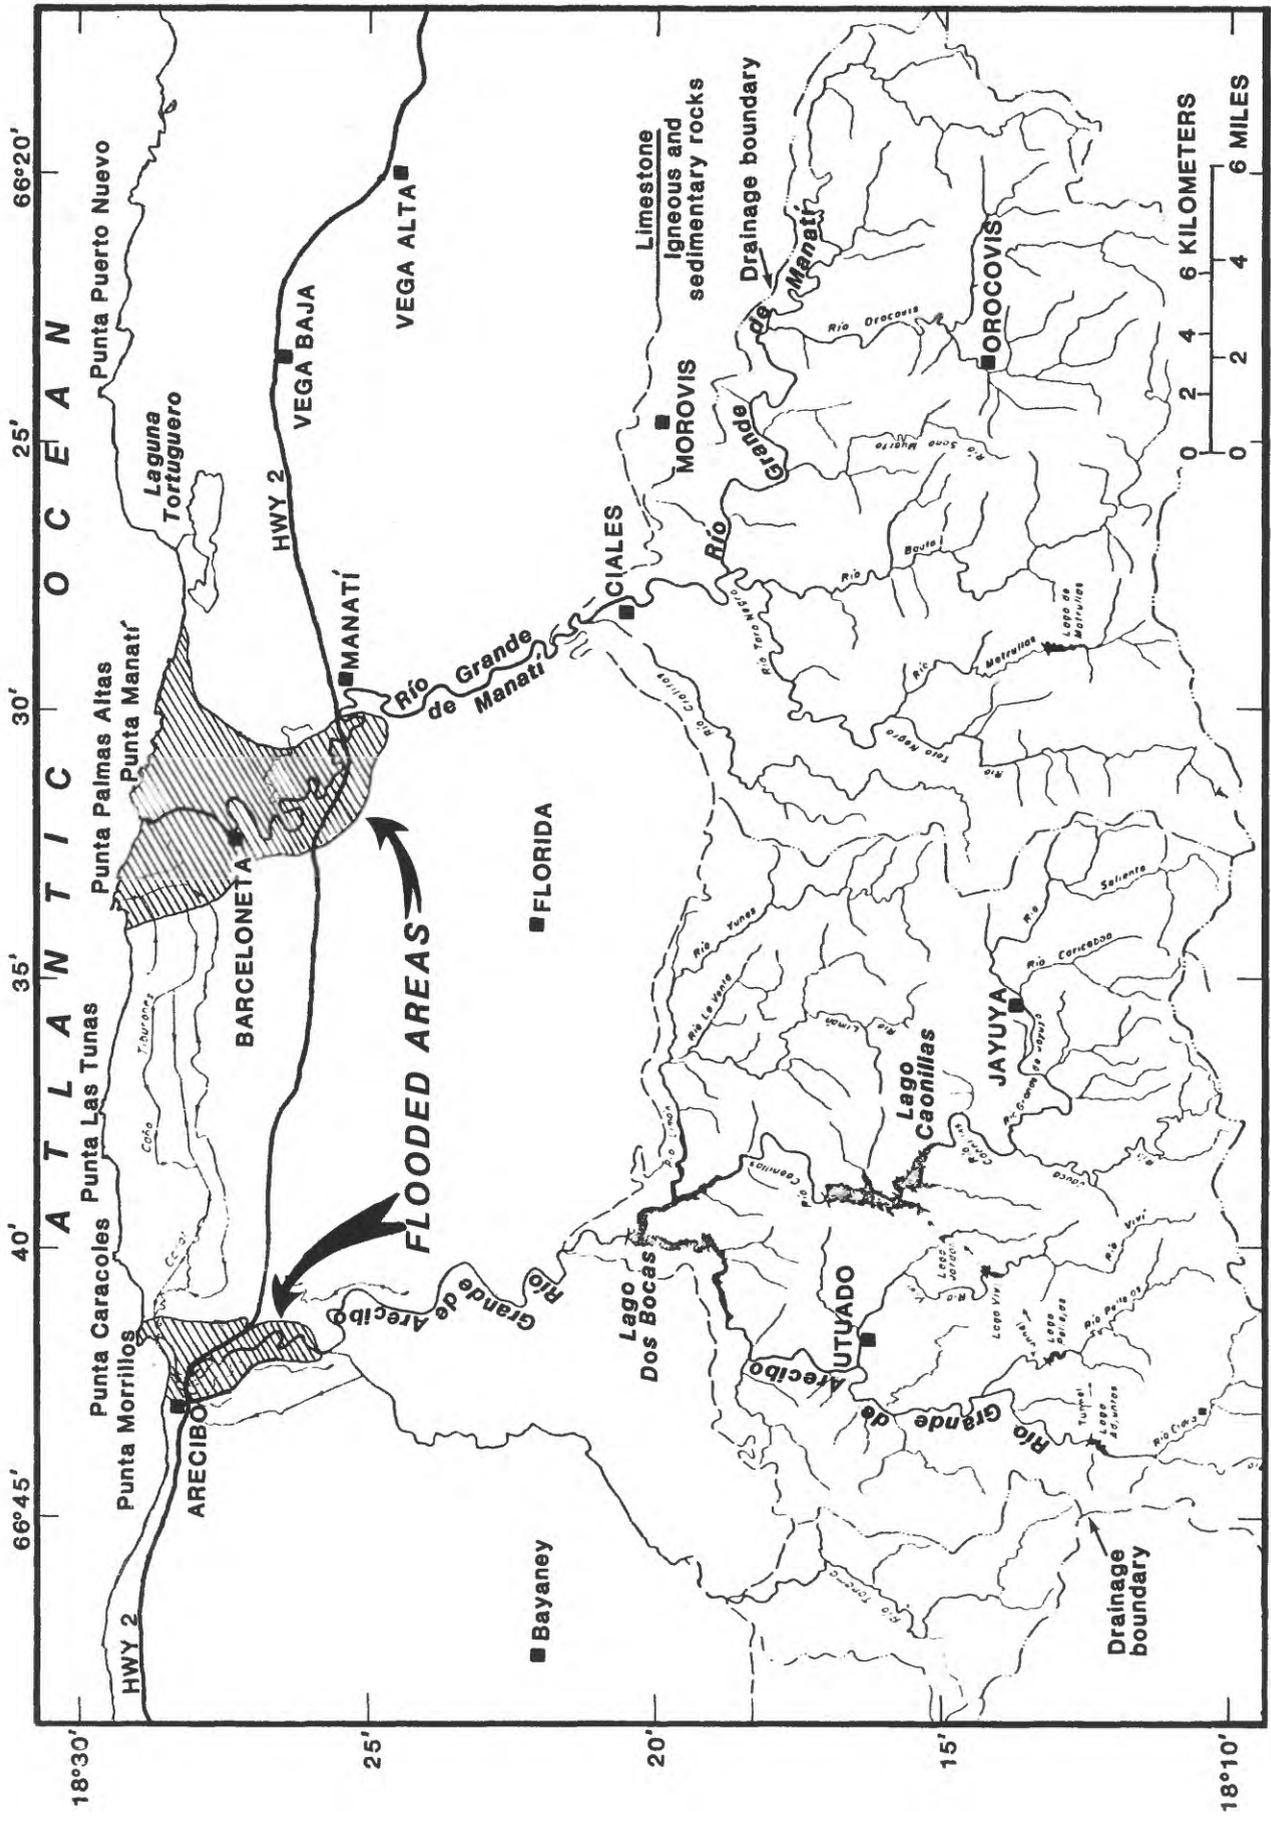
Figure 3.--Areas in Puerto Rico where flooding was most severe during May 1985.

The worst flooding occurred at Arecibo and Barceloneta, (fig. 3). The flooding at Arecibo covered slightly less area than during the 1928 record flood (Hickenlooper, 1968). The flood at the town of Barceloneta was lower and inundated a lesser area than the 1970 flood. Undefined conditions appear to have caused backwater effects in several areas in Barceloneta on the Río Grande de Manatí flood plain. The floods at the towns of Jayuya and Utuado were lower than the record floods of 1975 (Johnson, 1982).

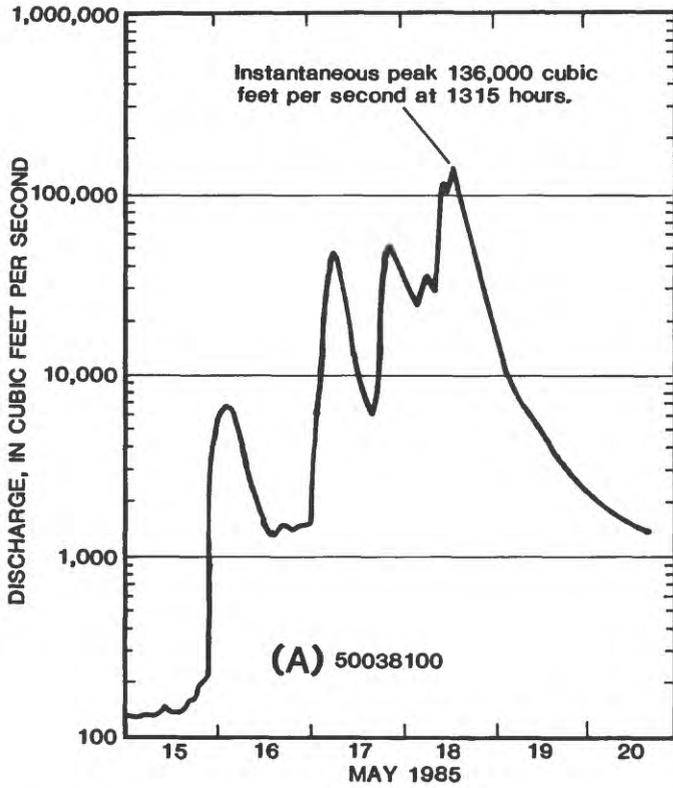
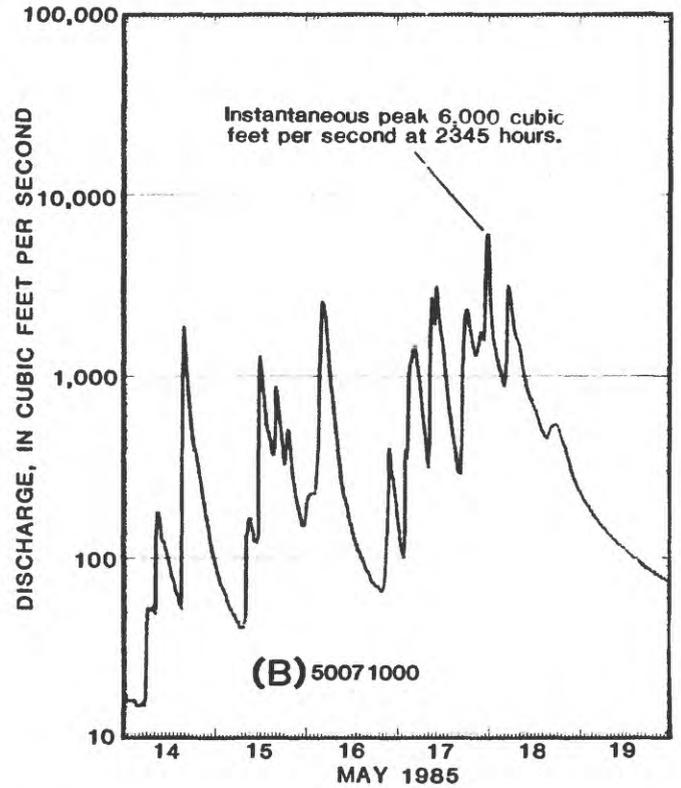
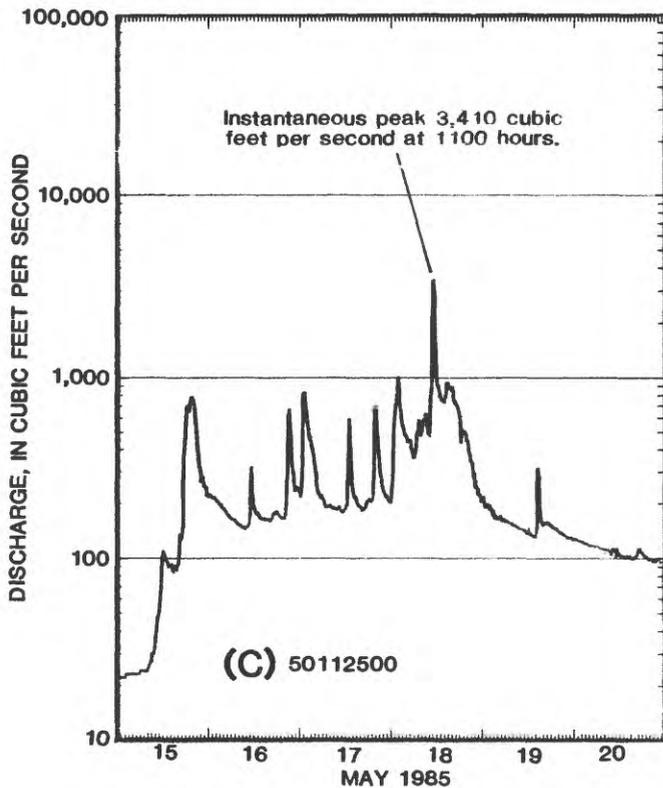
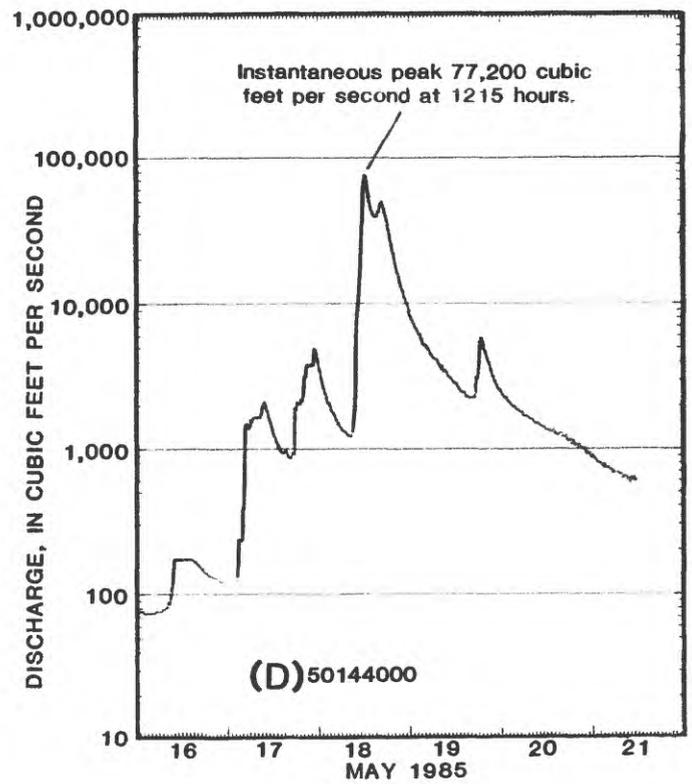
Figure 5.--Discharge hydrographs at key streamflow gaging stations during the May 15-19, 1985 floods at: (A) Río Grande de Manatí at Highway 2, near Manatí, (B) Río Fajardo near Fajardo, (C) Río Inabón at Real Abajo, and (D) Río Grande de Añasco near San Sebastián.

The U.S. Geological Survey collected peak stage and flow data from its network of gaging stations throughout Puerto Rico (fig. 4). At sites where recording instruments failed or were damaged during the floods, high-water marks were surveyed shortly after the event to determine the peak stage and discharge. Flood stages, discharges, and other information pertinent to the gaging stations are summarized in table 2. Flood hydrographs at key gaging stations for the period from May 15-21, 1985 are shown in figures 5a to 5d.

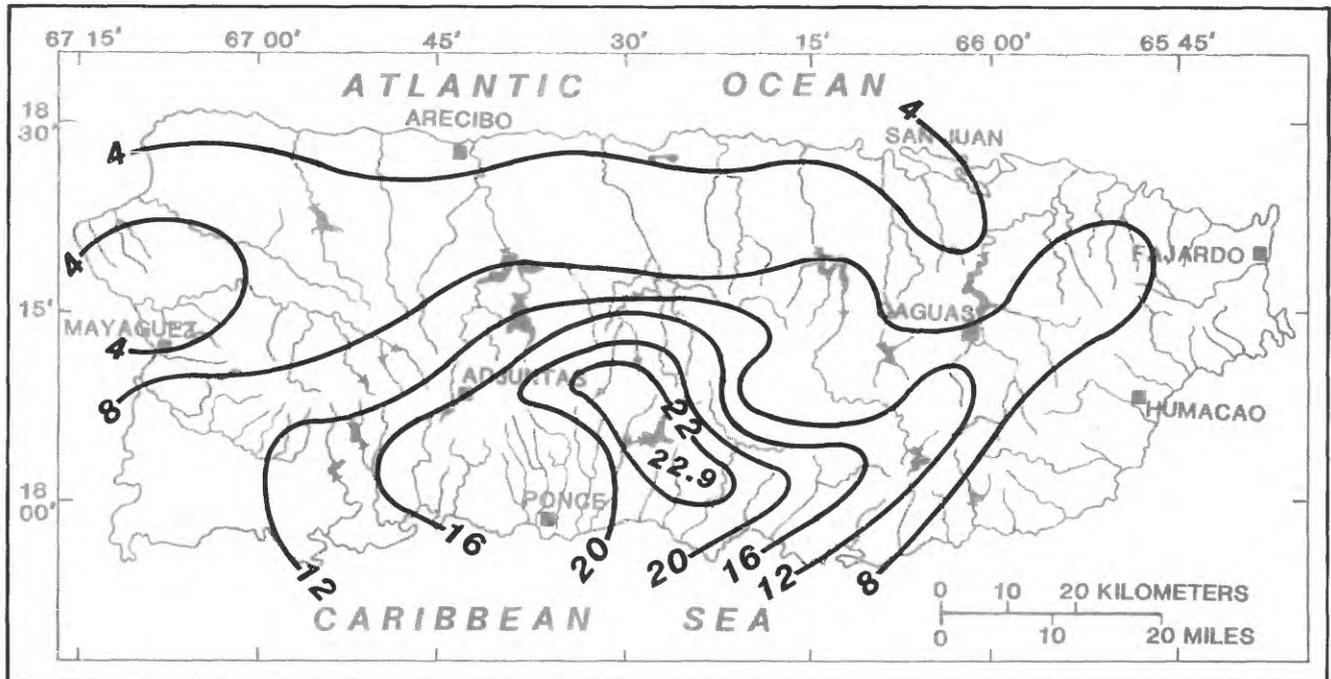
Figure 6.--Cumulative precipitation (Isohyets in inches) over Puerto Rico during October 6-7, 1985.

Intense precipitation induced by a nearly stationary tropical depression occurred over most of southern Puerto Rico during October 6-7, 1985. As much as 23 inches of rainfall occurred north of the towns of Ponce and Coamo during a 24-hour period (fig. 6). The intensity of the precipitation near the town of Peñuelas (fig. 7) was as high as 2.75 inches in one hour and 5.5 inches in two hours. The rainfall was equally distributed between the afternoon of October 6 and the early hours of October 7. Less intense precipitation occurred on October 5. Similarly less intense precipitation occurred on October 8 after the very intense storm of October 7. Precipitation totals for the 4-day period (October 5-8) were as high as 30.66 inches (table 3).

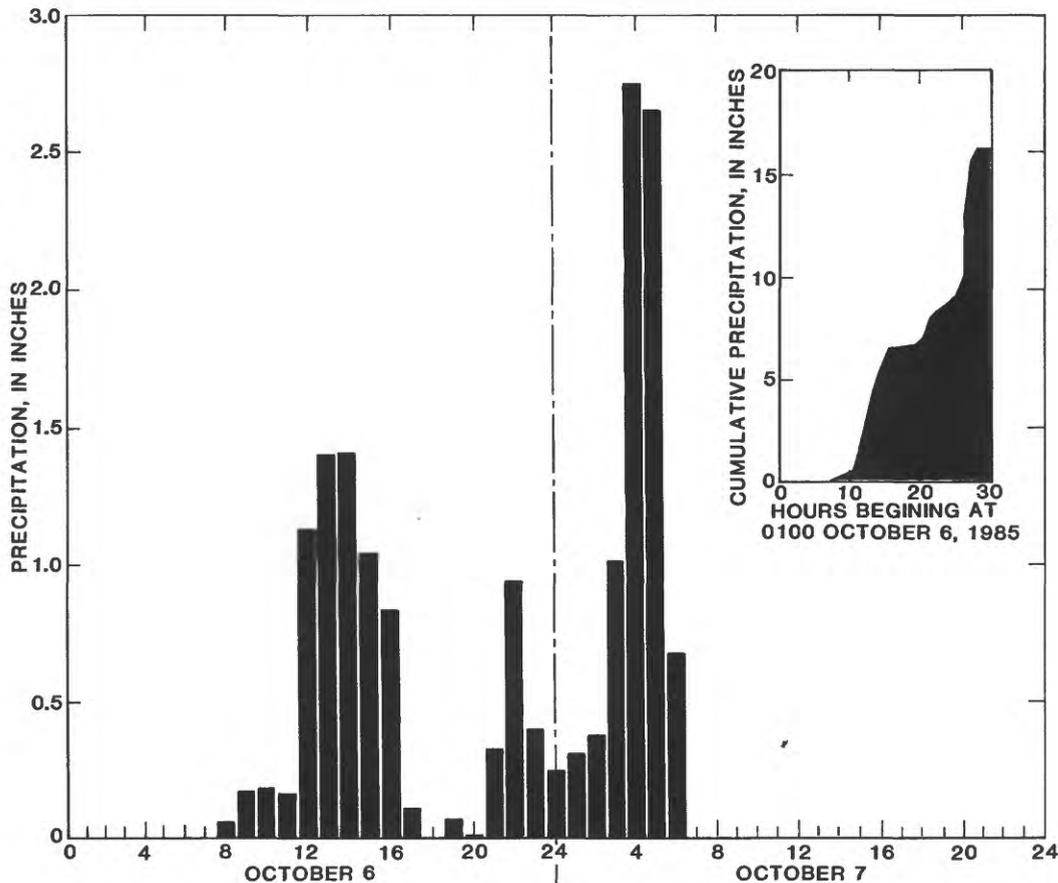
Figure 7.--Hourly and cumulative rainfall during October 6-7, 1985 at Tallaboa gage near Peñuelas, southern Puerto Rico. (Data courtesy of Puerto Rico Energy Power Authority.)

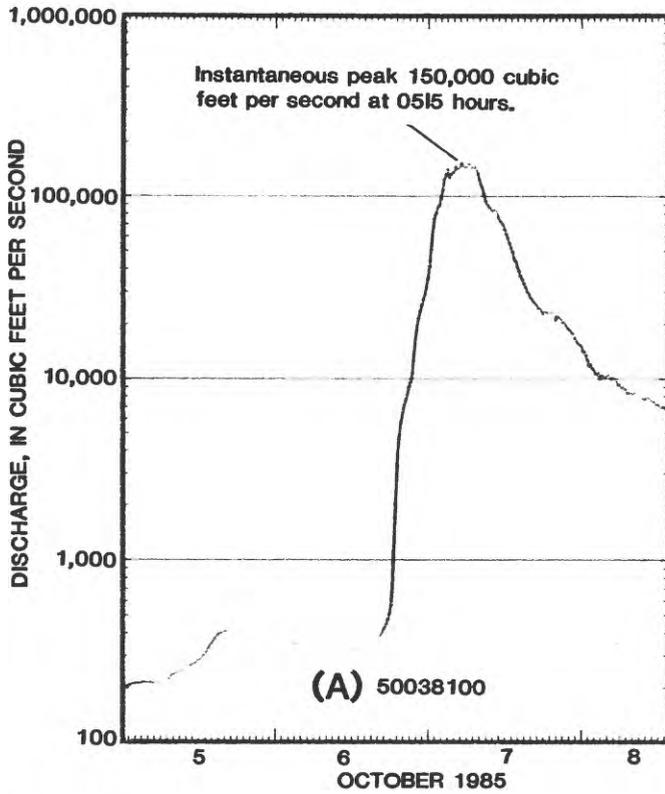
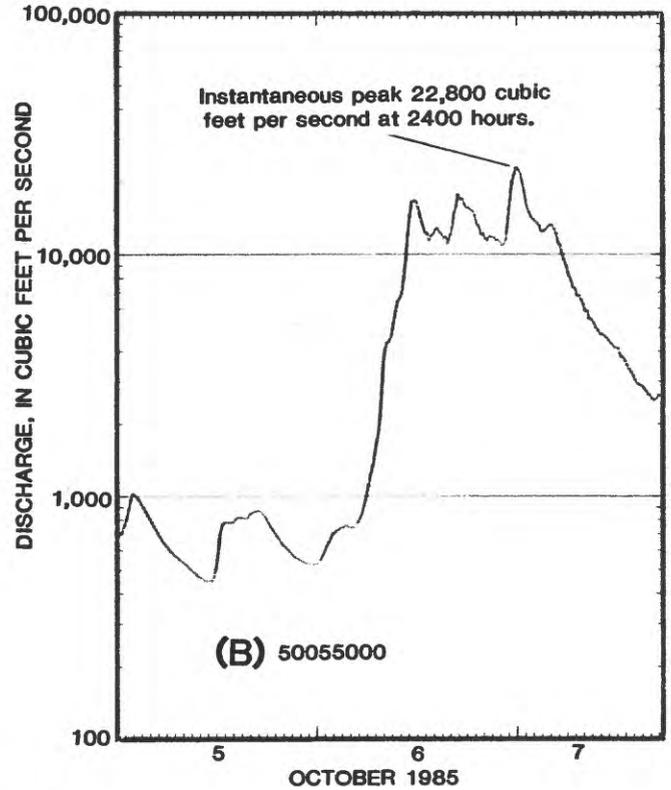
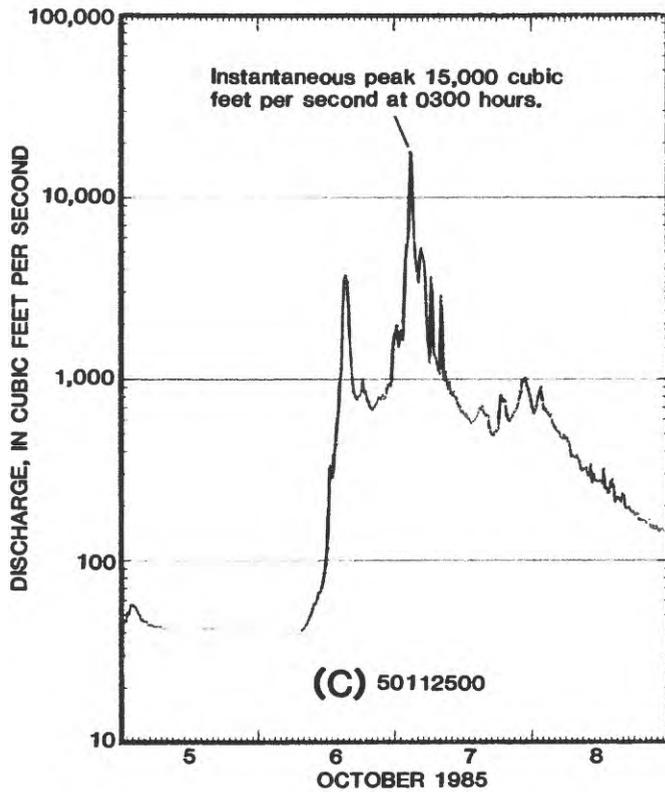
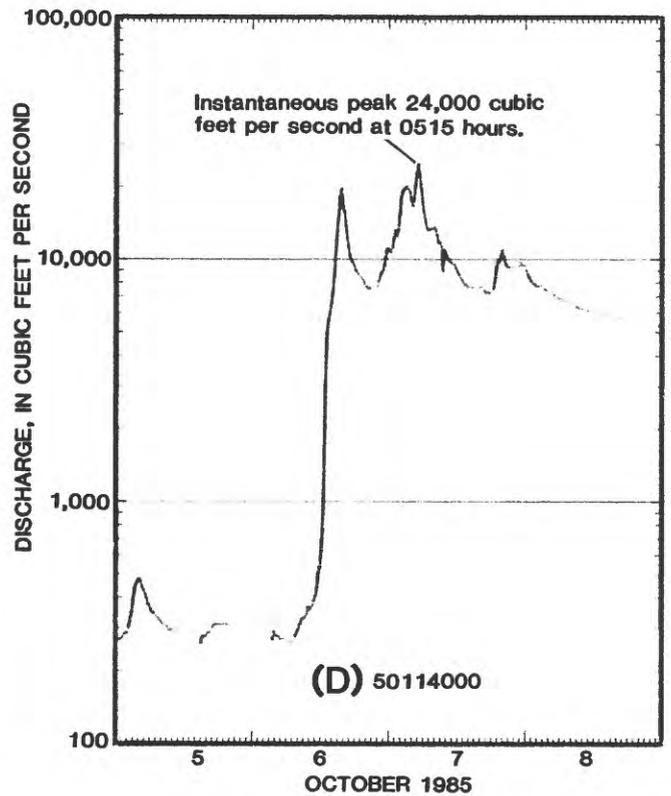
Figure 9.--Discharge hydrographs at key streamflow gaging stations during the October 6-7, 1985 floods at:
(A) Río Grande de Manatí at Highway 2 near Manatí,
(B) Río Grande de Loíza at Caguas,
(C) Río Inabón at Real Abajo, and
(D) Río Cerrillos near Ponce.

The U.S. Geological Survey collected peak stage and discharge information during and after the floods throughout its network of gaging stations in Puerto Rico. Historical peak flows were recorded at several stations in the network. These included gaging stations at the Río Coamo, the Río Inabón, the Río Descalabrado, the Río Jacaguas, the Río Cerrillos, the Río Portugués, and the Río Grande de Manatí (table 4). Recurrence intervals equal to or greater than 100 years were estimated for most of the peaks recorded at the gaging stations from Santa Isabel to Ponce. Discharge hydrographs at key gaging stations showed that the peak discharges occurred during the early hours of October 7 (fig. 9).

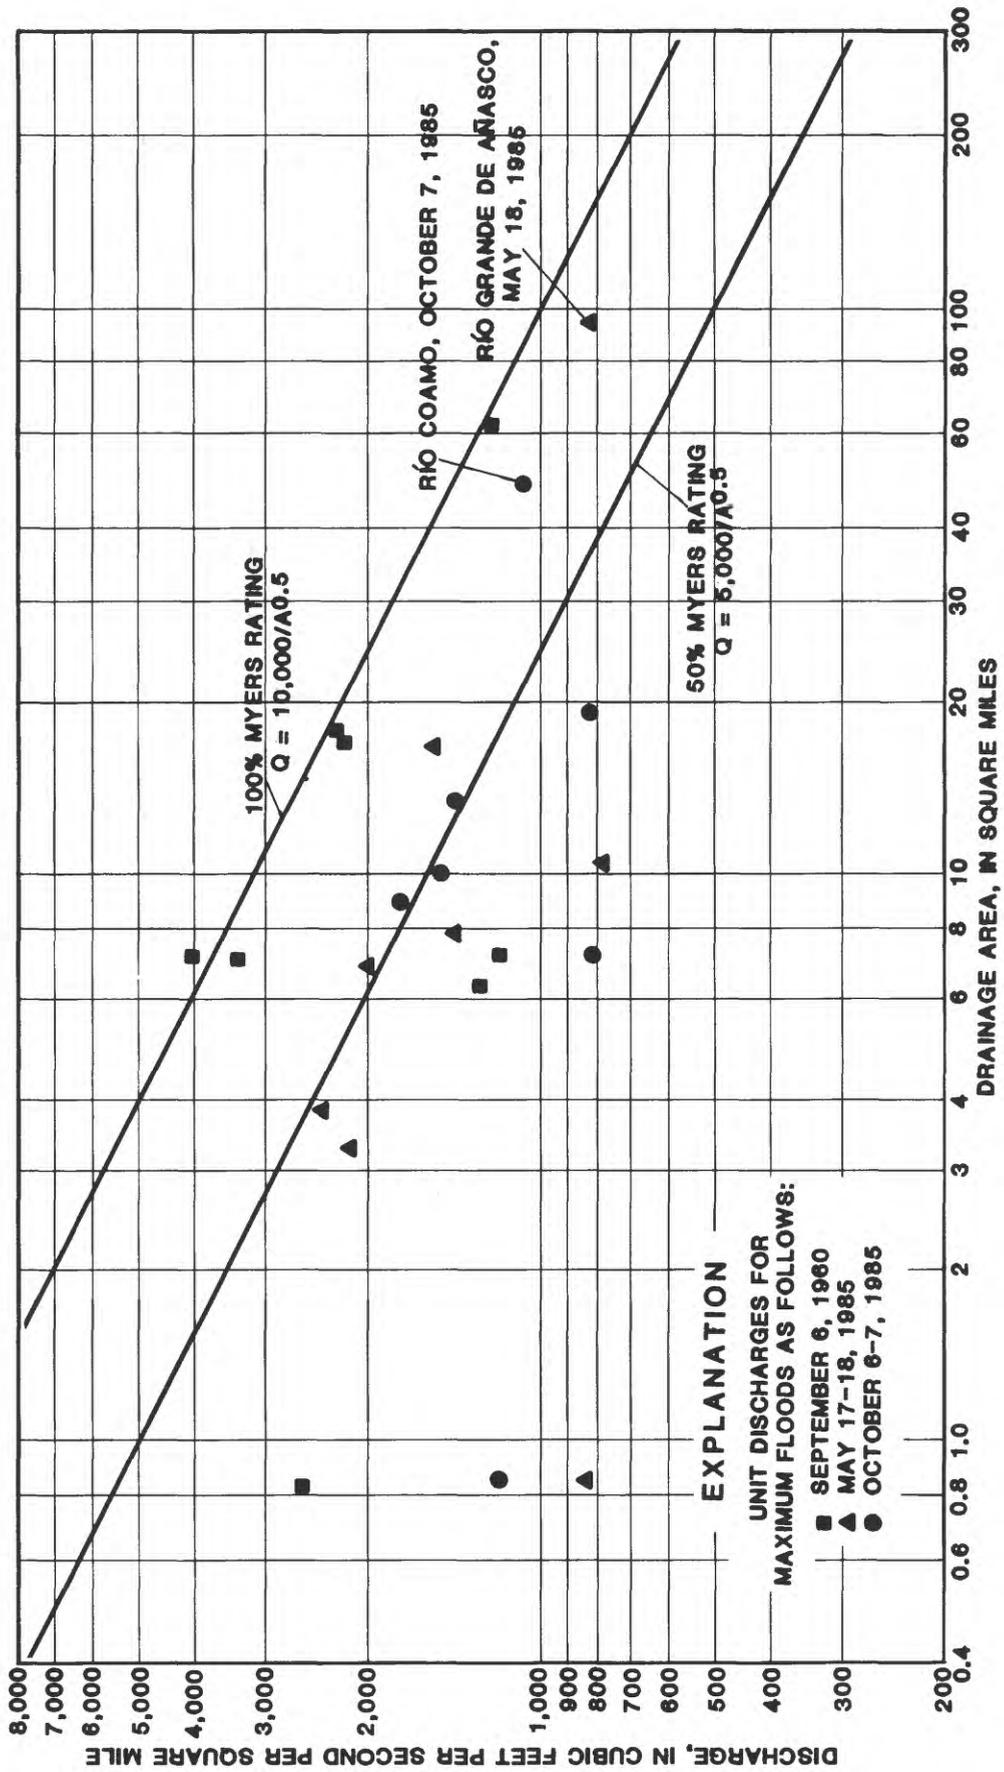
Figure 11.--Comparison of unit discharges during the 1960 and 1985 floods in Puerto Rico.

The upper line in figure 11 represents the maximum known floods in the world expressed as a correlation between the unit discharge and the drainage area by the equation $Q = 10,000/\sqrt{A}$. This is commonly referred to as the "100 percent Myers rating." The lower line represents the "50 percent Myers rating" expressed by the equation $Q = 5,000/\sqrt{A}$.

The data from the 1985 floods show that the unit discharges were not as high as the 1960 events. At least five (5) events during the 1960 floods approached the 100 percent Myers rating. In general, unit discharges for the 1985 floods were in the vicinity of the 50 percent Myers curve. The only events of the 1985 floods that approached the record 1960 unit discharges occurred at the Río Grande de Añasco near San Sebastián during the May event (table 2) and, the Río Coamo near Coamo during the October event (table 4).

The "Myers Rating" method can be utilized to compare the intensity of floods from different basins and/or different events (Haire, 1972). In the Myers's technique, the unit discharge (flow per unit area) of a particular flood is compared with the maximum known floods throughout the world or in the study area. In Puerto Rico, the most recent extreme floods occurred in 1960, 1970, and 1975. Data from the 1960 floods and the 1985 floods were compared using the Myers's technique (fig. 11).

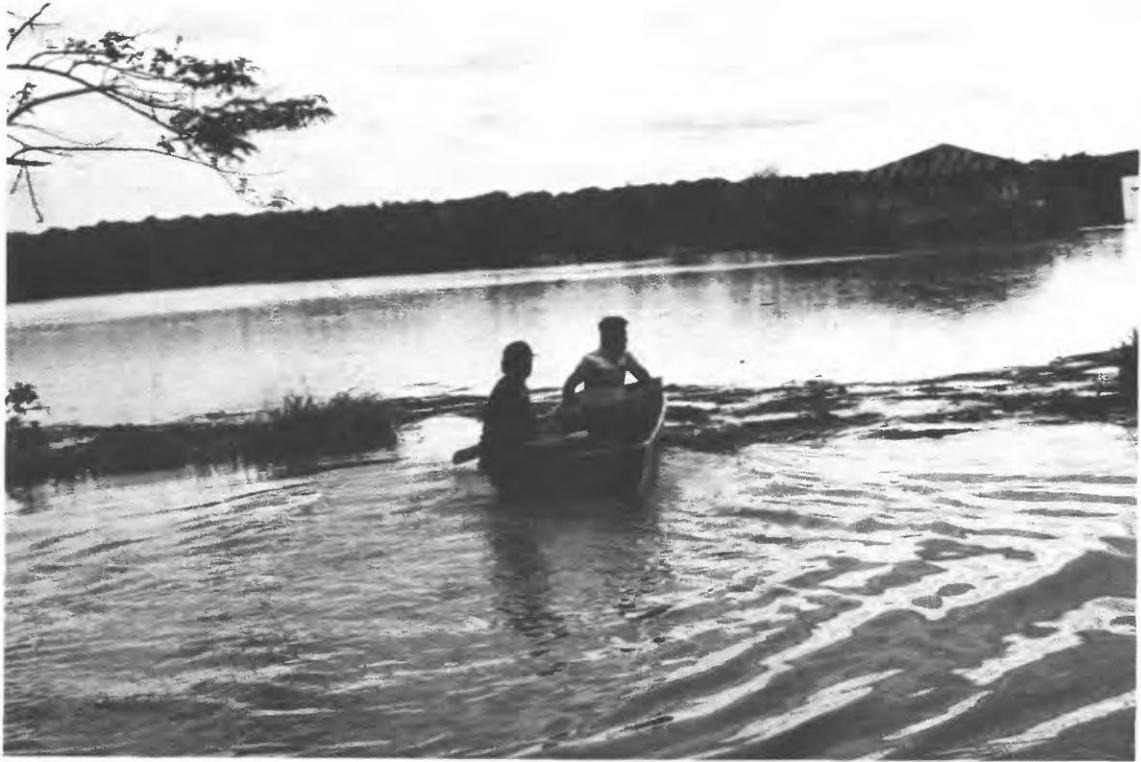
Río Grande de Arecibo at Sector Santa Bárbara, near Arecibo, May 19, 1985.

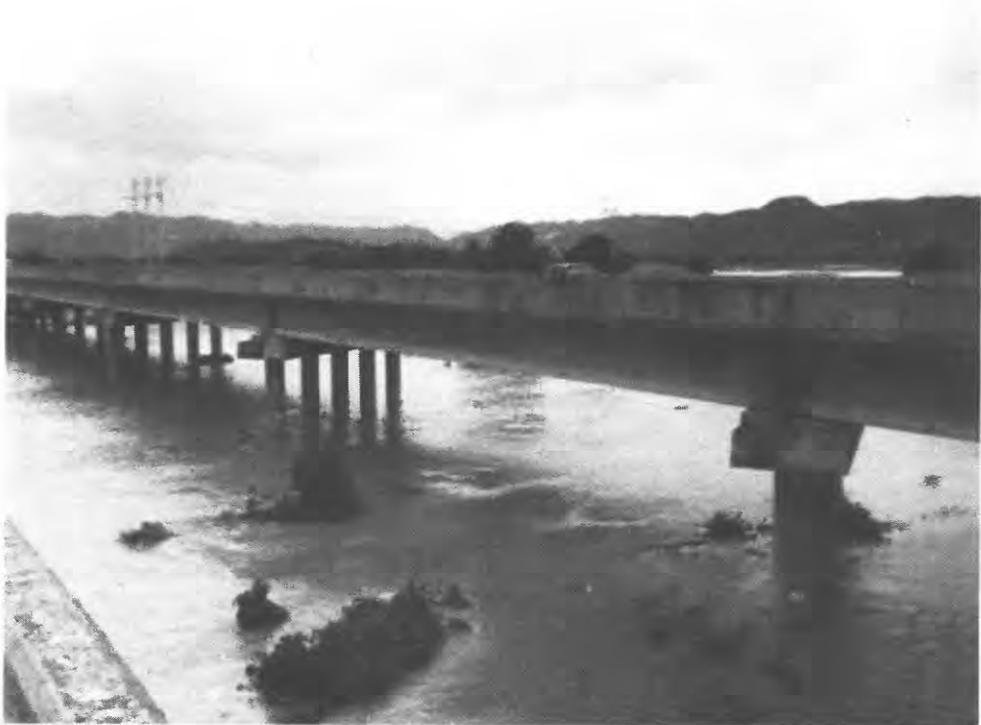
Río Grande de Arecibo at De Diego Expressway bridge in Arecibo, May 19, 1985.

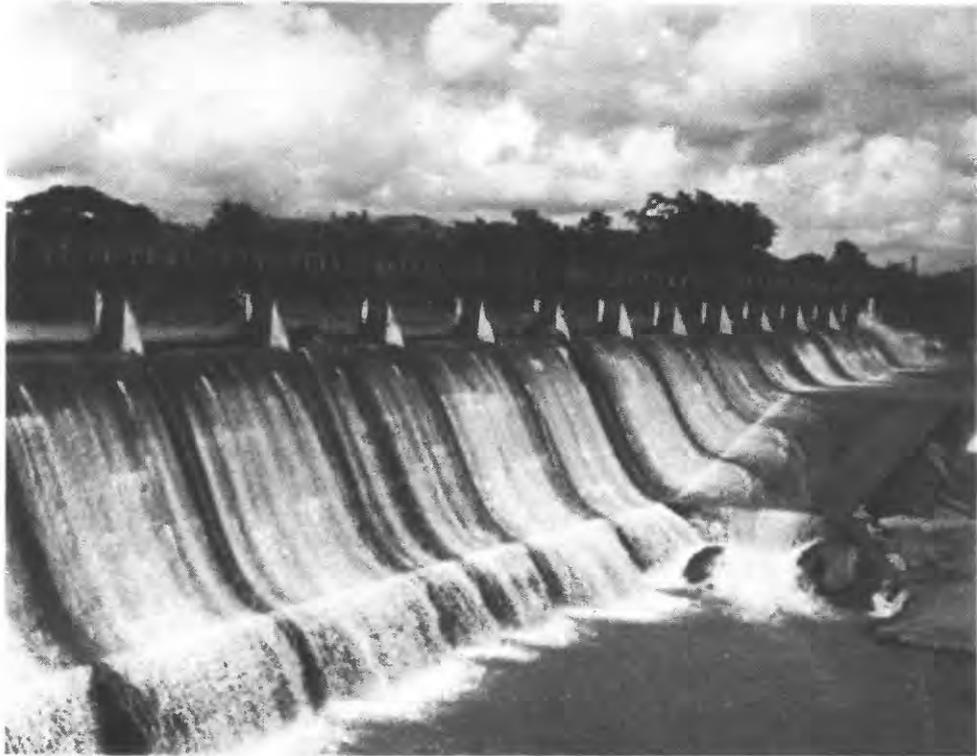
Coamo Dam, downstream side, October 8, 1985.

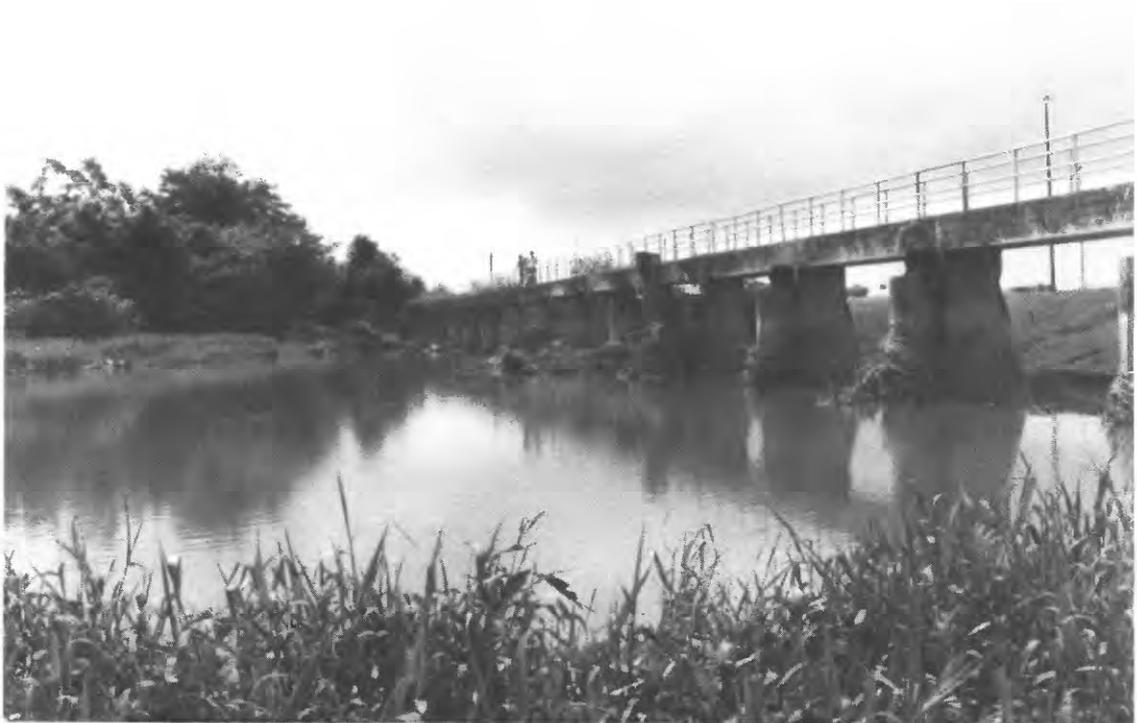
Lago Coamo at Coamo dam, October 20, 1985.
