DEPARTMENT OF THE INTERIOR

**CATALOG OF ALINEMENT ARRAY MEASUREMENTS IN CENTRAL
AND SOUTHERN CALIFORNIA FROM 1983 THROUGH 1986**

Open-File Report 87-280

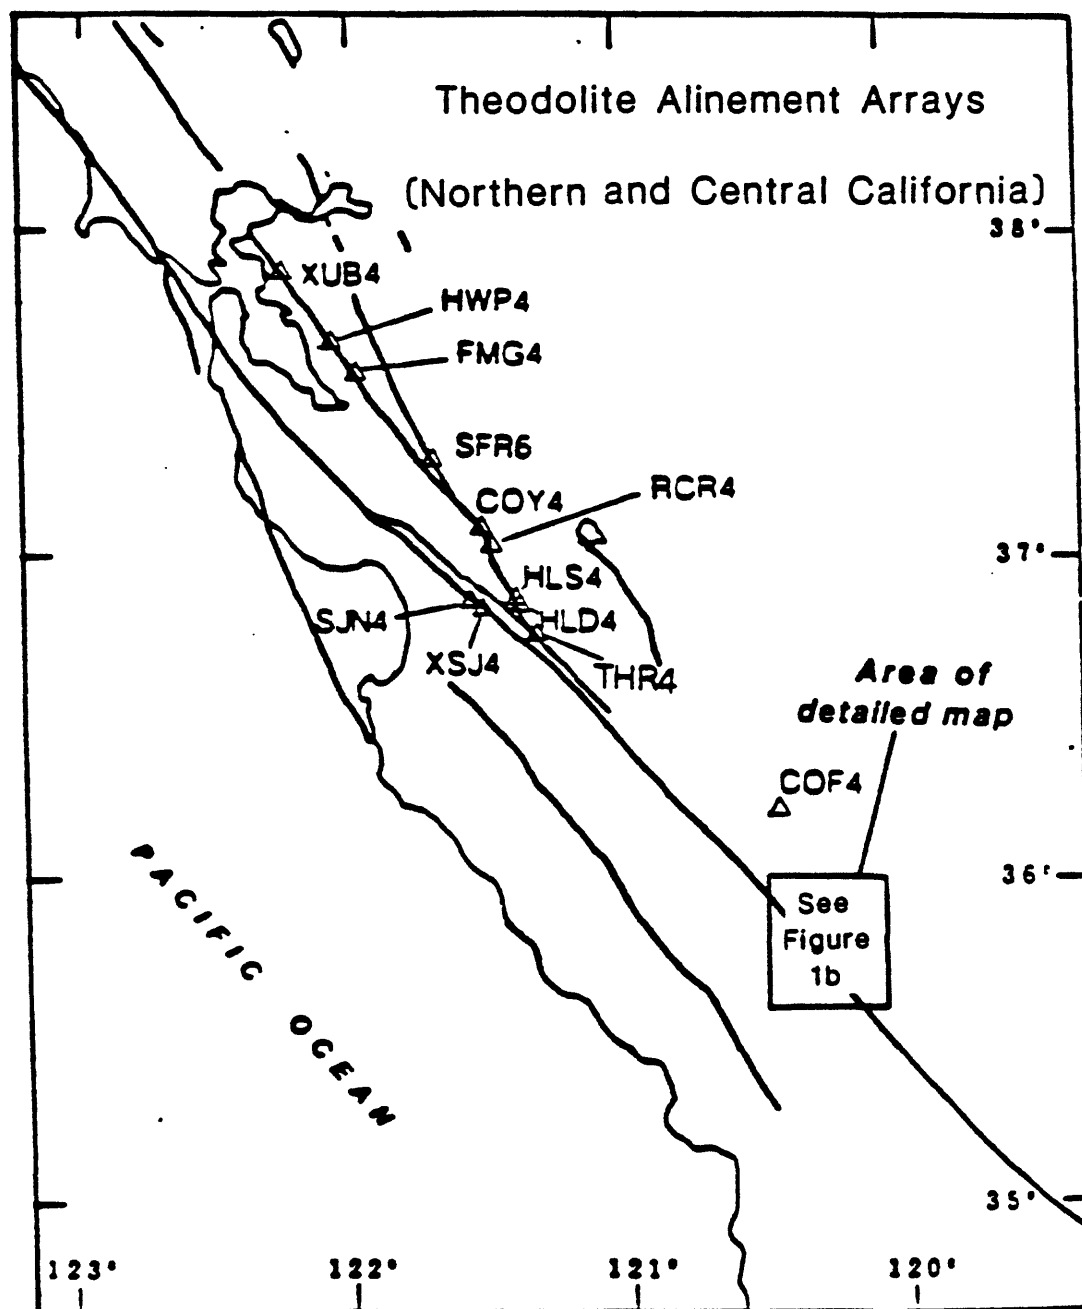
Figure 1a

Currently 37 alinement arrays along 5 active faults in California are being surveyed (Table 1, Figures 1 a, b, c). Each array consists of from 5 to 35 survey monuments placed at intervals in a line across an active fault. The lines range in length from 30 to 300 meters, and wing, or orientation, stations are used for control (Figure 2). The theodolite is centered and leveled over a fixed point designated the "instrument station" (IS) on one side of the fault. Traverse targets are centered and leveled over two fixed points: an orientation station (OS) on the same side of the fault as the IS, and an end station (ES), the last monument in line on the opposite side of the fault. These stations are emplaced such that the IS to ES line is as close to perpendicular to the fault trend as local topography will allow. On some arrays there will be more than one OS and/or an additional ES. Occasionally, when it is impractical to use an OS or ES that can be occupied with a traverse target, a distant cultural feature such as a powerline structure on the same side of the fault as the IS is used. Fault slip is determined by the formula

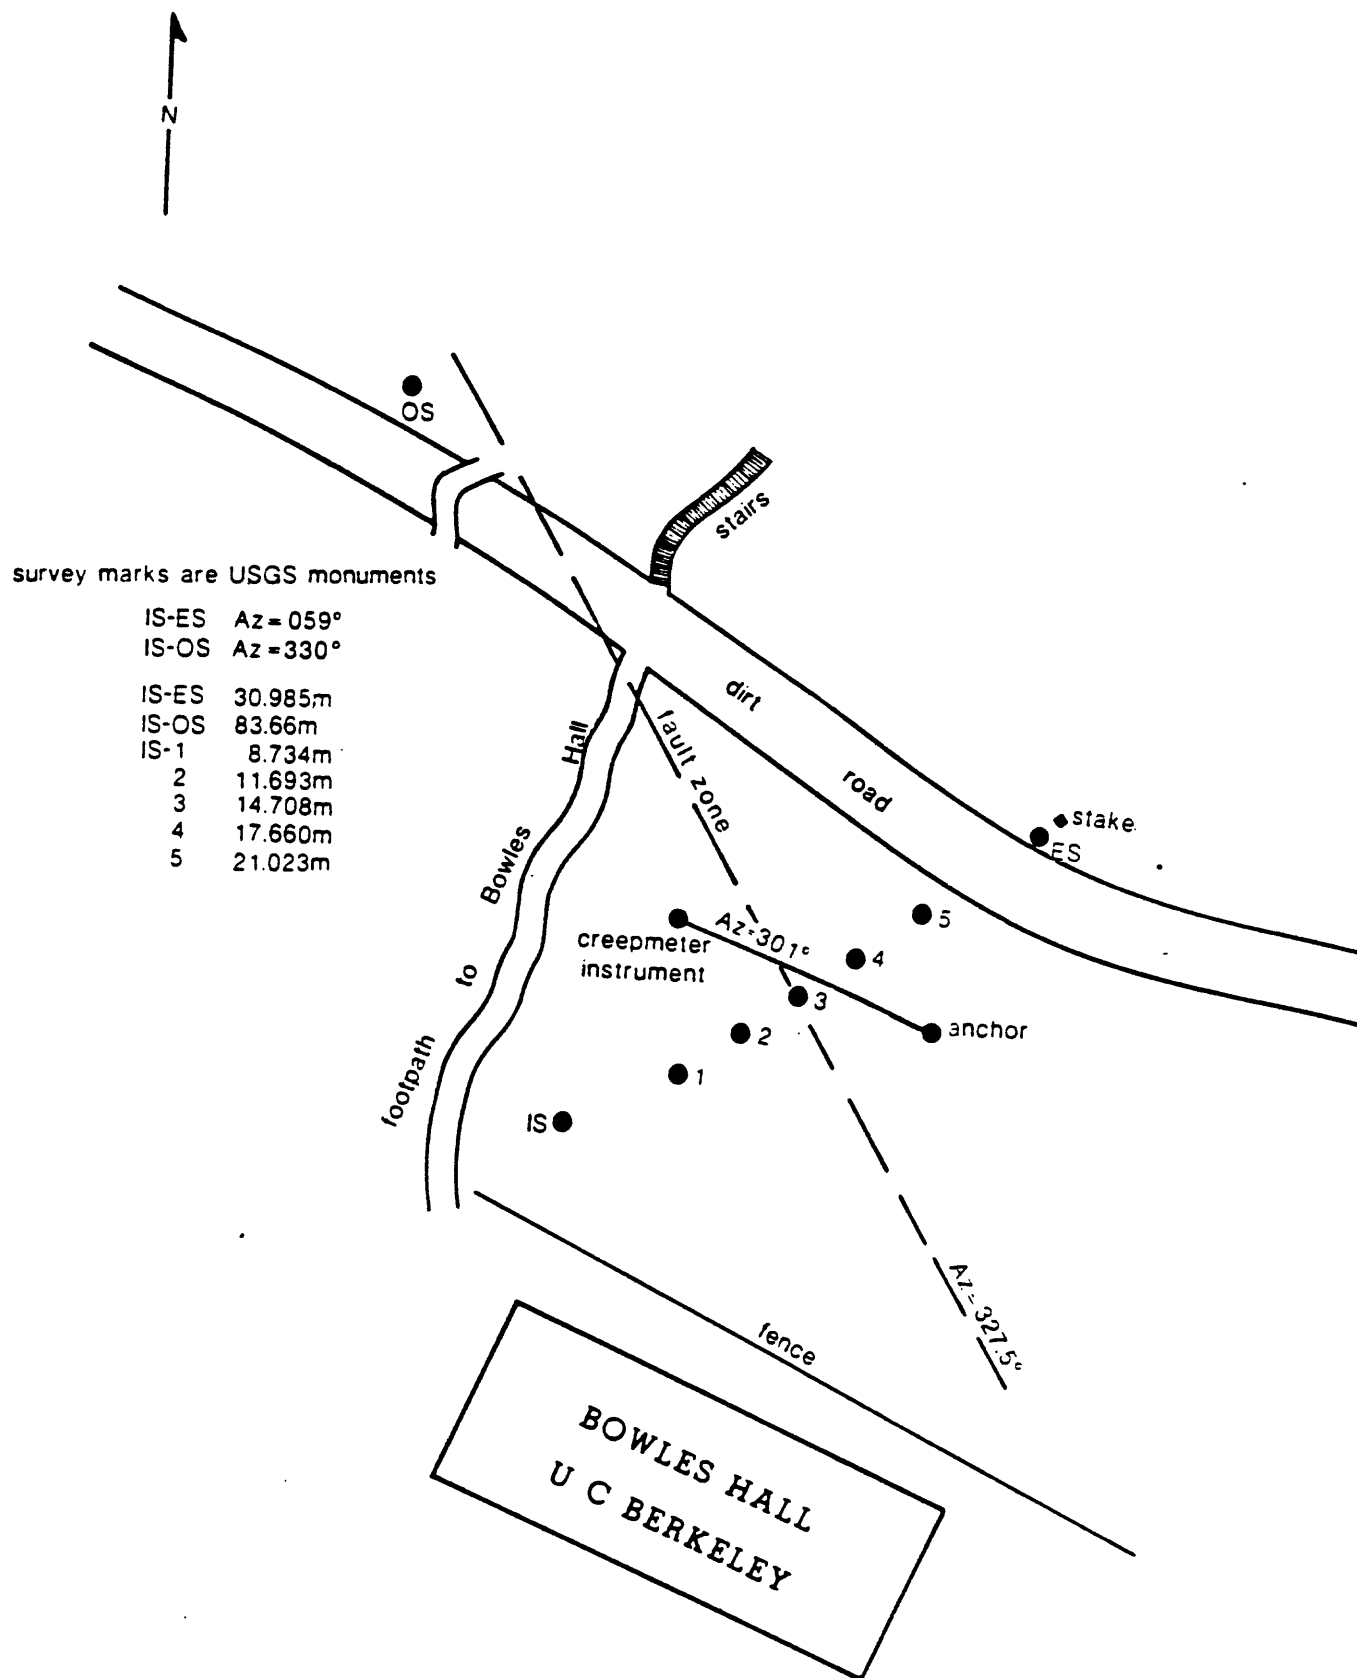
USGS : UC BERKELEY ALINEMENT ARRAY
(XUB4) installed 3/10/83

GENERAL DESCRIPTION: The array crosses between creepmeter vaults. IS is to west and ES is approximately one meter east of trail. OS is on east side of trail and north of stairway. Stations are subsurface monuments within p.v.c. pipes. Monuments were installed by USGS in 1983.

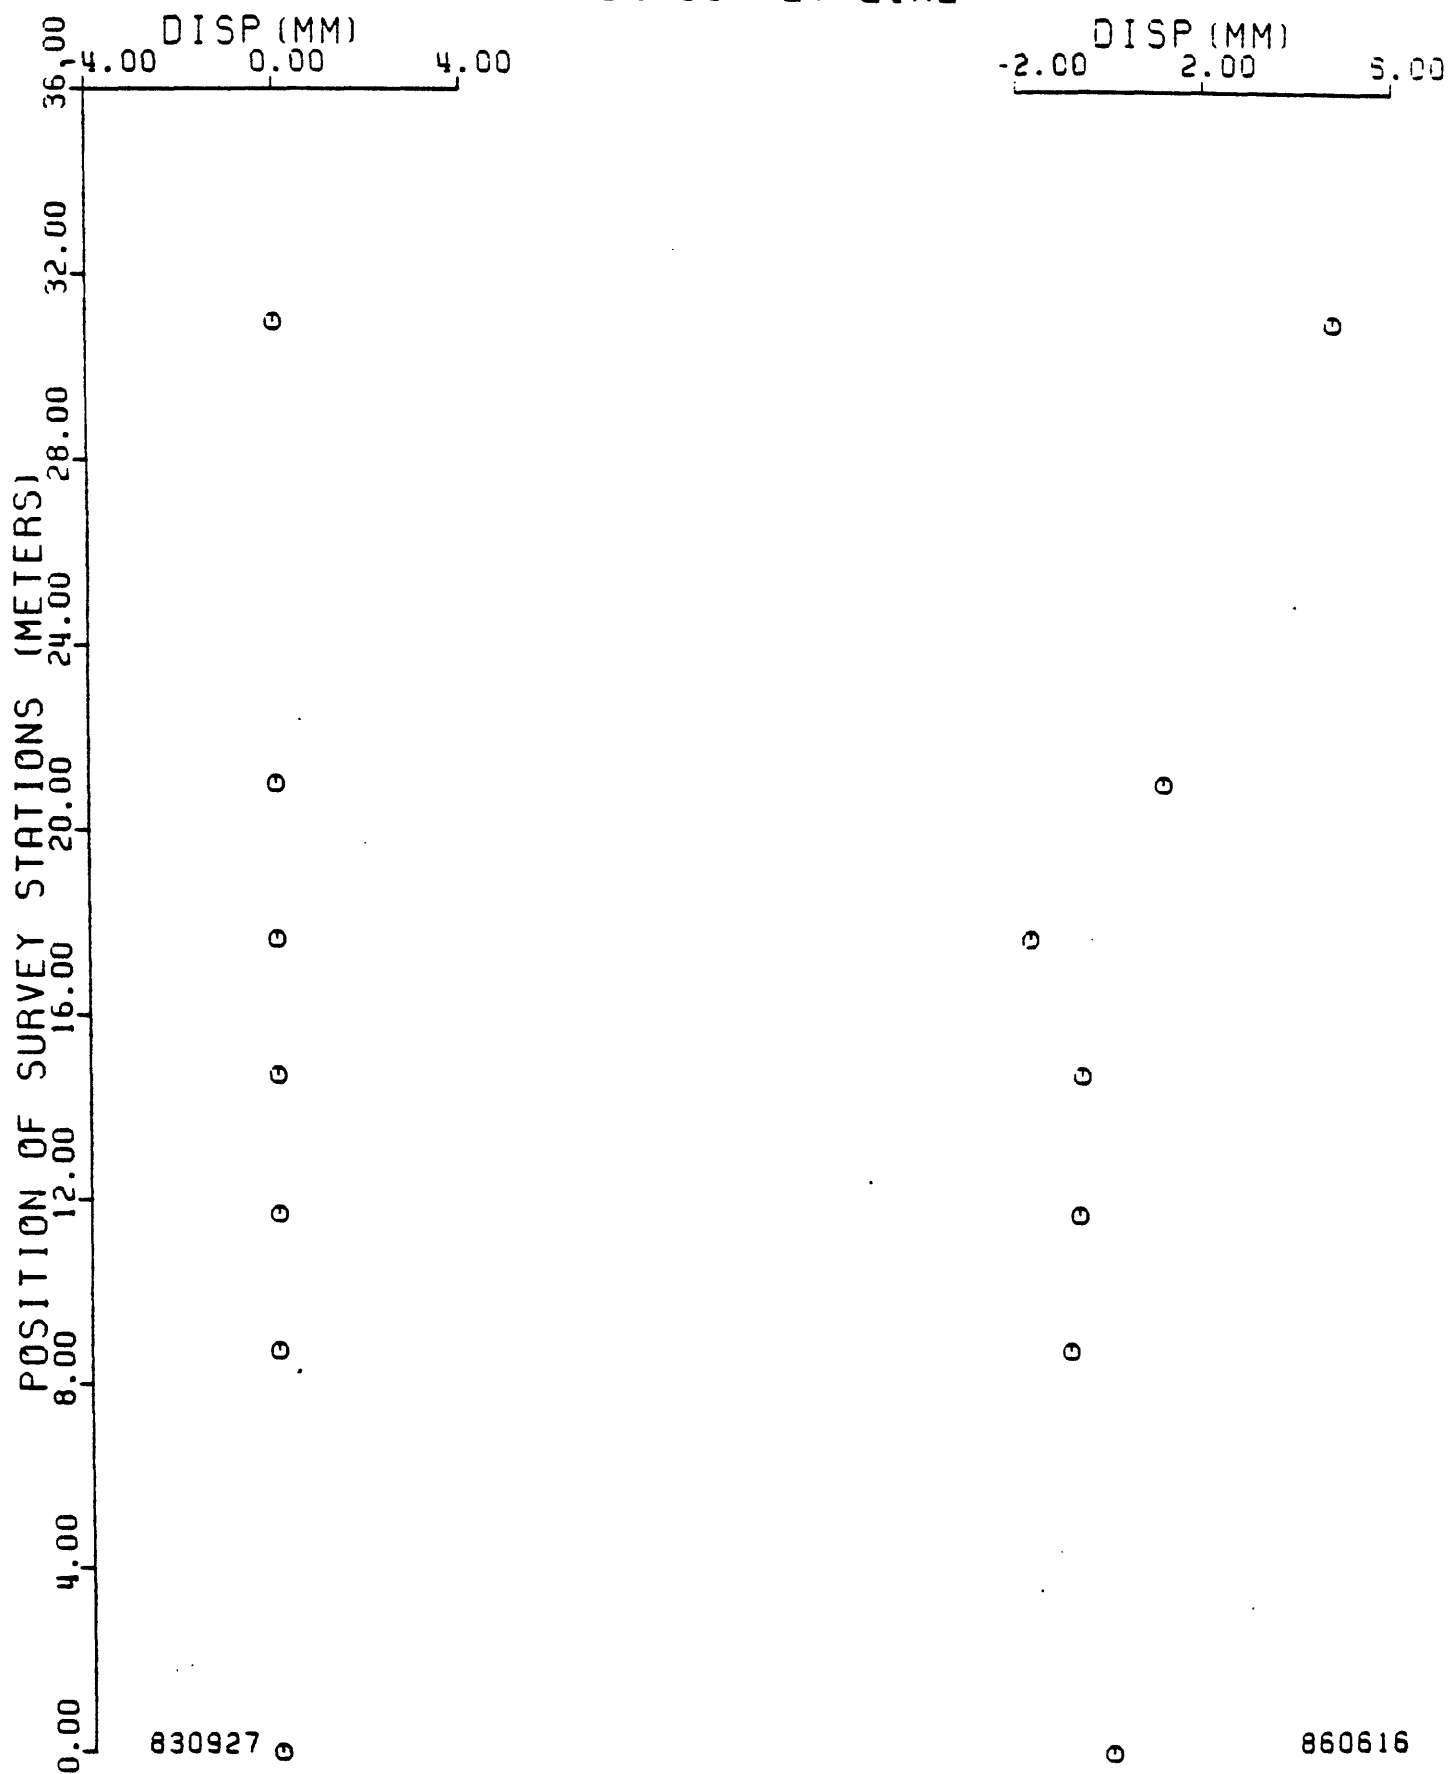
XUB4 SURVEY LINE

Date	Movement since last survey, mm	IS-ES distance, m	Correction factor	Cumulative movement, mm
<u>1983</u>				
Sep 27	0.00	30.99	Cos 1.5° 0.9996	0.00
<u>1984</u>				
Apr 6	3.60			3.60
<u>1985</u>				
Jan 14	0.87			4.47
Jul 17	0.08			4.55
<u>1986</u>				
Jun 16	0.22			4.77

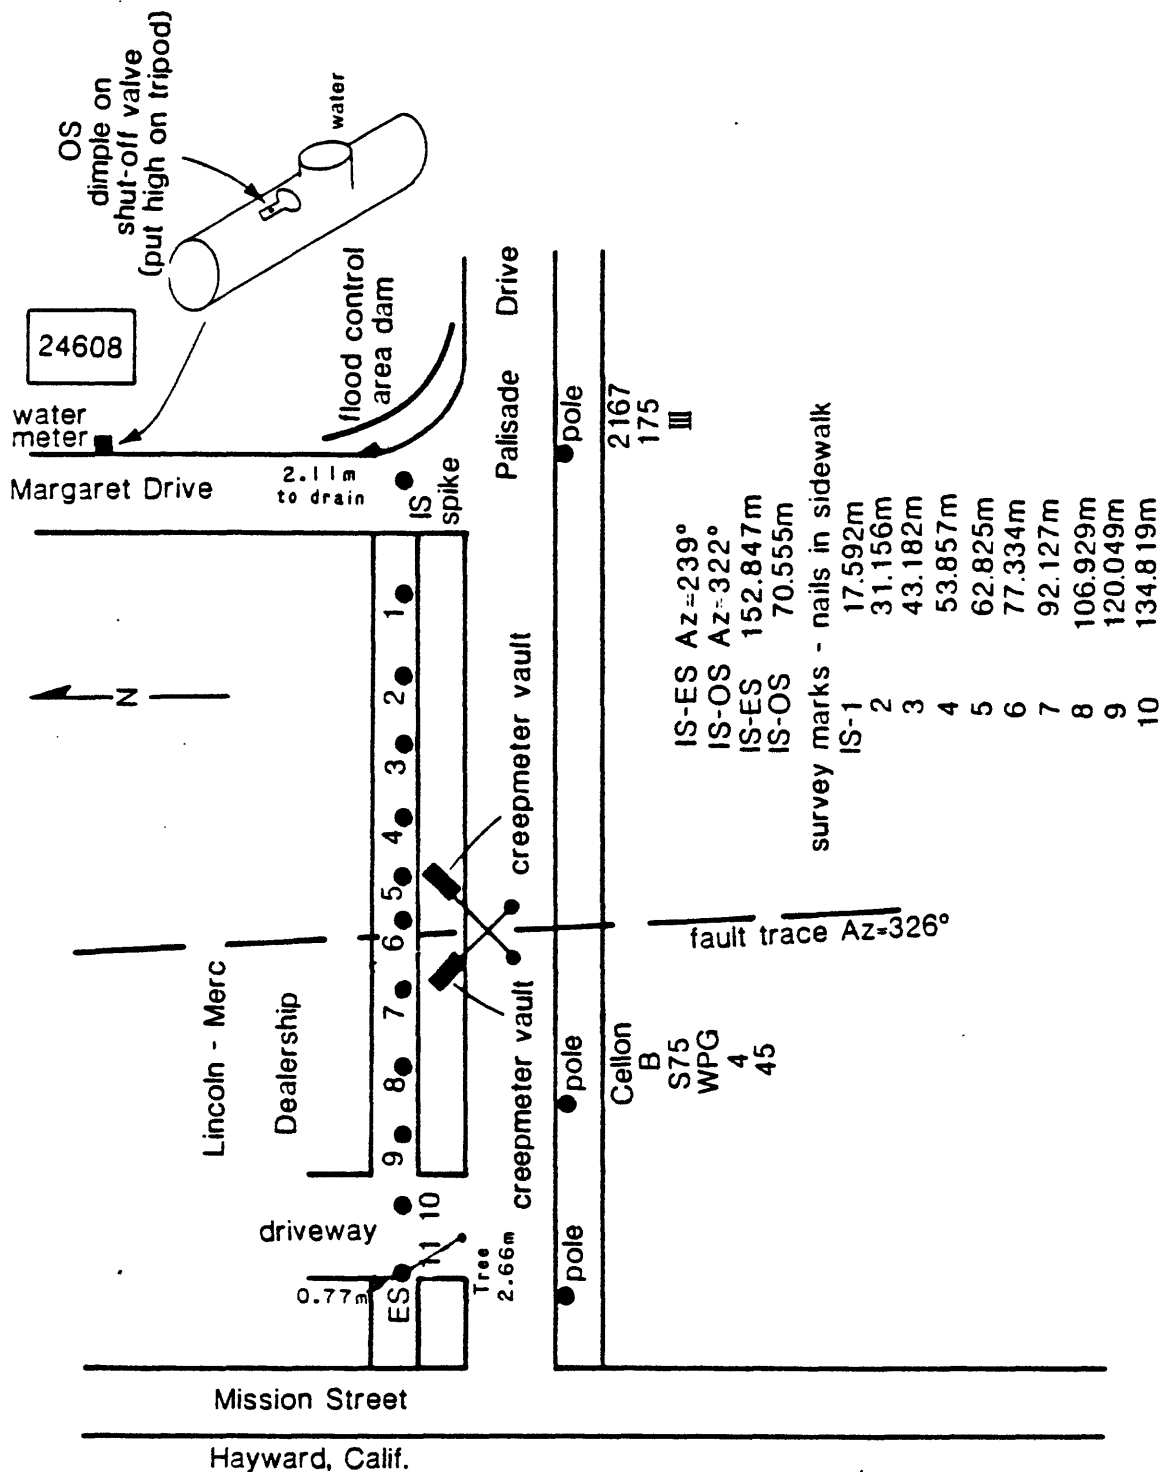
USGS: HAYWARD-PALISADE STREET ALINEMENT ARRAY HWP5 2/11/83

GENERAL DESCRIPTION: IS is a spike in line with sidewalk north of Palisade Drive. OS is a dimple on shut off valve on water meter in front of 24608 Margaret Drive. ES and deflection stations are nails in sidewalk next to Lincoln-Mercury dealership. Monuments were installed by City of Hayward (date unknown).

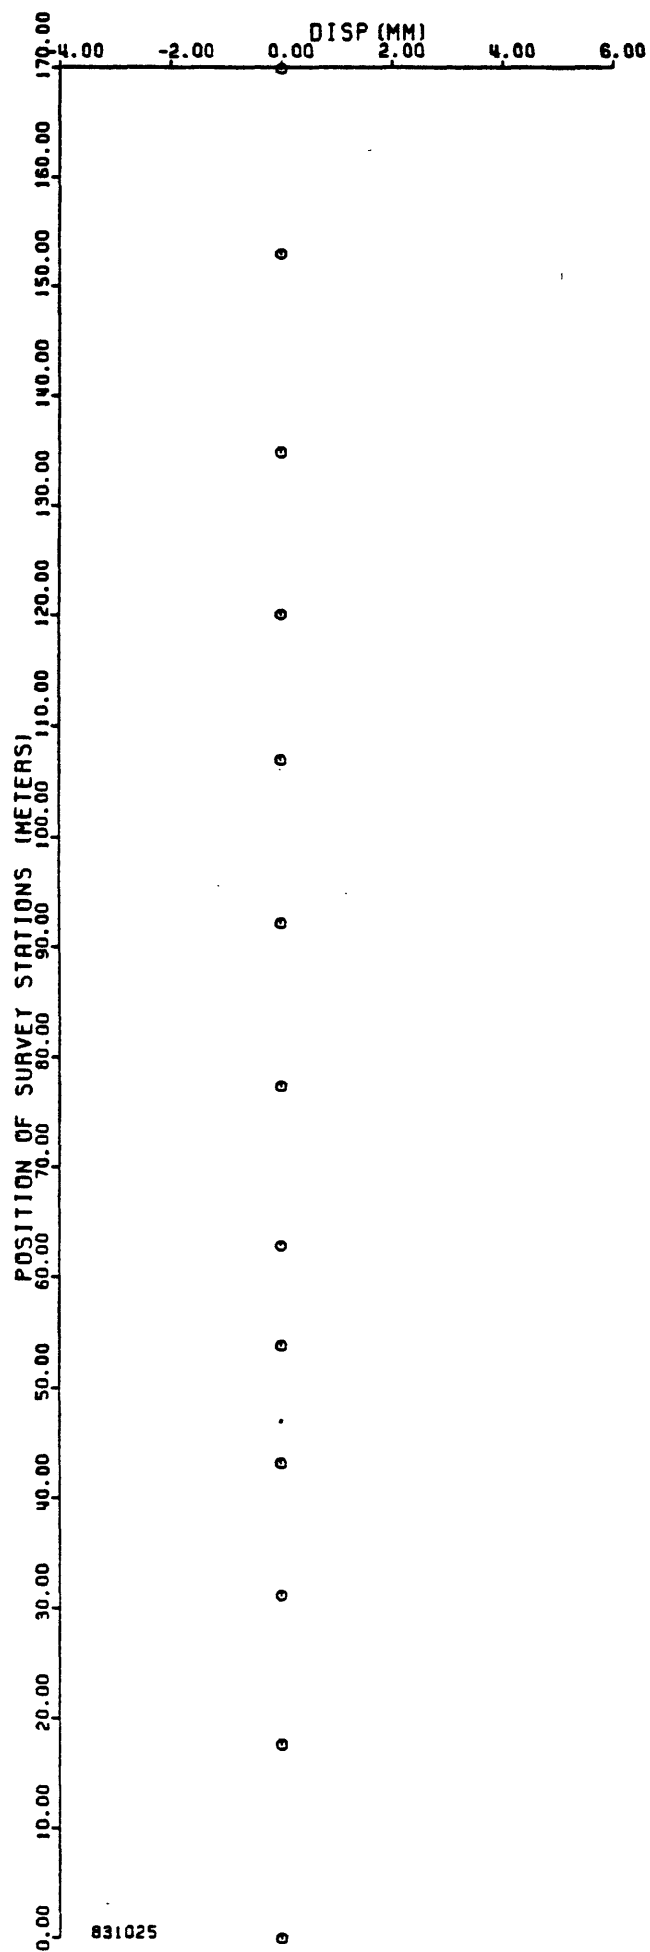
HWP4 SURVEY LINE

Date	Movement since last survey, mm	IS-ES distance, m	Correction factor	Cumulative movement, mm
<u>1983</u>			Cos 3.0°	
Oct 25	0.00	169.90	0.9986	0.00
<u>1984</u>				
Jun 12	1.68			1.68
<u>1985</u>				
Jan 15	0.85			2.53

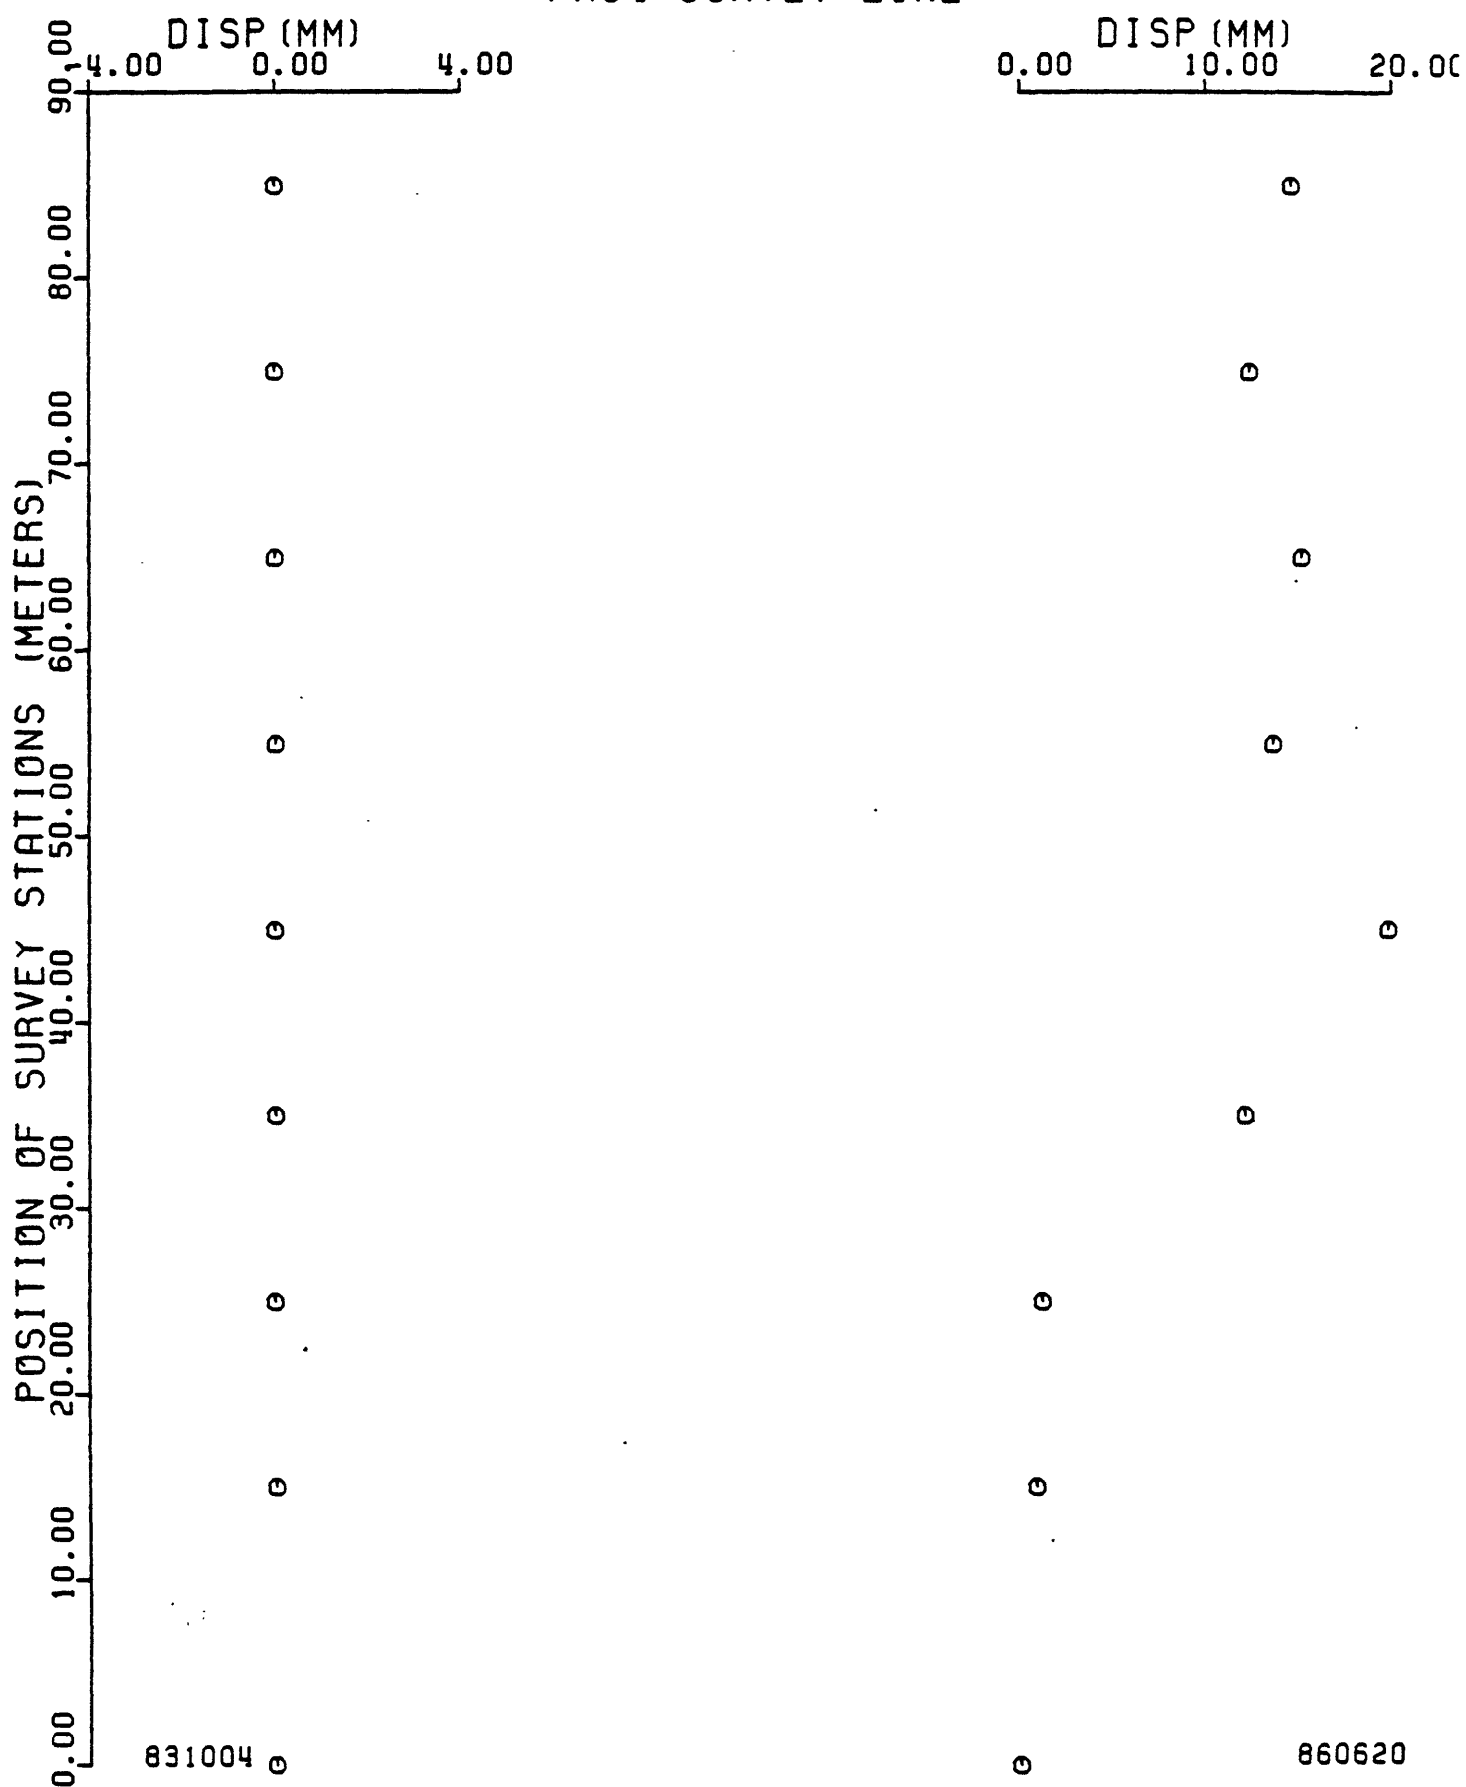
FMG4 SURVEY LINE

Date	Movement since last survey, mm	IS-ES distance, m	Correction factor	Cumulative movement, mm
<u>1983</u>			Cos 6.0°	
Oct 4	0.00	84.96	0.9945	0.00
Oct 27	0.33			0.33
<u>1984</u>				
Mar 23	0.20			0.53
Mar 26	0.46			0.99
Mar 30	-1.14			-0.15
Aug 14	-0.32			-0.47
<u>1985</u>				
Jan 29	0.66			0.20
Jul 12	0.98			1.18
<u>1986</u>				
Jun 20	13.40			14.58

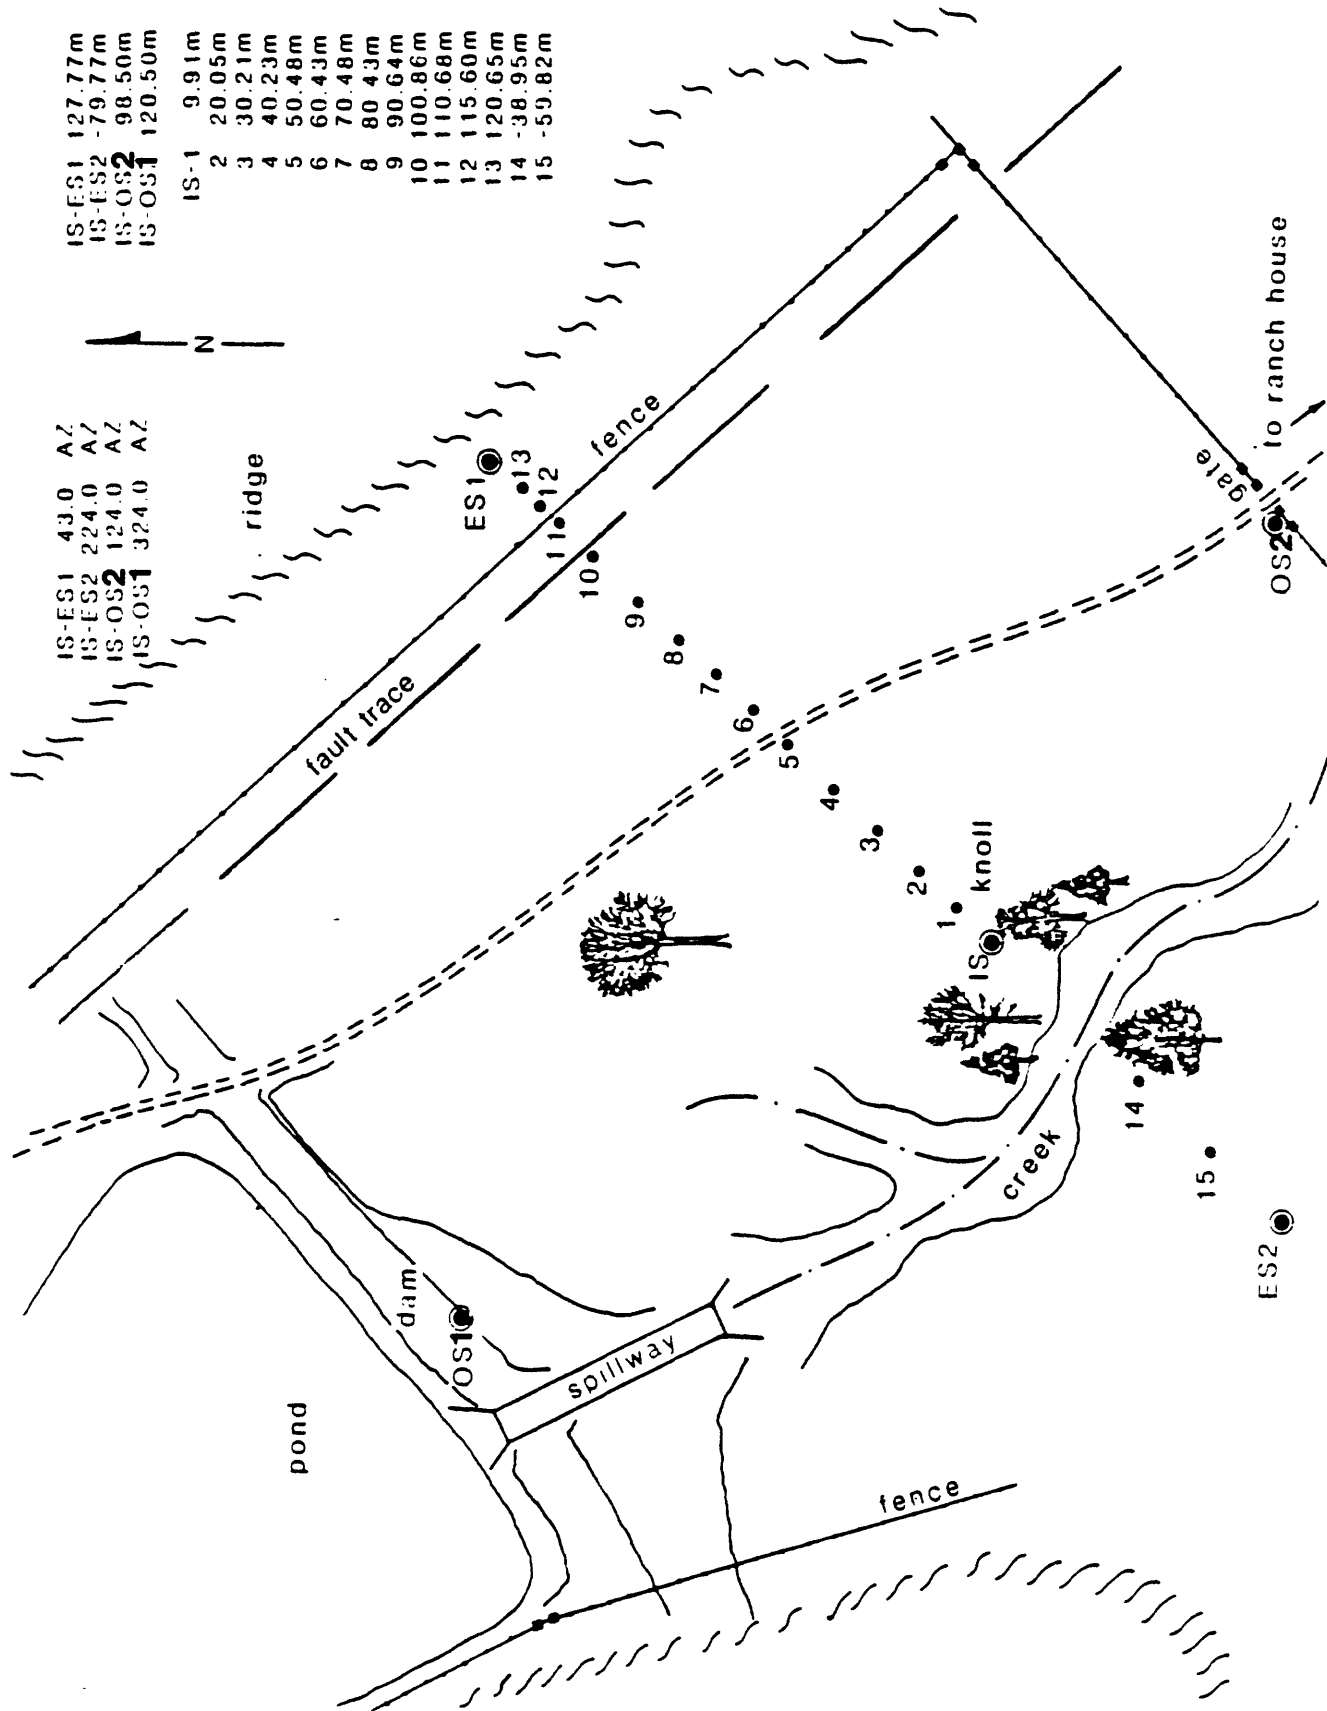
U.S.G.S. SAN FELIPE RANCH ALINEMENT ARRAY
(7/29/69)
SFR6

GENERAL DESCRIPTION: OS2 (monument #3) is just inside gate, approximately 2 meters to left of road. OS1 is at top edge of dam spillway. ES1 is just right of a large fence post, 5 metal posts north of an oak tree. Monuments are copper weld rods driven inside cement asbestos pipe sections. ES2 is 78.7 m from IS.
Ranch Foreman: Bob Andrade, 408/274-5303, wife Nicky.

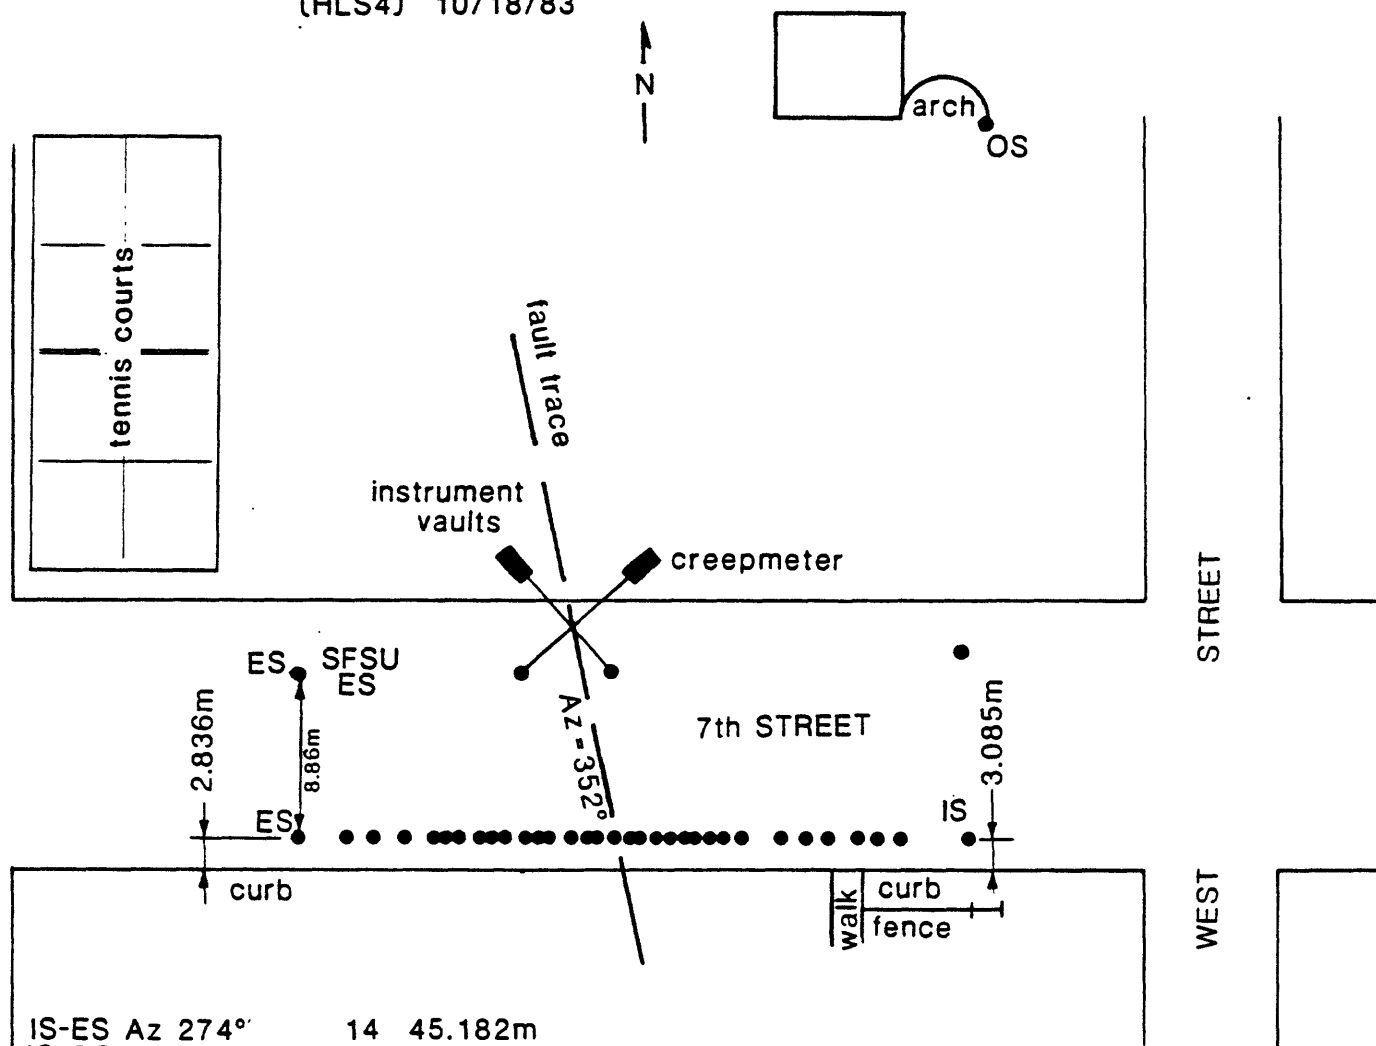
(HLS4) 10/18/83

IS-ES	Az	274°	14	45.182m
IS-OS	Az	005°	15	46.110m
IS-ES		89.508m	16	47.030m
IS-1		21.407m	17	47.952m
2		23.235m	18	48.862m
3		25.071m	19	49.778m
4		26.888m	20	50.691m
5		28.713m	21	51.614m
6		30.534m	22	52.514m
7		32.371m	23	54.347m
8		37.852m	24	56.173m
9		39.668m	25	58.001m
10		41.509m	26	59.843m
11		42.429m	27	61.67m
12		43.352m	28	63.65m
13		44.267m	29	65.31m
			30	67.13m
			31	68.96m

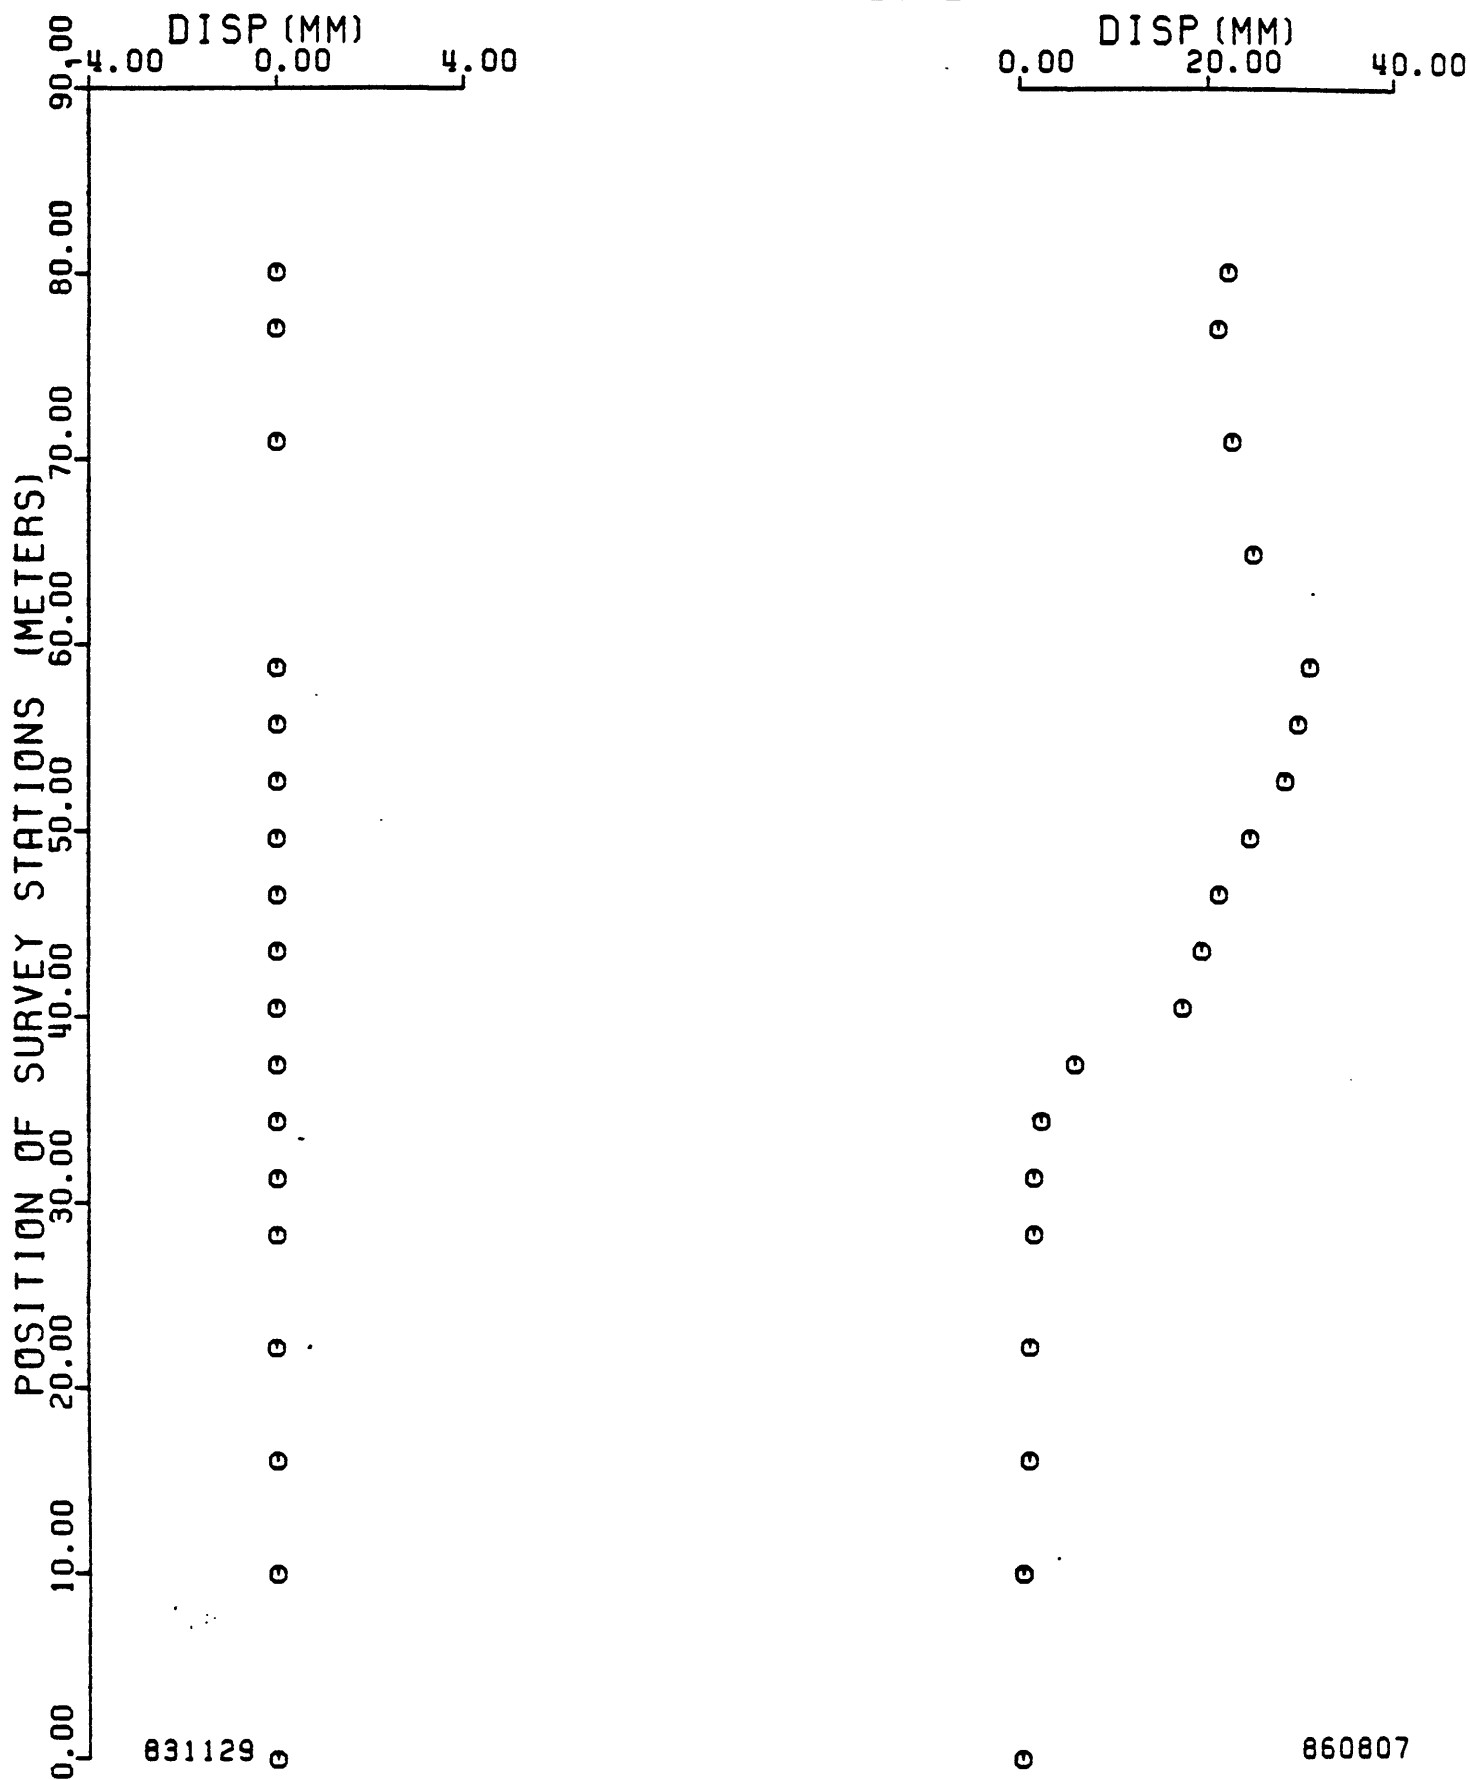
HLD4 SURVEY LINE

Date	Movement since last survey, mm	IS-ES distance, m	Correction factor	Cumulative movement, mm
<u>1983</u>			Cos 4.0°	
Nov 29	0.00	80.11	0.9976	0.00
<u>1984</u>				
Jul 5	12.89			12.89
<u>1985</u>				
Jul 16	9.22			22.11
<u>1986</u>				
Aug 7	-0.10			22.01

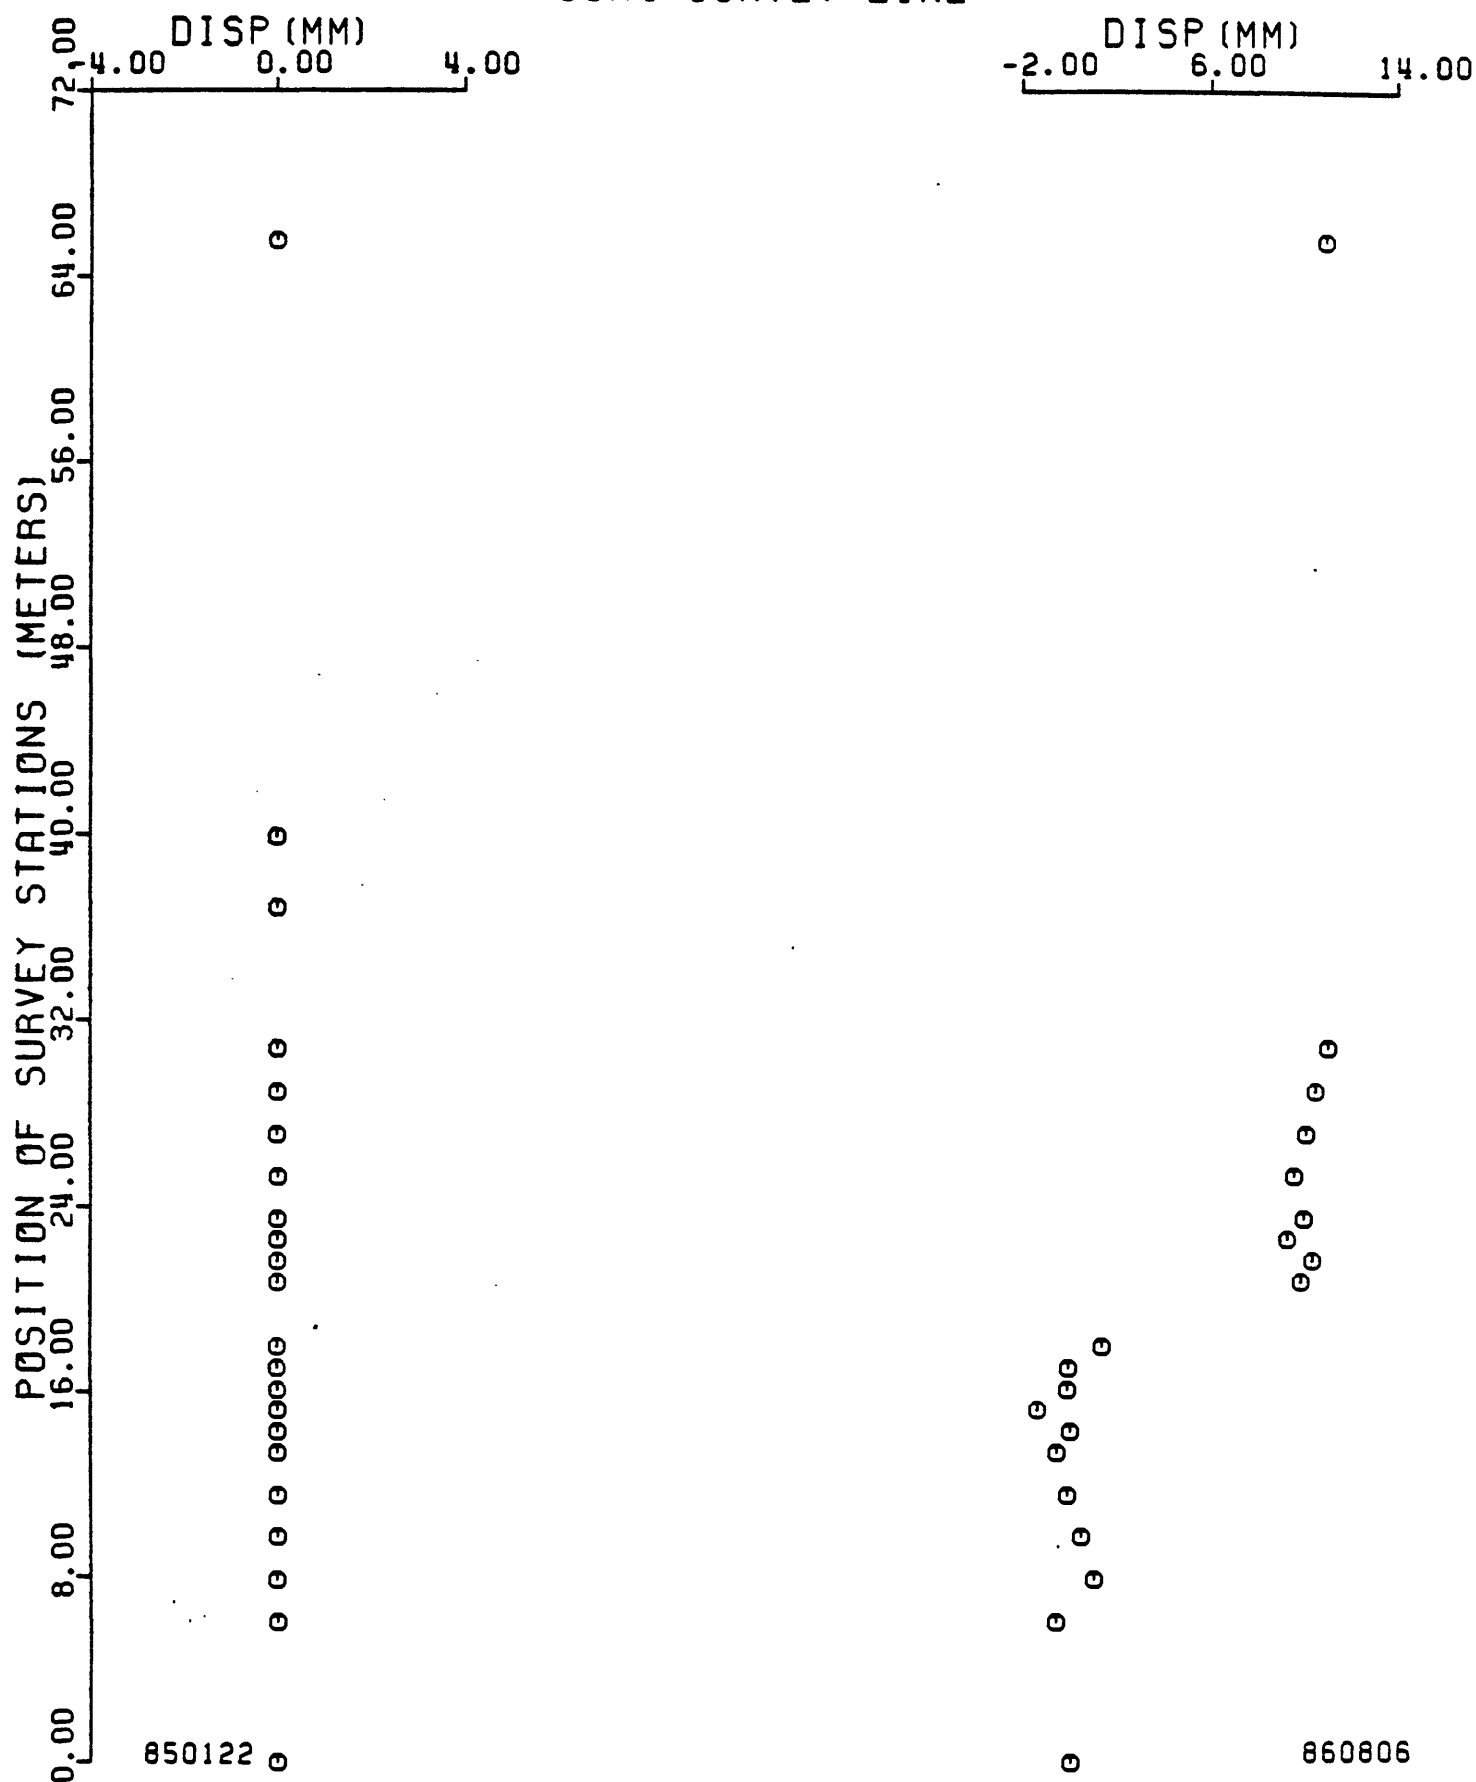
SJN4 SURVEY LINE

Date	Movement since last survey, mm	IS-ES distance, m	Correction factor	Cumulative movement, mm
<u>1984</u>			Cos 19.5°	
Aug 16	0.00	65.55	0.9426	0.00
<u>1985</u>				
Jan 22	4.07			4.07
Jul 11	1.53			5.60
<u>1986</u>				
Aug 6	5.33			10.93
