DEPARTMENT OF THE INTERIOR

**CATALOG OF ALINEMENT ARRAY MEASUREMENTS IN CENTRAL
AND SOUTHERN CALIFORNIA FROM 1983 THROUGH 1986**

Open-File Report 87-280

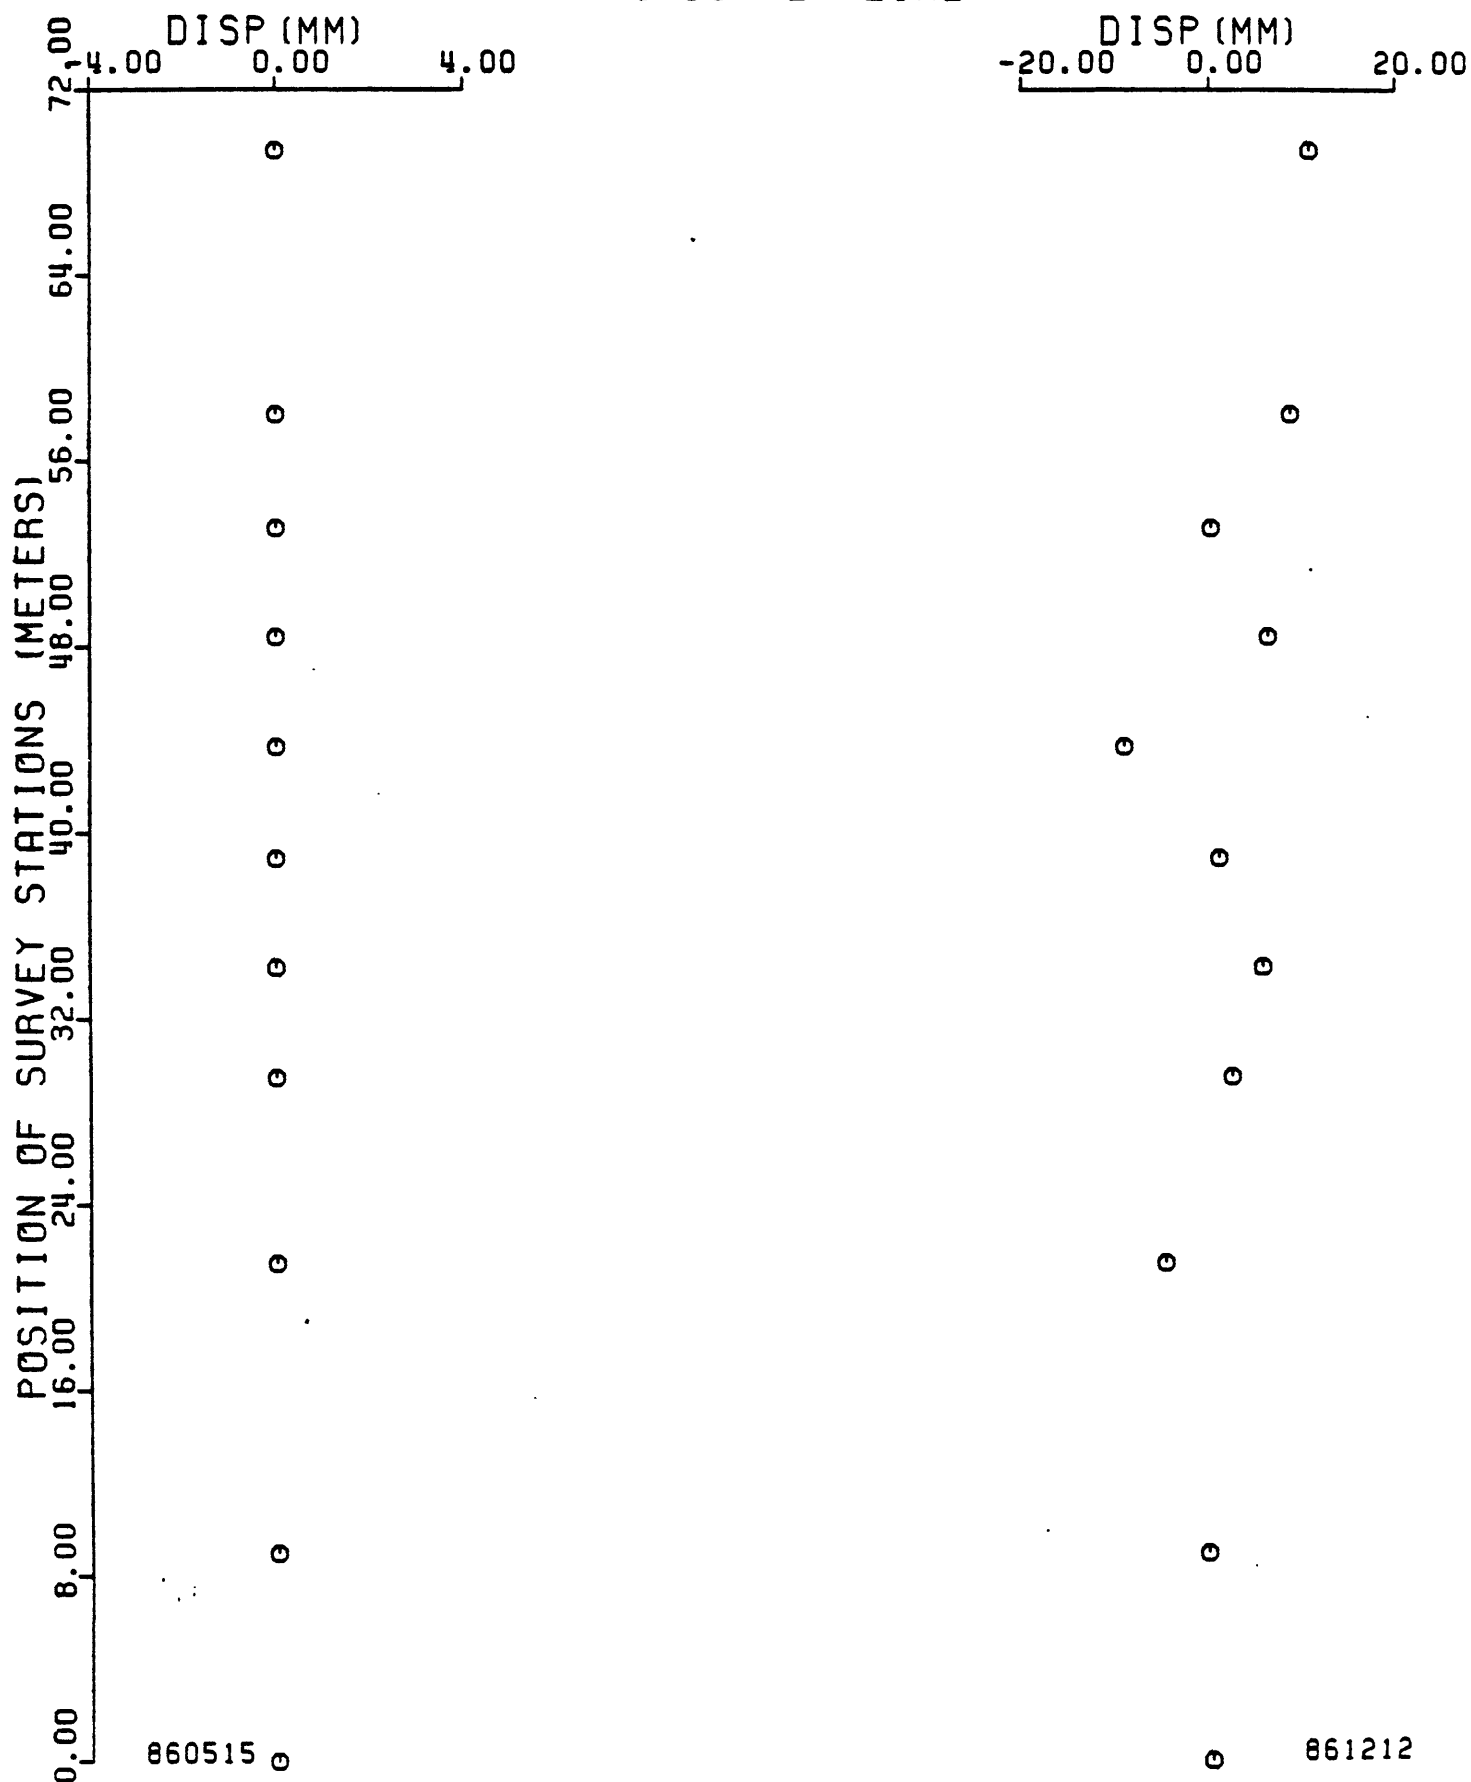
VAR4 SURVEY LINE

Date	Movement since last survey, mm	IS-ES distance, m	Correction factor	Cumulative movement, mm
<u>1986</u>			Cos 10.0°	
May 15	0.00	69.40	0.9848	0.00
Jun 25	3.85			3.85
Jul 24	2.85			6.70
Aug 13	-2.13			4.57
Oct 10	3.24			7.81
Dec 12	2.87			10.69

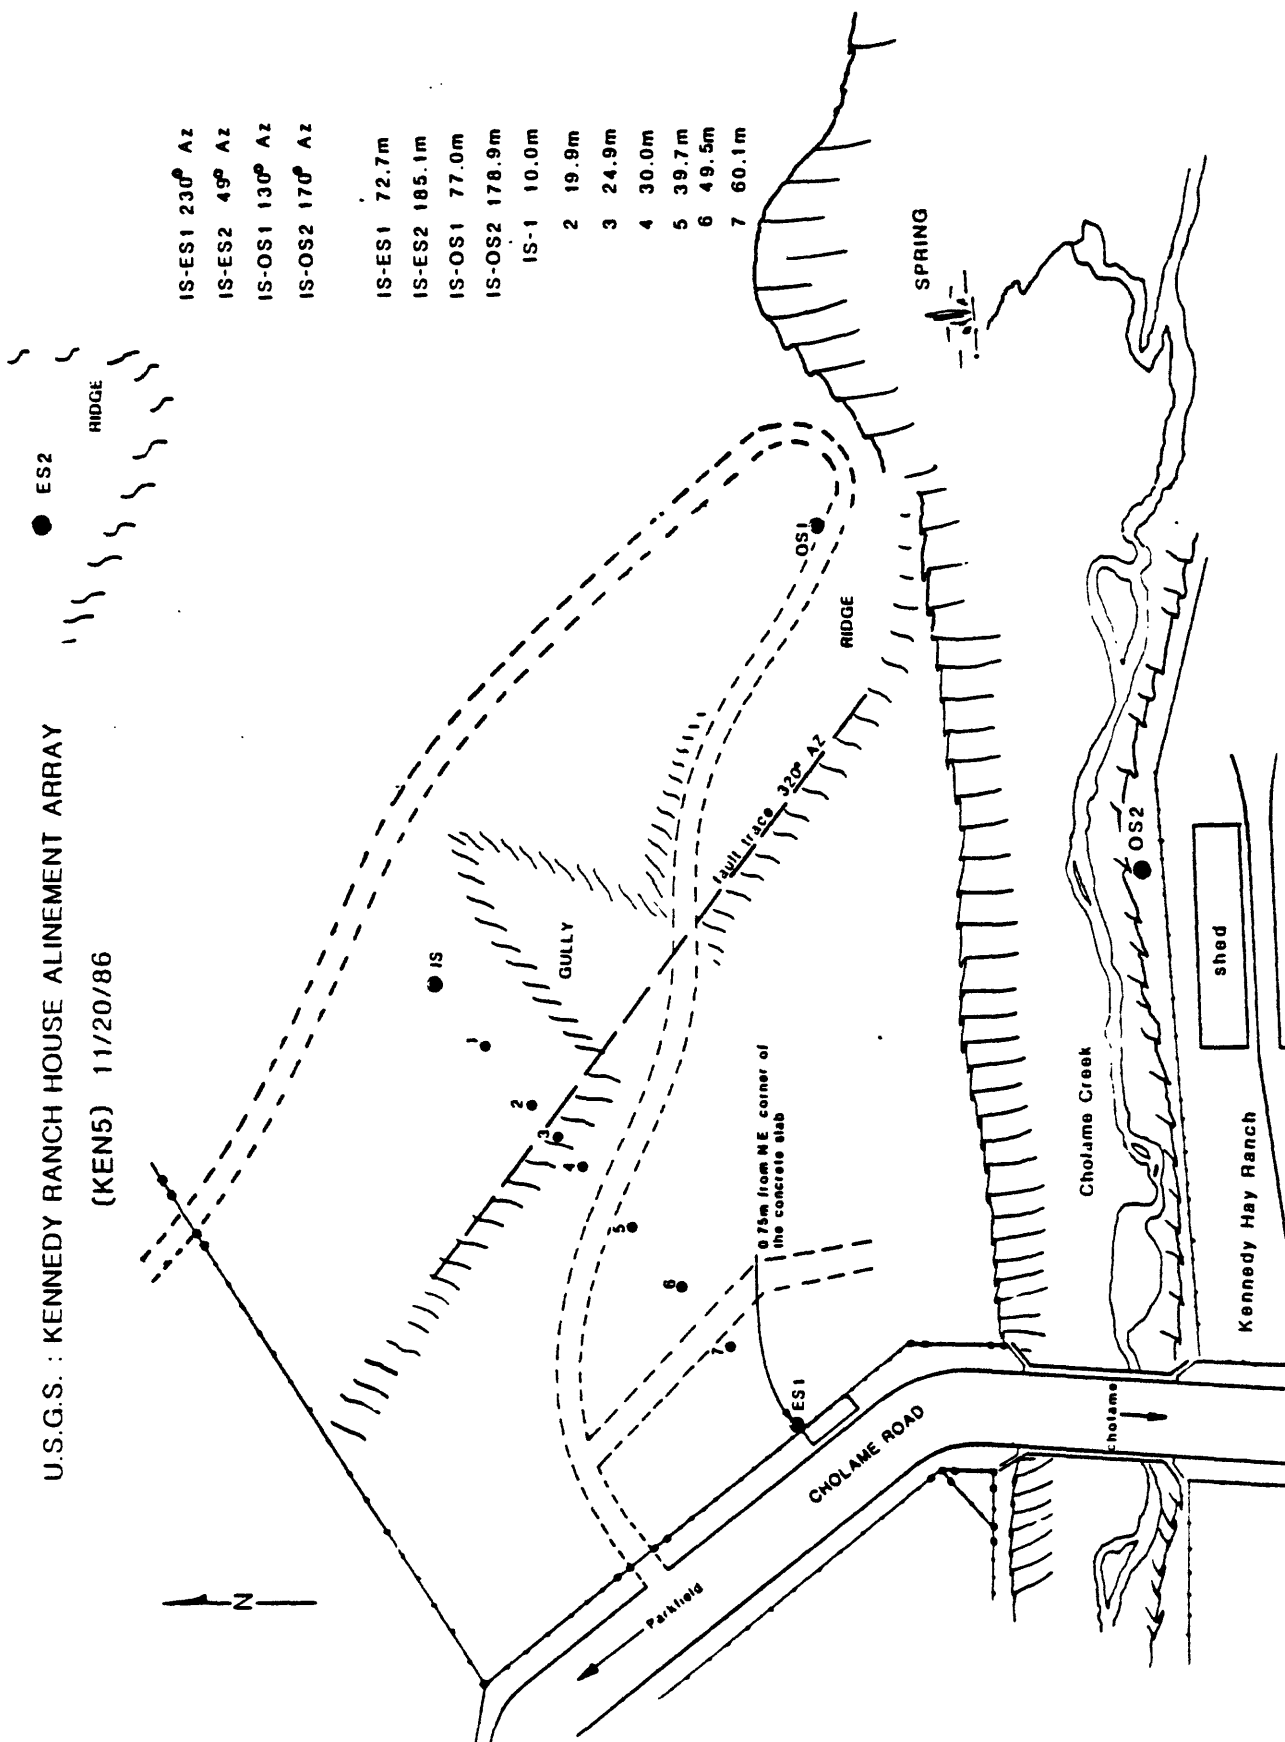
(KEN5) 11/20/86

GENERAL DESCRIPTION: ES1 is near the fenceline approximately 2 feet NW of old concrete slab near road. IS is at the crest of the scarp approximately 15 meters from the edge, deflection station 1 is at or near the edge. OS2 is across the creek near a large cottonwood tree. The OS2 is on the creek side of the fence and may need metal detector due to changes in the creek topography. ES2 is located NE of IS on first small ridge. (Site installed November, 1986, Wilmesher)

IS-ES1 230° Az
 IS-ES2 49° Az
 IS-OS1 130° Az
 IS-OS2 170° Az
