DEPARTMENT OF THE INTERIOR  
U.S. GEOLOGICAL SURVEY

Slope Movements in the Cheshire Quartzite, Southwestern Vermont

Open-File Report 88-20

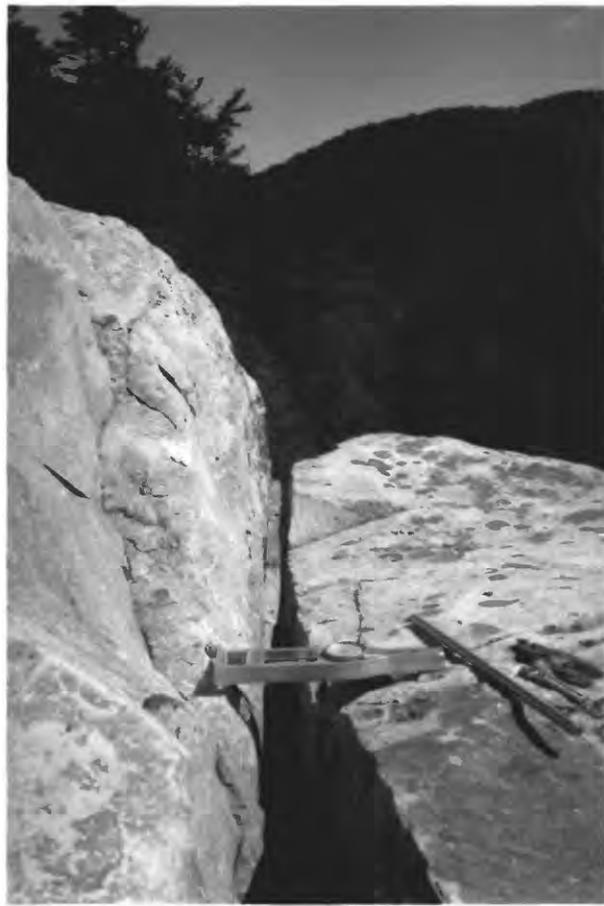
Figure 4.--Dial-gage extensometer bridging open tectonic joint parallel to cliff face in Cheshire Quartzite at site 1. Numerous and partly developed, but still intact, slabs and spalls can be seen on the face of the left (south-facing) joint block. Invar calibration bar lies next to extensometer.

Field displacement measurements were made over a period of 19 months (two freeze-thaw seasons) at four cliff locations using a dial-gage extensometer (fig. 4) with a resolution of 0.01 mm. Measurement points were established in joint blocks by cementing notched brass cylinders (1.27 x 6.35 cm) in drilled holes. The cylinders were tapped to receive a threaded stainless-steel anchor point having a drilled hole in the top to accommodate the conical hardened-steel measurement points on the dial-gage extensometer. Numerous wet and dry freezing tests of the system were made in the laboratory and they showed no breakup of the cement or weakening of the bond, and no anelastic (creep) deformation was measured between anchor points. The extensometer was calibrated for temperature-induced strains with an Invar steel bar. Displacements are positive, indicating crack widening and ranged from 0.03 to 0.75 mm. The largest value was from a cliff-edge block and the lowest value is from a neighboring upslope block. The average displacement of two cliff-edge blocks was 0.30 mm (0.15 mm annually), a small value but in agreement with a typical laboratory freeze-cycle displacement of 0.13 mm (see Appendix). These data suggest that cliff retreat by rockfall in the Cheshire Quartzite is a very slow process compared to other modes of slope failure. Although they are not a widespread occurrence at this site, rockfalls are annual phenomena where marginally stable blocks are driven over cliff edges. The modest postglacial accumulation of rockfall blocks below cliffs in the site 1 area (a volume of approximately  $100 \text{ m}^3$ ) also attests to the slowness of block movement. A minimum rate of 15-20 cm per 1,000 yrs is suggested by the data.

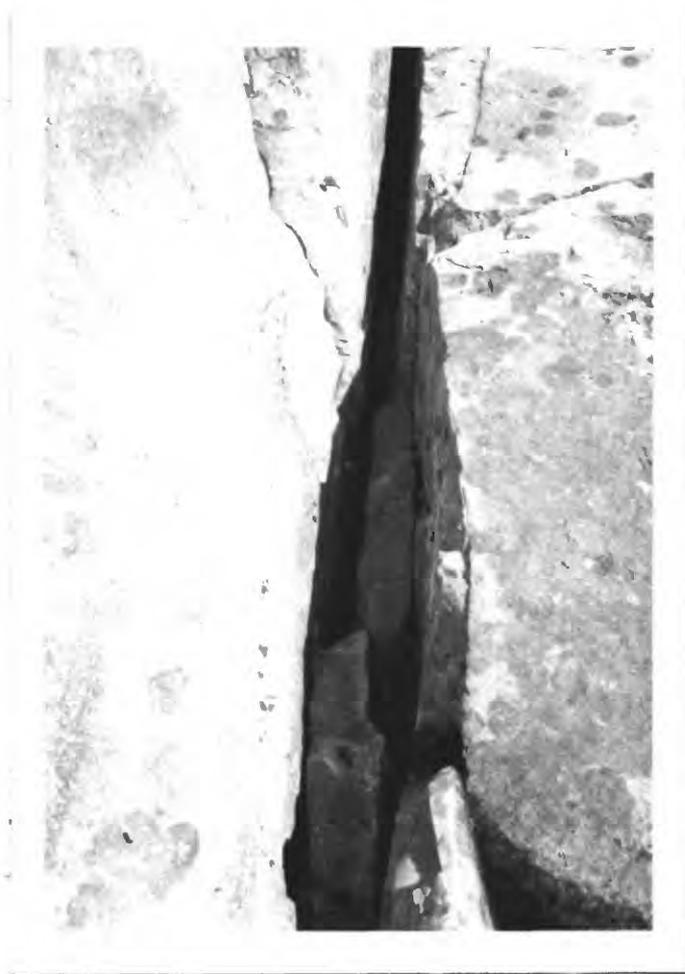
Figure 5.--Photograph of open joint shown in figure 4, looking downward, and showing several slabby wedges of quartzite that have dropped into opening. The distance across photograph is 0.85 m.

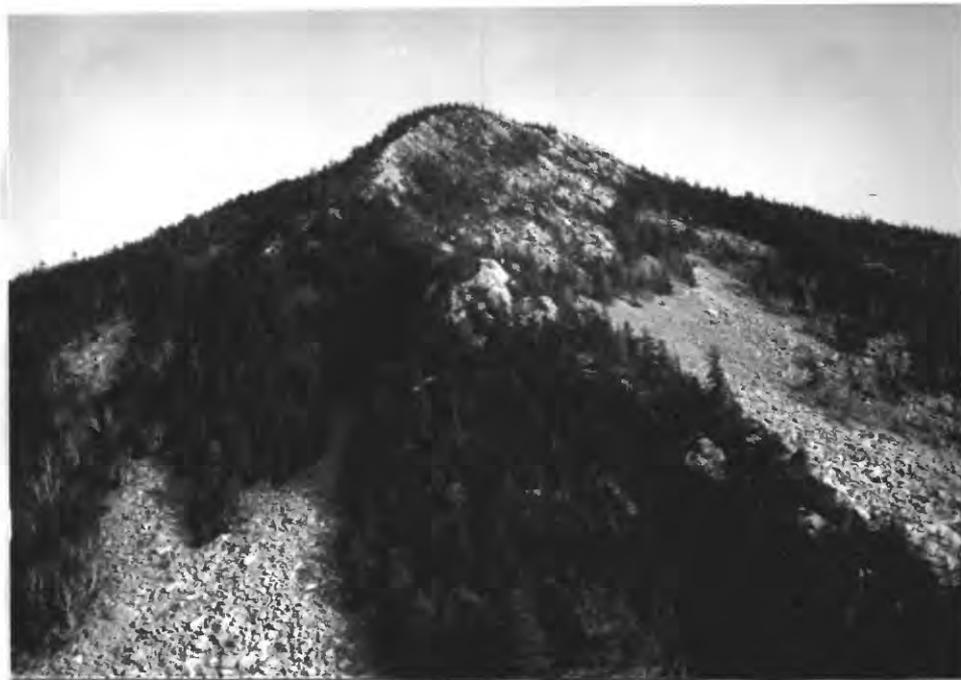
Figure 7.--View of Cheshire Quartzite at site 2 ("White Rocks") showing talus accumulation at base of slopes. View to the south.

Figure 7 is a view of the White Rocks showing the accumulation of joint blocks at the base of the slope. Bedding dips parallel to the hillslope ("dip slope") in the direction N. 70° W. The most active parts of the mountainside have dip slopes greater than 45°. Vertical travel distances of blocks are as much as 400 m from the upper cliffs to the talus pile. Angles of repose range from approximately 30° to 50°. The higher values represent the influence of asperities on the sliding surfaces. High-angle joints strike approximately parallel with and perpendicular to the dip-slope trend.

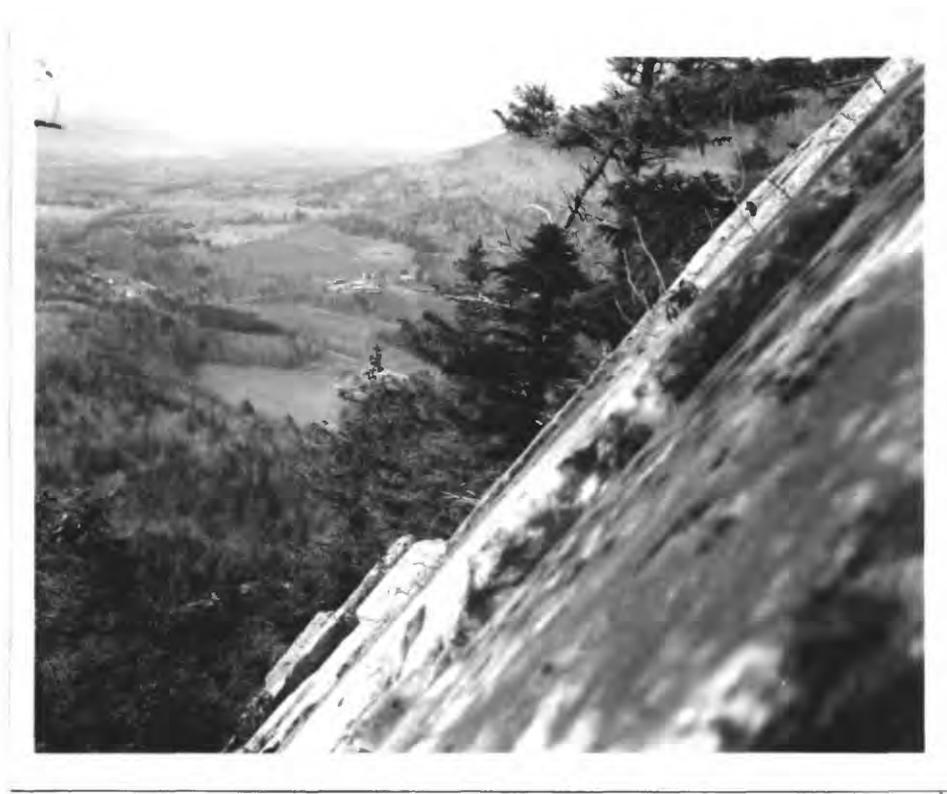
Figure 8. Dip slope of Cheshire Quartzite at site 2 ("White Rocks") showing loose, slabby blocks. View to the north.

Slow downslope translation of joint blocks is characteristic of slabby, thin-bedded quartzite (figs. 8 and 9), whereas more equant blocks from thick-bedded zones commonly rotate and tumble downslope with much greater velocity. In both cases, major movement was observed to be one block deep. The rock surface on the slope studied displays a complete sequence of block loosening and downslope gravitational movement: there are both large, smooth surfaces that show no loosening and isolated, cliff-like remnants that show the results of extensive slope movement (fig. 10). The equant blocks travel farther than the slabby blocks as shown by the geometric distribution of variously shaped blocks in the talus piles at the base of the slope; the slabs lie nearer to the base than do the equant blocks.

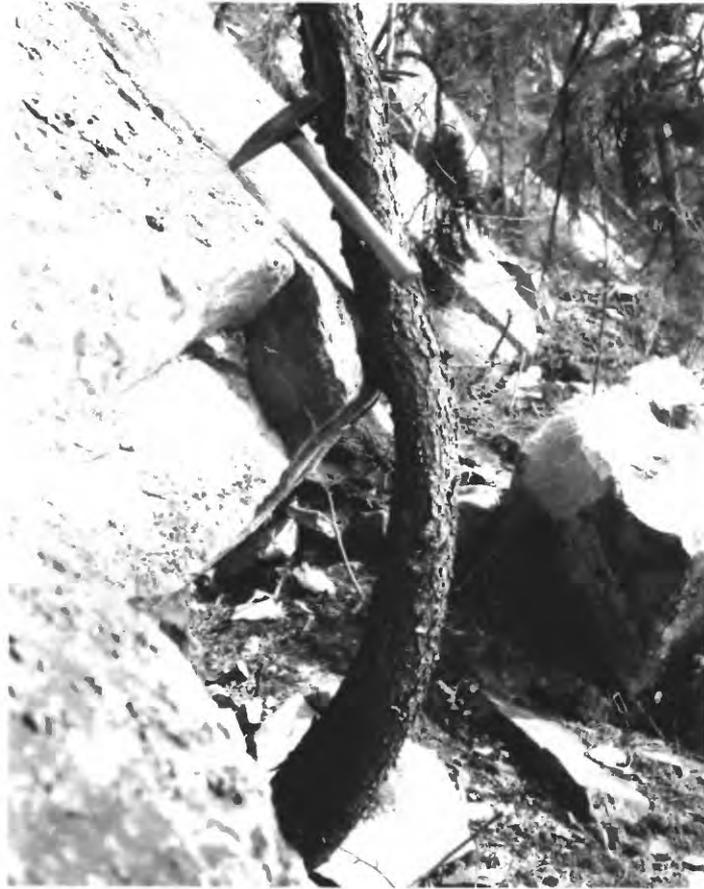
Figure 9.--Downslope creep of blocks at site 2. Bedding is parallel to slope and dips at a  $50^{\circ}$  angle.

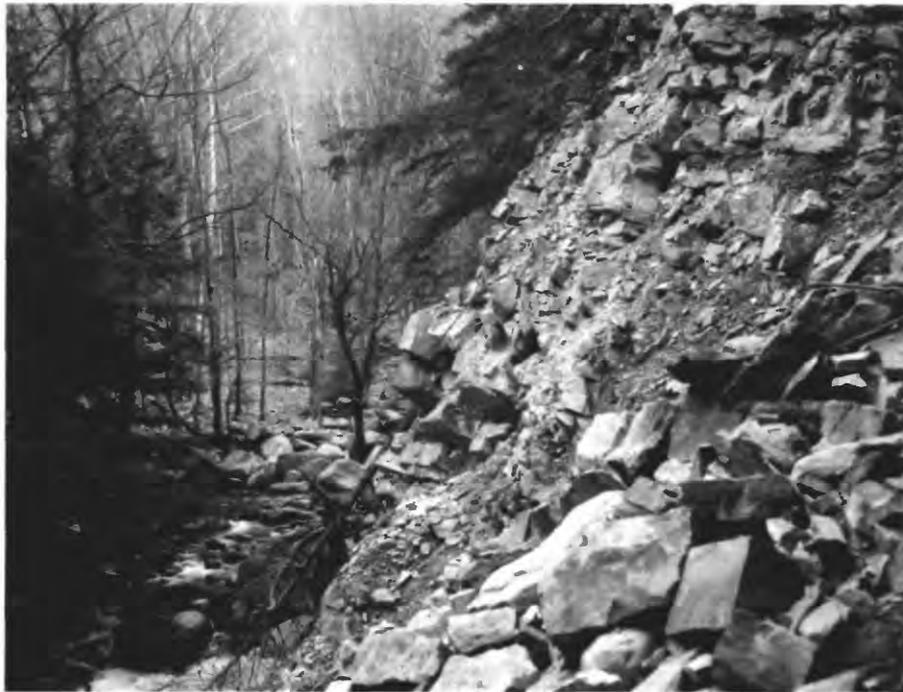
Figure 12.--View (looking east) of slide at site 3 from the base near the level of Mad Tom Brook. The Cheshire Quartzite here is much less competent than at the other sites owing to closer jointing and the presence of thin beds of graphitic schist.

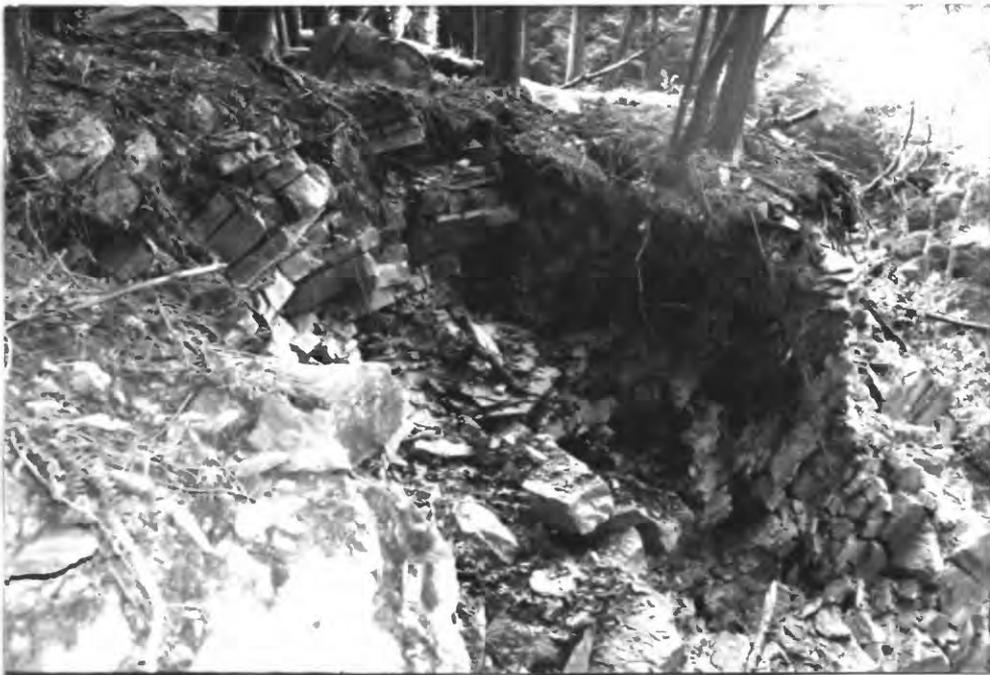
Figure 14. Overturning and toppling beds of Cheshire Quartzite at a slide-head topple location near the top of site 3.

The most dramatic deformation at this site has been block toppling similar to the type that Teme and West (1983) have designated slide-head toppling. In this failure mode, major movement occurs in areas of relatively high bedding dip angles and low joint-friction angles, conditions that are present at the Mad Tom Brook slide but not at the other two sites. While friction angles of blocks are as high as 55° on slopes underlain by massive, unaltered quartzite, the sliding friction angles determined at the Mad Tom site are in the range of 30°-40°. The overall slope angle is greater than this range because, at many locations on this slope, there are (1) no well-developed, throughgoing, weakness surfaces parallel to the strike of bedding, (2) individual blocks commonly "keyed" or interlocked with adjacent blocks, and (3) beds dipping into the slope. These structural conditions make overturning and toppling mechanically more likely than sliding (fig. 14). The overturning and toppling beds shown in figure 14 are presently moving at an average annual rate of 44 mm based on tape-extensometer measurements. Overturning produces unstable overhangs, and individual blocks tumble downslope, many reaching the brook below.

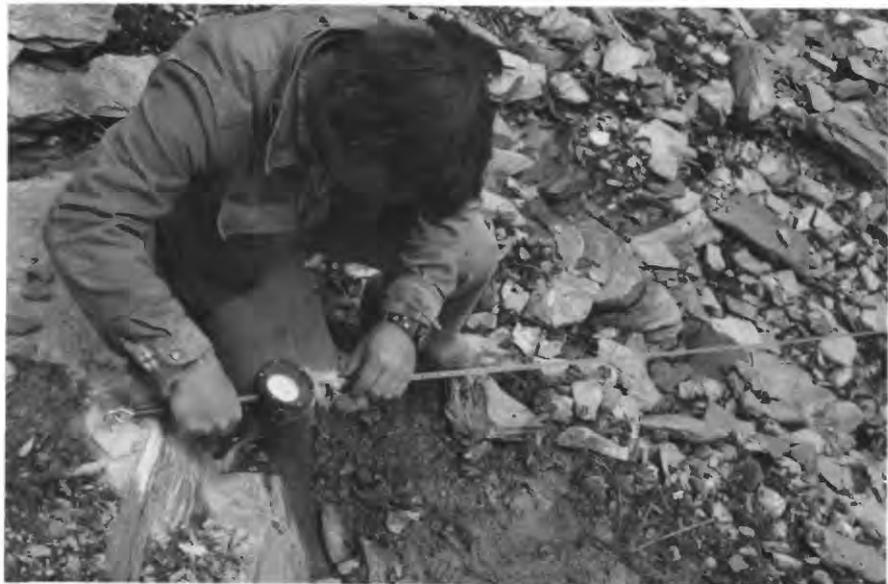
Figure 15. Photograph of tape extensometer used to measure displacements of joint blocks at widely spaced stations.
