UNITED STATES DEPARTMENT OF THE INTERIOR  
GEOLOGICAL SURVEY

Measurements of slope distances and zenith angles  
at Newberry and South Sister volcanoes, Oregon, 1985-1986

Open File Report 88-377

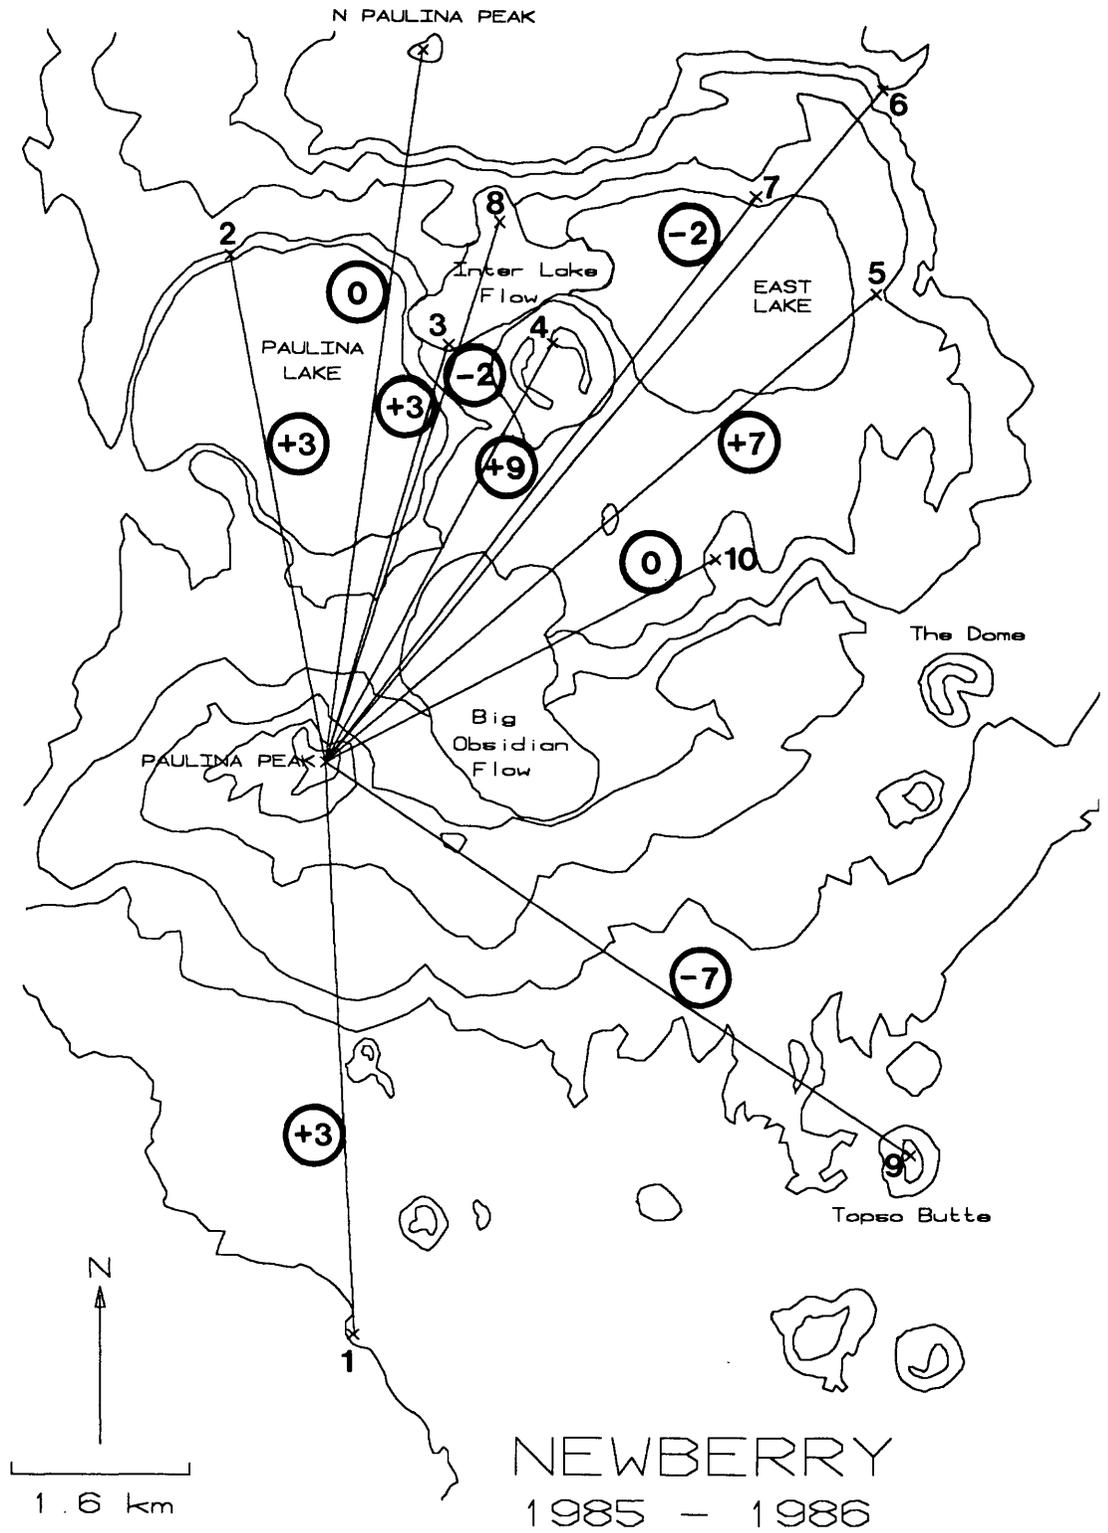
Figure 2. Schematic map showing endpoint mark-to-mark slope distance changes in millimeters at Newberry, Oregon.

Figures 2 and 3 show the network at Newberry with the endpoint and flightline mark-to-mark slope distance changes, respectively. Figures 4 and 5 show the network at South Sister with the endpoint and flightline changes, respectively. A change in the calculation of flightline data was made and is explained in Appendix D. Maps showing station locations, line numbers, station photographs, and bench mark descriptions are in Appendices A and B.

The Newberry EDM network is unique in the CVO system in that all measurements are made from only one instrument station, at Paulina Peak (fig. A1). Survey data indicate little or no apparent deformation between 1985 and 1986. All of the data fall well within the overall calculated precision. The endpoint and flightline mark-to-mark slope distance changes have a mean difference of  $0.70 \pm 0.63$  ppm, and  $0.53 \pm 0.31$  ppm, respectively.

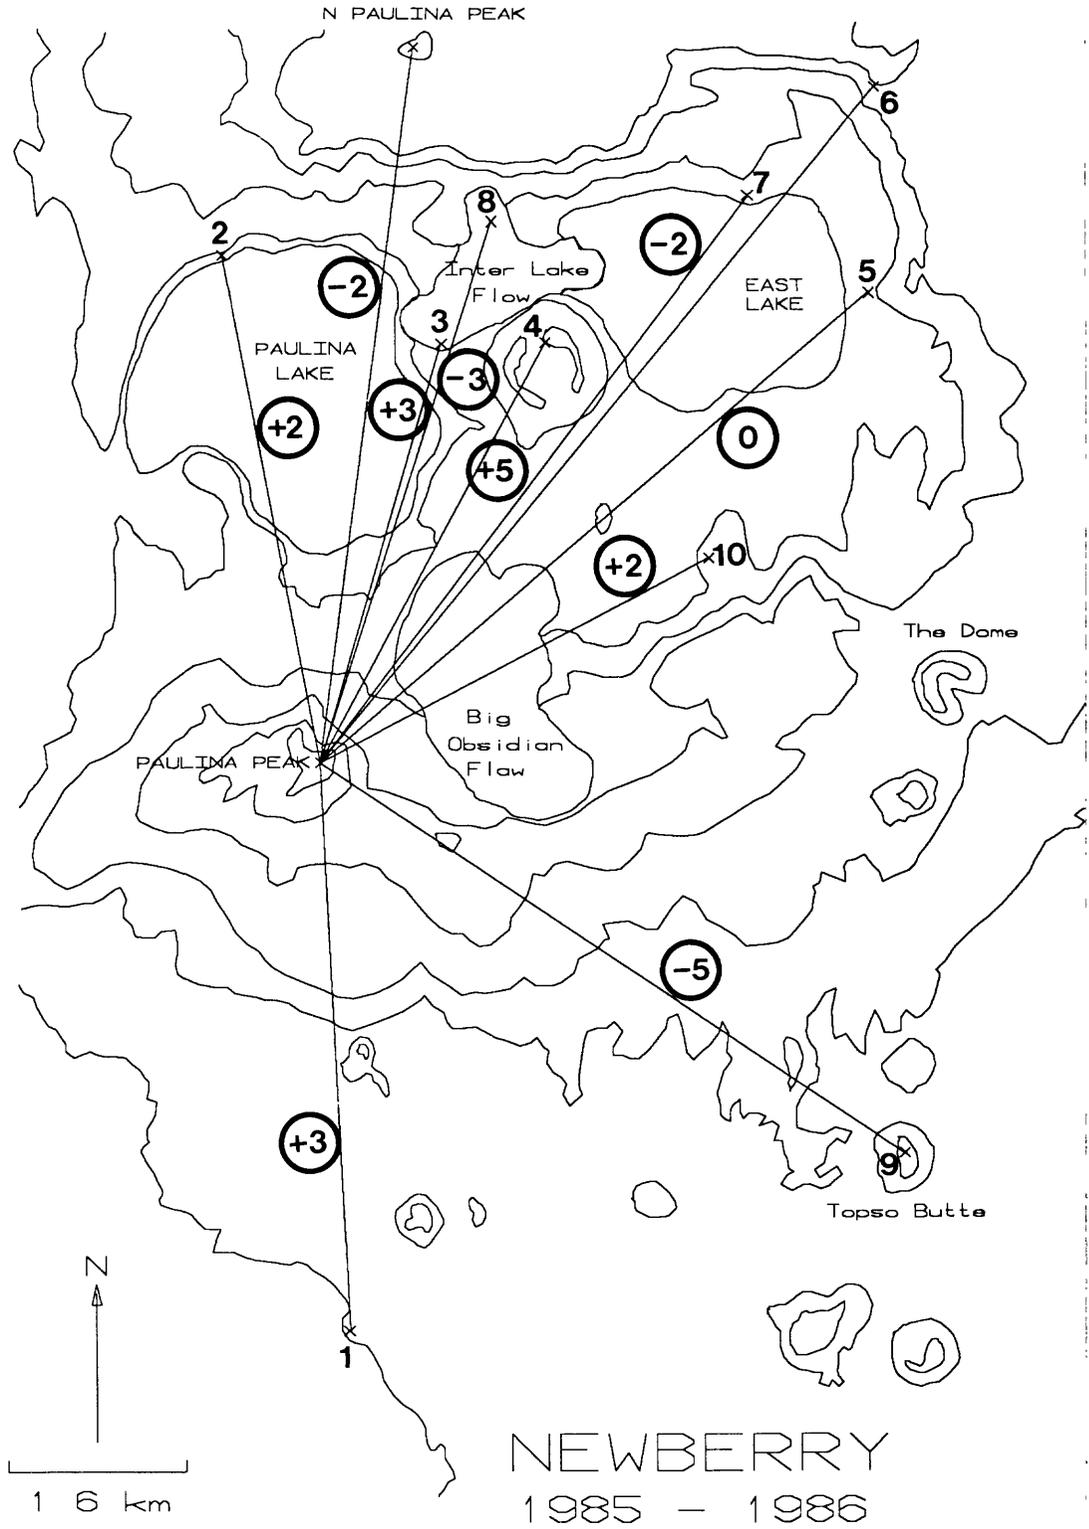
Figure 3. Schematic map showing flightline mark-to-mark slope distance changes in millimeters at Newberry, Oregon.

In 1985, a new system for recording airborne temperatures and humidity was tested. As for many new systems, the first field test was less than completely successful. The airborne data collected appeared to be good but when reduced showed temperatures approximately  $10^{\circ}\text{C}$  cooler than the air temperature measured 6 m above the ground. A bad connector plug on the probe was found, after the fact, to be at fault. Therefore, to obtain the Newberry flightline data in Table 2, two assumptions were made. The first assumption was that the erroneous data due to the faulty plug were of constant magnitude. A plot of the 1985 raw temperature data of one flightline against its 1986 counterpart suggests that this assumption is valid (fig. 6). All other 1985 flightlines show analogous patterns when compared to their 1986 values. If the errors were intermittent, the data would be more erratic. The second assumption is based on comparisons of 90 other flightline and endpoint temperature data pairs collected in 1985 and 1986. The flightline data are consistently about  $0.5^{\circ}\text{C}$  cooler than the endpoint temperatures. With these assumptions, the flightline temperature data for 1985 were adjusted and better agree with the endpoint data than do the unadjusted data.

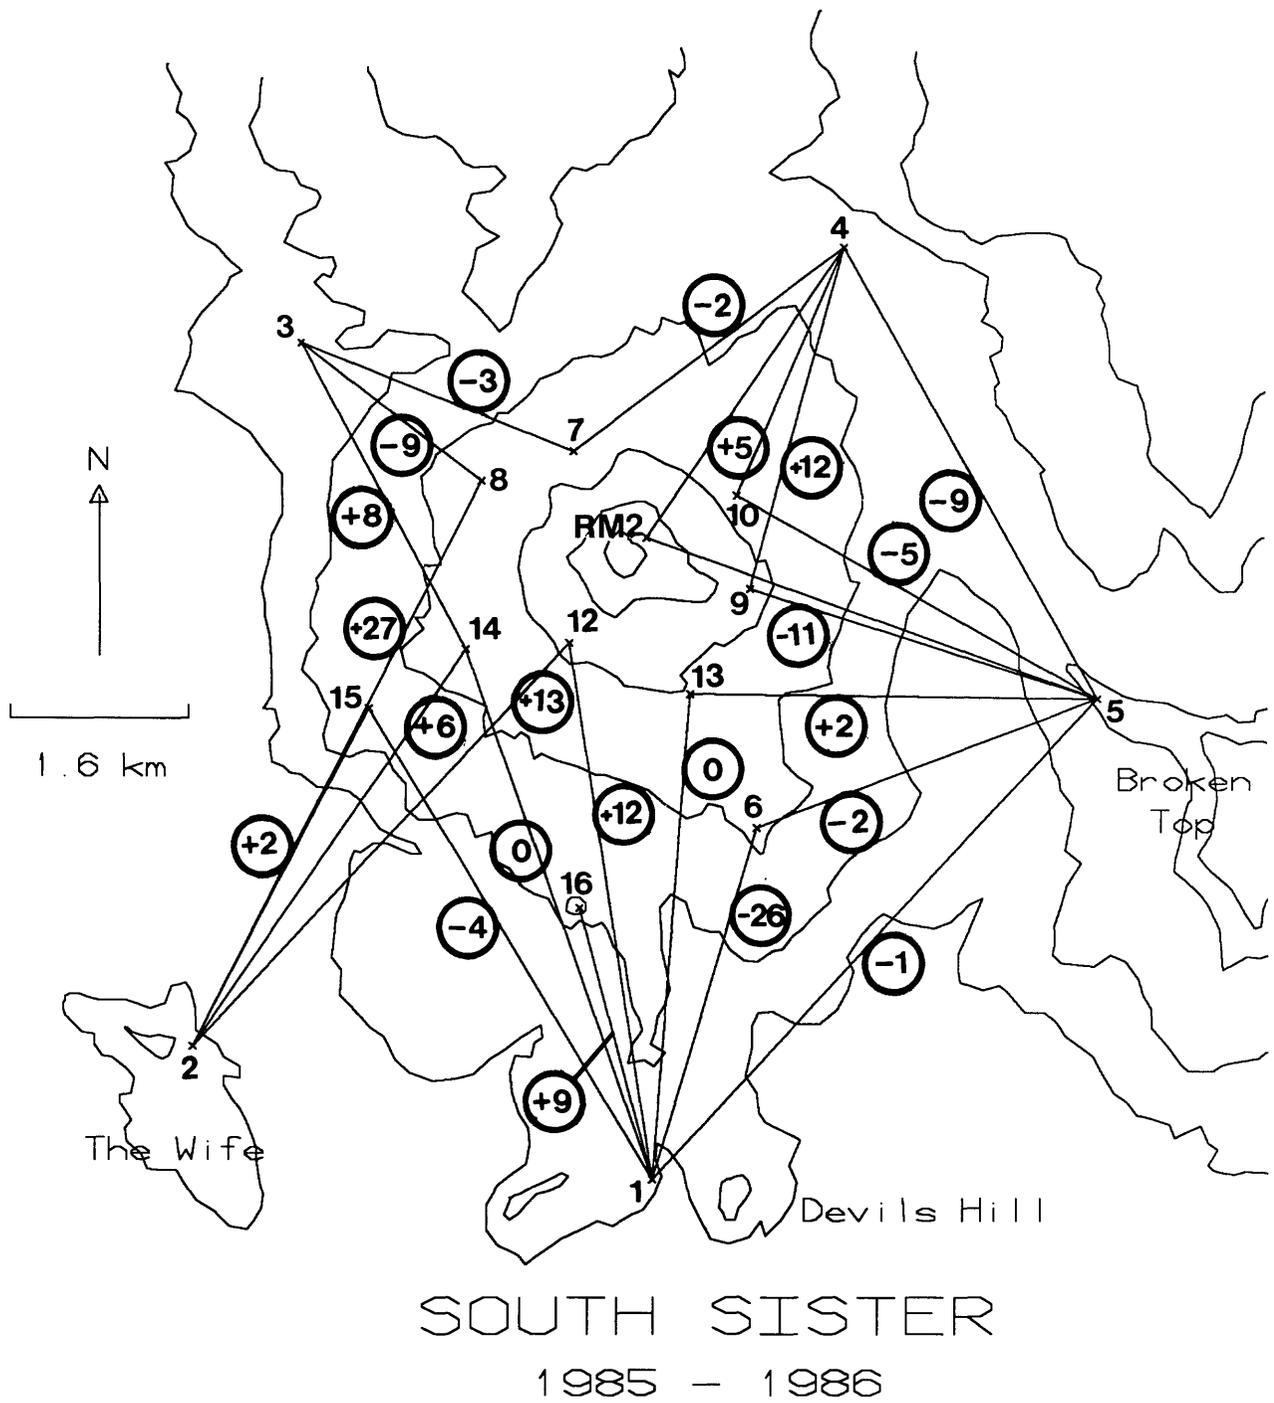
Figure 4. Schematic map showing endpoint mark-to-mark slope distance changes in millimeters at South Sister, Oregon.

Four of the largest apparent changes, on lines 15, 19, 22, and 24, are associated with two bench marks, SS12 and SS8. Both the endpoint and flightline data yield similar distances, so it is unlikely that the apparent changes were caused by environmental effects. These relatively large changes may have been due either to inaccurate setups by the instrument or reflector person, unstable bench marks, anomalously bad readings, or real deformation. The most likely explanation for the apparent changes at bench mark SS12 (lines 15 and 19) was a noncentered reflector setup in either 1985 or 1986. Bench mark SS8 (lines 22 and 24), because of its location on a moraine (see appendix B), could be unstable, but a bad reflector setup cannot be ruled out.

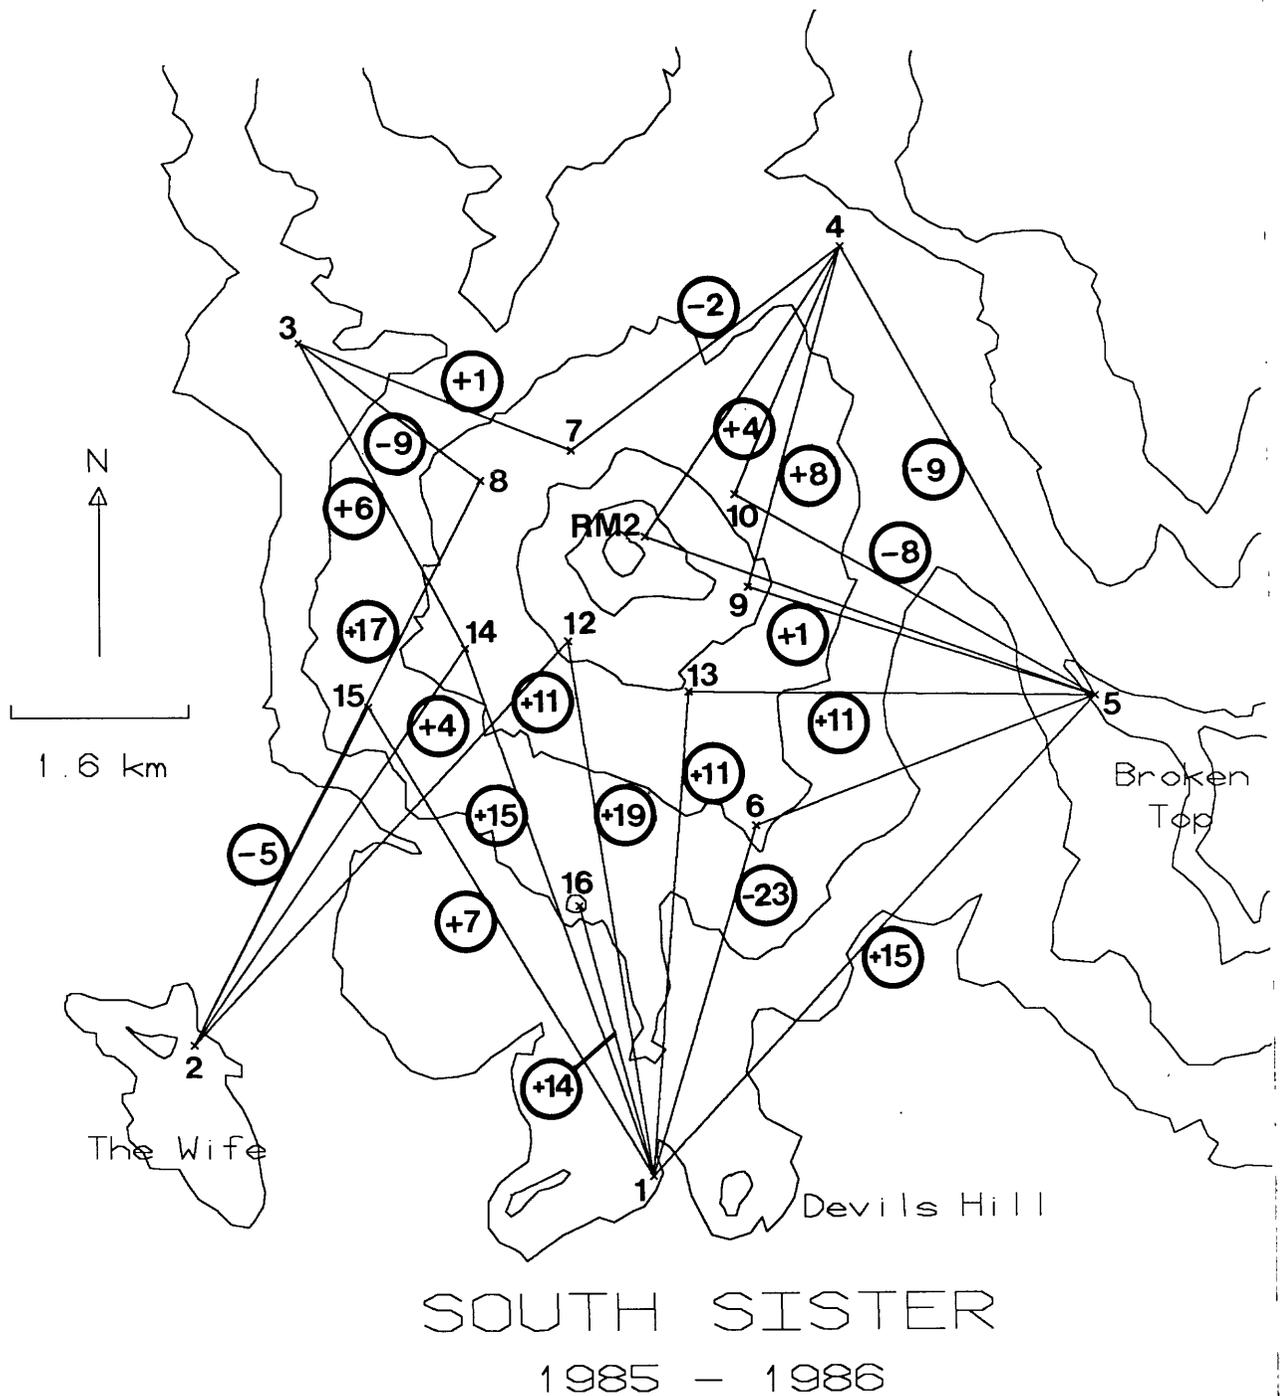
Figure 5. Schematic map showing flightline mark-to-mark slope distance changes in millimeters at South Sister, Oregon.

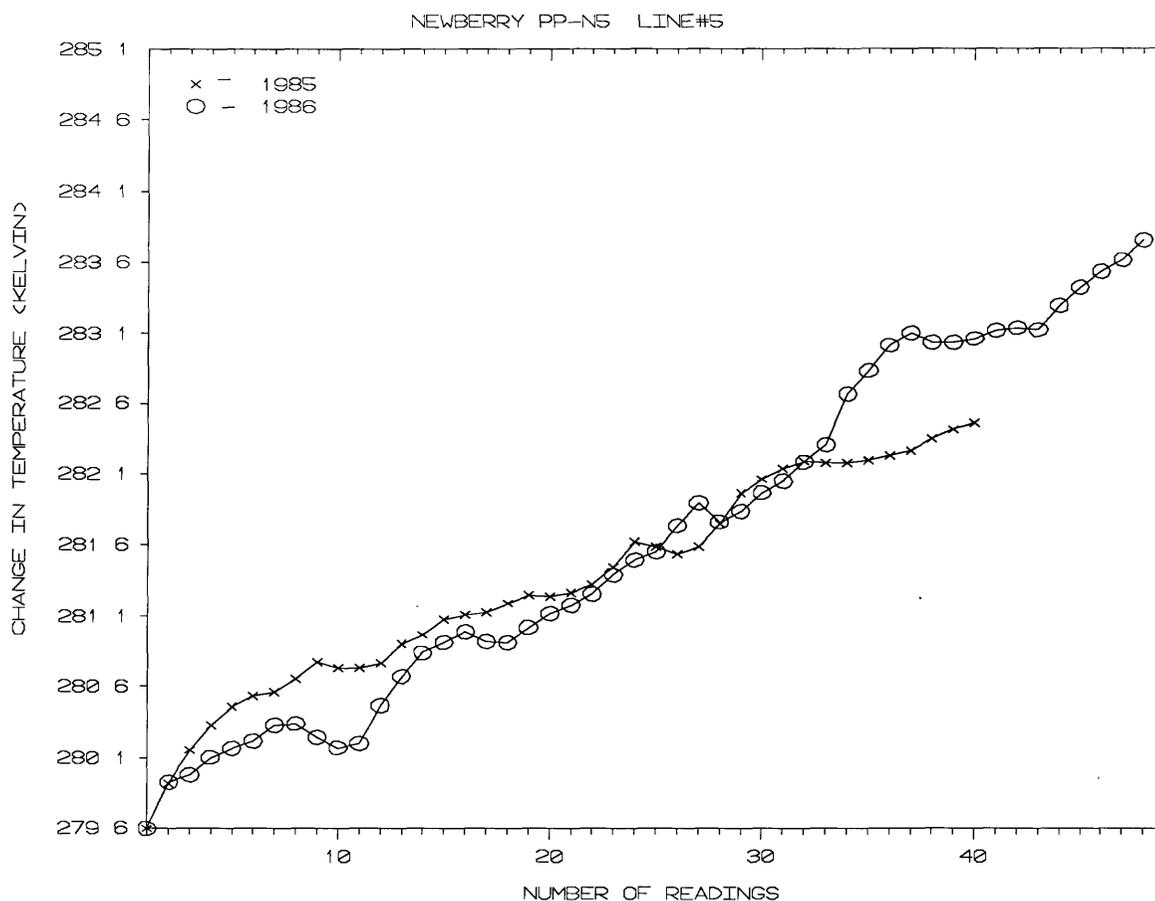
Figure 6. Raw flightline temperature data showing 1985 data similar to 1986 data. Data points are approximately 5 seconds apart. Air speed in 1986 was slower than in 1985, so that more data points were obtained.

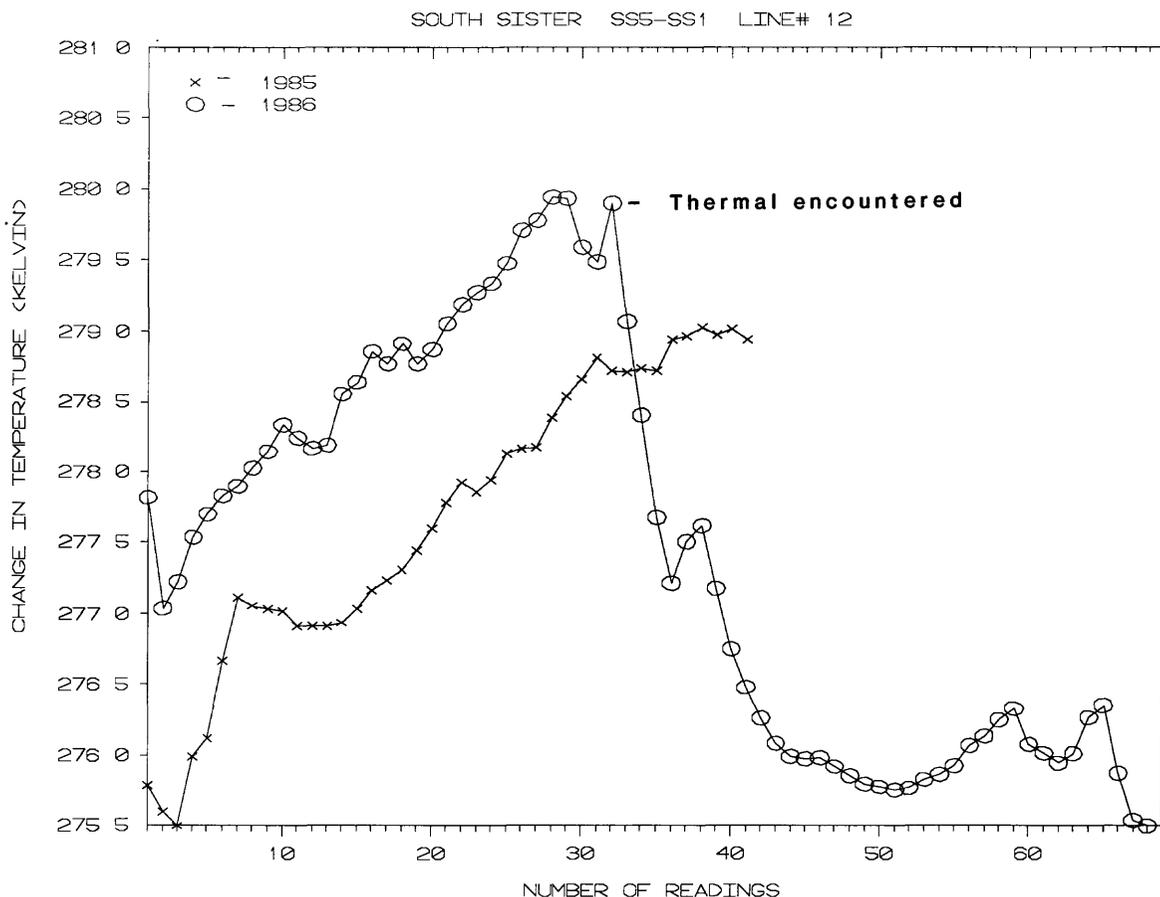
Figure 7. Raw flightline temperature data indicating thermal encountered in 1986. Data points are approximately 5 seconds apart. Air speed in 1986 was much slower than in 1985, so more data points were obtained.

The results of the 1985 to 1986 surveys are much more precise than those reported by Chadwick and others (1985), both for the endpoint and the flightline data. The data in tables 1 and 2 show that the endpoint mark-to-mark slope distance changes are still generally smaller, and hence probably more reliable than the corresponding flightline changes, as Chadwick and others (1985) also found. Flightline data are collected along the entire flight path and should reflect the true temperature of the line shot by the EDM; indeed, in most cases, the temperature gradient is rather linear with elevation changes (see figure 6). Occasionally, however, thermals are encountered, and the linear trend does not hold true (fig. 7). In such a case, the calculated flightline temperature is an average of all the temperatures, whether along linear or thermal (non-linear) trends. Since the temperature along the flight path is recorded by a helicopter, it is possible that the helicopter is being affected much more than the signal of the EDM. Figure 7 shows the helicopter in the thermal for a minimum of 50 seconds, which could affect the handling and air speed of the helicopter. The thermals could be an indirect cause of the error for such a line.

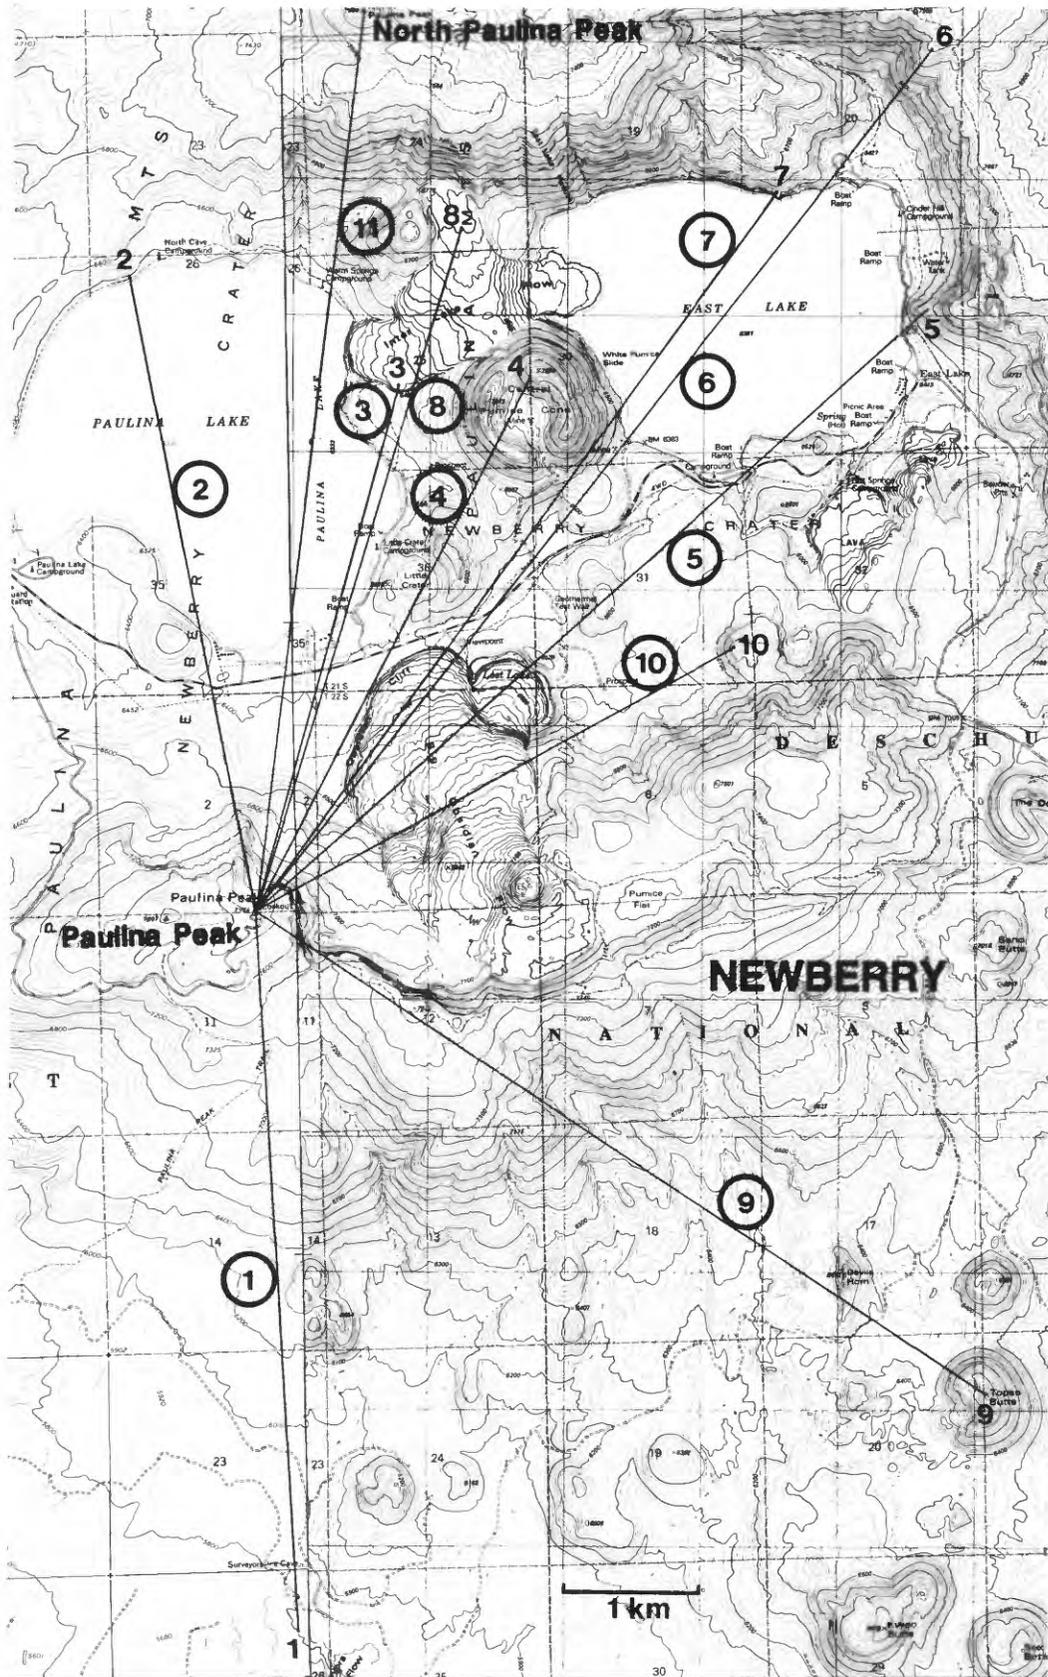
Figure A1. Map showing bench marks, line numbers (circled), and station locations for distance measuring network at Newberry, Oregon.

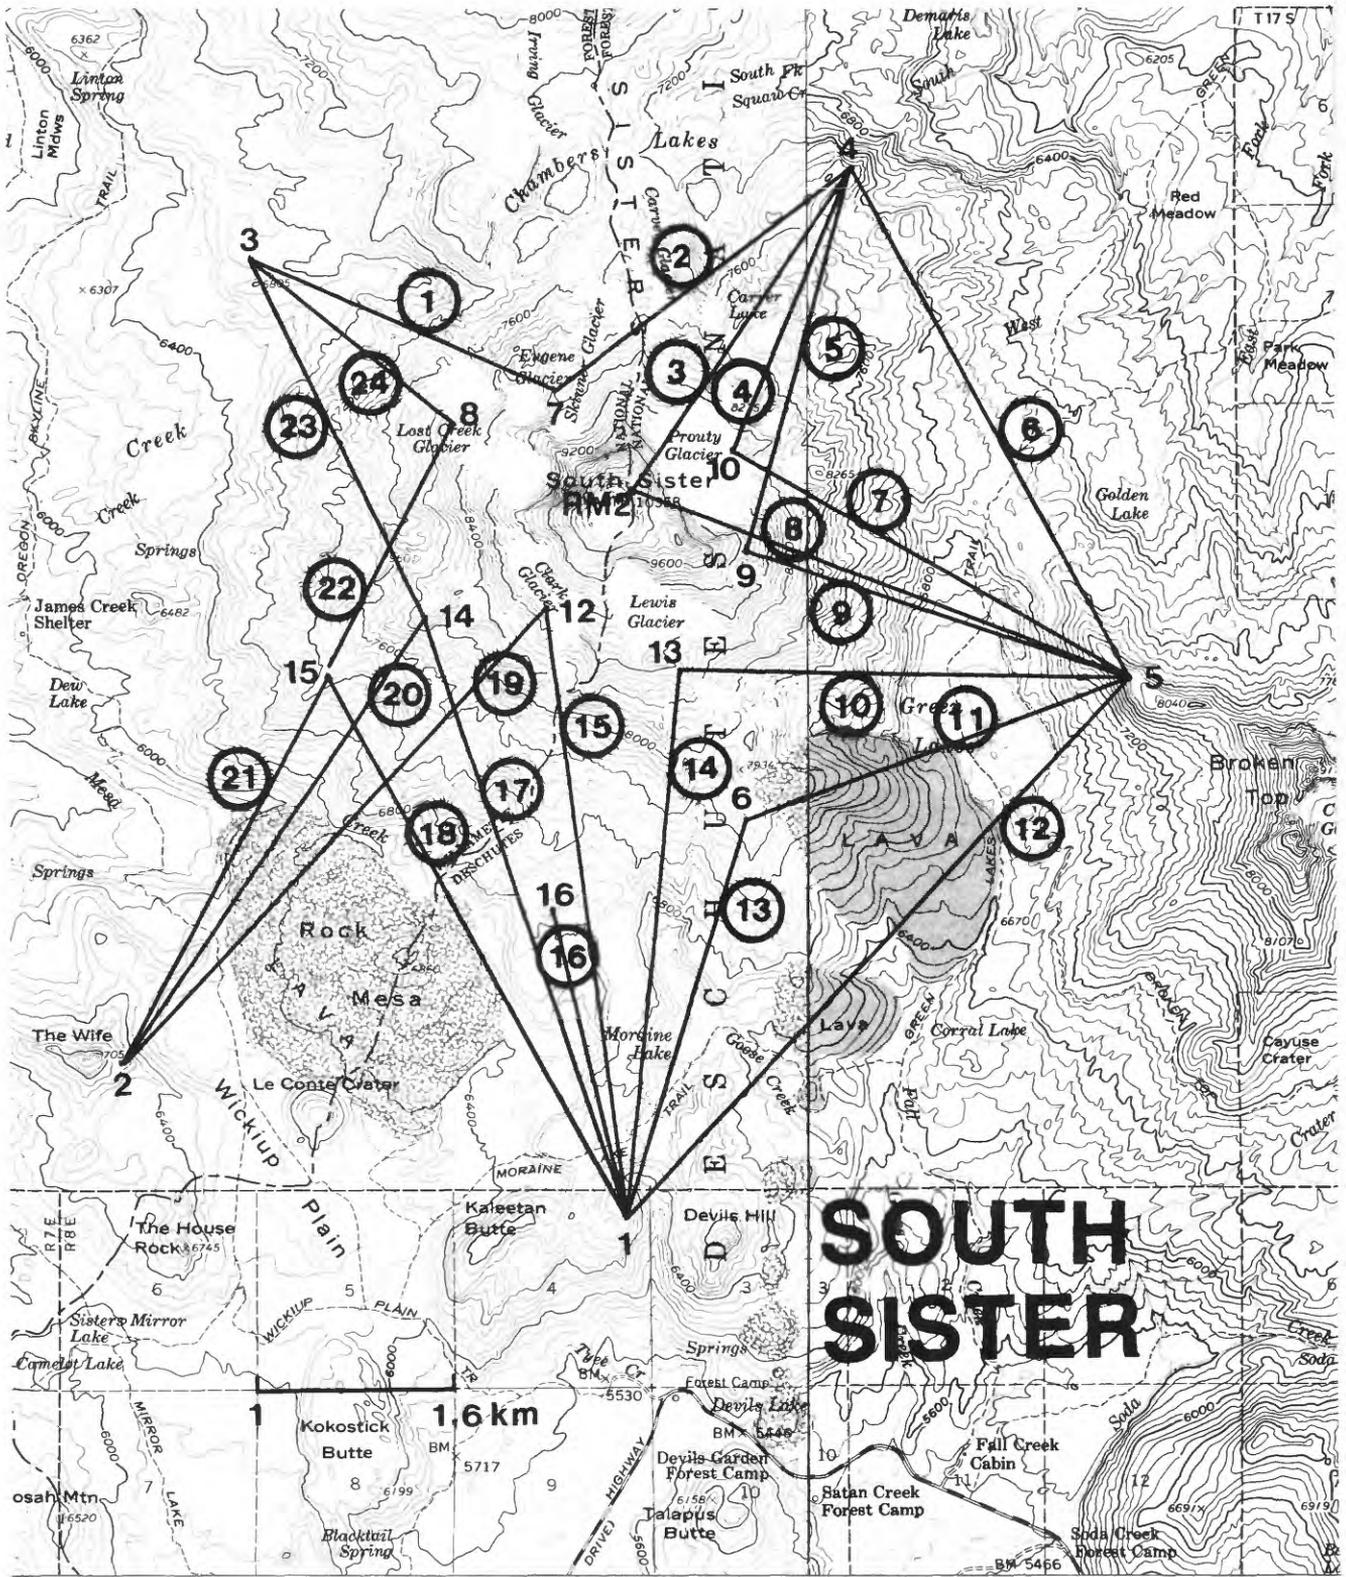
Figure B1. Map showing bench marks, line numbers (circled), and station locations of the trilateration network at South Sister, Oregon.

The South Sister trilateration network is shown in figure B1. The results indicate little or no apparent deformation between 1985 and 1986. Endpoint mark-to-mark slope distance changes have a mean of  $2.04 \pm 1.82$  ppm, and flightline distance changes have a mean of  $2.39 \pm 1.54$  ppm.
