WATER FACT SHEET

U.S. GEOLOGICAL SURVEY, DEPARTMENT OF THE INTERIOR

GEOLOGY IN ACTION—JÖKULHLAUPS ON MOUNT RAINIER

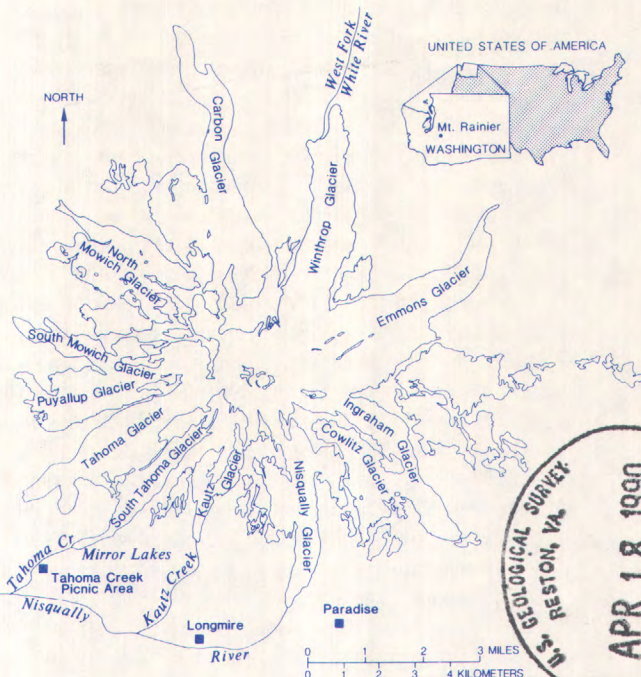
Schematic diagram of major glaciers on Mt. Rainier.

Four glaciers on Mount Rainier are known to produce jökulhlaups—the Nisqually, Kautz, South Tahoma, and Winthrop Glaciers. At least three other glaciers—the Carbon, South Mowich, and Emmons—are suspect.

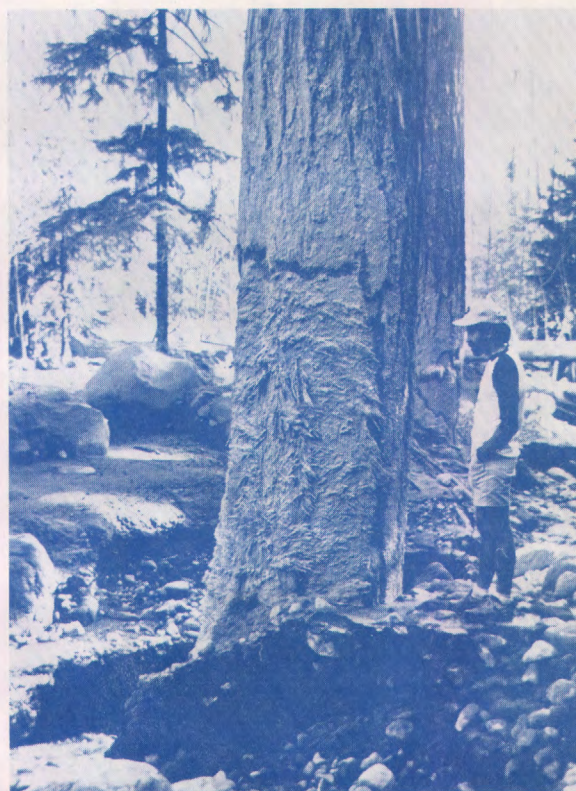
Flood damage and mud lines on a Douglas fir in the former Tahoma Creek picnic area.

Down-valley, lobes of sediment buried tables, signs, and a parking lot by 3 feet or more at the Tahoma Creek picnic area and trailhead. This area is now closed to visitors, although it is visible from the Westside Road.
