U.S. DEPARTMENT OF THE INTERIOR
GEOLOGICAL SURVEY

Typhoon Russ Effects on the Shoreline of Guam

U.S. Geological Survey Open-File Report 91-571

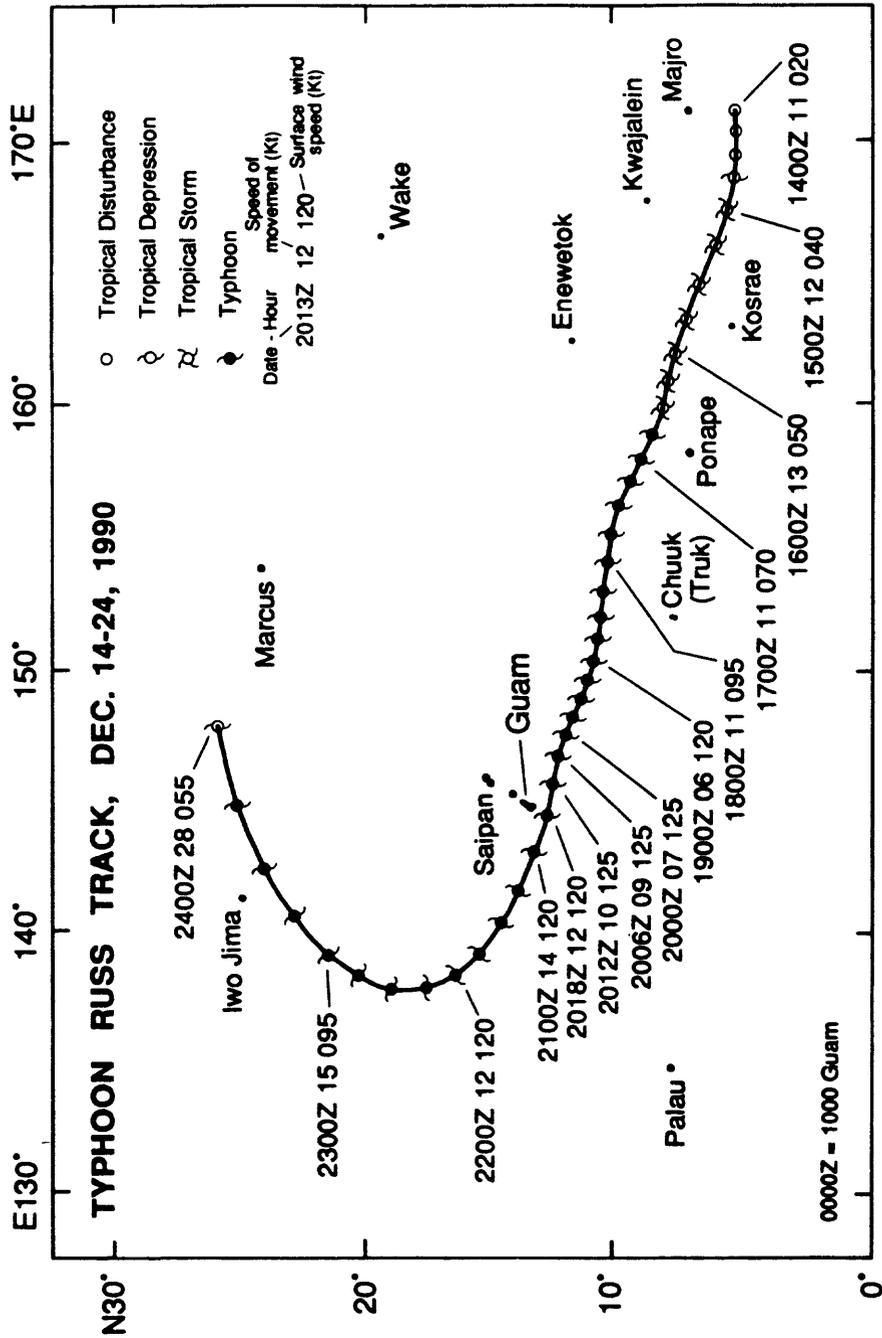
Figure 1. Track of Typhoon Russ from Dec 14-24, 1991. Modified from C.P. Guard, written commun., 1991.

On December 20 and 21, 1991, the eye of Typhoon Russ passed within 65 km (40 mi) to the south of Guam (Fig. 1) causing extensive wind and overwash damage. Russ traveled in a southeast to northwest direction creating sustained winds on southern Guam of 190 km/hr (120 mph) with gusts up to 240 km/hr (150 mph). Overwash, a super elevation of the water level resulting from a combination of low barometric pressure, wind set-up, wave set-up, and wave swash, caused extensive property damage along the south and east coasts. The last typhoon of this magnitude to strike Guam was Pamela in May 1976. Because storm surge information from previous typhoons on Guam is poorly documented (Weir, 1983), the present study measured evidence for maximum water-level elevations on the coast in an effort to determine the pattern of overwash. In addition, a general assessment of shoreline changes included beach profiling at selected sites, and re-profiling of beach profiles established on Cocos Island as part of 1990 SOPAC* -USGS Coastal Mapping Workshop.

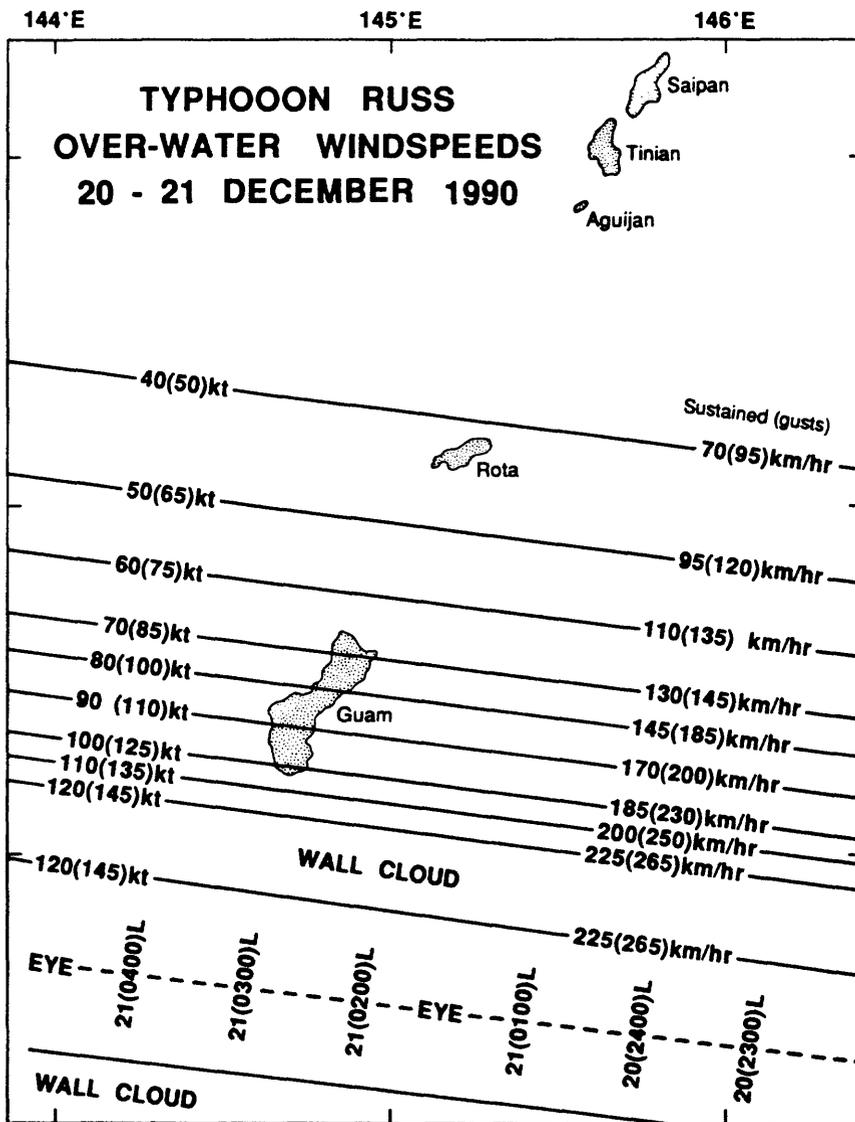
Figure 2. Calculated over-water wind speeds for Typhoon Russ as it passed Guam. Modified from C.P. Guard, written commun., 1991.

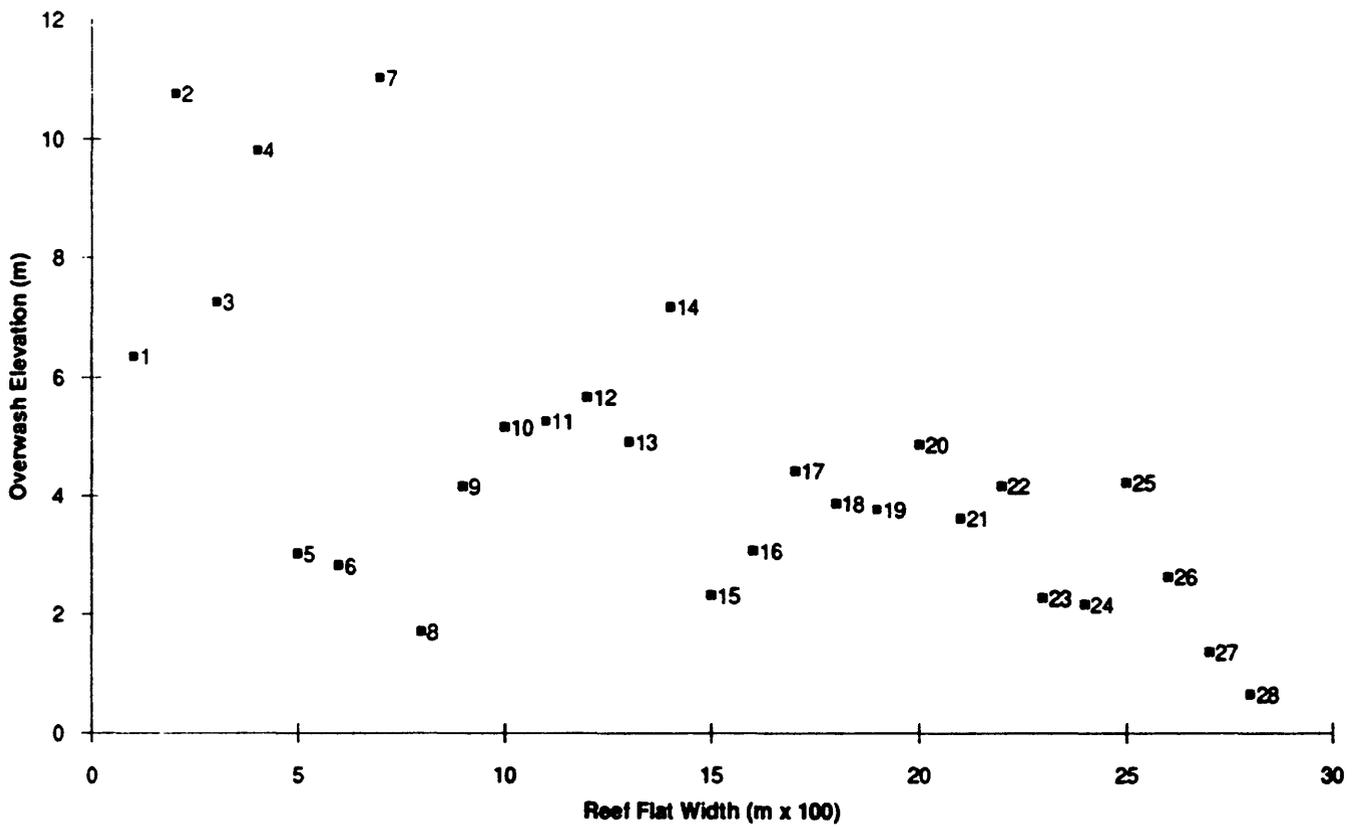
Figure 3. Plot of measured overwash height versus adjacent reef width for twenty-seven locations and the best-fit line (location 28, Merizo, is not shown, OH = 0.65 m, RW = 2900 m).

Table I presents the overwash measurement locations from north to south, the date and time of measurement, overwash height, reef width, reef facing direction, and the shoreline facing direction at the measurement site. The reef width and facing directions were determined from USGS 1:24,000 topographic maps. The shortest distance between the shoreline and the edge of the reef is the distance used as the reef width (this is not necessarily orthogonal to the shore). Overwash height versus the reef width, reef facing direction, and shoreline facing direction are presented in Figures 3, 4, and 5 respectively. There is a strong inverse relationship between reef width and overwash height (correlation coefficient = 0.73, significant at the 99 percent level). The narrower the reef, the higher the overwash. The three highest measured overwash sites, Fadian Point (10.75 m), University of Guam Marine Labs (9.8 m), and Tagachan Beach (11.0 m), are bordered by a narrow fringing reef backed by a steep coastline. The relationships between overwash height and facing directions are less dramatic. In general, it appears that east-facing coastlines underwent somewhat higher overwash than those facing south.

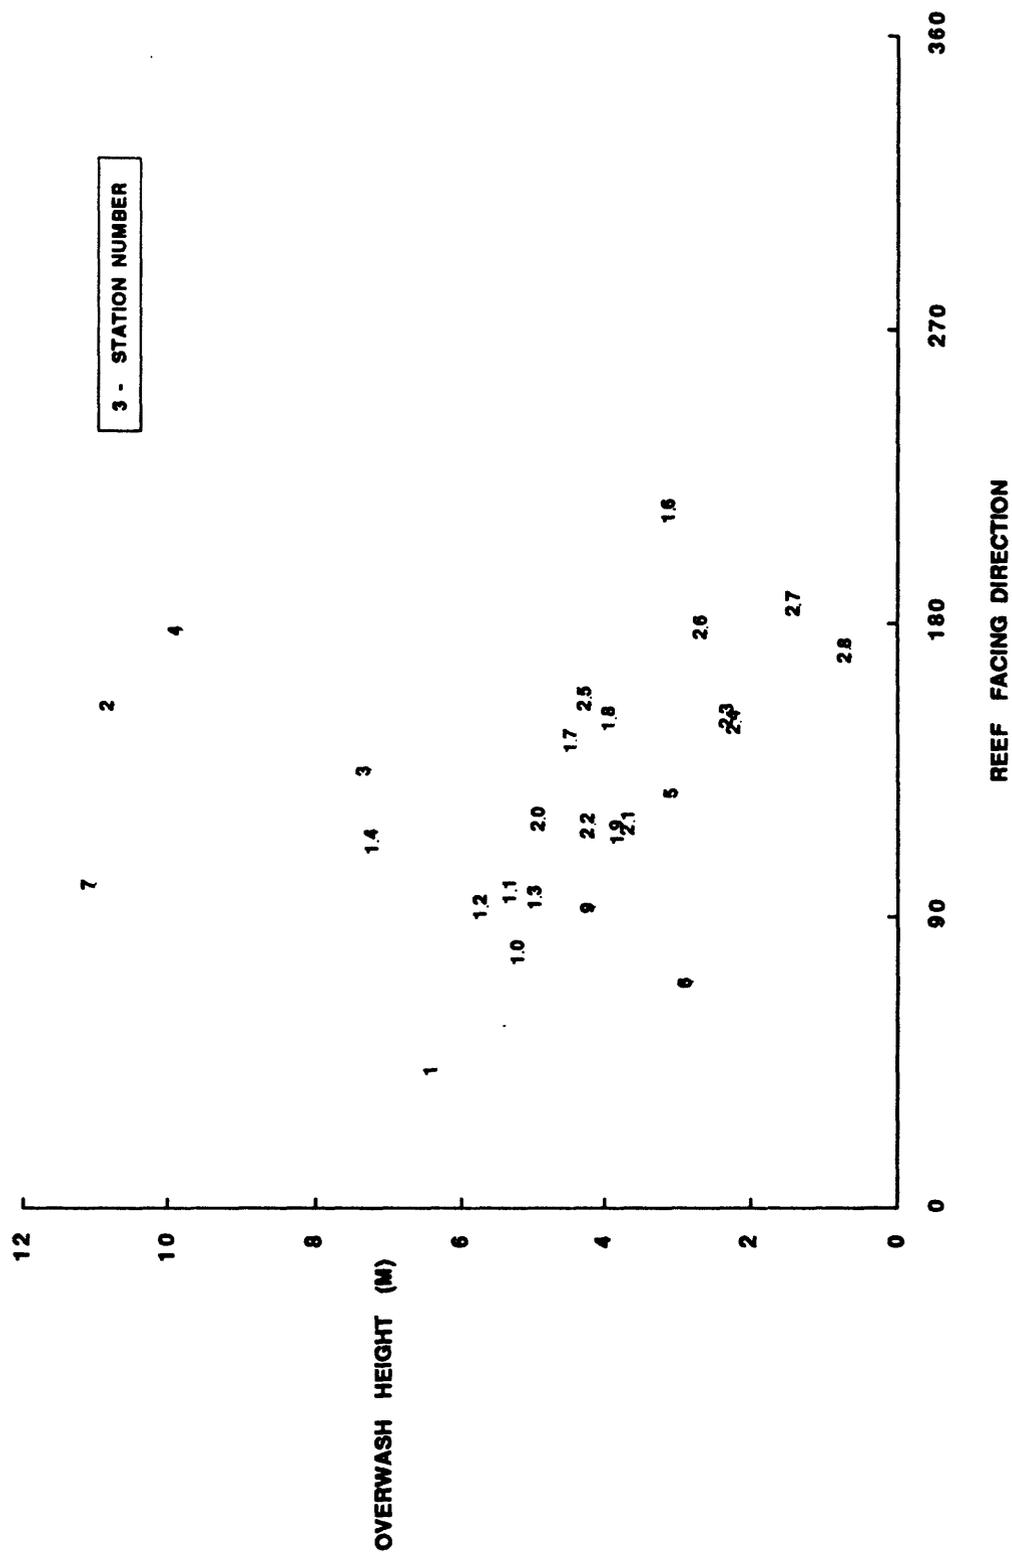
Figure 4. Plot of overwash height versus reef facing direction.

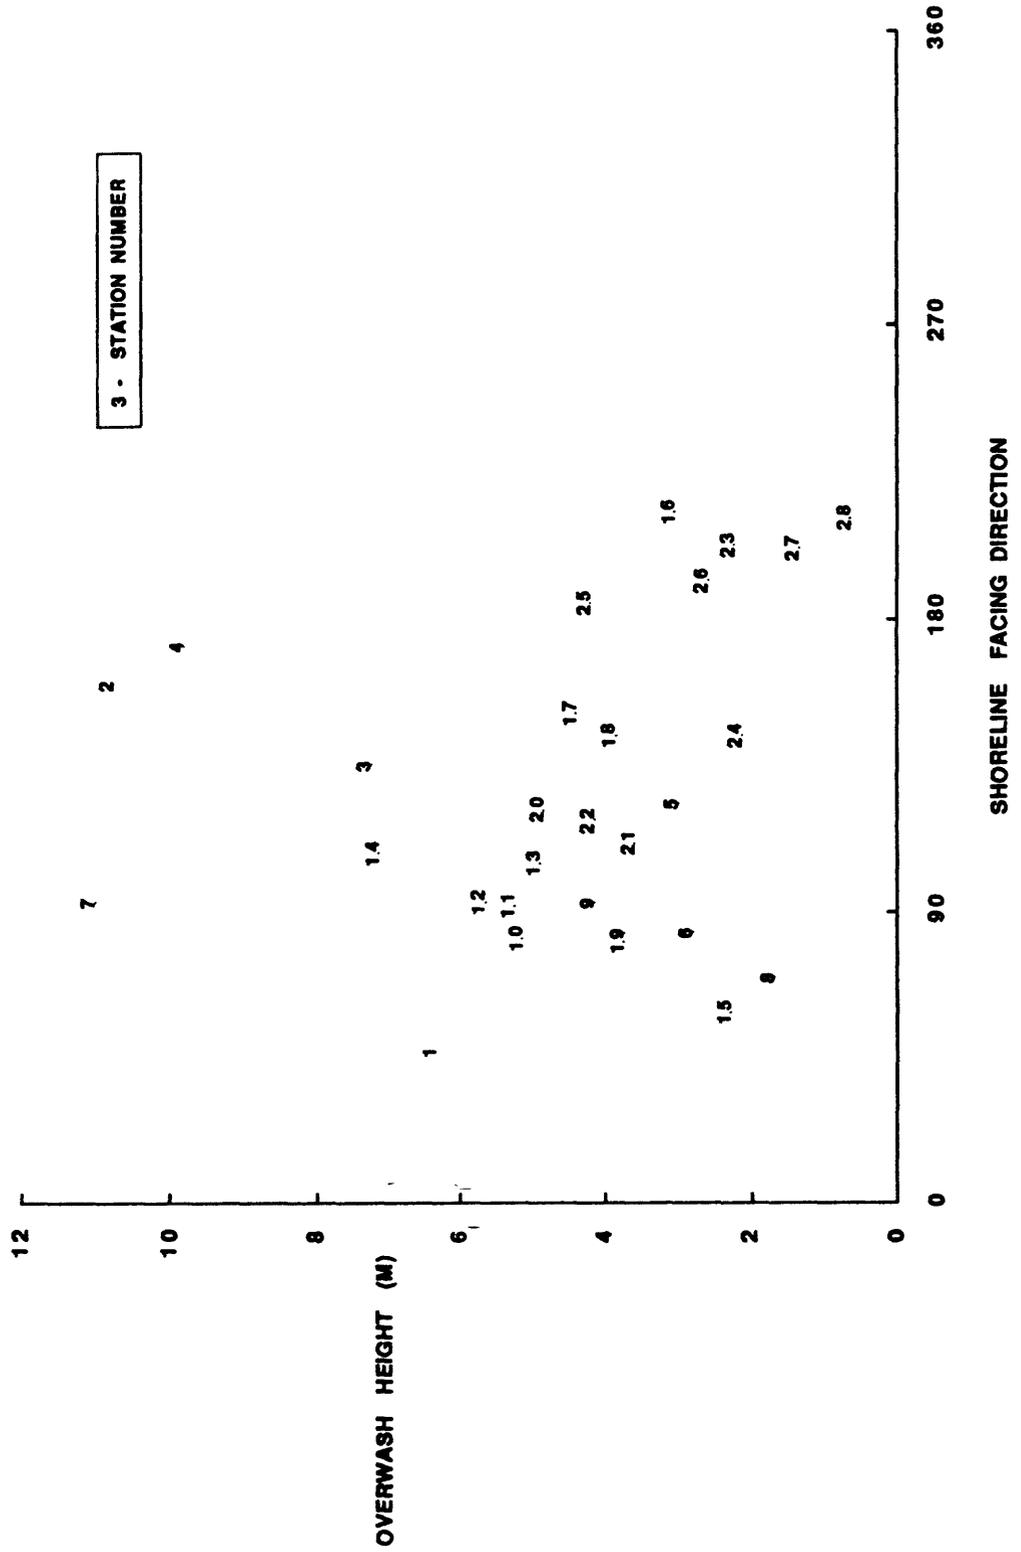
Figure 5. Plot of overwash height versus shoreline facing direction.

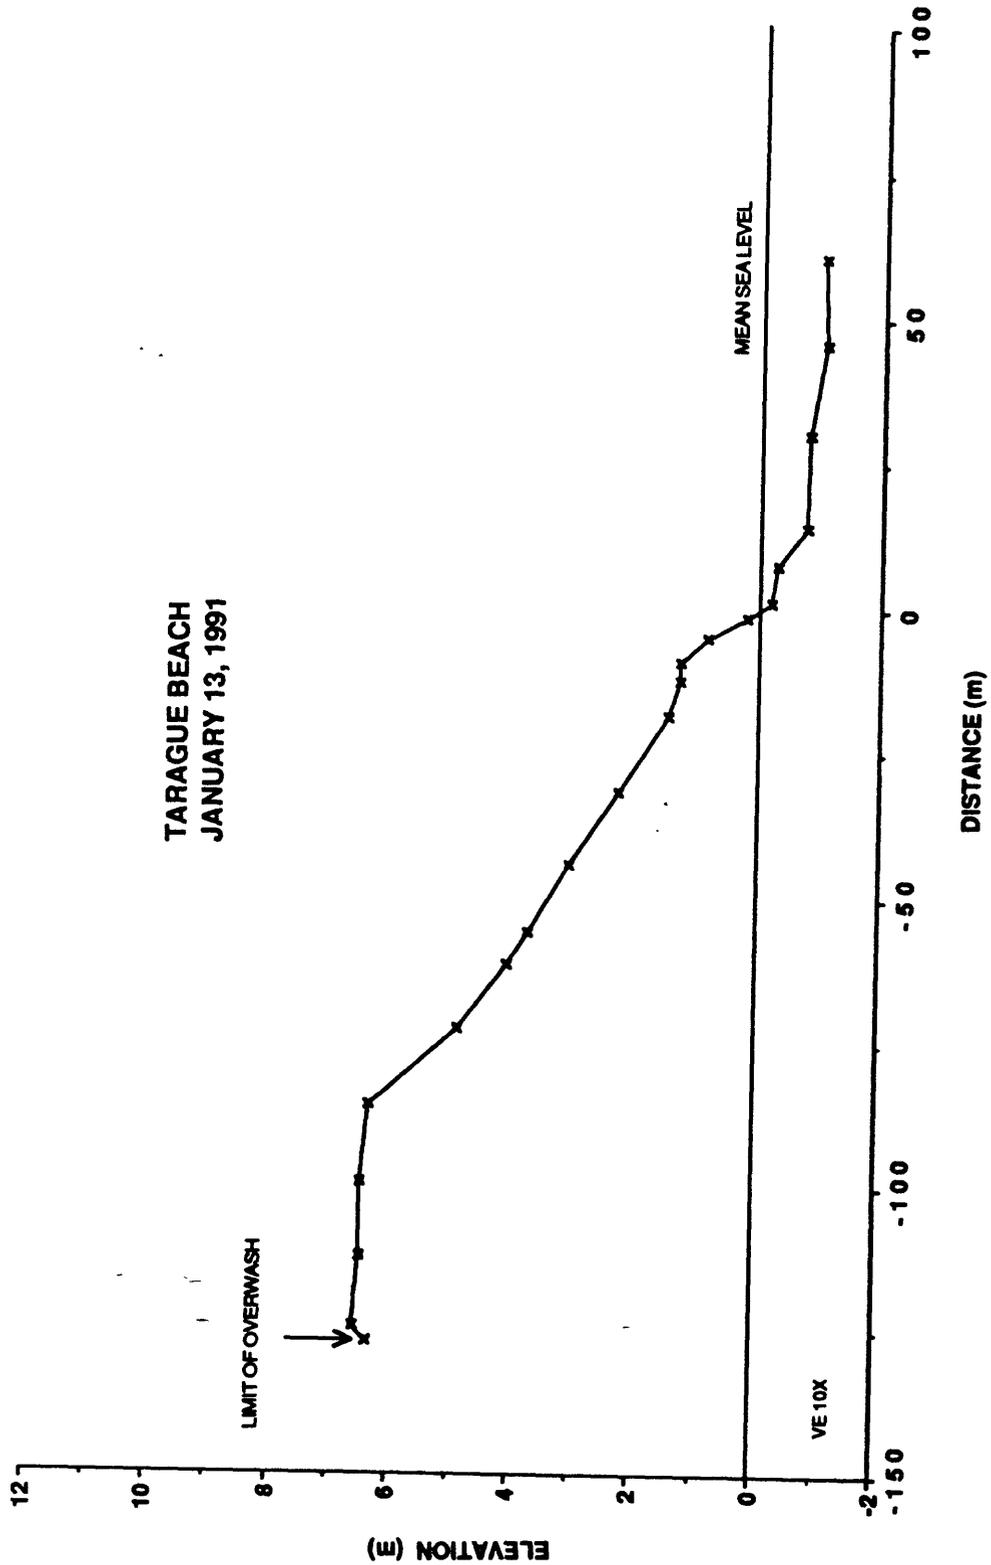
Figure 6a. Beach profile plot of Tarague Beach taken January 13, 1991. Mean sea-level position, for this and the other beach profiles, is approximate and is based on the average water-level at the time of profiling corrected for tide stage. The active berm crest is the small terrace-like feature at about 1.5 m asl.

Tarague beach is located on the northeastern tip of the island within the confines of Anderson Air Force Base. It is a wide (100+ m), northeastern-facing, carbonate-sand beach fronted by a narrow (<200 m) fringing reef. At the time of profiling a small, active berm crest was developed at the upward limit of the swash zone (Fig. 6a). The back-beach area is a near-planar, gently-sloping, slightly-vegetated surface extending to a level approximately 6 m asl where it flattens out. This flat surface is in part due to the road which traverses it and contains numerous coconut palms. There were small patches of beachrock exposed in the inner surf zone, but overall, there was very little evidence suggesting an erosion problem.

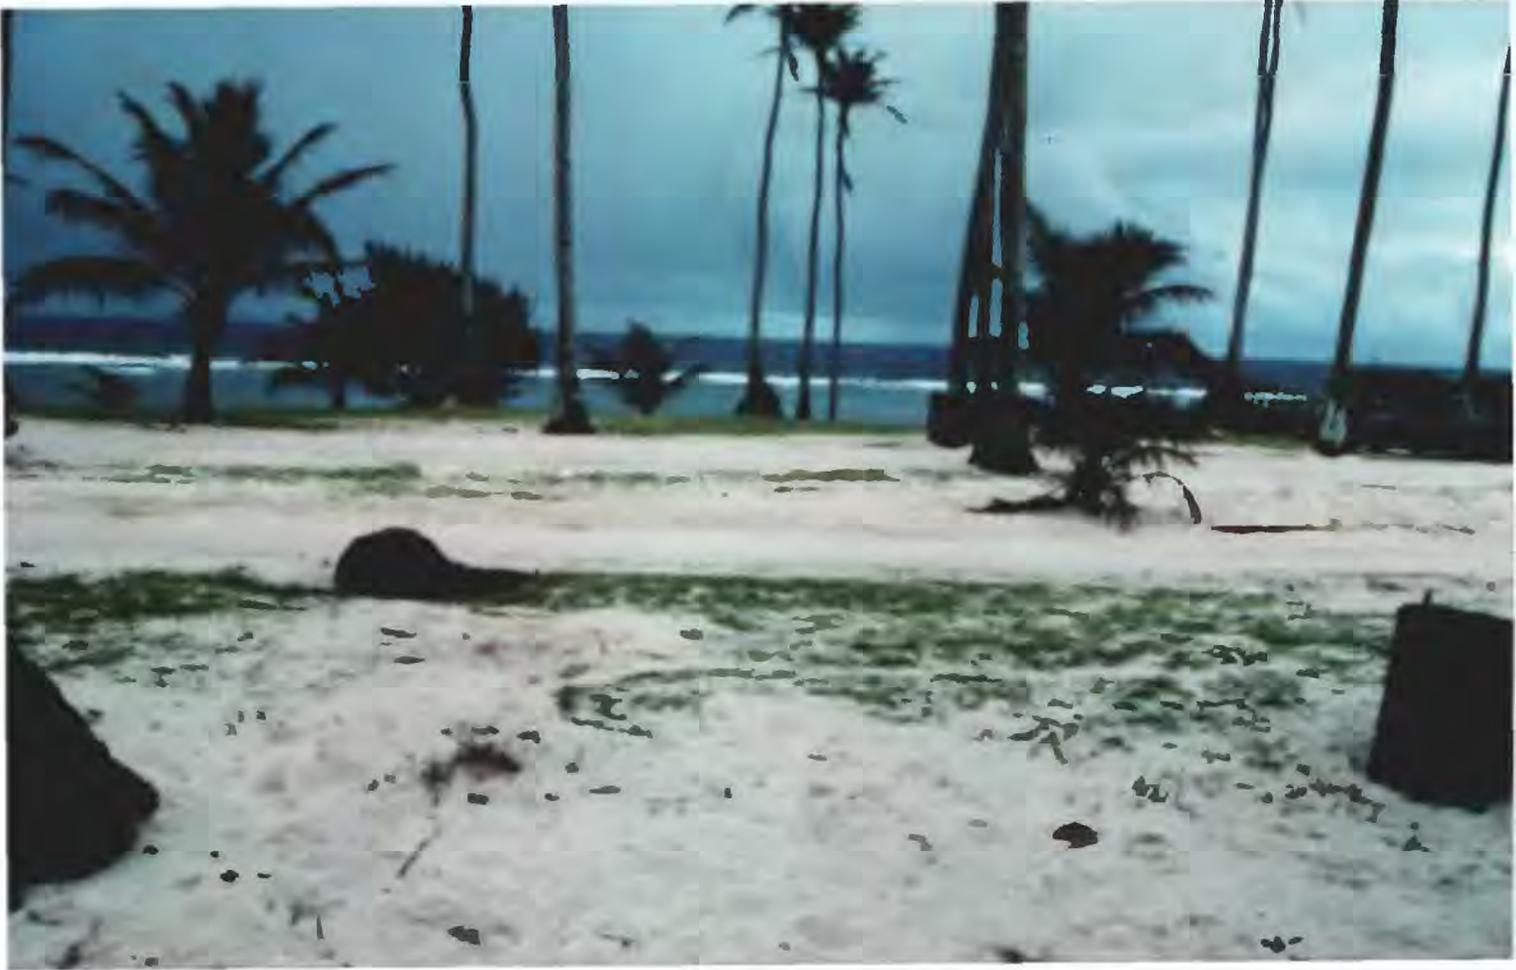
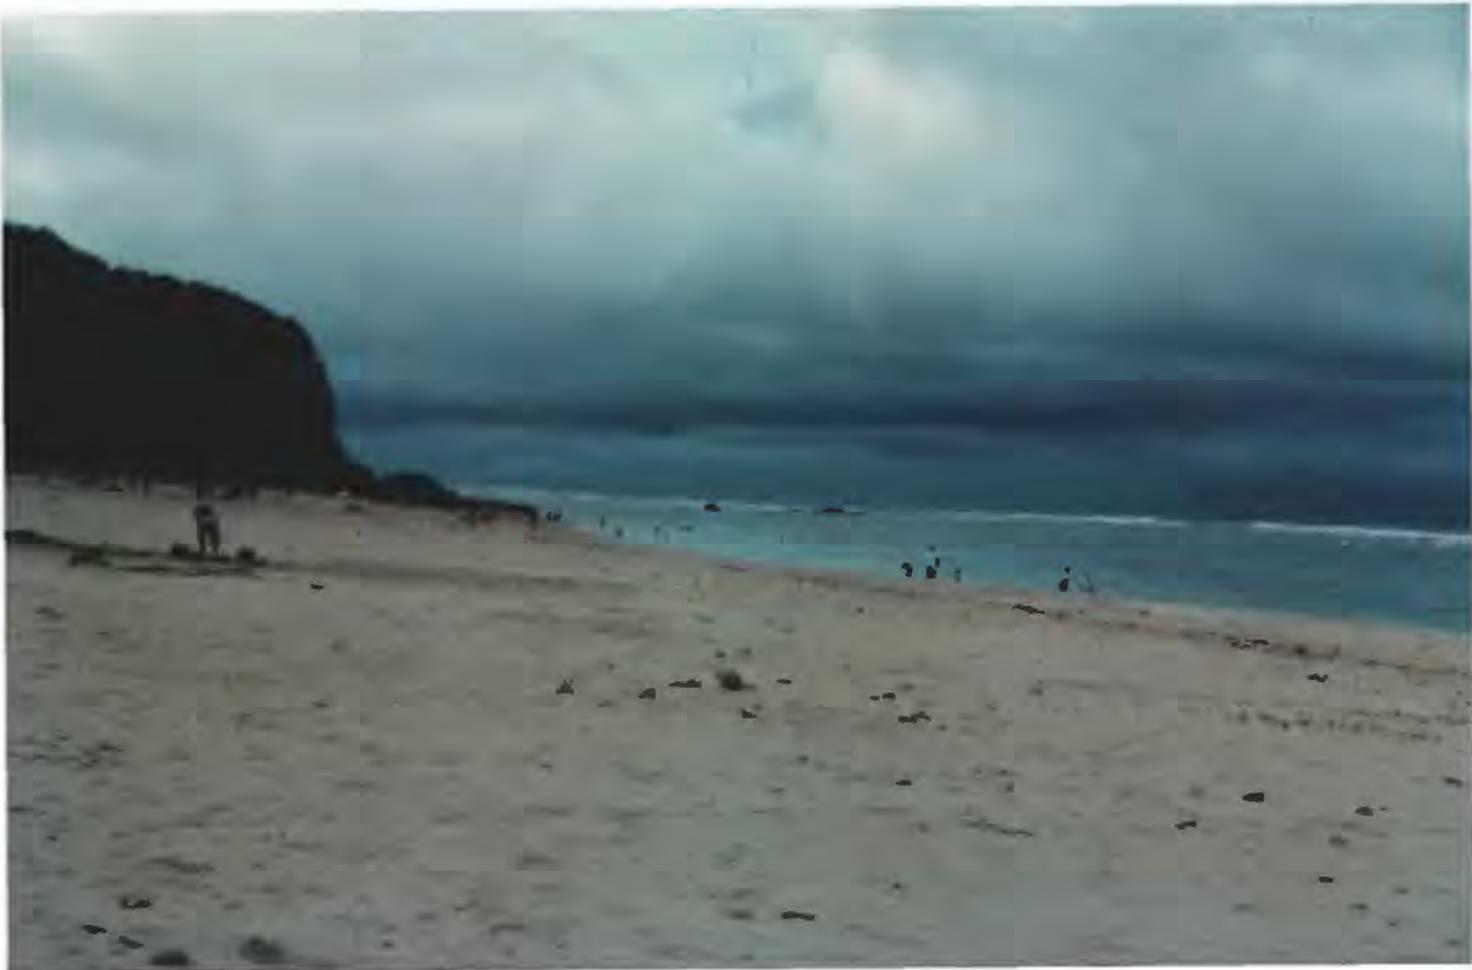
Figure 6b (top). Seaward-looking view along the profile line showing the sand-covered road and flat surface of the upper backbeach. 6c (bottom). View to the north of the gently-sloping backbeach.

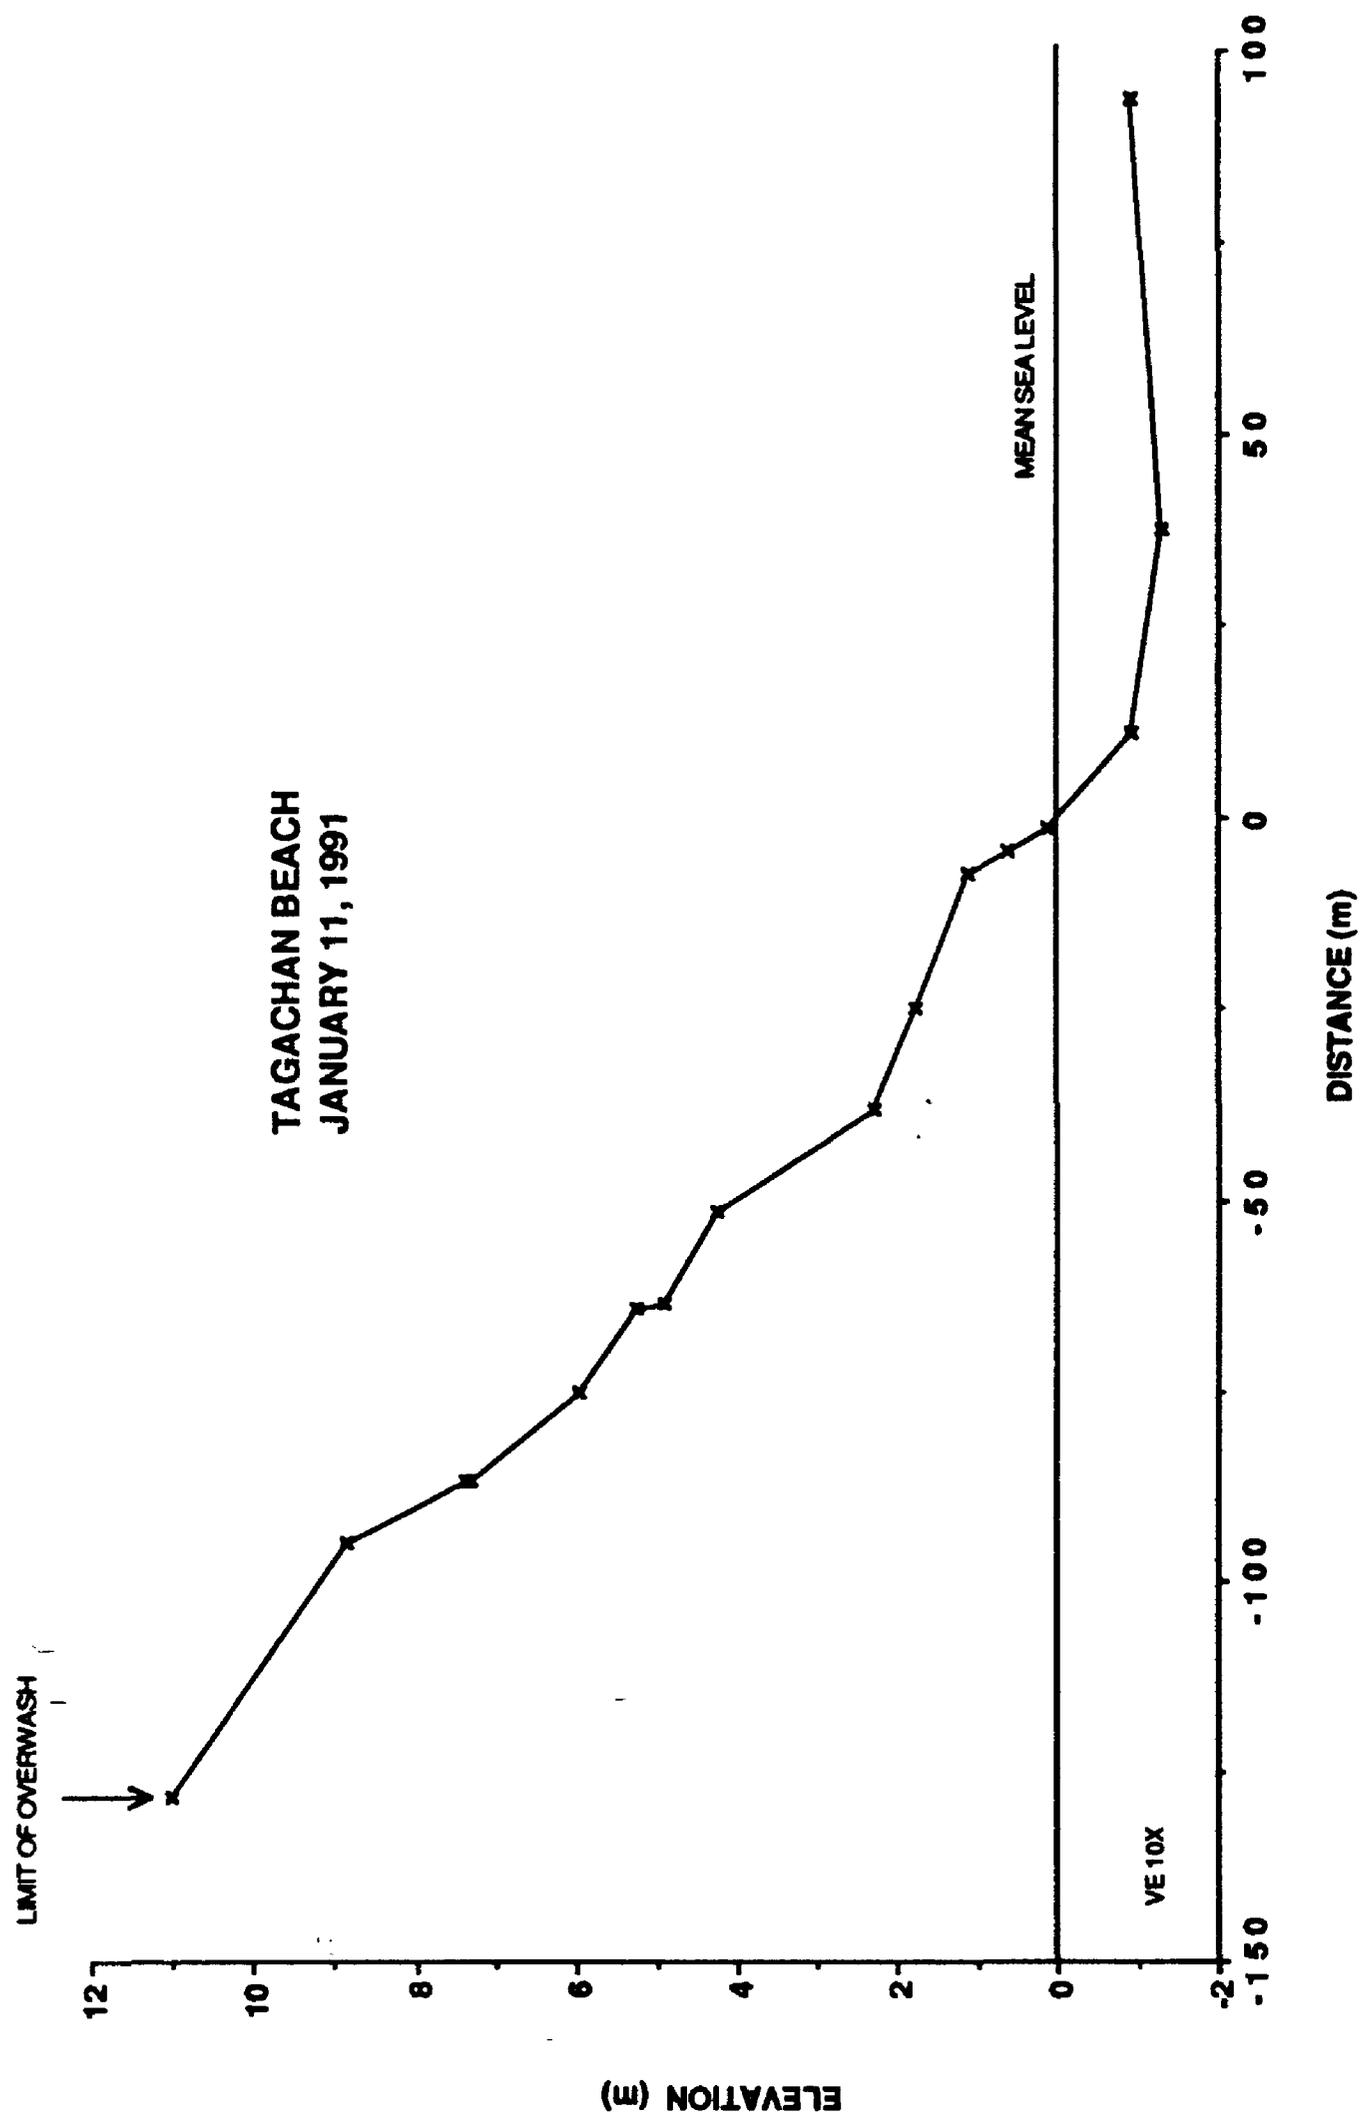
Figure 7a. Beach profile plot of Tagachan Beach taken January 11, 1991. The small step in the profile at approximately 5 m elevation is an erosional scarp.

Tagachan Beach is an east-facing, carbonate sand and rubble pocket beach (Fig. 7) located within a relatively steep and rugged section of coastline. It is fronted by a narrow (about 120 m wide) fringing reef, the inner surface of which is a reef pavement with a thin, patchy veneer of sediment. The gently-sloping backbeach is composed of a mixture of carbonate sand with large amounts of coral rubble. At the south end of the beach the sediment had been stripped away exposing a bare limestone platform (Fig 7c). Other evidence of erosion, presumably Typhoon Russ induced, included erosional scarps and exposed soil horizons.

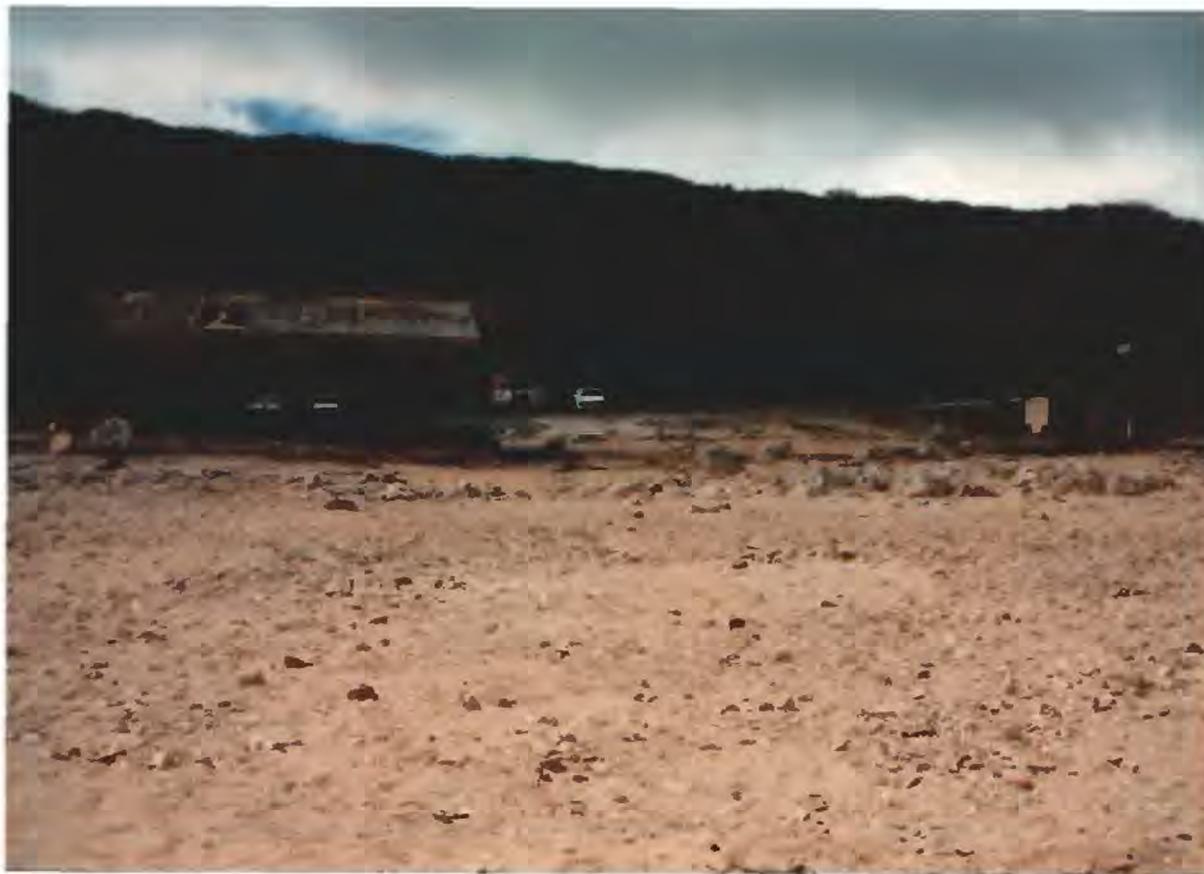
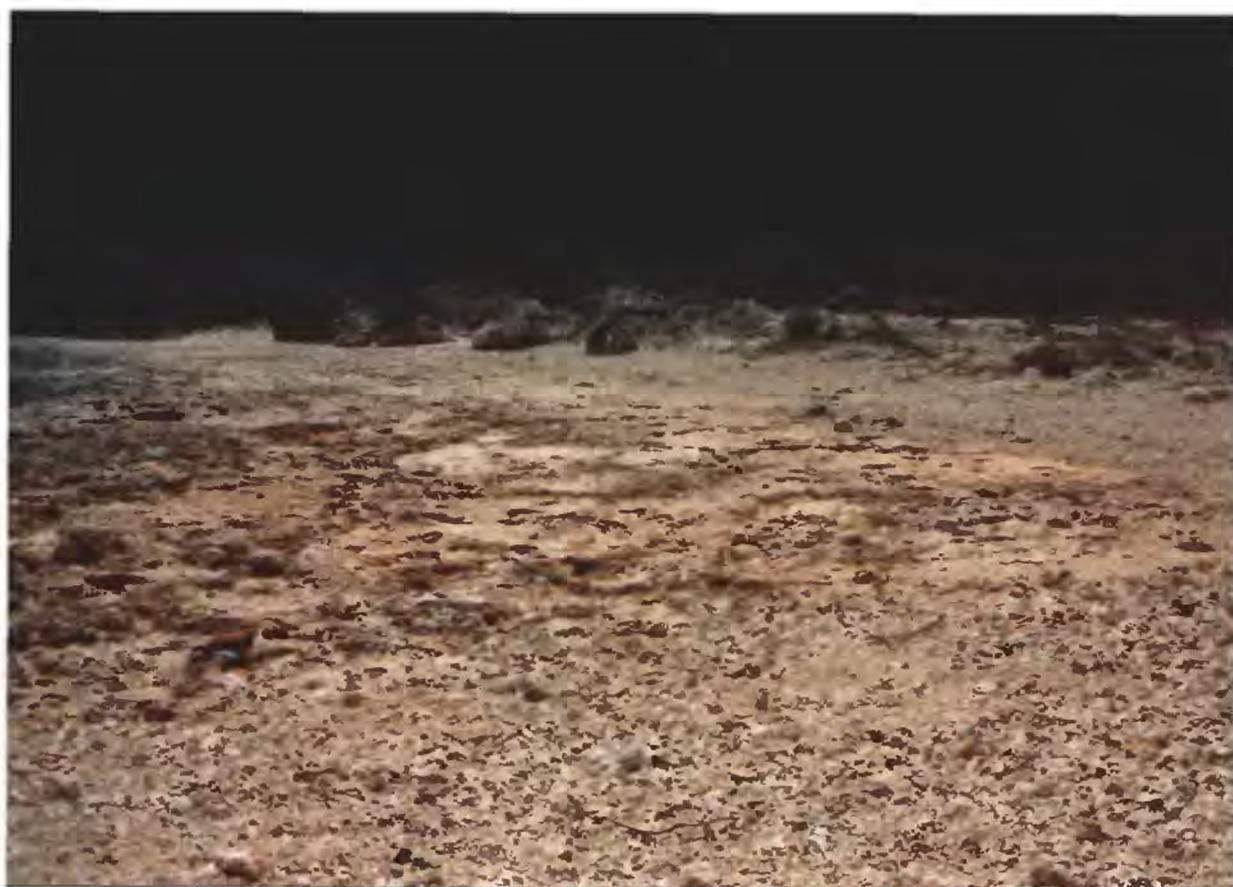
Figure 7b (top). Landward-looking view at Tagachan Beach showing the main backbeach area. Exposures of white limestone in the central portion of the photograph indicate recent exposure. 7c (bottom). Area on the southern part of the beach where the unconsolidated sediment has been stripped away exposing a bare limestone surface.

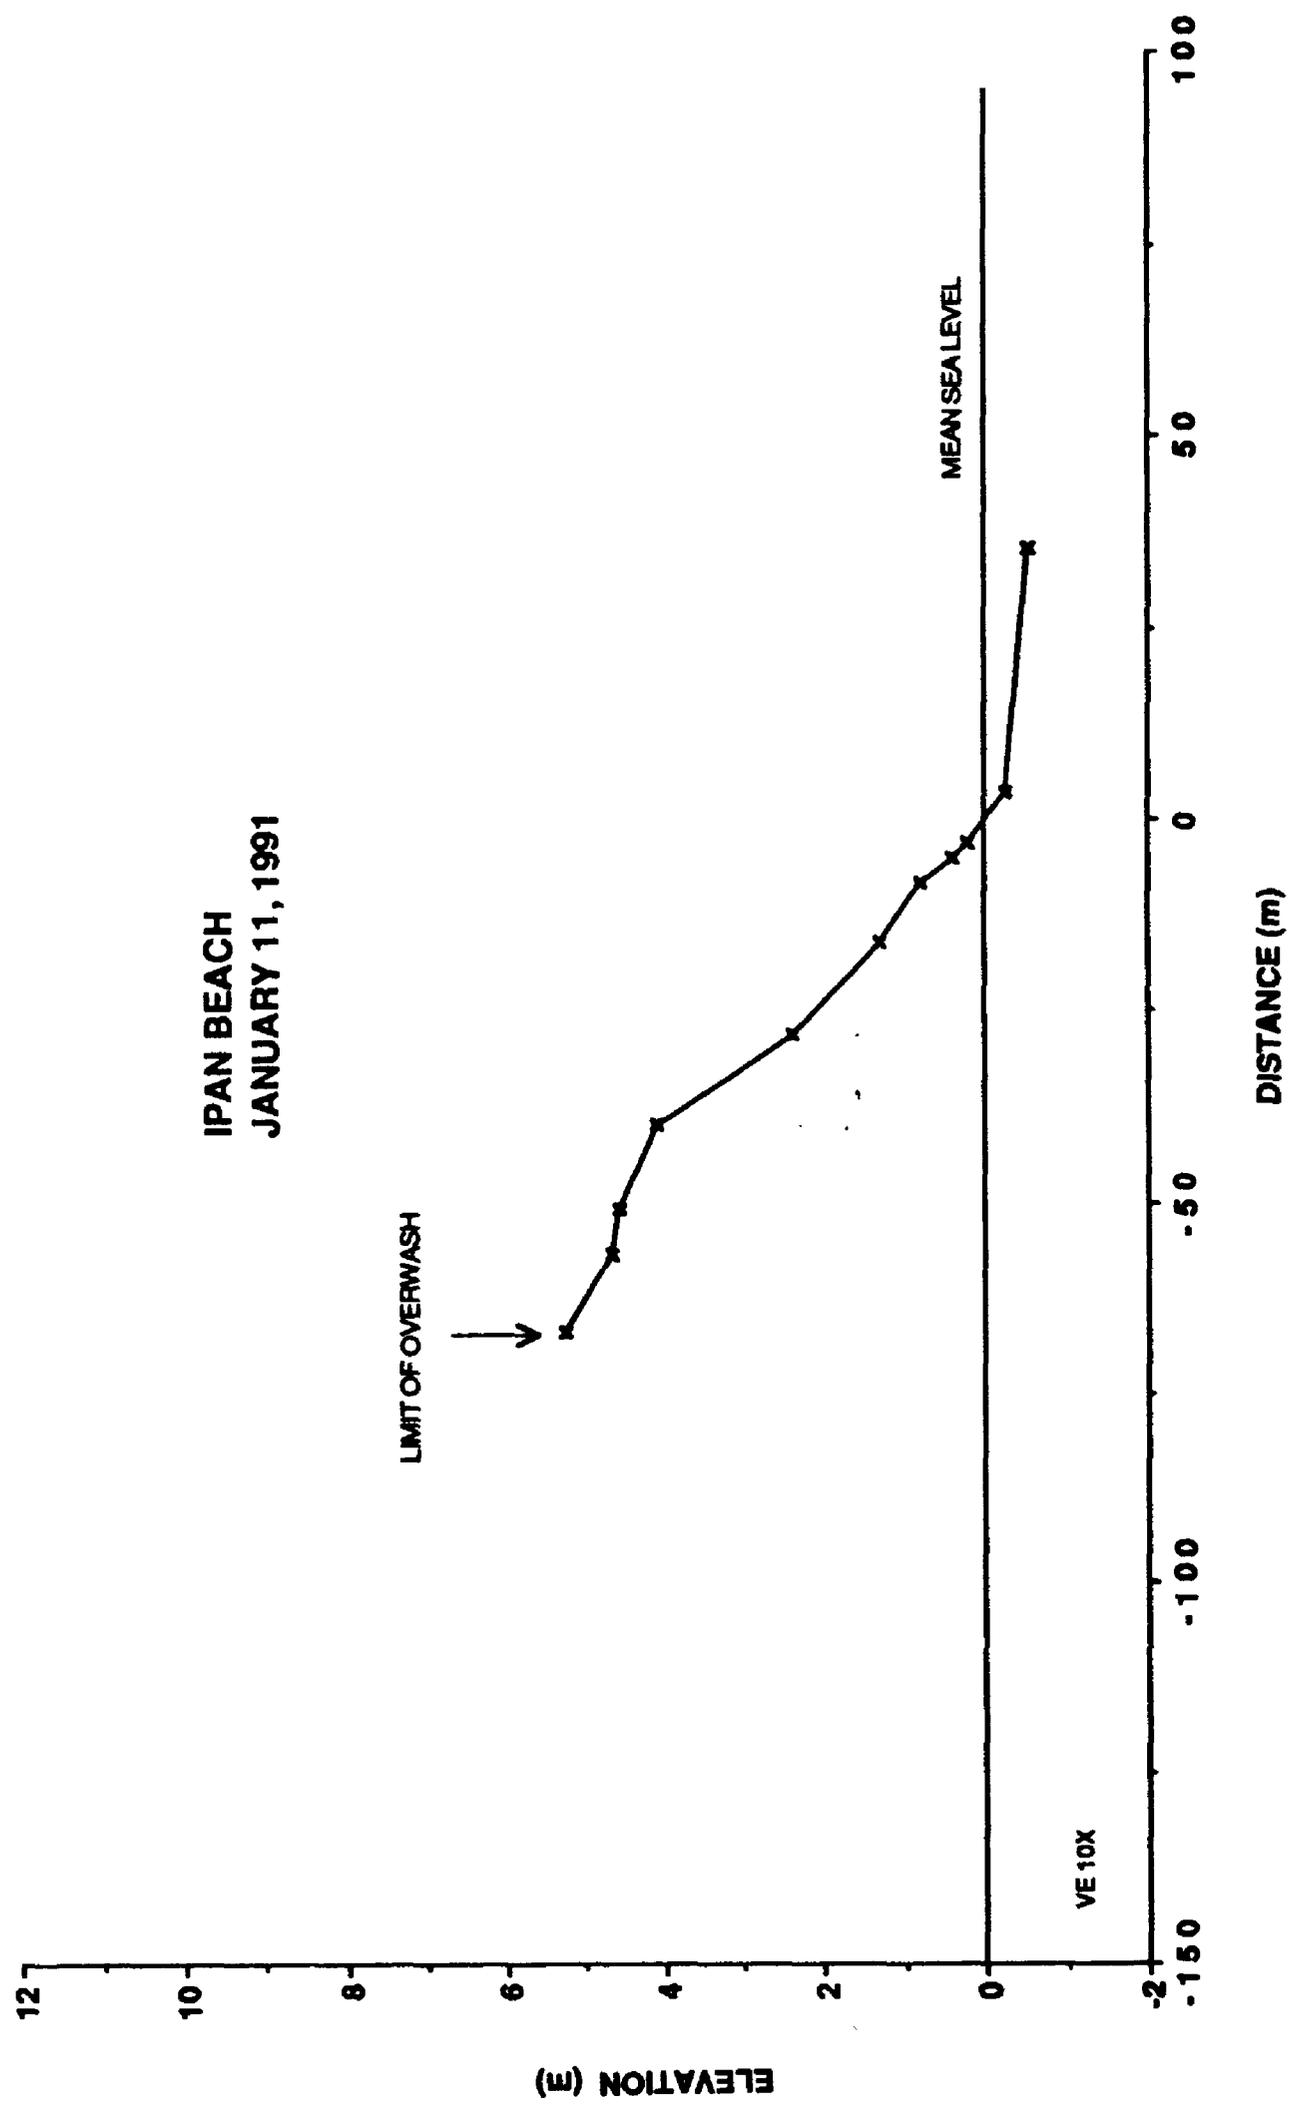
Figure 8a. Beach profile plot of Ipan Beach taken on Jan. 11, 1991.

Ipan Beach is another east-facing, carbonate sand beach (Fig. 8). It is bordered by a fringing reef that is about 365 m wide. The beach has less than 50 m of non-vegetated sand and is narrower than either Tarague or Tagachan beaches. The backbeach has numerous stands of *Casuarina* trees and large grassy areas. Ipan Beach is part of a five kilometer stretch of sandy shoreline that extends from Ylig Point to Asanite Point. There were no obvious signs of erosion on Ipan Beach at the time of observation.
