U.S. DEPARTMENT OF THE INTERIOR
GEOLOGICAL SURVEY

Typhoon Russ Effects on the Shoreline of Guam

U.S. Geological Survey Open-File Report 91-571

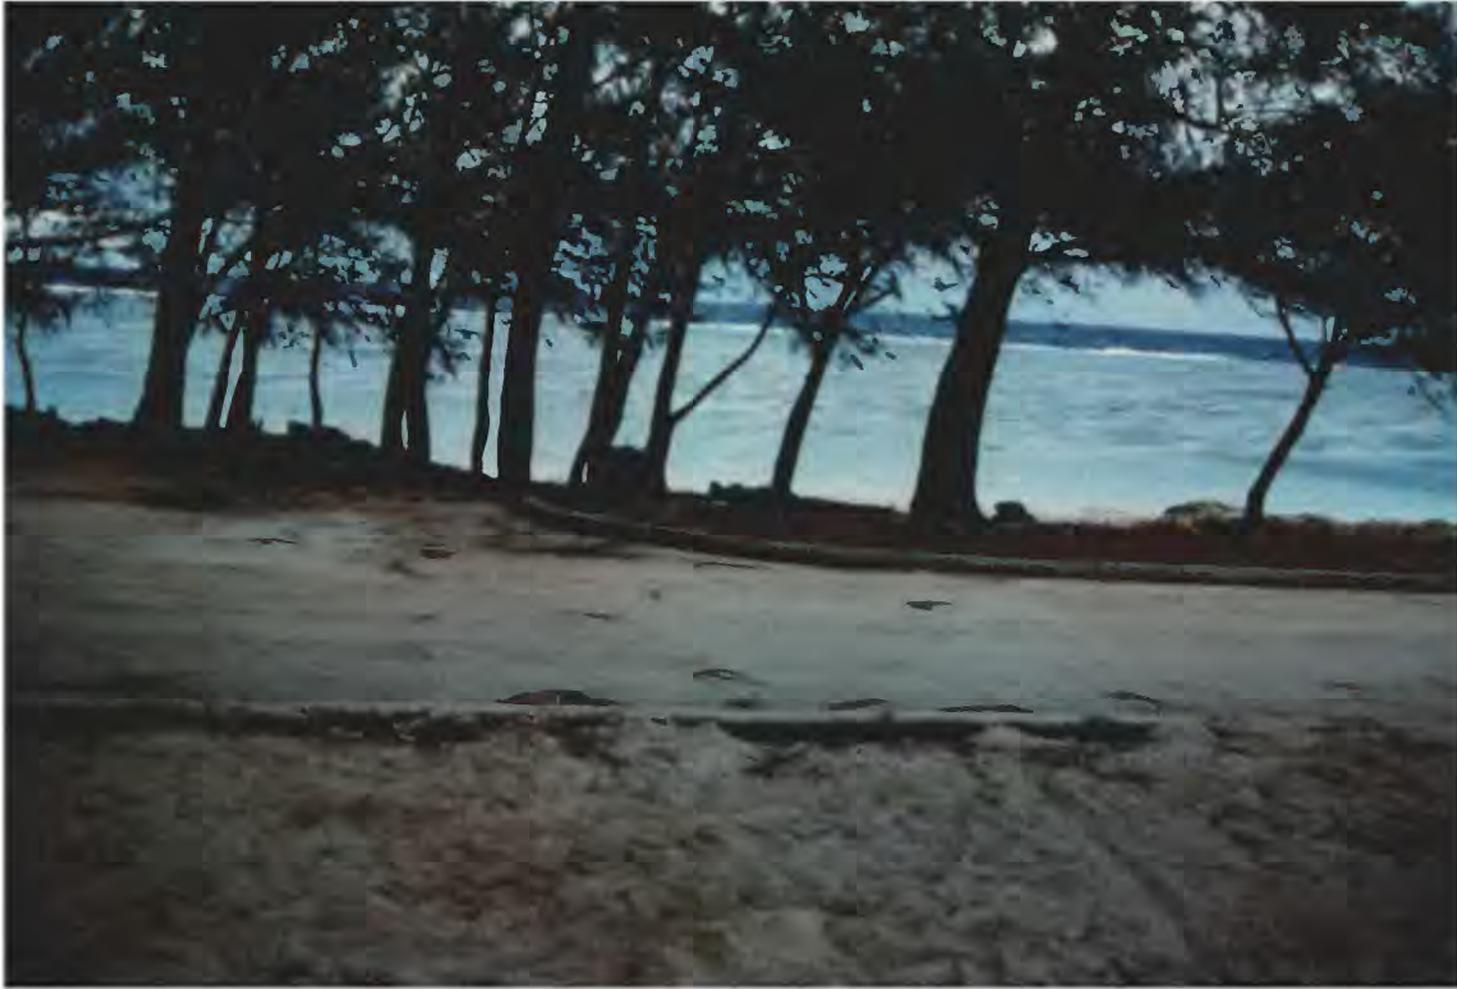
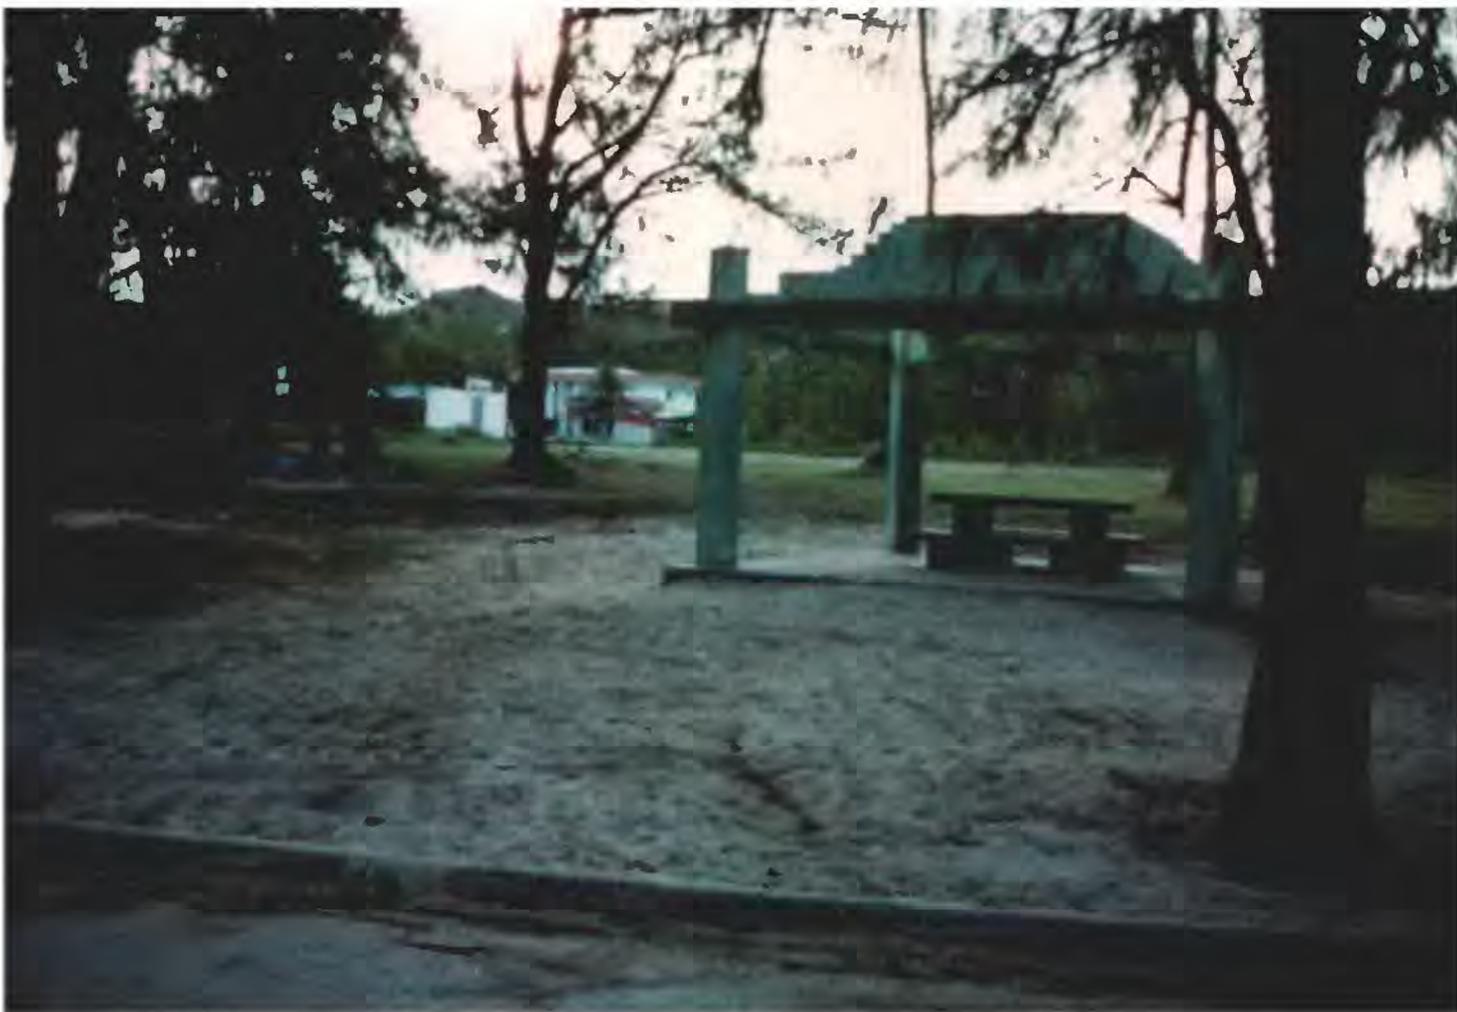
Figure 8b (top). Seaward-looking (to the east) view of Ipan Beach from the backbeach area showing overwash sand deposits. 8c (bottom). Landward view of the backbeach area.

Ipan Beach is another east-facing, carbonate sand beach (Fig. 8). It is bordered by a fringing reef that is about 365 m wide. The beach has less than 50 m of non-vegetated sand and is narrower than either Tarague or Tagachan beaches. The backbeach has numerous stands of *Casuarina* trees and large grassy areas. Ipan Beach is part of a five kilometer stretch of sandy shoreline that extends from Ylig Point to Asanite Point. There were no obvious signs of erosion on Ipan Beach at the time of observation.

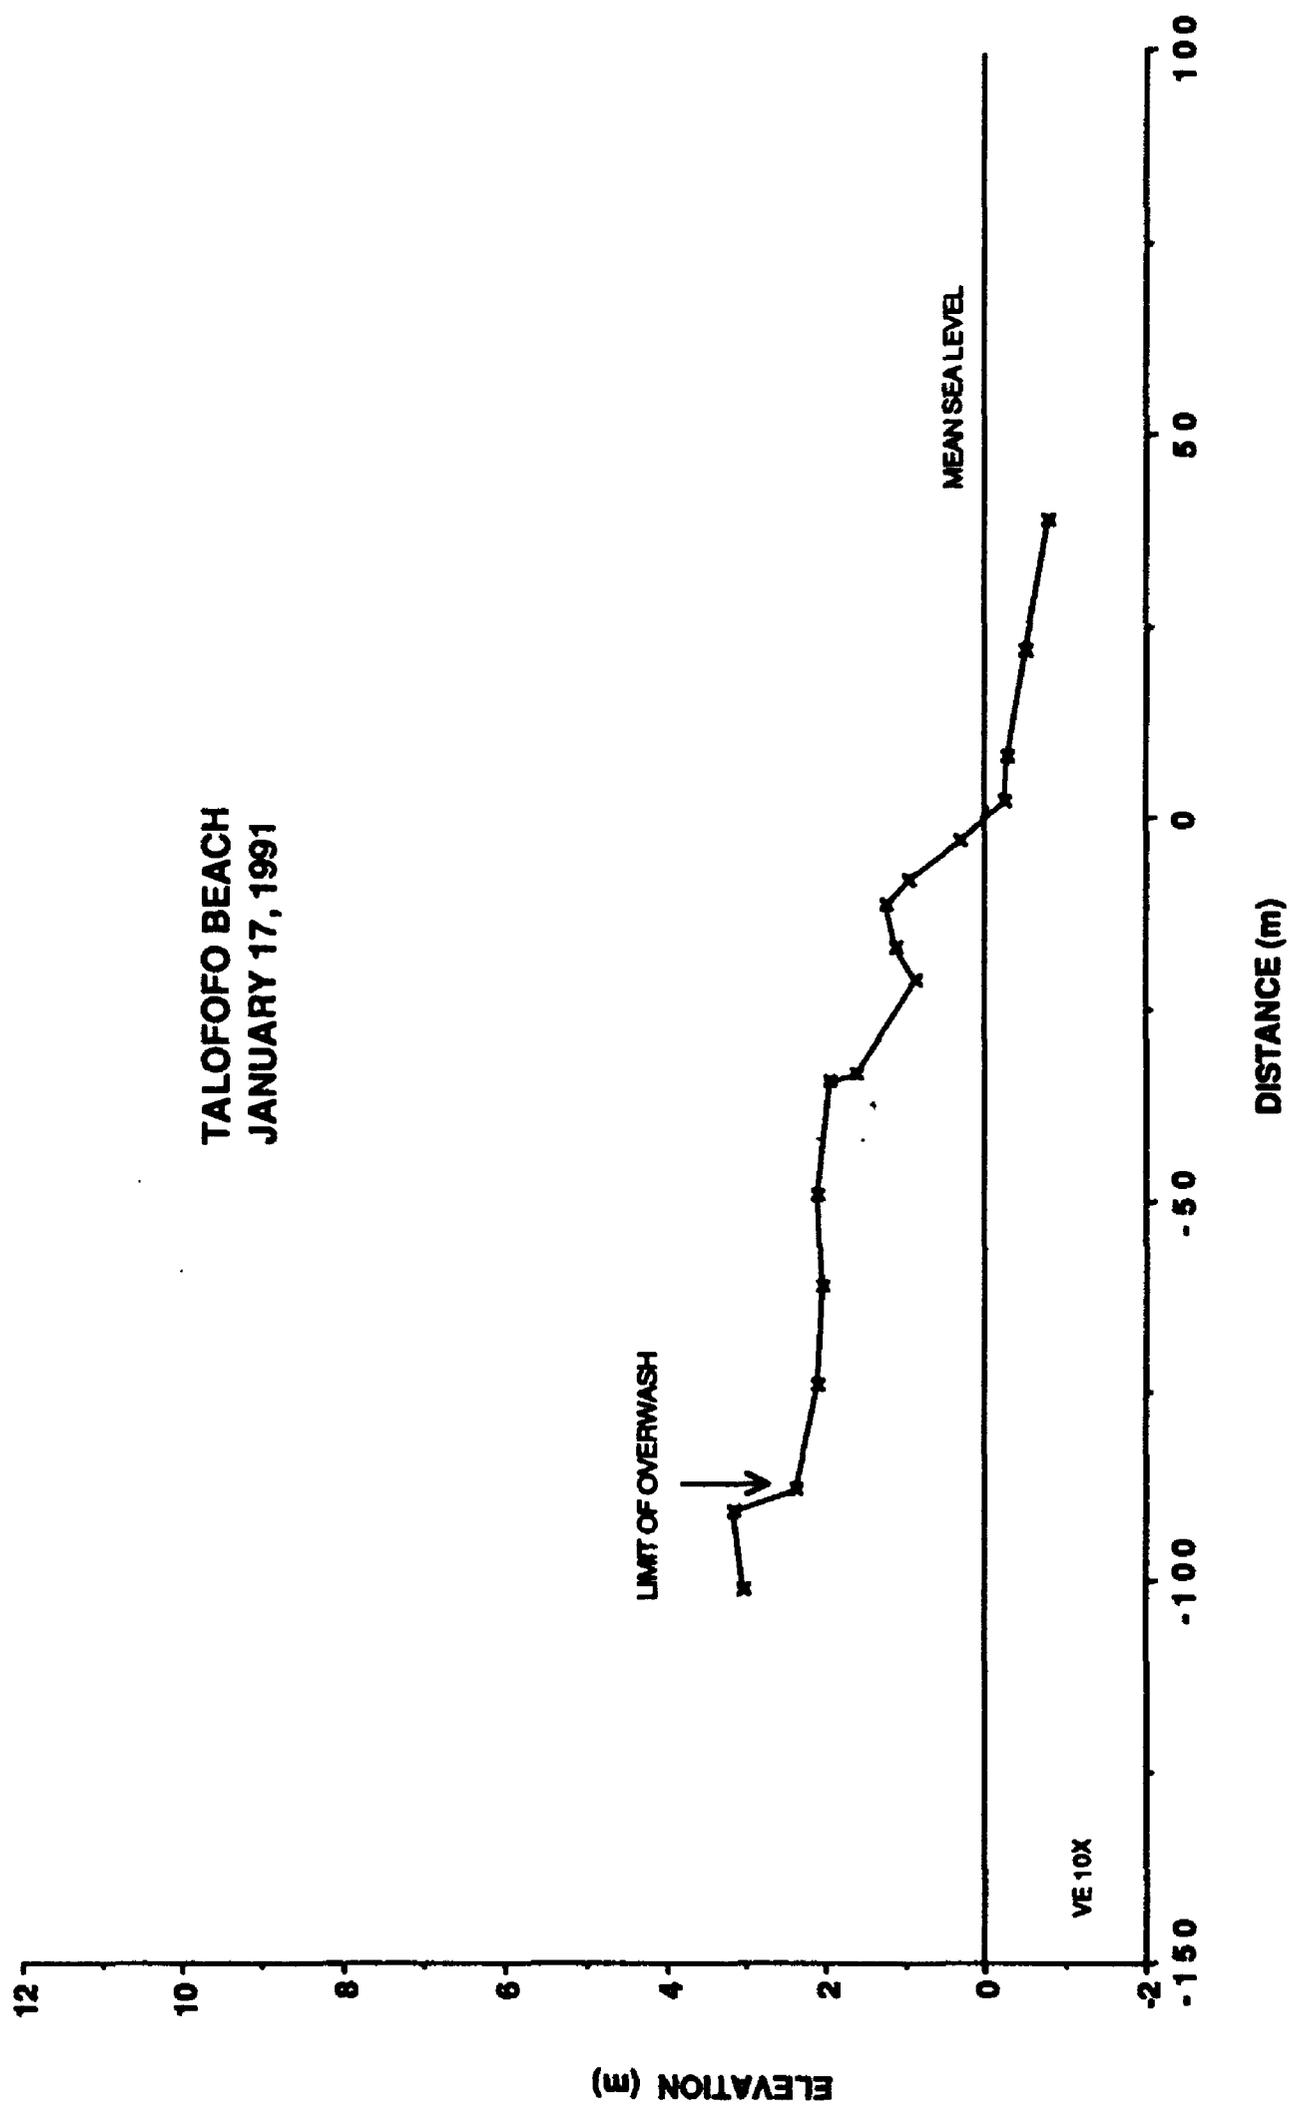
Figure 9a. Beach profile plot of Talofofu Beach taken on Jan. 17, 1991.

Talofoto Beach is a small beach developed at the head of Talofoto Bay -- a narrow embayment which extends for about one kilometer (Fig. 9) inland. The beach is composed mostly of terrigenous sand derived from the Talofoto and Ugum Rivers. Because it is developed at the head of an embayment where reef growth has not blocked the entrance, refracted ocean waves reach the beach causing the formation of nearshore bars. The overall profile is much flatter than the other open-coast beaches. A small erosional scarp was developed on the upper beach face and the backbeach area supports grass and coconut palms.

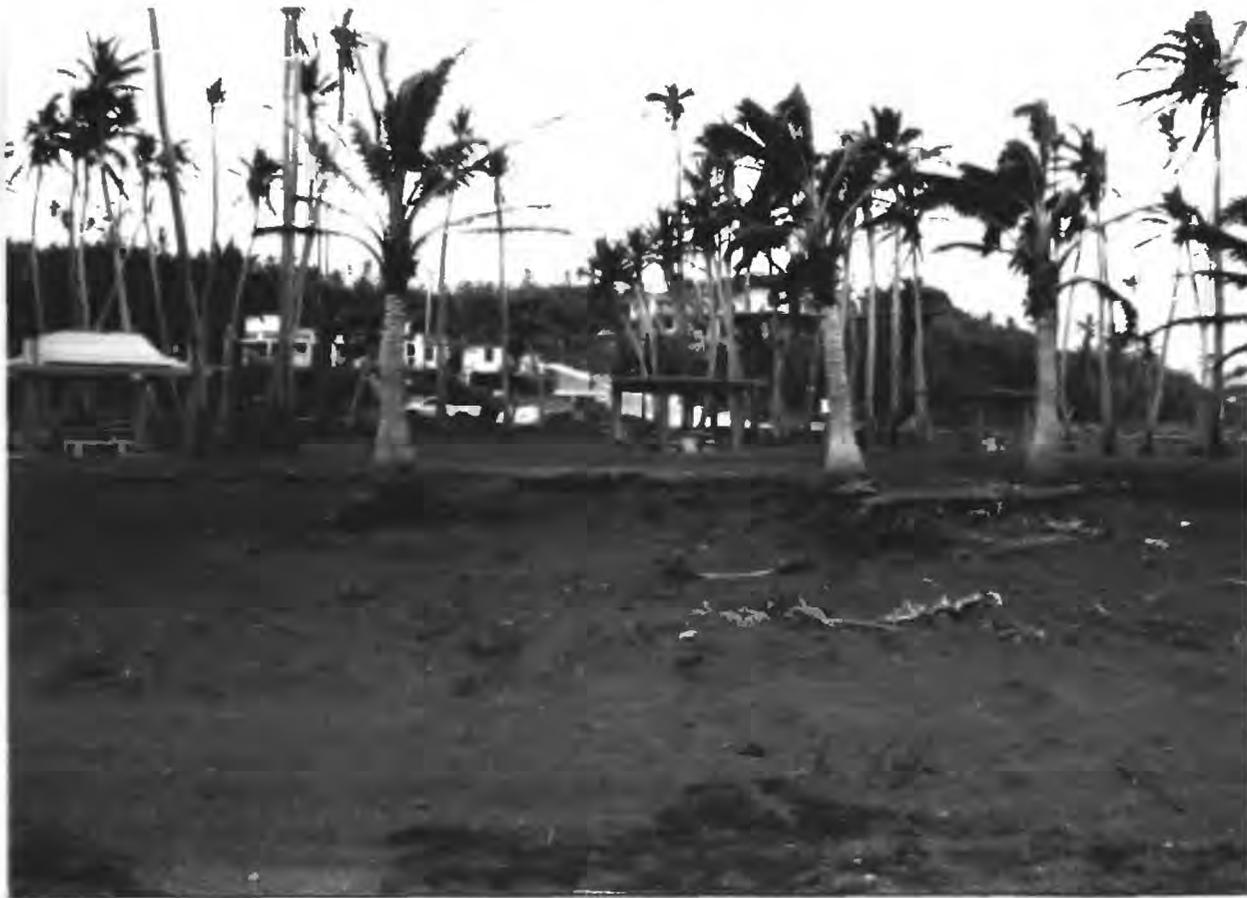
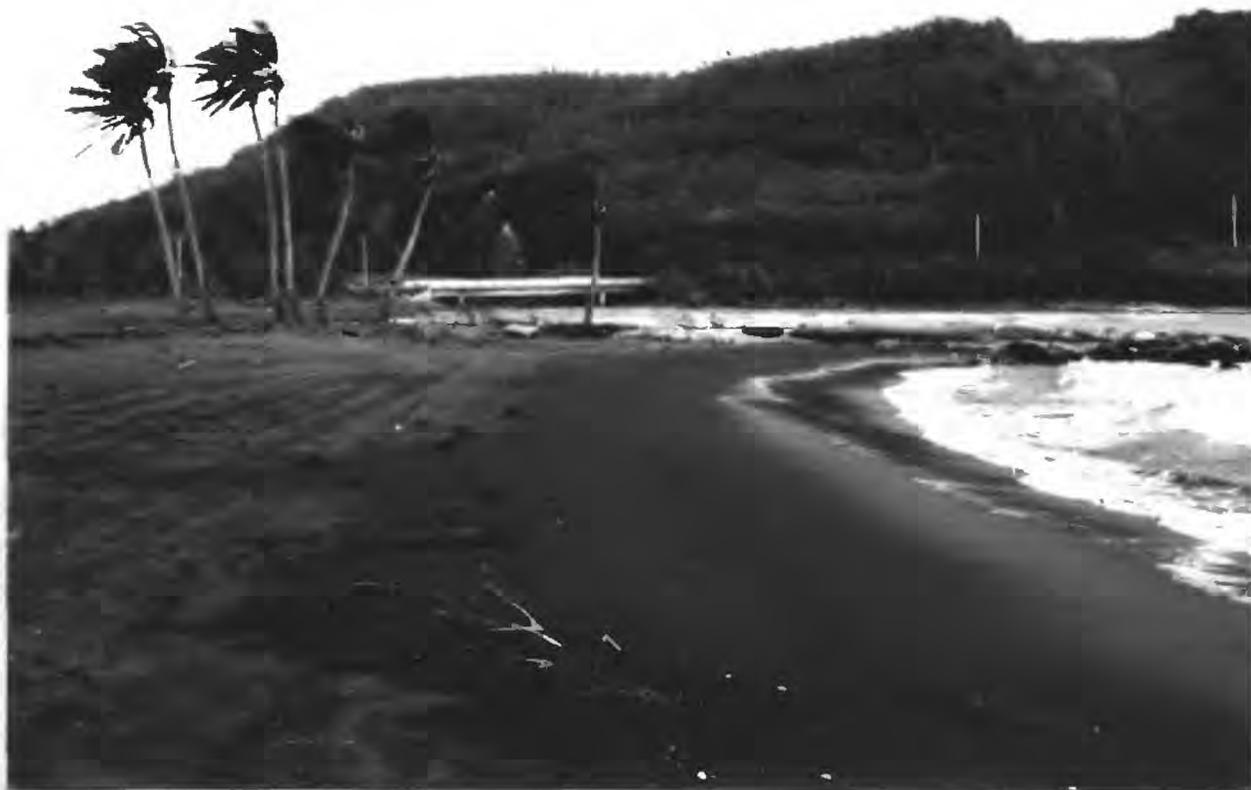
Figure 9b (top). Landward view of Talofofu Beach from the upper beach face showing a small erosional scarp and minor erosion at the base of the front-left coconut palm. 9c (bottom). North-looking view from the berm crest showing the active swash zone.

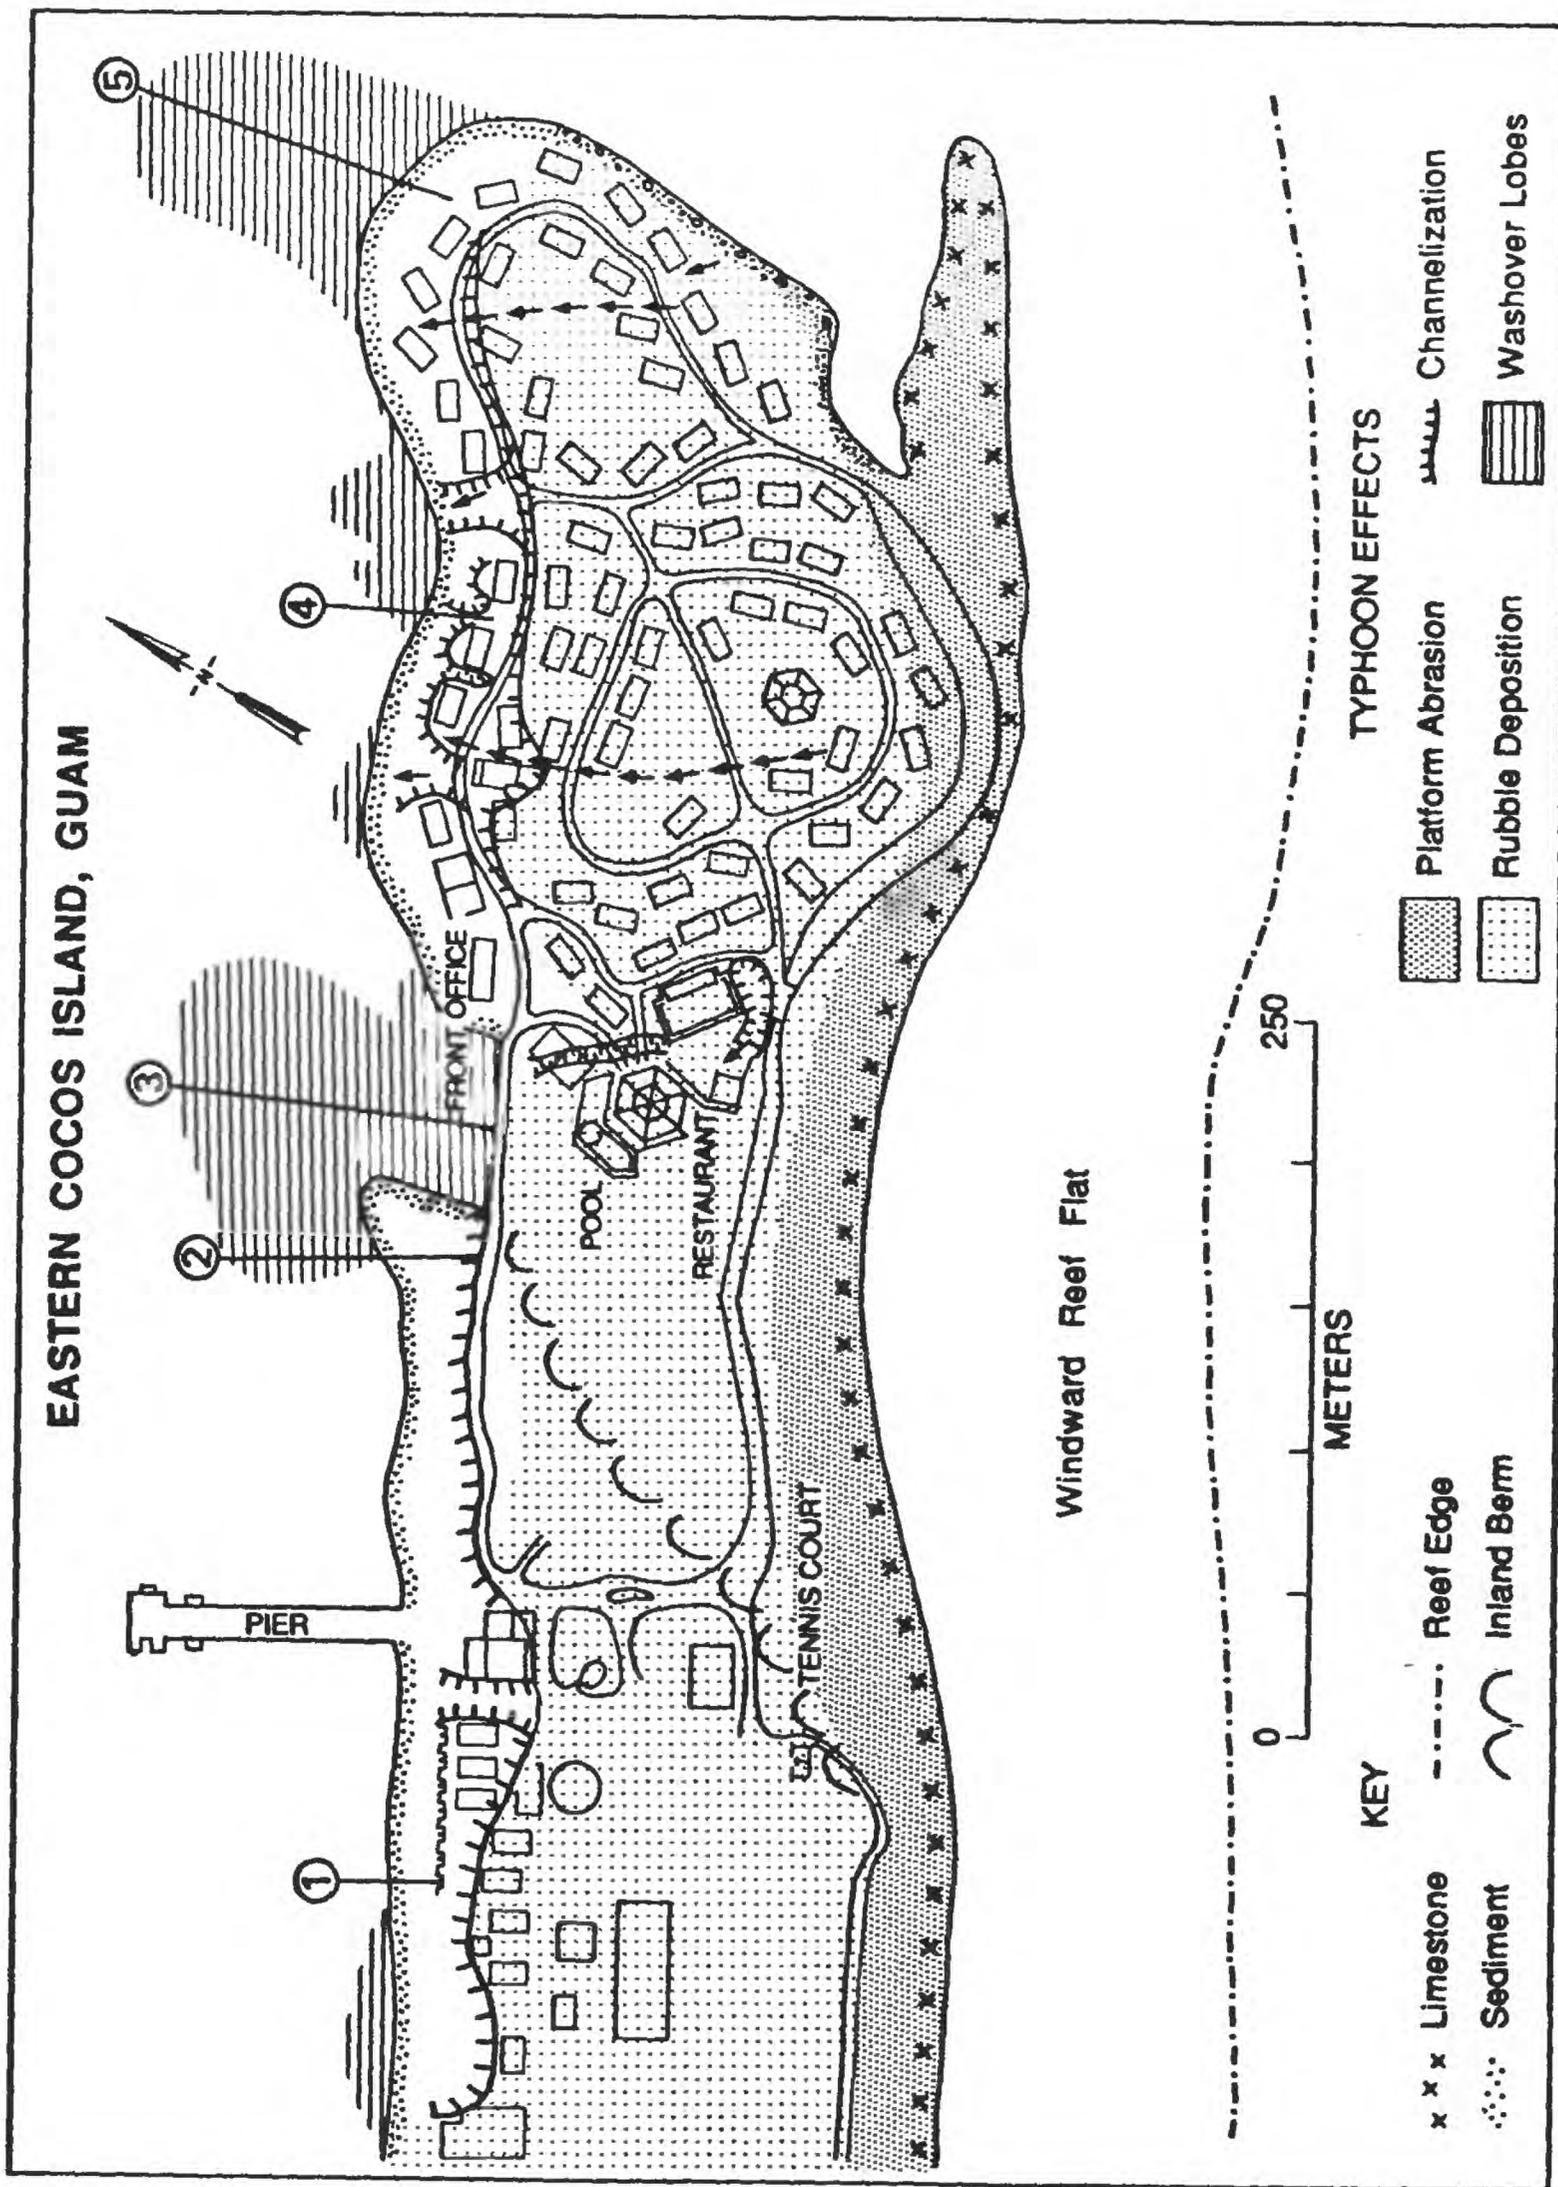
Four types of water-induced typhoon effects were recognized on the islet (Figure 10). In a seaward (southerly) to lagoonward (northerly) direction these effects are: a) Platform Abrasion. The oceanside reef flat and seaward islet margins underwent erosion of unconsolidated sediment and vegetation (Fig. 11b). Most of this area is underlain by emergent Holocene Merizo Limestone which consists of in-place reef and reef flat deposits. The pre-Russ sediment of this platform consisted mostly of storm-derived reef rubble and sand. b) Rubble Deposition. Landward of the zone of extensive erosion and abrasion is a zone of sediment reworking and deposition. Extensive gravel sheets covered large areas of the islet surface (Fig.11c). Some of this material was presumably derived from the abraded platform, other from reworking of islet deposits, and, in some cases, destruction of man-made structures. In areas of mostly sand deposits, bedforms were produced which, in every case examined, indicated lagoonward flowing currents. c) Channelized Zones. Widespread channelization occurred along the lagoonward margin of the islet producing erosional scarps up to 1.5 m in height. Some of this channelization was clearly directed by the presence of man-made structures which acted to funnel and concentrate water flow (Fig. 11d). In natural parts of the islet (ie. the western part where there are no large man-made structures), the pattern of abraded platform - rubble deposition - channelization was also present. d) Washover Lobes. Several large washover lobes of predominantly sandy sediment were deposited on the lagoonside reef flat (Fig.11e). These deposits occurred opposite areas of extensive channelization and along the eastern tip of the islet.

Figure 10. Interpretative sketch map of eastern Cocos Island showing pre-Russ building locations, beach profile locations, and the general distribution of the various typhoon effects.

Observations on Cocos Island revealed a dramatic difference in response between the developed eastern part of the islet and the relatively undeveloped western half. Platform abrasion was effective along the entire seaward margin, but dense vegetation limited the overwash in the west. Overwash lobes on the lagoon reef flat were primarily limited to the ends of the islet and the developed eastern margin even though there were seawalls constructed to prevent such occurrences. The causeway vicinity is an area of previous historical washovers and will probably be prone to washovers in the future. In general, sand cay islets of this type owe their existence to major storms where washover events deposit material from the adjacent reefs in a subaerial accumulation forming an islet. However, in our examination of Typhoon Russ deposits we saw very little evidence that fresh coral had been eroded, rather, most of the deposits consisted of previously reworked material.

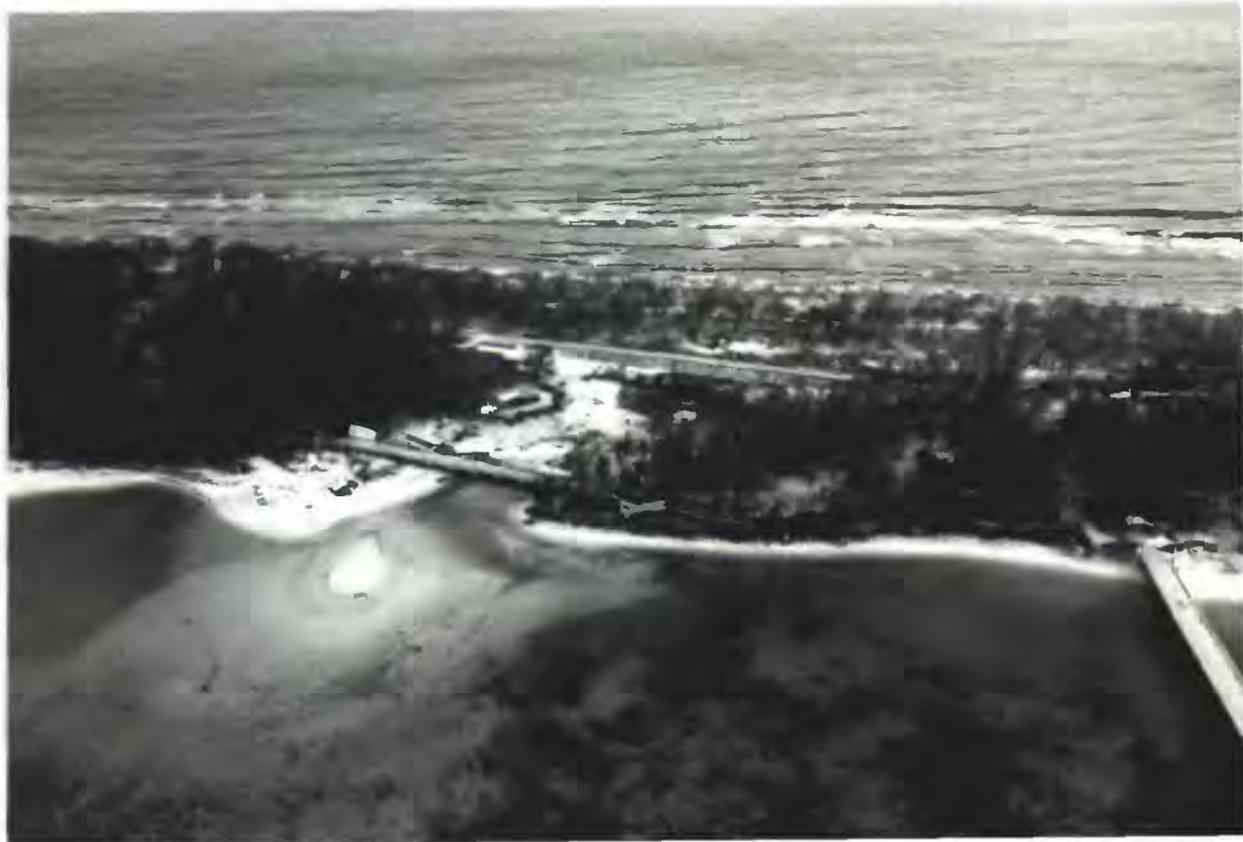
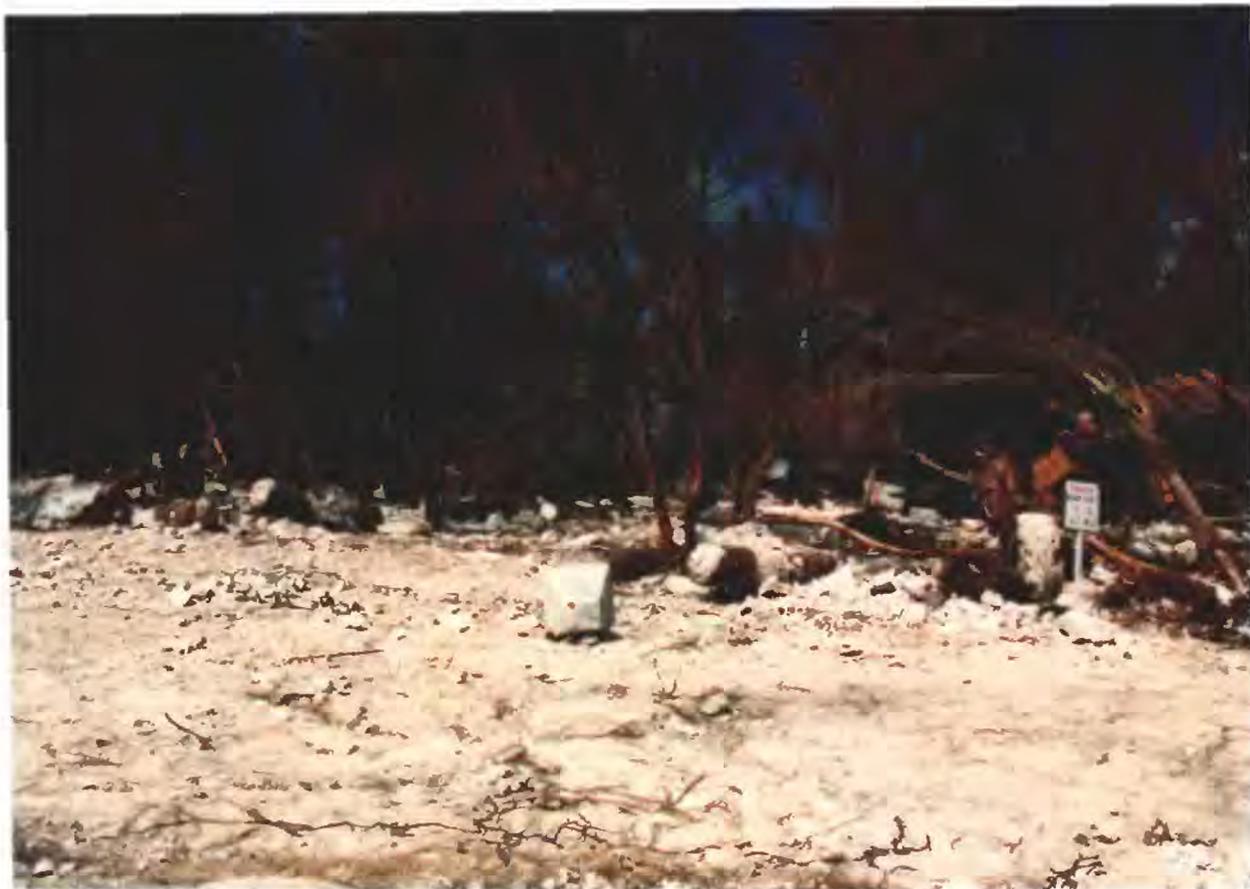
Figure 11a (top). Oblique aerial photograph of washover channel on the eastern end of Cocos Island. A washover lobe is developed in the center foreground opposite the causeway. A seawall is visible across the center of the islet. View to the south. **11b (bottom).** View of the seaward margin of the islet showing the area of principal erosion (the abraded platform).

Cocos Island Resort, a private complex on the eastern half of the islet, was extensively damaged by wind and water during the passage of Russ. Most of the housing units were either destroyed or severely damaged. Evidence of water deposition on the higher parts of the islet indicate a minimum of 3.1 m of overwash and possibly up to 5m. It appears much of the eastern half of the islet and parts of the west were underwater during the peak of Russ' passage. Several of the housing units along the exposed seaward side of the islet were transported several tens of meters.

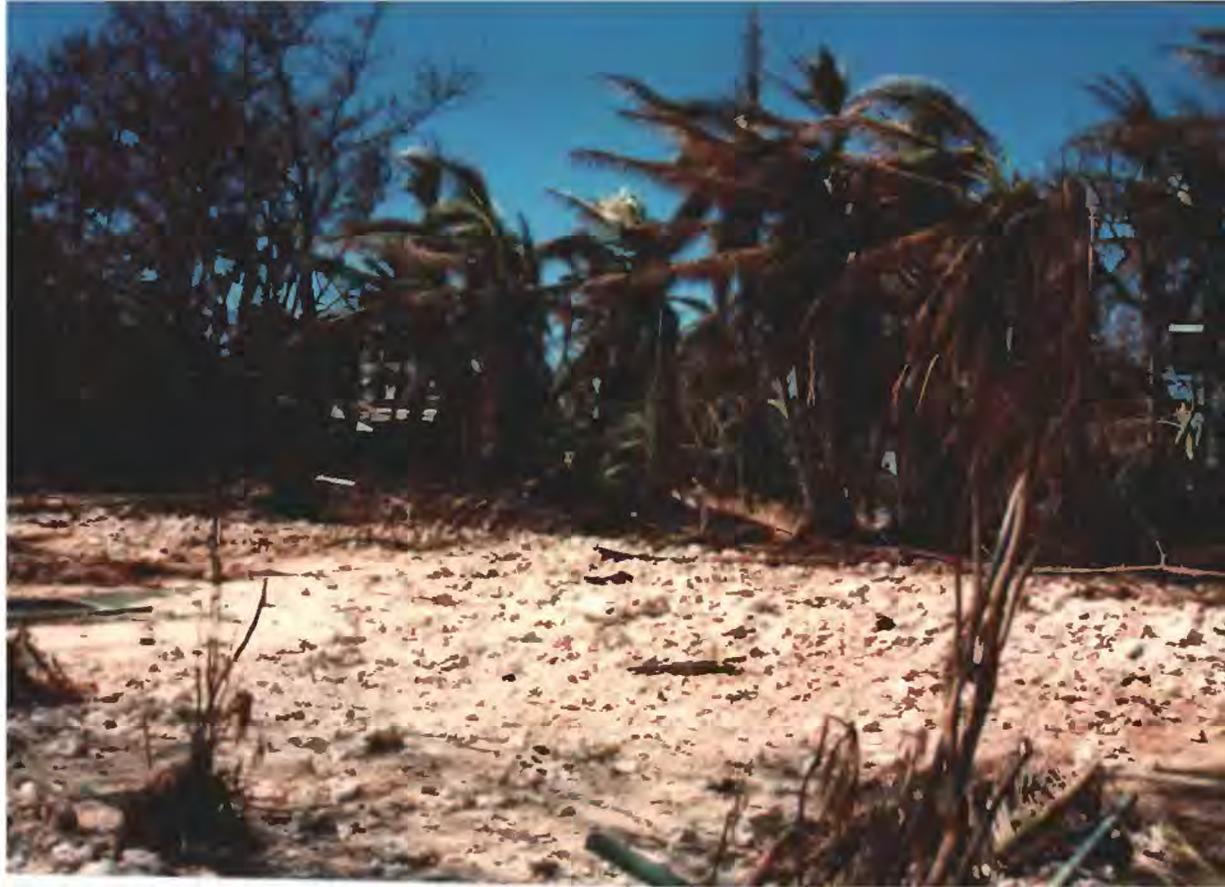
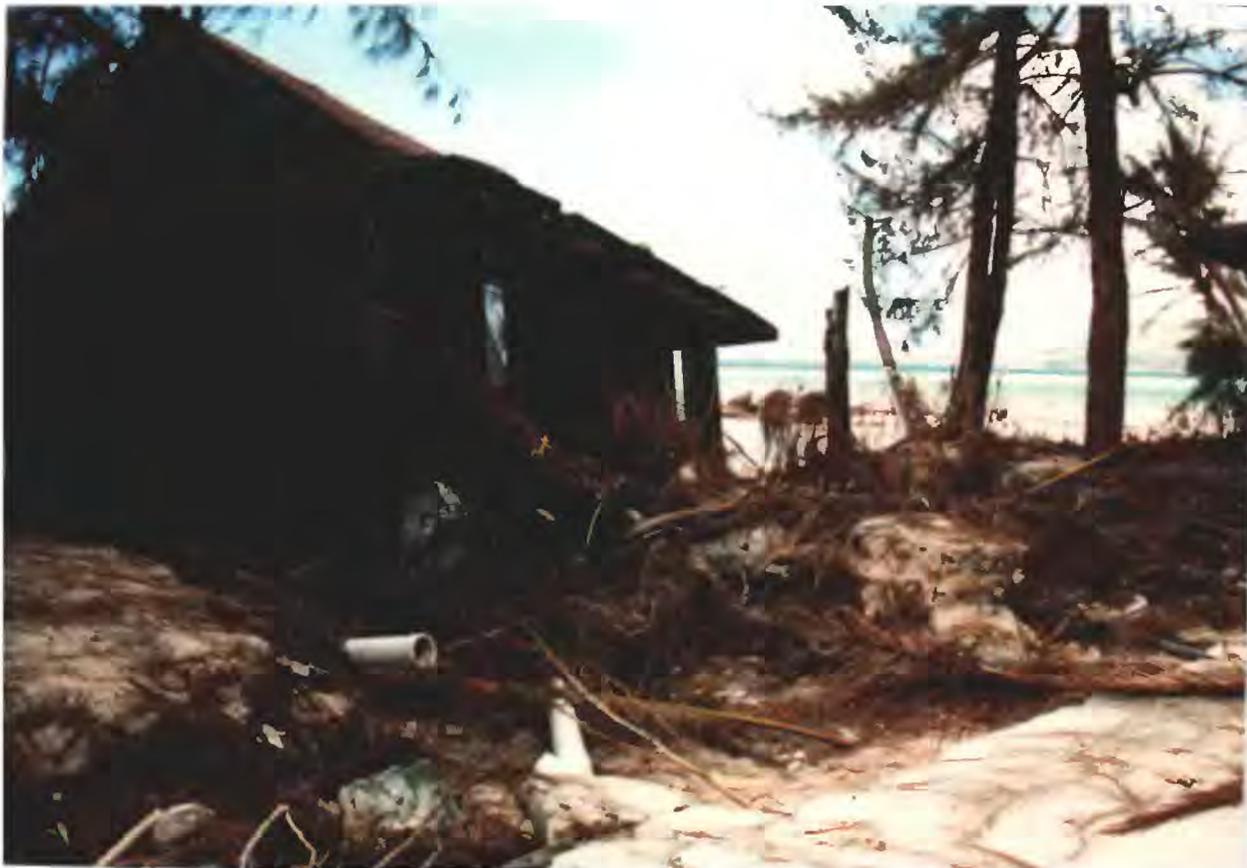
Figure 11c (top). Much of the central portion of the islet underwent sediment transport and deposition; here coral rubble is deposited on the tennis courts. **11d (bottom).** Severe erosion and channelization occurred along the northern (leeward) side of the islet undermining buildings and roads.

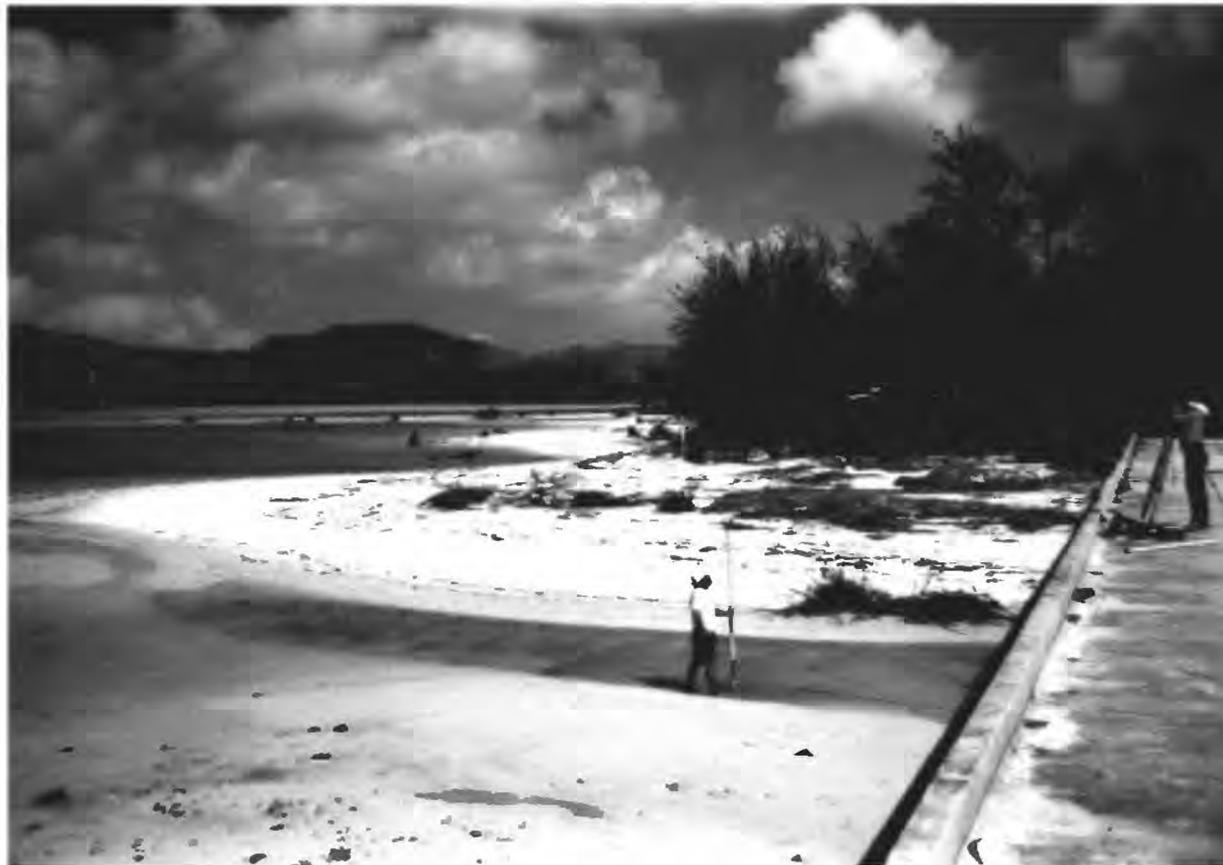
Figure 11e. Deposition of mostly sand-sized sediment occurred as lobes opposite channels along the lagoonside reef flat.

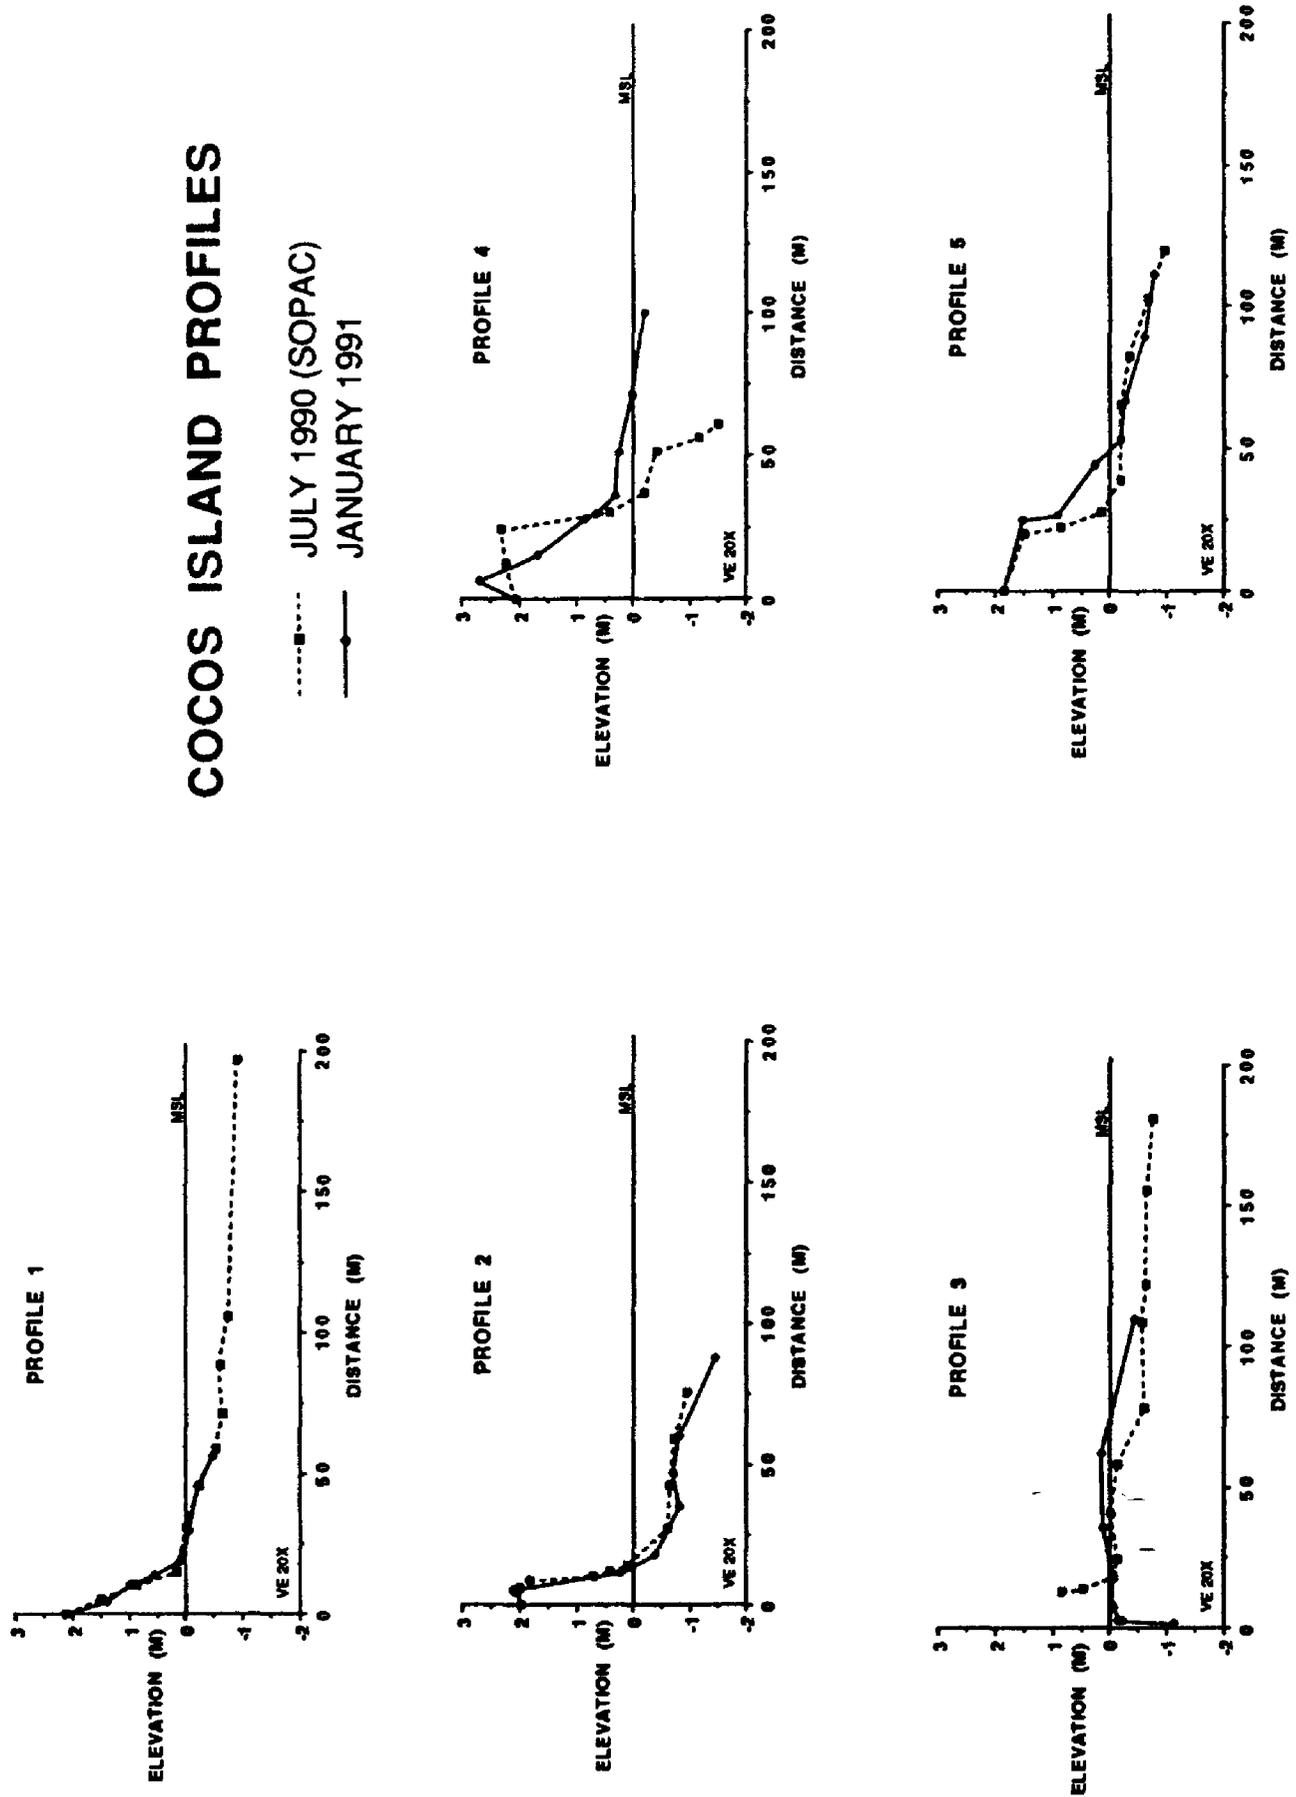
COCOS ISLAND PROFILES

Comparison of pre- and post-Russ beach profiles are shown in Figure 12 and the profile data are presented in Appendix II. Modification of each profile from a west to east direction can be summarized as follows: Profile 1) This is the only profile west of the pier, it consists of a gentle-sloping beach backed by a scalloped shaped vertical seawall. Overall profile change was minor with slight erosion of the upper beach face and deposition of the lower beach face. Profile 2) A well-developed back-beach scarp was eroded adjacent to road. Slight erosion of the entire profile line occurred, however this may be an artifact attributed to difficulties in occupying the exact bench mark location. Profile 3) This profile started on the causeway which crosses an older washover channel. Channelization underneath the causeway eroded the former beach face; an extensive washover lobe was deposited offshore on the reef flat with a thickness approaching 0.5 m. Profile 4) Consists of a gently-sloping beach fronting several housing units. The berm crest was displaced landward (and upward) while a washover lobe in excess of 1.5 m thick was deposited lagoonward. Profile 5) This profile was on the northeastern tip of the islet in front of several housing units. The beach face aggraded lagoonward and there appears to have been some slight erosion (< 0.2 m) of a previously developed depositional lobe. Visual inspection of the site suggested an extensive washover lobe was present both pre- and post-

Russ but the lobe was larger after the typhoon. Some of the enlargement was probably due to reworking of the previous deposit, hence, the slight erosion of the lobe profile.

Figure 12. Cocos Island Beach profile plots at locations 1,2,3,4,5 from pre-Russ (June 1990) and post-Russ (January, 1991) measurements. Profile locations are shown in Figure 10. Mean sea-level used here is the temporary vertical datum established during the SOPAC-USGS Coastal Mapping Workshop.

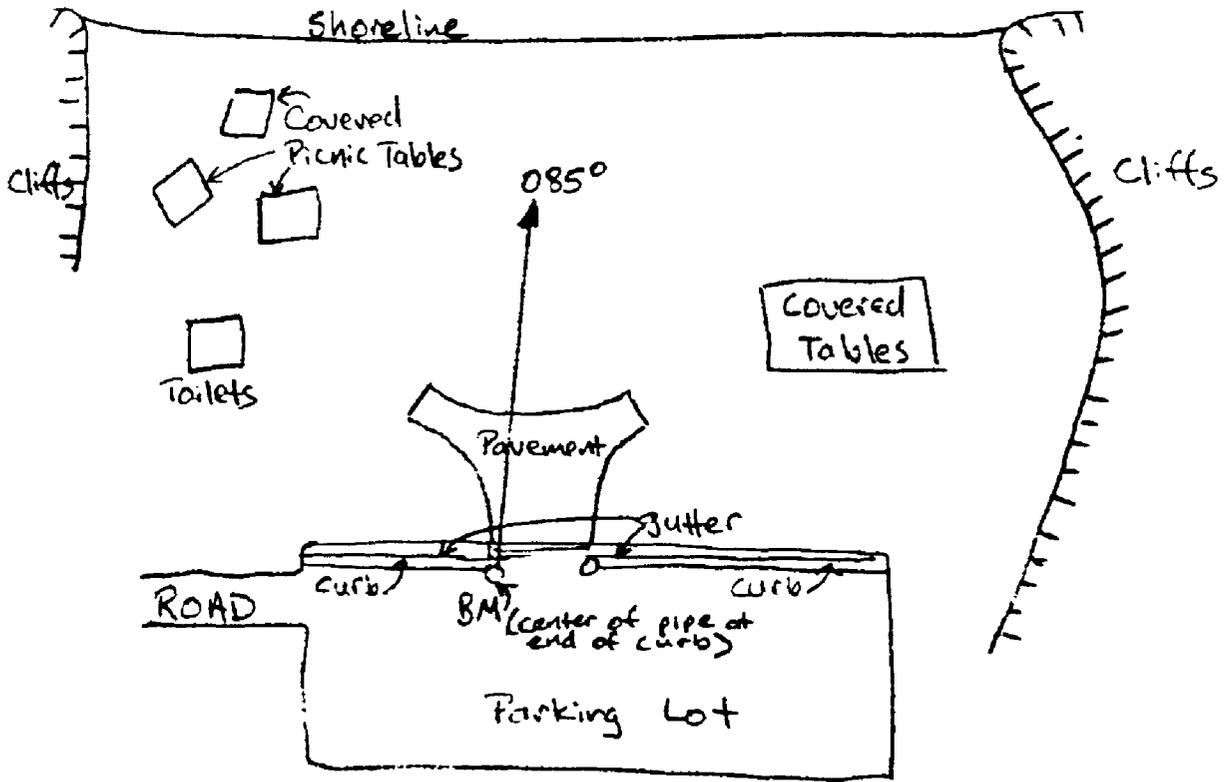
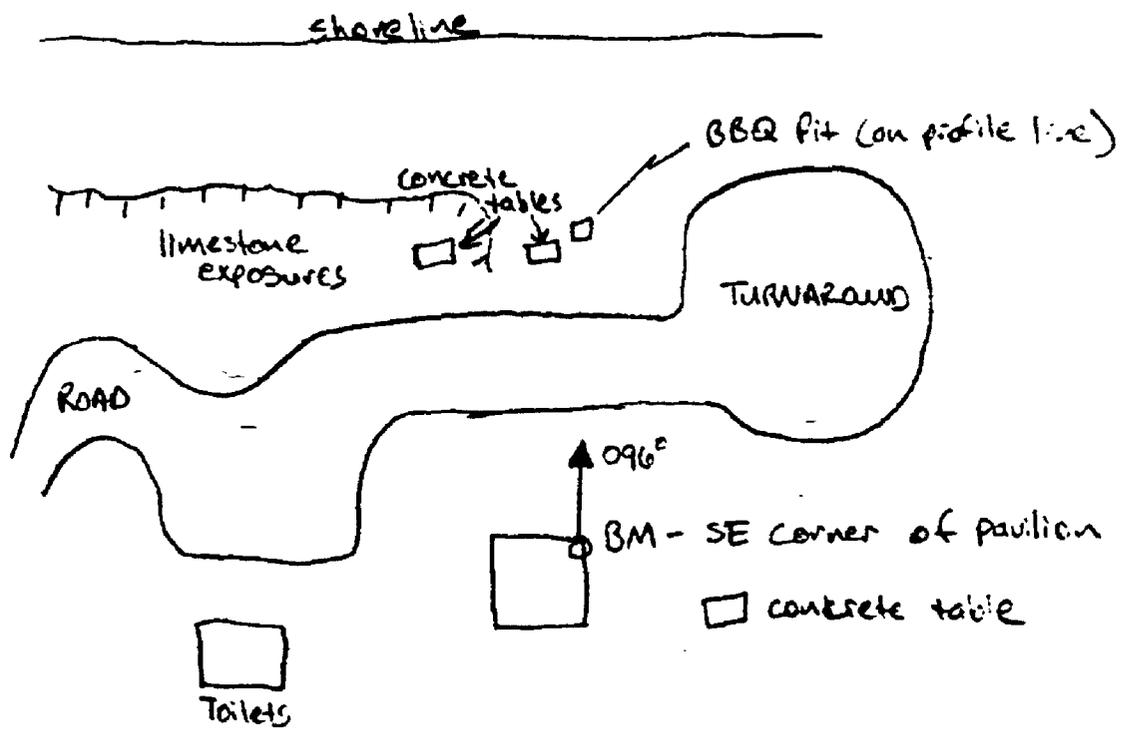
Sketch diagrams of beach profile locations for Tagachan (upper) and Ipan (lower) beaches.
