U.S. DEPARTMENT OF THE INTERIOR
GEOLOGICAL SURVEY

Typhoon Russ Effects on the Shoreline of Guam

U.S. Geological Survey Open-File Report 91-571

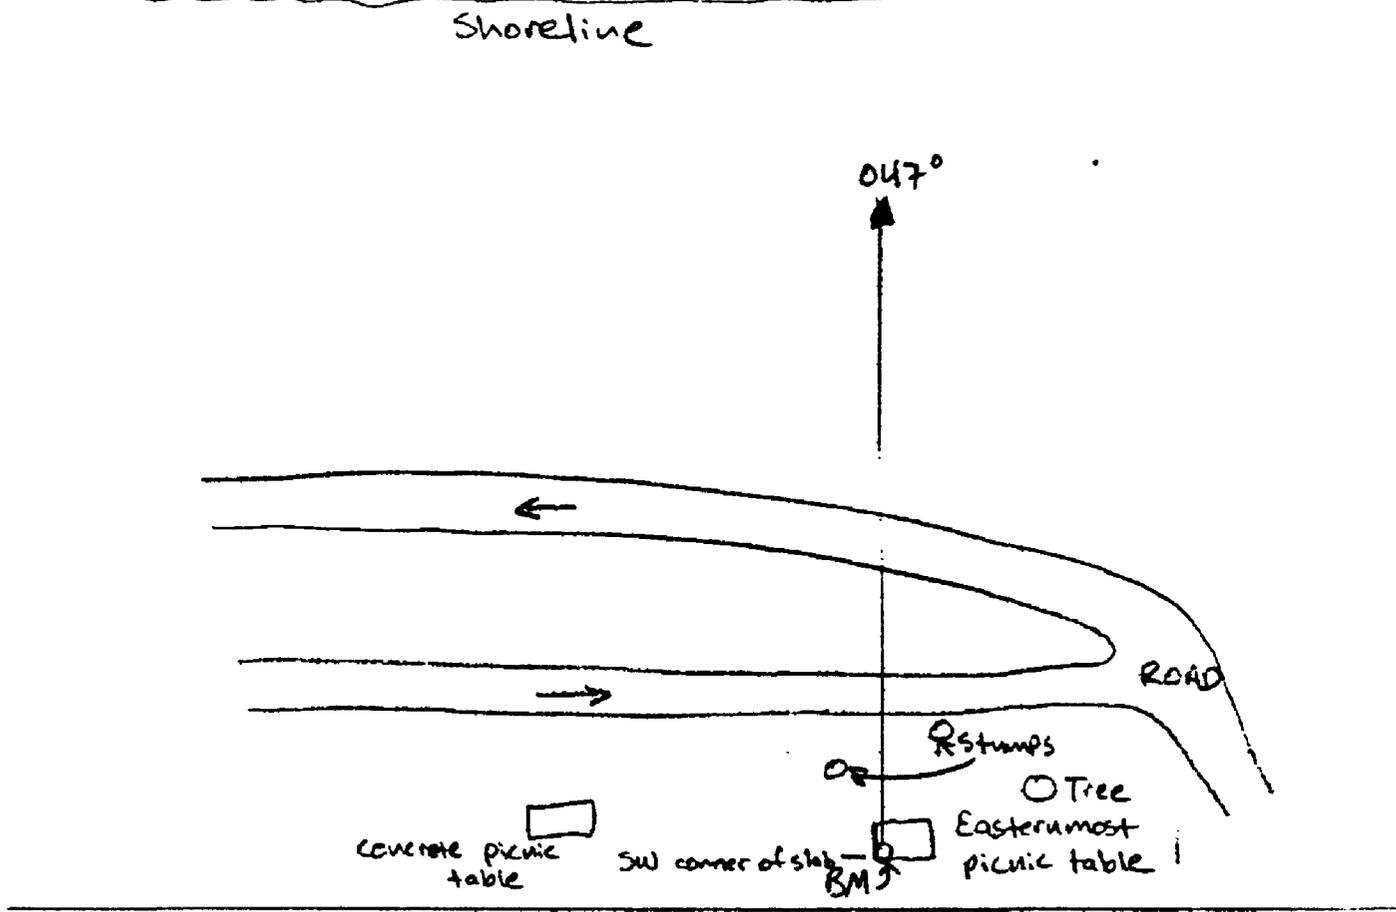
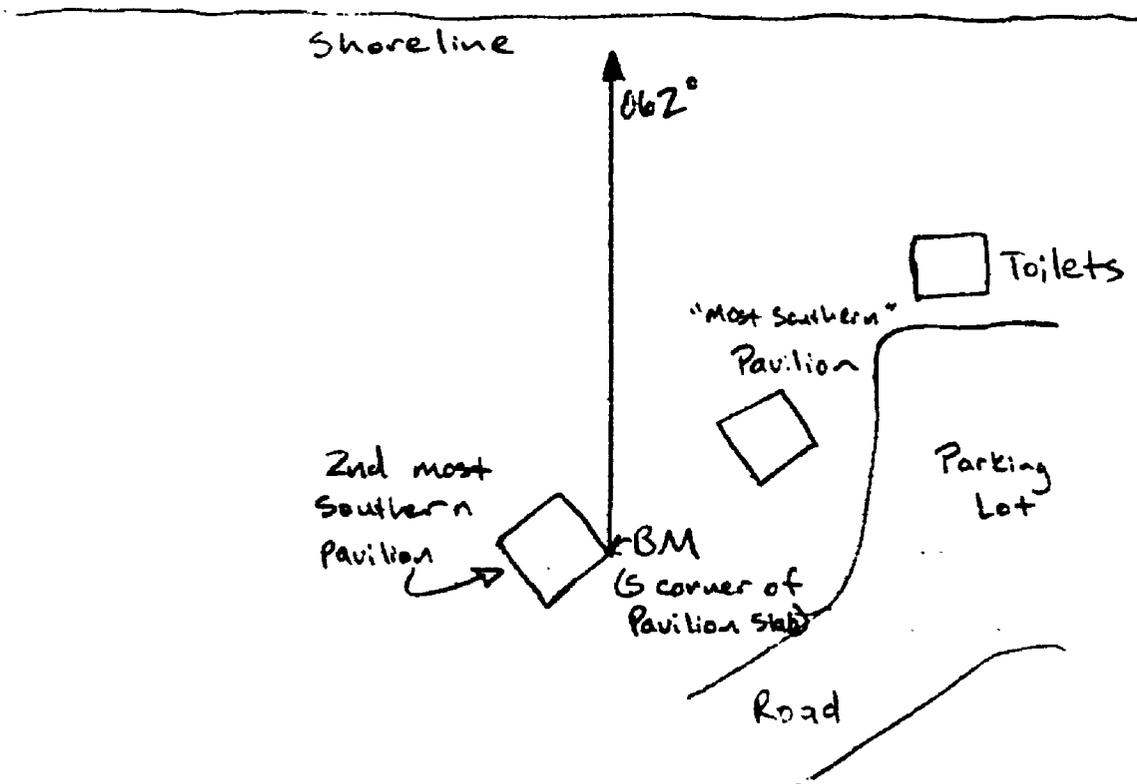
Sketch diagrams of Tarague (upper) and Taloforo (lower) beach profile locations.
