PLATE 3.1

This report is preliminary and has not been reviewed for conformity with U.S. Geological Survey editorial standards or with the North American Stratigraphic Code. Any use of trade, product or firm names is for descriptive purposes only and does not imply endorsement by the U.S. Government.

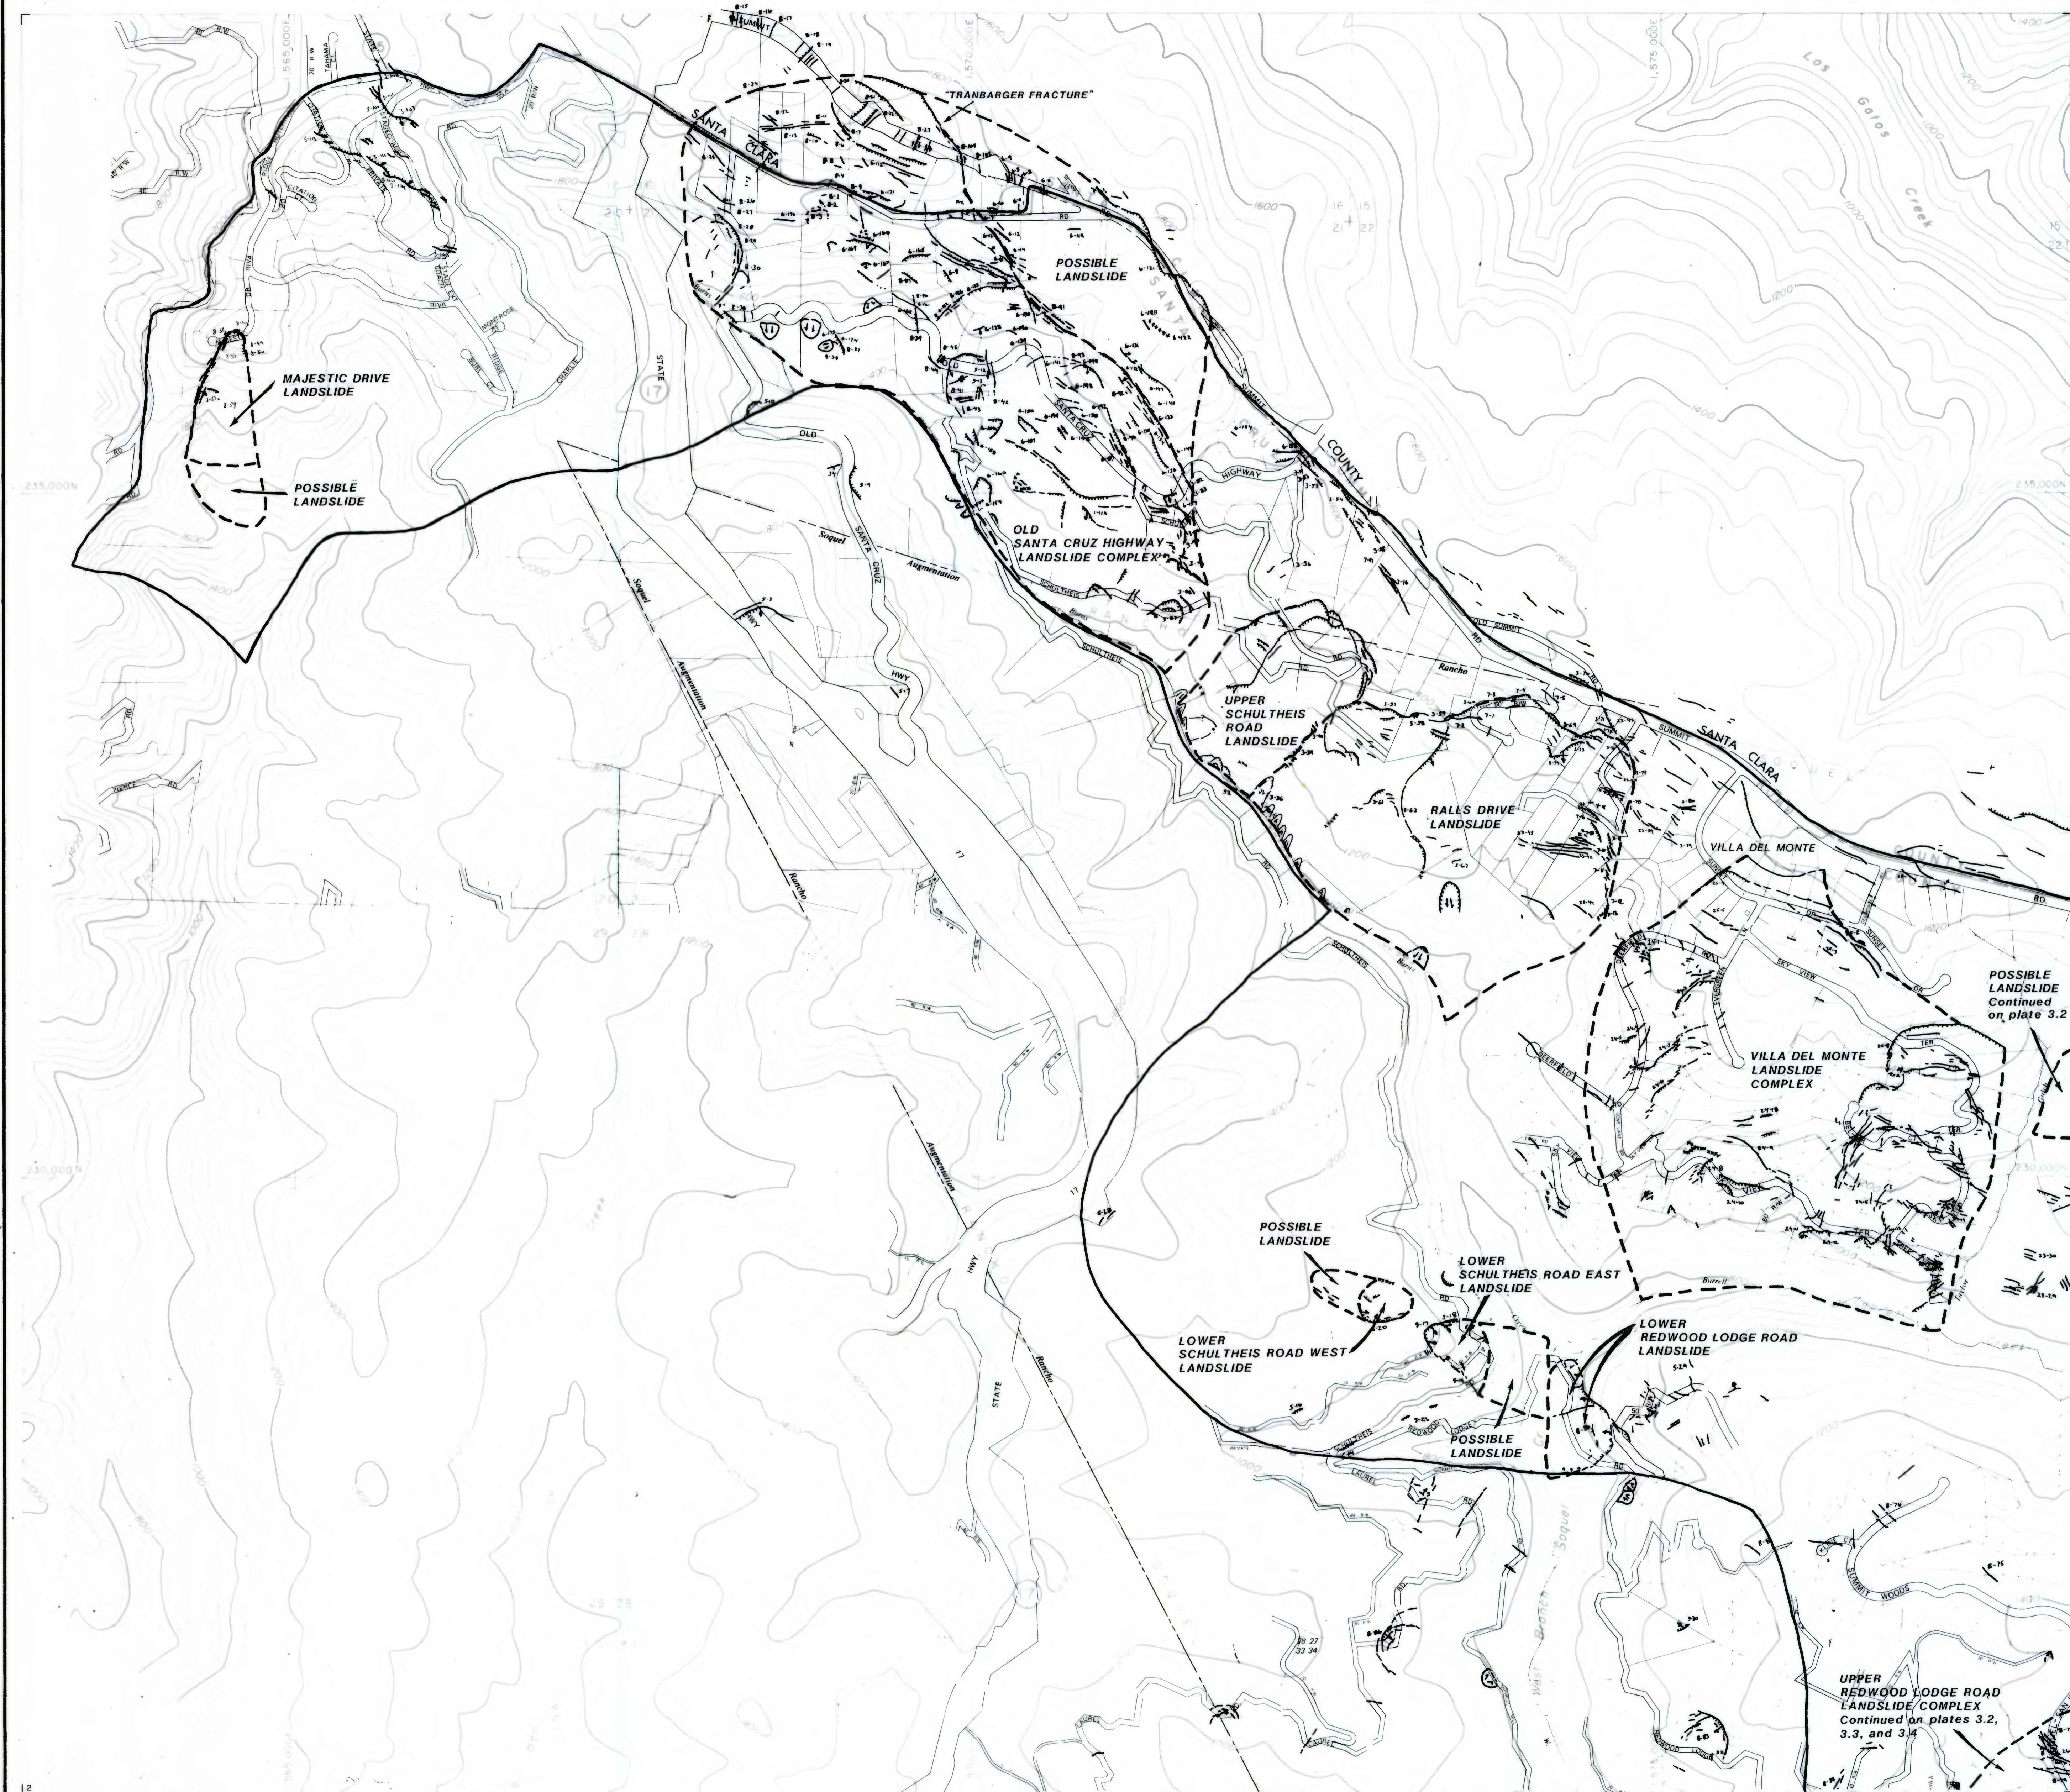
Fissure, fracture, or shear formed during the Loma Prieta earthquake. Arrow indicates direction of separation.
-

Relatively small landslide triggered by the Loma Prieta earthquake.
-

Approximate, inferred boundary of large landslide, landslide complex, or possible landslide that moved during the Loma Prieta earthquake.
-
