**GEOMORPHIC AND VEGETATIVE RECOVERY
PROCESSES ALONG MODIFIED
STREAM CHANNELS OF WEST TENNESSEE**

Prepared by the
U.S. GEOLOGICAL SURVEY

in cooperation with the
TENNESSEE DEPARTMENT OF TRANSPORTATION

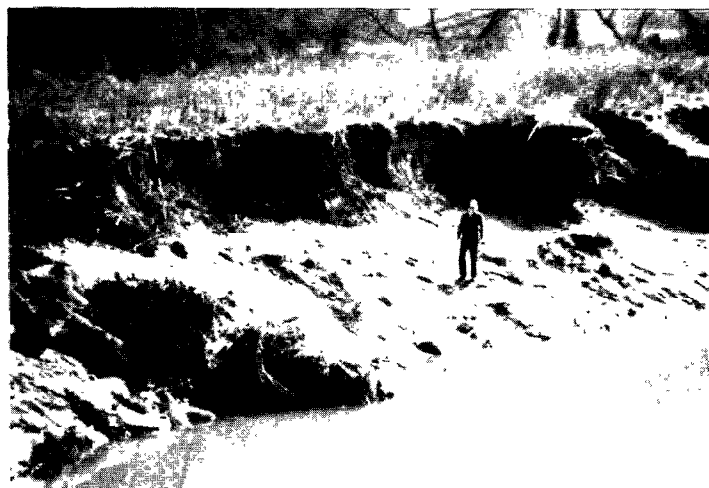
Figure 34.—Typical planar failure, South Fork Obion River (station number 07024550, river mile 11.4, 1984).

top-bank edge along reaches dominated by rotational failures. Banks dominated by planar failures generally do not have a scalloped appearance but can often be identified by sharp breaks in slope between the vertical face and the upper bank (figs. 30 and 34). These failures are the most frequent types of failures on most reaches of the studied streams except for the loess tributaries. This distinction is not clear in all cases and rotational failures share dominance with planar failures in the most degraded reaches just upstream from the AMD.

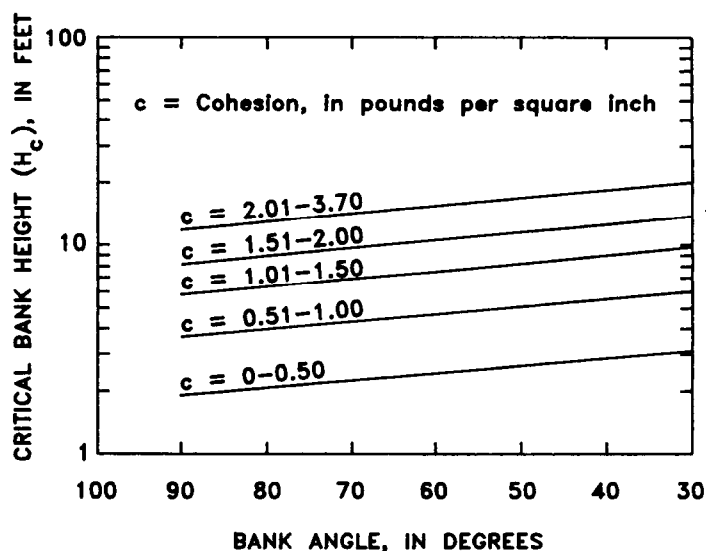
Figure 36.--Critical bank-slope configurations for various ranges of cohesive strengths under saturated conditions.

vertical-saturated bank with a cohesion of 1.75 lbs/in² could support a bank height of no more than 7.6 feet (fig. 36). Similarly, bank instability may be estimated for a site from figure 36 if increases in bank height by bed degradation can be anticipated. Banks at 90-degrees have been undercut fluvially and have been subjected to toe removal.

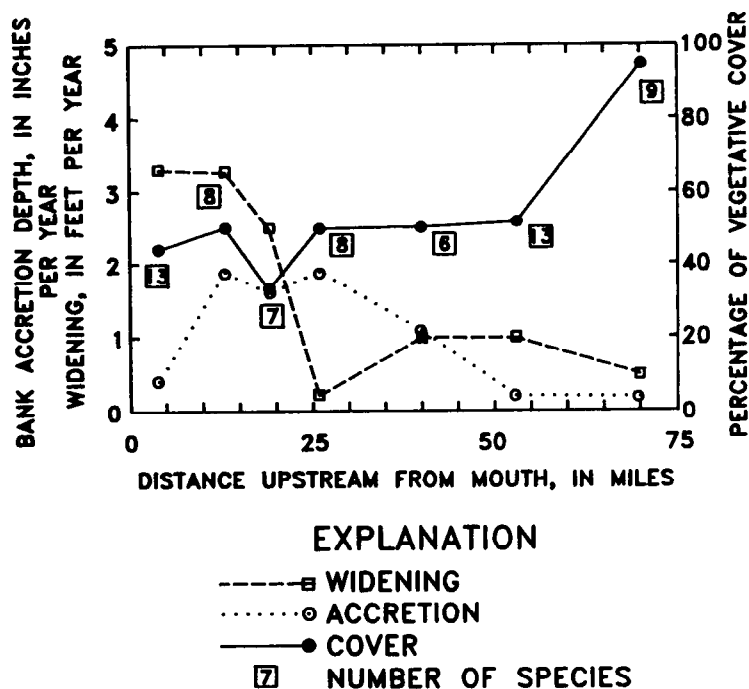
Figure 39.—Channel widening, bank accretion depth, and percentage of vegetative cover at selected locations along the Wolf River,

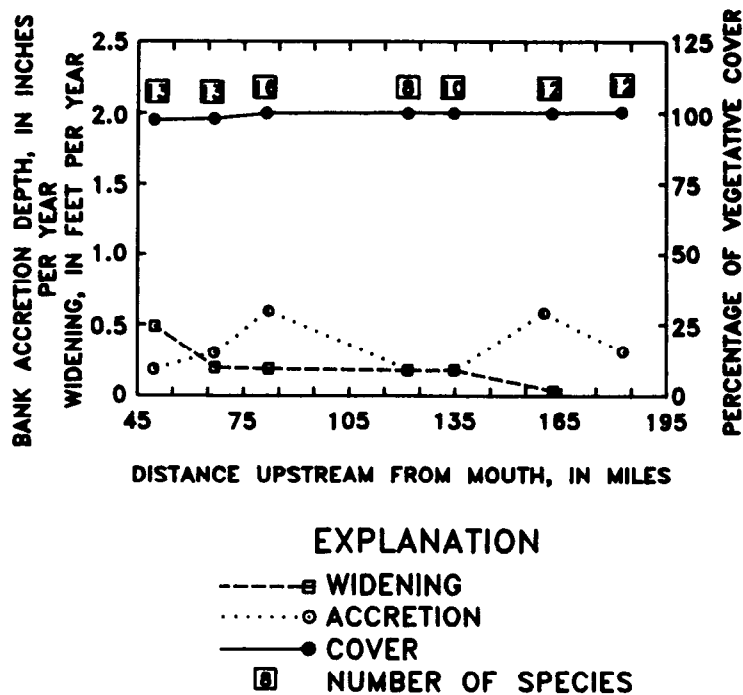
Figure 40.--Channel widening, bank accretion depth, and percentage of vegetative cover at selected locations along the Hatchie River.

The Hatchie River is the study-control stream and has been designated a State scenic river. Bank-widening rates do not exceed 0.6 ft/y, and any widening is due largely to "natural" bank caving through fluvial action on outside bends. The entire length of the Hatchie River is in stage I of the bank-slope development model. Bank heights rarely exceed 4 to 5 feet; cut banks are usually near vertical in cross section while inside point bars have low angles and are highly depositional. Bank accretion is uniform throughout its length, reaching a maximum of 0.5 in/y (fig. 40).

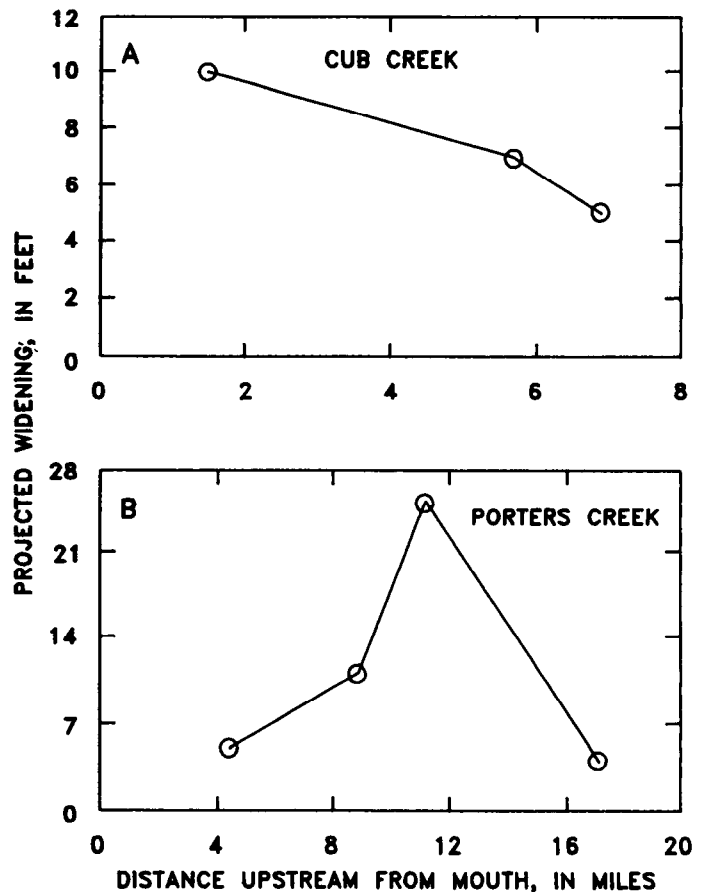
Figure 44.--Projected widening along (A) Cub and (B) Porters Creeks.

Future projected widening on Cub and Porters Creeks ranges from 5 to 42 feet depending on the relative amount of bed-level lowering (fig. 44). Due to the placement of grade-control structures at various times, longitudinal relations with widening are not longitudinally consistent (Simon, in press). These channels have adjusted between the structures at magnitudes commensurate with the changes in gradient that were imposed between the structures (Simon, in press). Like noncontrolled streams, degradation migrates upstream, beginning at the upstream side of each structure. Therefore, downcutting and widening along creeks such as Cub and Porters will be high just downstream of the structure, relatively low just upstream of the structure, and increase with distance upstream of the structure. The site on Porters Creek near RM 12 is a severely degraded reach near the downstream side of a structure. The most downstream reaches are in stage V and would certainly be closer to complete restabilization (stage VI) if not for re-dredging of the lower 1.2 miles of Cub Creek and 3.6 miles of Porters Creek after filling just 2 years after the original channel work.

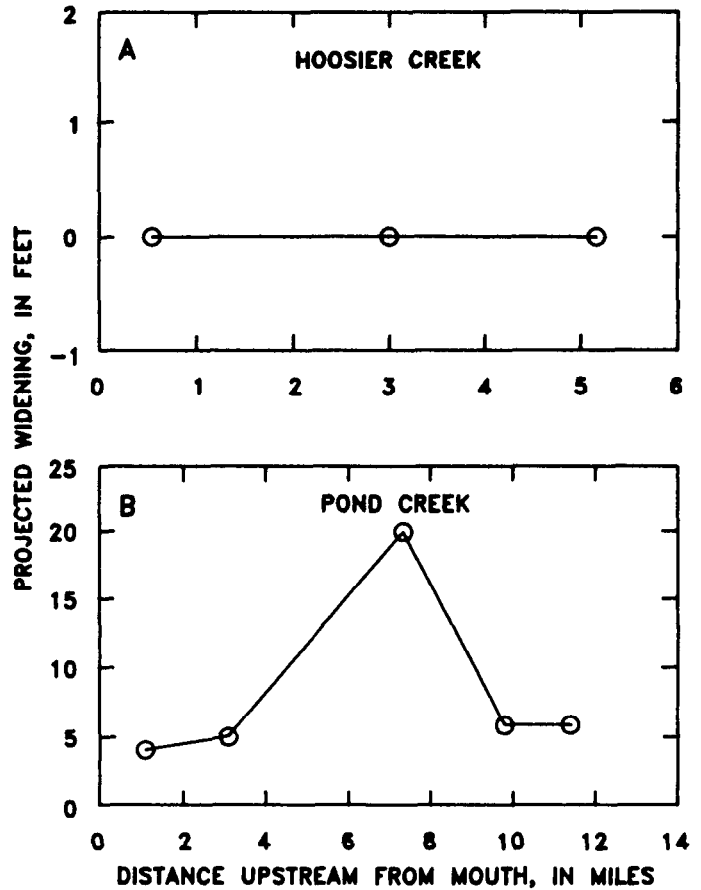
Figure 45.--Projected widening along (A) Hoosier and (B) Pond Creeks.

These loess-bed creeks have strikingly similar material properties (Simon, in press) and show different projected widening trends because of dissimilar modifications. Whereas Hoosier Creek was channelized from its confluence with the North Fork Obion River, Pond Creek (tributary to the North Fork Forked Deer River) was locally dredged by landowners and cleared throughout its length. Like Cane Creek, the banks of Hoosier Creek have been dominated by deep-seated rotational failures since construction of the channel in the mid-1960's. The most downstream reaches of this creek are protected by backwater and, in places where bank angles have been reduced considerably, slough-line surfaces have developed above an inner channel. Top-bank widening has for the most part ceased, after roughly 20 years of widening (fig. 45a).

Pond Creek, also affected by backwater (from the North Fork Forked Deer River) has degraded upstream of some localized disturbances, creating moderately unstable banks. Planar failures appear to be more common than rotational failures. Projected widening ranges from 5 to 20 feet (fig. 45b).
