**KINEMATIC ELEMENTS OF THE ALANI-PATY AND HULU-WOOLSEY
LANDSLIDES IN MANOA VALLEY, HONOLULU, HAWAII**

By
Flex L. Baum and Mark E. Reid

1992

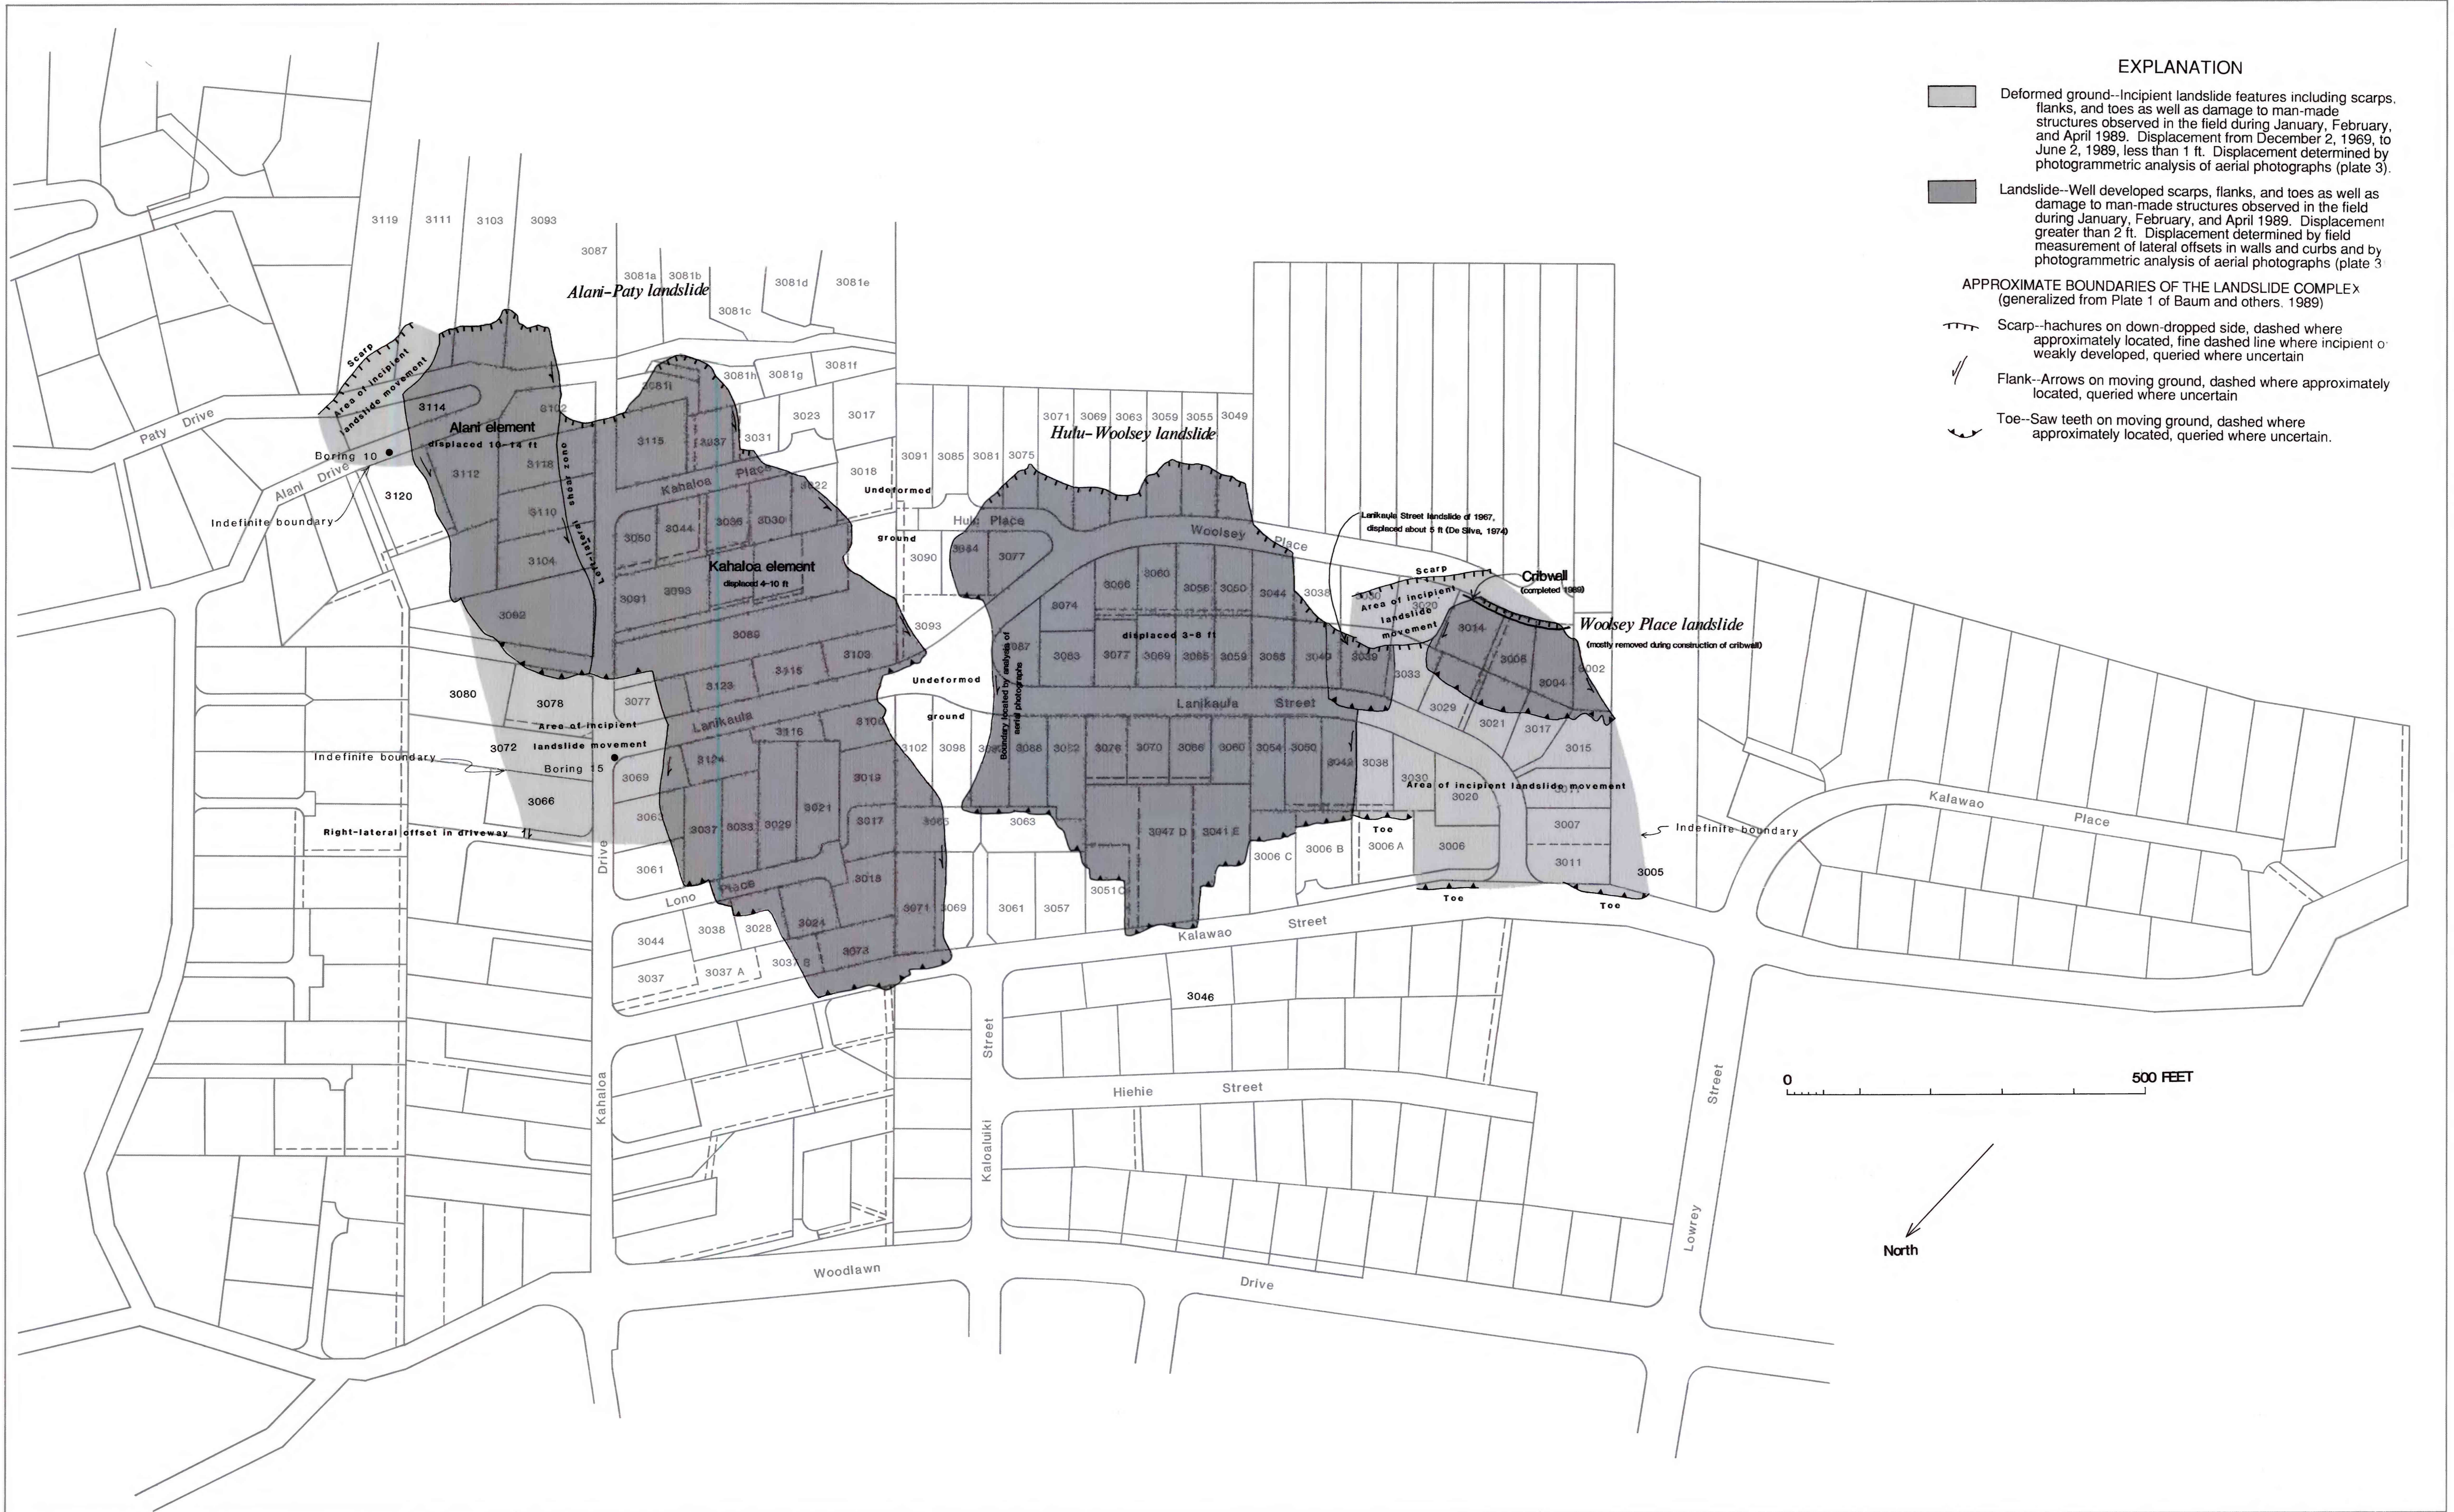
- EXPLANATION**
- Deformed ground--Incipient landslide features including scarps, flanks, and toes as well as damage to man-made structures observed in the field during January, February, and April 1989. Displacement from December 2, 1969, to June 2, 1989, less than 1 ft. Displacement determined by photogrammetric analysis of aerial photographs (plate 3).

- Landslide--Well developed scarps, flanks, and toes as well as damage to man-made structures observed in the field during January, February, and April 1989. Displacement greater than 2 ft. Displacement determined by field measurement of lateral offsets in walls and curbs and by photogrammetric analysis of aerial photographs (plate 3).

- APPROXIMATE BOUNDARIES OF THE LANDSLIDE COMPLEX**
(generalized from Plate 1 of Baum and others, 1989)
- Scarp--hachures on down-dropped side, dashed where approximately located, fine dashed line where incipient or weakly developed, queried where uncertain

- Flank--Arrows on moving ground, dashed where approximately located, queried where uncertain
 - Toe--Saw teeth on moving ground, dashed where approximately located, queried where uncertain.
