U.S. GEOLOGICAL SURVEY

**Description, Origin, and Implications of a Newly Identified
Slumgullion Landslide Deposit, San Juan Mountains,
Southwestern Colorado**

Open-File Report 93-548

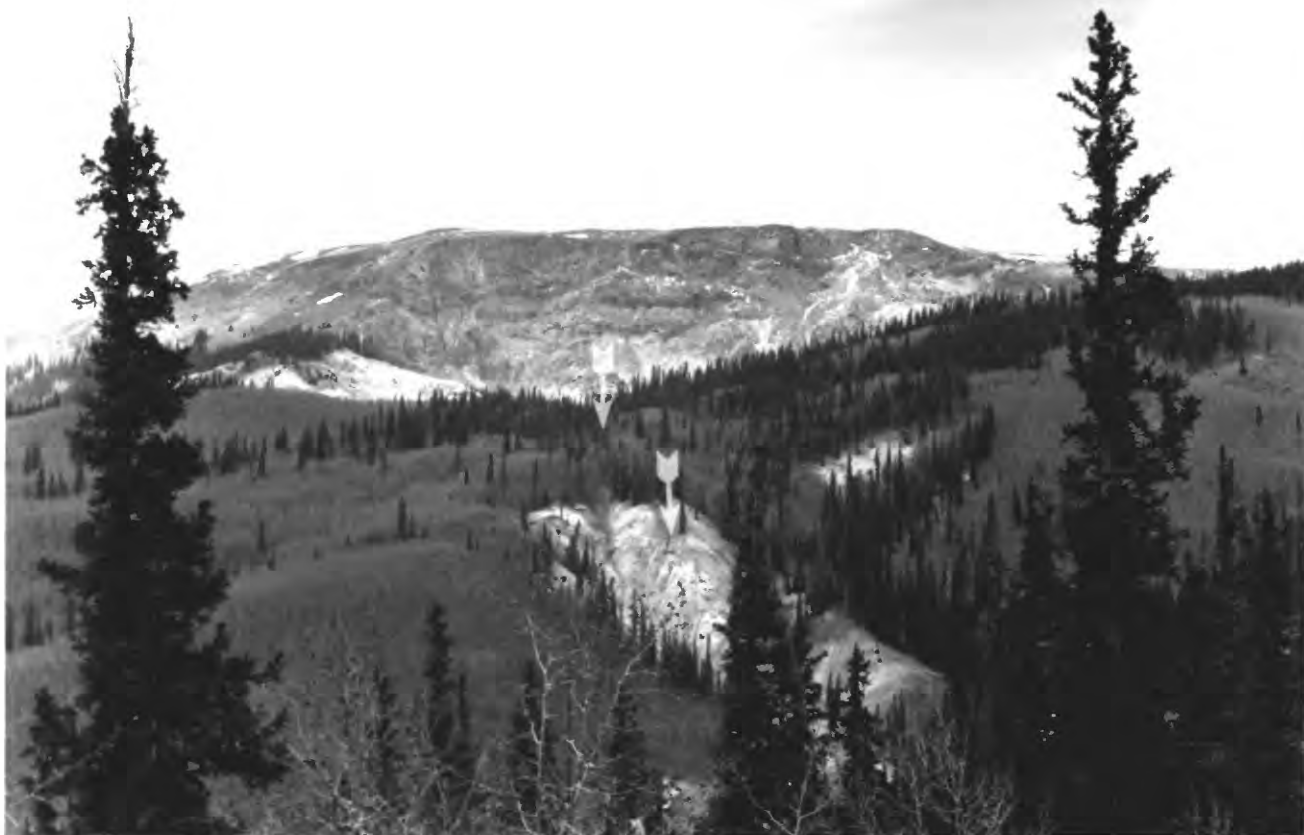
Figure 3.--Panoramic view (looking north) of the area of the newly identified landslide deposit (middle foreground). Arrows point to the exposed lower part of the deposit and the tree covered, hummocky upper part. The 250-m-(820-ft)-high headwall of the Slumgullion landslide is in the background. Photograph was taken from Windy Point Overlook located approximately 0.8 km (0.5 mi) south of the deposit (fig. 1).

Much of the upper surface of the deposit is covered by vegetation that obscures the underlying landslide material (fig. 3). However, patches of mostly pale yellow (2.5Y 8/6) to yellow (10YR 7/8), stoney, clay-rich landslide debris are visible at a few upper surface locations. In addition, exposures of concentrated rock debris that are somewhat elongate in the downslope direction and are composed of boulders or blocks of volcanic rock having a maximum dimension of about 2 m (6 ft) are present at two locations on the upper part of the deposit (figs. 2 and 4). The concentrations of rock debris are generally similar in shape, composition, and orientation with respect to direction of landslide movement as groupings of rock debris on the main body of the Slumgullion landslide reported by previous investigators (Parise and Guzzi, 1992).

The southern fork or branch of the lower end of the landslide deposit, below elevation 3,340 m (10,960 ft), is steep and nearly barren of vegetation (fig. 3). The material in that part of the deposit is mostly white (2.5Y 8/2) to pale yellow (2.5Y 8/4) and yellow (10YR 7/8), clay-rich debris with scattered stones or blocks of volcanic rock of various sizes and shapes and some buried tree parts and wood fragments. A partly buried log (fig. 5) at an elevation of approximately 3,290 m (10,800 ft) was sampled for radiocarbon dating.

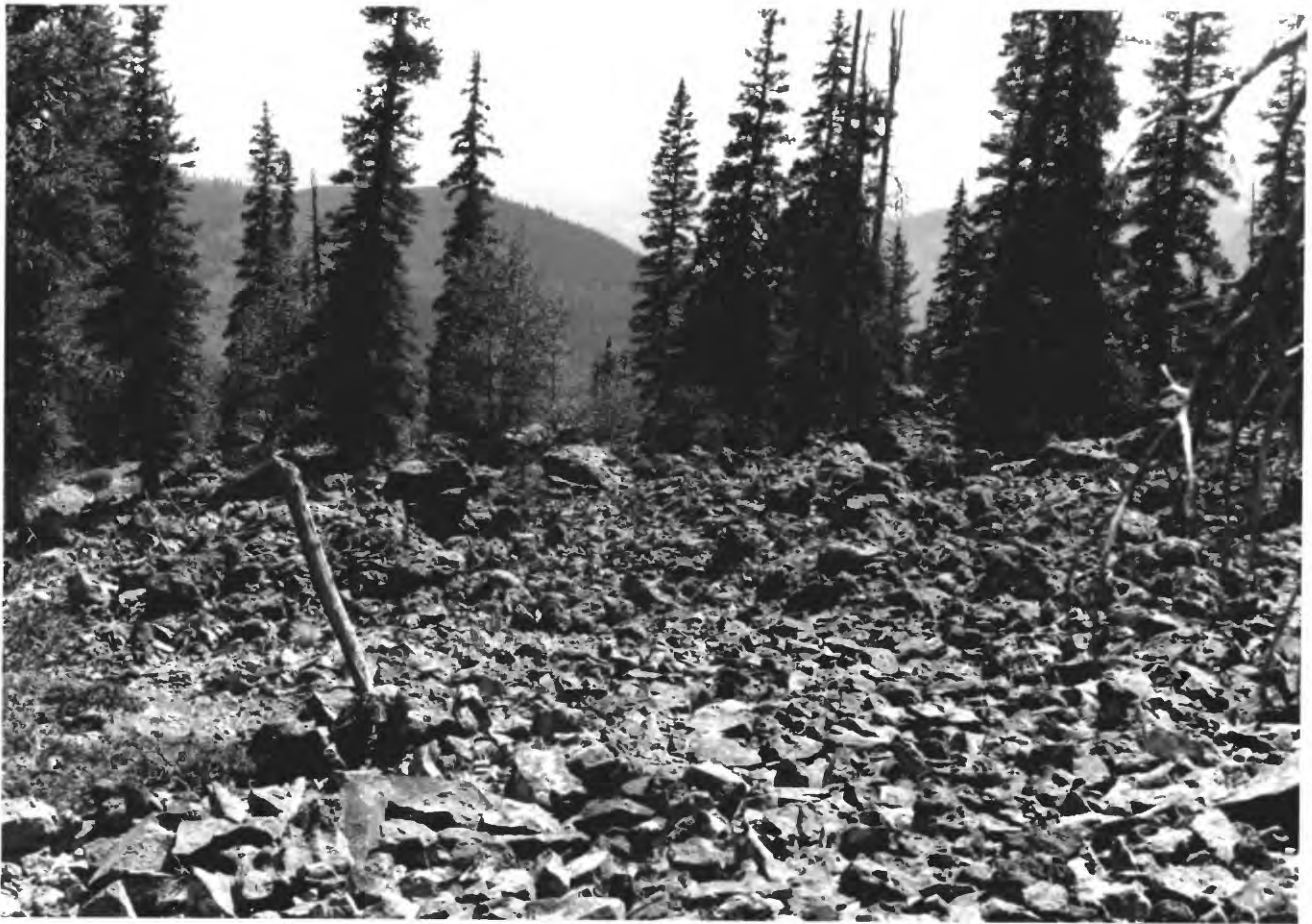
Figure 4.--Area of concentrated rock debris located on the upper part of the newly identified landslide deposit. View is to the southwest.

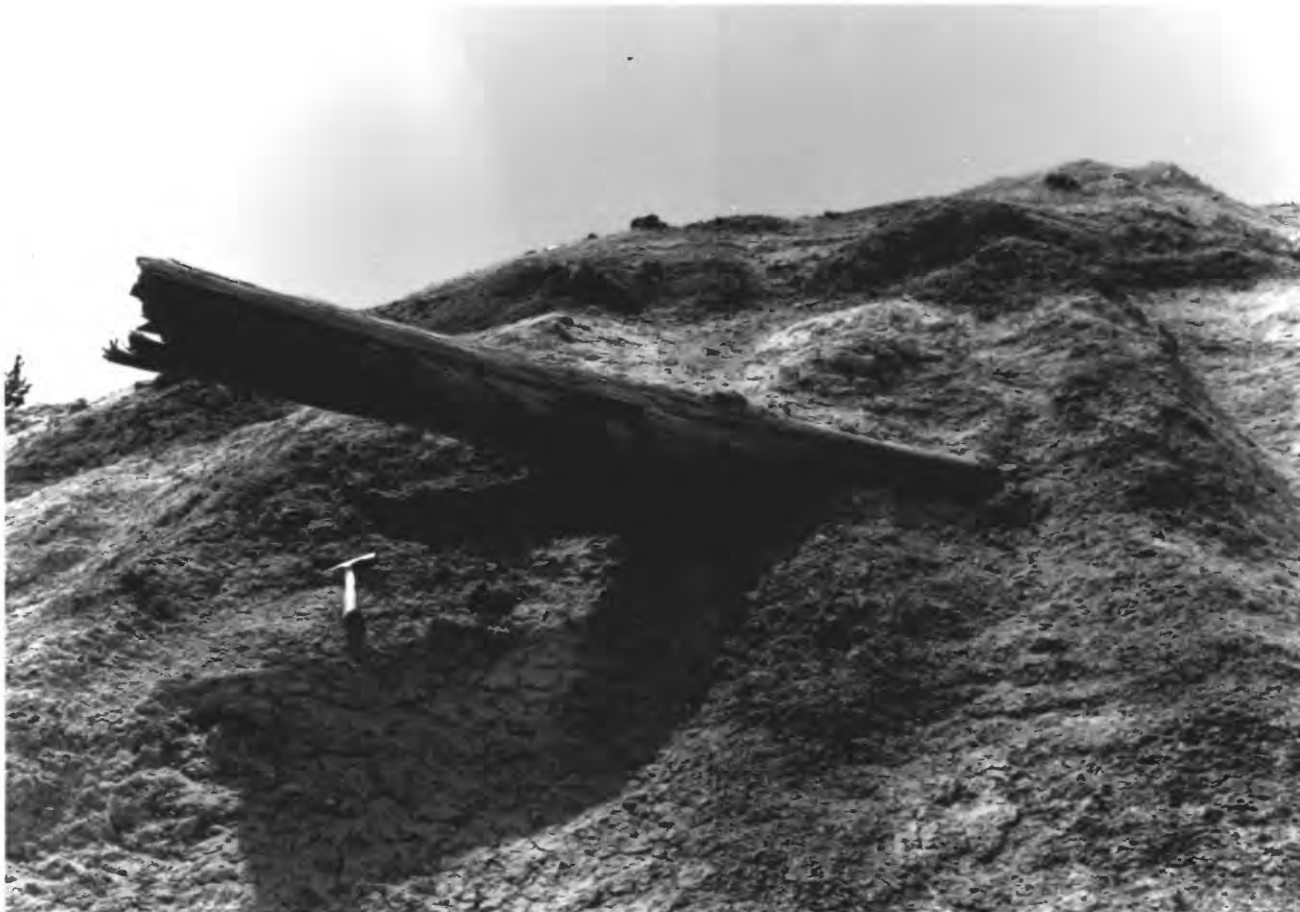
Figure 5.--Photograph of partly buried log at an elevation of about 3,290 m (10,800 ft) on the nearly barren lower part of the newly identified landslide deposit. The log was sampled for radiocarbon dating.

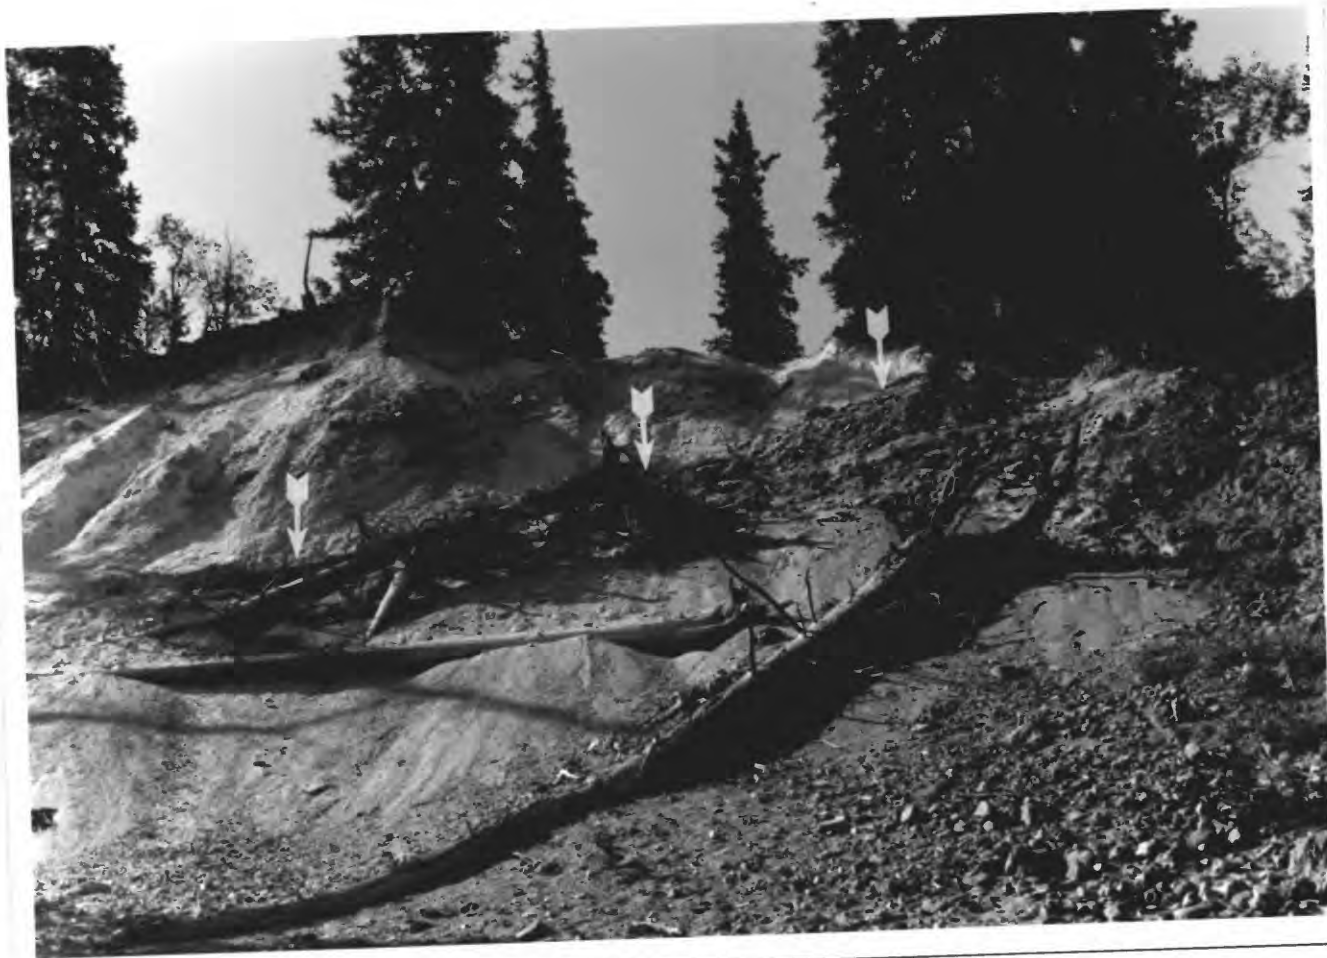
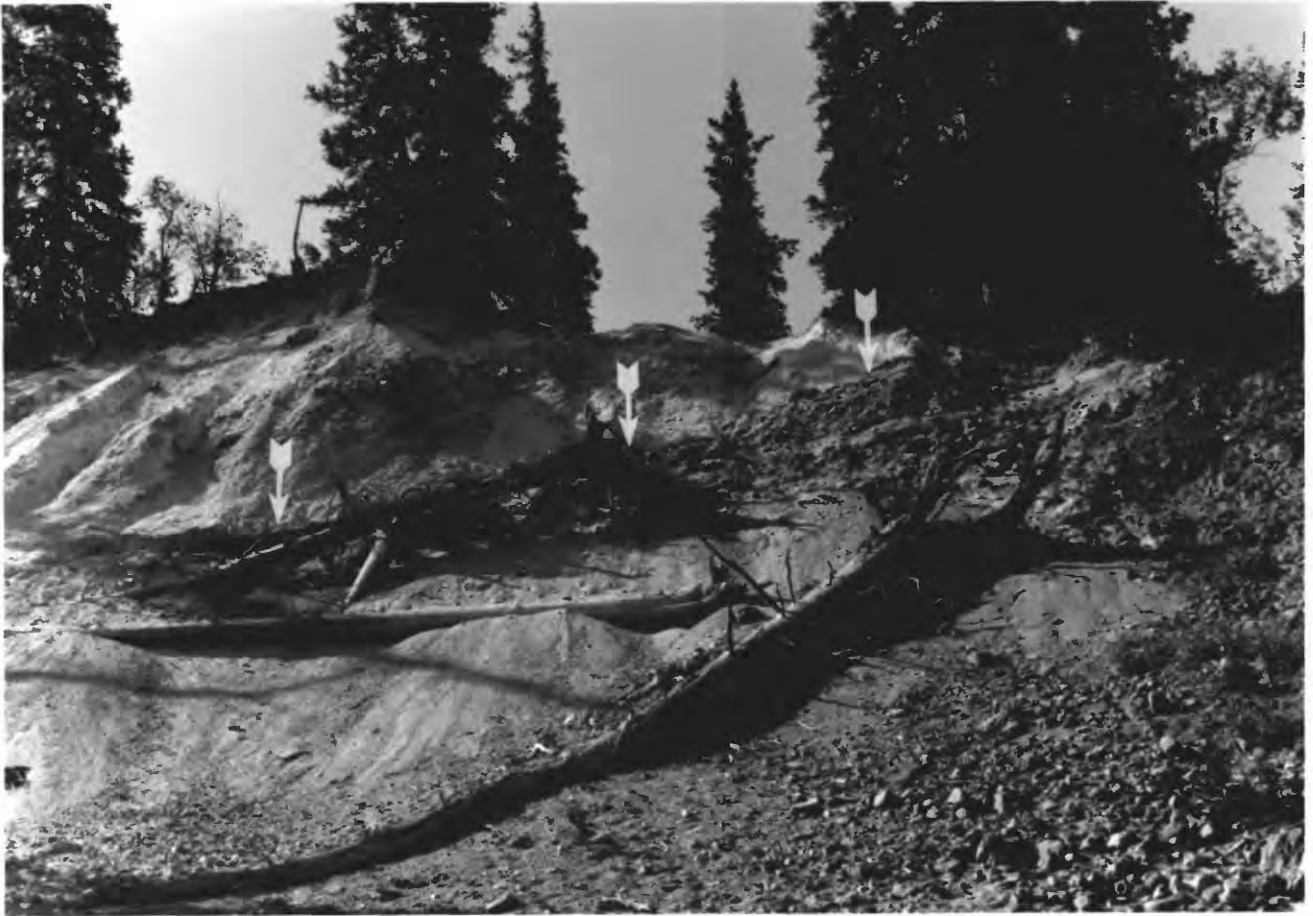
Figure 6.--View (looking south) of the truncated northwest corner of the newly identified landslide deposit. Arrows mark the basal contact.

A basal contact was exposed at the truncated northwest corner of the deposit by removing a thin layer of landslide-debris-derived colluvium from the scarp face (fig. 6). The exposure, 15 m (50 ft) long from east to west, revealed a sharp, gently undulating contact between a brown (10YR 5/3) to dark-brown (10YR 3/3) stoney colluvium and overlying, mostly white (2.5Y 8/2) to pale yellow (2.5Y 8/4), clay-rich, landslide debris (fig. 7). The buried surface of dark, stoney colluvium is continuous with the present surface located at the top of the scarp west of the northwest corner of the landslide. Because of the contrast between the light-colored landslide debris and dark colluvium, it is readily apparent that little or no

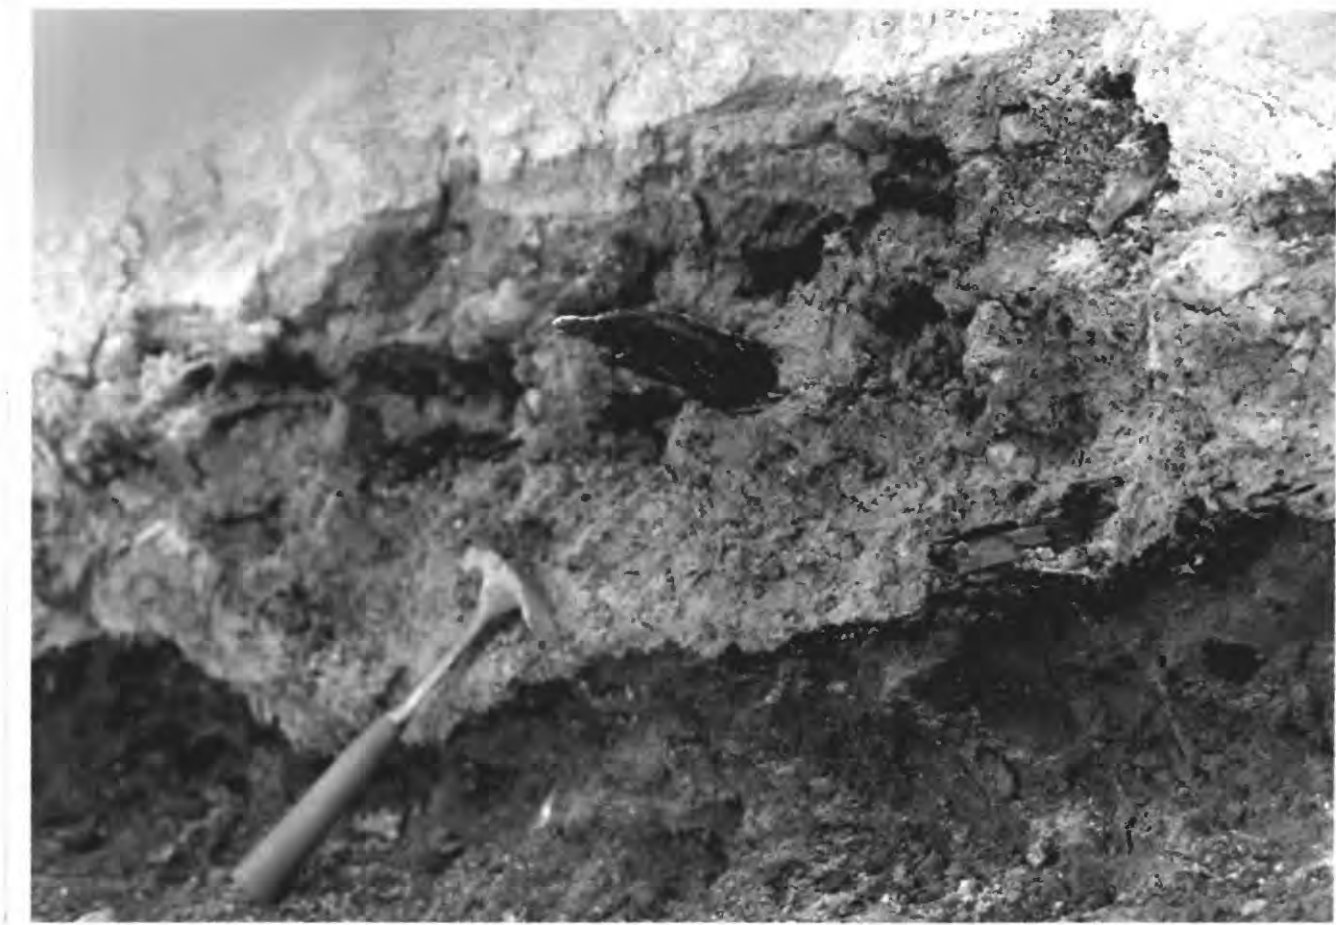
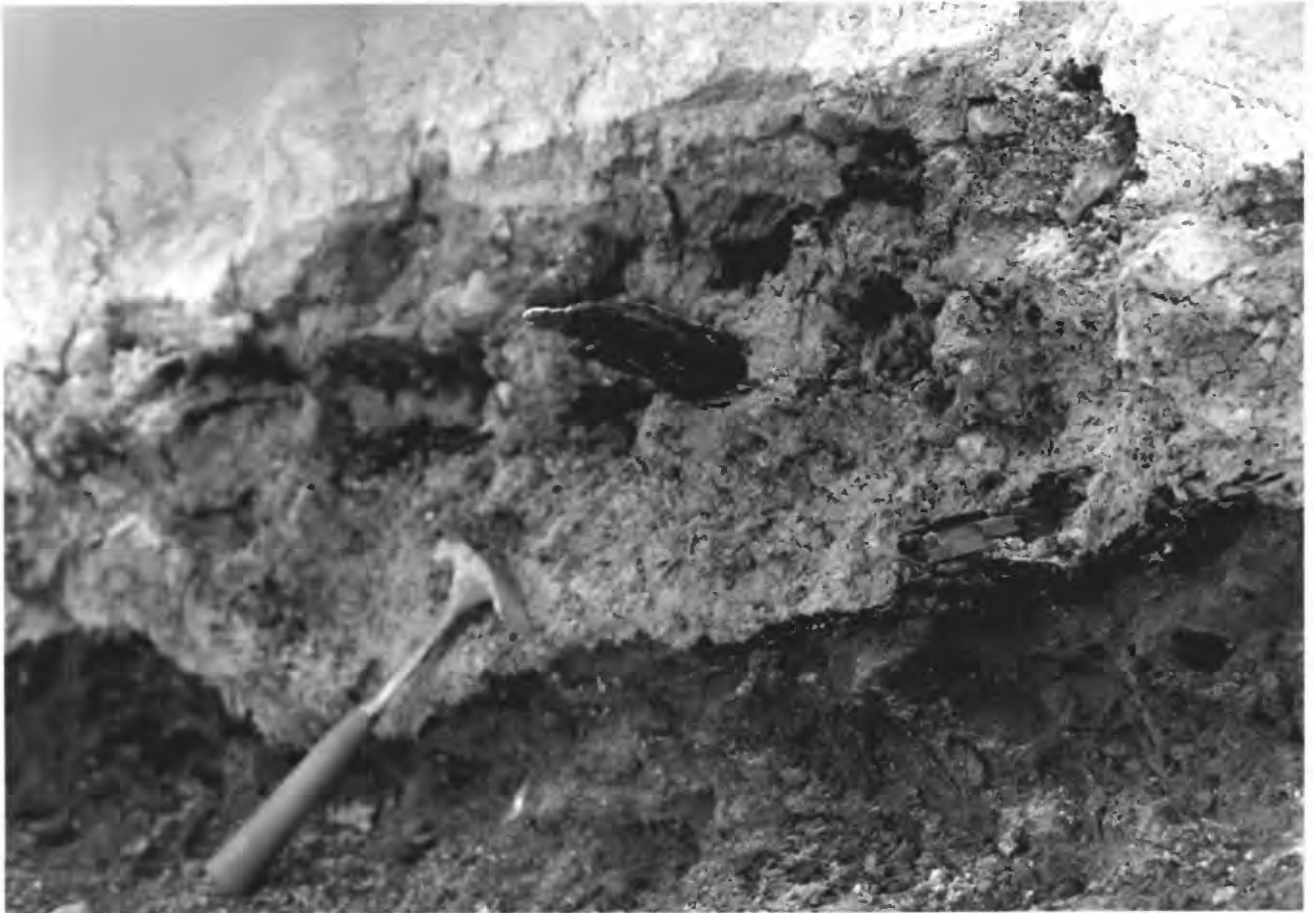
Figure 7.--Photograph showing sharp contact between landslide debris and underlying colluvium. Abundant wood fragments are present in the clay-rich landslide debris in a 0.3 m (1 ft) zone above the contact.

mixing or churning of the two materials resulted from emplacement of landslide debris. In addition, there is a notable absence of slickensides or other structure that would indicate basal shearing in the zone of contact. Wood fragments, in various states of decomposition, are abundant in the landslide debris in a 0.3-m-(1-ft)-wide zone above the contact. Nearly all of the wood fragments in the landslide debris are oriented parallel or subparallel to the contact. Wood from the debris was sampled for future radiocarbon dating. A thin layer of dark-brown, decomposed organic material is present at the top of the buried surface that, in most places, is less than 2 cm (1 in) thick. A few wood fragments, interpreted as decomposing roots, were visible in the buried colluvium a few centimeters below the contact. Further excavation of the contact to the east was prevented by deeper, unstable colluvium on the steep scarp face.
