THE SUNDANCE FAULT: A NEWLY RECOGNIZED SHEAR ZONE AT YUCCA MOUNTAIN, NEVADA

U.S. GEOLOGICAL SURVEY

Open-File Report 94-49

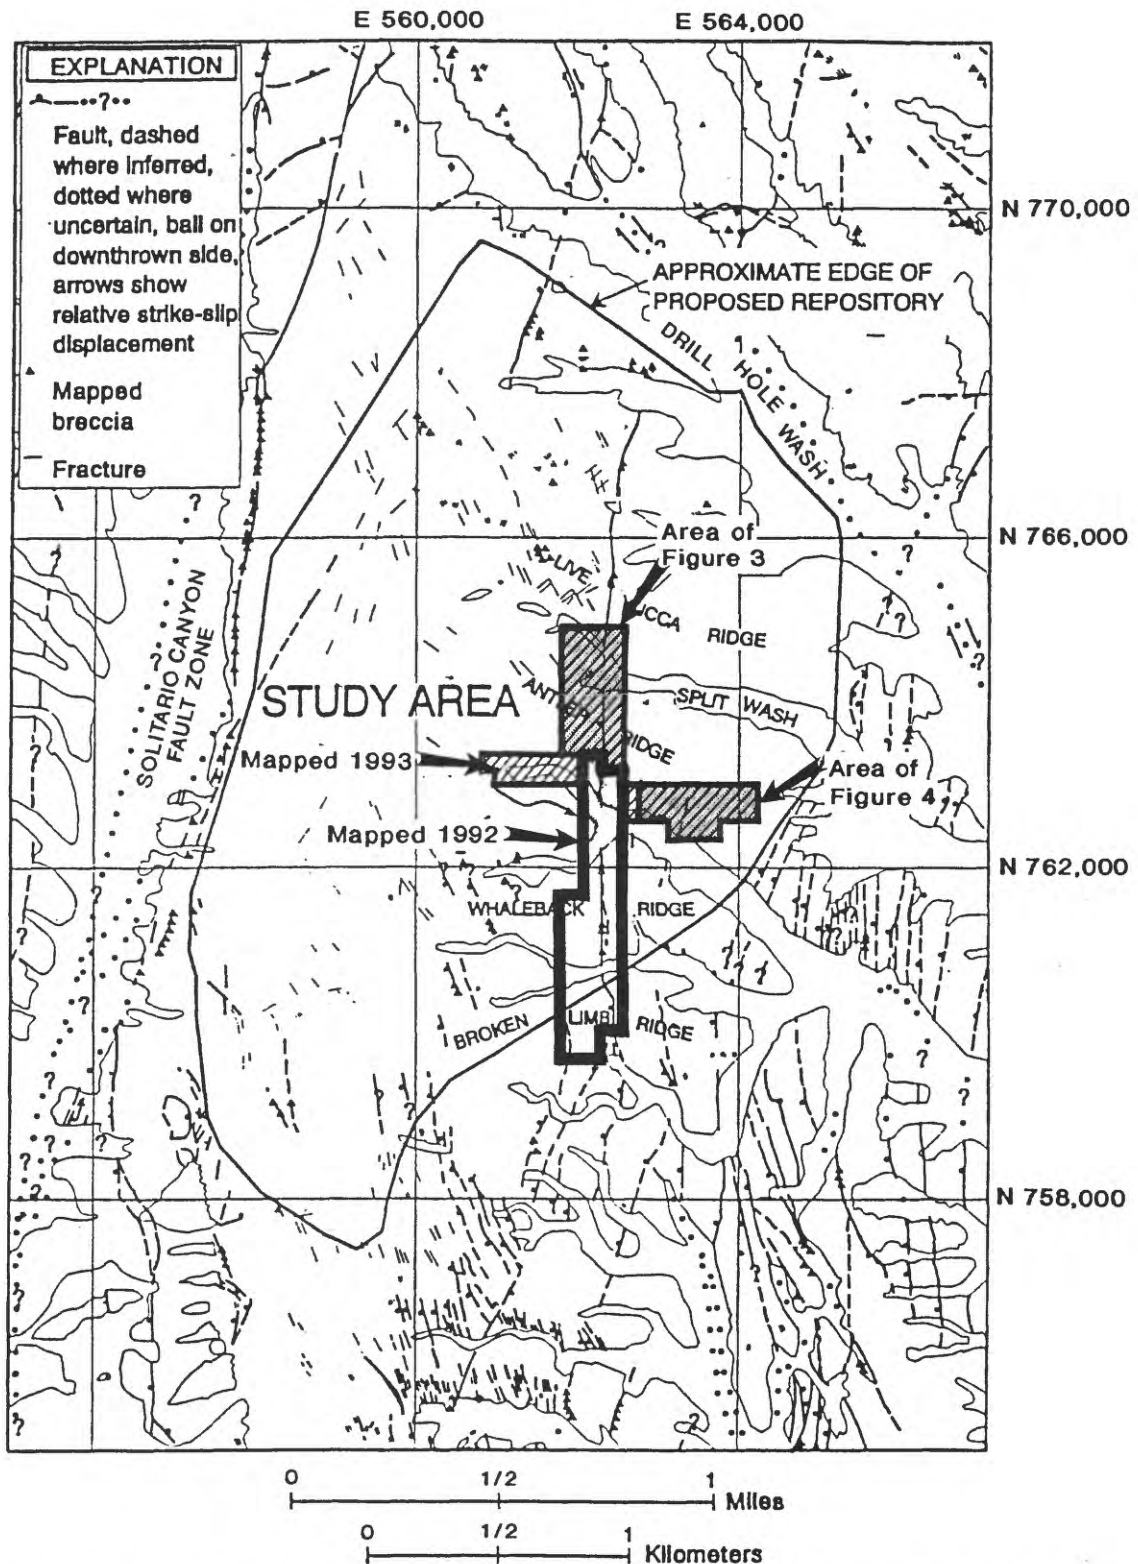
Figure 1.--Map of Yucca Mountain showing the distribution of structural features within and surrounding the proposed repository area and the location of study areas along the southern and central parts of the Ghost Dance fault (structural features from Scott and Bonk, 1984). Nevada State Coordinates are shown in feet.

faults extend northward well into the proposed repository but details of their character have not been studied (fig. 1). This paper summarizes salient structural features that have been identified from detailed field mapping of parts of the central structural domain.

Northward progression of our structural mapping has led to the recognition of numerous northwest and northeast trending structures north of Whale Back Ridge (fig. 1). Most of these structures indicate apparent offsets of lithostratigraphic units of the Tiva Canyon Tuff by only a few meters. However, geometrical relations of many diffusely spaced northeast- and northwest-trending faults are incompletely understood.

A conspicuous variation in structural style appears to occur north of Antler Ridge and along the southeastern flank of Antler Ridge, which suggests the existence of a previously unrecognized shear zone. The existence and character of this shear zone are based on the appearance of the following structural complexities: 1) abrupt increase in northeastward dip of foliation in lithostratigraphic units, 2) closely spaced northwest-trending shears with apparent right lateral separation, 3) intensely brecciated rock in close proximity to northwest-trending fractures, 4) abrupt decrease in vertical separation along the Ghost Dance fault, and 5) apparent right lateral offset of the Ghost Dance fault system. These field observations have been documented at three critical but isolated exposures along the northern flank of Antler Ridge, along southern flank of Live Yucca Ridge, and along the southeastern flank of Antler Ridge (fig. 1, 3, 4).

North of Split Wash a conspicuous and abrupt change in structural style occurs. Along the south-facing slope of Live Yucca Ridge (fig. 1, 3), we have mapped numerous parallel N30°-40°W-striking structures, many of which are spaced 5 to 10 m (16 and 33 ft) apart and commonly show less than a few meters of right (or) east-side-down separation of lithostratigraphic contacts. Simple geometric considerations suggest that right slip on northwest-trending faults in an area of gentle eastward dips should result in left separation of contacts along south-facing slopes, which are steeper than the dips. The right separation seen along Live Yucca Ridge (and at some places to the south) may be due to local variations in attitudes of lithostratigraphic units and (or) by a vertical component of slip. Within the Ghost Dance fault system, where lithostratigraphic units are nearly horizontal, near-horizontal fault slip can produce variable outcrop patterns depending on local variations in slip line, attitudes of lithostratigraphic units and topography. Alternatively, some offsets, mapped in poorly exposed areas, may be related to slope movements or zonal variations within the Tiva Canyon Tuff.

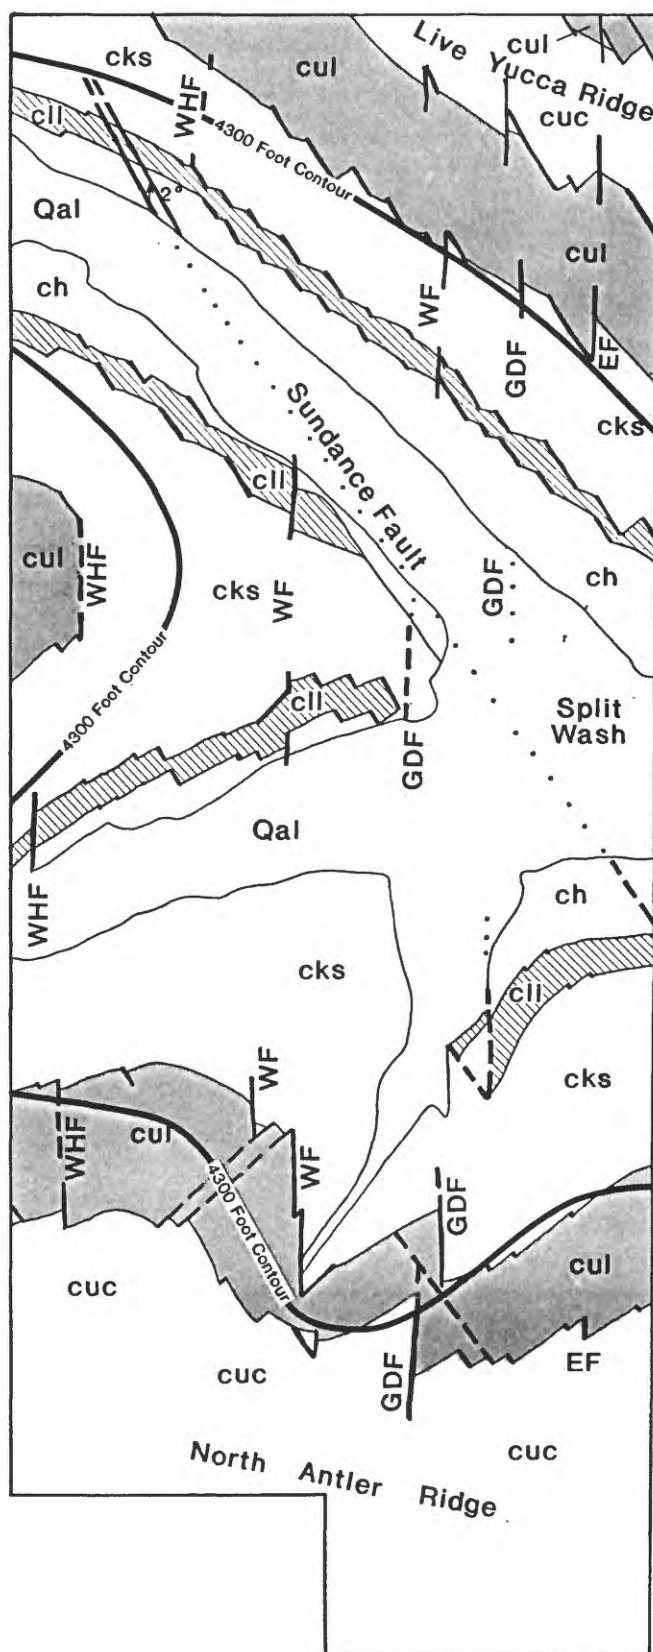
Figure 3.--Generalized geologic map of the Split Wash area showing offset of lithostratigraphic units along the Ghost Dance fault and Sundance fault systems.

Mapping of a 244-m (800-ft)-wide area from the southern flank to the northern flank of Antler Ridge reveals a gradual increase in structural complexity (fig. 3). Small-scale northwest- and northeast-trending faults increase in abundance. For the most part, the north-trending faults are traceable northward, maintaining a similar horizontal spacing and vertical separation as mapped to the south. From the south side of Antler Ridge to the north side of Antler Ridge, a distance of about 168 m (550 ft), vertical separation of lithostratigraphic units along the Ghost Dance fault is relatively uniform, varying from 15 to 12 m (50 to 40 ft). However, the high-angle Ghost Dance fault is offset in an apparent right lateral sense by about 15 m (50 ft) along an inferred northwest-trending shear (fig. 3).

The West Hinge, Ghost Dance, and East faults maintain a similar relative horizontal spacing on Live Yucca Ridge as seen to the south. The spacing between the West fault and Ghost Dance fault decreases slightly north of Split Wash. Some of the north-trending structures along Live Yucca Ridge appear to break into left-stepping segments connected by short northwest-trending breccia zones. These deflections from a northerly strike may be due to preexisting northwest-trending structures. However, the locations of identifiable north-trending faults within the Ghost Dance fault system along Live Yucca Ridge suggest an apparent right lateral offset of about 52 m (170 ft) relative to northern Antler Ridge (fig. 3).

A set of the high-angle N30°W fractures, dipping 85° to 90° to the southwest, is well exposed at drainage level along Split Wash and extends northwestward for several tens of meters along the south slope of Live Yucca Ridge (fig. 3). A breccia zone, 1 m (3 ft) wide, as well as slickensides with a rake of about 2° to the northwest were also found at this exposure. Some fracture surfaces display subtle mullion structures, suggesting a smoother fracture surface in a near-horizontal direction. Internal layering within the clinkstone unit is well developed at this

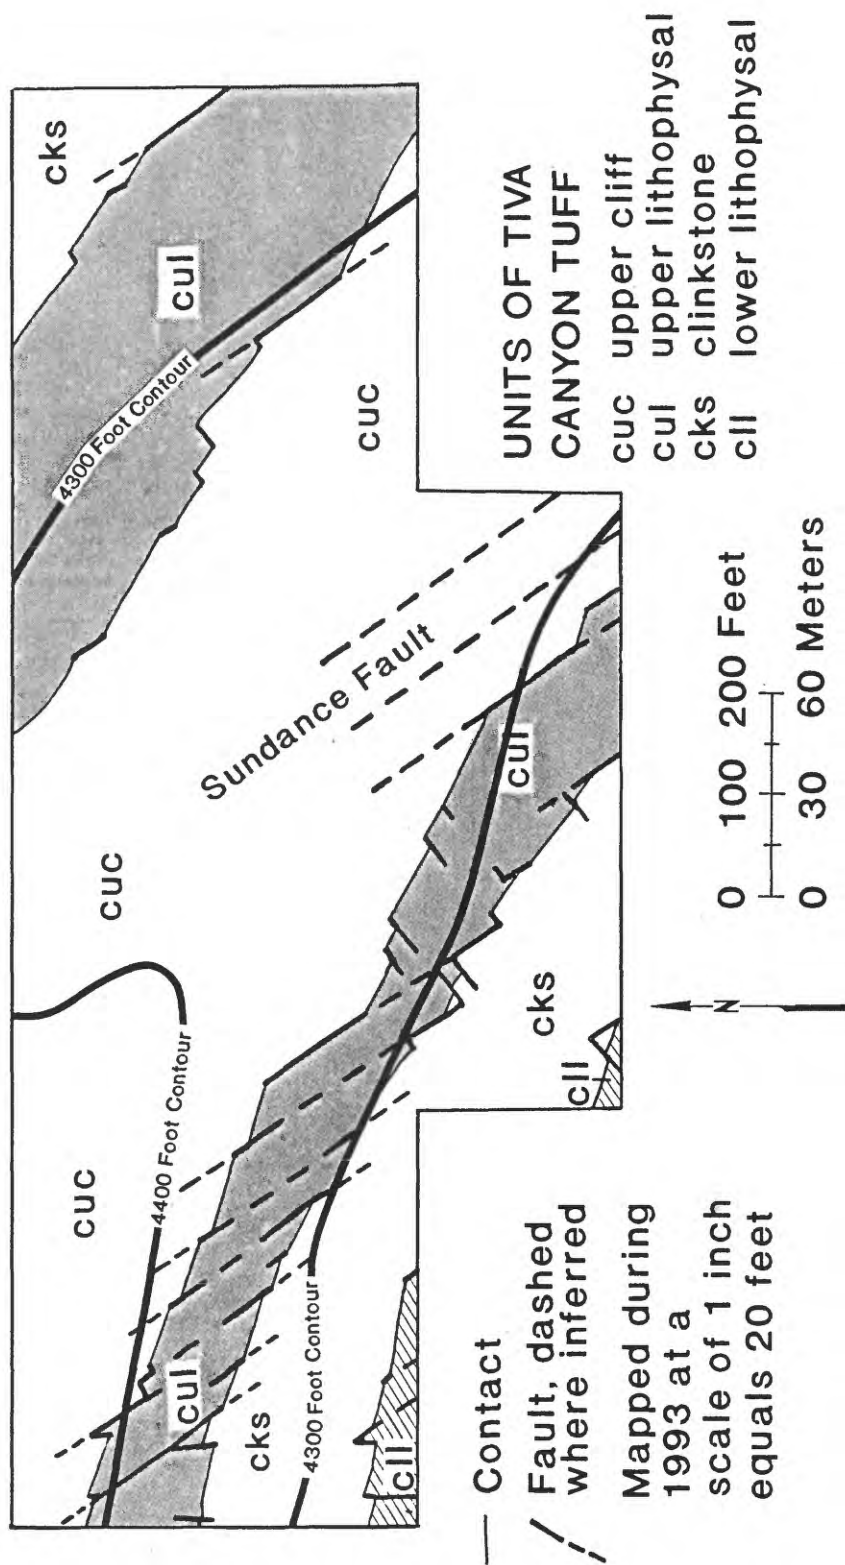
Figure 4.--Generalized geologic map of the eastern part of Antler Ridge showing offset of lithostratigraphic units along the Sundance fault.

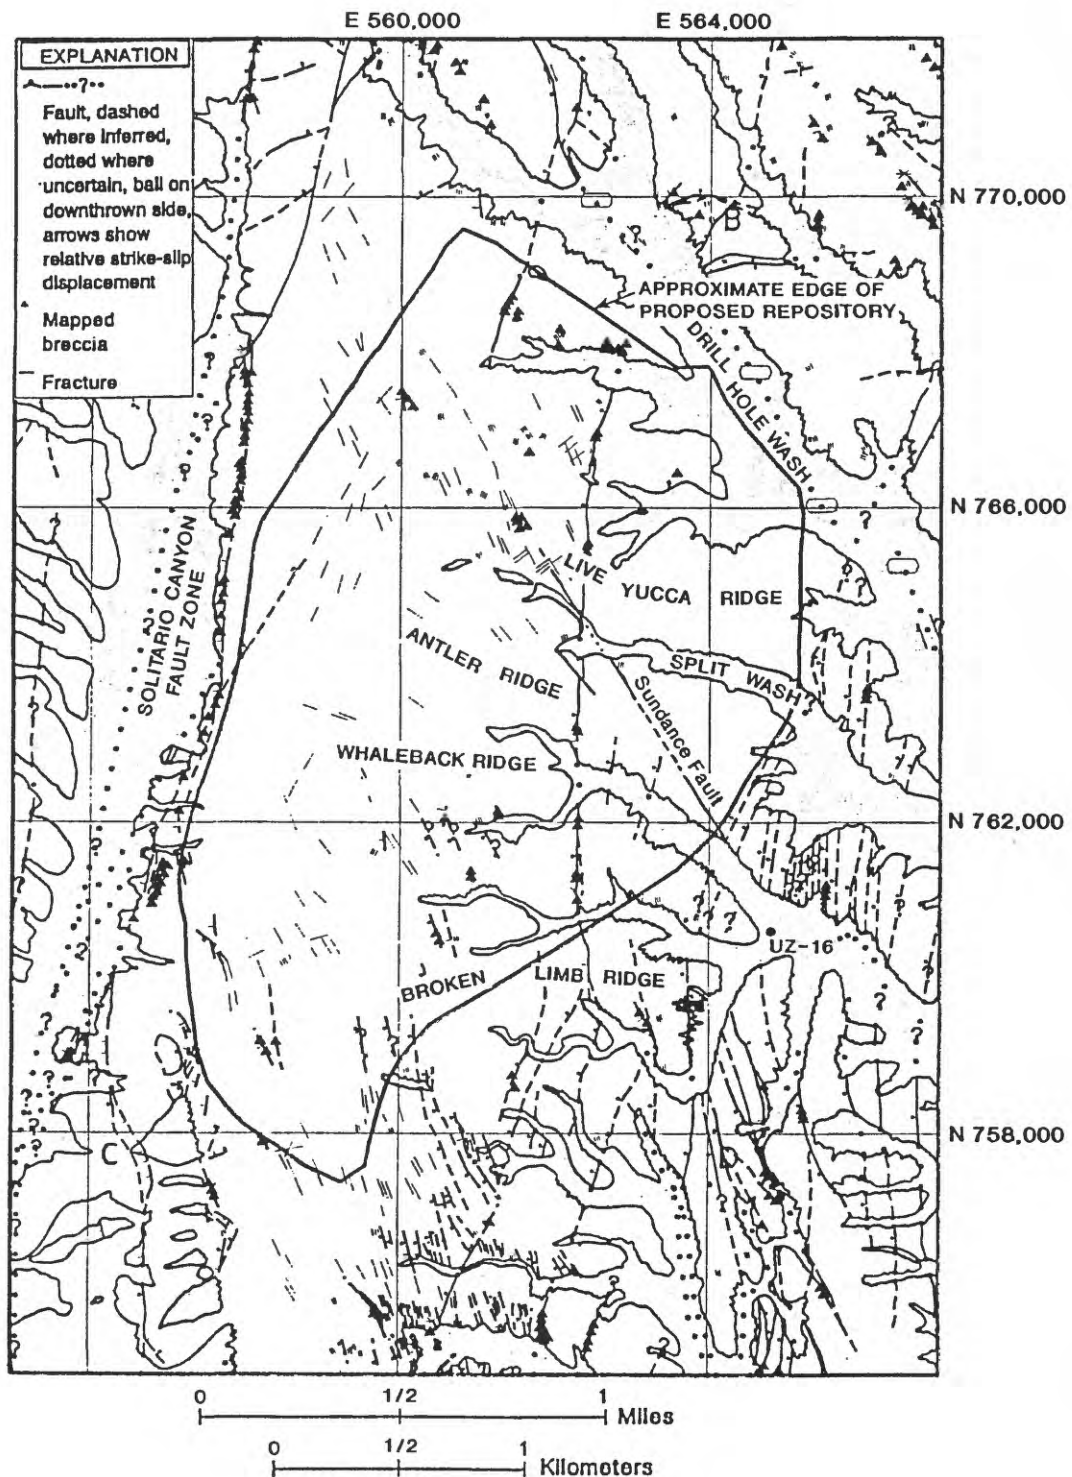
Figure 5.--Map of Yucca Mountain showing the location of the Sundance Fault relative to structural features mapped by Scott and Bonk (1984), and location of USW UZ-16 drill hole.

The uppermost part of the upper cliff unit of the Tiva Canyon Tuff commonly forms a ridge-capping cliff several meters thick over much of Yucca Mountain. This cliff is conspicuously absent along the ridge crest of Antler Ridge directly northwest of drill hole USW UZ-16. Close examination of exposures of the upper cliff unit indicate that it is about 14 m (45 ft) thick to the west and about 23 m (75 ft) thick to the east of this geomorphic feature. Measurement of foliation attitudes in the upper cliff unit along the crest of Antler Ridge indicates an attitude of about N20° W 3°NE directly below this geomorphic feature, which increases to about N40°W 15°NE east of the feature. Mapping along the south-facing slope of Antler Ridge directly below the geomorphic anomaly indicates the presence of multiple apparent right separations of the contact between the upper cliff and the upper lithophysal units (fig. 4). Although this locality is poorly exposed and no discrete fault planes are observable, more than ten apparent right separations of contacts, commonly spaced 15 to 20 m (49 to 66 ft) apart, have been documented within a zone that is at least 274-m (900-ft) wide and trends in a N30°-40°W direction. These apparent right lateral separations in an area of anomalous northeasterly dips of foliation are consistent with right lateral offsets and suggest an apparent cumulative right separation of as much as 107 m (350 ft; fig. 4). Alternatively, map patterns may suggest anomalous down-to-the-east displacements. On the basis of reconnaissance mapping, this structurally disrupted zone has been traced southeastward to the base of exposures at Antler Ridge. In the area directly south of drill hole USW UZ-16 numerous northwest-trending structures and (or) conspicuous lineaments have been mapped by Scott and Bonk (1984; fig.5).

brecciated rock (initially identified by Scott and Bonk (1984); fig. 5), our detailed mapping, and reconnaissance observations made outside of our mapped area, this zone appears to extend northwestward across the potential repository area. To the southeast, the Sundance fault system appears to project into a conspicuous set of northwest-trending faults that occurs directly southeast of the southeastern margin of the potential repository area (fig. 5). If these previously mapped structural features are the northwestern and southeastern extensions of this same northwest-trending system, it may extend over a distance of at least 3 km (1.9 mi, fig. 5).
