FINAL REPORT: ACOUSTIC MAPPING OF DREDGED MATERIAL DISPOSAL SITES
AND DEPOSITS IN MAMALA BAY, HONOLULU, HAWAII

Open-File Report 95-17

**Department of the Interior
U.S. Geological Survey**

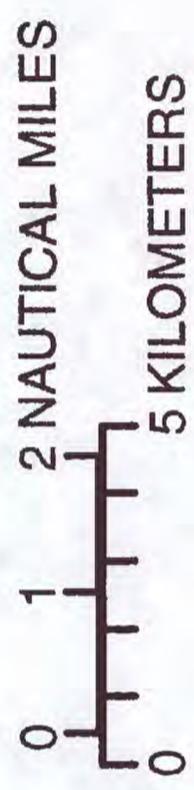
FIGURE 2

- Figure 1. Location map showing the Hawaiian islands and the five active dredged material disposal sites.
- Figure 2. Location map of Mamala Bay showing disposal sites and general bathymetry. Isobaths in meters. Areas marked “CE Study Sites” are alternative disposal sites examined by the COE during the 1977–1978 designation process for the South Oahu site.

Figure 2 shows the location of three major disposal sites in Mamala Bay (the former Pearl Harbor site, the former Honolulu Harbor site, the active South Oahu site), two U.S. Army Corps of Engineers study sites used as part of the process for designating the South Oahu site in 1980 (U.S. Environmental Protection Agency, 1980) and the 1972 disposal site. The South Oahu disposal site, located offshore of Honolulu, Hawaii, in Mamala Bay (figure 2), receives the most dredged material and currently serves Pearl, Honolulu, and Barbers Point Harbors. From 1959 through 1978 disposal sites in Mamala Bay received about 5.3 million m³ of dredged materials from both Pearl and Honolulu Harbors (U.S. Environmental Protection Agency, 1980, table 3-4). Of that total, Pearl Harbor accounts for about 87% (4.7 million m³) while Honolulu Harbor generated the remaining 13% (0.6 million m³) of the dredged material (Goeggel, 1978; EPA, 1980, table 3-14). In comparison to all Hawaiian Island disposal sites, the South Oahu site receives the overwhelming majority of dredged material, and may approach 90%. For example, in the 1977-1978 dredging cycle each Hawaiian harbor was dredged, and all five Hawaiian disposal sites were used. Of the total amount of dredged material disposed of in 1977-1978 (about 2.1 million m³), 71% (1.47 million m³) originated from Pearl Harbor, and 17% (0.35 million m³) was dredged from Honolulu Harbor, totaling 88% (Tetra Tech, 1977; Goeggel, 1978; U.S. Environmental Protection Agency, 1980). The remaining 12% (0.26 million m³) of dredged material was
